# Mount Pleasant Municipal Airport

## Pavement Management Report

**JULY 2024**

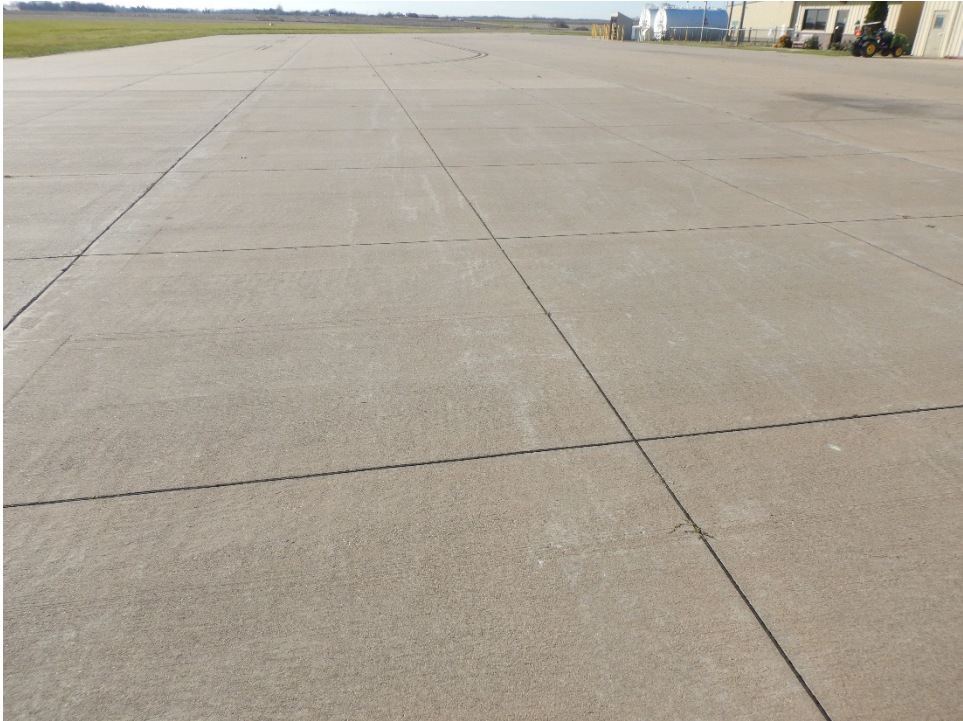
A02MP-01. Overview.

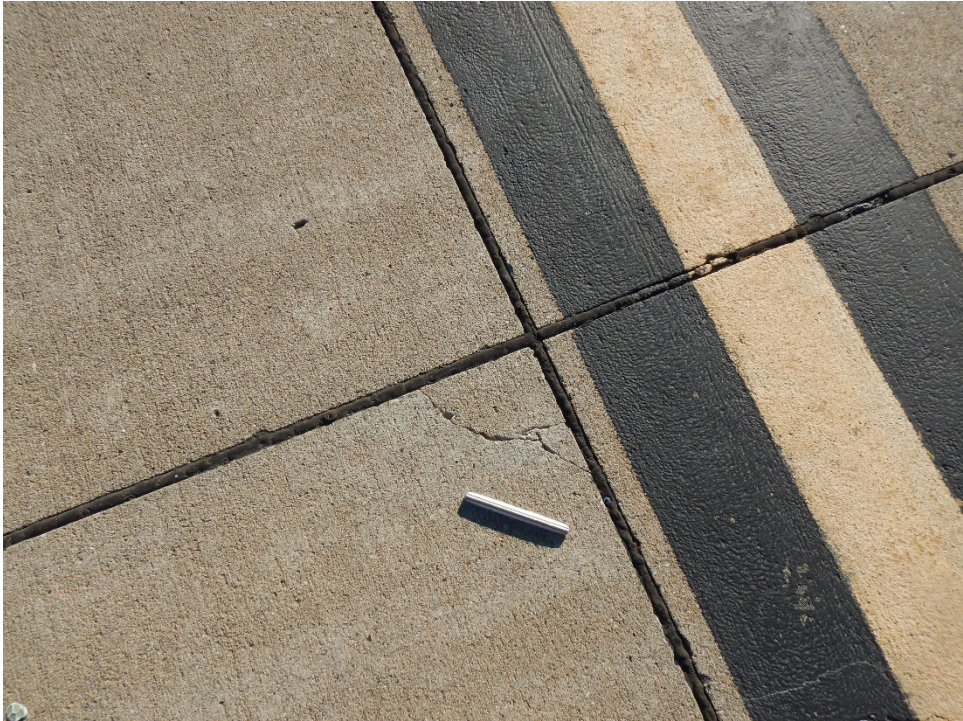
A02MP-01. Corner Spalling (Sample Unit No. 18).

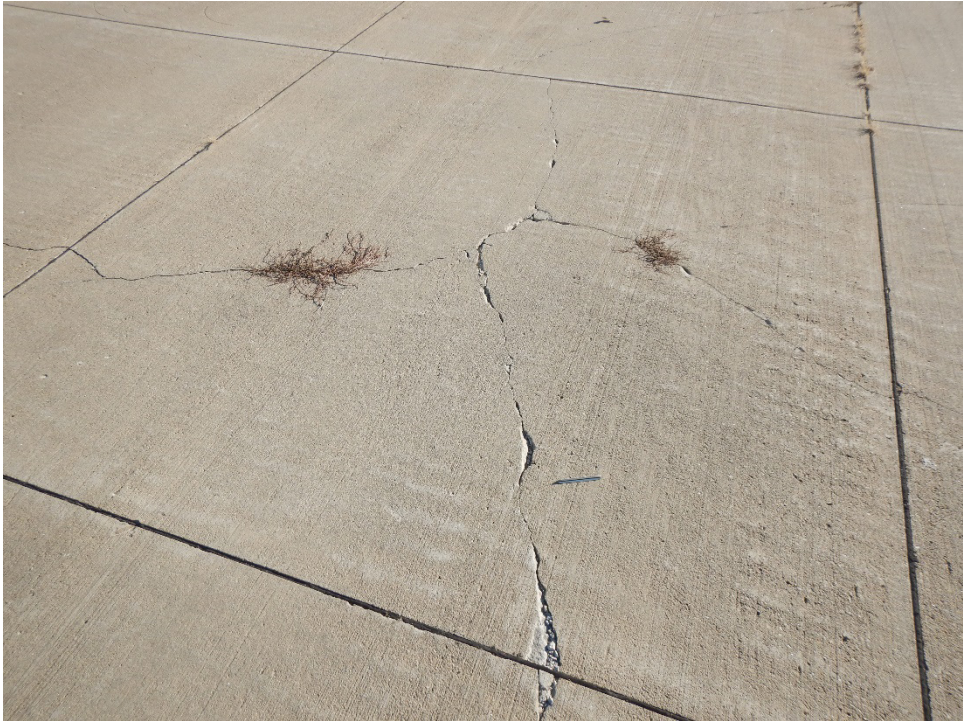
A02MP-01. Shattered Slab (Sample Unit No. 06).

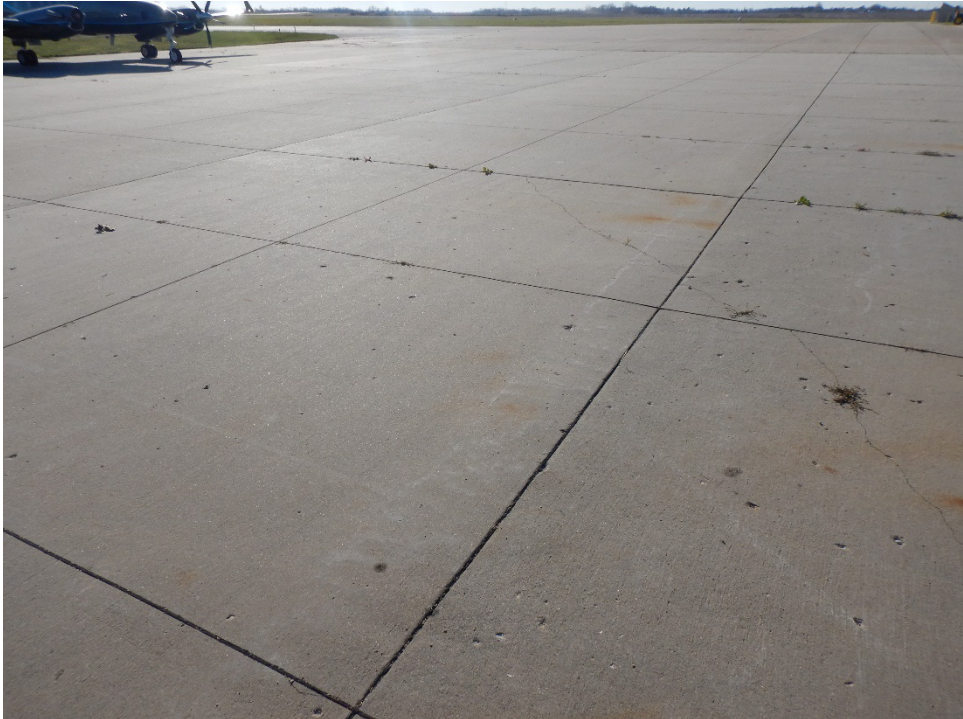
A02MP-02. Overview.

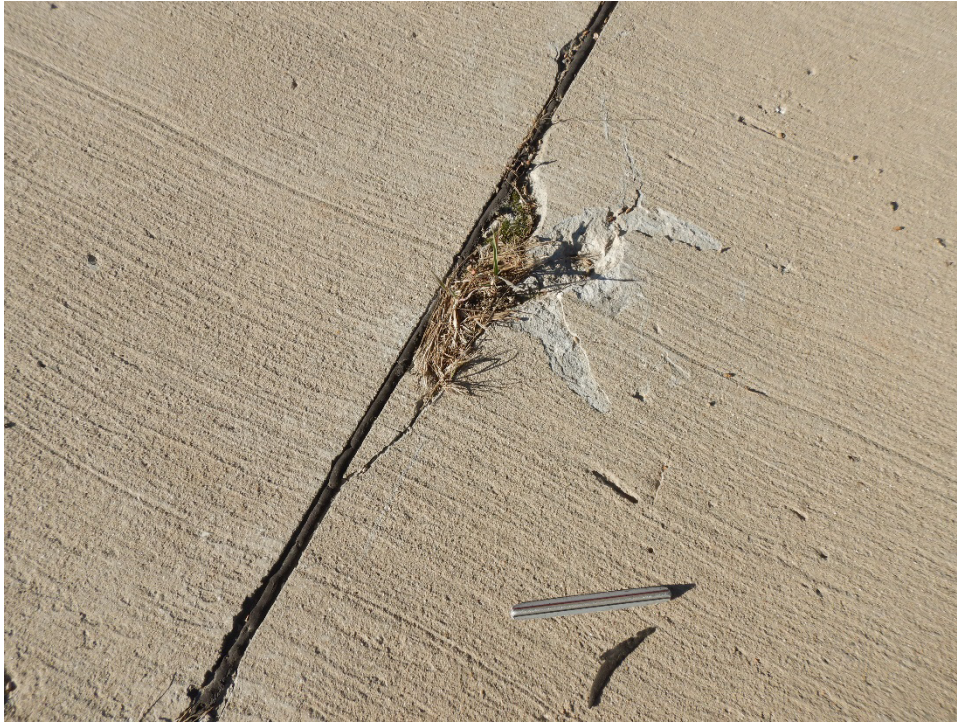
A02MP-02. ASR (Sample Unit No. 06).

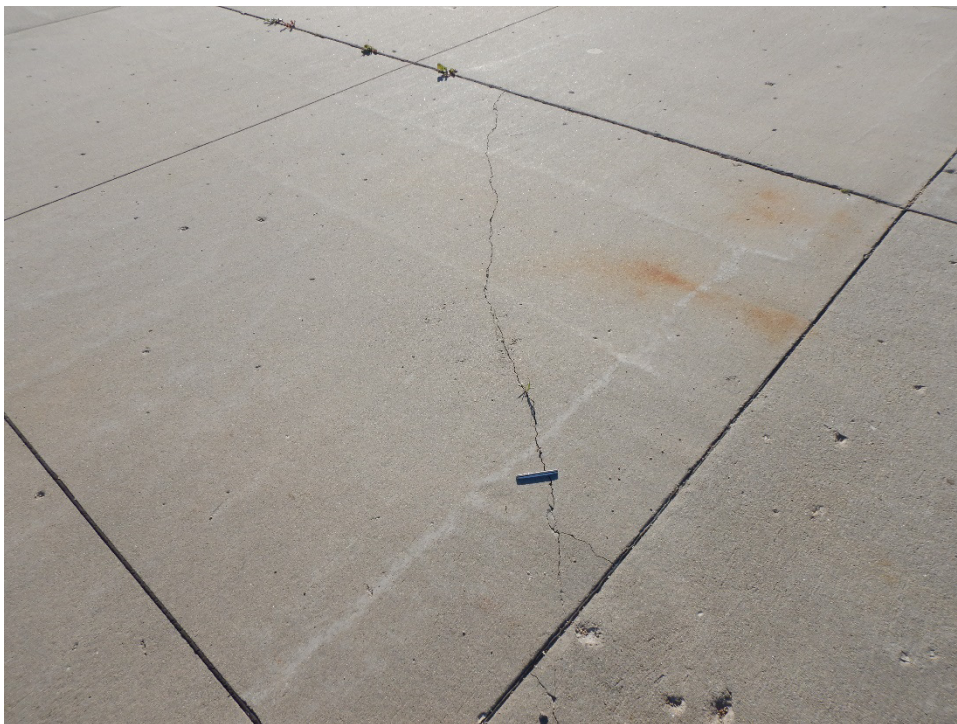
A02MP-02. LTD Cracking (Sample Unit No. 01).

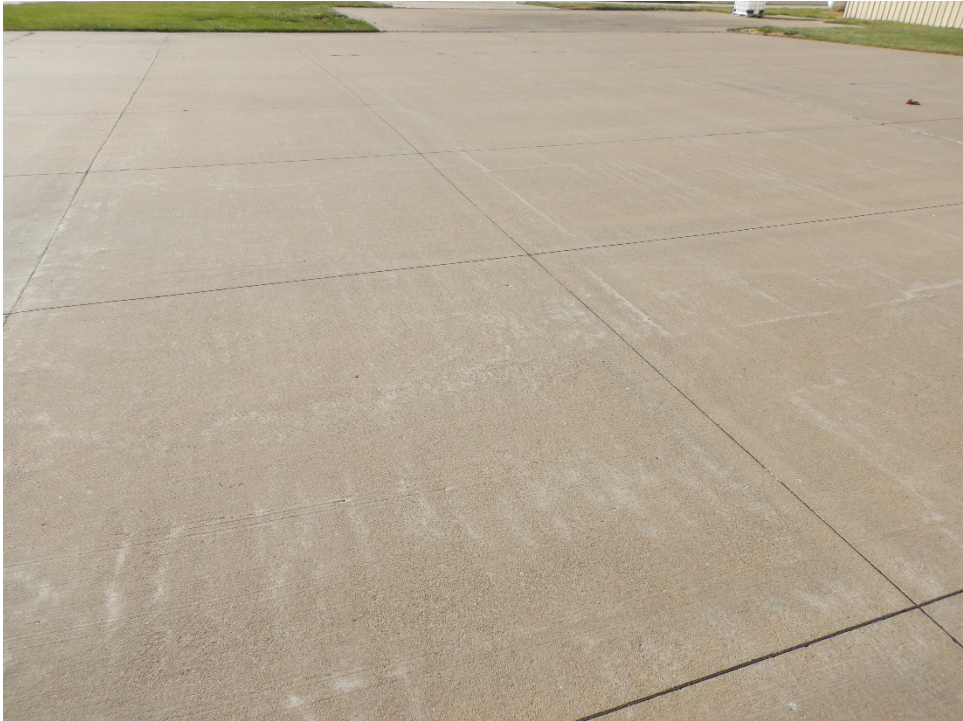
A02MP-03. Overview.

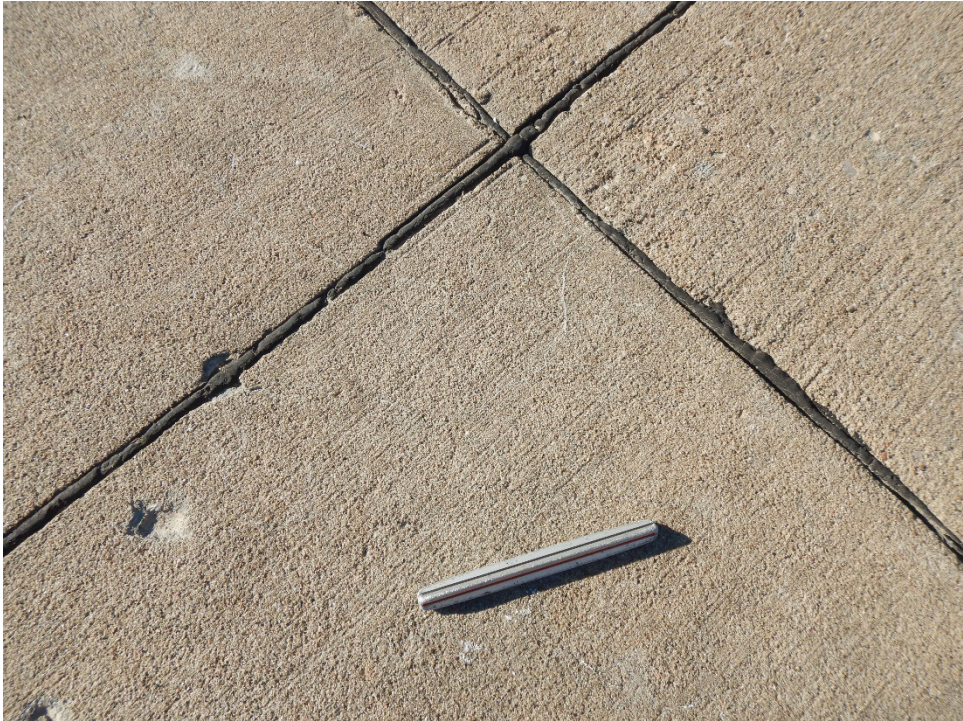
A02MP-03. ASR (Sample Unit No. 02).

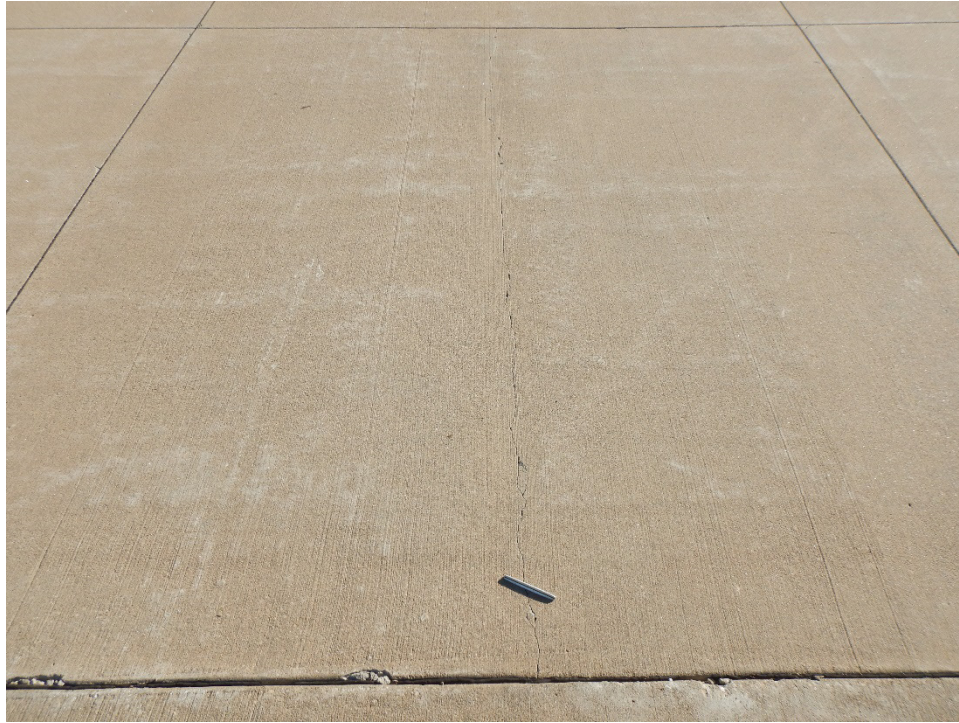
A02MP-03. LTD Cracking (Sample Unit No. 06).

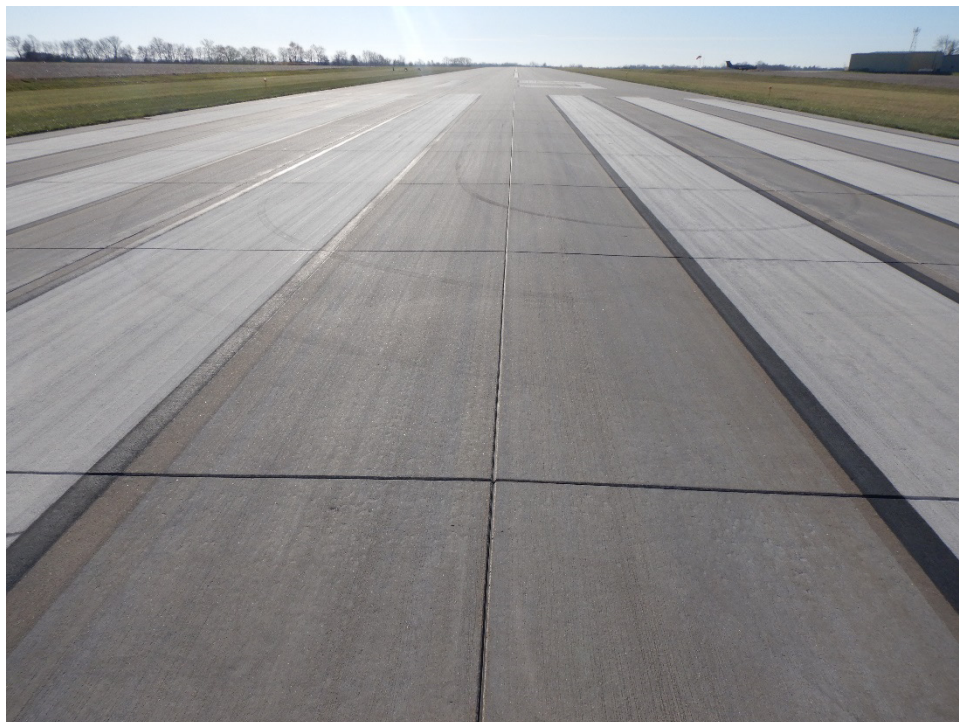
Runway 15/33 was defined by one section in excellent condition. No distress was observed in Section 01 at the time of inspection.

R15MP-01. Overview.

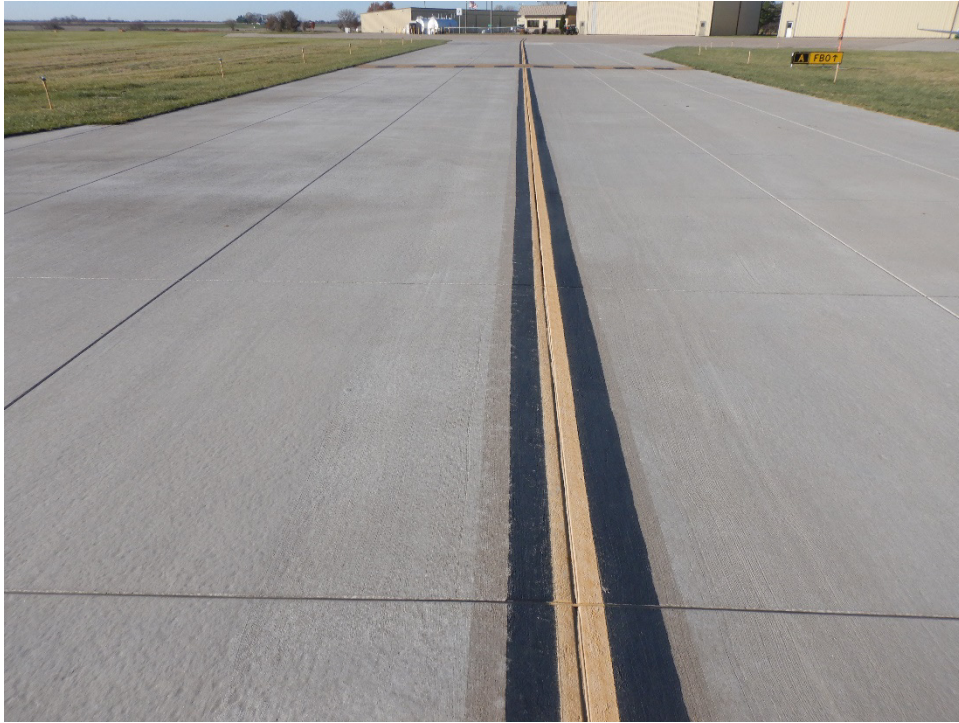
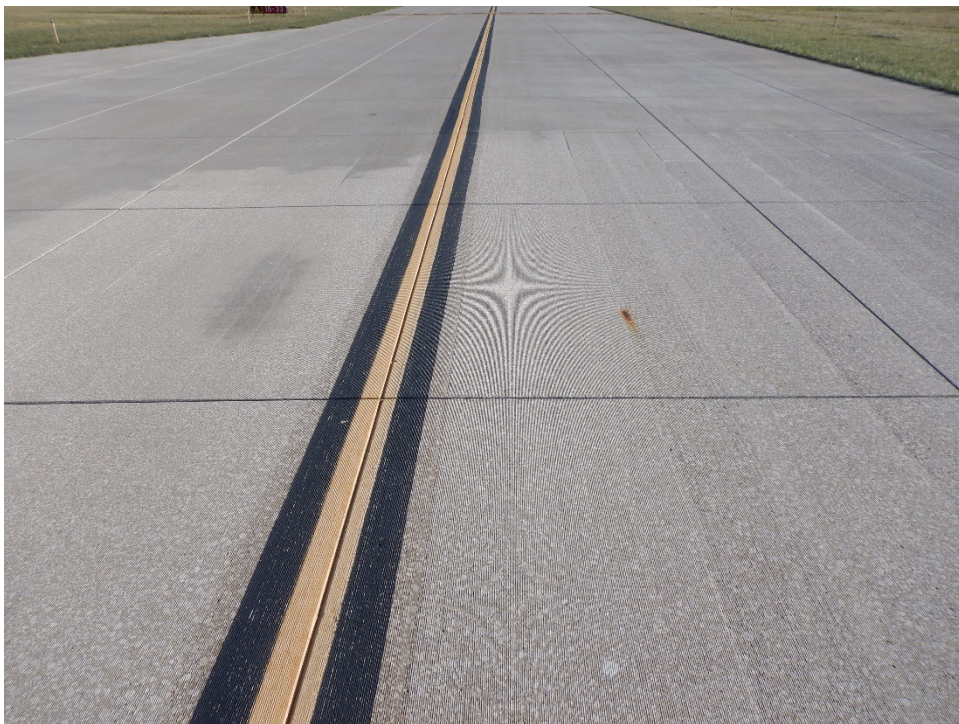
Taxiway A contained one section that connected Runway 15/33 to the apron area. Section 01 was in excellent condition with no distress identified.

TAMP-01. Overview (1).

TAMP-01. Overview (2).

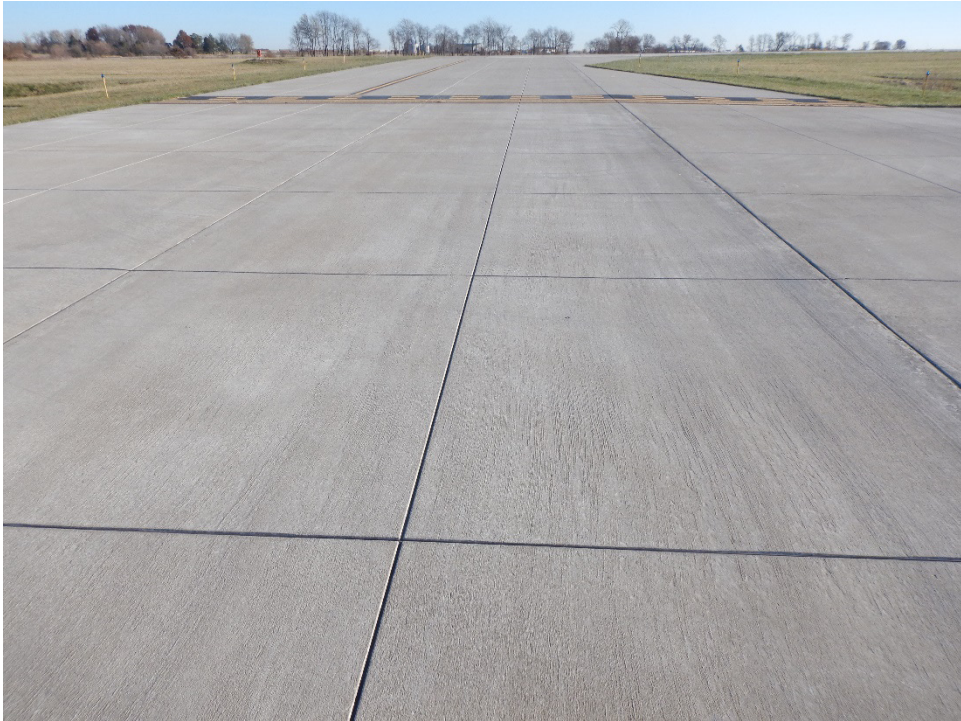
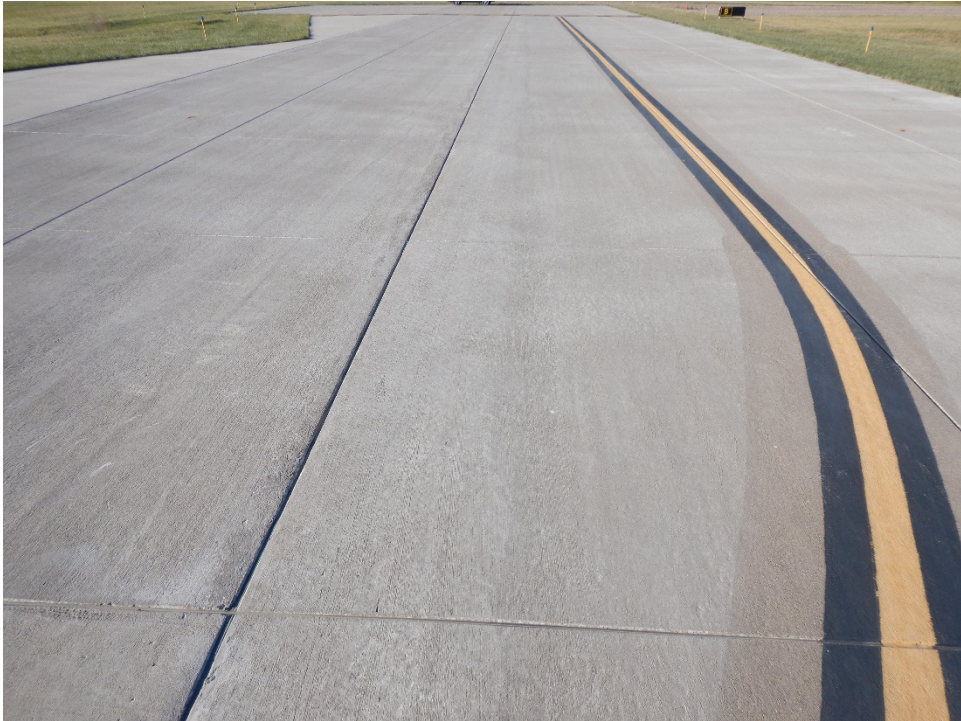
Taxiway B was defined by one section that was connected to the Runway 33 approach. Section 01 was in excellent condition with no distress observed during the inspection.

TBMP-01. Overview (1).

TBMP-01. Overview (2).

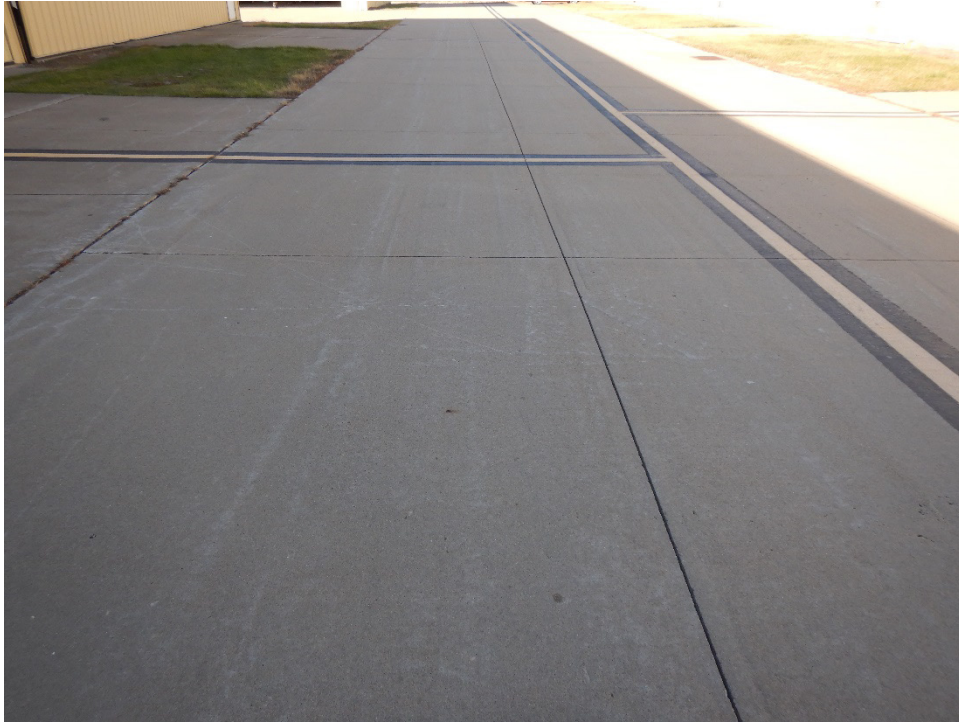
TH01MP-01. Overview.

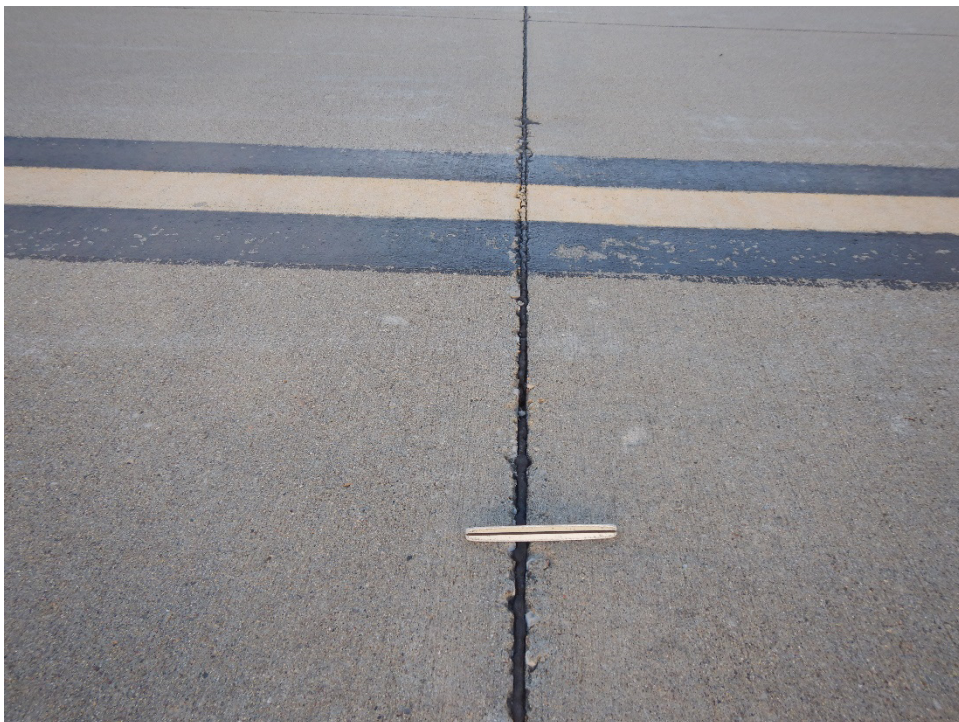
TH01MP-01. Joint Seal Damage (Sample Unit No. 08).

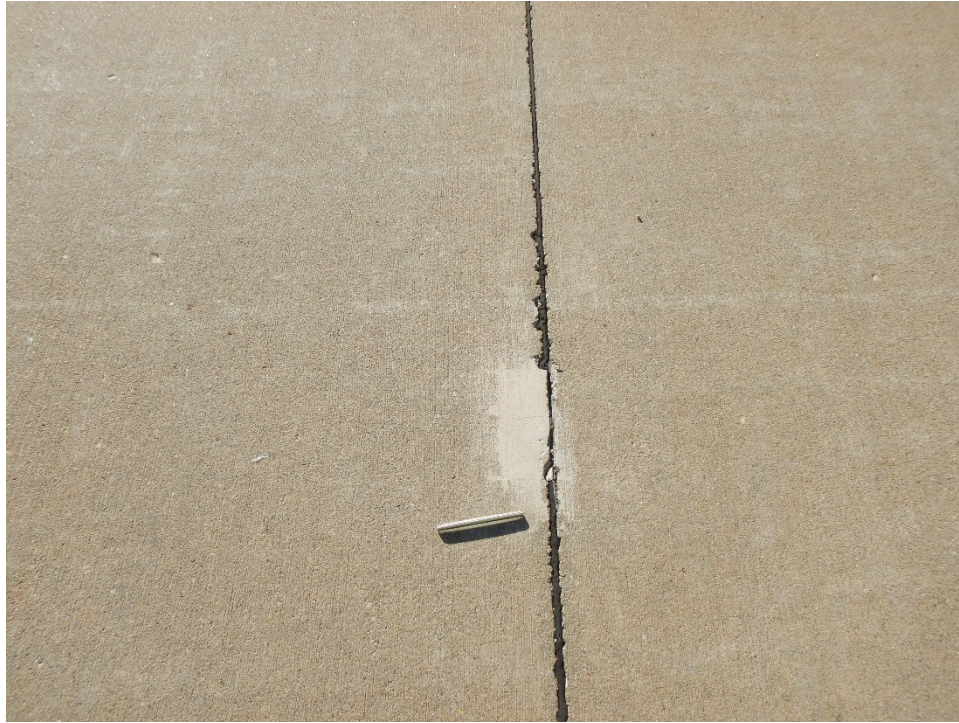
TH01MP-01. Small Patching (Sample Unit No. 07).

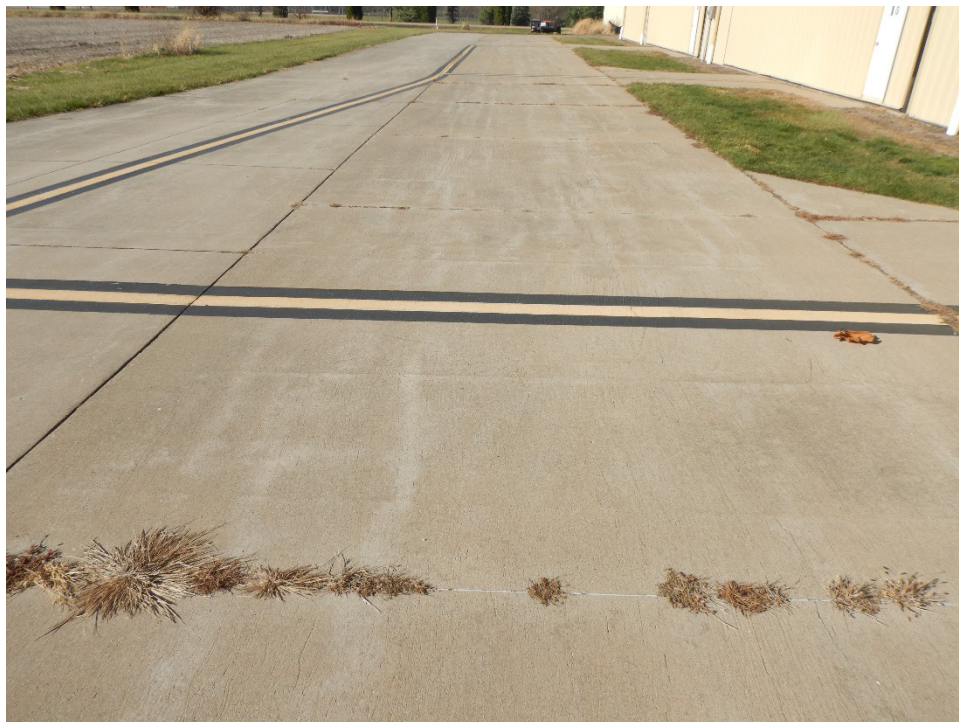
TH01MP-02. Overview.

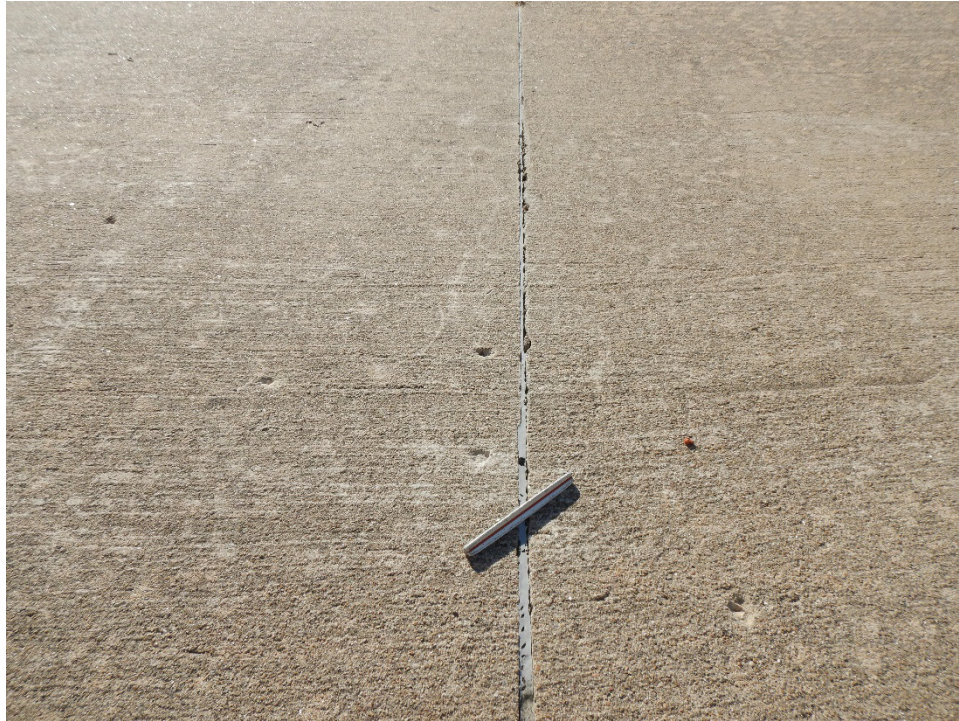
TH01MP-02. Joint Seal Damage (Sample Unit No. 01).

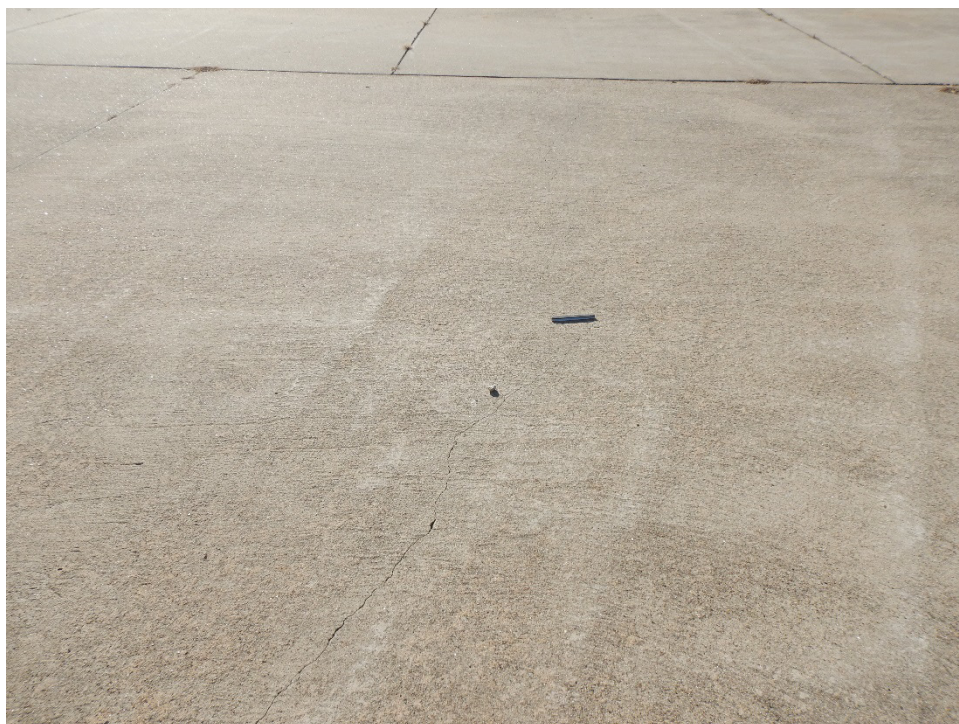
TH01MP-02. LTD Cracking (Sample Unit No. 01).
