# Newton Municipal Airport– Earl Johnson Field

## PAVEMENT MANAGEMENT REPORT

**JULY 2022**

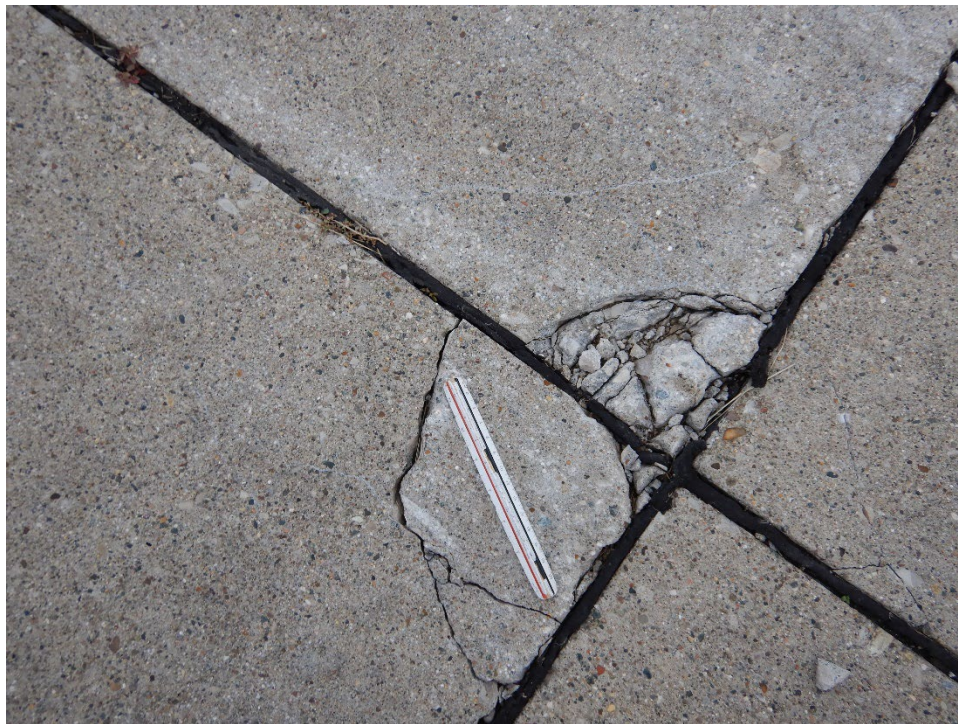
Apron 01 consisted of one section that had areas of low- and medium-severity ASR, LTD cracking, joint spalling, and corner spalling; medium-severity corner break; low-severity large patching and faulting; and high-severity joint seal damage recorded during the inspection.

A01NE-01. ASR (Sample Unit No. 04).

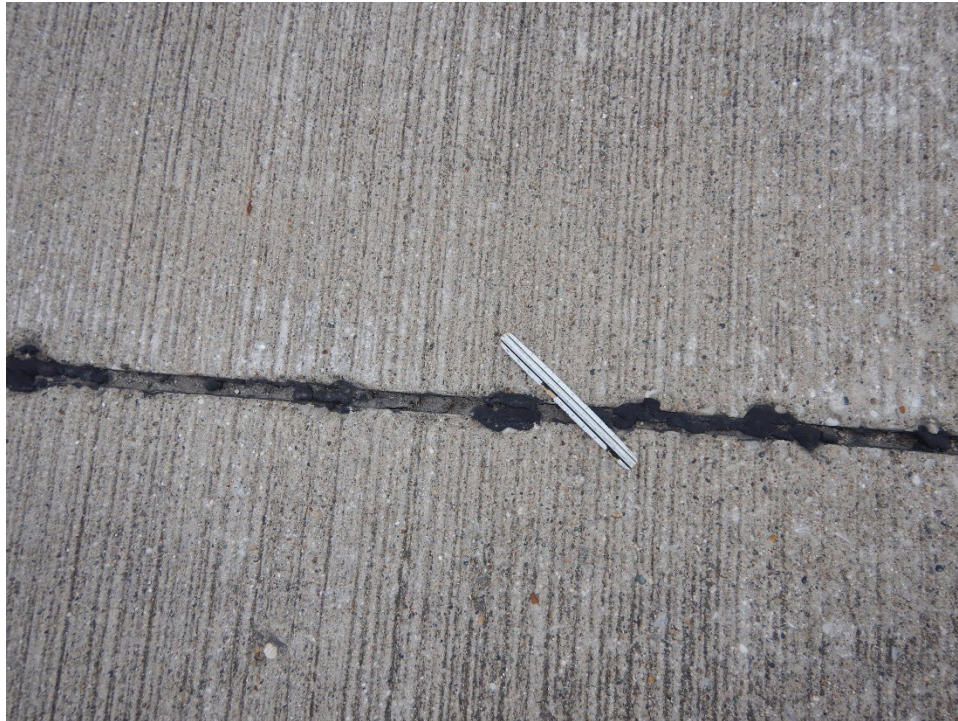
A01NE-01. Joint Seal Damage (Sample Unit No. 17).

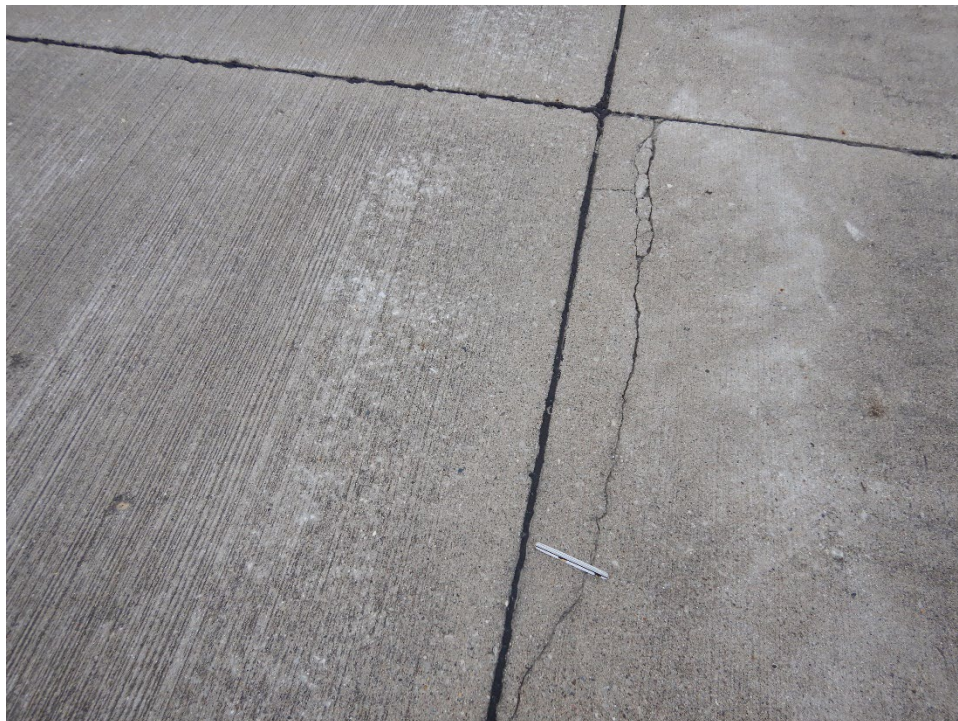
A01NE-01. Joint Spalling (Sample Unit No. 17).

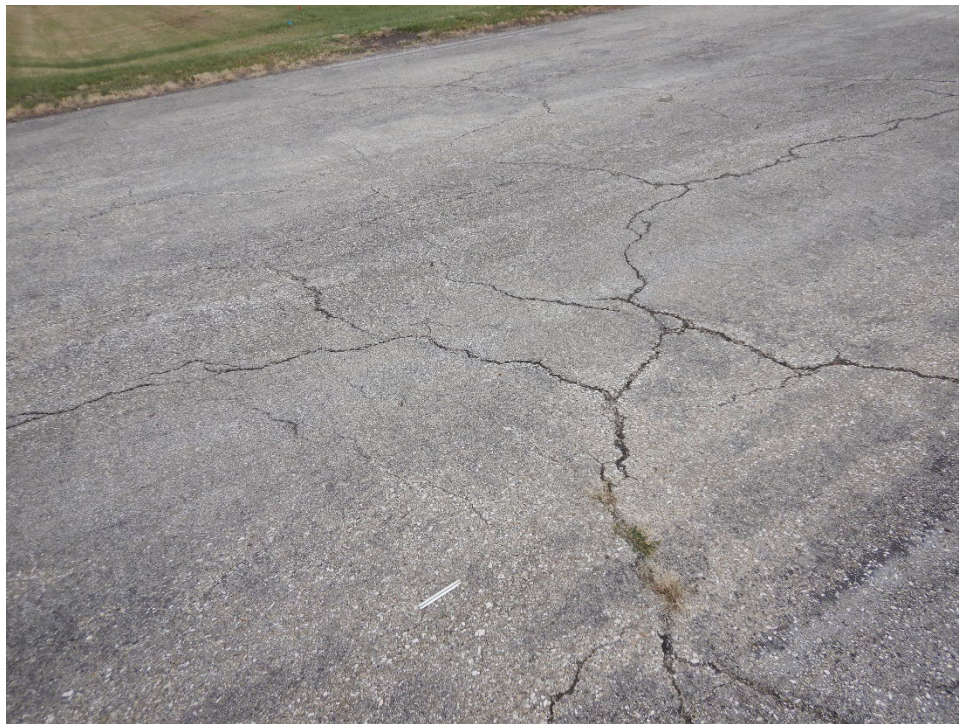
Apron 02 contained one section. Medium-severity block cracking and weathering were observed throughout Section 01.

A02NE-01. Block Cracking (Sample Unit No. 02).

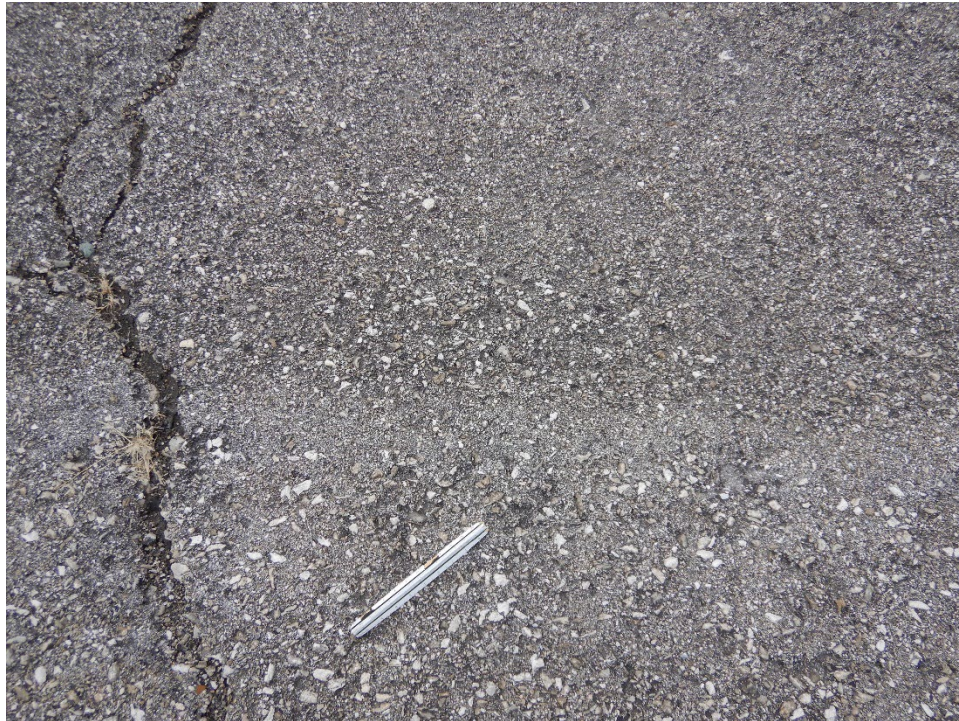
A02NE-01. Weathering (Sample Unit No. 02).

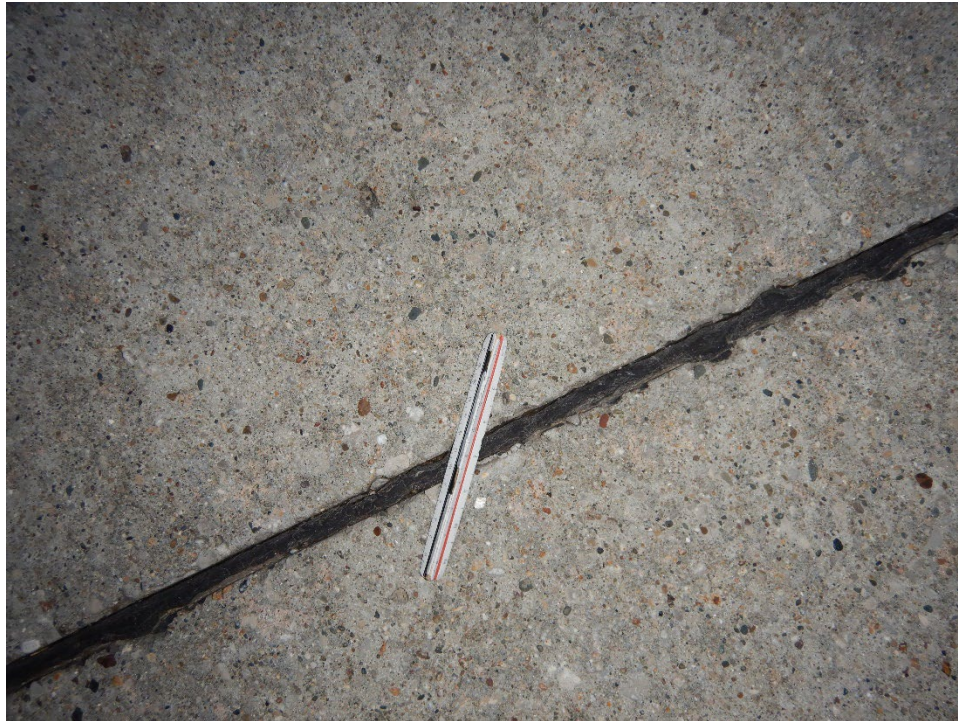
A03NE-01. Joint Seal Damage (Sample Unit No. 15).

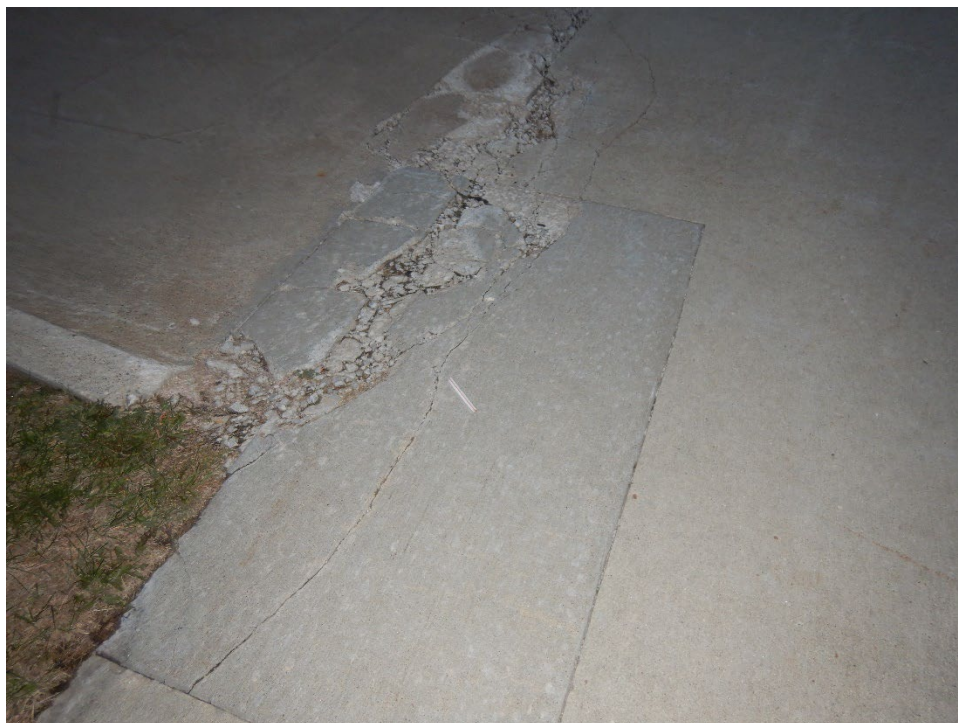
A03NE-01. Large Patching (Additional Sample Unit No. 16).

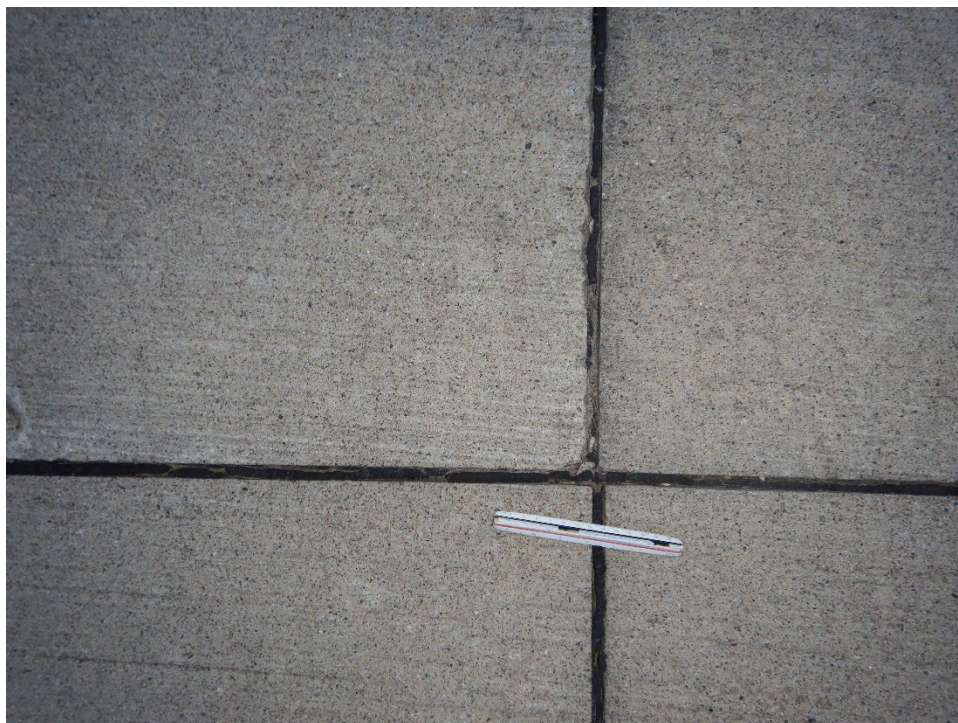
A03NE-02. Joint Seal Damage (Sample Unit No. 10).

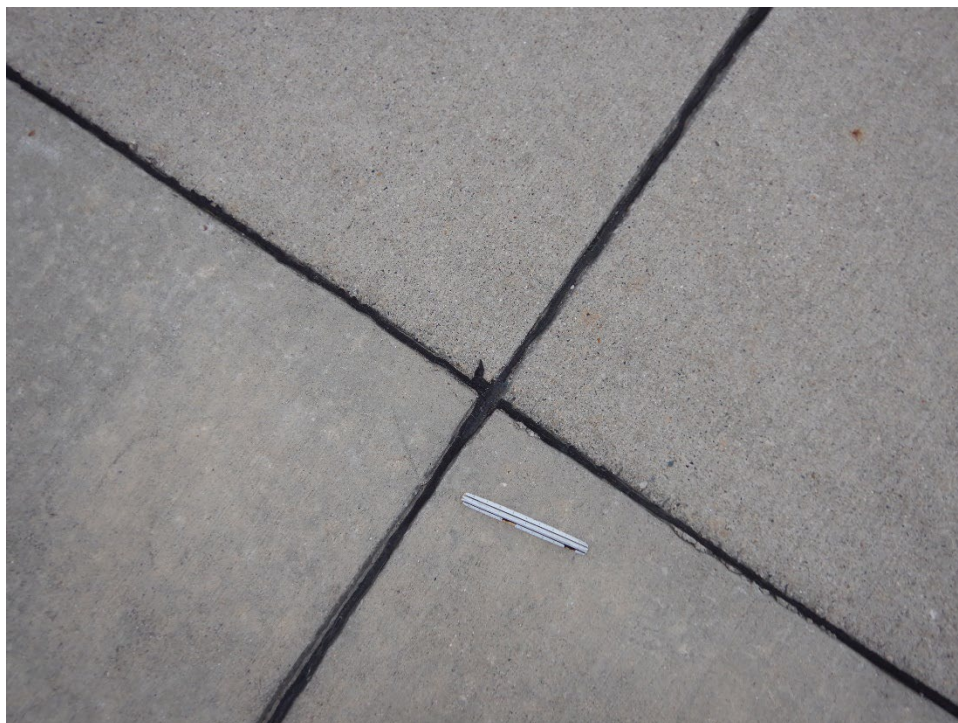
A03NE-03. Joint Seal Damage (Sample Unit No. 10).

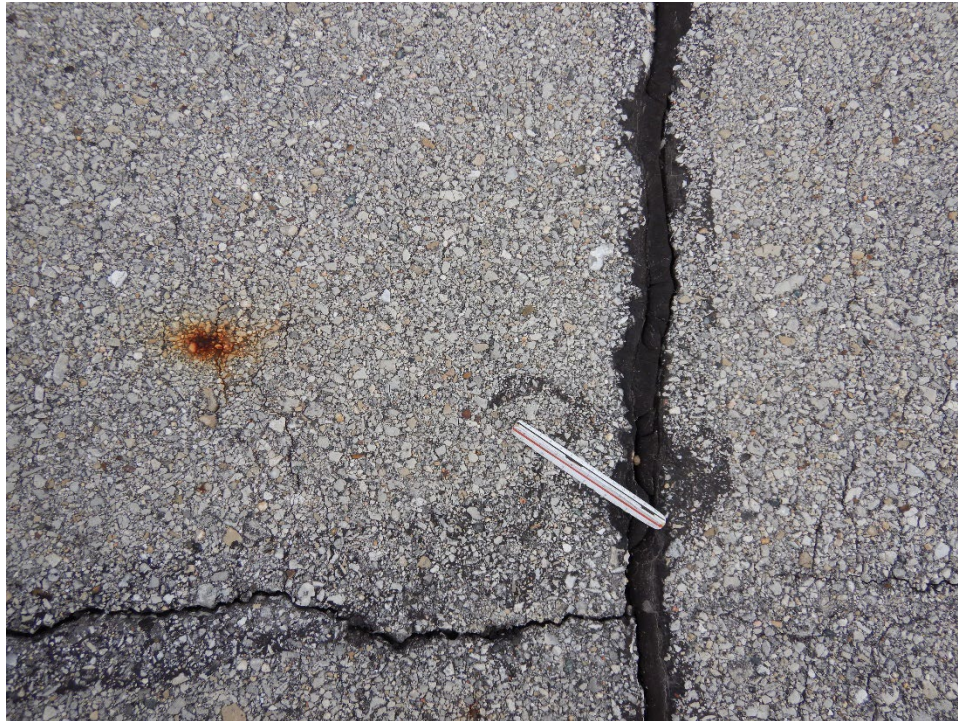
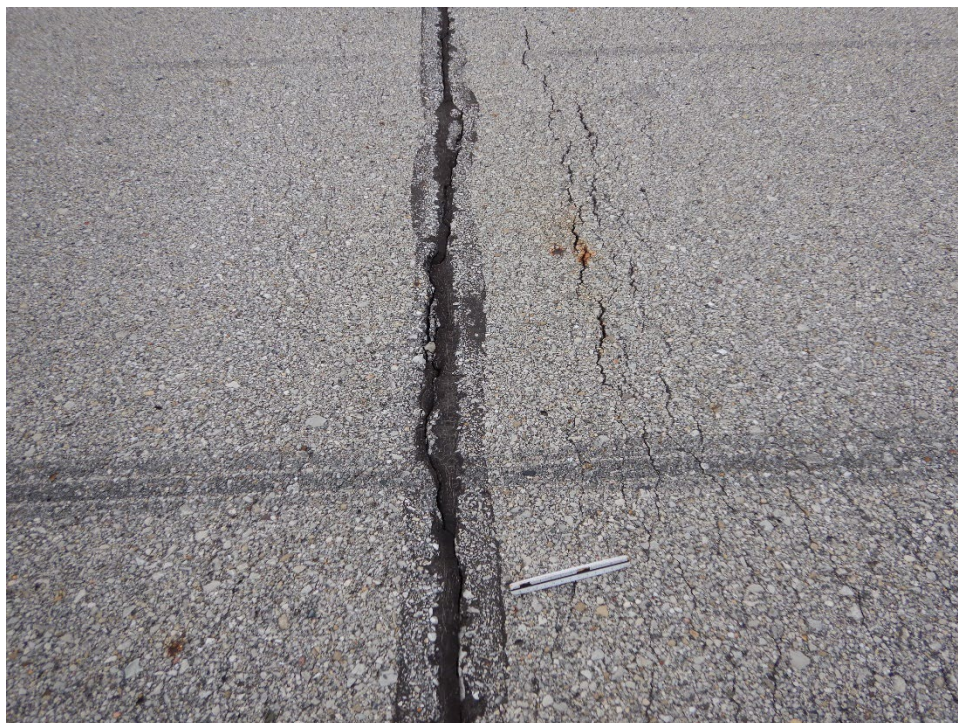
Runway 14/32 was defined by three sections that contained all severities of longitudinal and transverse (L&T) cracking and low-severity weathering. In all three sections, the low-severity L&T cracking was unsealed, while the medium-severity L&T cracking was recorded where either unsealed crack widths exceeded  $\frac{1}{4}$  in, secondary cracking had developed, or where crack sealant was unsatisfactory. High-severity L&T cracking was recorded where secondary cracking had developed that was greater than 1 ft wide.

R14NE-01. L&T Cracking (Sample Unit No. 01).

R14NE-01. L&T Cracking (Sample Unit No. 08).

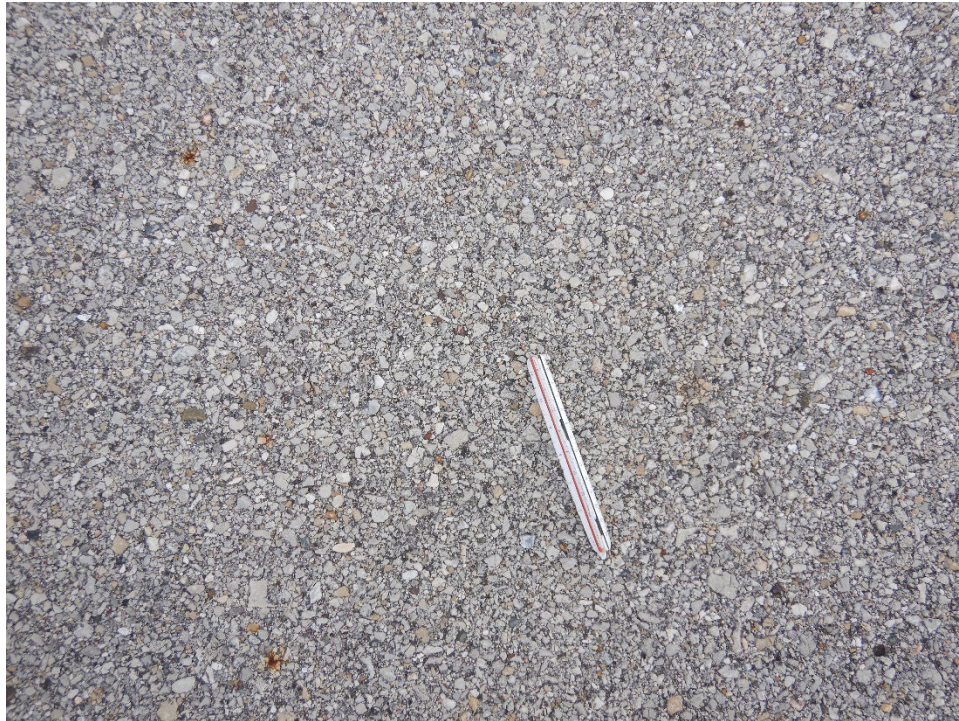
R14NE-01. Weathering (Sample Unit No. 01).

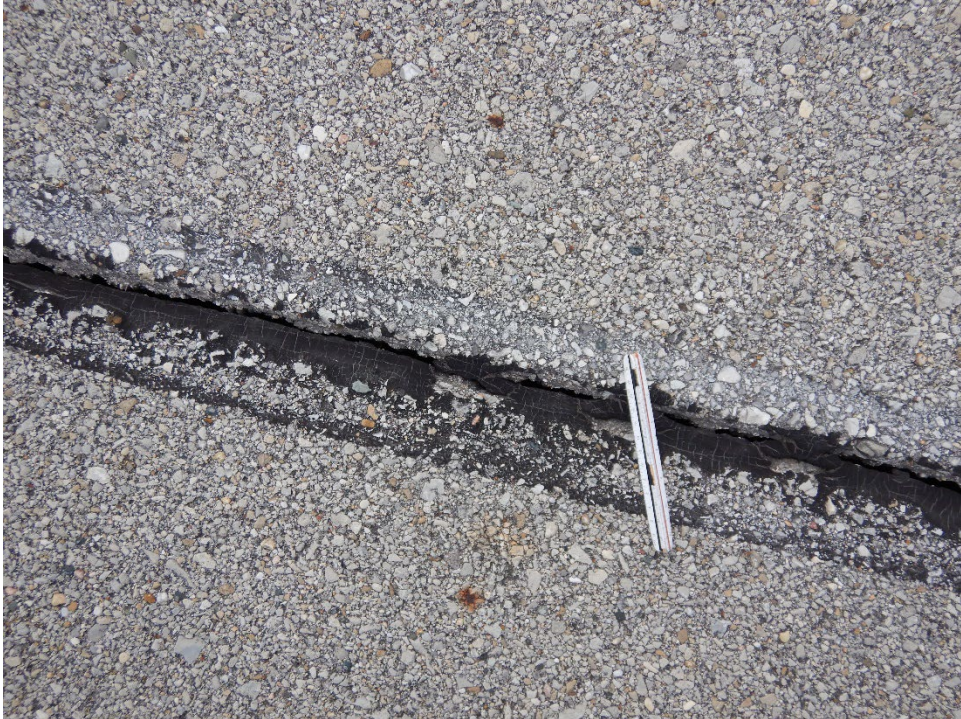
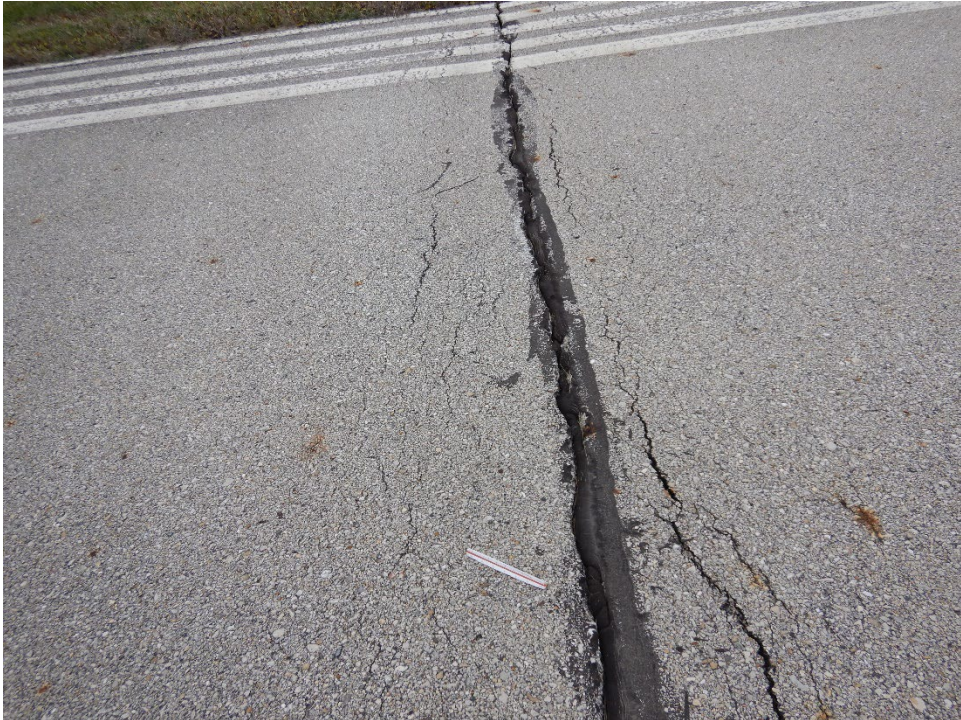
R14NE-02. L&T Cracking (Sample Unit No. 14) (1).

R14NE-02. L&T Cracking (Sample Unit No. 14) (2).

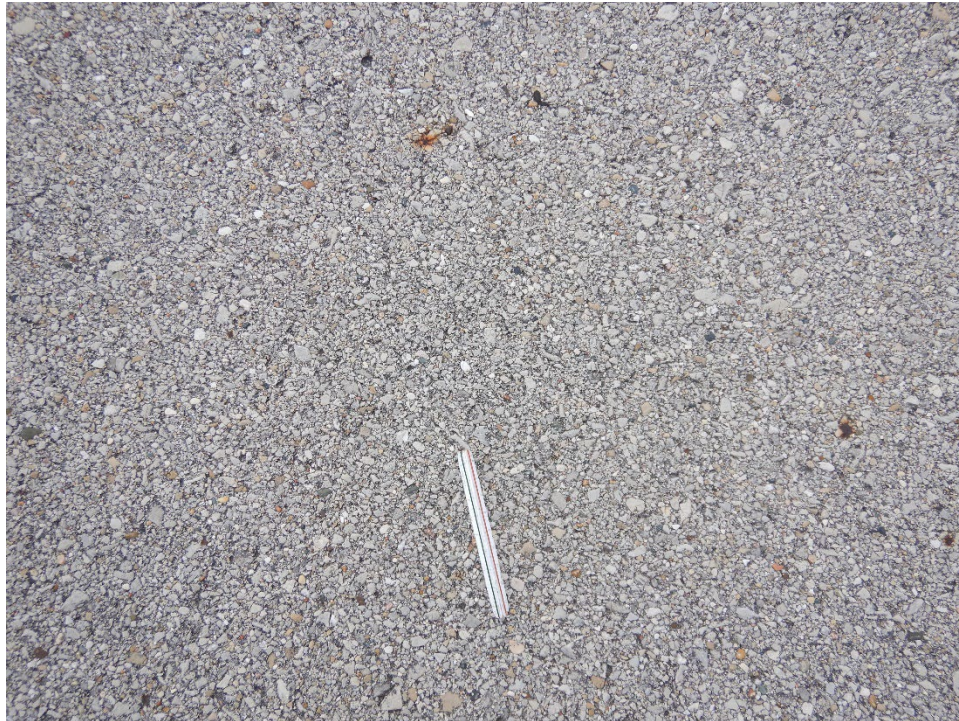
R14NE-02. Weathering (Sample Unit No. 14).

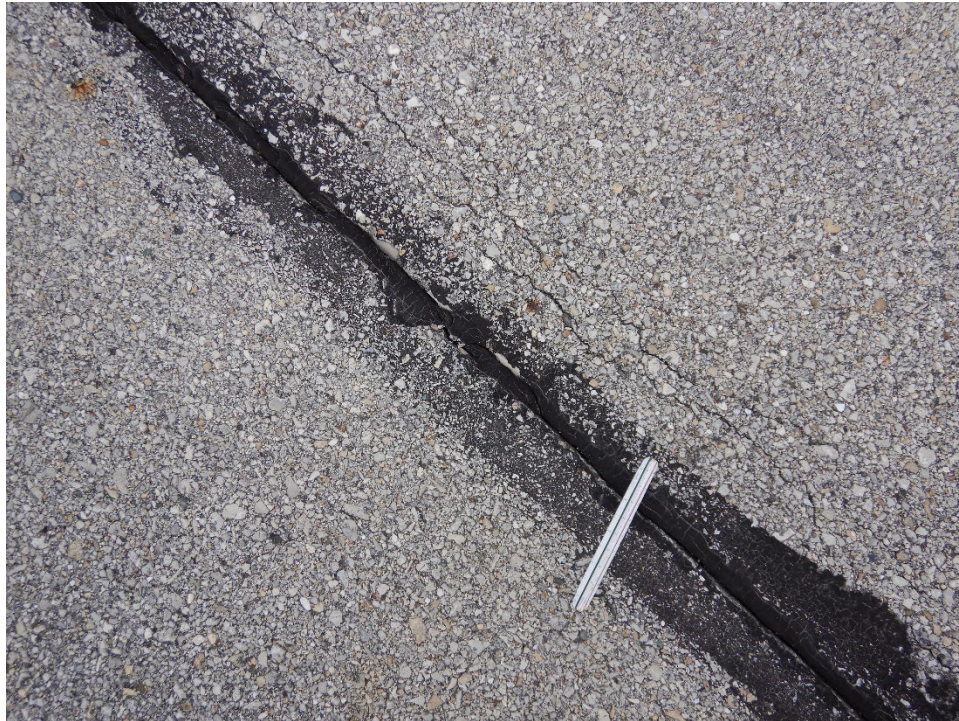
R14NE-03. L&T Cracking (Sample Unit No. 11).

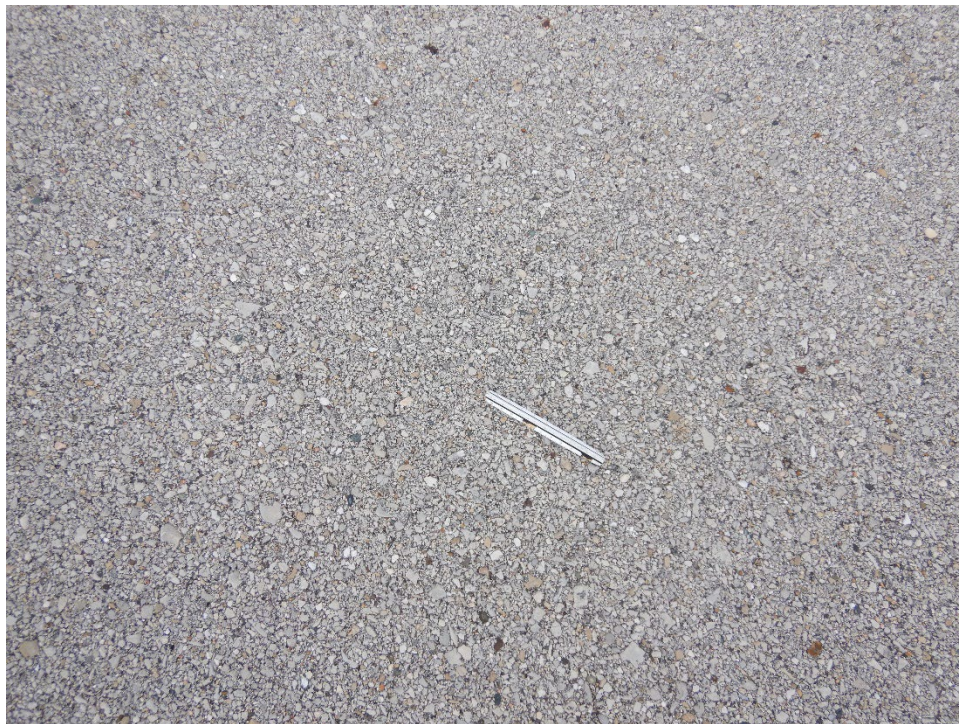
R14NE-03. Weathering (Sample Unit No. 11).

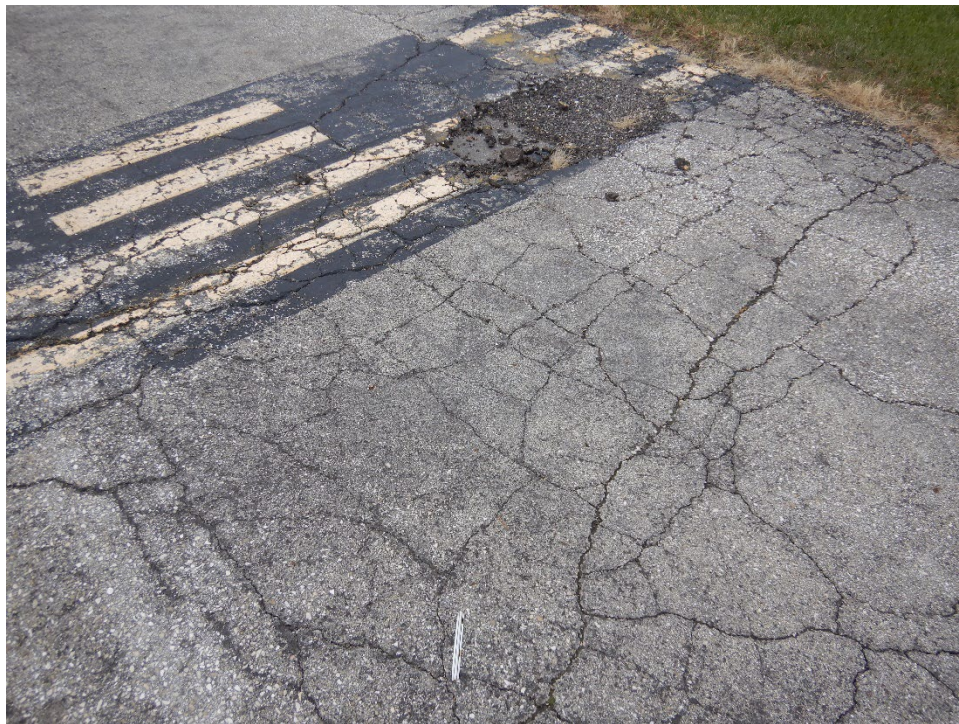
Taxiway 01 connected the Runway 14 approach with Apron 01 and consisted of one section. Section 01 contained medium- and high-severity alligator cracking; medium-severity L&T cracking, raveling, and weathering; and high-severity patching. The medium-severity L&T cracking was recorded where unsealed crack widths exceeded  $\frac{1}{4}$  in.

T01NE-01. Alligator Cracking (Sample Unit No. 08).

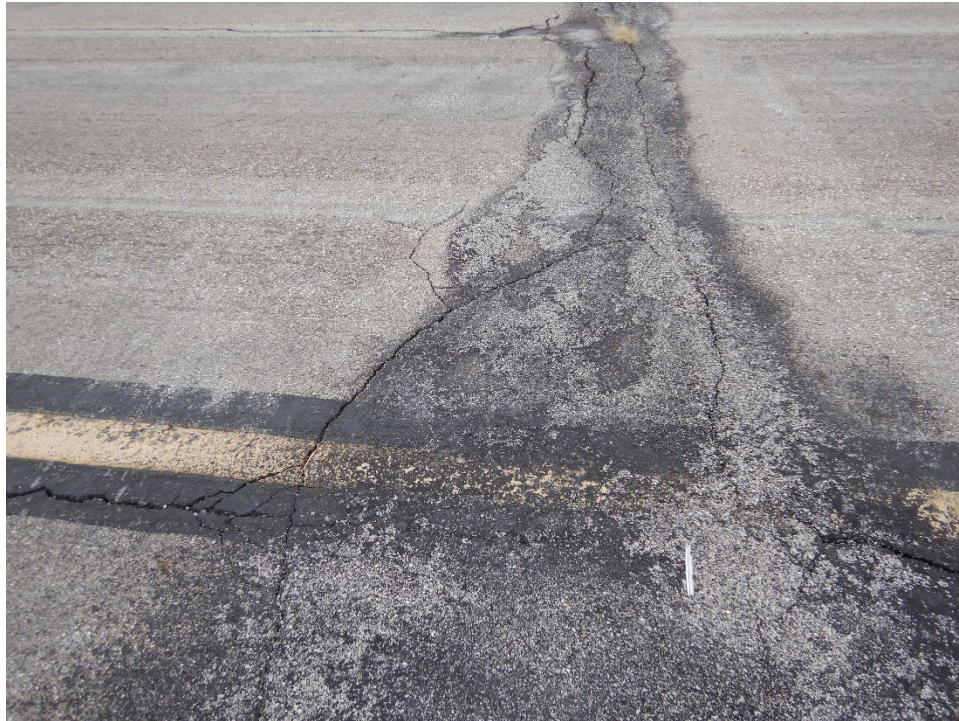
T01NE-01. Patching (Sample Unit No. 08).

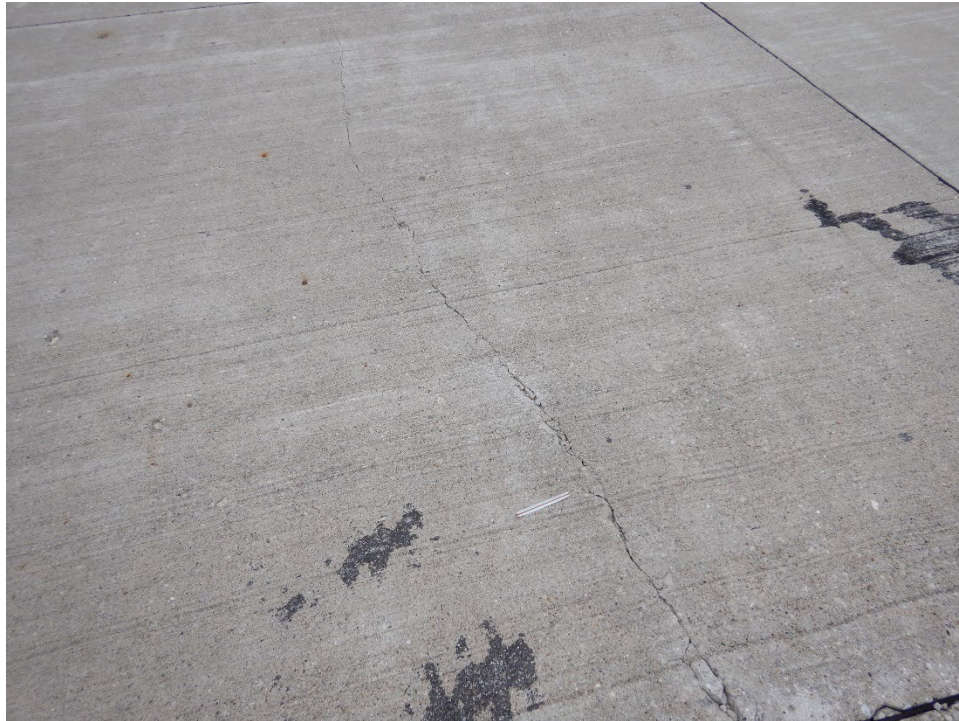
Taxiway 02 contained two sections that connected Runway 14/32 with Apron 01. Low-severity corner spalling, faulting, and longitudinal, transverse, and diagonal (LTD) cracking; high-severity joint seal damage; and shrinkage cracking were observed in Section 01. Section 02 had low- and medium-severity L&T cracking and low-severity weathering recorded throughout. The low-severity L&T cracking was unsealed, while the medium-severity L&T cracking was noted where the crack sealant had failed.

T02NE-01. LTD Cracking (Sample Unit No. 01).

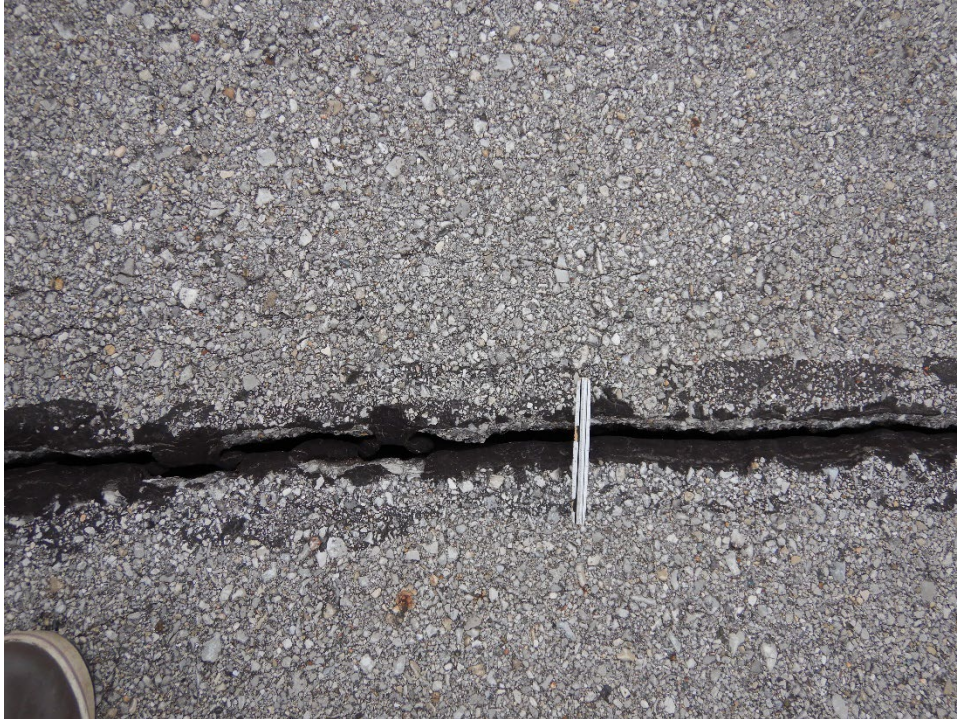
T02NE-02. L&T Cracking (Sample Unit No. 01).

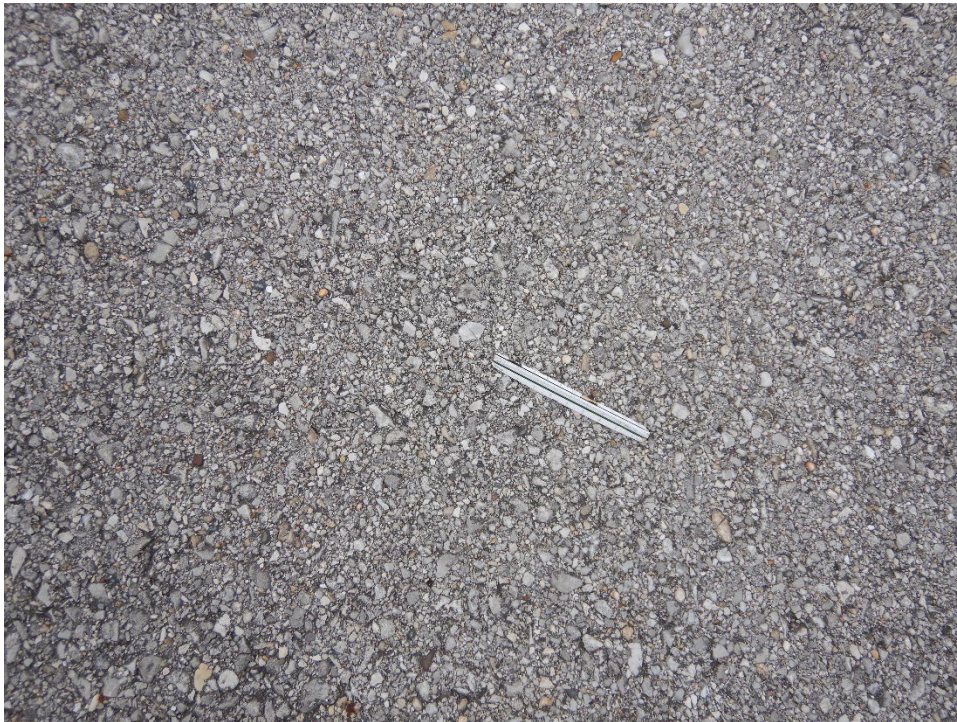
T02NE-02. Weathering (Sample Unit No. 01).

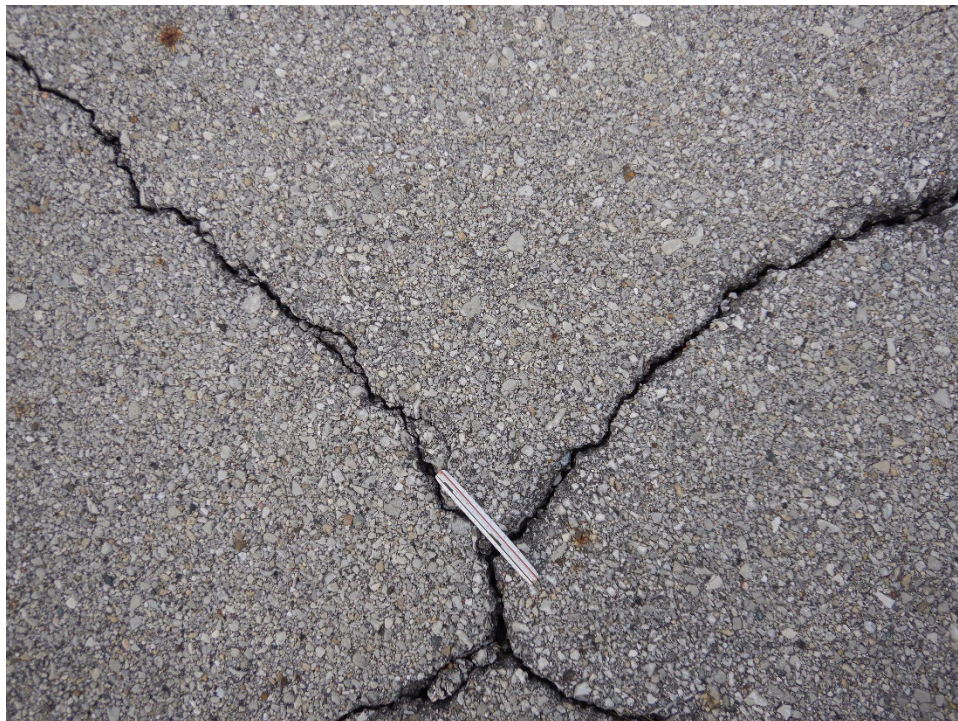
Taxiway 03 was defined by one section that had all severities of L&T cracking and low-severity weathering. The low-severity L&T cracking was both sealed and unsealed, while the medium-severity L&T cracking was recorded where either unsealed cracks exceeded  $\frac{1}{4}$  in in width, secondary cracking had developed, or where crack sealant was unsatisfactory. The high-severity L&T cracking was recorded where secondary cracking was greater than 1 ft wide.

T03NE-01. L&T Cracking (Sample Unit No. 06).

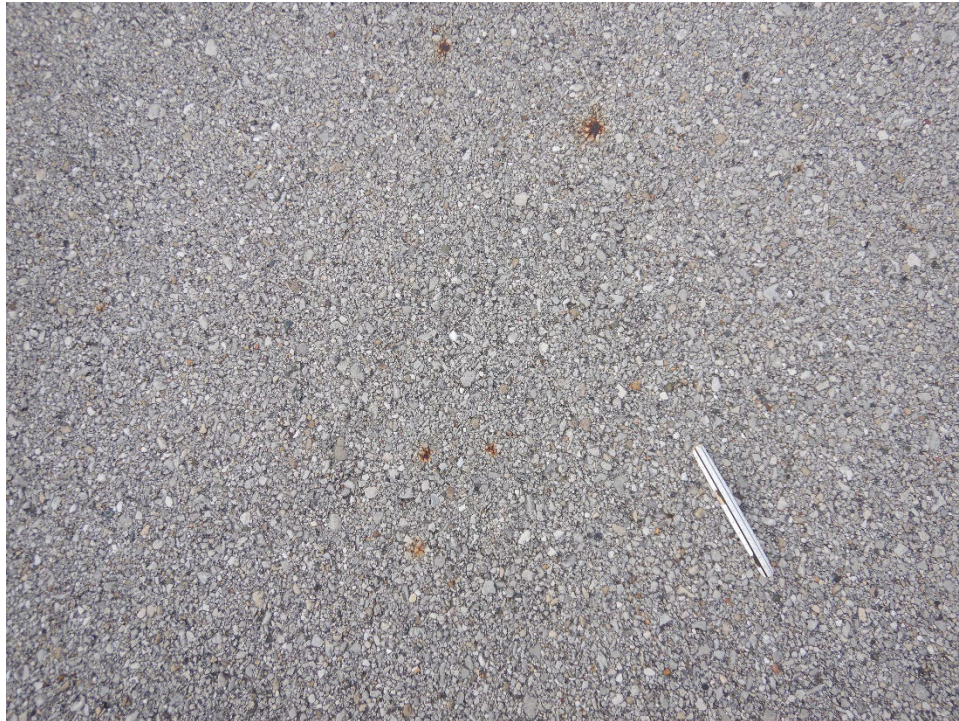
T03NE-01. Weathering (Sample Unit No. 06).

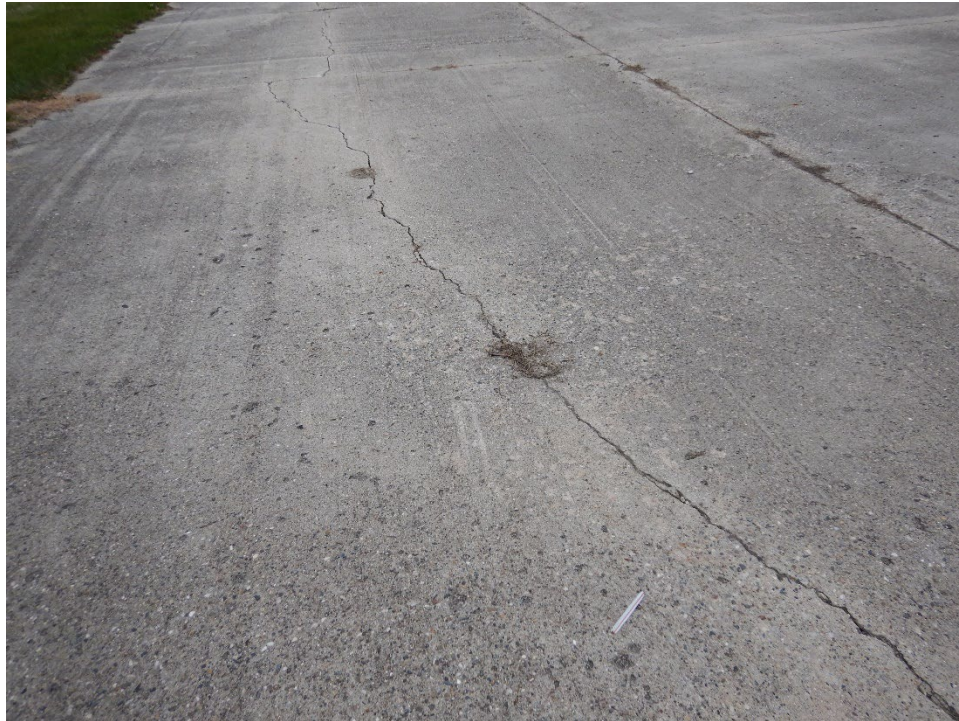
Taxiway 04 contained one section. Section 01 was in poor condition with all severities of joint spalling, low- and medium-severity corner spalling, medium-severity shattered slab and LTD cracking, high-severity joint seal damage and scaling, medium- and high-severity corner break, and popouts noted during the inspection.

T04NE-01. LTD Cracking (Sample Unit No. 01).

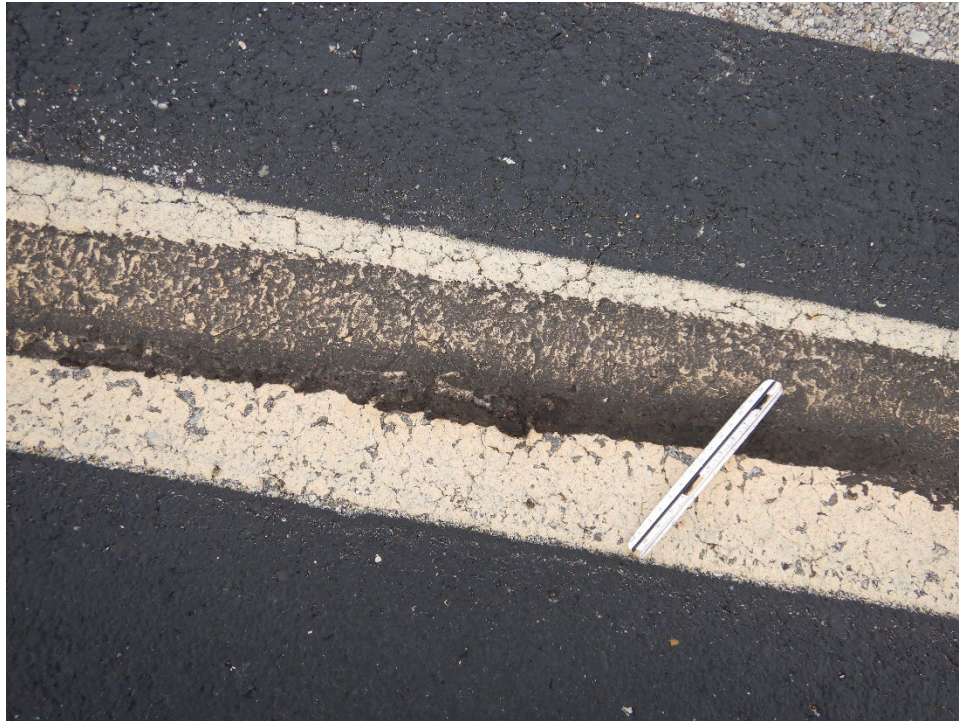
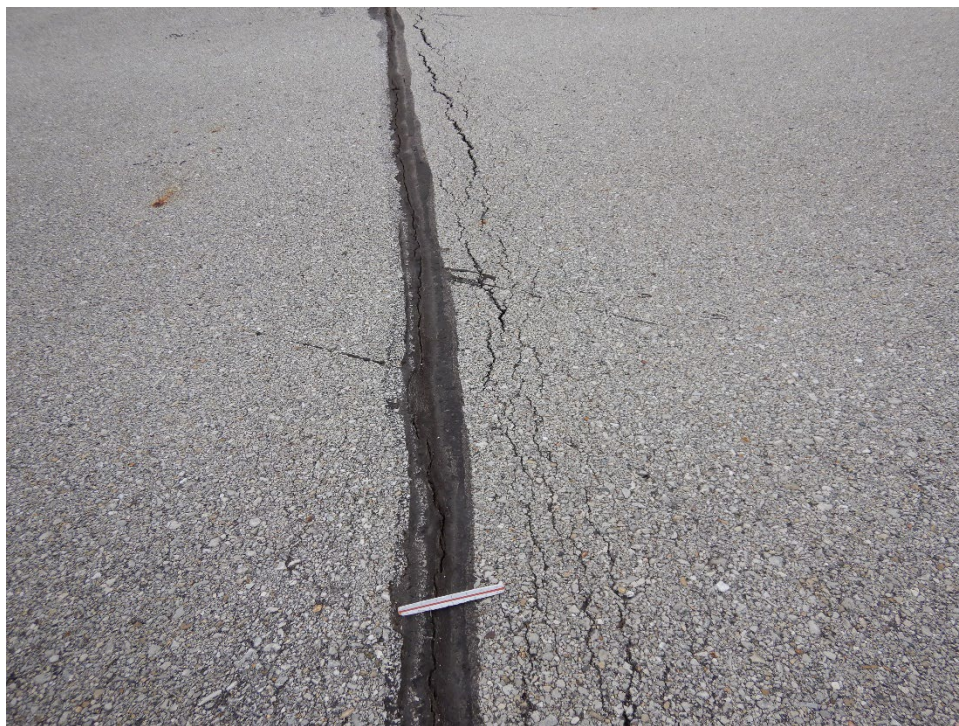
Taxiway 05 consisted of one section that contained all severities of L&T cracking and low-severity weathering. The low-severity L&T cracking was both sealed and unsealed, while the medium-severity L&T cracking was recorded where either the unsealed crack widths were greater than  $\frac{1}{4}$  in, secondary cracking had developed, or crack sealant had failed. High-severity L&T cracking was recorded where secondary cracking wider than 1 ft had developed.

T05NE-01. L&T Cracking (Sample Unit No. 20) (1).

T05NE-01. L&T Cracking (Sample Unit No. 20) (2).

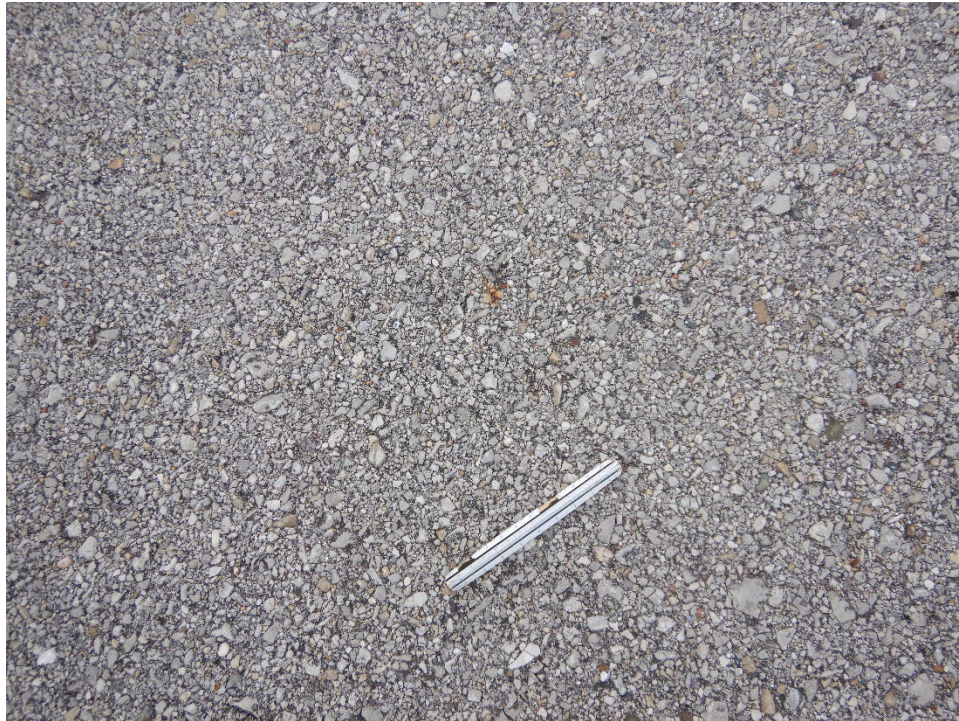
T05NE-01. Weathering (Sample Unit No. 20).

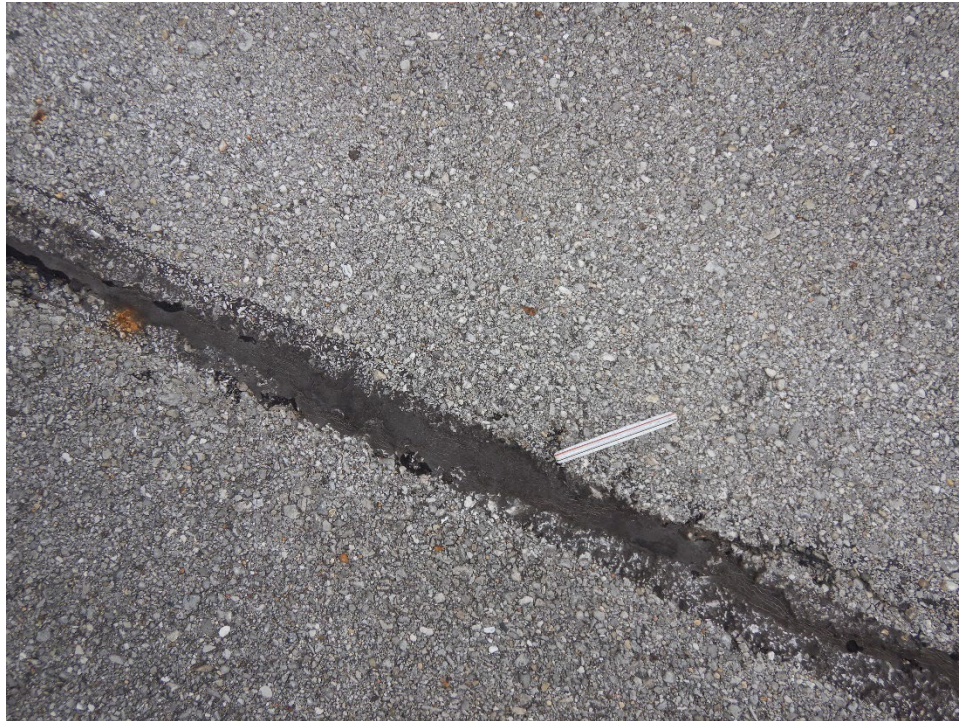
Taxiway 06 connected the parallel taxiway with the runway and contained one section. Low- and medium-severity L&T cracking and low-severity weathering were observed in Section 01. The low-severity L&T cracking was both sealed and unsealed, while the medium-severity L&T

cracking was recorded where either unsealed crack widths were greater than  $\frac{1}{4}$  in or where crack sealant was unsatisfactory.

T06NE-01. L&T Cracking (Sample Unit No. 02).

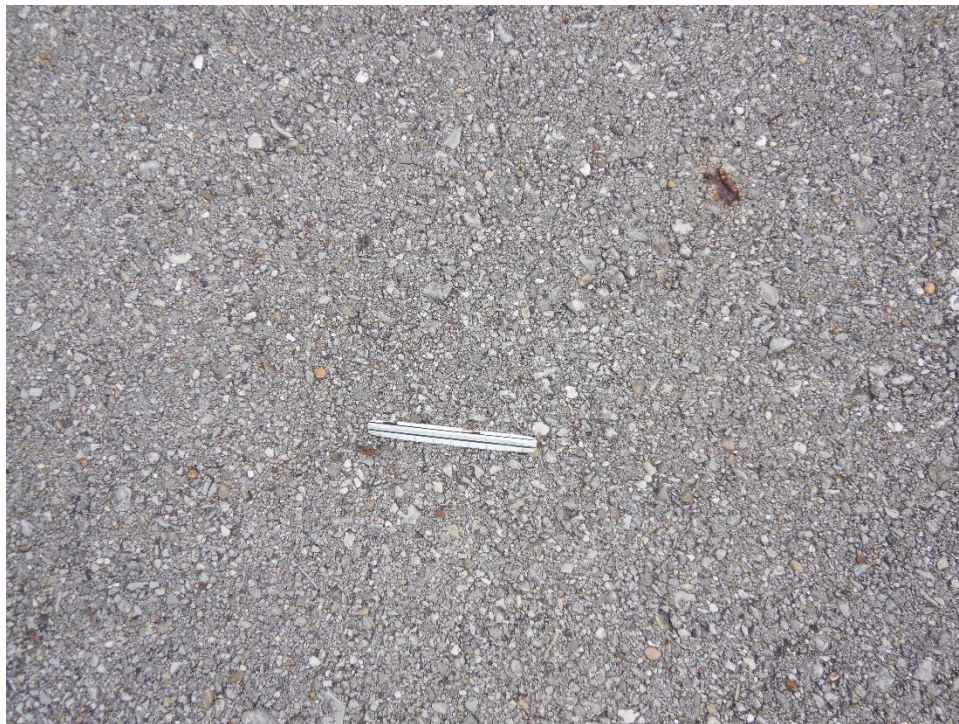
T06NE-01. Weathering (Sample Unit No. 02).
