# Newton Municipal Airport– Earl Johnson Field

## PAVEMENT MANAGEMENT REPORT

**JULY 2022**

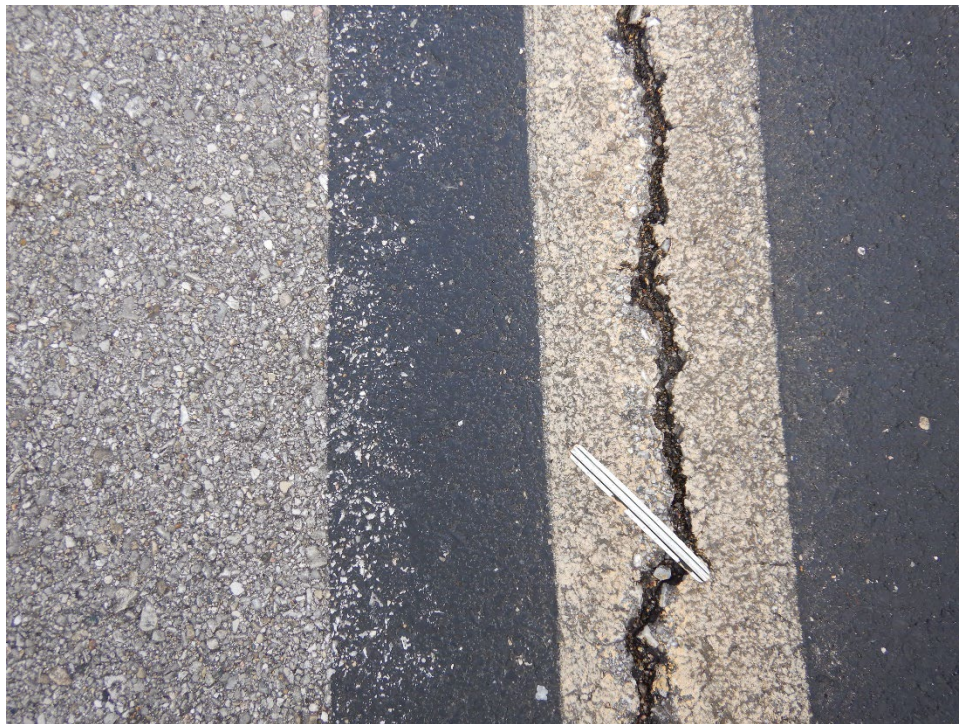
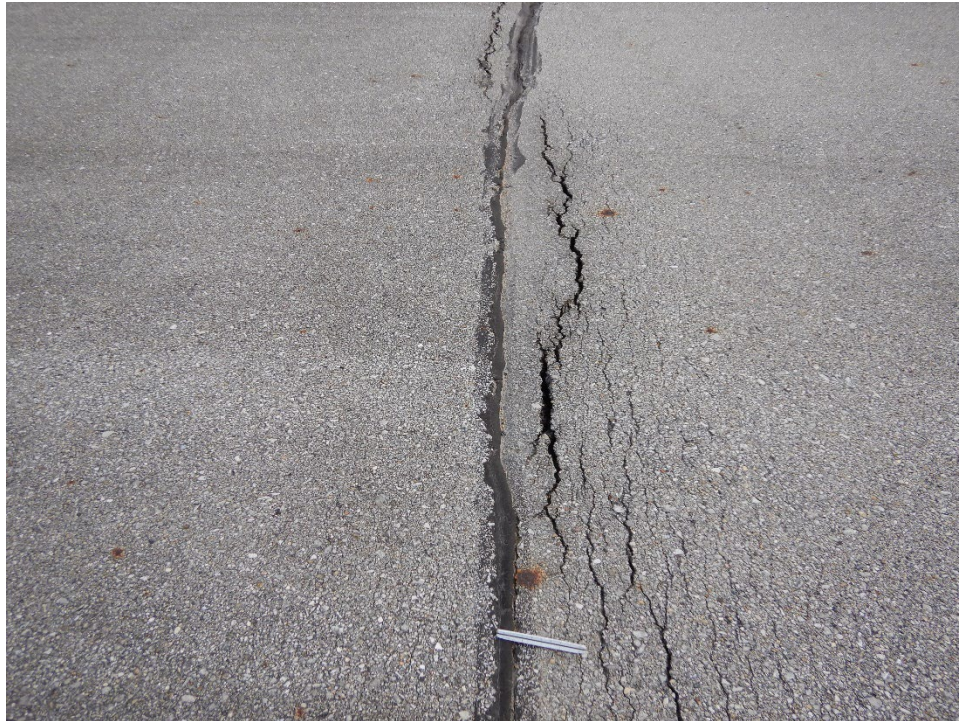
Taxiway 07 connected the Runway 32 approach to the parallel taxiway and was defined by one section that had areas of low-severity depression and weathering, all severities of L&T cracking, and high-severity raveling noted during the inspection. The low-severity L&T cracking was unsealed, while the medium-severity L&T cracking was recorded where either unsealed crack widths were greater than  $\frac{1}{4}$  in., secondary cracking had developed, or where crack sealant had failed. High-severity L&T cracking was recorded where secondary cracking exceeded 1 ft in width.

T07NE-01. L&T Cracking (Sample Unit No. 02) (1).

T07NE-01. L&T Cracking (Sample Unit No. 02) (2).

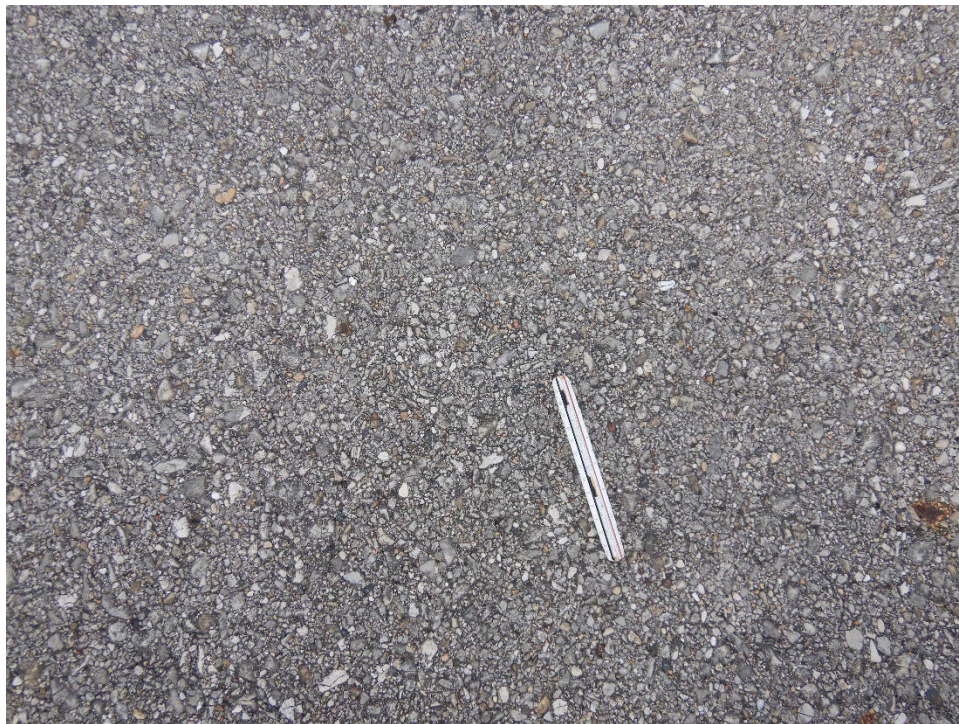
T07NE-01. Weathering (Sample Unit No. 02).

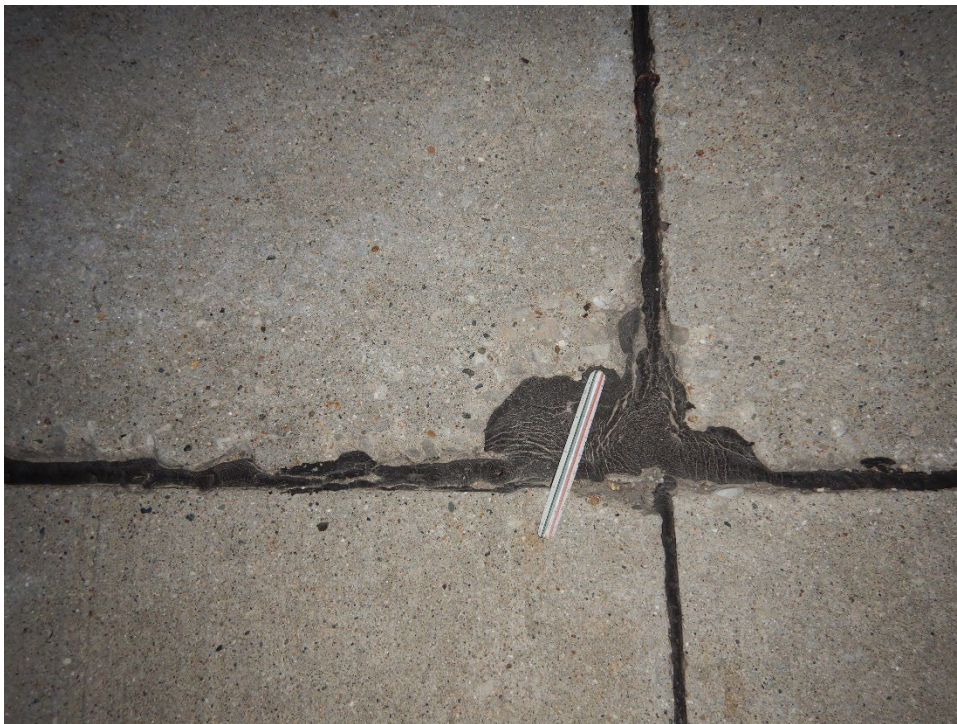
Taxiway 08 was divided into two sections. Medium-severity joint seal damage was identified throughout both sections. Additionally, medium-severity corner spalling was observed in Section 01.

T08NE-01. Corner Spalling (Sample Unit No. 01).

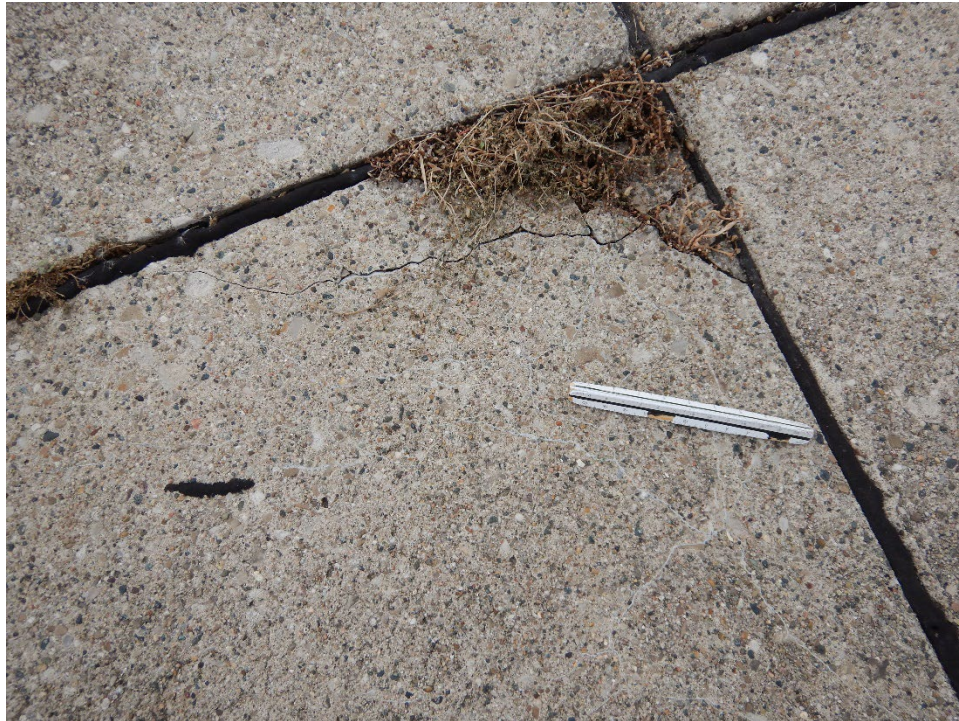
T-hangar 01 consisted of one section that contained low- and medium-severity ASR and LTD cracking, medium-severity corner spalling, medium- and high-severity joint seal damage and joint spalling, and shrinkage cracking.

TH01NE-01. ASR (Sample Unit No. 02).

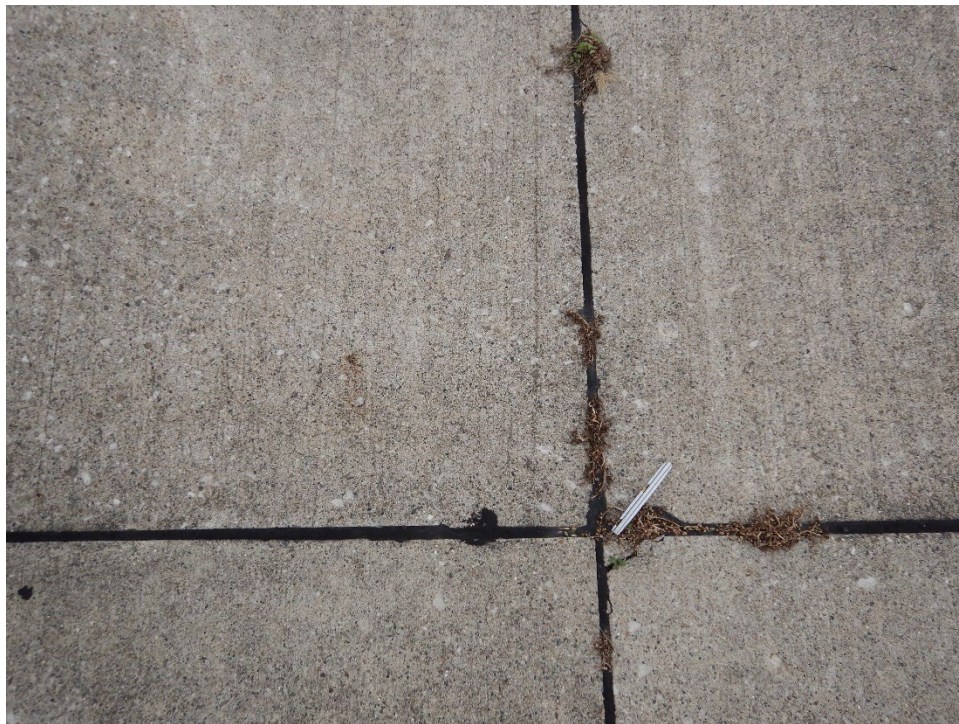
TH01NE-01. Joint Seal Damage (Sample Unit No. 02).

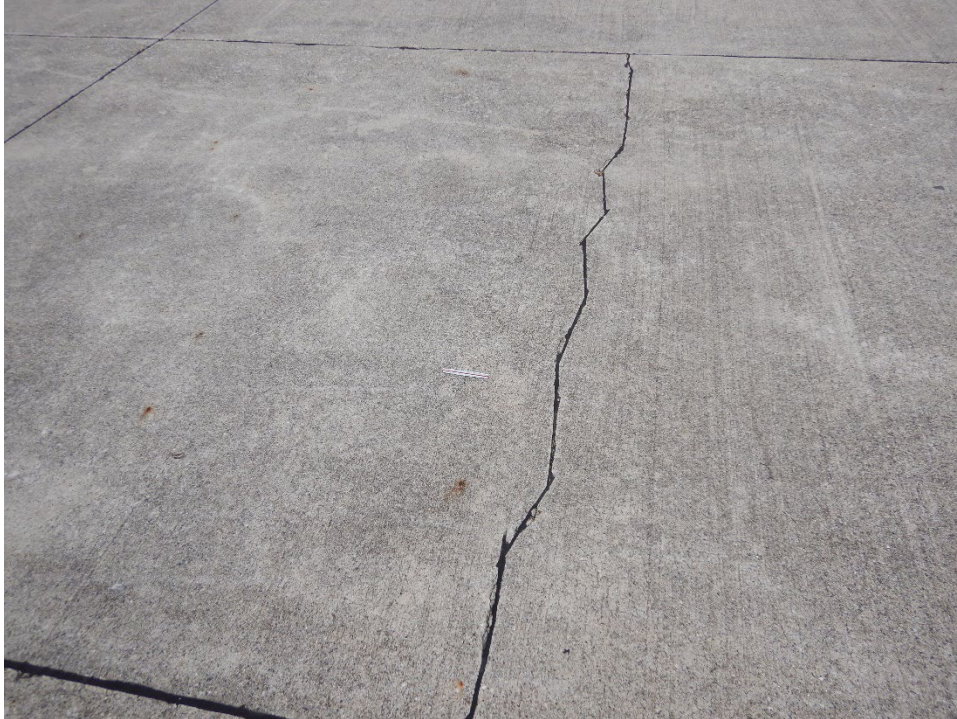
TH01NE-01. LTD Cracking (Sample Unit No. 02).

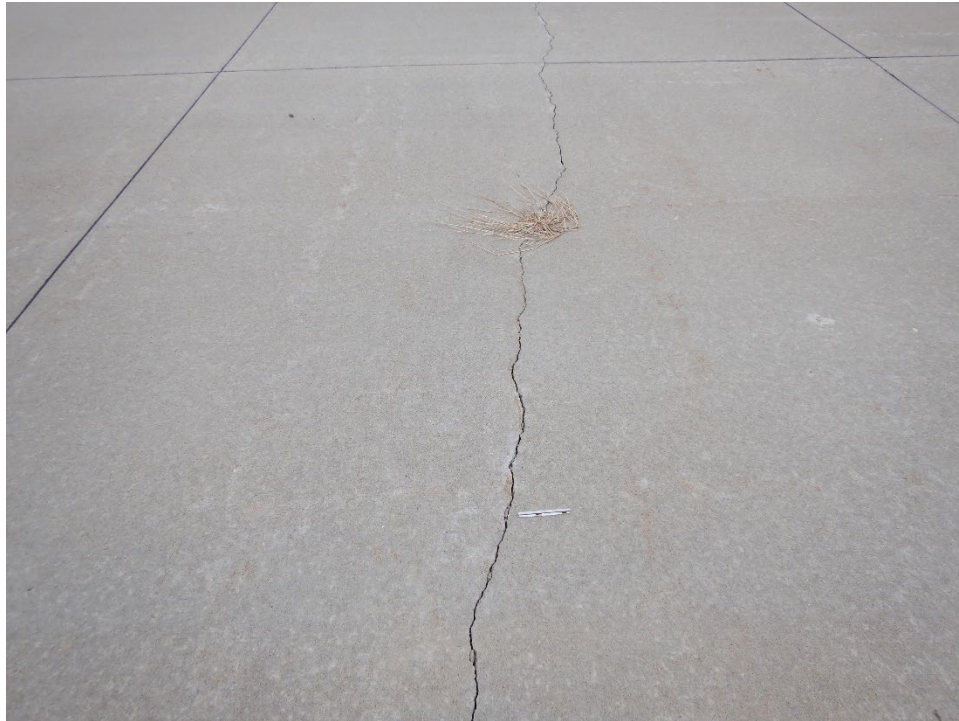
T-hangar 02 was defined by one section. Low-severity faulting, medium-severity joint seal damage, low- and medium-severity LTD cracking and small patching, and shrinkage cracking were recorded in Section 01.

TH02NE-01. LTD Cracking (Sample Unit No. 01).

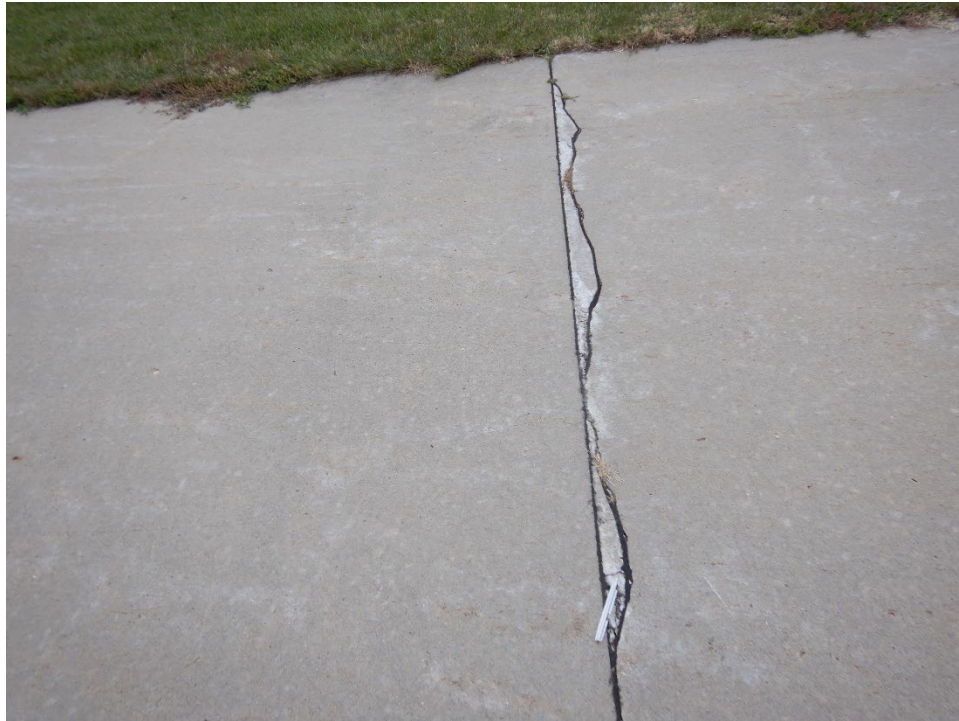
T-hangar 03 contained one section. Section 01 was in excellent condition with low-severity faulting, joint seal damage, and LTD cracking; low- and medium-severity joint spalling; and shrinkage cracking observed during the inspection.

TH03NE-01 Joint Spalling (Sample Unit No. 09).
