Northeast Iowa Regional Airport

Pavement Management Report

JULY 2023

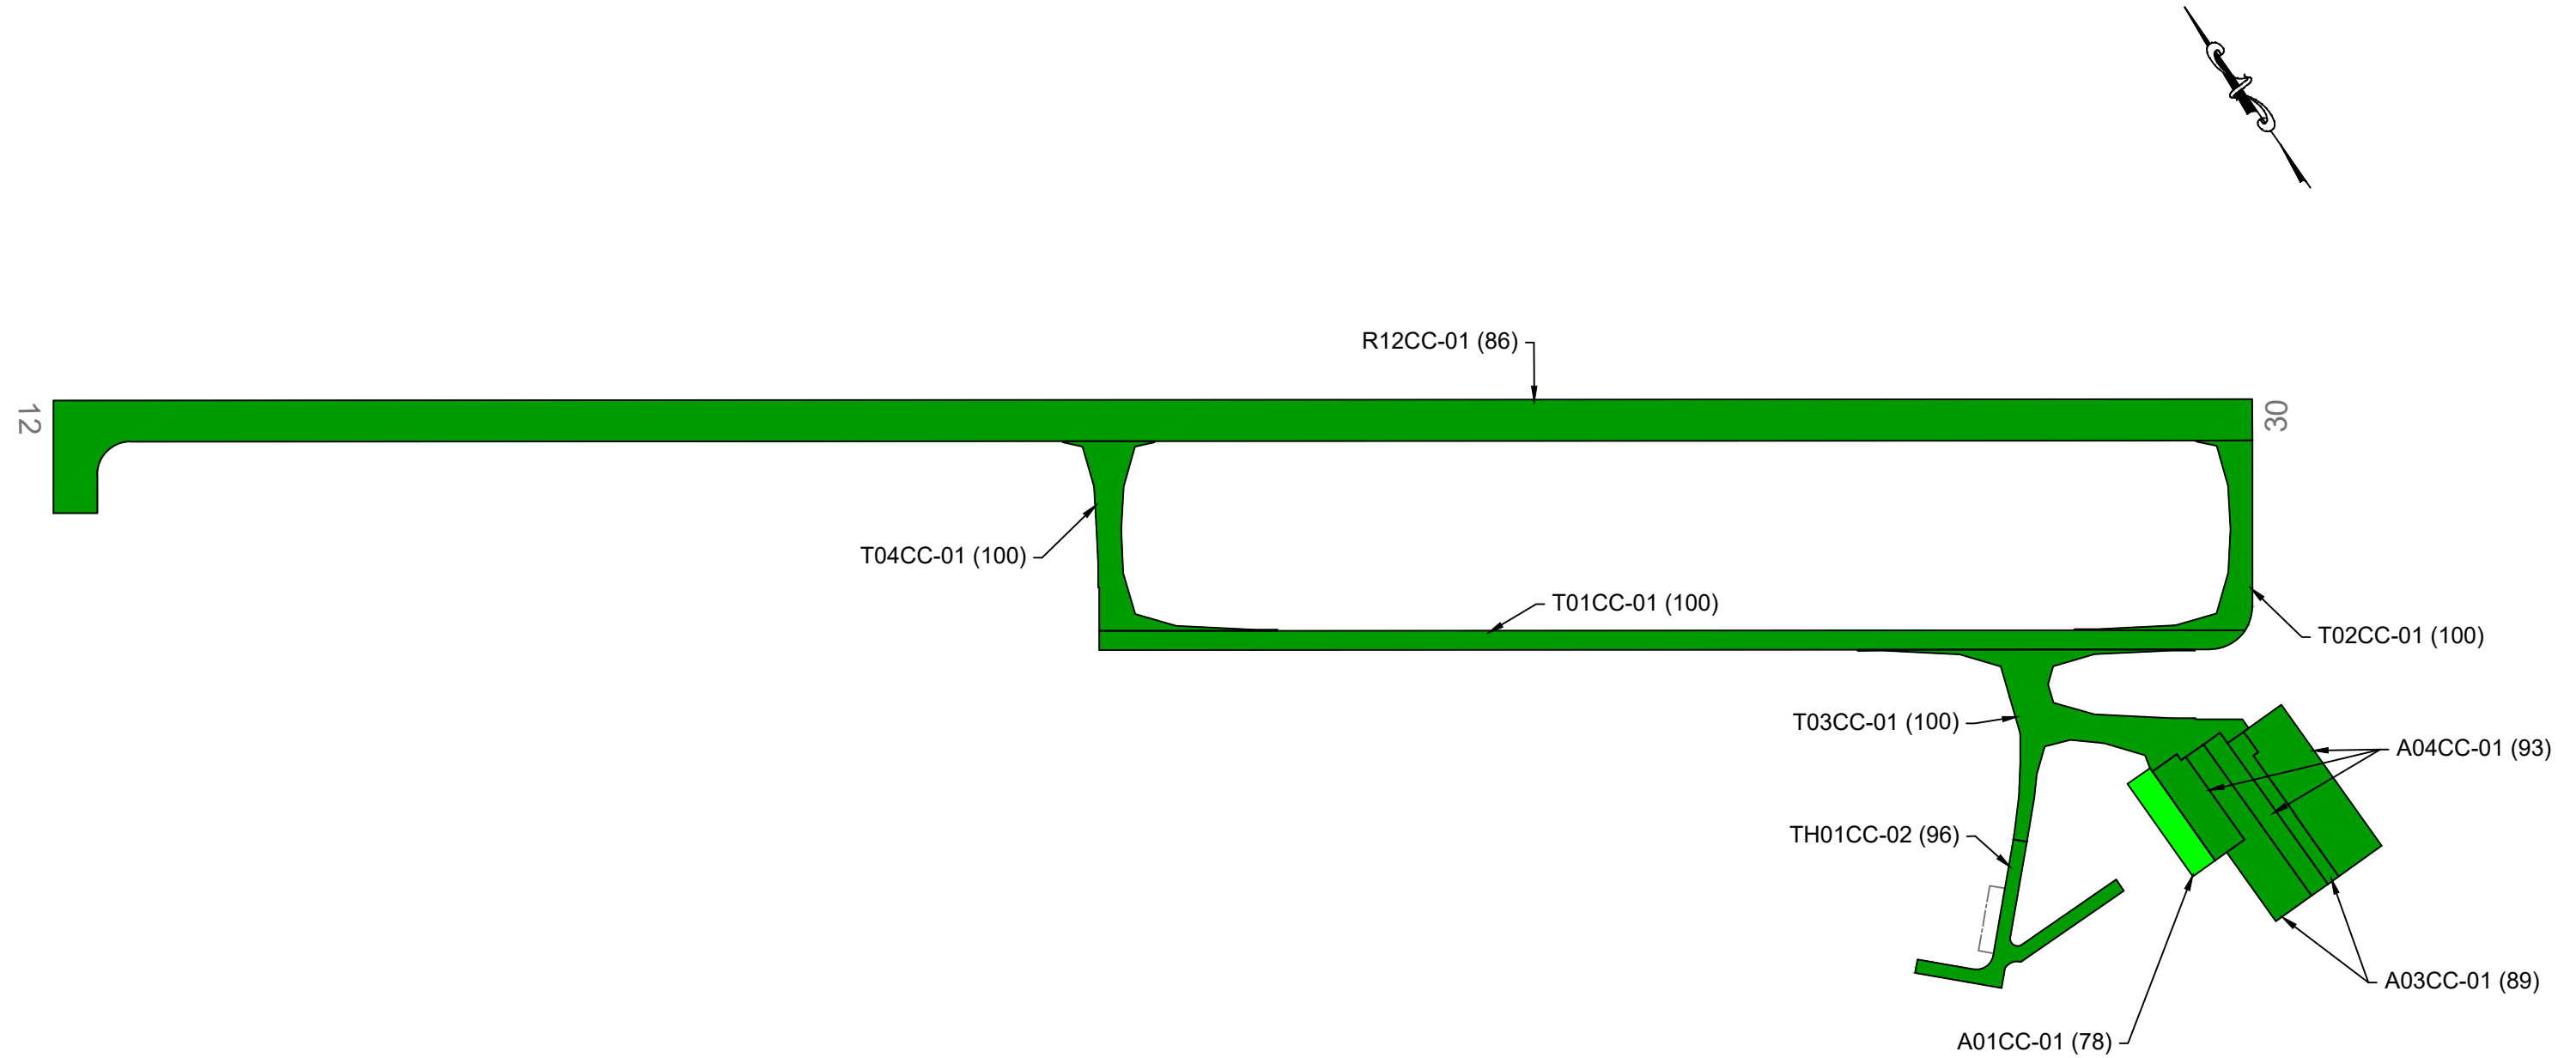
FIGURE 8. PCI MAP.

The pavements at Northeast Iowa Regional Airport were inspected in November 2022. The 2022 area-weighted condition of Northeast Iowa Regional Airport is 91, with conditions ranging from 78 to 100 (on a scale of 0 [failed] to 100 [excellent]). During the previous pavement inspection in 2019, the area-weighted PCI of the airport was 73.

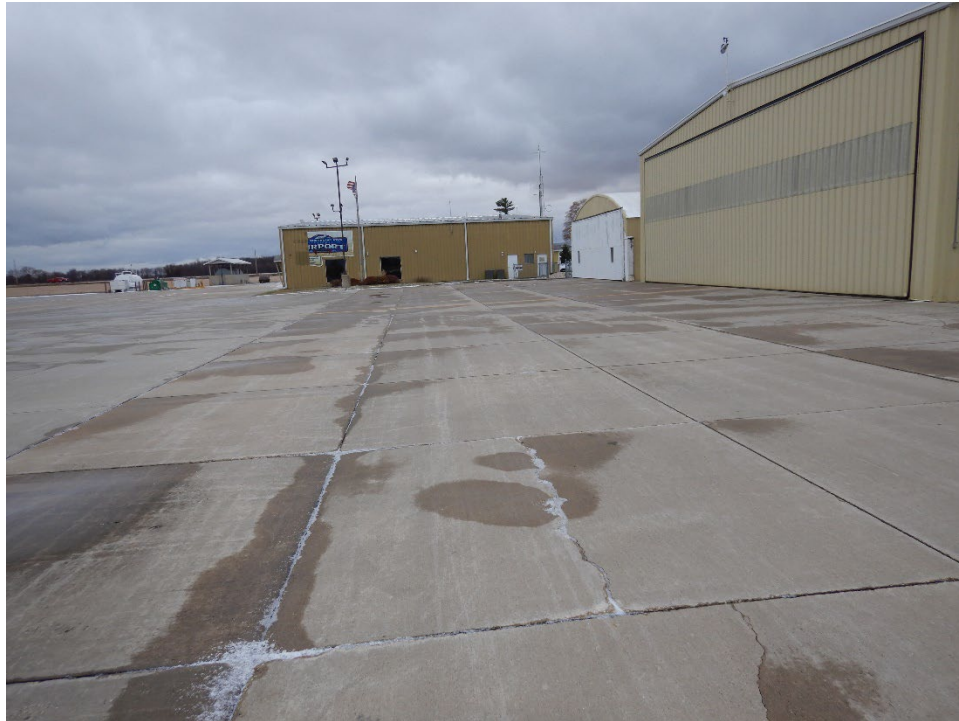
Apron 01 consisted of one section. Section 01 contained areas of low-severity small patching, corner spalling, and faulting; medium-severity LTD cracking and corner break; high-severity joint seal damage; low- and medium-severity joint spalling; and shrinkage cracking.

A01CC-01. Overview.

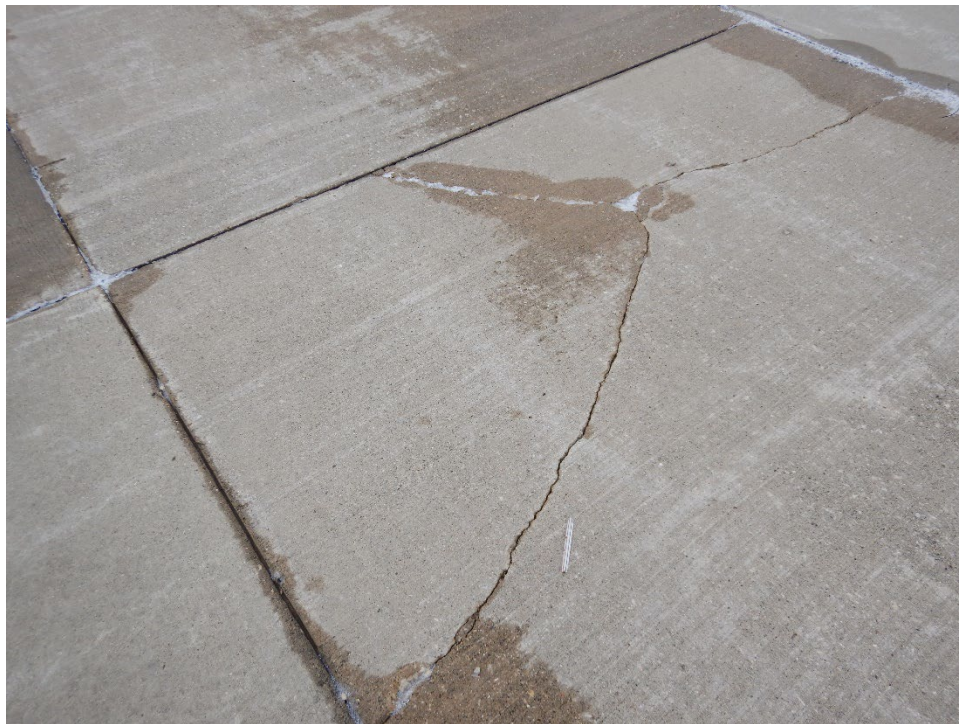
A01CC-01. LTD Cracking (Sample Unit No. 05).

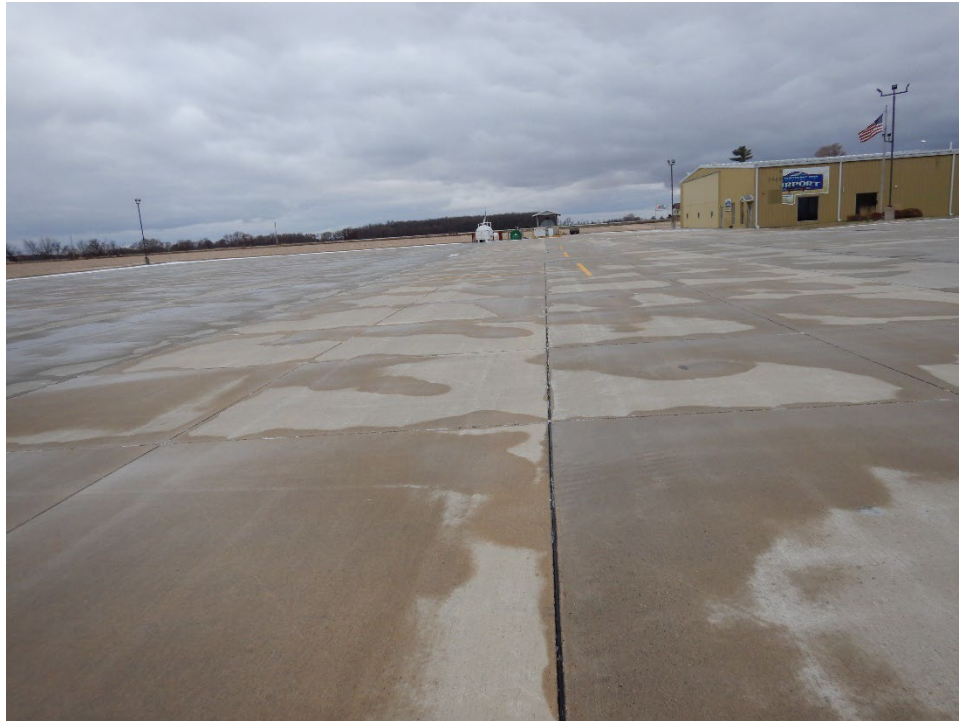
Apron 03 contained one section. Low-severity corner break, faulting, joint seal damage, joint spalling, LTD cracking, and shattered slab were observed in Section 01.

A03CC-01. Overview.

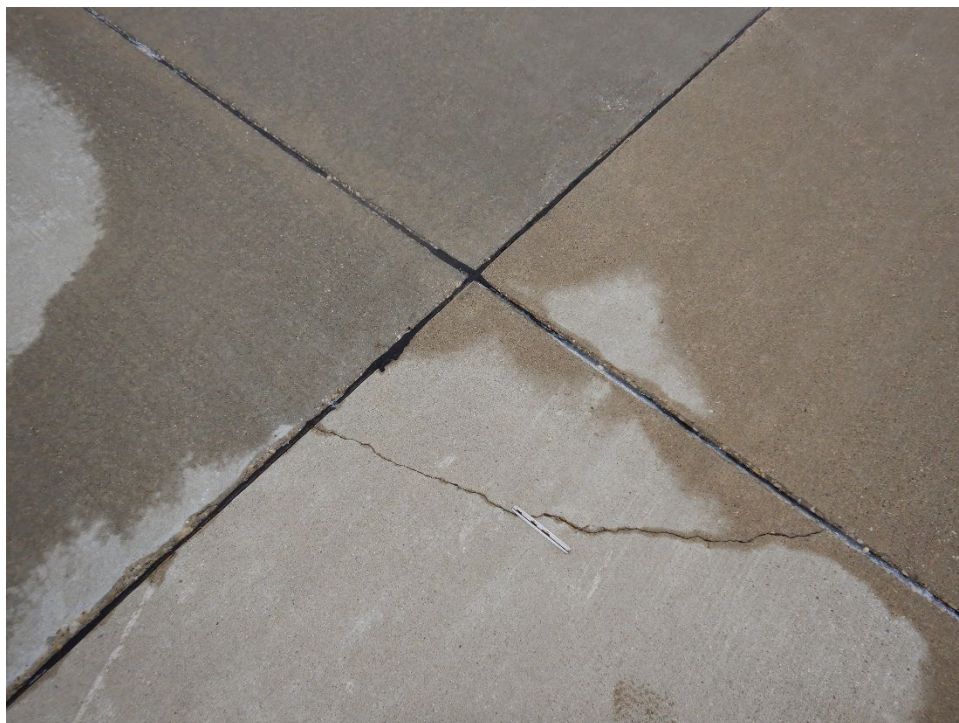
A03CC-01. Corner Break (Sample Unit No. 09).

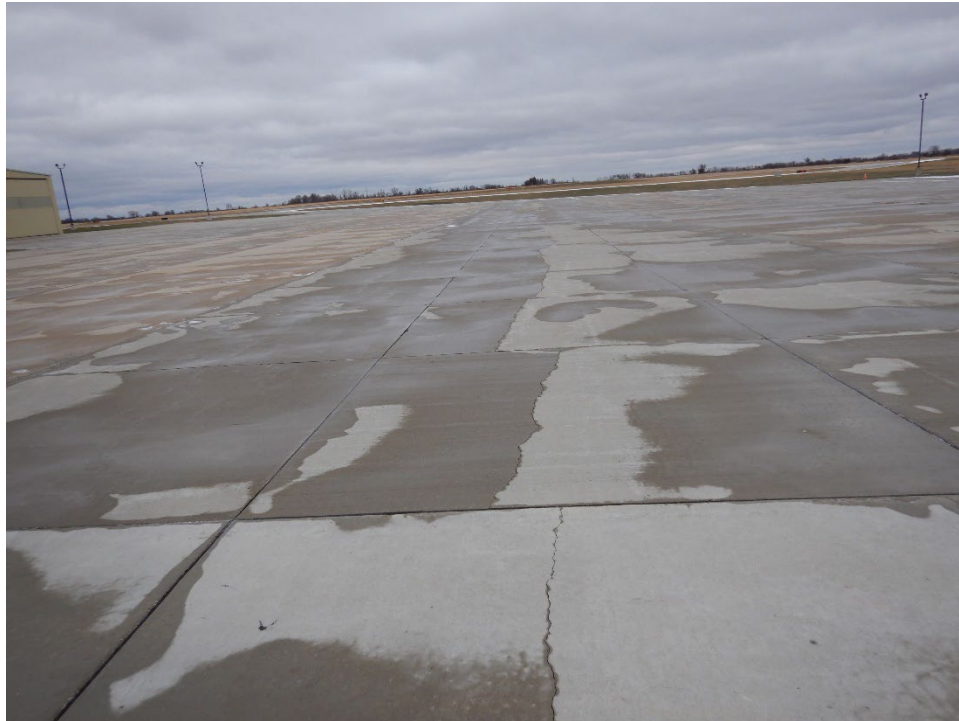
Apron 04 was defined by one section. Section 01 contained low-severity corner break, faulting, and LTD cracking at the time of inspection.

A04CC-01. Overview.

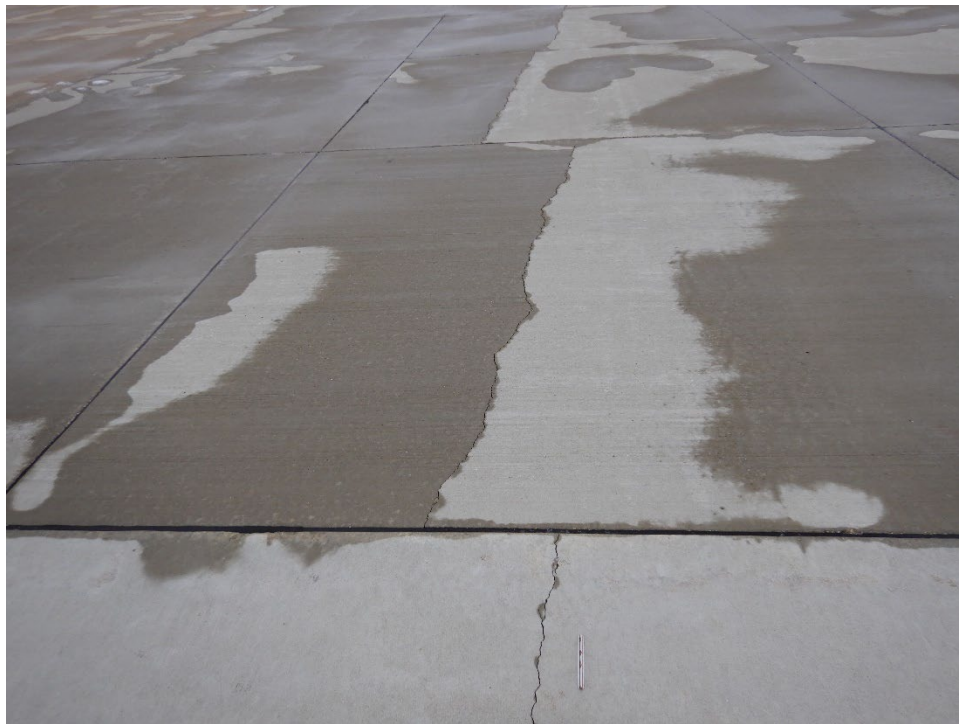
A04CC-01. LTD Cracking (Sample Unit No. 02).

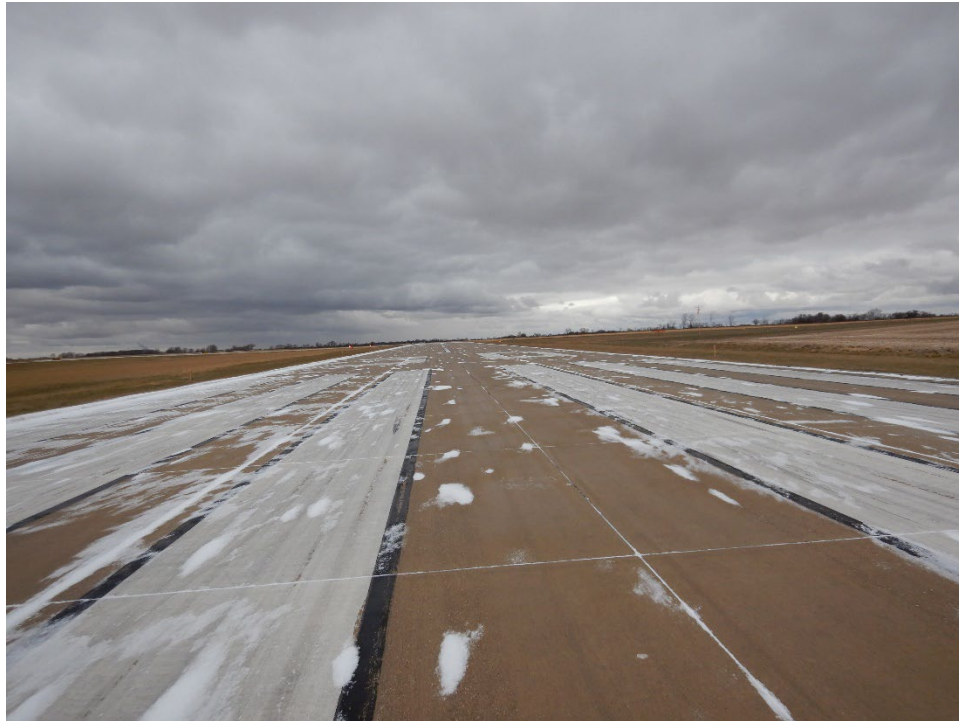
Runway 12/30 contained one section. Section 01 contained low-severity faulting and joint spalling; medium-severity joint seal damage and longitudinal, transverse, and diagonal (LTD) cracking; and low- and medium-severity corner spalling at the time of inspection.

R12CC-01. Overview.

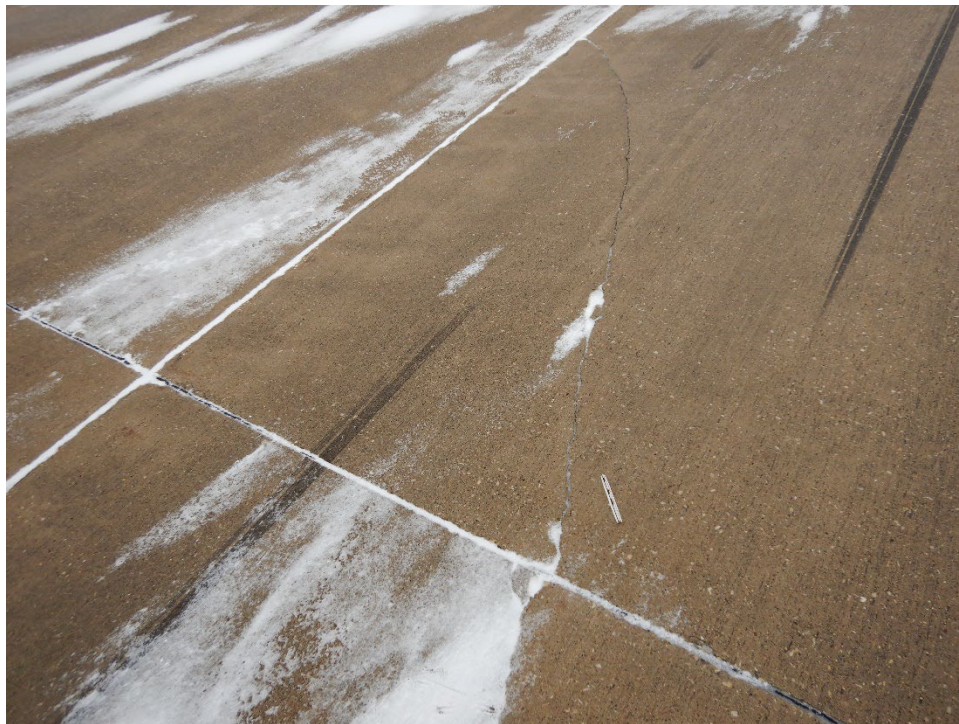
R12CC-01. LTD Cracking (Sample Unit No. 20).

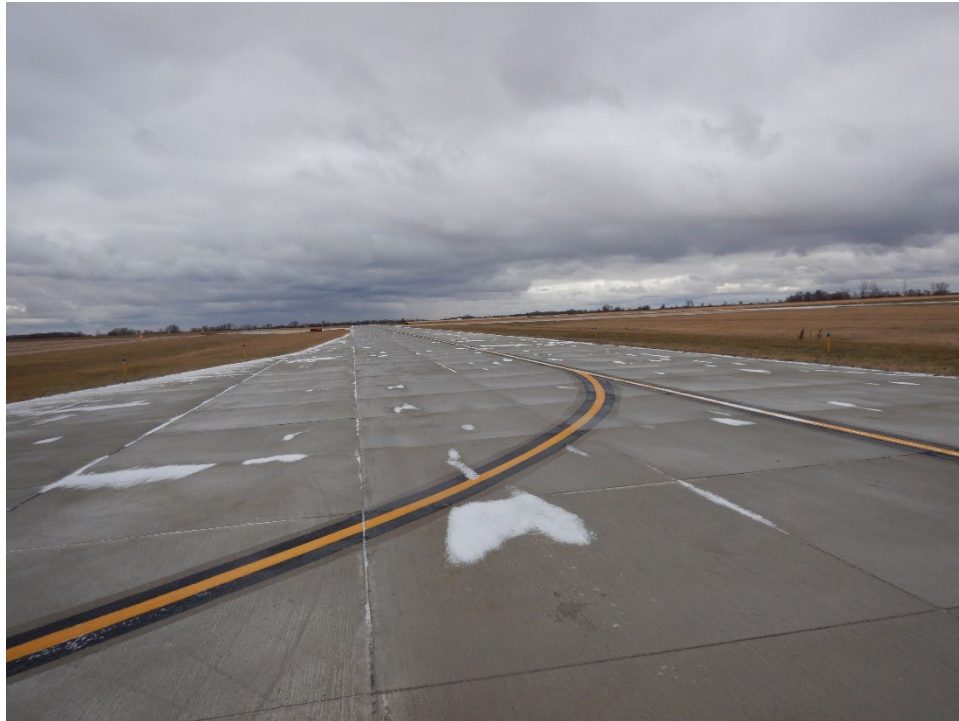
Taxiways 01, 02, 03, and 04 were each defined by one recently constructed section. All four sections were in excellent condition with no distress noted at the time of inspection.

T01CC-01. Overview.

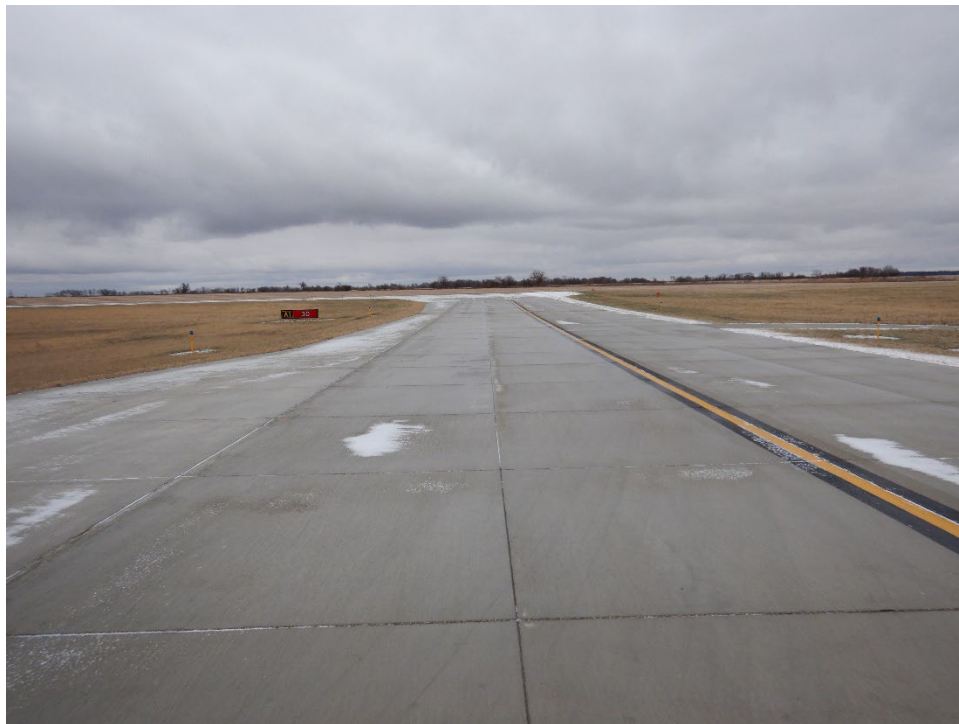
T02CC-01. Overview.

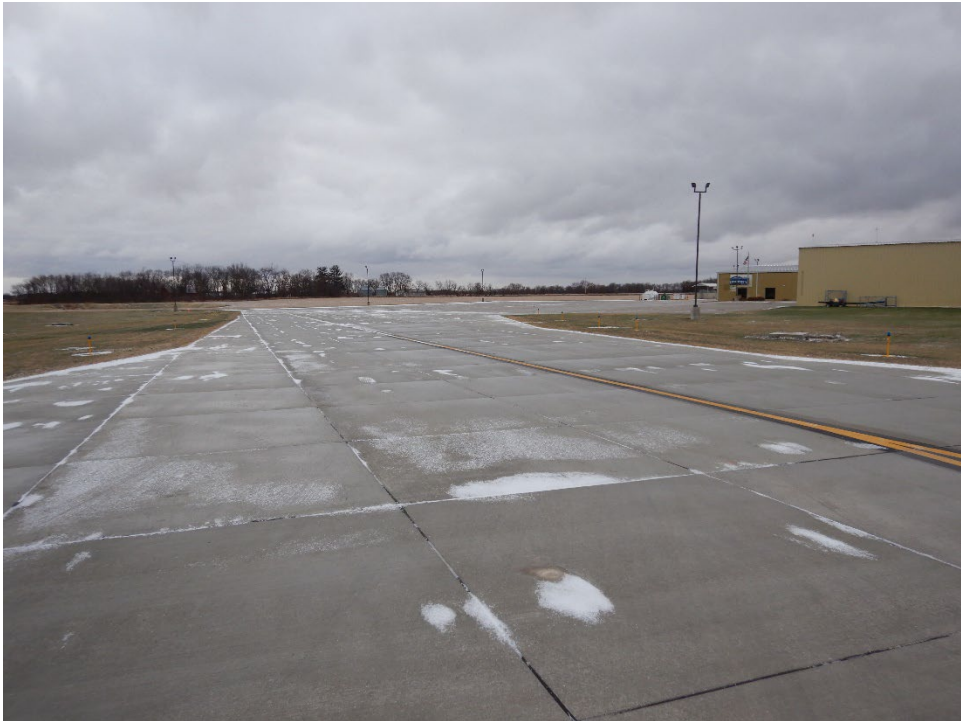
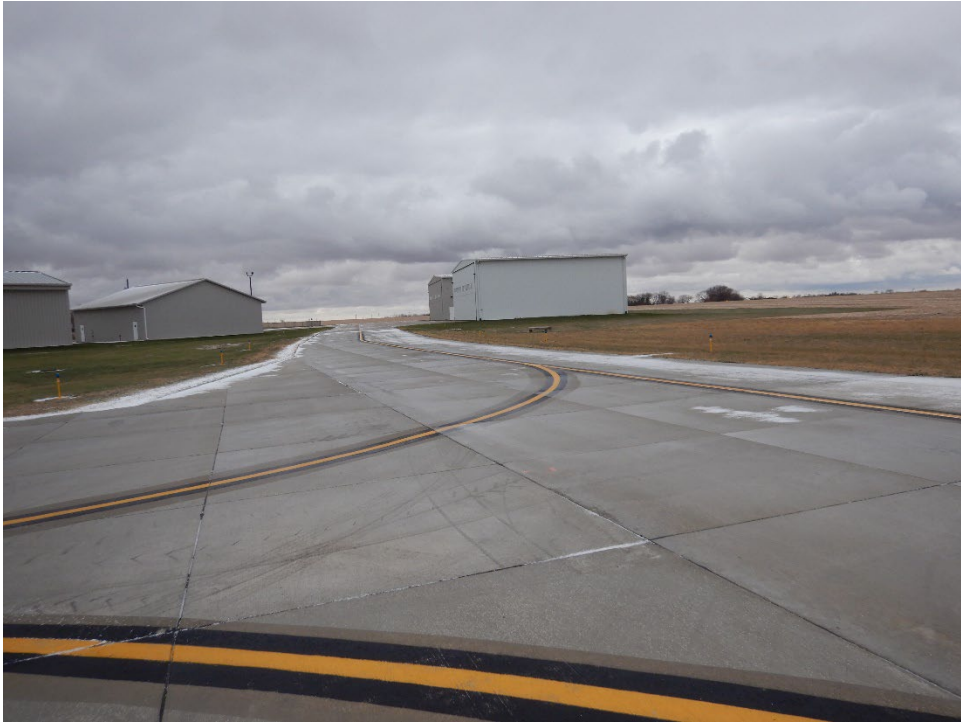
T03CC-01. Overview (1).

T03CC-01. Overview (2).

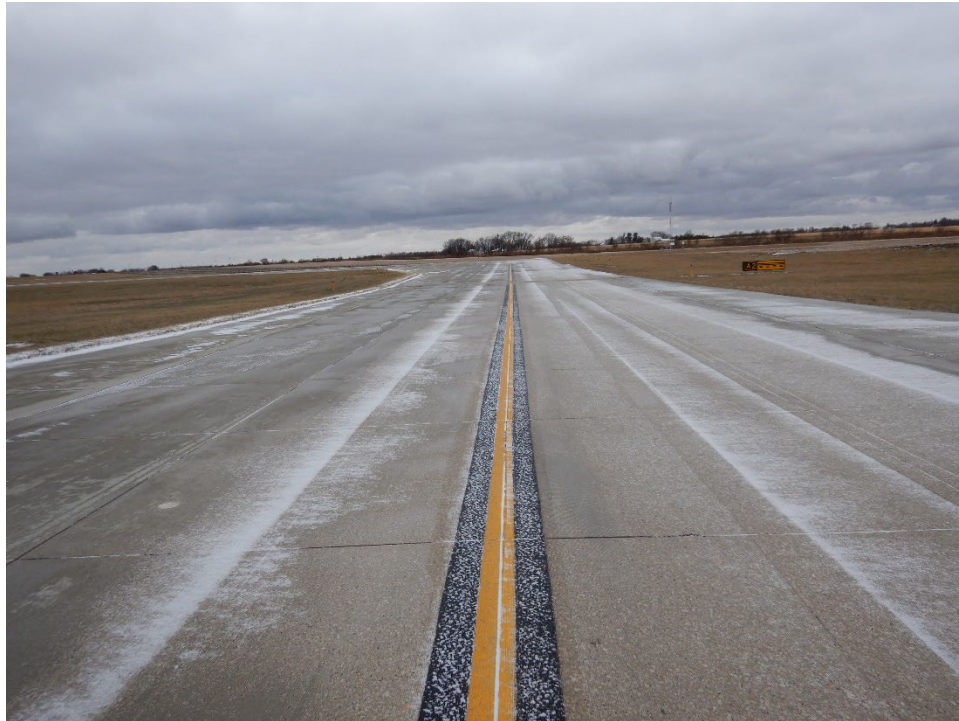
T04CC-01. Overview.

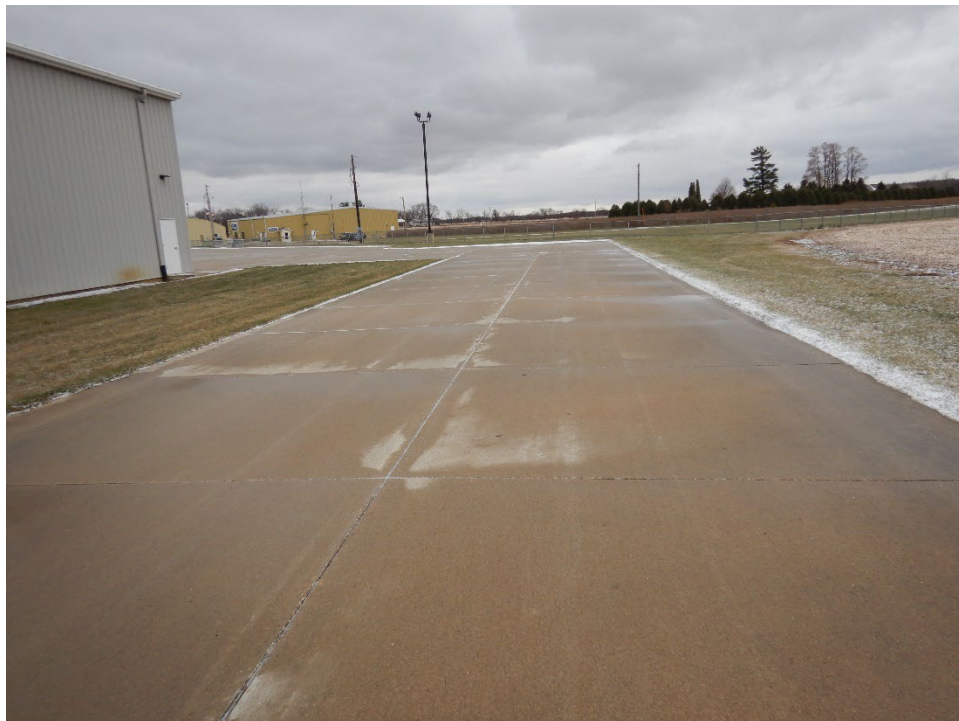
The T-hangar area contained one section. Section 02 was in excellent condition with low-severity corner break, corner spalling, joint seal damage, joint spalling, and small patching identified during the inspection.

TH01CC-02. Overview.

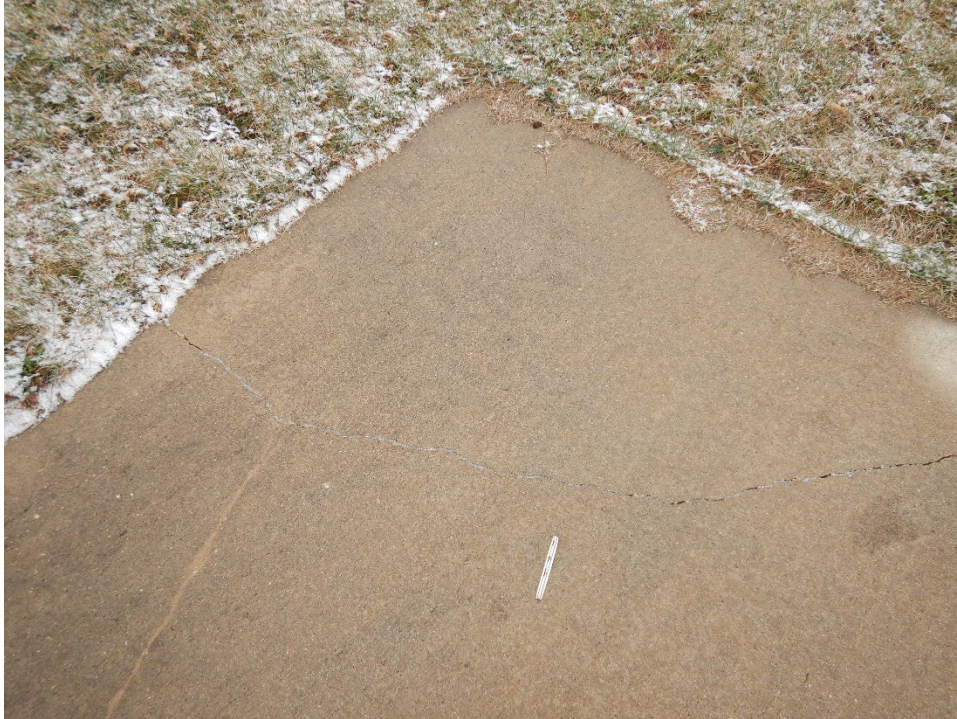
TH01CC-02. Corner Break (Sample Unit No. 05).
