Oelwein Municipal Airport

Pavement Management Report

JULY 2023

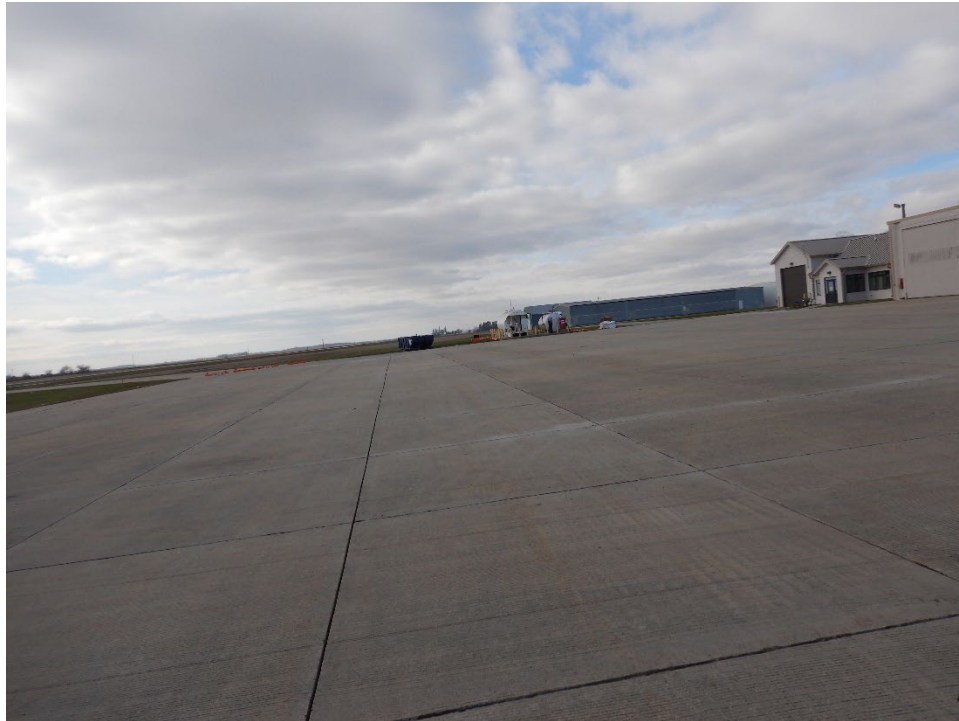
A01OE-01. Overview.

The apron area consisted of one section. Section 01 contained areas of low-severity small patching, corner spalling, faulting, joint spalling, and large patching; medium-severity corner break; and low- and medium-severity LTD cracking.

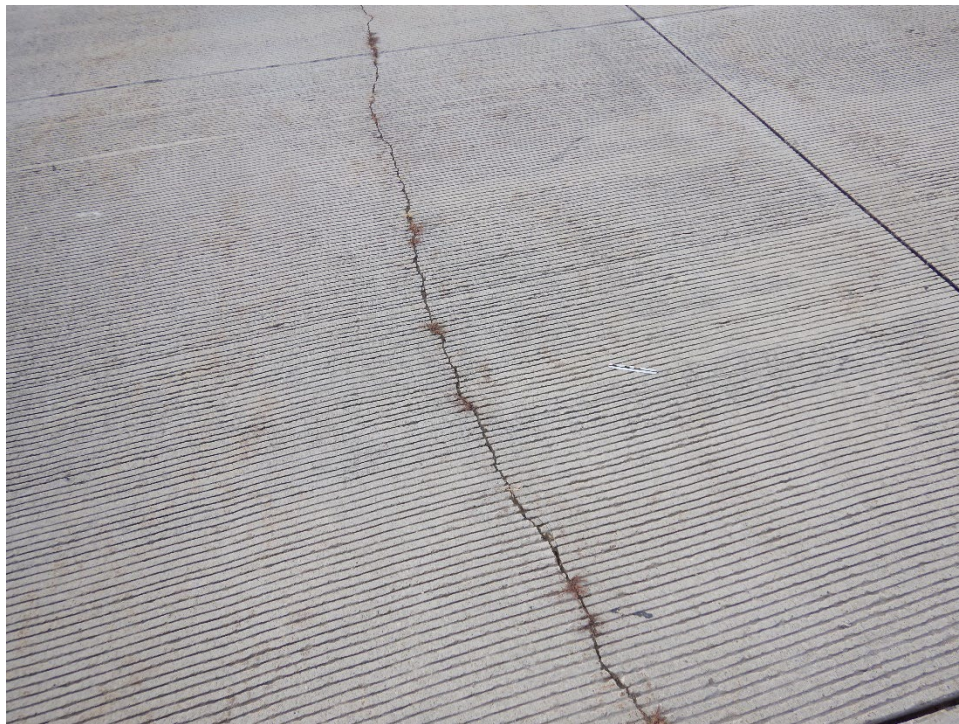
A01OE-01. LTD Cracking (Sample Unit No. 03).

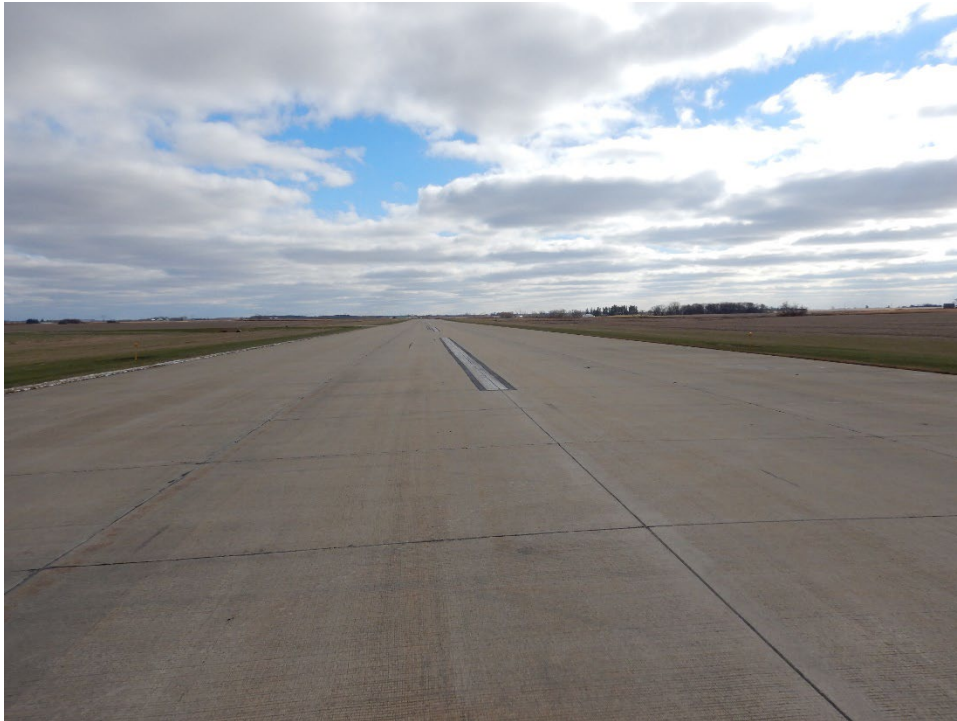
R13OE-01. Overview.

Runway 13/31 contained one section. Section 01 was in excellent condition with low-severity corner spalling, faulting, joint spalling, large patching, and small patching noted during the inspection.

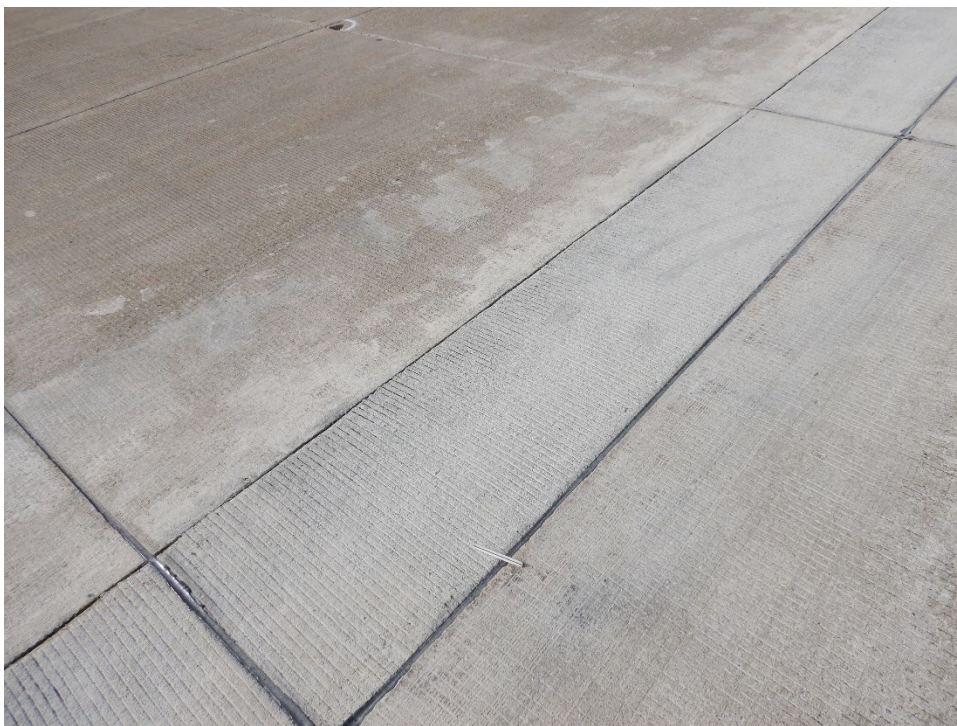
R13OE-01. Large Patching (Sample Unit No. 44).

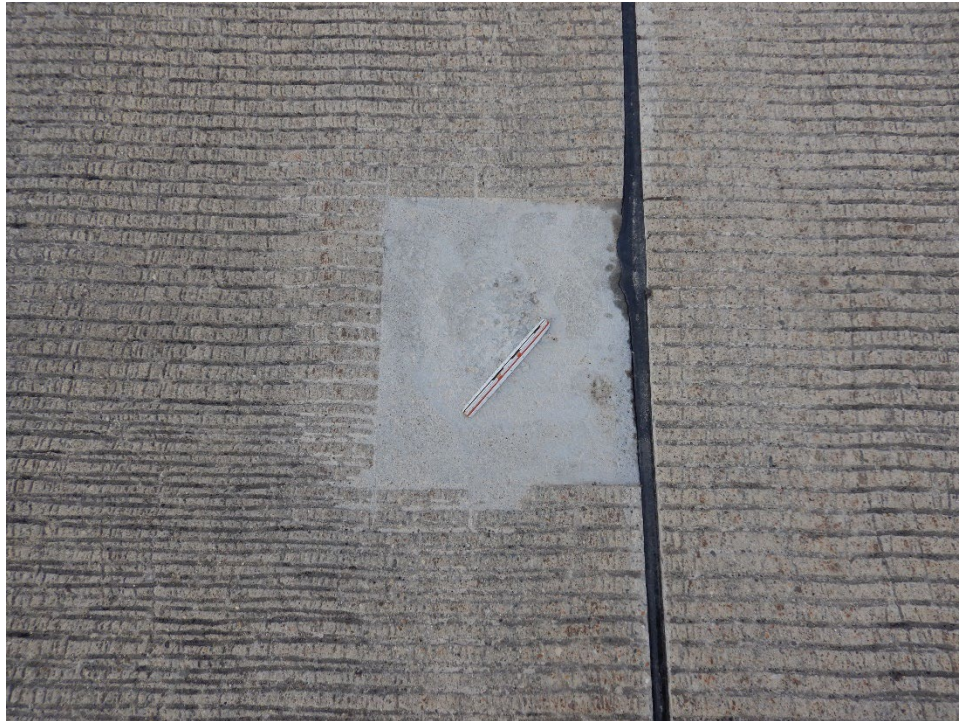
R13OE-01. Small Patching (Sample Unit No. 08).

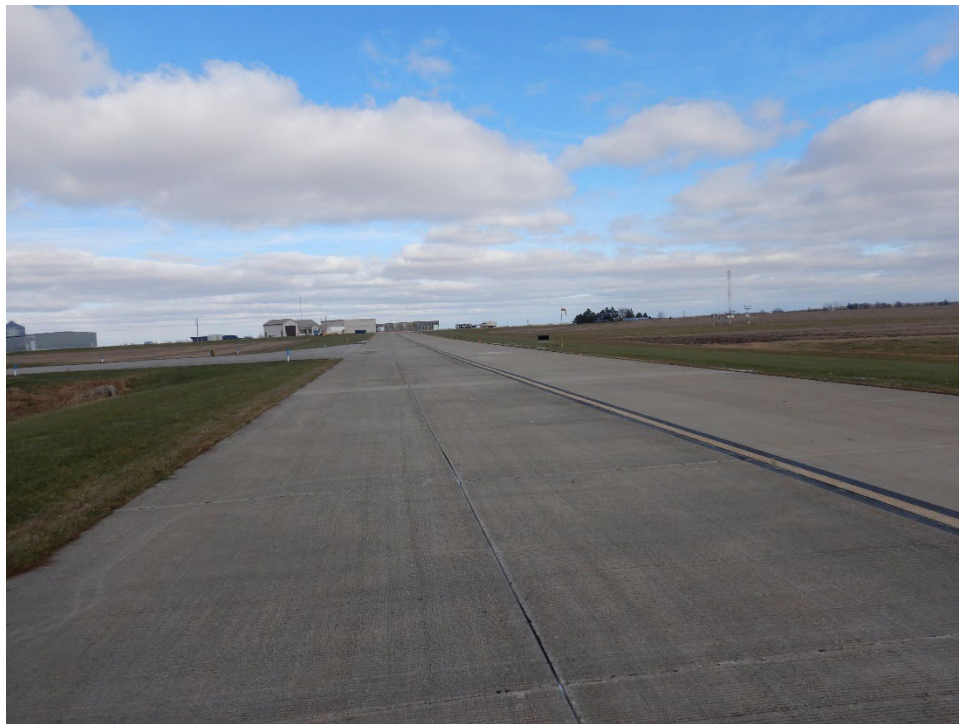
T01OE-01. Overview.

Taxiway 01 was defined by two sections. Section 01 contained areas of low-severity joint spalling, large patching, and small patching; low- and high-severity corner spalling; and medium-severity longitudinal, transverse, and diagonal (LTD) cracking. Areas of low-severity longitudinal and transverse (L&T) cracking and weathering were observed in Section 02. The low-severity cracking in Section 02 was unsealed.

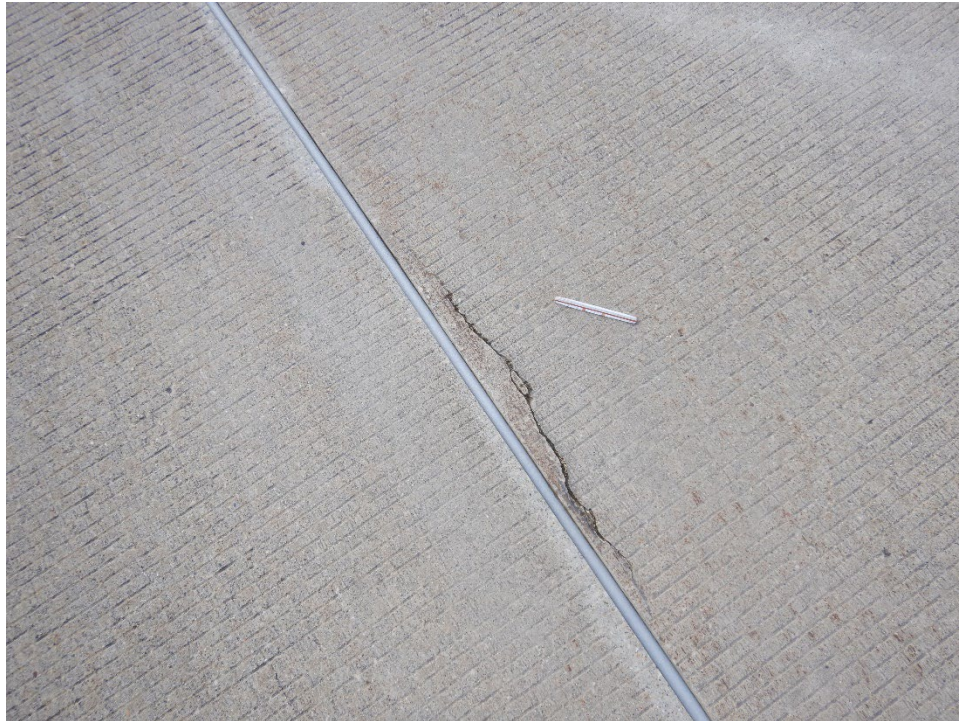
T01OE-01. Joint Spalling (Sample Unit No. 07).

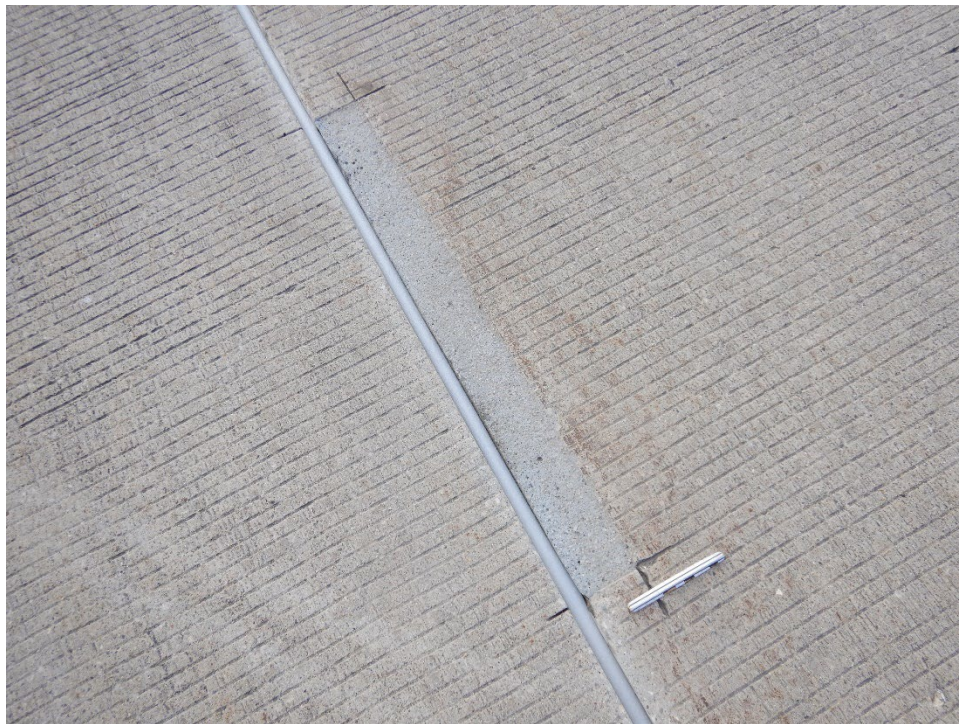
T01OE-01. Small Patching (Sample Unit No. 07).

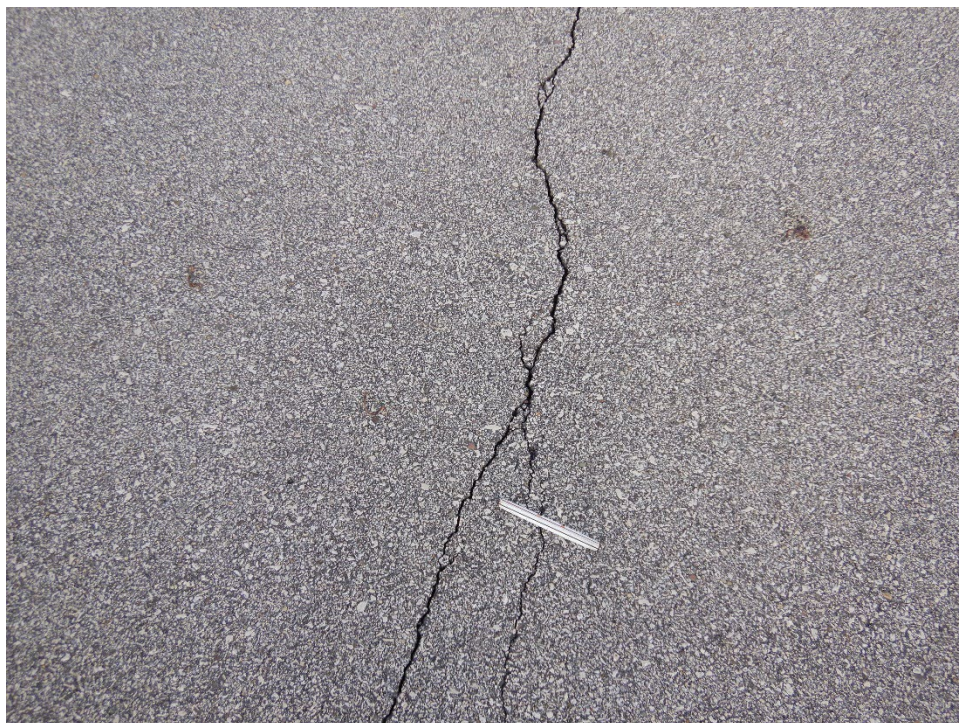
T01OE-02. L&T Cracking (Sample Unit No. 05).

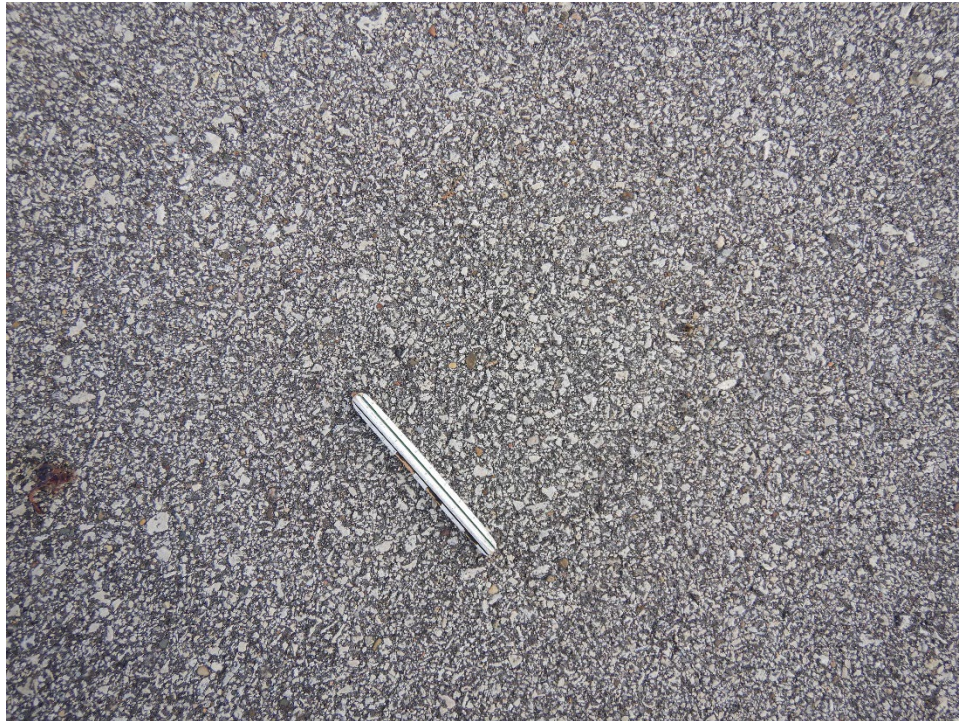
T01OE-02. Weathering (Sample Unit No. 05).

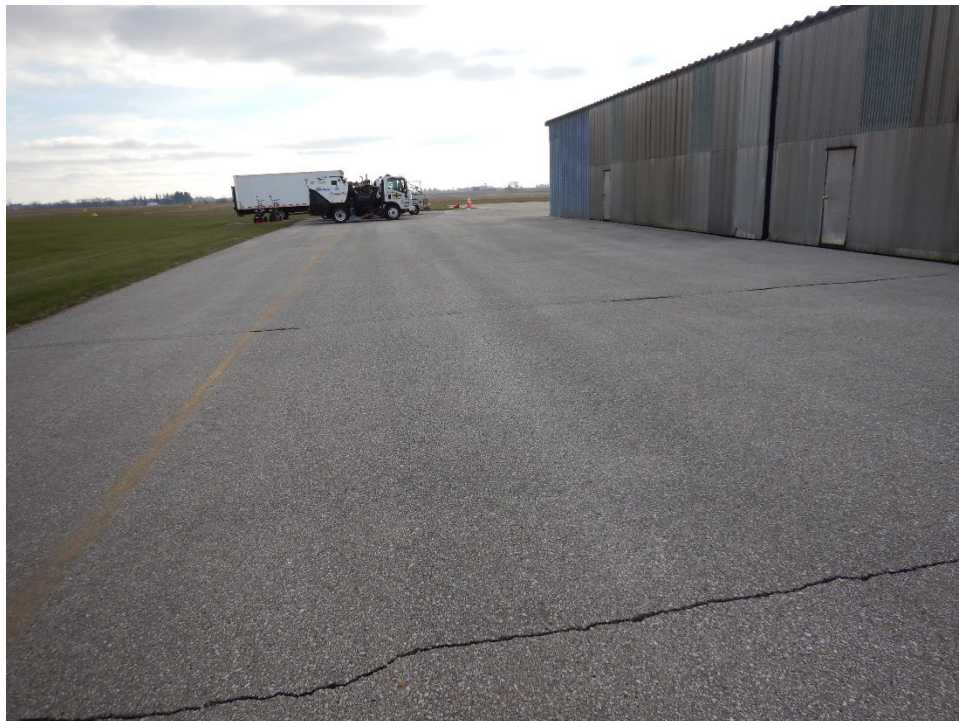
TH01OE-01. Overview.

The T-hangar area was defined by four sections. Medium-severity alligator cracking, low-severity block cracking, and low- and medium-severity L&T cracking and weathering were observed in Section 01. Section 02 contained low- and medium-severity L&T cracking and alligator cracking, high-severity depression and patching, low-severity rutting, and medium-severity weathering at the time of inspection. The low-severity cracking in Sections 01 and 02 was unsealed, and the medium-severity cracking was due to either the development of secondary cracking or unsealed crack widths that exceeded $\frac{1}{4}$ in. Medium-severity alligator cracking and weathering, low-severity block cracking, and low- and medium-severity L&T cracking were identified in Section 03. Section 04 contained areas of medium-severity corner break and corner spalling, high-severity joint seal damage, and low- and medium-severity LTD cracking.

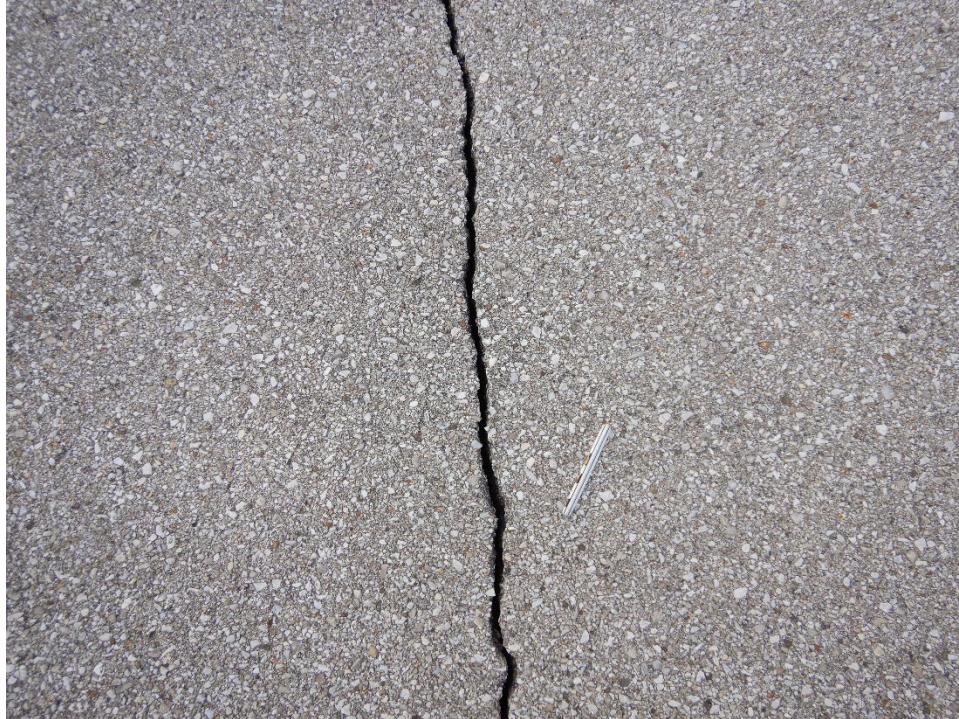
TH01OE-01. L&T Cracking (Sample Unit No. 02).

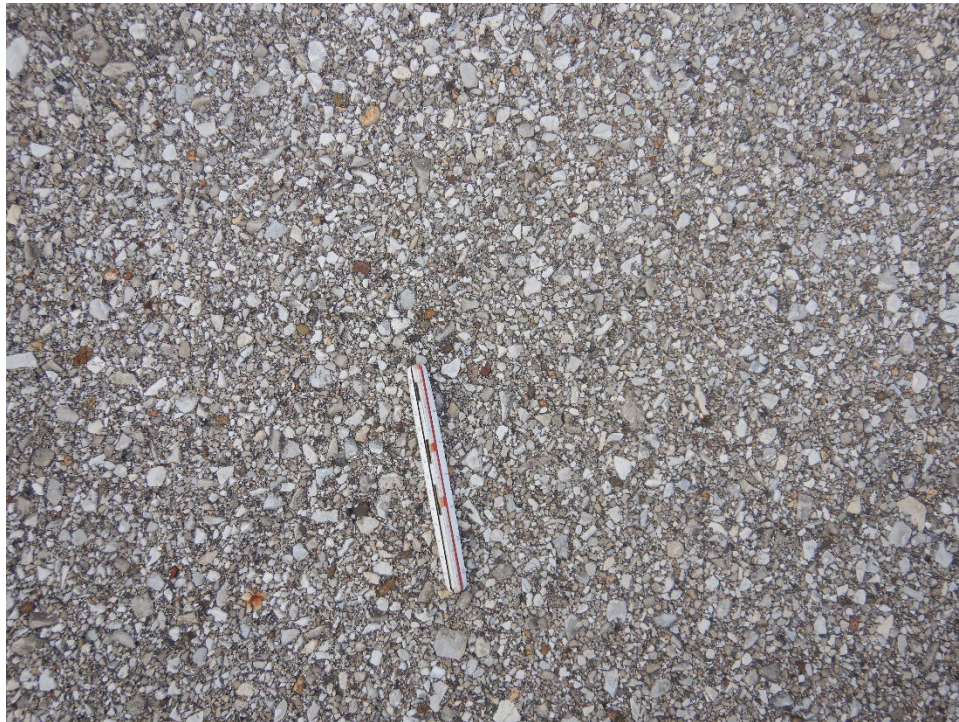
TH01OE-01. Weathering (Sample Unit No. 02).

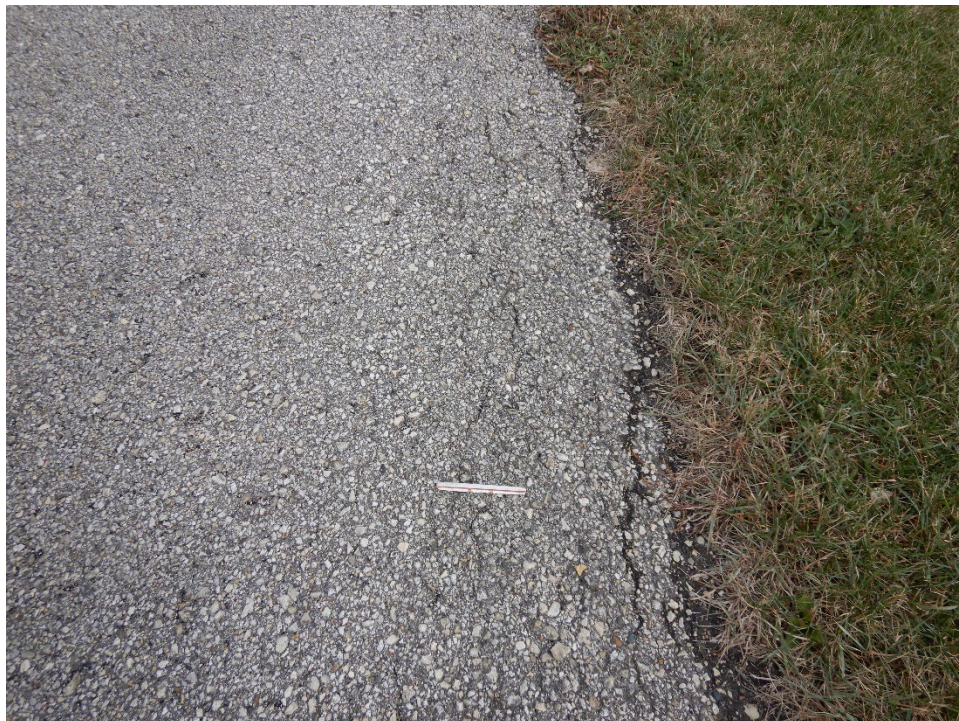
TH01OE-02. Alligator Cracking (Sample Unit No. 02).

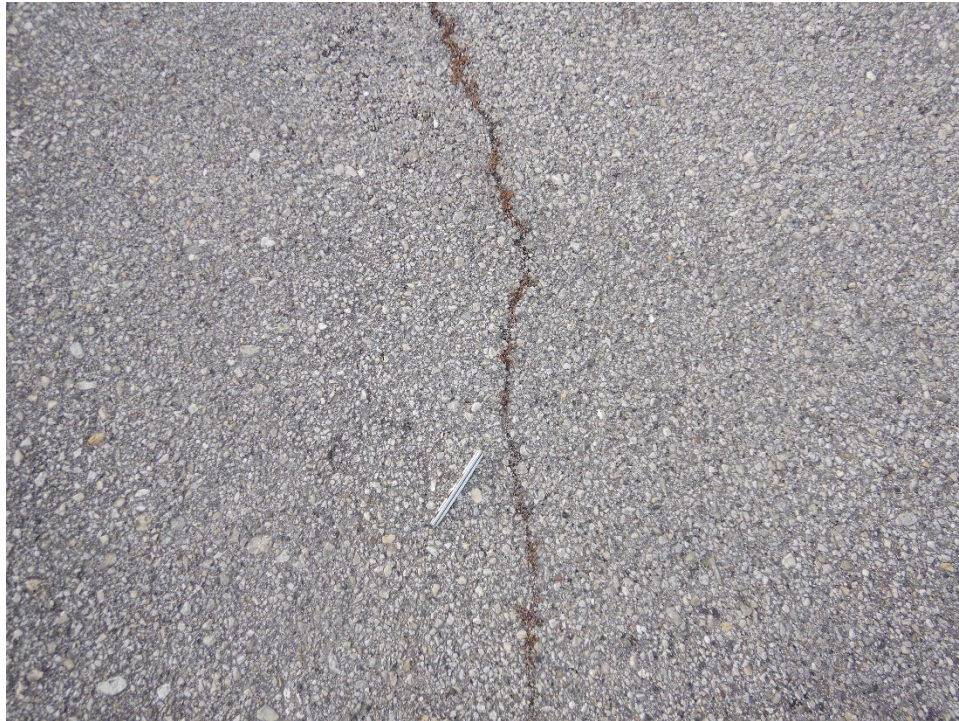
TH01OE-02. L&T Cracking (Sample Unit No. 02).

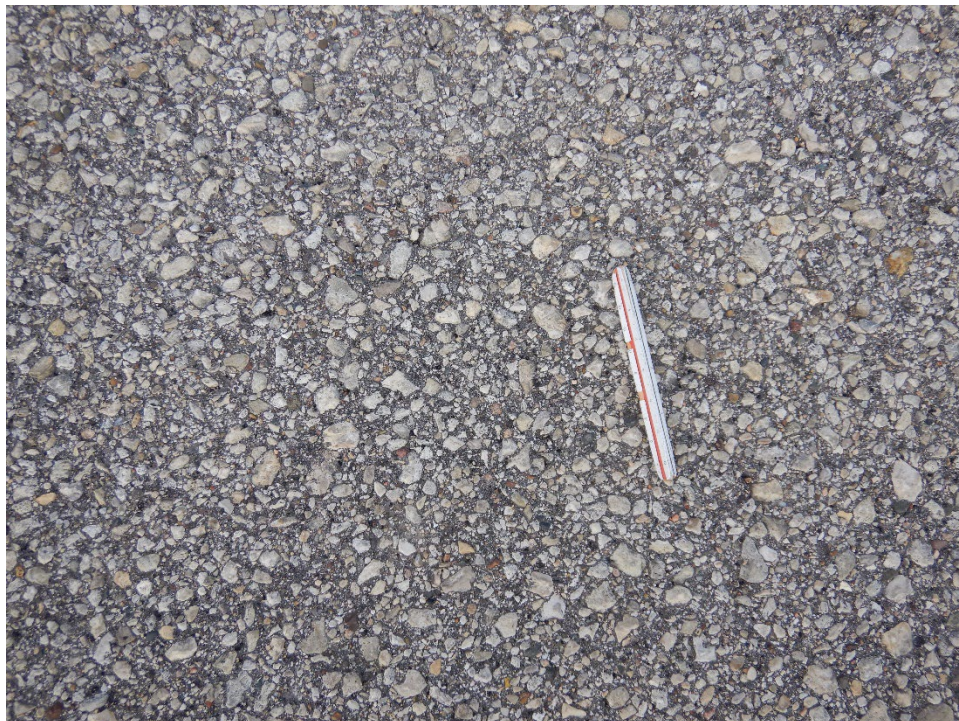
TH01OE-02. Weathering (Sample Unit No. 02).

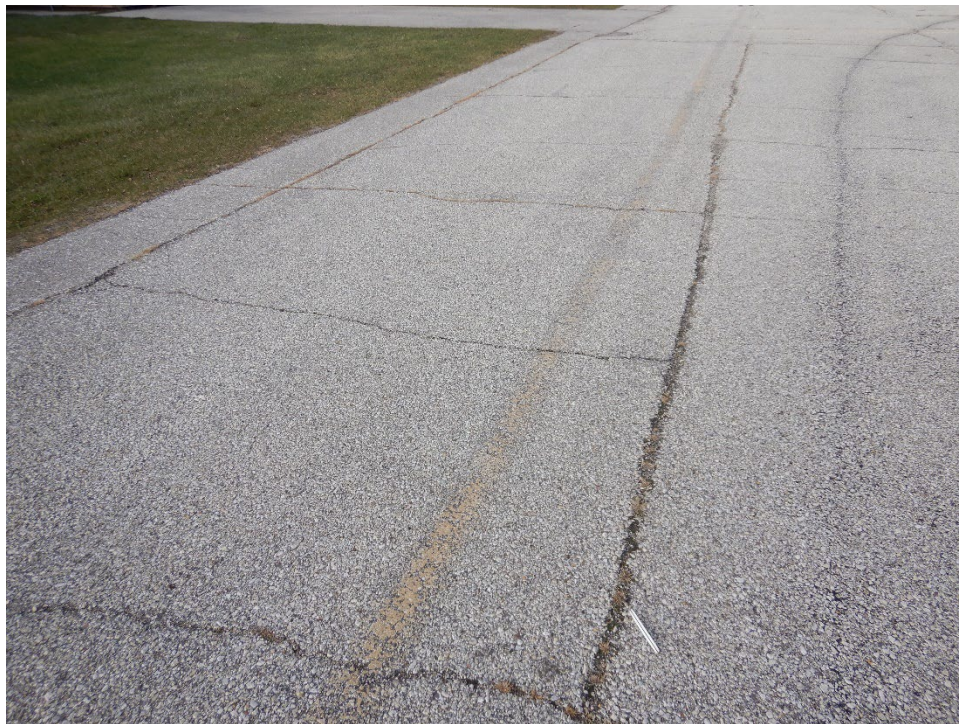
TH01OE-03. Block Cracking (Sample Unit No. 01).

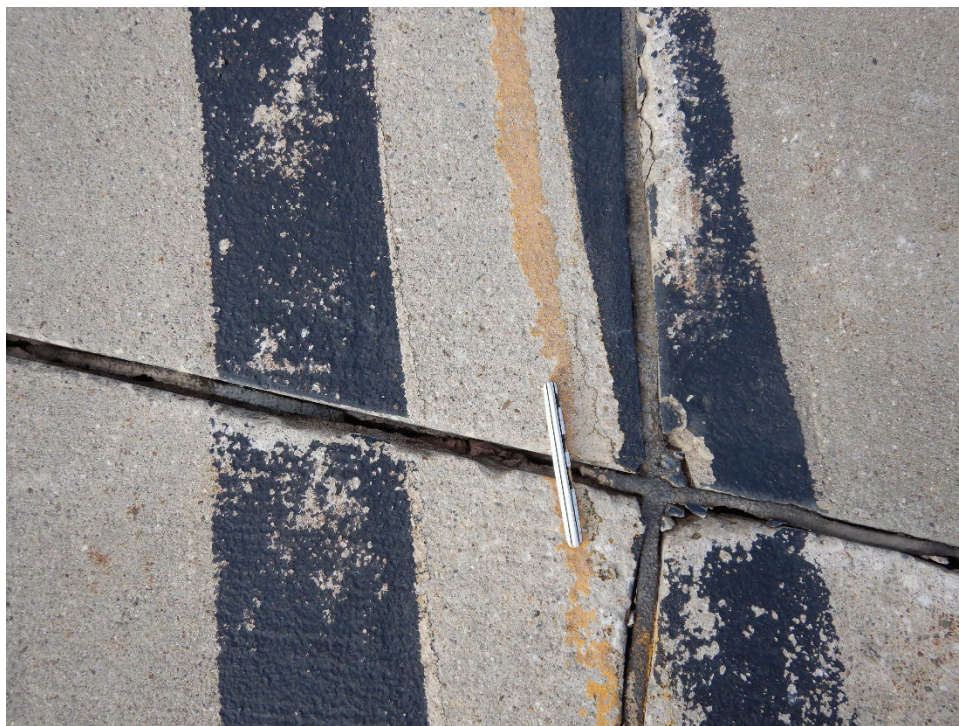
TH01OE-04. Joint Seal Damage (Sample Unit No. 01).

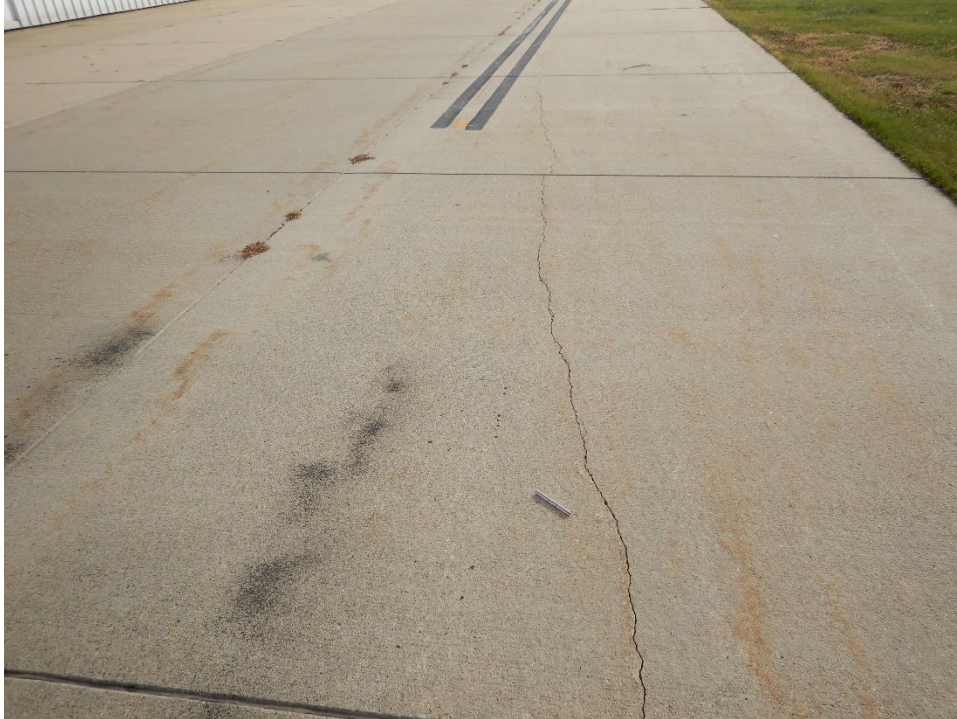
TH01OE-04. LTD Cracking (Sample Unit No. 01).
