# Osceola Municipal Airport

**PAVEMENT MANAGEMENT REPORT**

**AUGUST 2019**

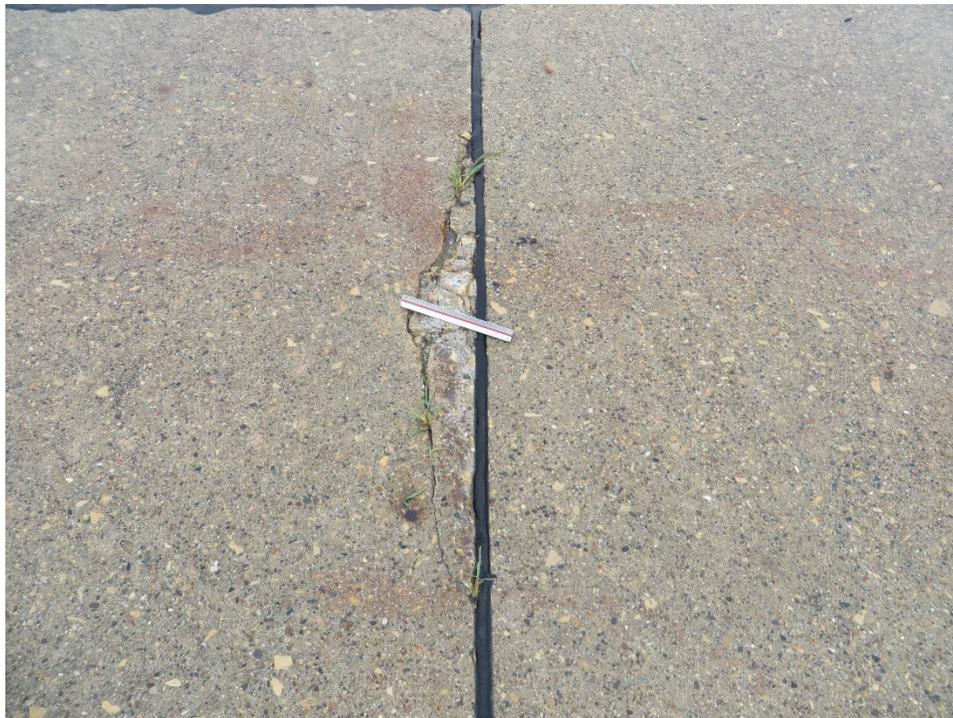
A01OA-01. Joint Spalling (Sample Unit No. 01).

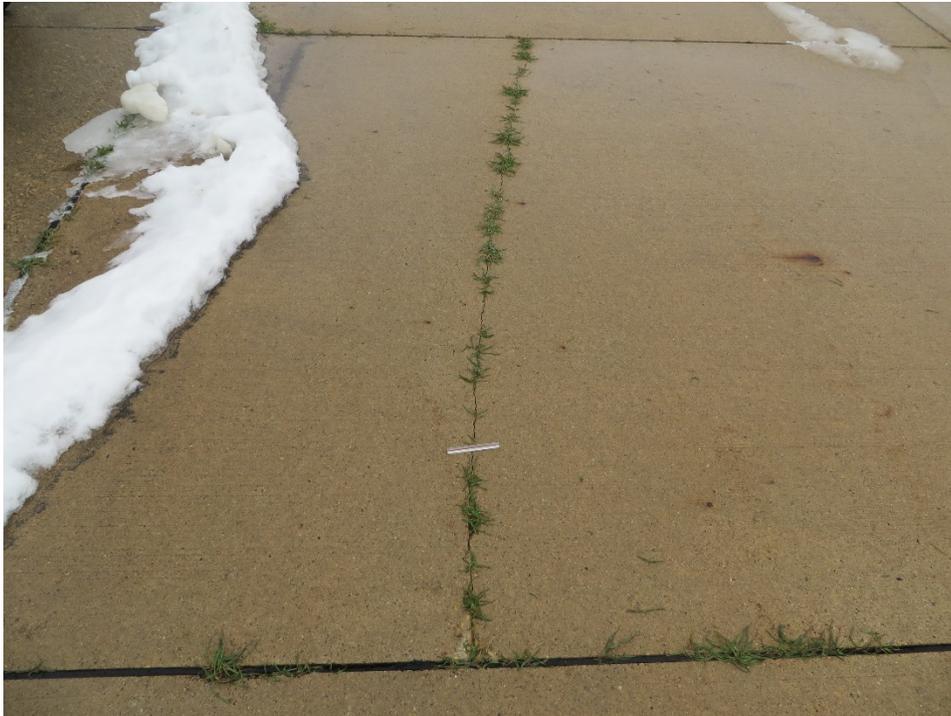
A01OA-01. LTD Cracking (Sample Unit No. 02).

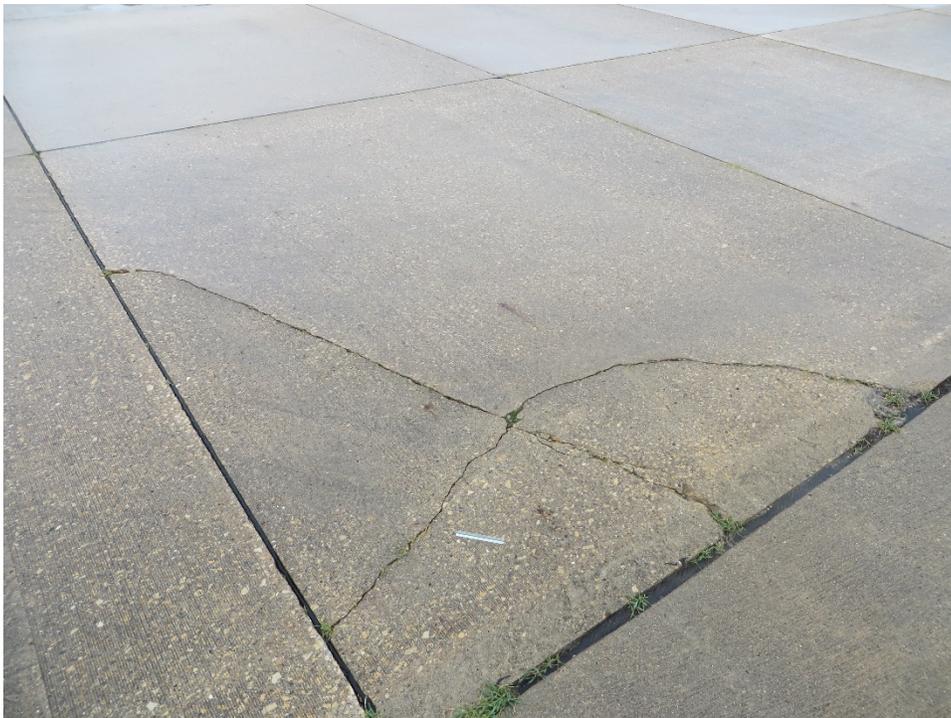
A01OA-01. Shattered Slab (Sample Unit No. 05).

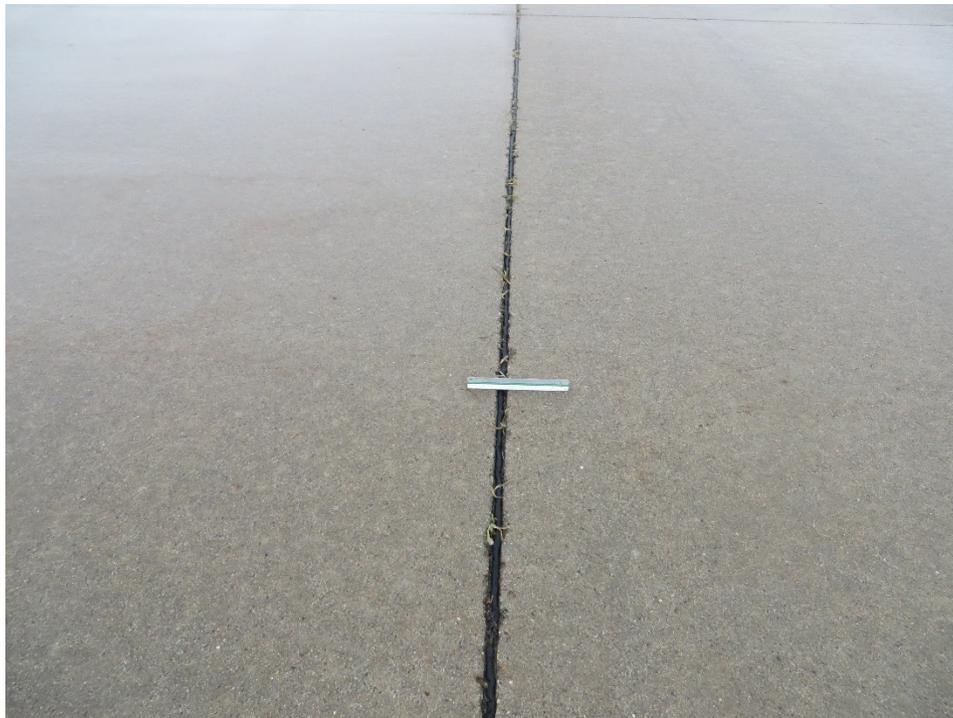
A01OA-02. Joint Seal Damage (Sample Unit No. 06).

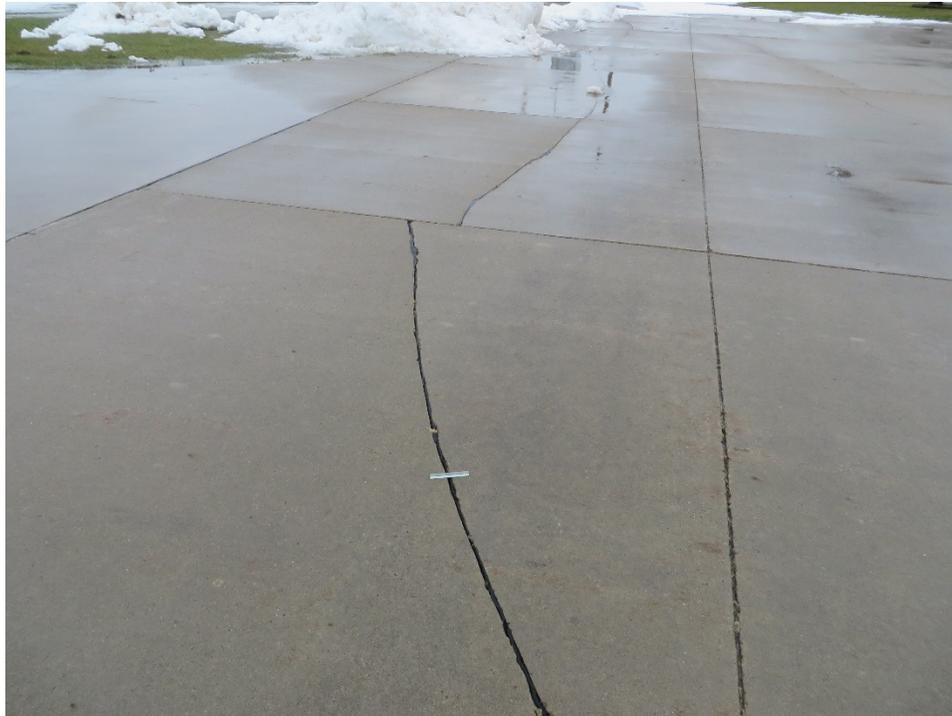
A010A-02. LTD Cracking (Additional Sample Unit No. 08).

Sample Number: 08 Type: A Area: 15.00Slabs PCI = 34  
Sample Comments:  
75 CORNER SPALLING M 1.00 Slabs Comments:  
74 JOINT SPALLING M 1.00 Slabs Comments:  
63 LINEAR CRACKING M 7.00 Slabs Comments:  
75 CORNER SPALLING L 1.00 Slabs Comments:  
62 CORNER BREAK L 1.00 Slabs Comments:  
65 JOINT SEAL DAMAGE H 15.00 Slabs Comments:

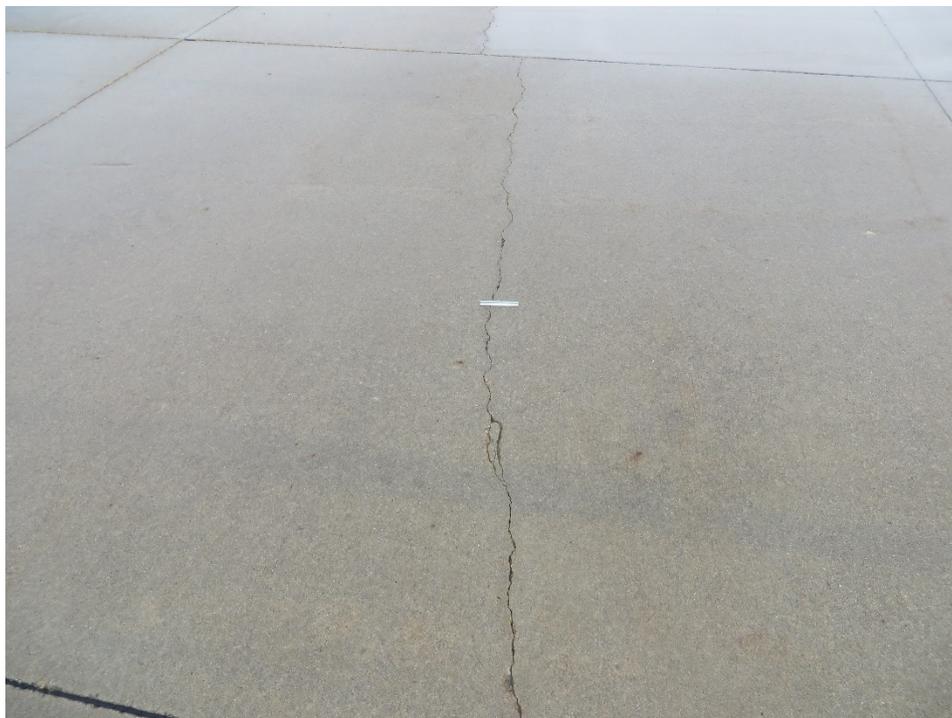
A010A-02. LTD Cracking (Sample Unit No. 06).

Sample Number: 06 Type: R Area: 20.00Slabs PCI = 81  
Sample Comments:  
63 LINEAR CRACKING L 3.00 Slabs Comments:  
65 JOINT SEAL DAMAGE H 20.00 Slabs Comments:

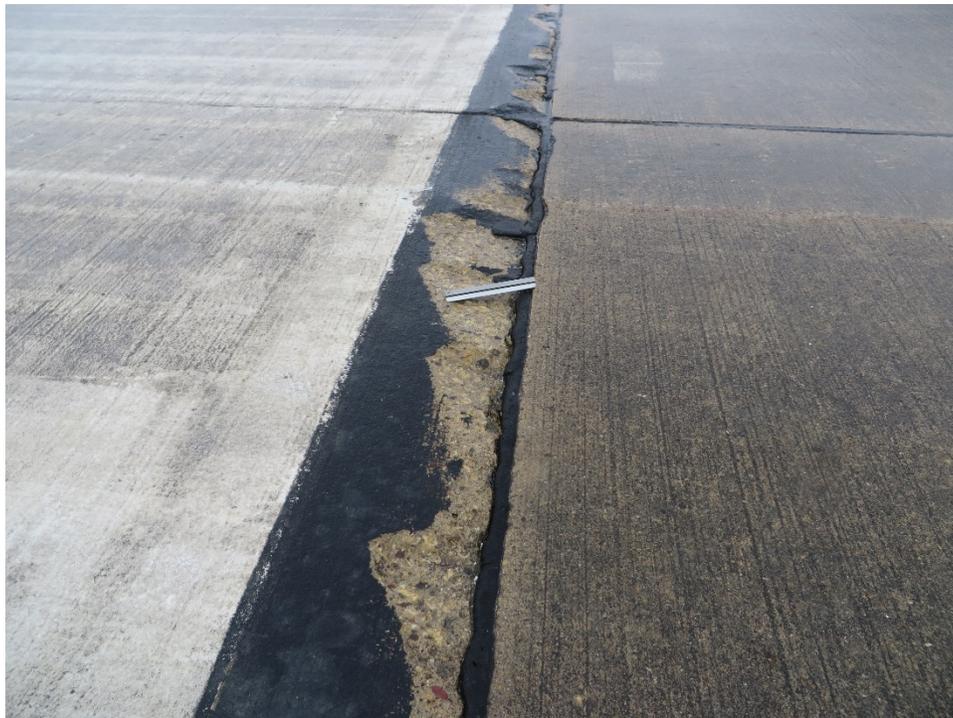
R180A-01. Joint Spalling (Sample Unit No. 23).

Sample Number: 023 Type: R Area: 24.00Slabs PCI = 75  
Sample Comments:  
71 FAULTING L 6.00 Slabs Comments:  
74 JOINT SPALLING M 4.00 Slabs Comments:  
65 JOINT SEAL DAMAGE L 24.00 Slabs Comments:

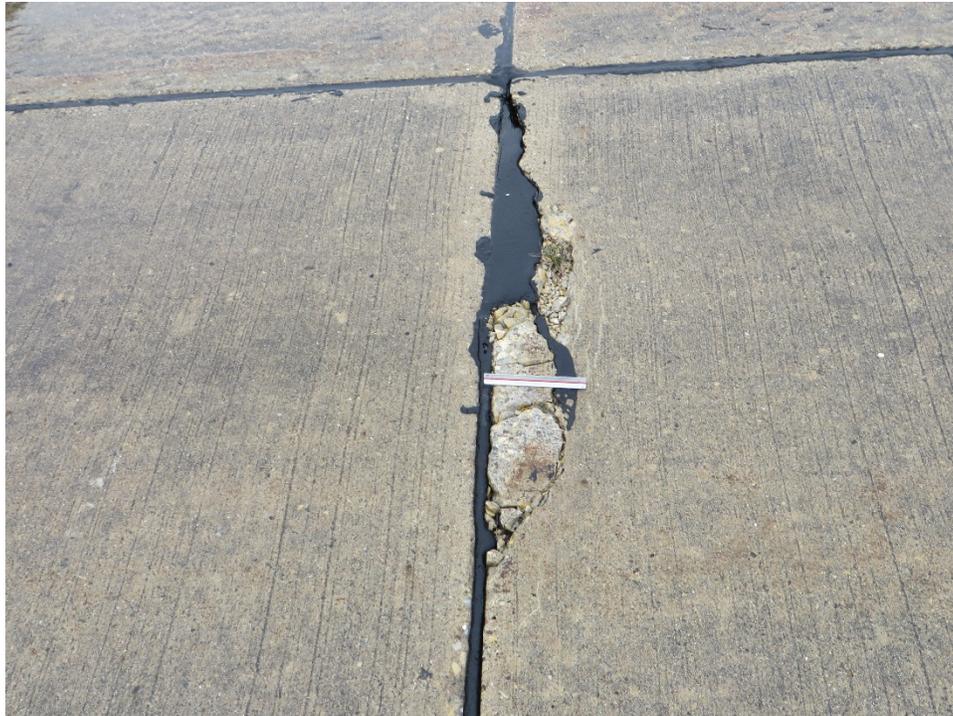
R180A-01. Joint Spalling (Sample Unit No. 50).

Sample Number: 050 Type: R Area: 24.00Slabs PCI = 95  
Sample Comments:  
74 JOINT SPALLING M 1.00 Slabs Comments:  
65 JOINT SEAL DAMAGE L 24.00 Slabs Comments:

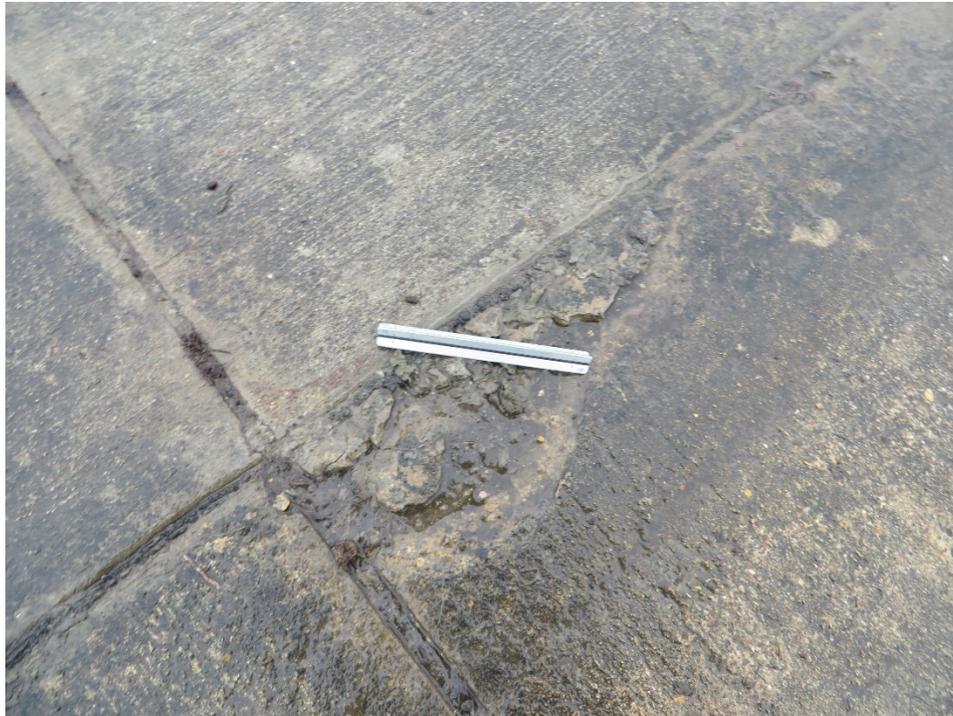
Taxiway 01 was defined by one section that was located between the apron area and Runway 18/36. High-severity joint seal damage was identified throughout the section, along with isolated amounts of high-severity corner spalling and medium-severity joint spalling.

T010A-01. Corner Spalling (Sample Unit No. 02).

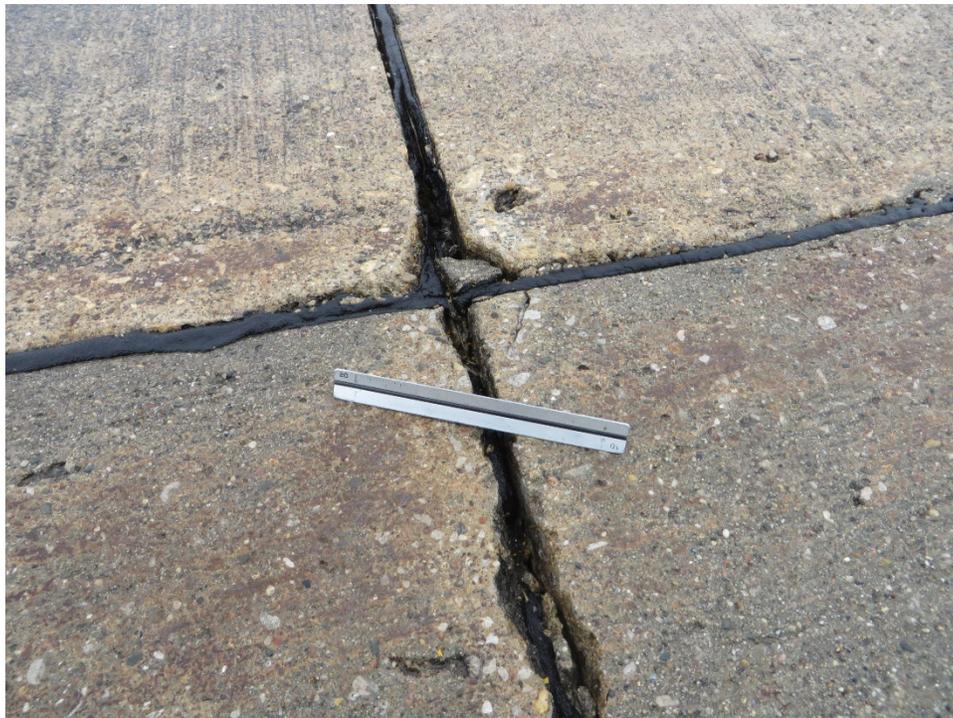
T010A-01. Joint Seal Damage (Sample Unit No. 05).

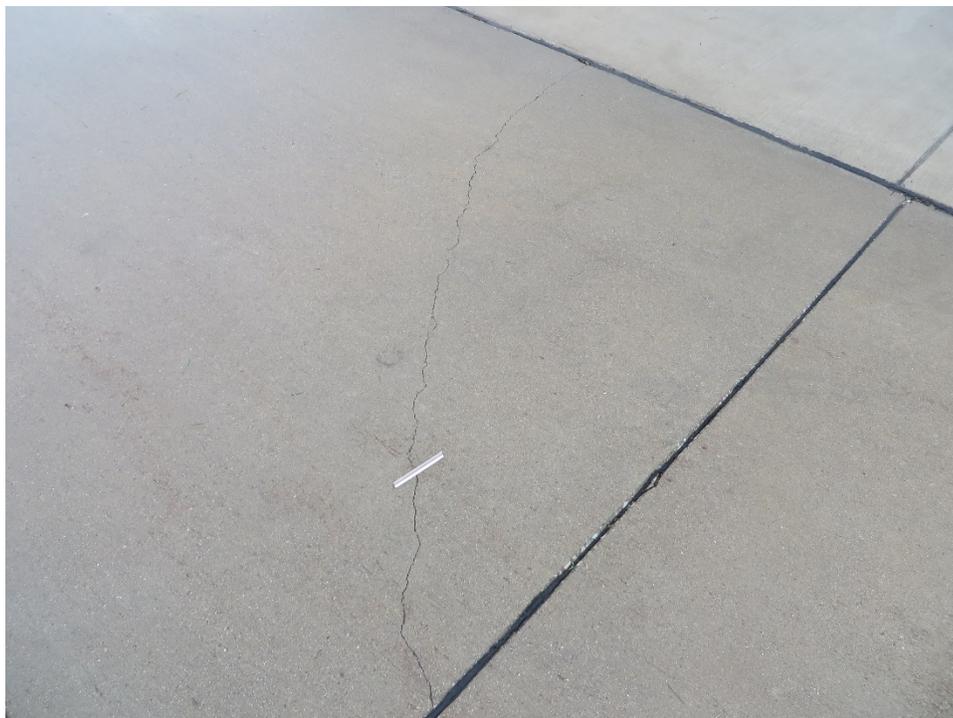
T-hangar 01, located south of the apron area, consisted of two sections in excellent condition. No distresses were observed in Section 01 during the inspection. Section 02 was identified with only one area of low-severity corner break and medium-severity joint spalling that was recorded as an additional sample unit according to ASTM D5340-12.

TH01OA-02. Corner Break (Additional Sample Unit No. 07).

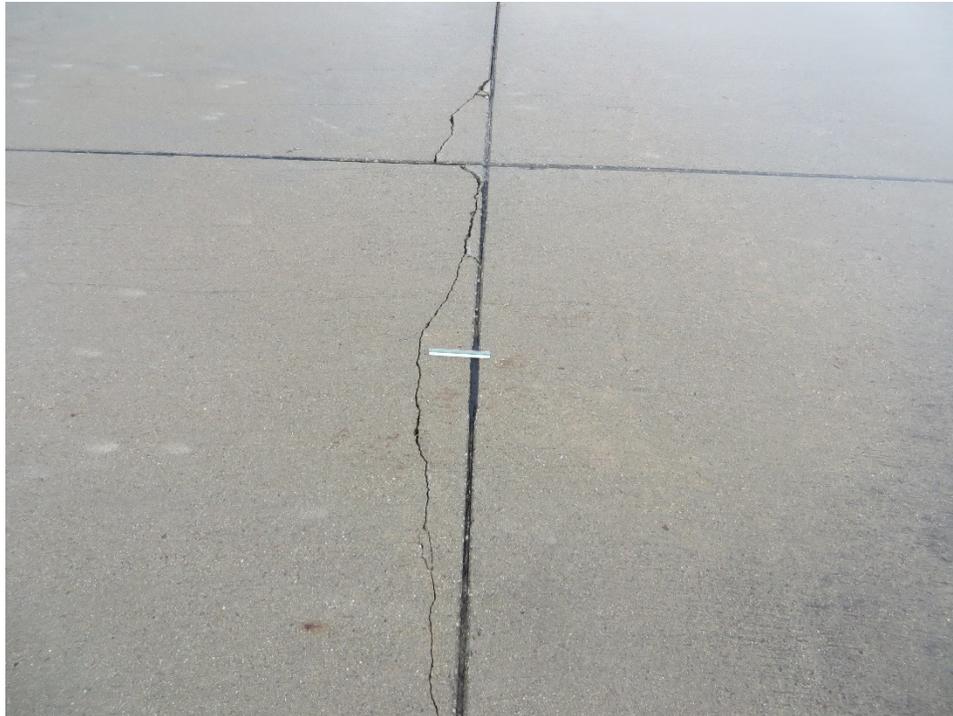
TH01OA-02. Joint Spalling (Additional Sample Unit No. 07).

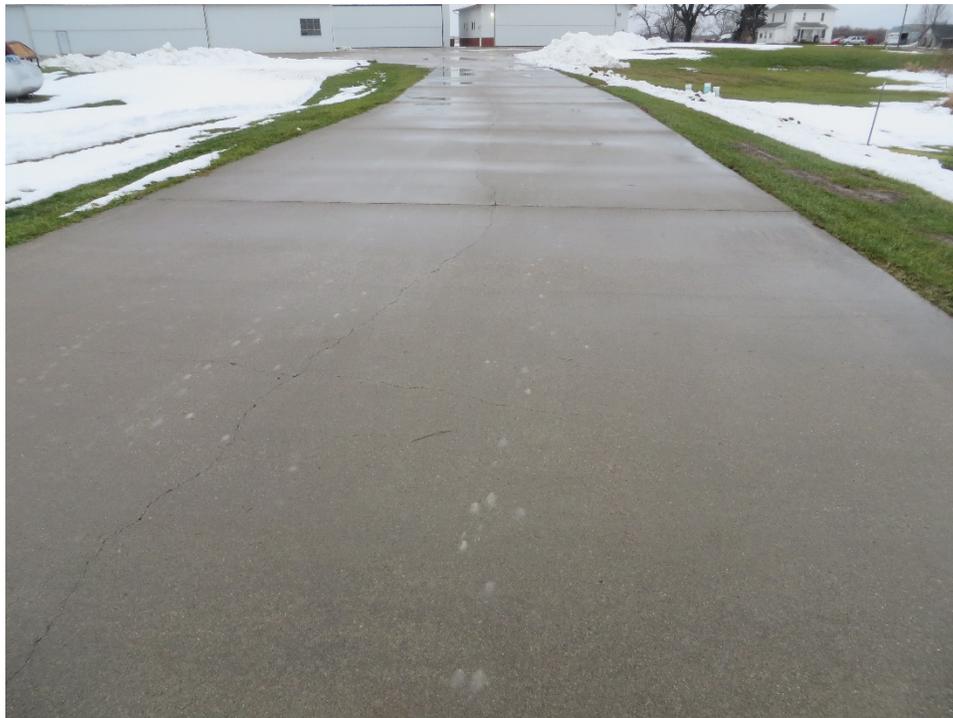
TH02OA-01. Overview.

T-hangar 02 was defined by two sections that were located to the west of the apron area. Section 01 was in poor condition with low-severity ASR, corner break, corner spalling, faulting, and large patching; high-severity joint seal damage; medium-severity joint spalling; low- and medium-severity LTD cracking, shattered slab, and small patching; and shrinkage cracking recorded throughout. Section 02 was in excellent condition with no distresses identified during the inspection.

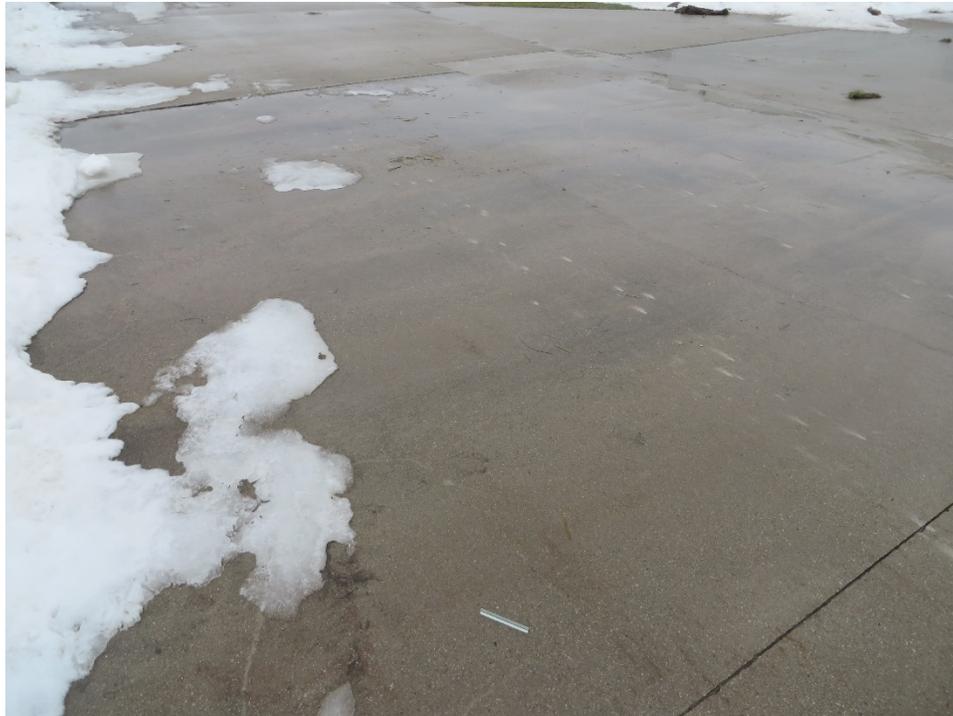
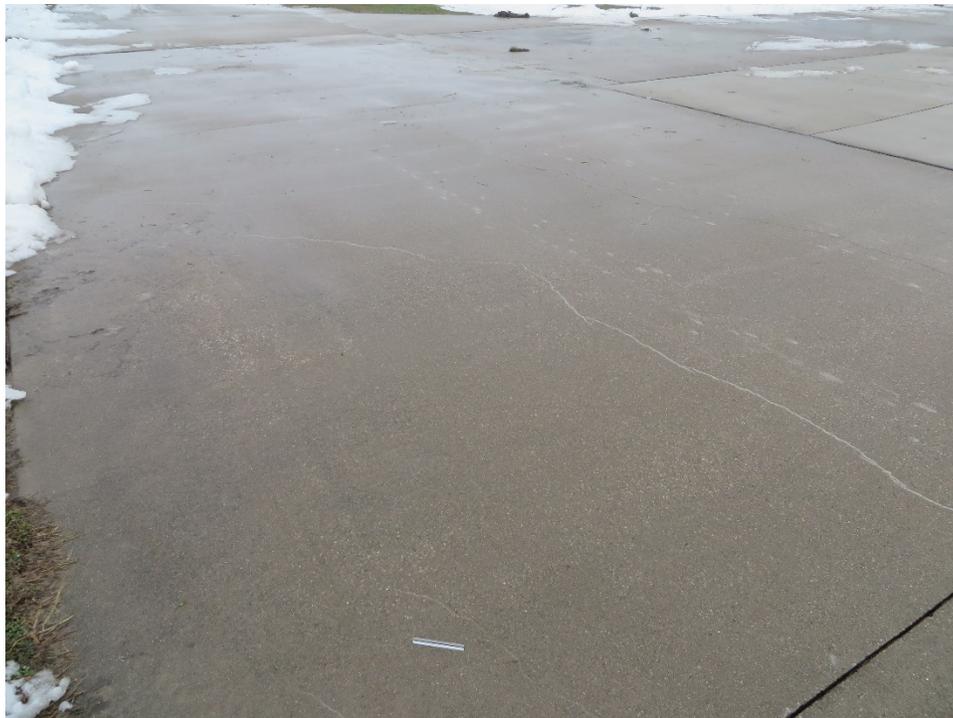
TH02OA-01. Shattered Slab (Sample Unit No. 01) (1).

TH02OA-01. Shattered Slab (Sample Unit No. 01) (2).

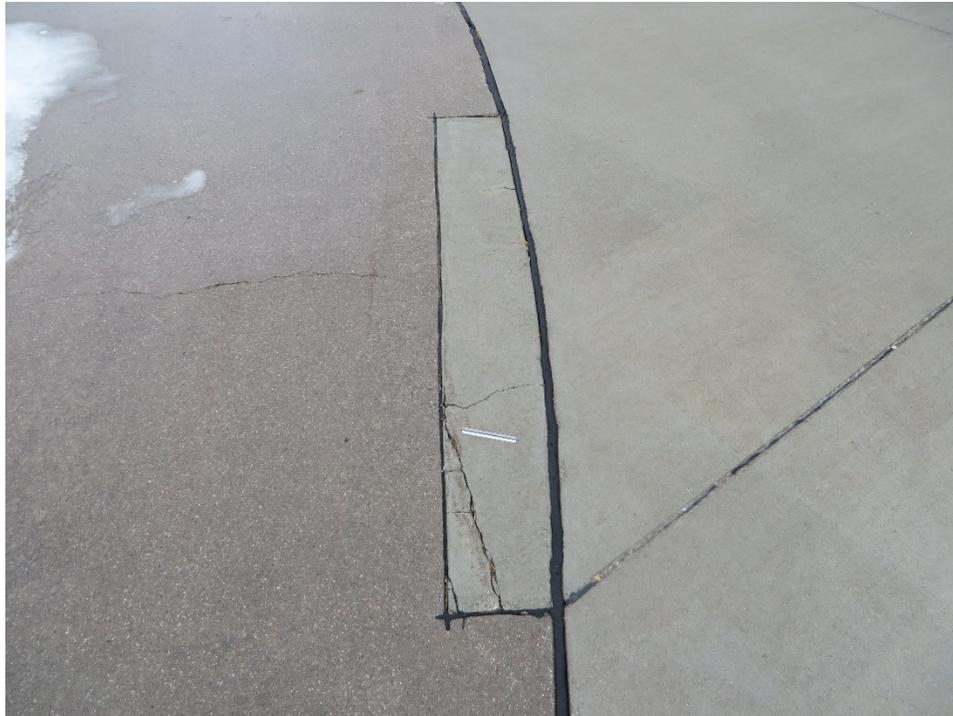
TH02OA-01. Small Patching (Sample Unit No. 01).
