Osceola Municipal Airport

PAVEMENT MANAGEMENT REPORT

JULY 2022

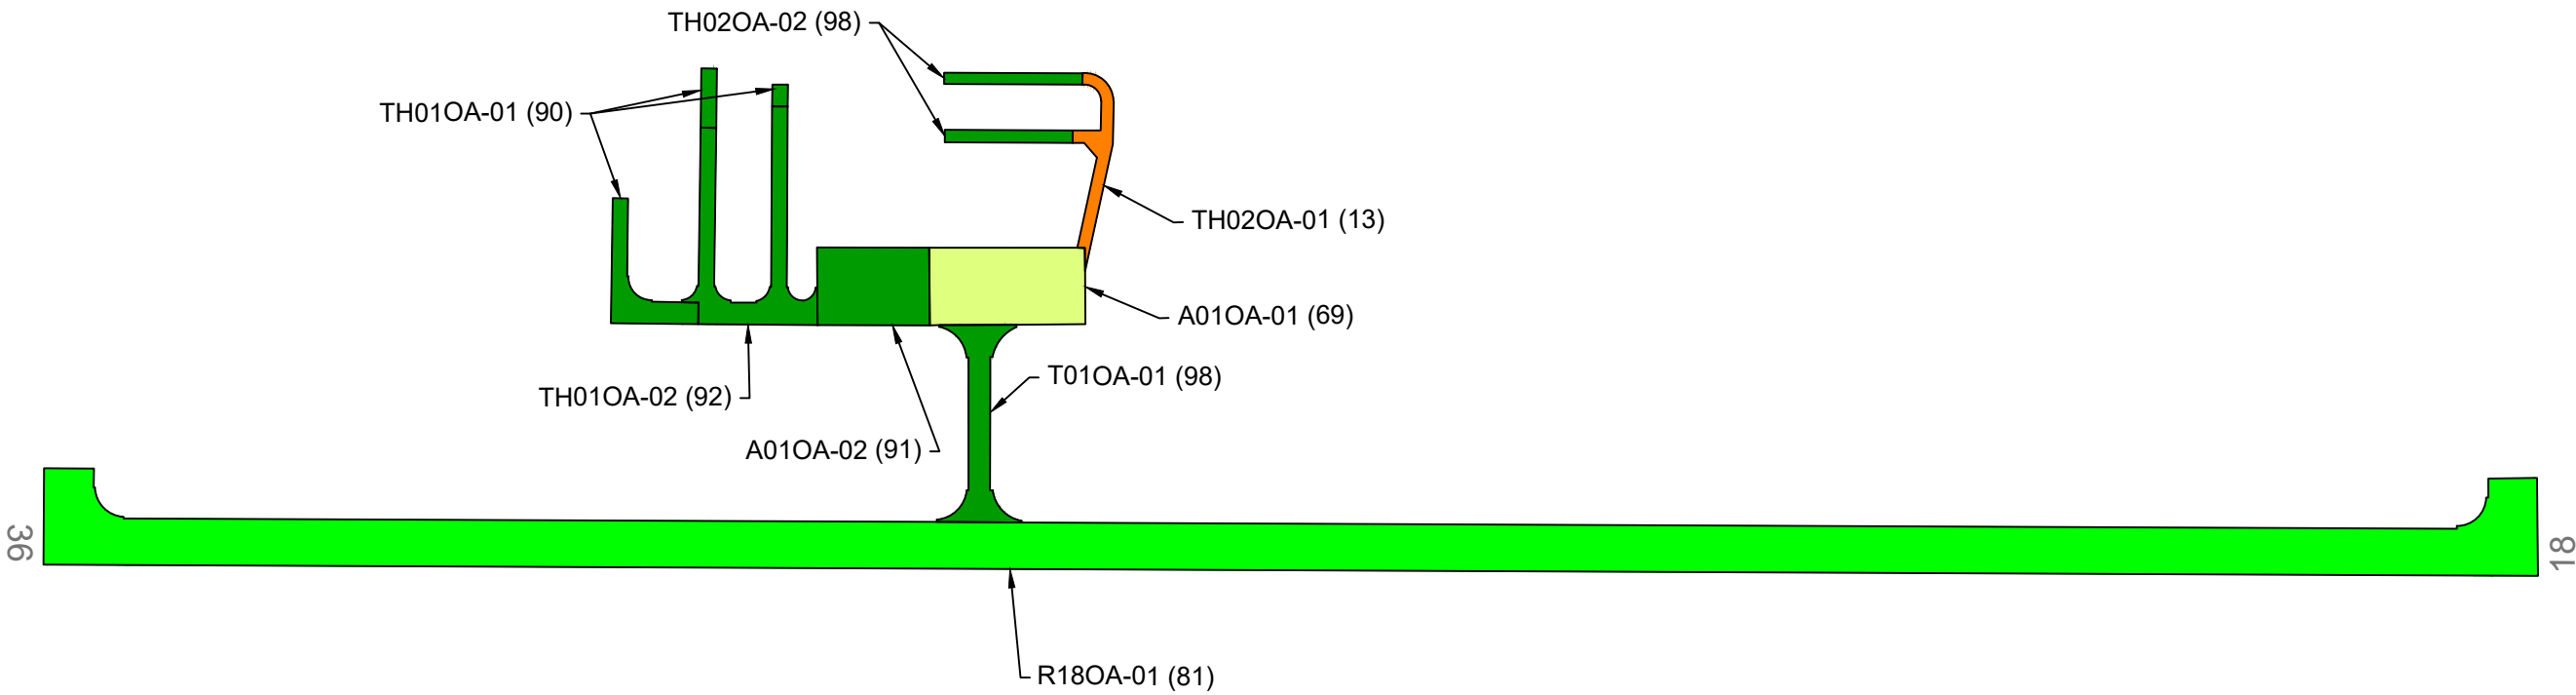
FIGURE 8. PCI MAP.

The pavements at Osceola Municipal Airport were inspected in November 2021. The 2021 area-weighted condition of Osceola Municipal Airport is 81, with conditions ranging from 13 to 98 (on a scale of 0 [failed] to 100 [excellent]). During the previous pavement inspection in 2018, the area-weighted PCI of the airport was 87.

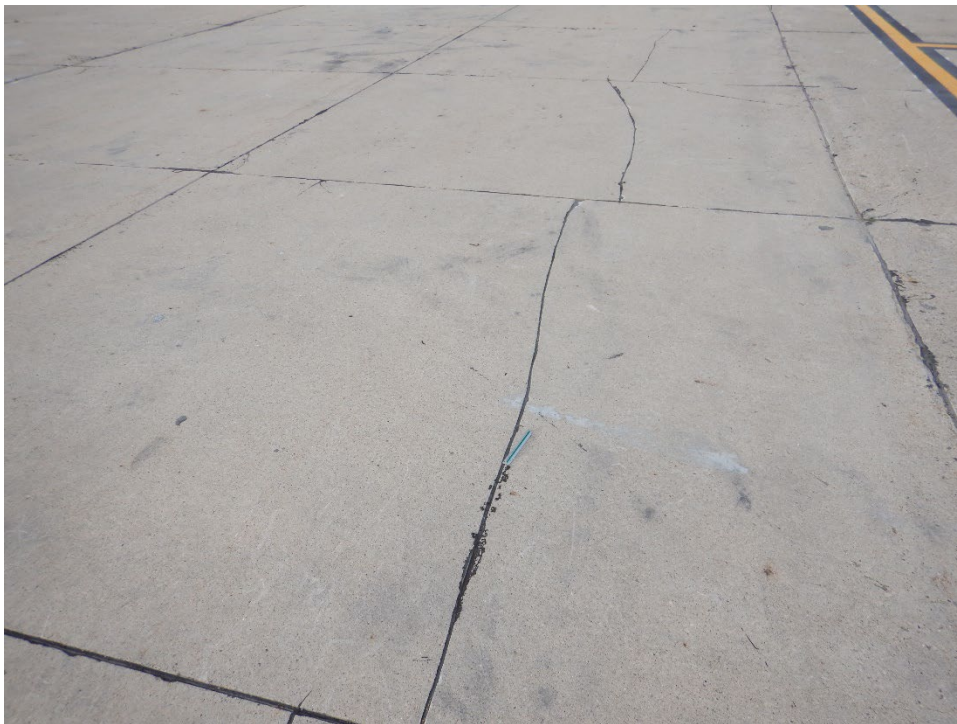
A010A-01. LTD Cracking (Sample Unit No. 01).

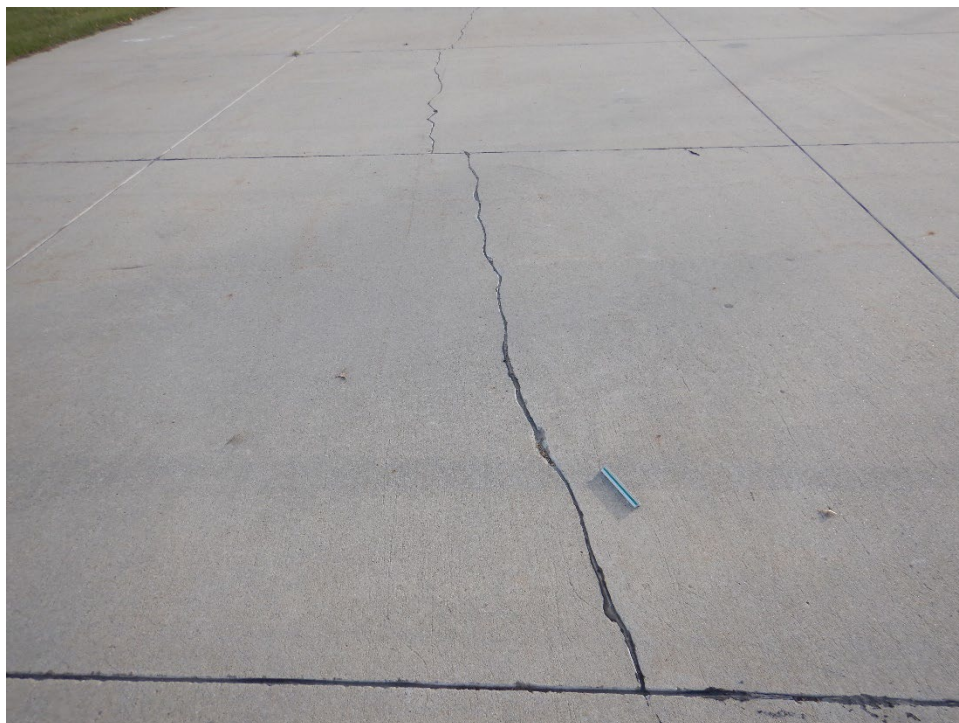
A010A-02. LTD Cracking (Sample Unit No. 06).

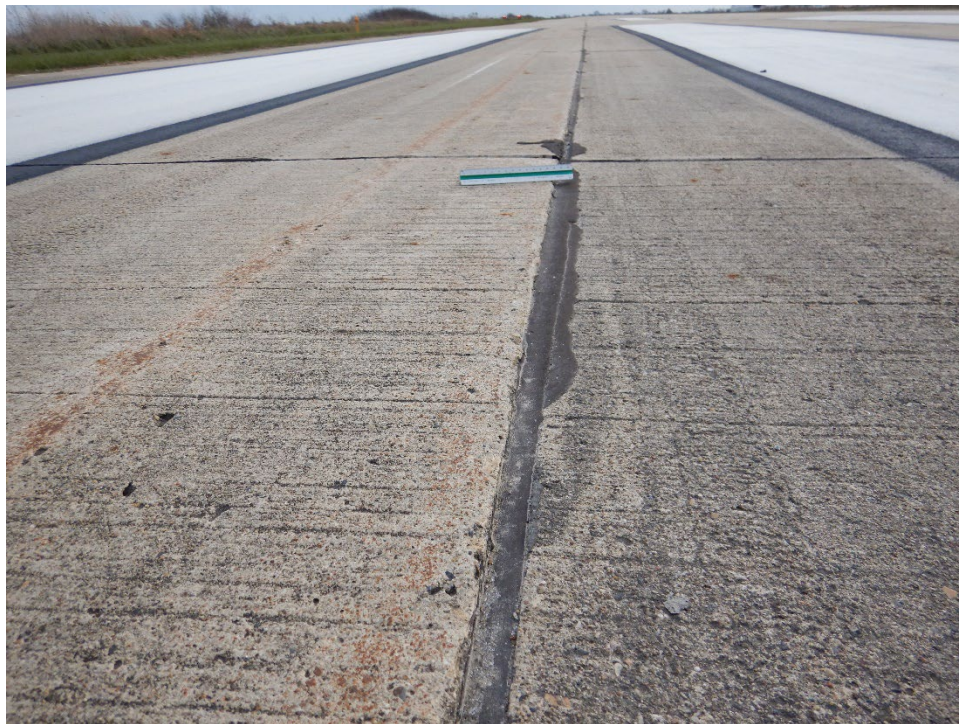
Runway 18/36 contained one section that had all severities of corner spalling; low- and medium-severity small patching and faulting; high-severity joint spalling; and low-severity ASR, corner break, and large patching.

R18OA-01. Faulting (Sample Unit No. 05).

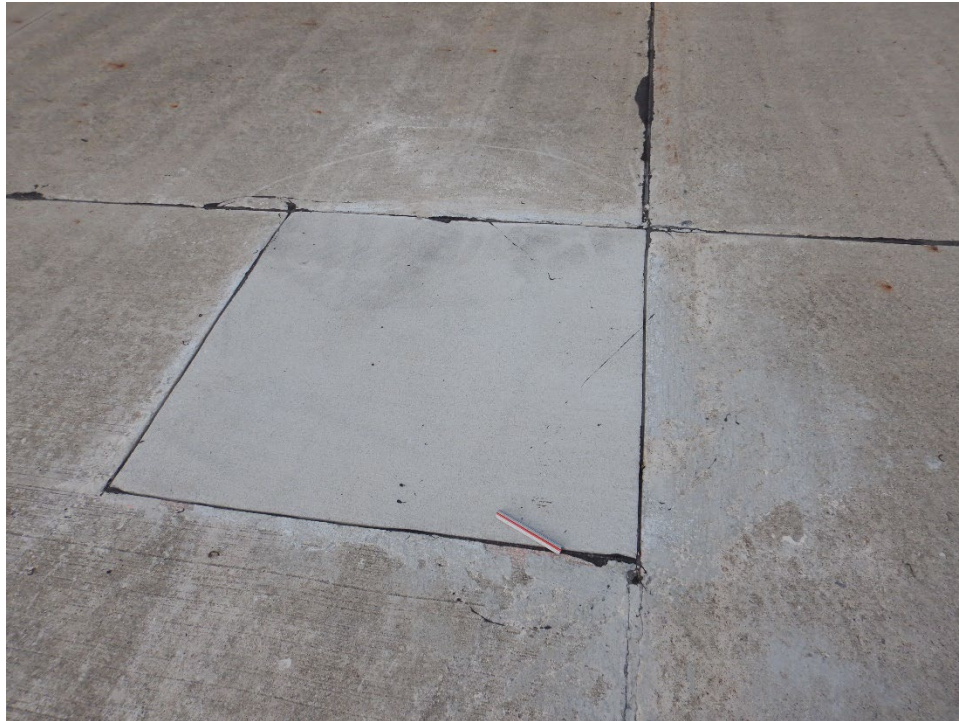
R180A-01. Large Patching (Sample Unit No. 50).

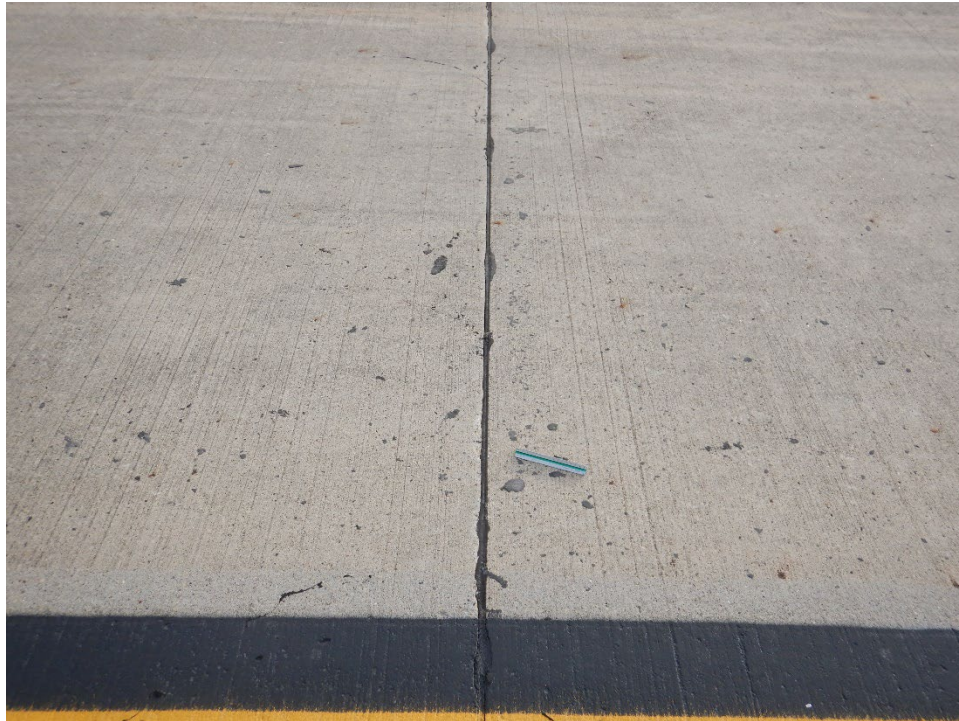
Taxiway 01 consisted of one section in excellent condition that connected the runway to the apron area. Only low-severity joint seal damage was noted in Section 01.

T01OA-01. Joint Seal Damage (Sample Unit No. 04).

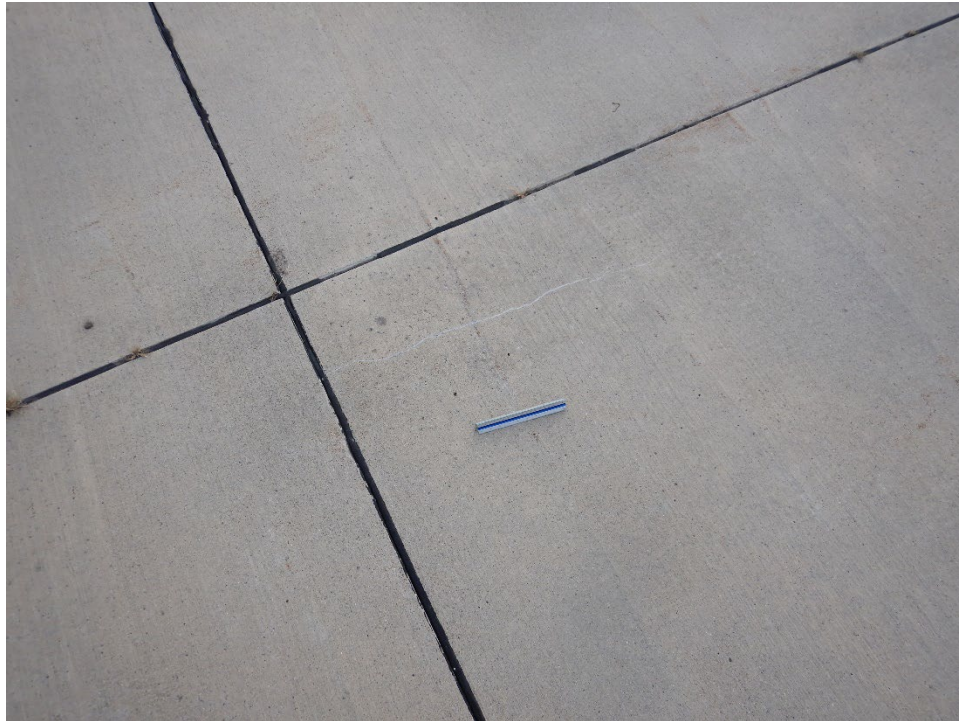
T-hangar 01 consisted of two sections. Section 01 had areas of low- and medium-severity joint seal damage and low-severity ASR, corner spalling, and faulting noted during the inspection. Section 02 contained low-severity ASR and faulting, low- and medium-severity joint seal damage, and medium-severity small patching. Additionally, an atypical area that contained medium-severity joint spalling and low-severity LTD cracking was recorded as an additional sample unit, in accordance with ASTM D5340-20.

TH01OA-01. ASR (Sample Unit No. 04).

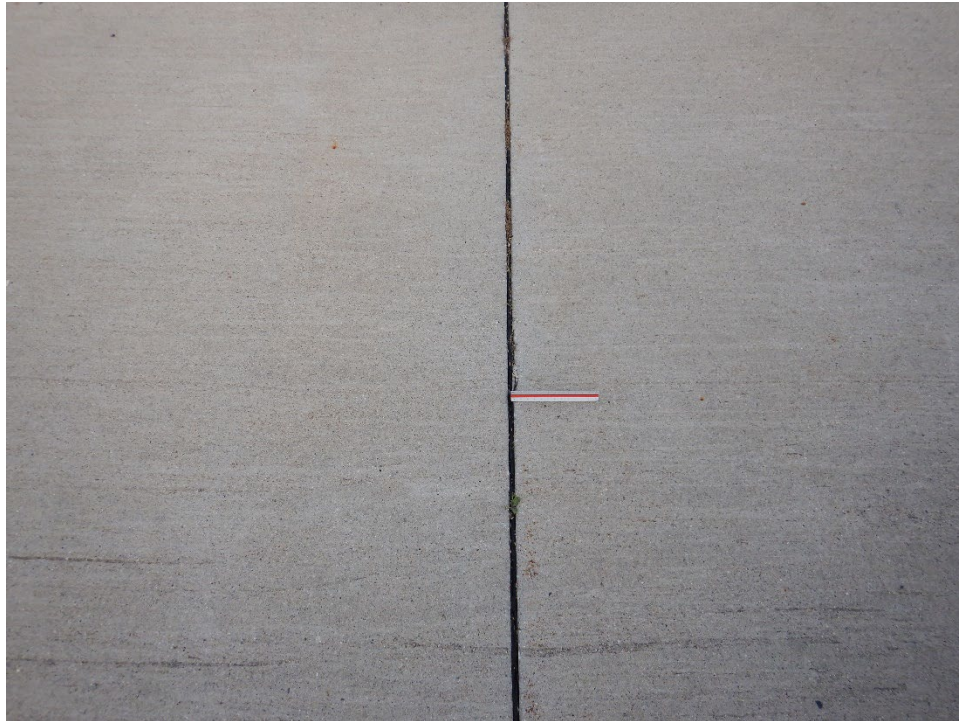
TH01OA-02. Joint Seal Damage (Sample Unit No. 01).

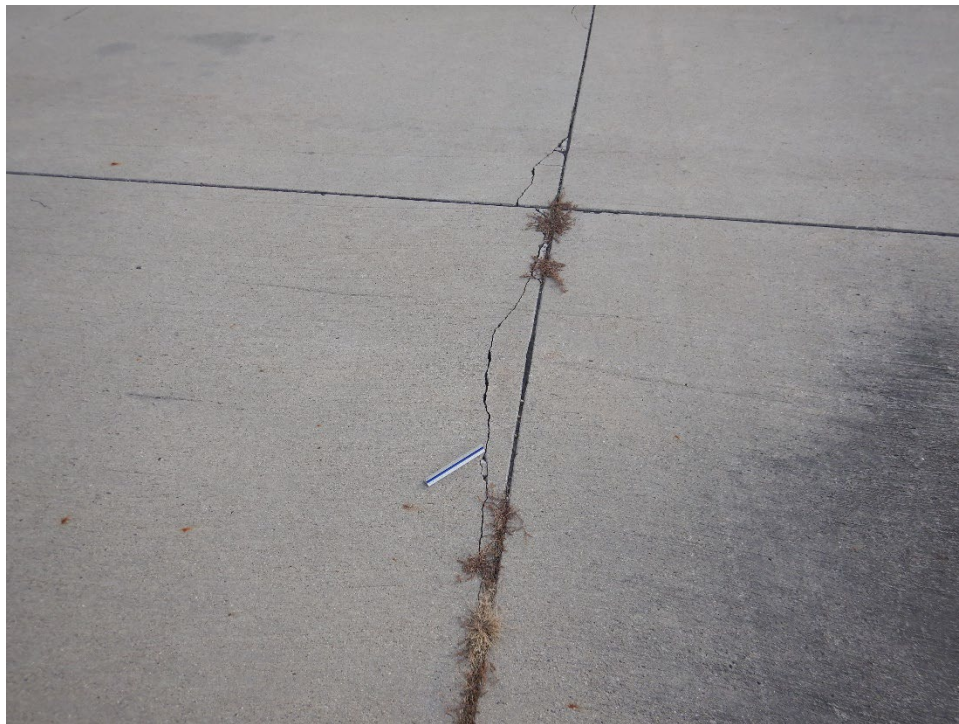
TH01OA-02. Joint Spalling (Additional Sample Unit No. 07).

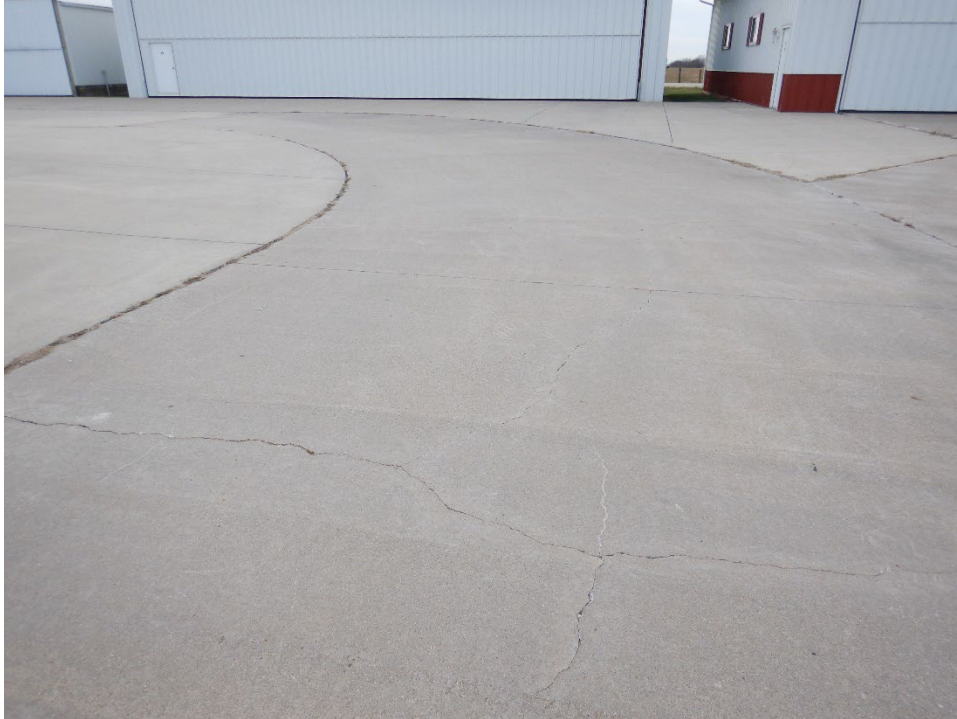
TH02OA-01. Overview.

T-hangar 02 contained two sections. Section 01 was in poor condition and had areas of low-severity ASR, corner break, large patching, corner spalling, and faulting; high-severity joint seal damage; medium-severity joint spalling; pumping; and low- and medium-severity LTD cracking, shattered slab, and small patching. Section 02 was in excellent condition, with only low-severity joint spalling recorded throughout.

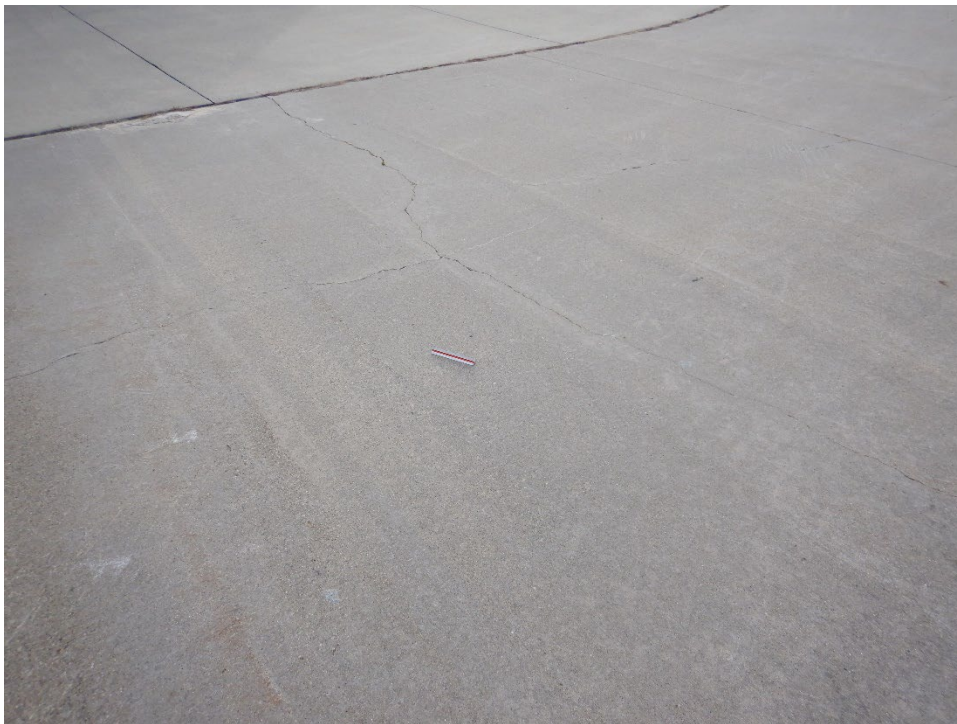
TH02OA-01. Shattered Slab (Sample Unit No. 01).

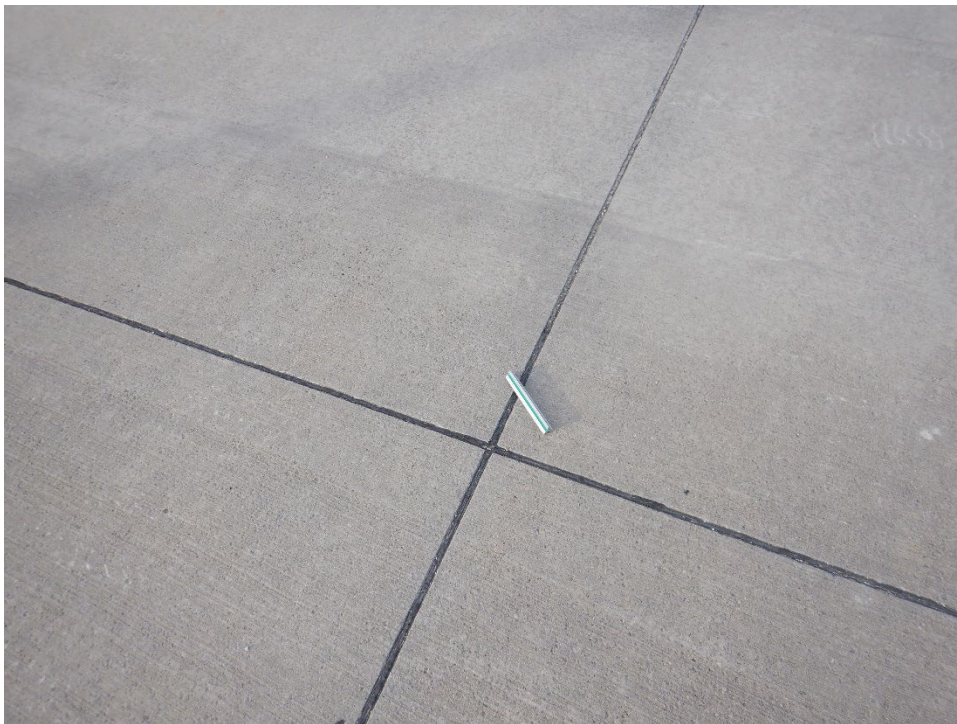
TH02OA-02. Joint Seal Damage (Sample Unit No. 01).
