Oskaloosa Municipal Airport

PAVEMENT MANAGEMENT REPORT

JULY 2022

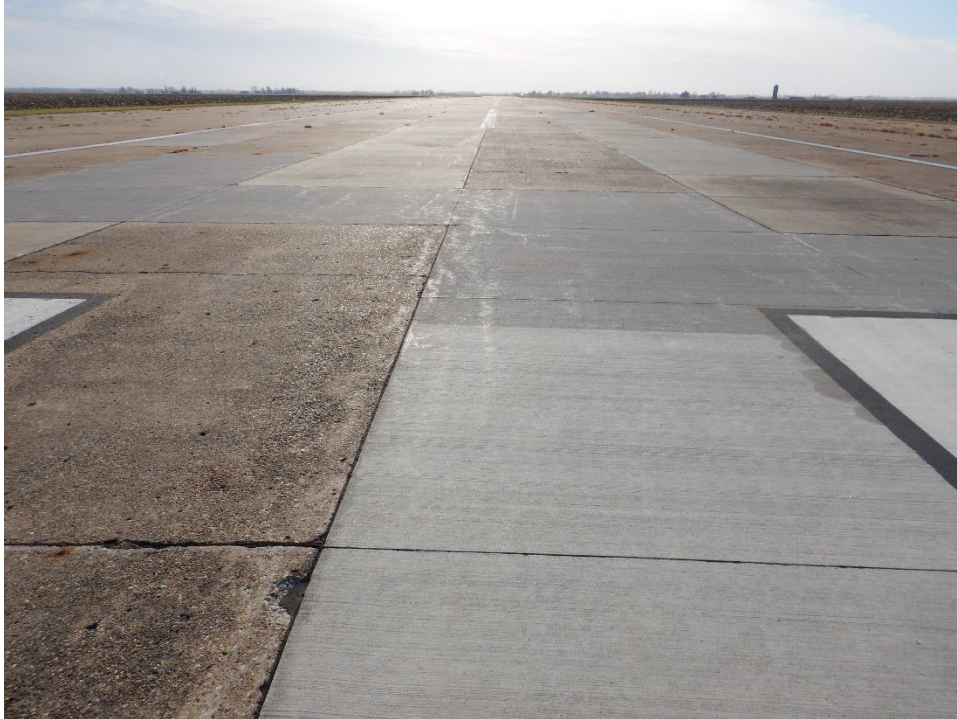
R04OK-01. Overview.

Runway 04/22 consisted of one section that had areas of low- and medium-severity corner break, scaling, and faulting; all severities of corner spalling and joint spalling; low-severity large patching; high-severity joint seal damage; popouts; shrinkage cracking; and medium-severity shattered slab, small patching, and longitudinal, transverse and diagonal (LTD) cracking noted throughout.

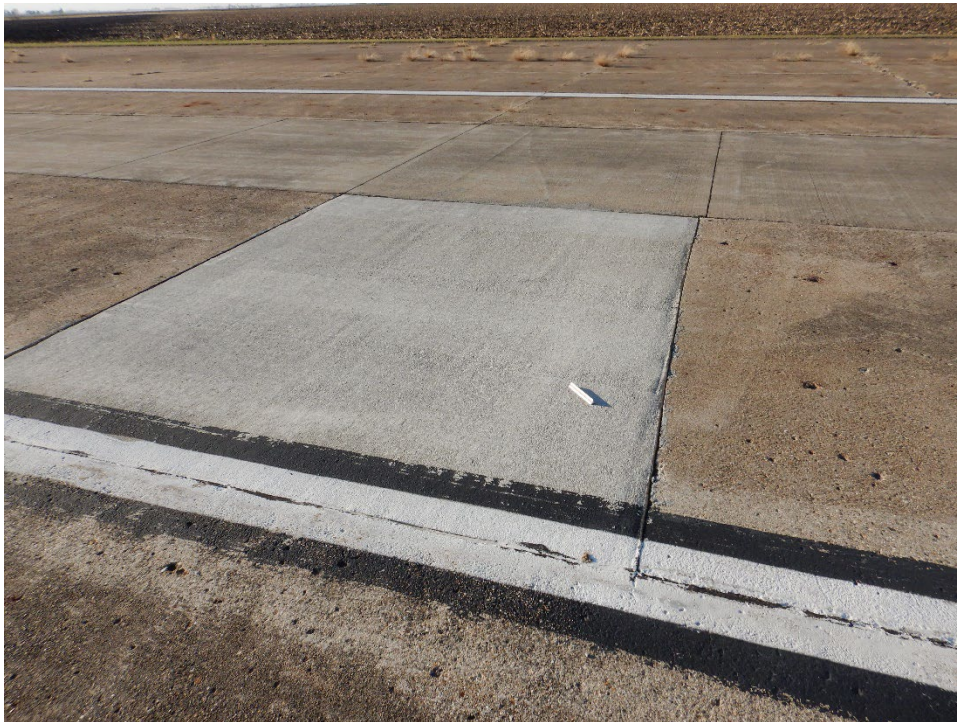
R04OK-01. Large Patching (Sample Unit No. 16).

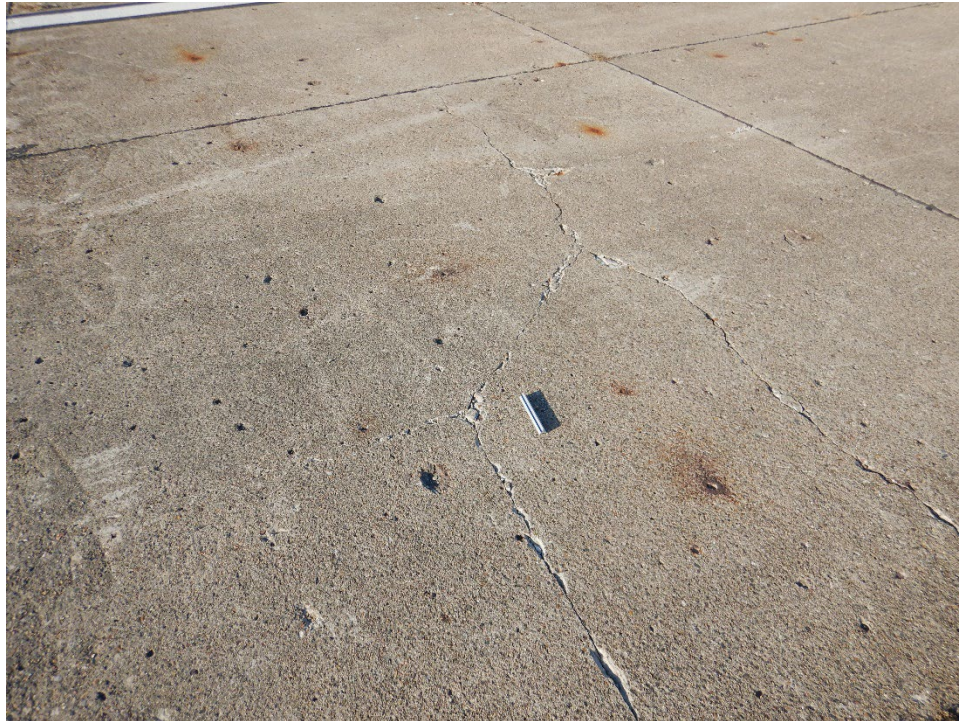
R04OK-01. Shattered Slab (Sample Unit No. 03).

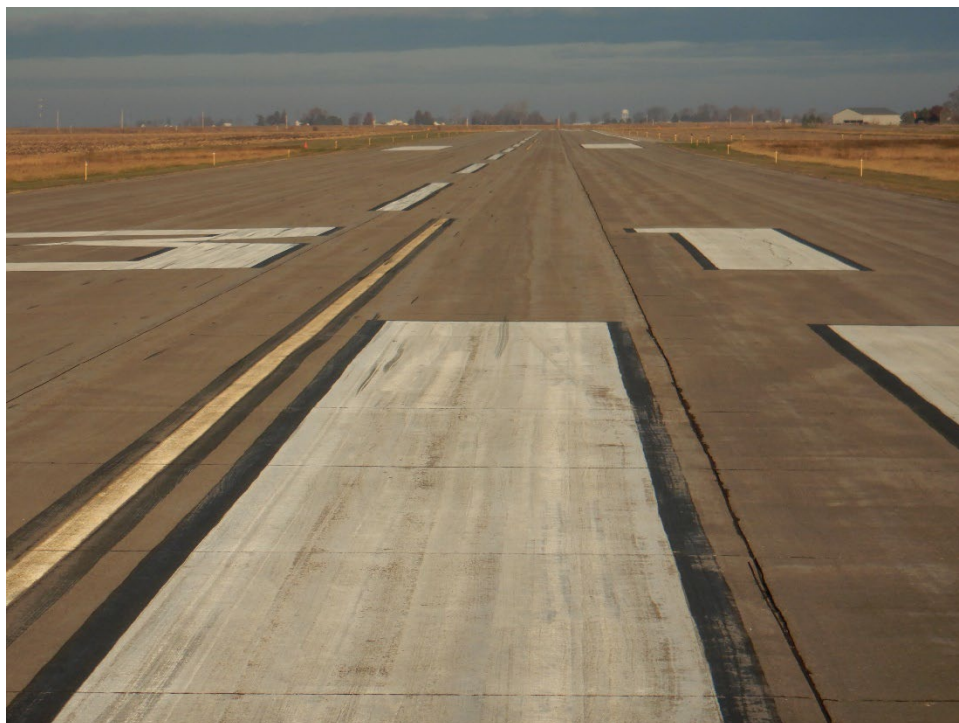
R13OK-01. Overview.

Runway 13/31 was defined by one section. Low- and medium-severity corner break and ASR, all severities of corner spalling and faulting, high-severity joint seal damage, medium-severity joint spalling, low-severity LTD cracking, and low- and high-severity small patching were recorded in Section 01.

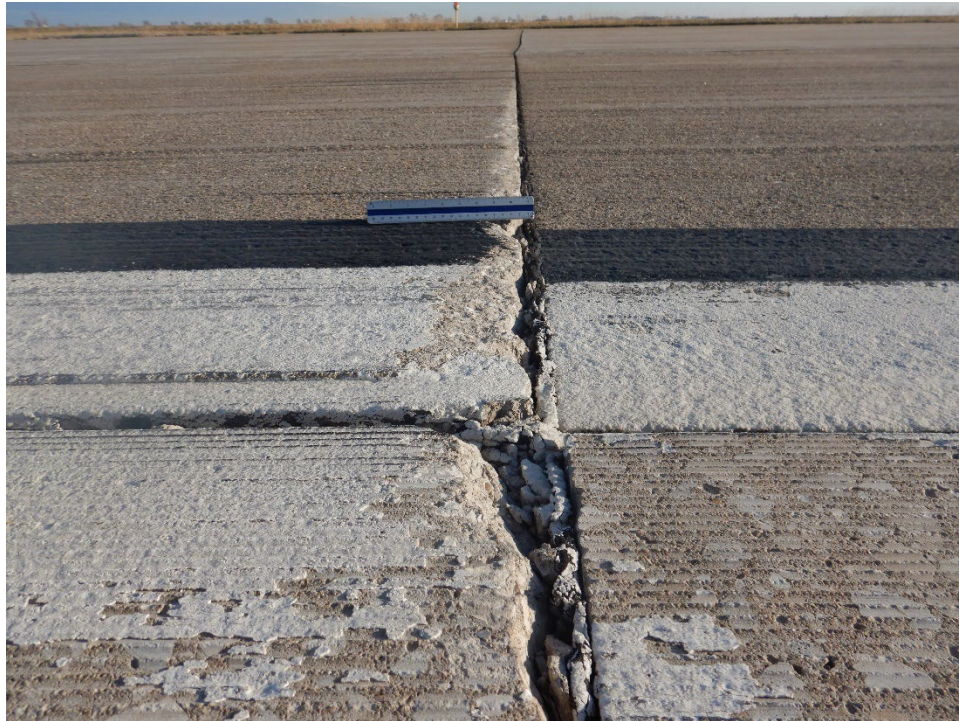
R13OK-01. Faulting (Additional Sample Unit No. 66).

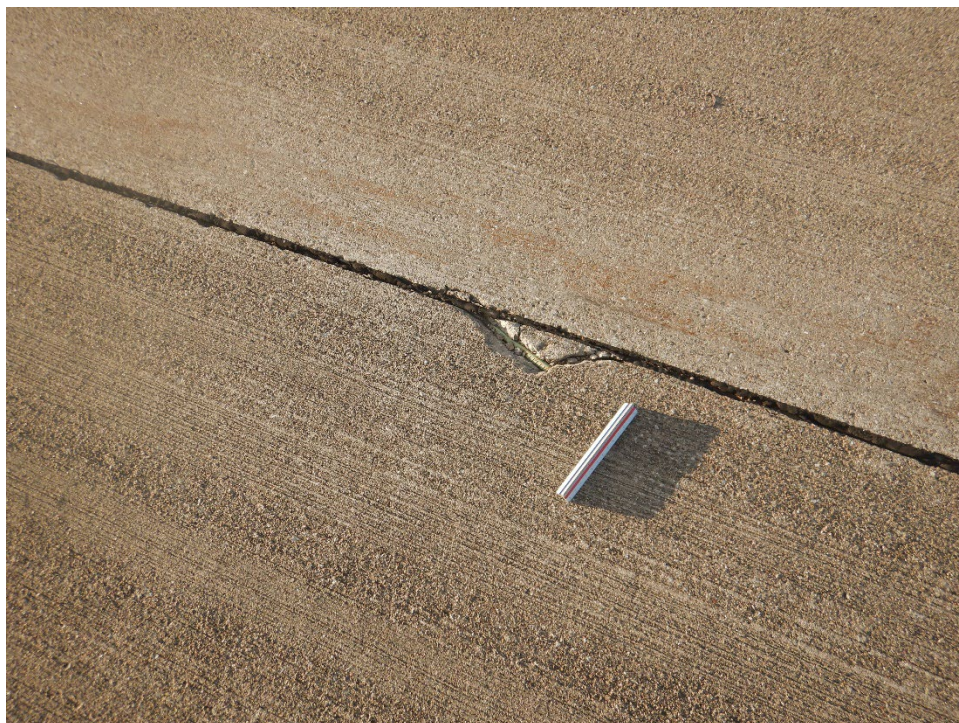
R13OK-01. Joint Spalling (Sample Unit No. 16).

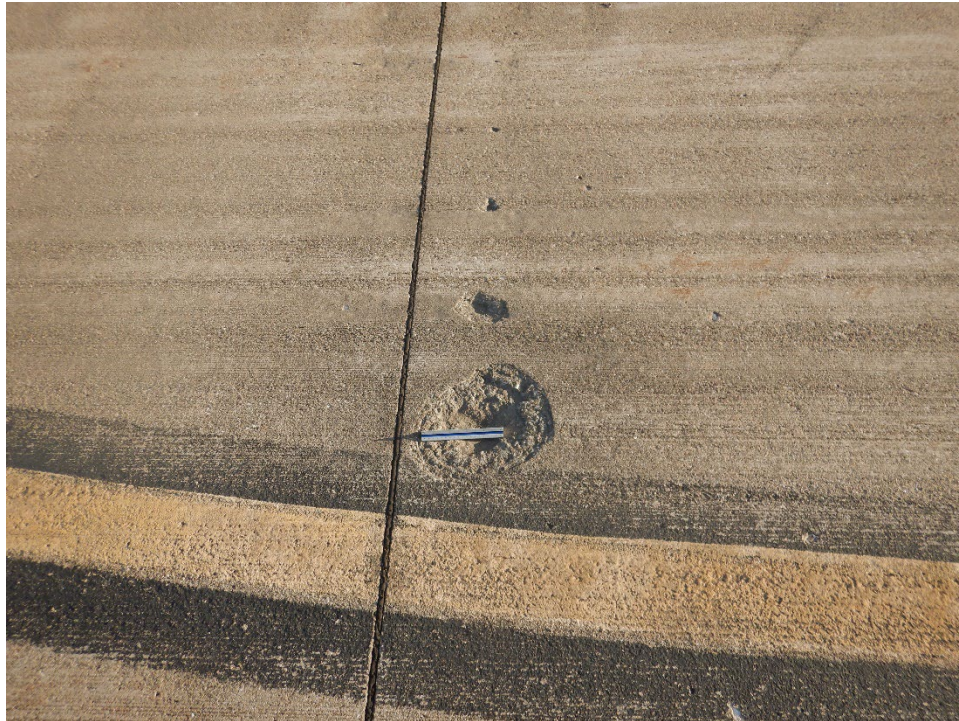
R13OK-01. Small Patching (Sample Unit No. 24).

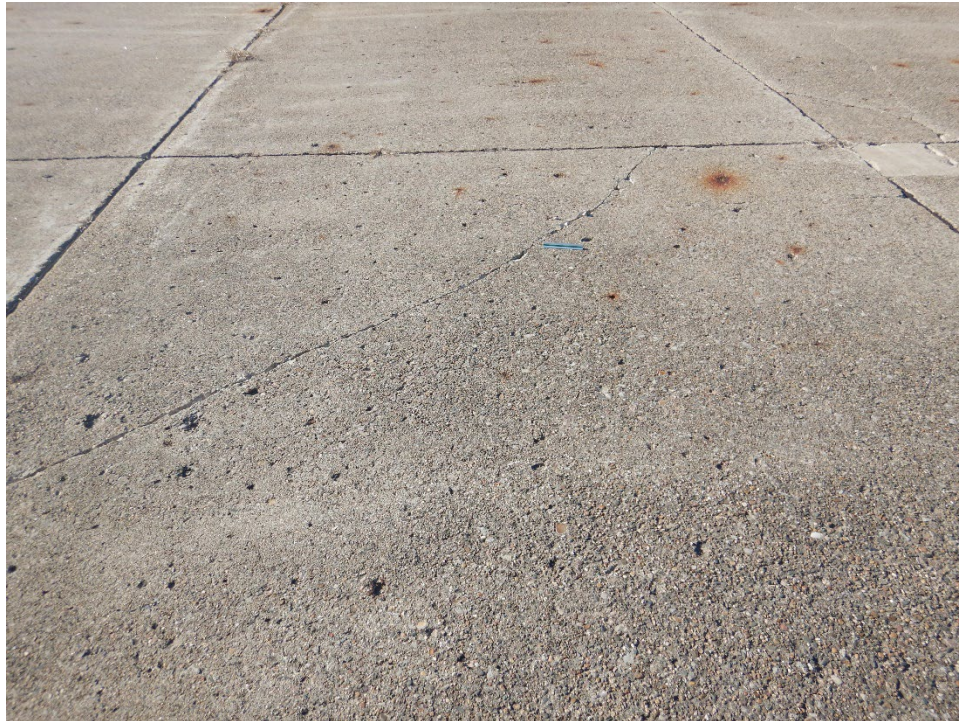
T01OK-01. LTD Cracking (Sample Unit No. 02).

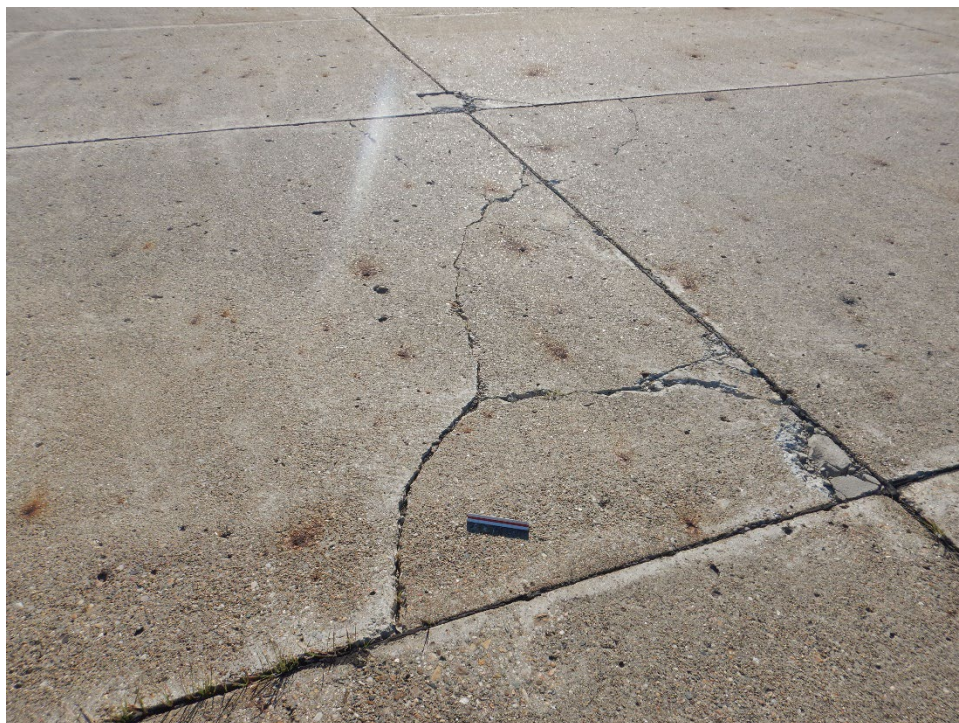
T01OK-01. Shattered Slab (Sample Unit No. 14).

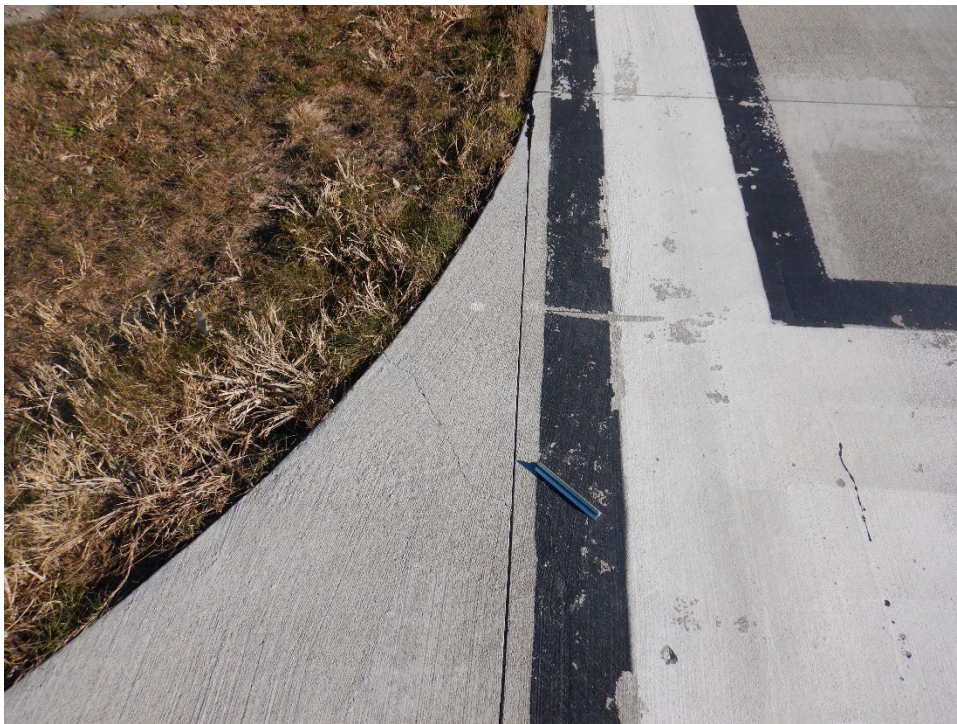
T01OK-02. Corner Break (Sample Unit No. 01).

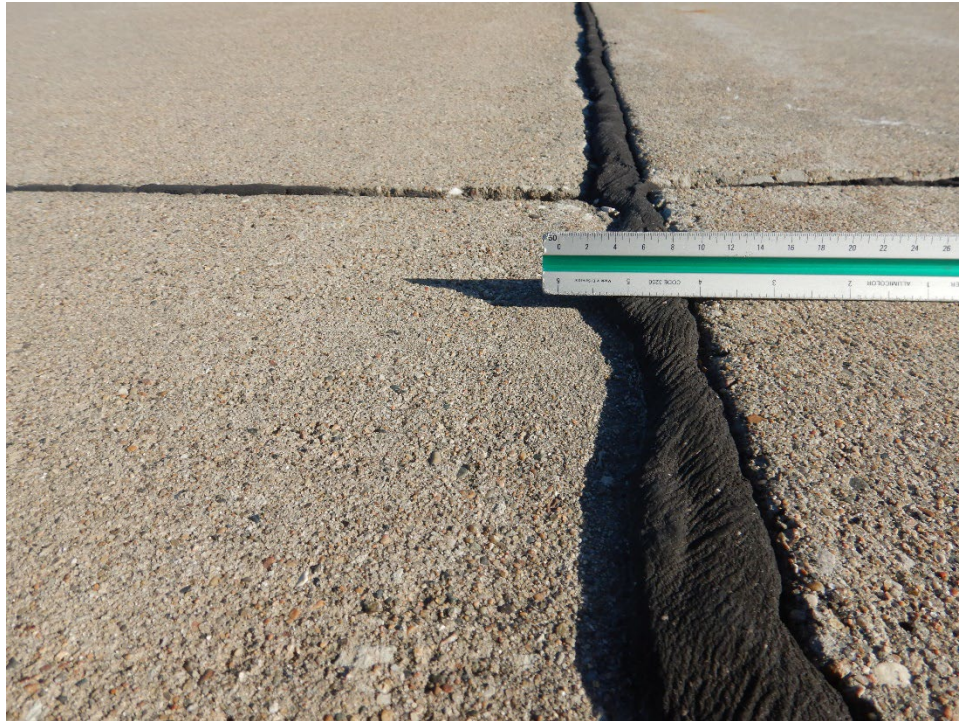
T01OK-02. Faulting (Sample Unit No. 04).

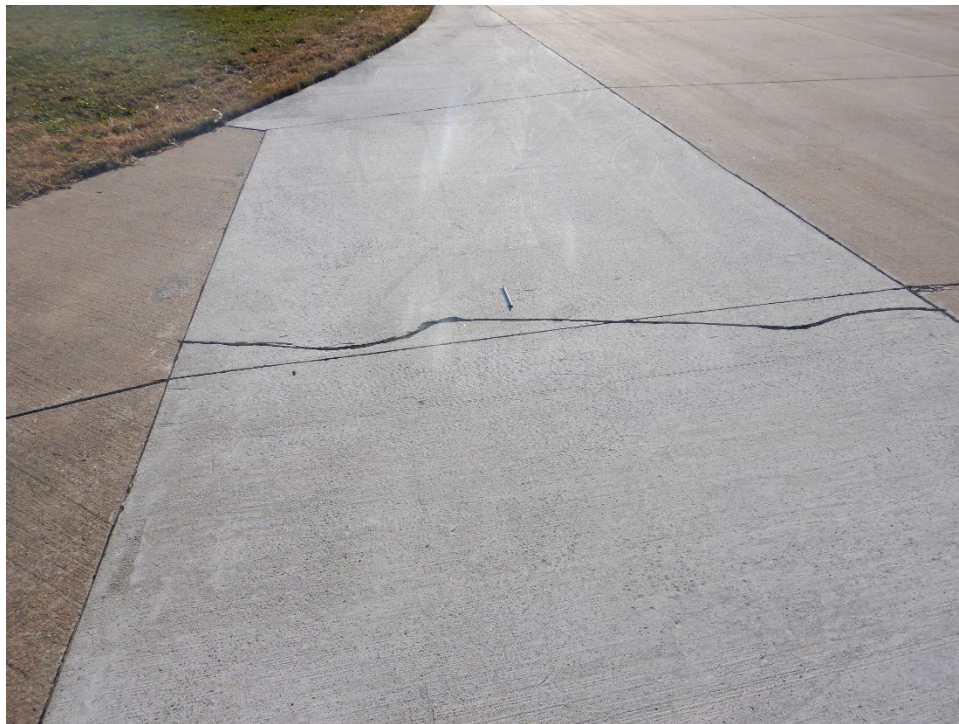
T01OK-02. LTD Cracking (Sample Unit No. 01).

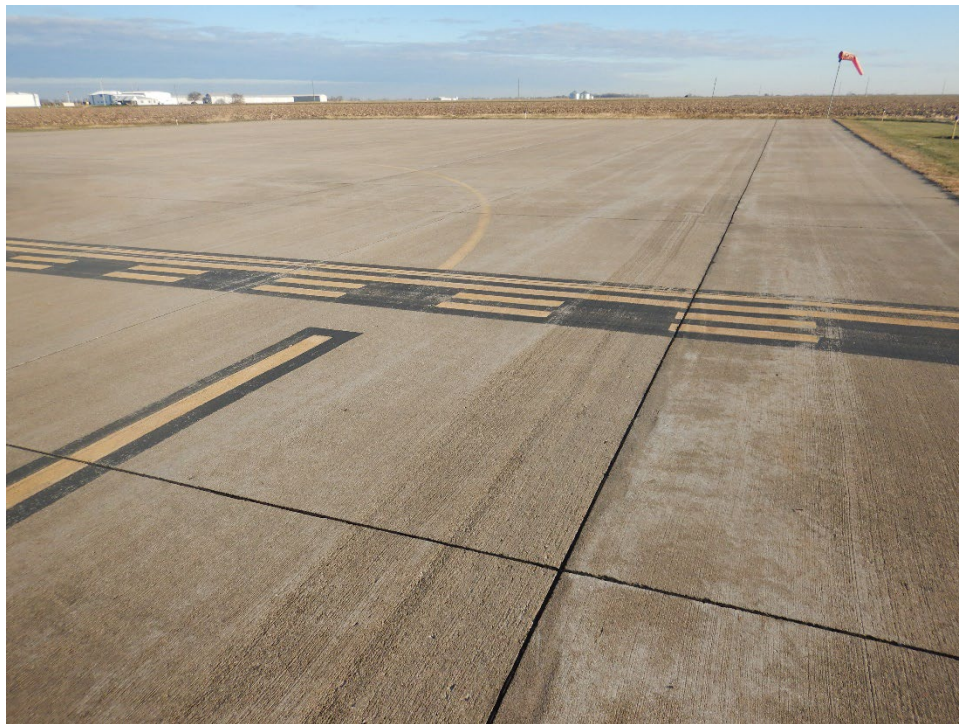
T02OK-01. Overview.

Taxiway 02 consisted of one section with areas of low- and medium-severity corner break and corner spalling; high-severity joint seal damage; medium-severity joint spalling; and low - severity LTD cracking, large patching, and faulting noted during the inspection.

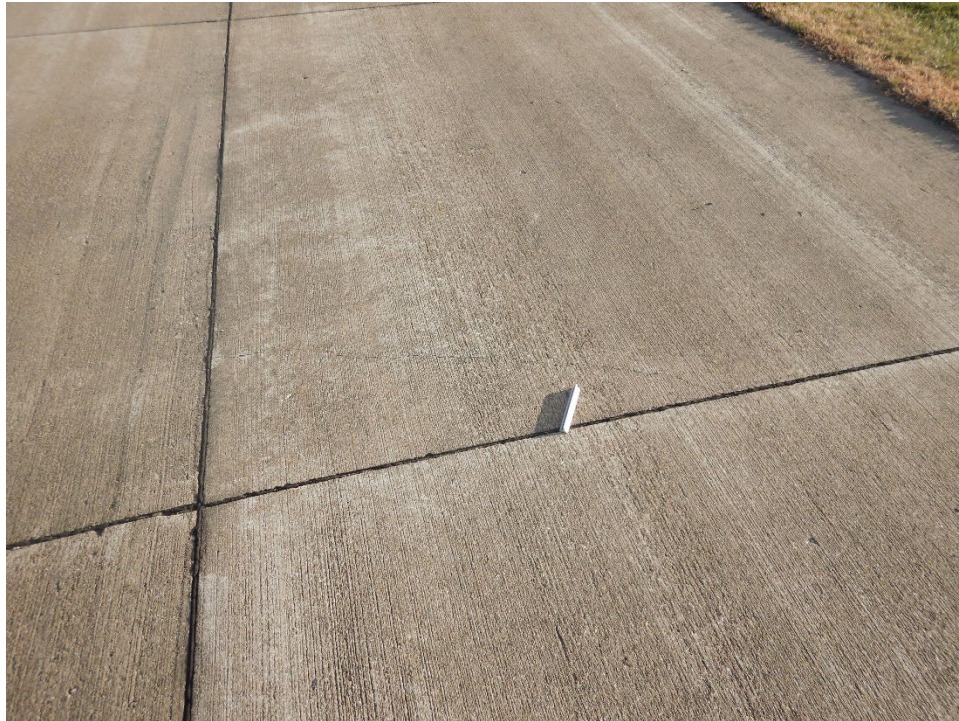
T02OK-01. Corner Break (Sample Unit No. 04).

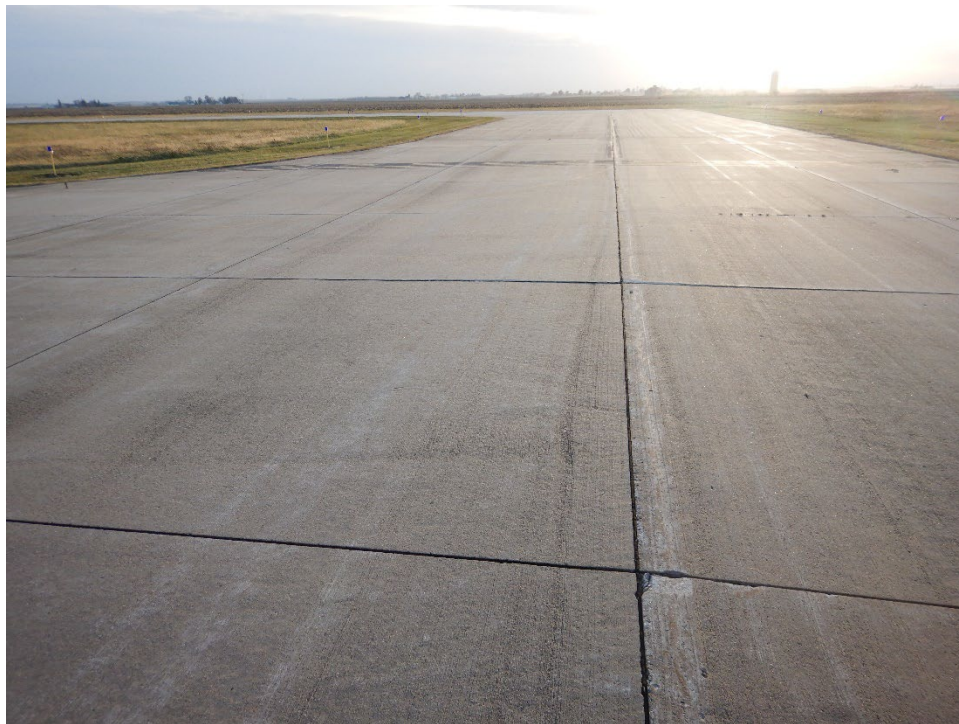
T03OK-01. Overview.

Taxiway 03 contained one section. Medium- and high-severity corner spalling and joint spalling, low-severity faulting, high-severity joint seal damage, and medium- and high-severity small patching were recorded in Section 01.

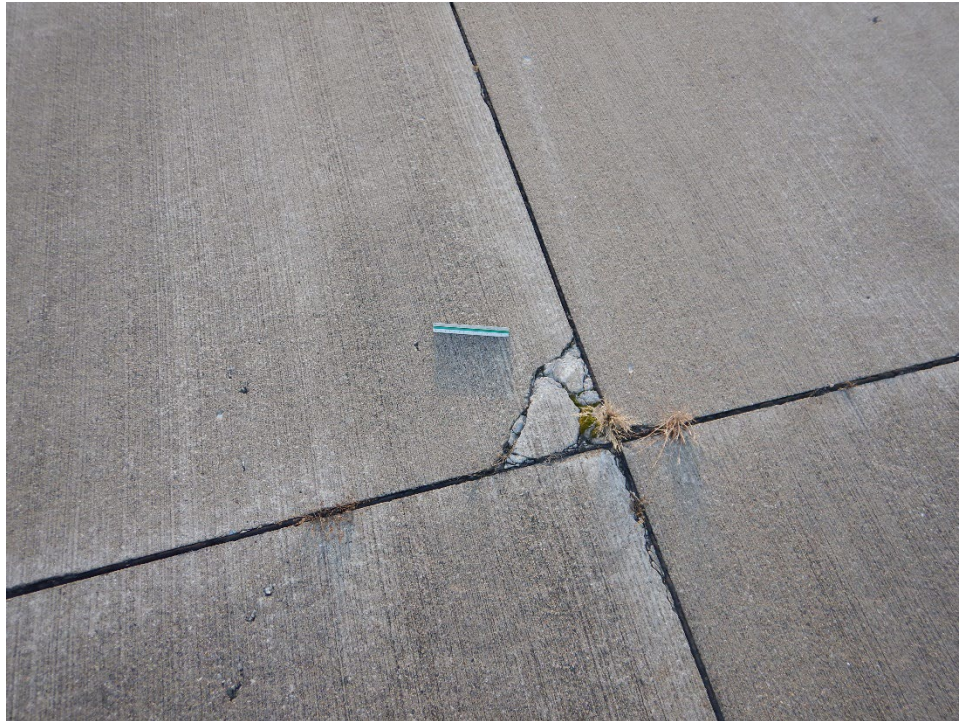
T03OK-01. Corner Spalling (Sample Unit No. 05).

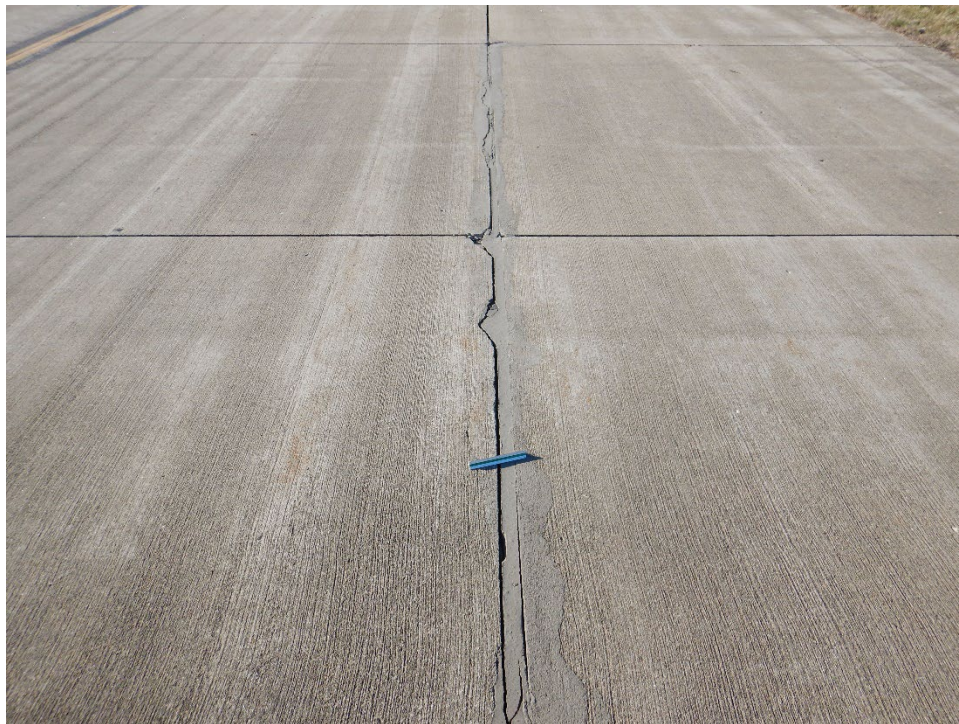
T03OK-01. Small Patching (Sample Unit No. 02).

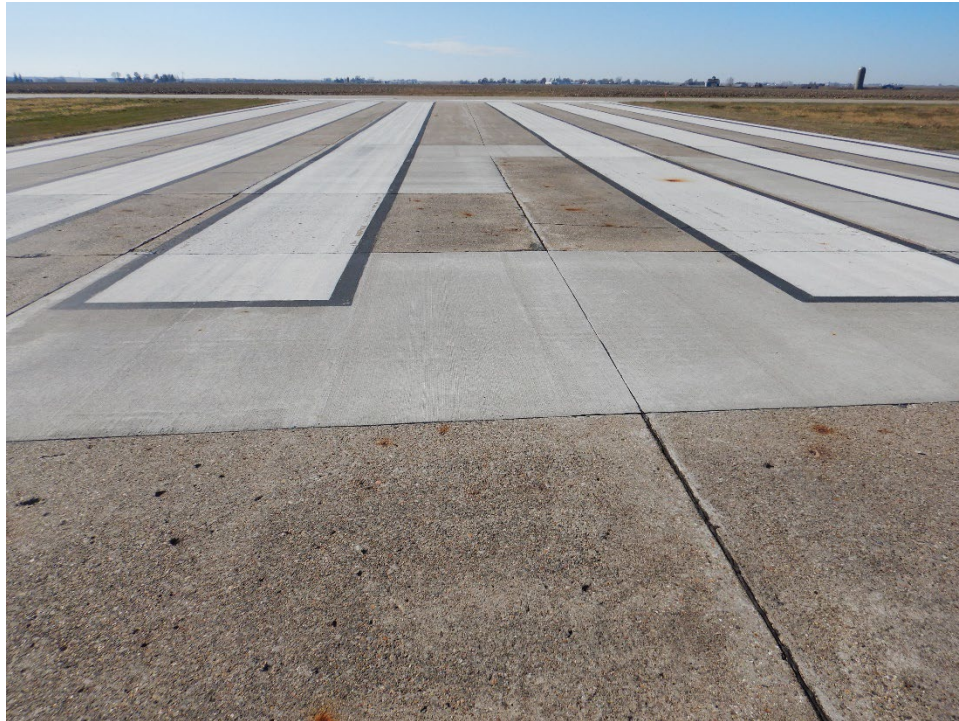
T04OK-01. Overview.

Taxiway 04 was defined by one section that contained low-severity corner break and faulting, low- and medium-severity corner spalling and joint spalling, and medium-severity joint seal damage and LTD cracking.

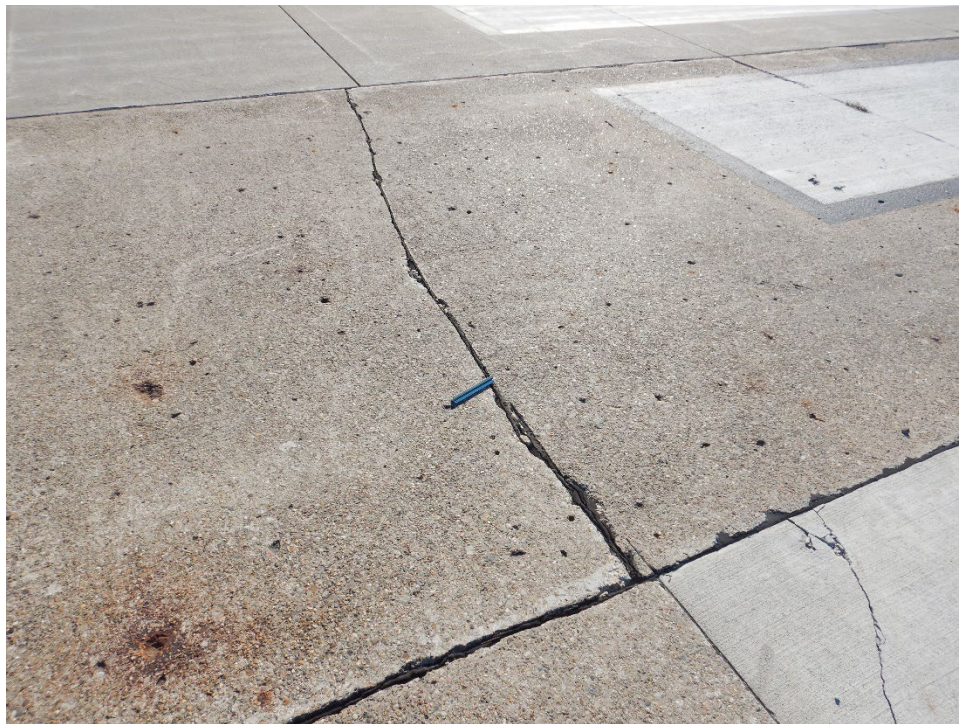
T04OK-01. LTD Cracking (Sample Unit No. 01).

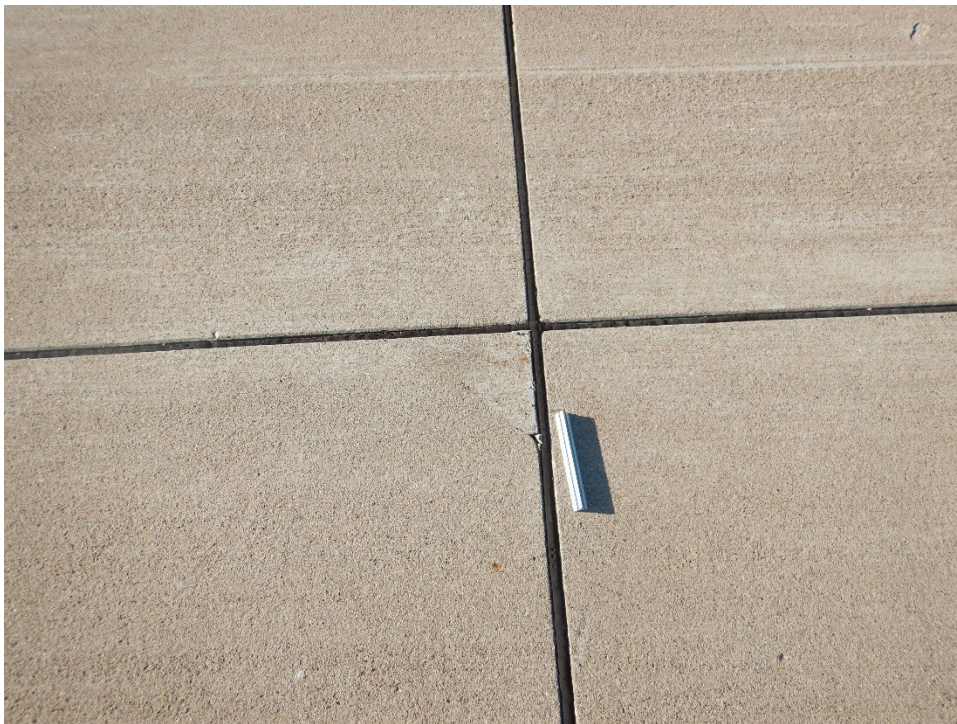
T05OK-01. Corner Spalling (Sample Unit No. 06).

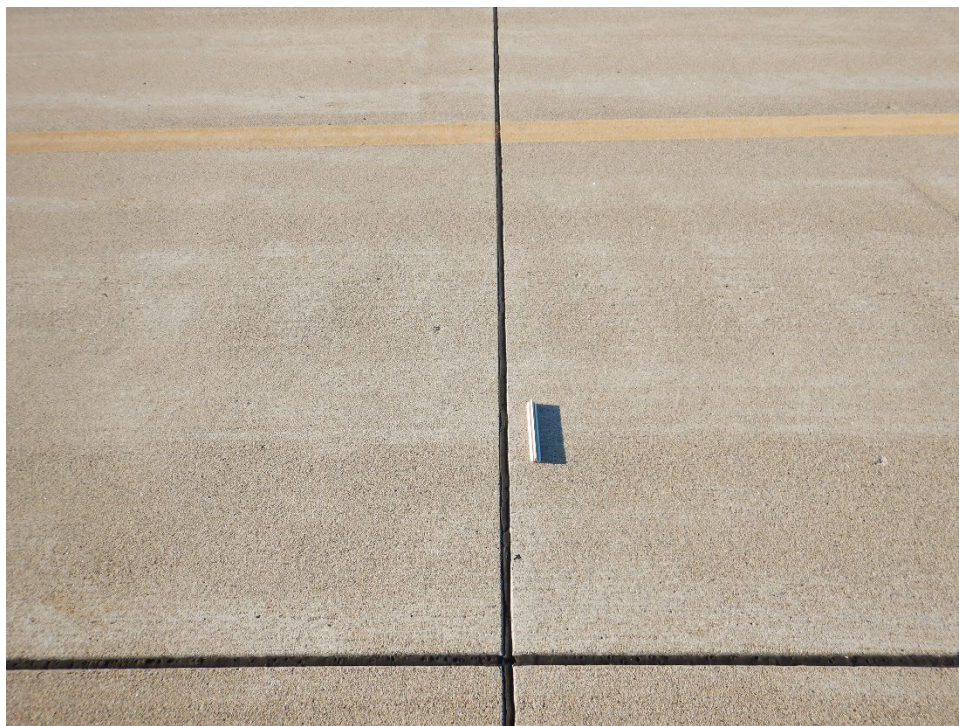
T05OK-02. Joint Seal Damage (Sample Unit No. 15).

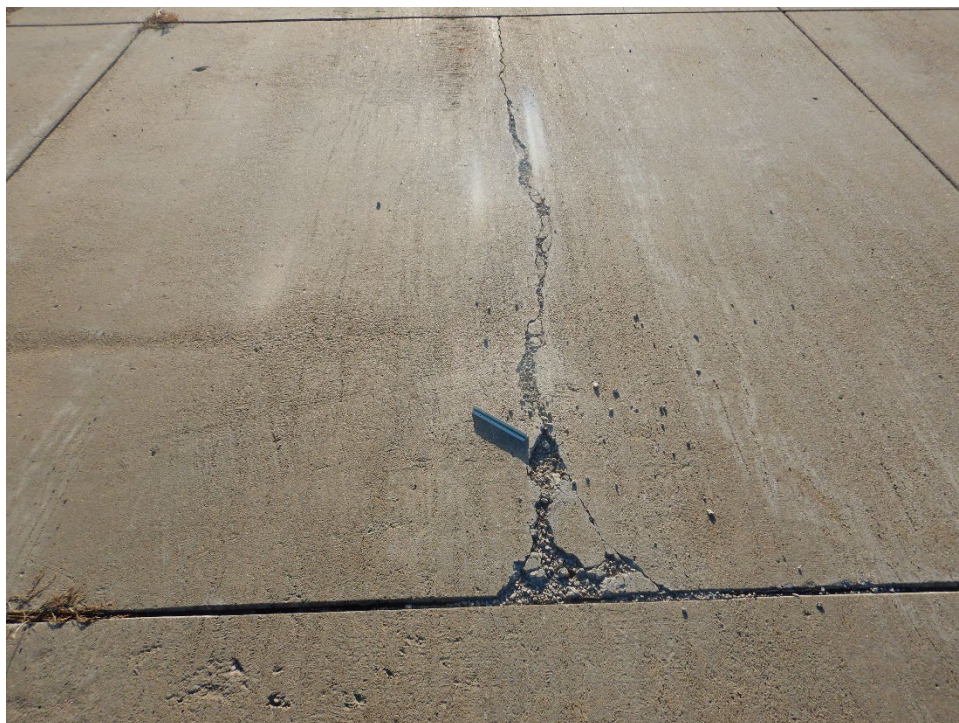
spalling. An atypical area that contained high-severity ASR was recorded as an additional sample unit, in accordance with ASTM D5340-20.

T05OK-03. ASR (Additional Sample Unit No. 01).

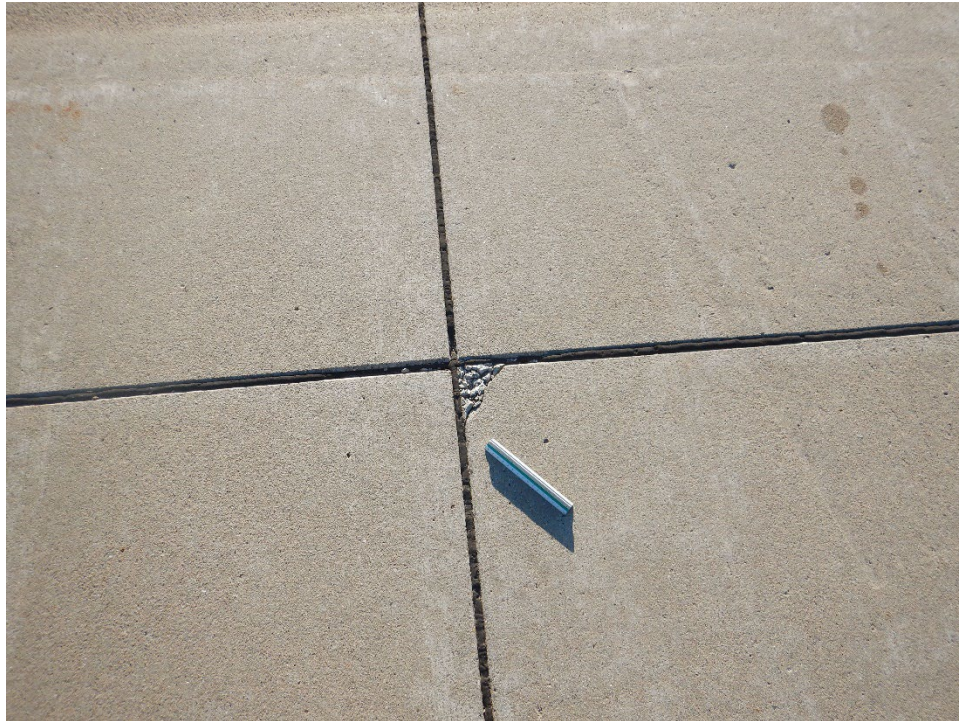
T05OK-03. Corner Spalling (Sample Unit No. 07).

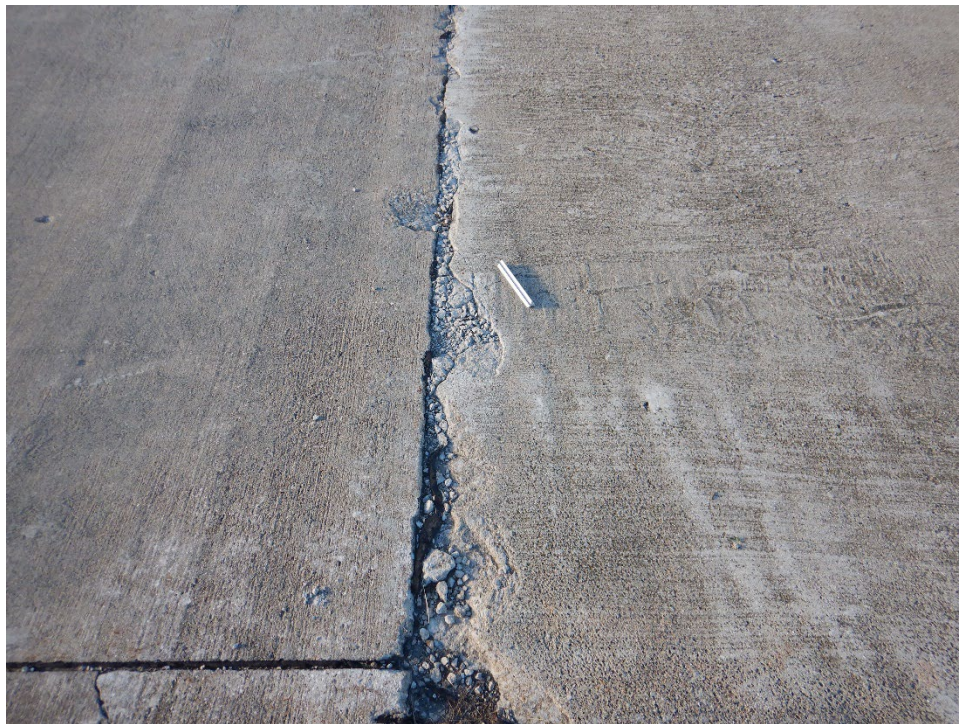
T05OK-03. Joint Spalling (Additional Sample Unit No. 01).

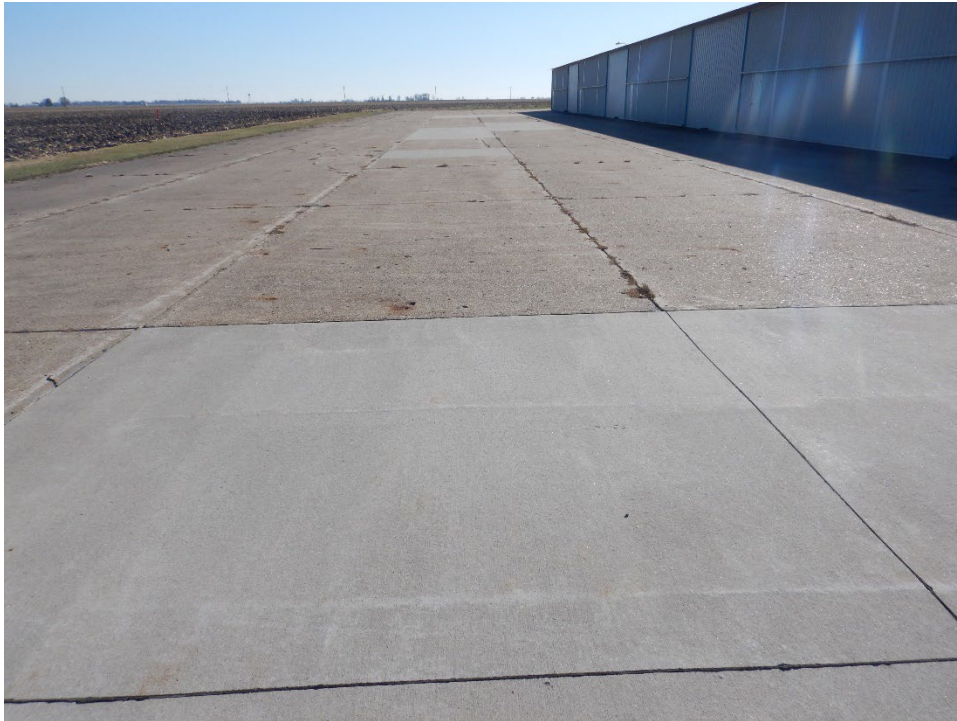
TH01OK-01. Overview.

The T-hangar area contained one section that was in poor condition. Medium- and high-severity corner spalling and joint spalling; low-severity faulting, scaling, and large patching; high-severity joint seal damage; low- and medium-severity LTD cracking and small patching; popouts; medium-severity shattered slab; and shrinkage cracking were observed in Section 01.

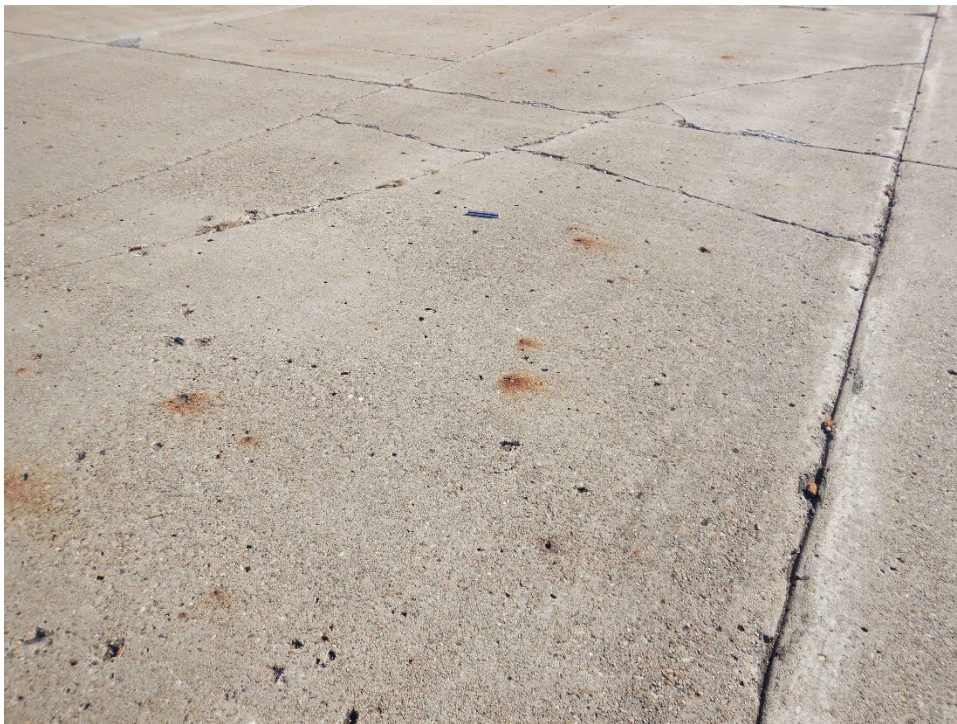
TH01OK-01. Shattered Slab (Sample Unit No. 01).
