Paullina Municipal Airport

PAVEMENT MANAGEMENT REPORT

AUGUST 2019

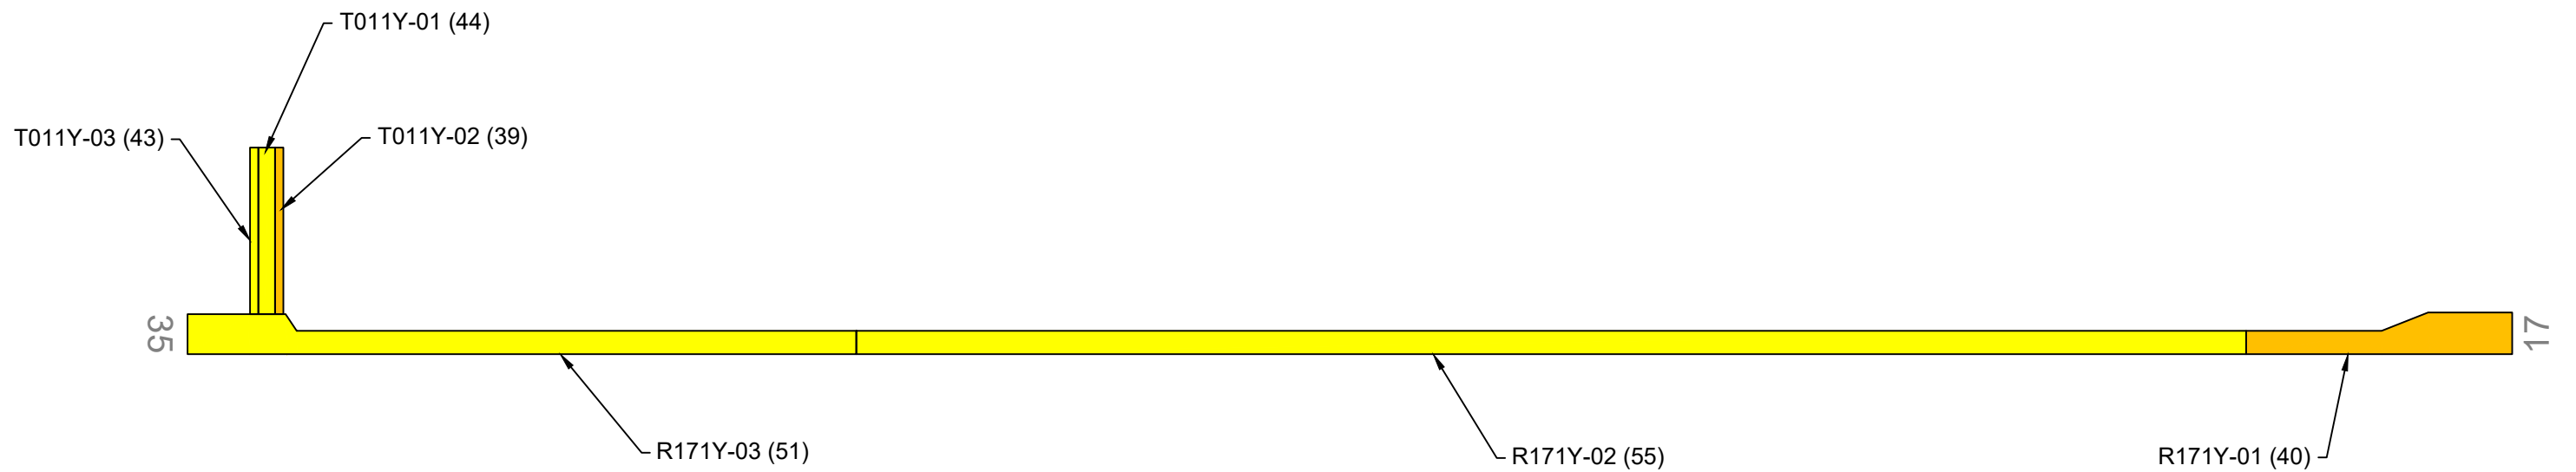
FIGURE 8. PCI MAP.

The pavements at Paullina Municipal Airport were inspected on November 18, 2018. The 2018 area-weighted condition of Paullina Municipal Airport is 51, with conditions ranging from 39 to 55 (on a scale of 0 [failed] to 100 [excellent]). During the previous pavement inspection in 2014, the area-weighted PCI of the airport was 68.

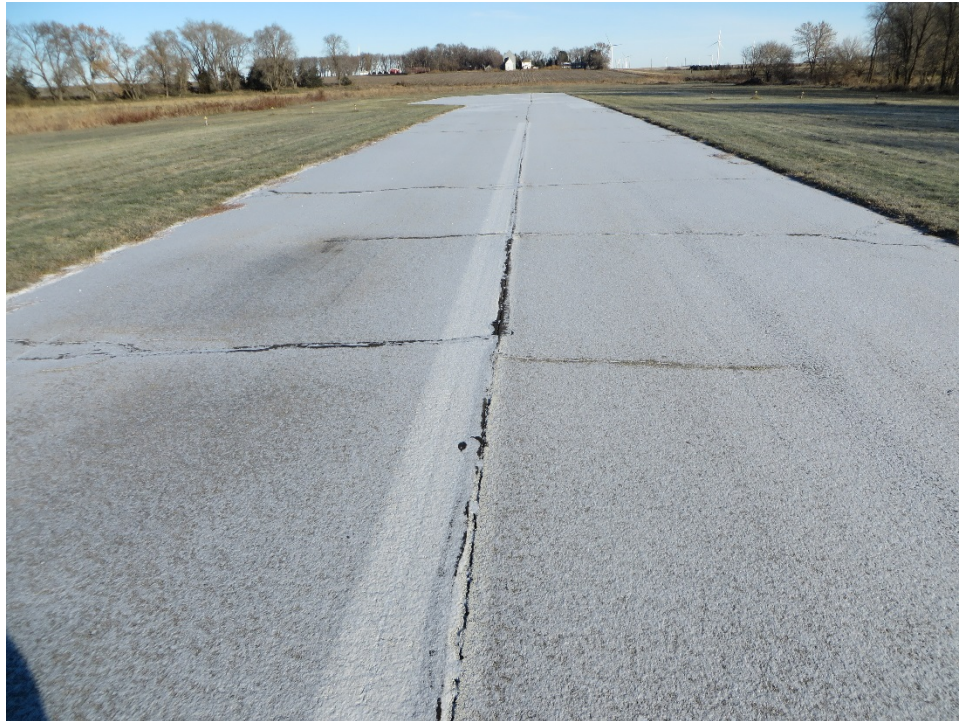
Runway 17/35 consisted of three sections. Section 01, located at the Runway 17 approach, was recorded with low- and medium-severity longitudinal and transverse (L&T) cracking and alligator cracking, medium-severity rutting, and low-severity weathering. The low-severity L&T cracking was unsealed, and the medium-severity L&T cracking was due to either unsatisfactory crack sealant or the development of secondary cracking. The low-severity alligator cracking was noted where pattern cracking had developed that was wider than 1 ft. Some of the medium-severity alligator cracking was observed at the edge of the pavement. Section 02 was identified with low-severity weathering throughout along with low- and medium-severity alligator cracking and L&T cracking. The low-severity L&T cracking was unsealed, and the medium-severity L&T cracking was due to either unsealed crack widths that exceeded 1/4 in, the development of secondary cracking, or unsatisfactory crack sealant. Section 03, located at the Runway 35 approach, had low- and medium-severity alligator cracking and L&T cracking and low-severity raveling and weathering recorded throughout. The low-severity L&T cracking was unsealed, and the medium-severity L&T cracking was due to failed crack sealant or the development of secondary cracking.

R171Y-01. Overview.

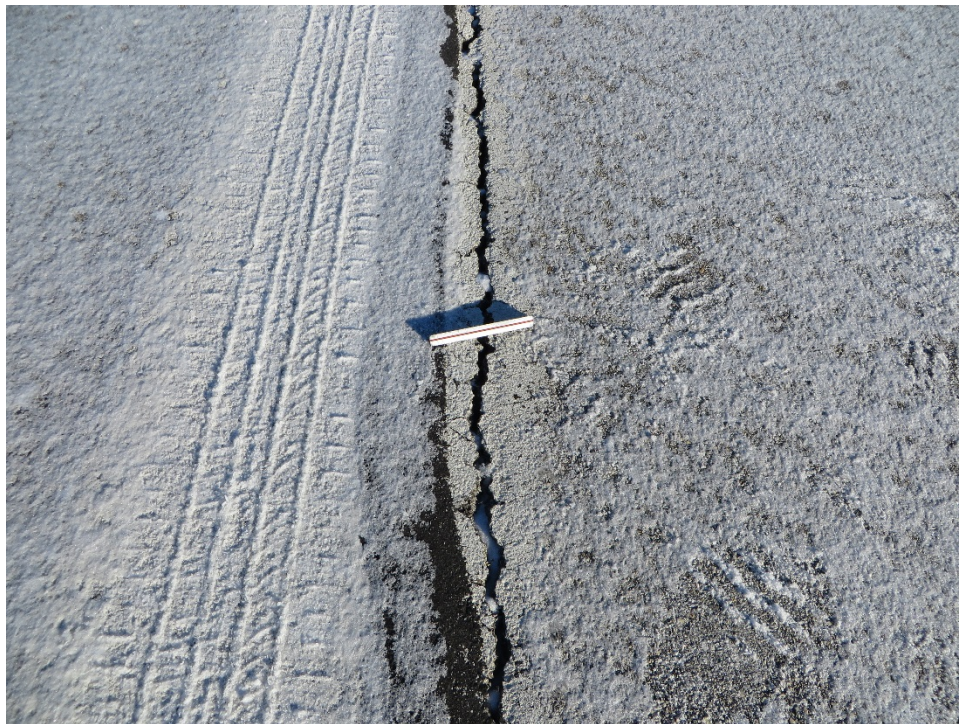
R171Y-01. L&T Cracking (Sample Unit No. 02).

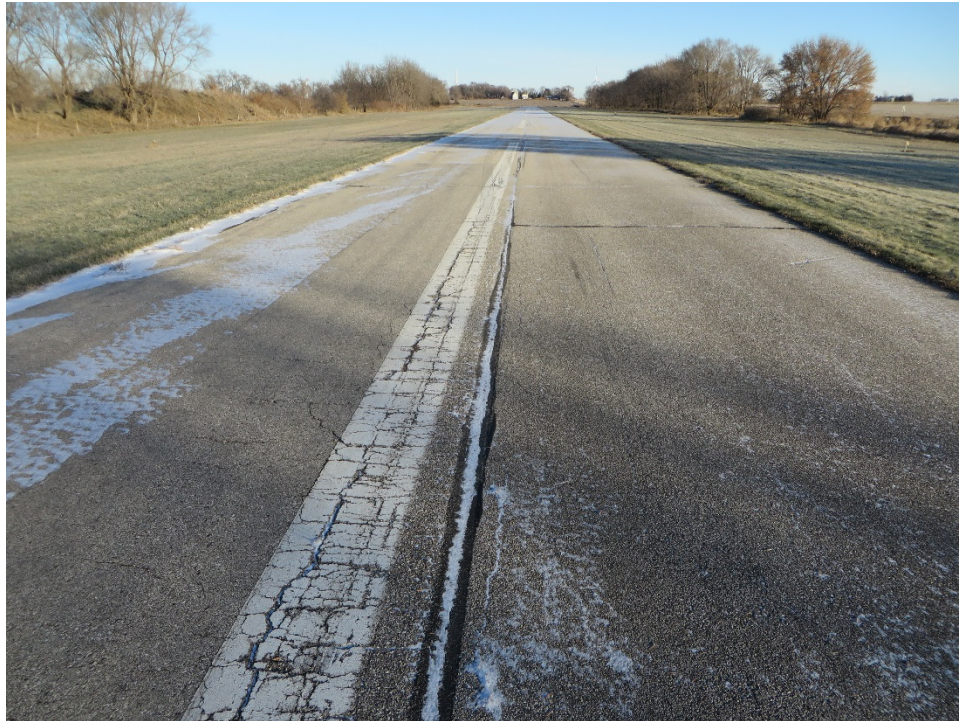
R171Y-02. Overview.

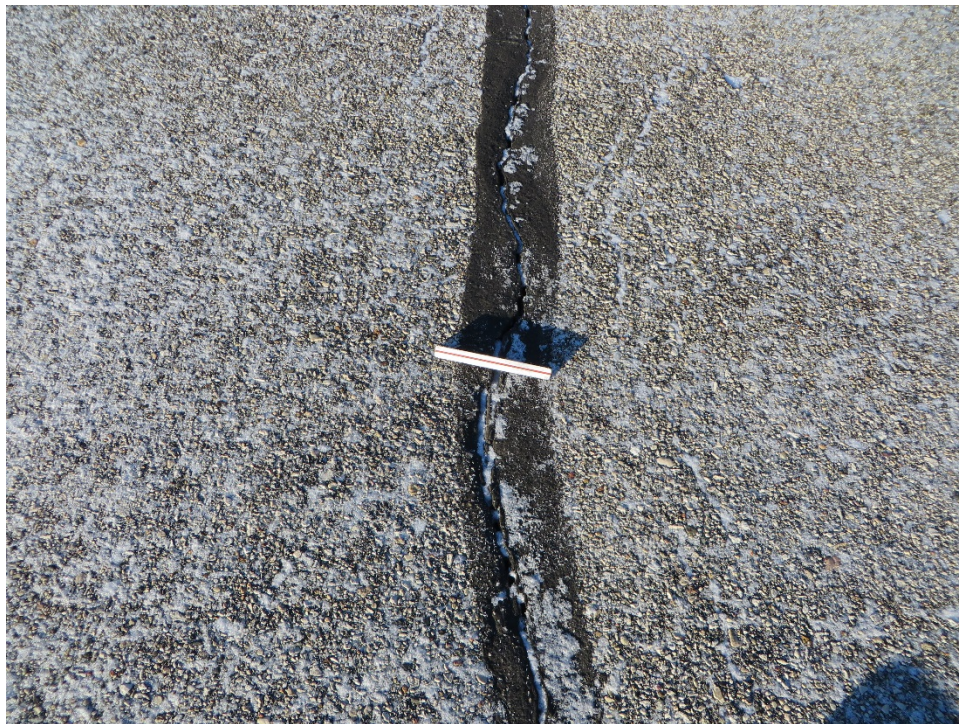
R171Y-02. L&T Cracking (Sample Unit No. 08).

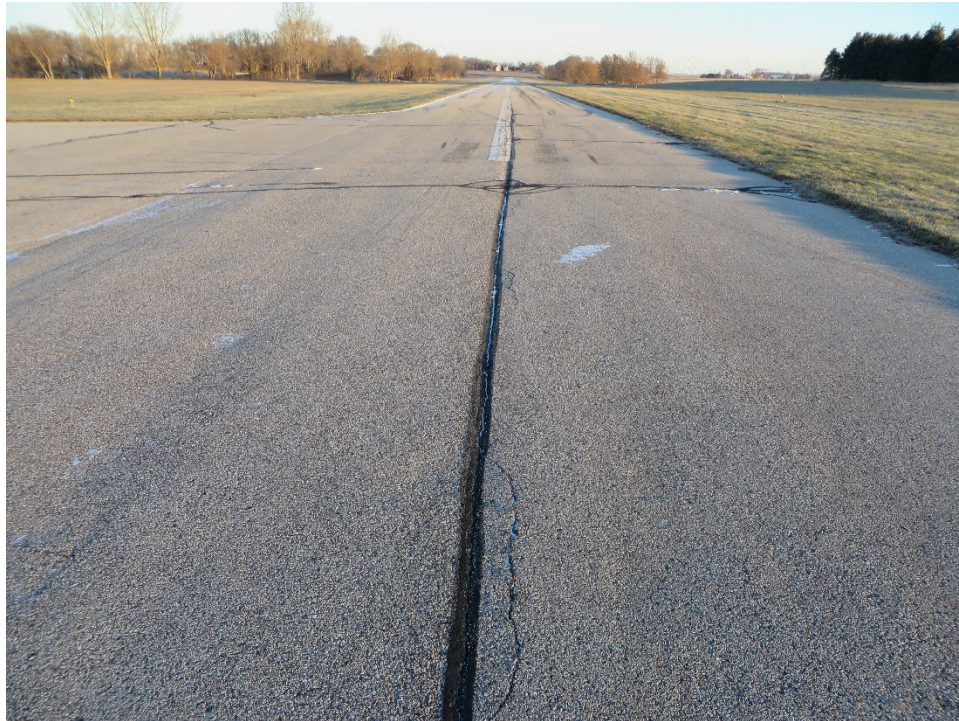
R171Y-03. Overview.

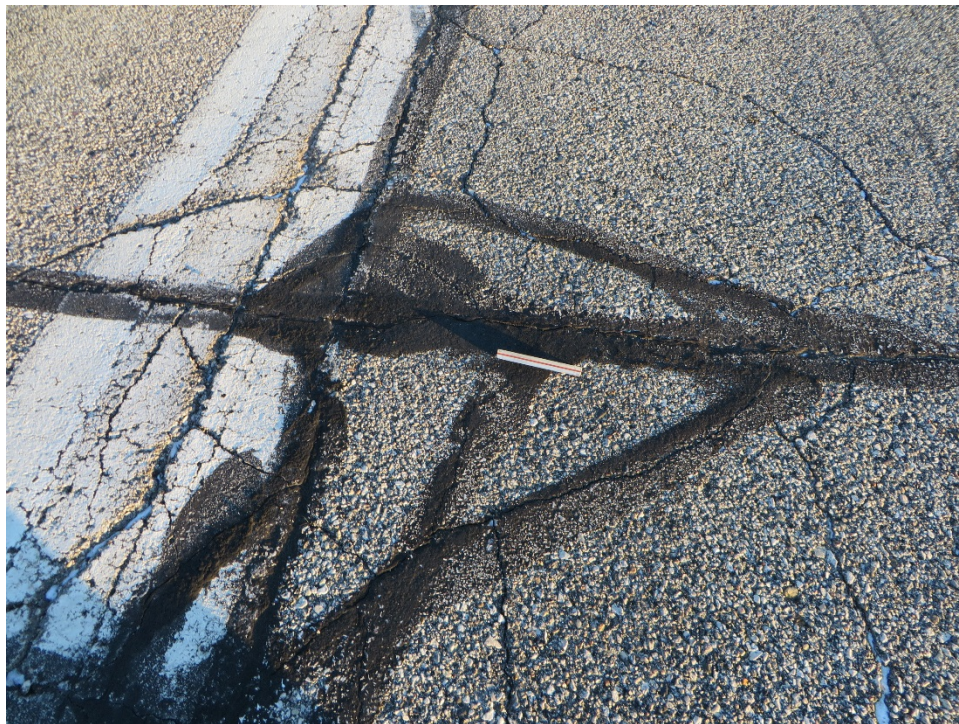
R171Y-03. Alligator Cracking (Sample Unit No. 04).

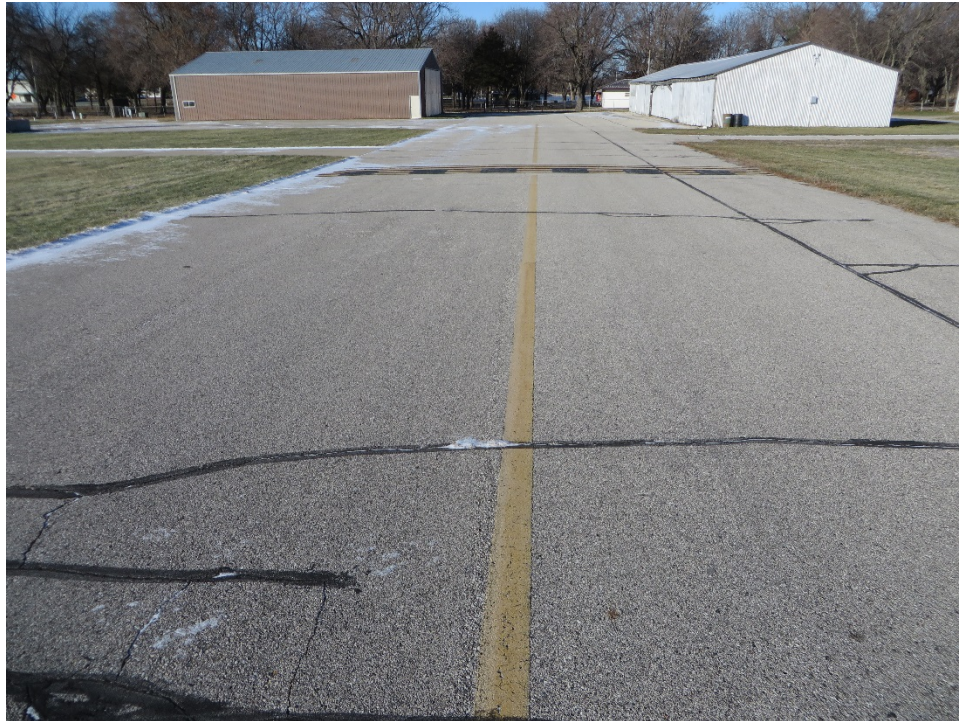
Taxiway 01 was defined by three sections. Sections 01 and 03 were in similar condition with medium-severity alligator cracking, low- and medium-severity L&T cracking and low-severity raveling and weathering observed. Section 02 was identified with low- and medium-severity L&T cracking, low-severity weathering, and low-severity alligator cracking located at the edge of the pavement. The low-severity L&T cracking in all three sections was unsealed, and the medium-severity L&T cracking was due to either crack sealant that was no longer performing satisfactorily or unsealed crack widths that exceeded 1/4 in.

T011Y-01. Overview.

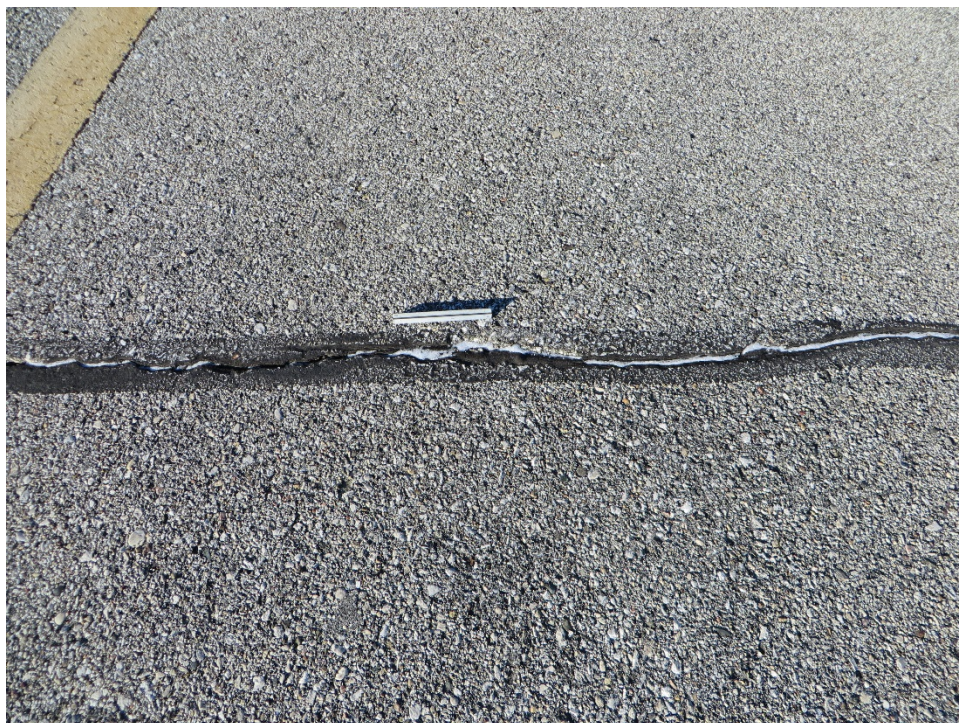
T011Y-01. L&T Cracking (Sample Unit No. 01).

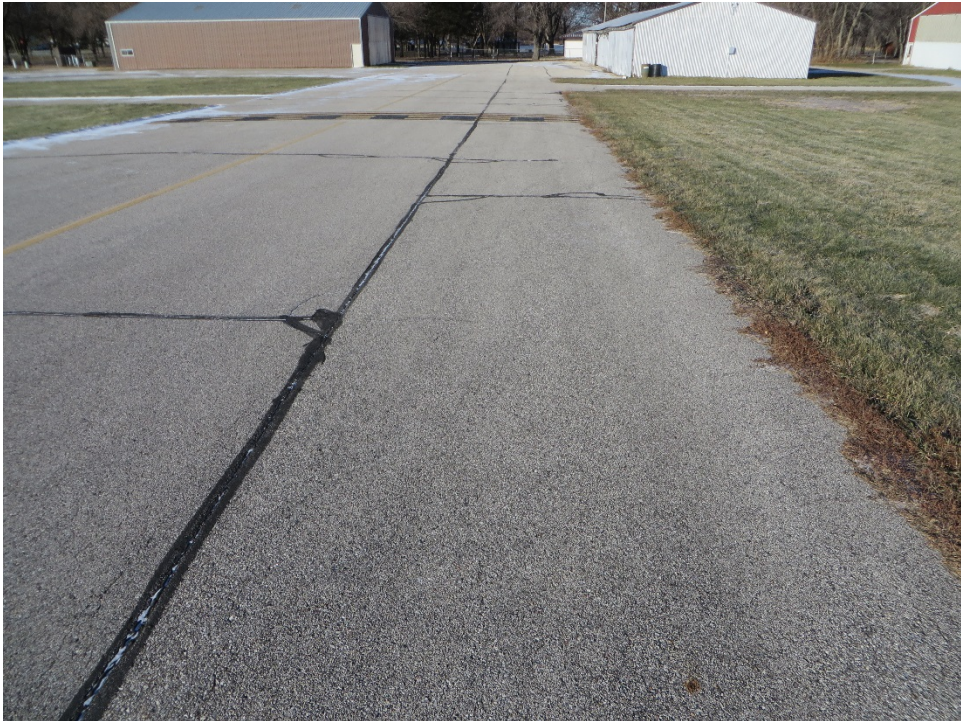
T011Y-02. Overview.

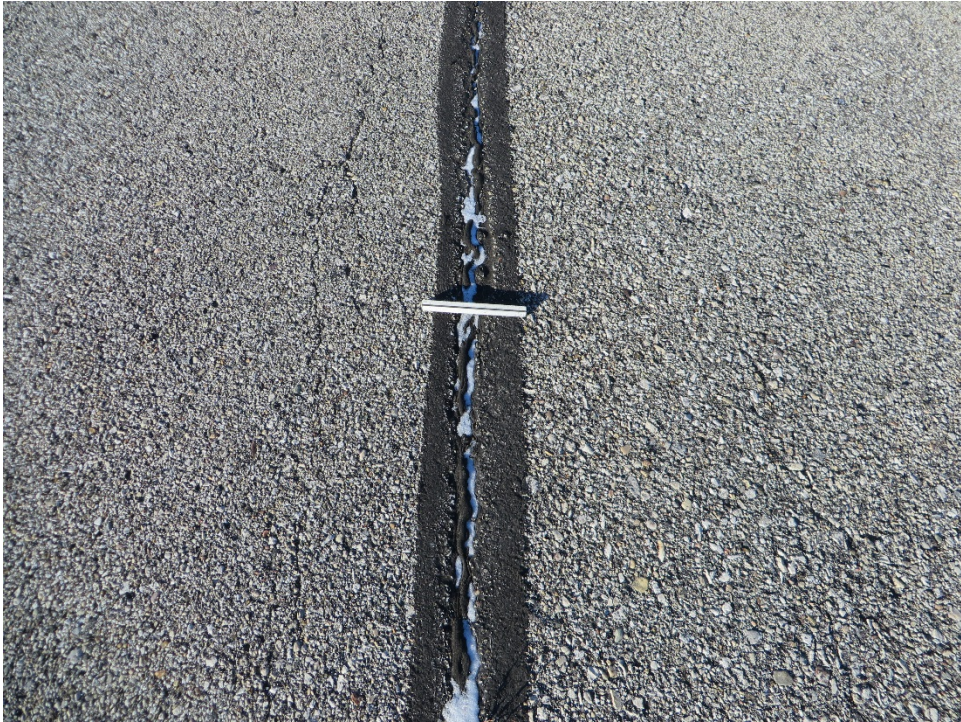
T011Y-02. L&T Cracking (Sample Unit No. 01).

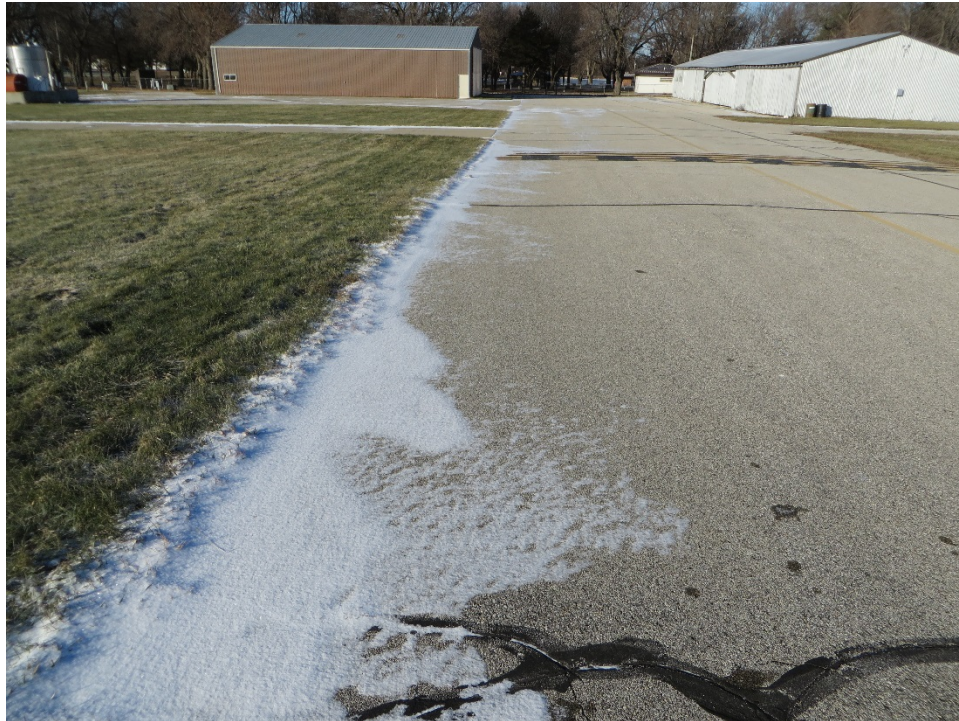
T011Y-03. Overview.

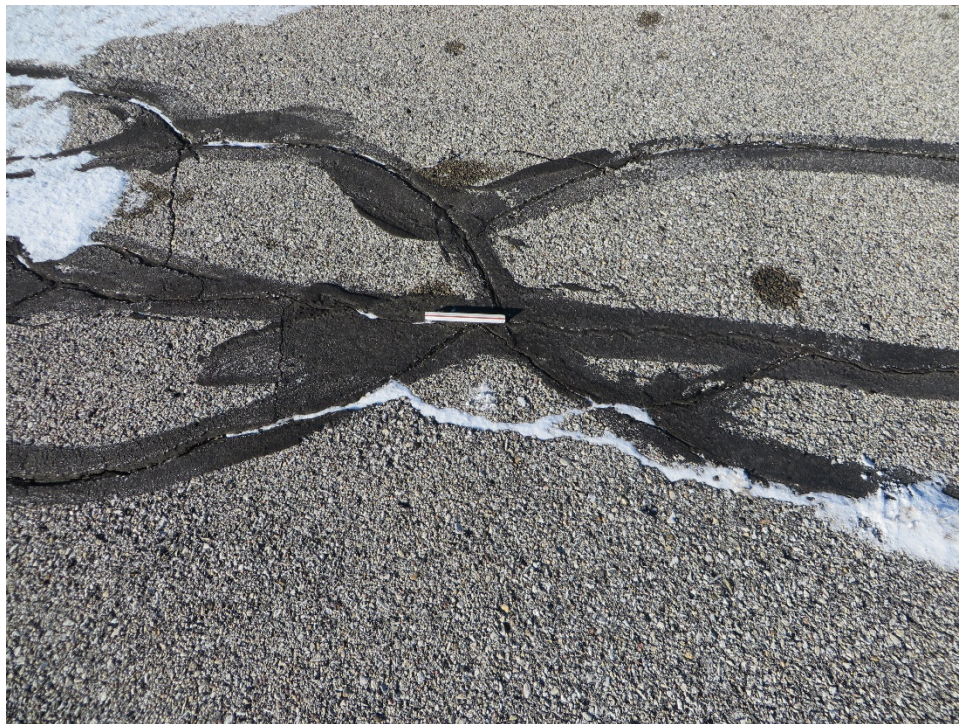
T011Y-03. Alligator Cracking (Sample Unit No. 01).
