Pella Municipal Airport

PAVEMENT MANAGEMENT REPORT

JULY 2022

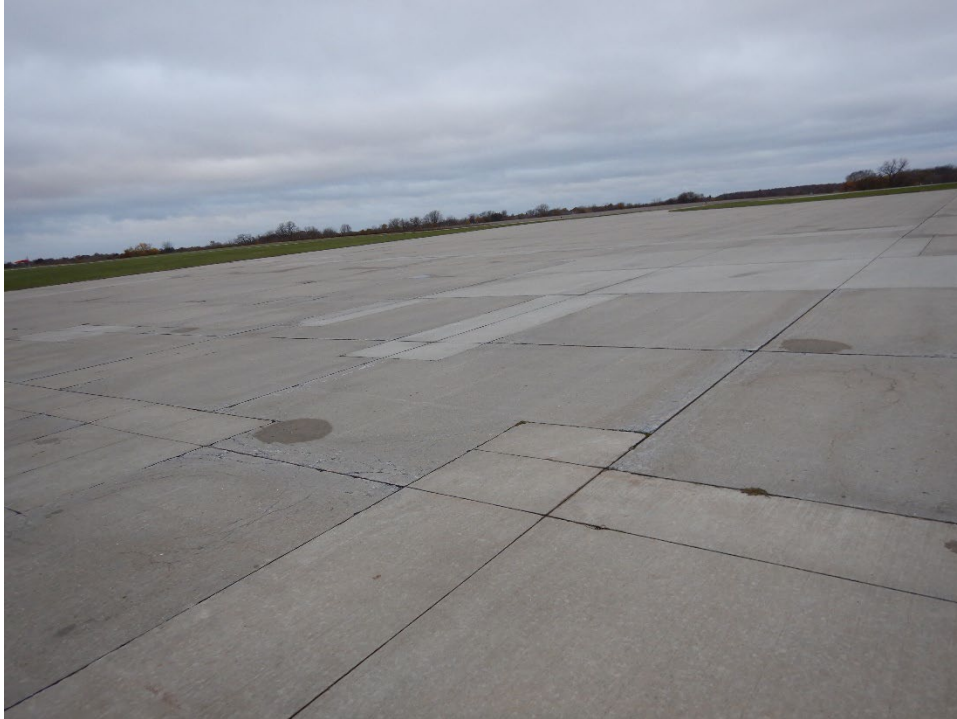
A01PE-01. Overview.

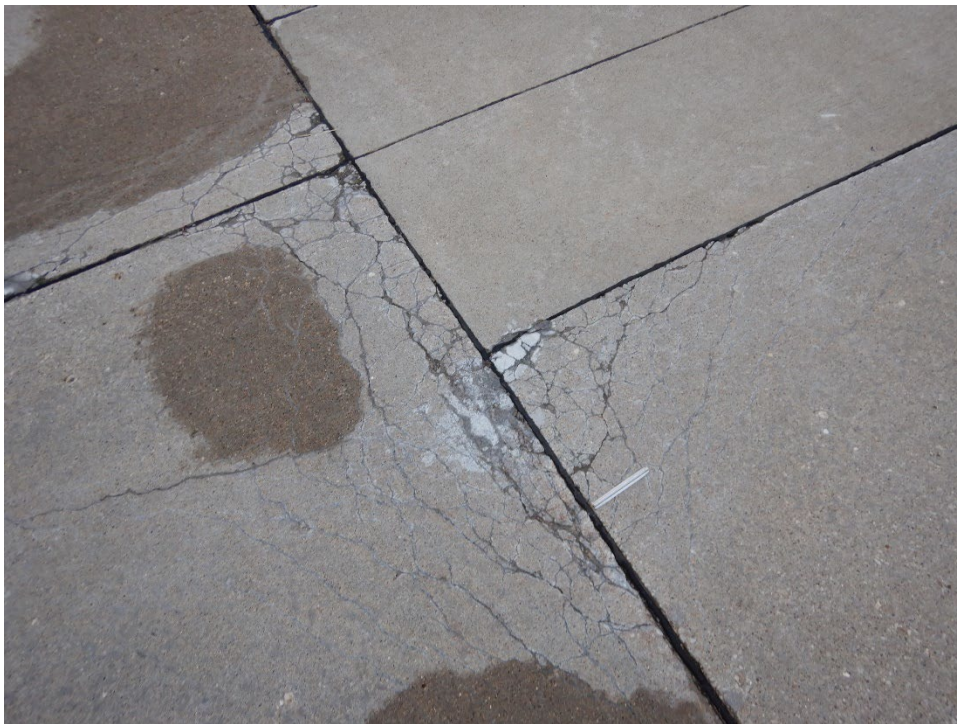
A01PE-01. ASR (Sample Unit No. 15).

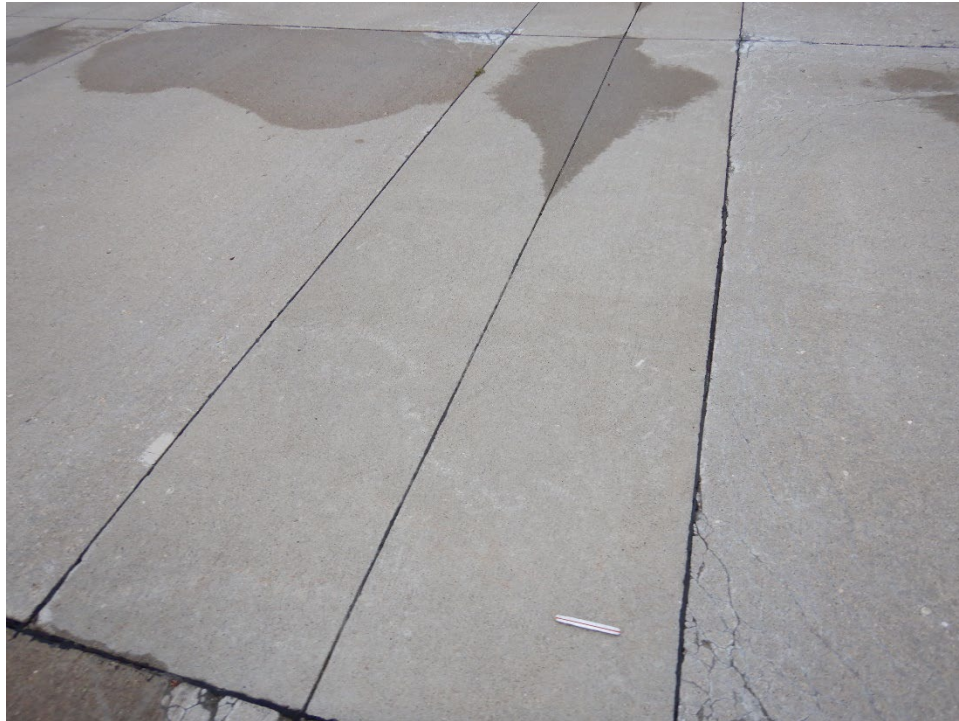
A01PE-01. Large Patching (Sample Unit No. 15).

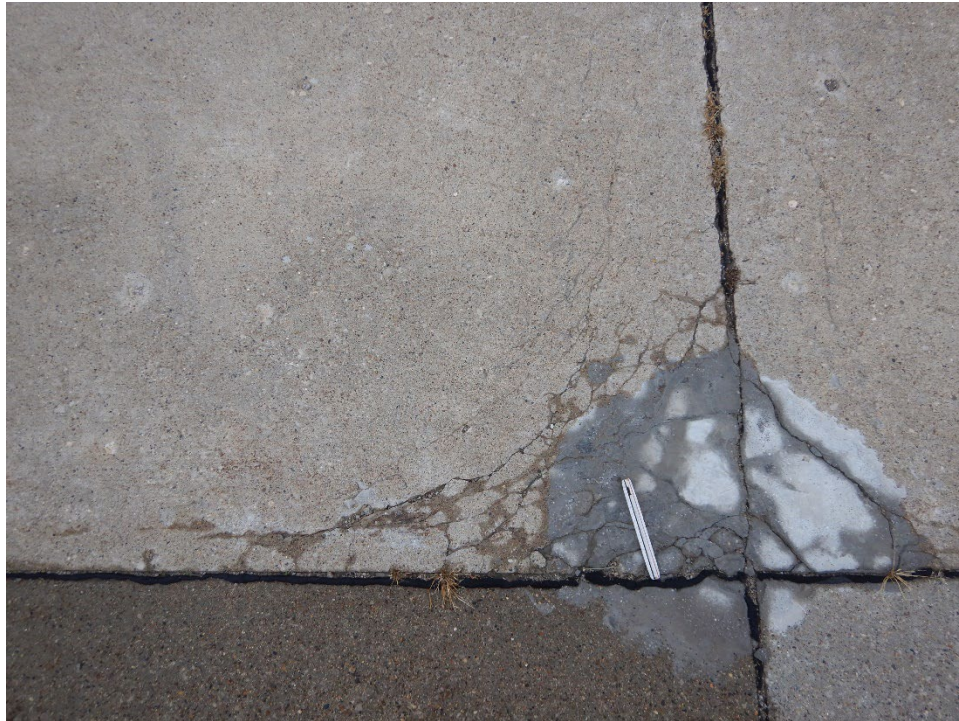
A01PE-02. ASR (Sample Unit No. 03) (1).

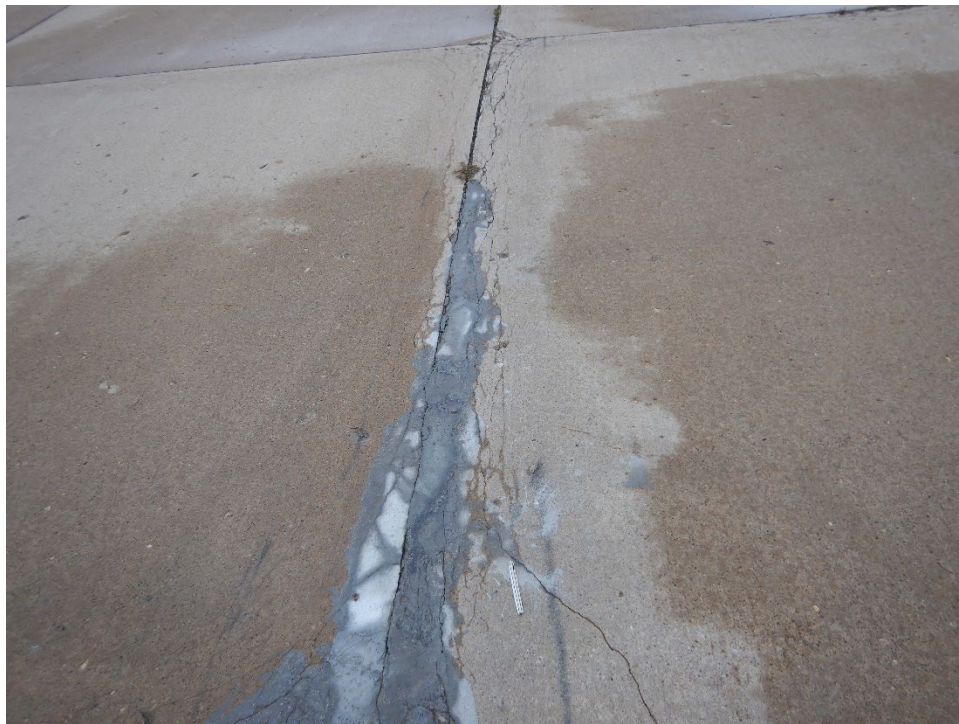
A01PE-02. ASR (Sample Unit No. 03) (2).

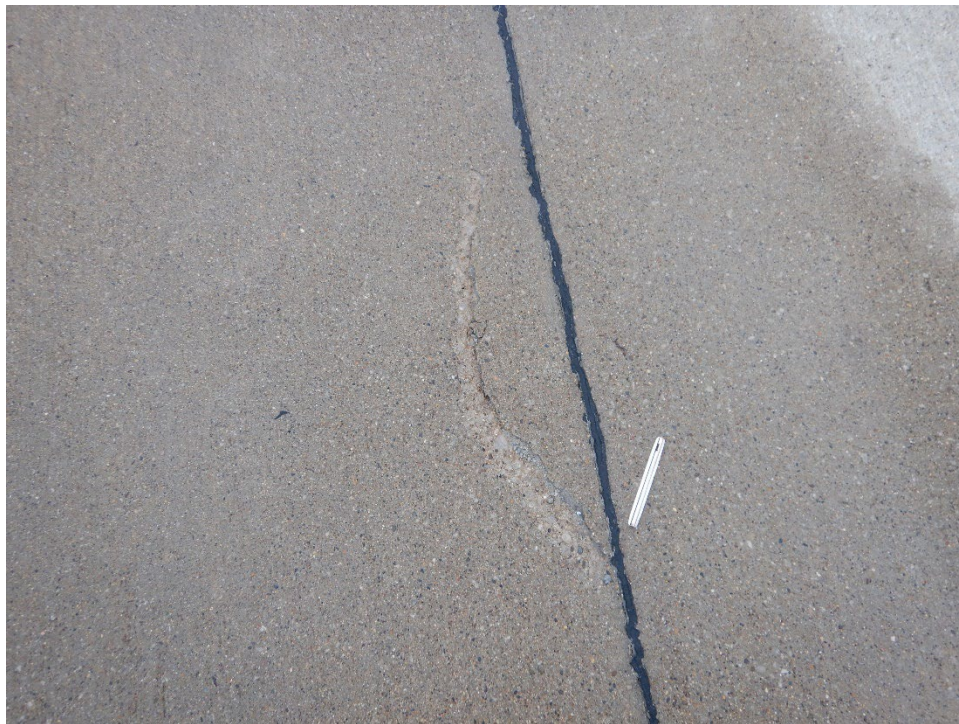
A01PE-03. Joint Spalling (Sample Unit No. 02).

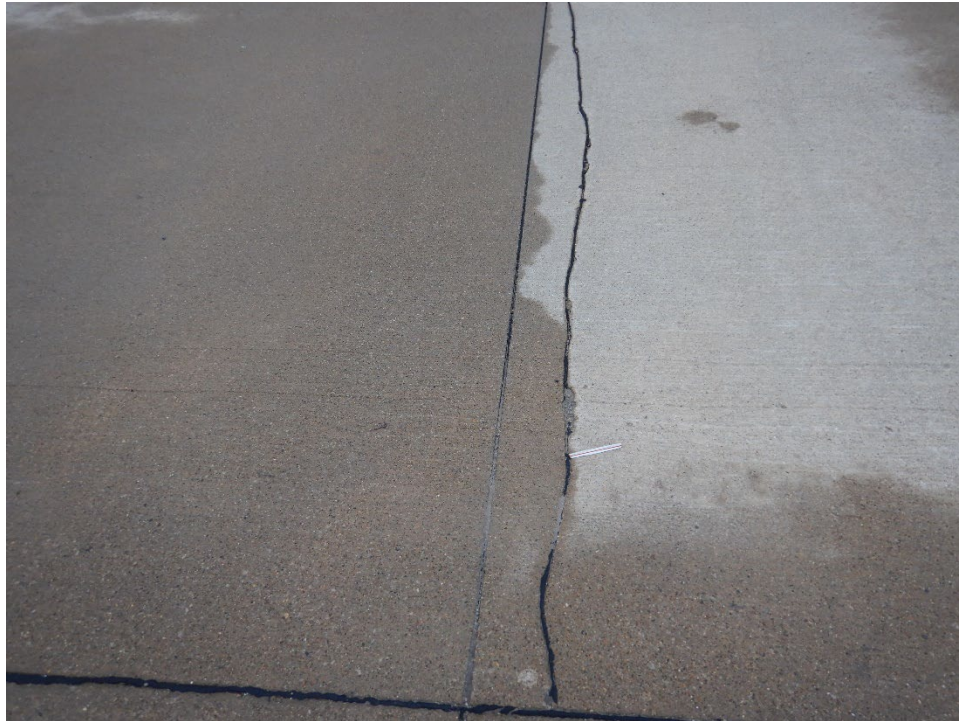
A01PE-03. LTD Cracking (Sample Unit No. 03).

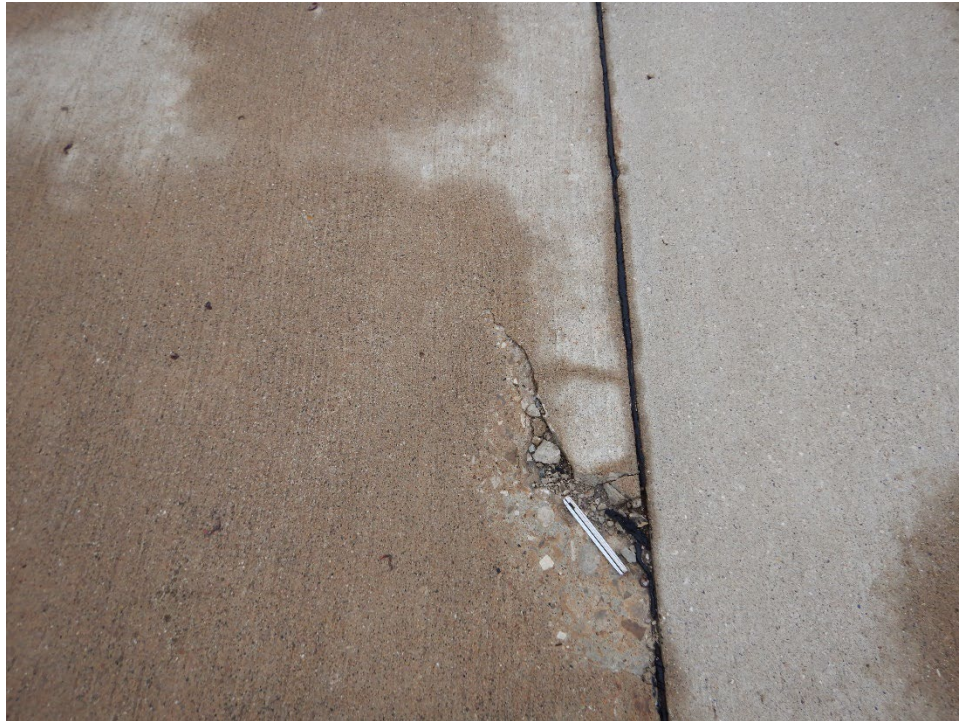
A01PE-04. Joint Spalling (Sample Unit No. 02).

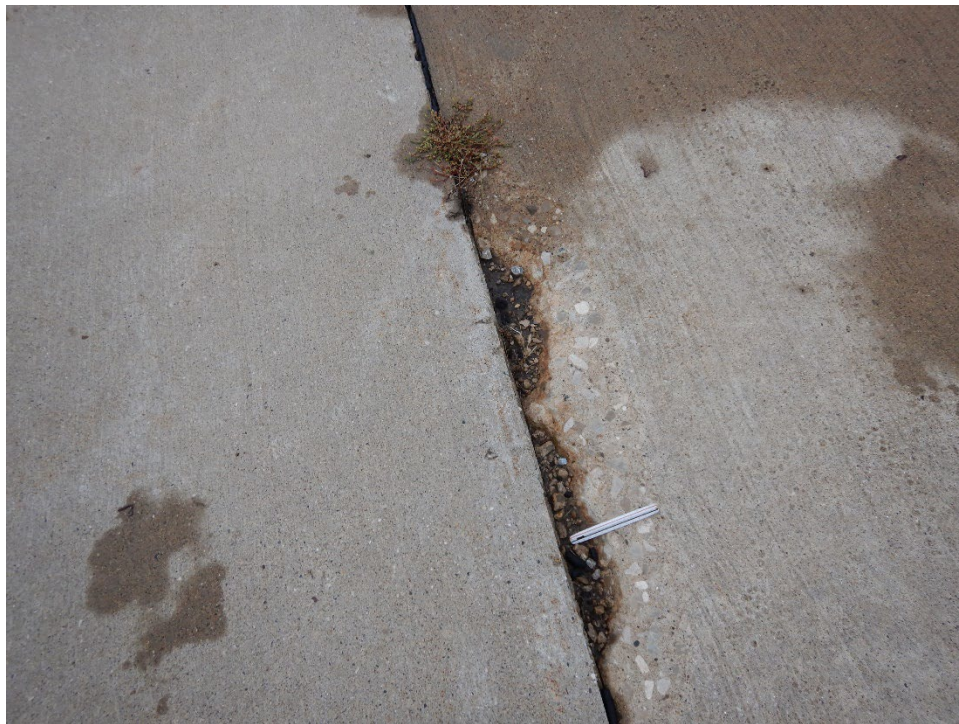
A01PE-04. Joint Spalling (Sample Unit No. 03).

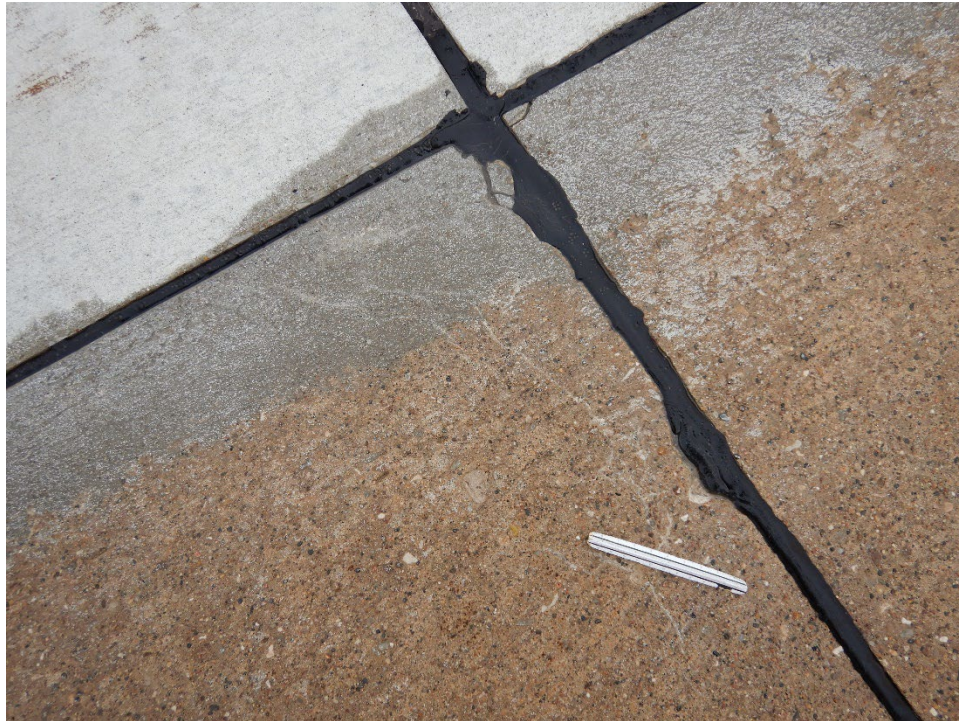
R16PE-03. ASR (Sample Unit No. 06).

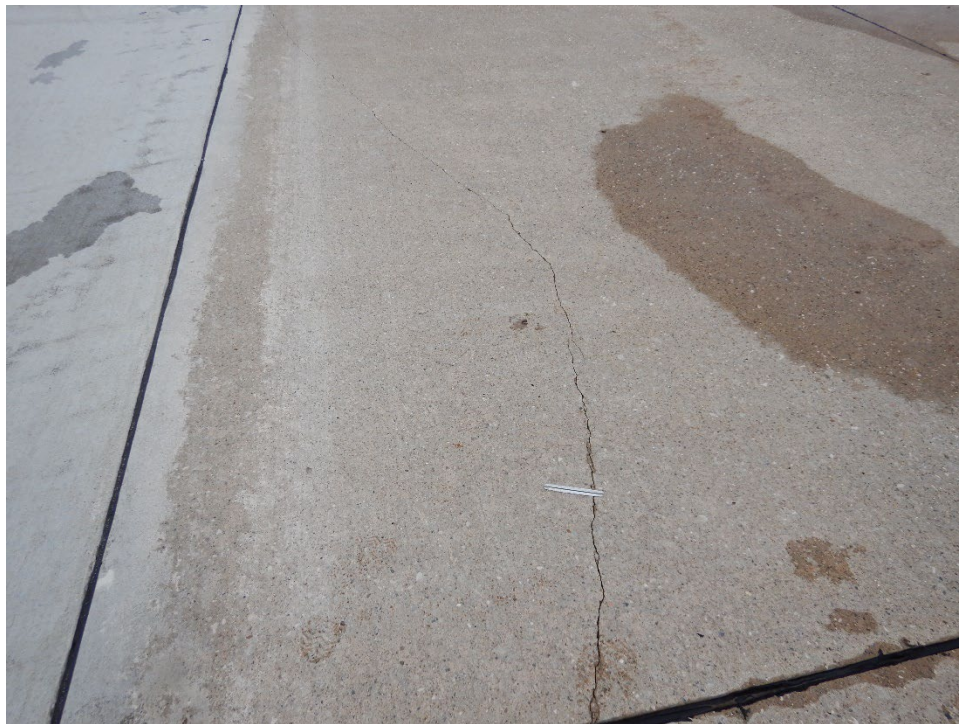
R16PE-03. LTD Cracking (Sample Unit No. 27).

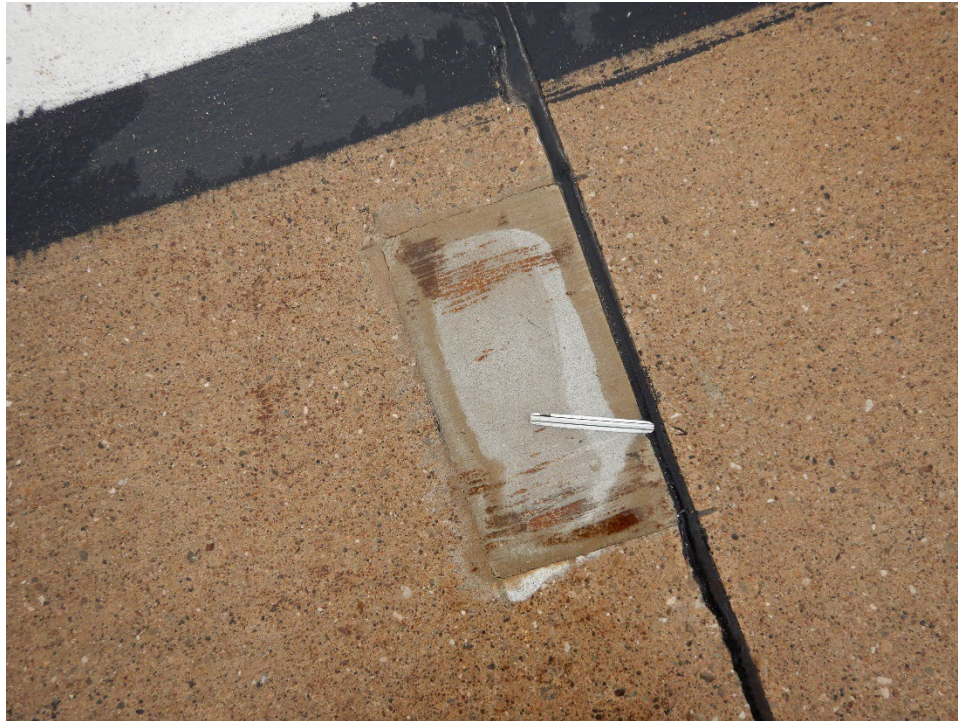
R16PE-03. Small Patching (Sample Unit No. 34).

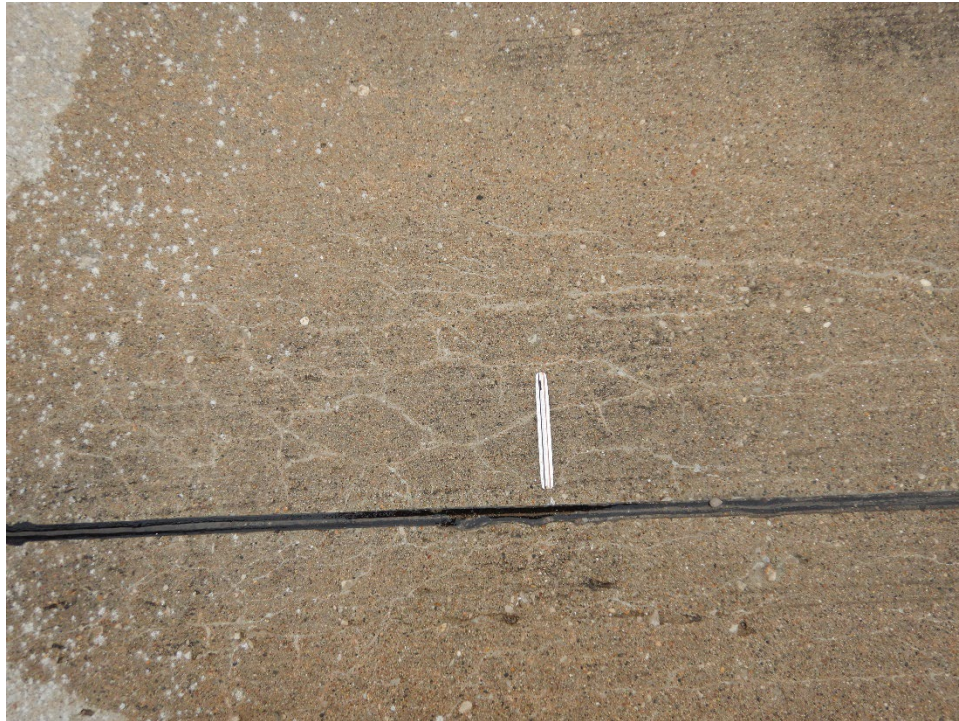
R16PE-05. ASR (Sample Unit No. 01).

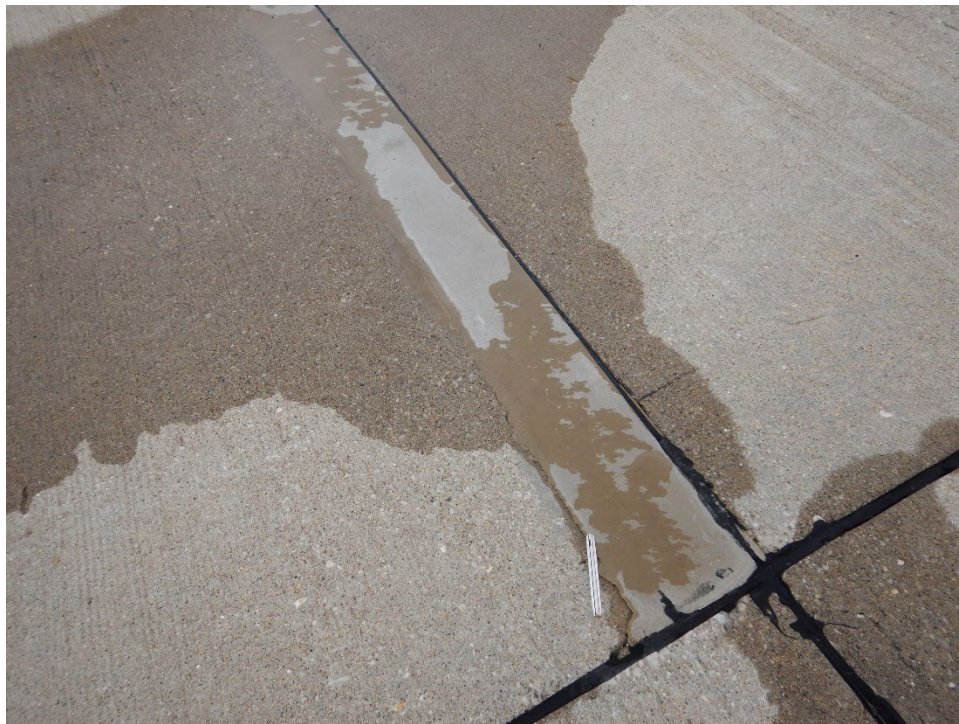
R16PE-05. Large Patching (Sample Unit No. 01).

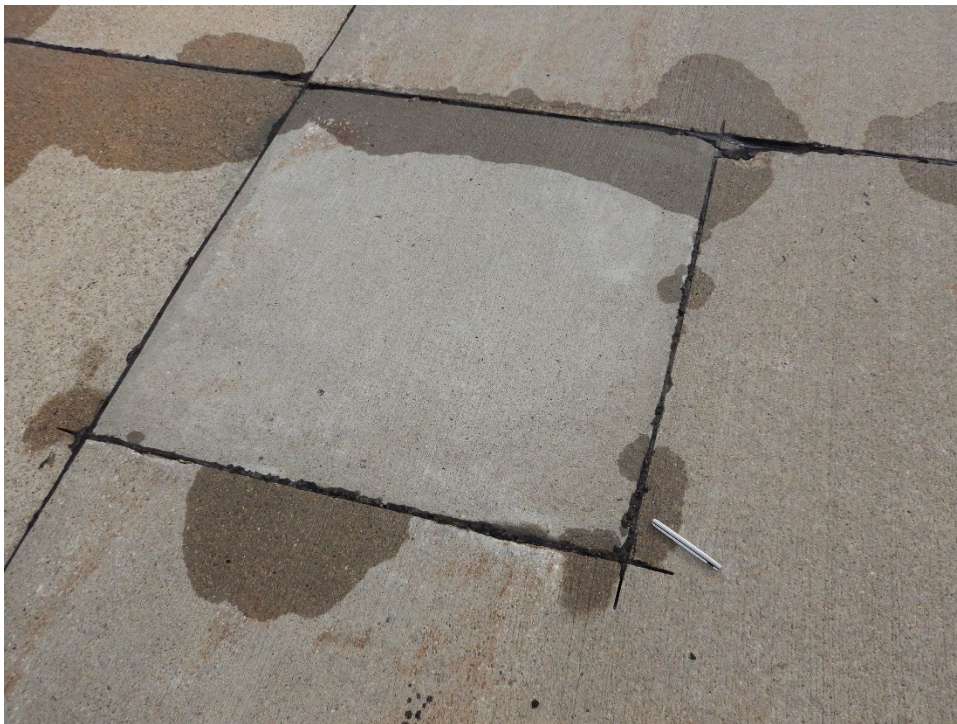
R16PE-06. Large Patching (Sample Unit No. 02).

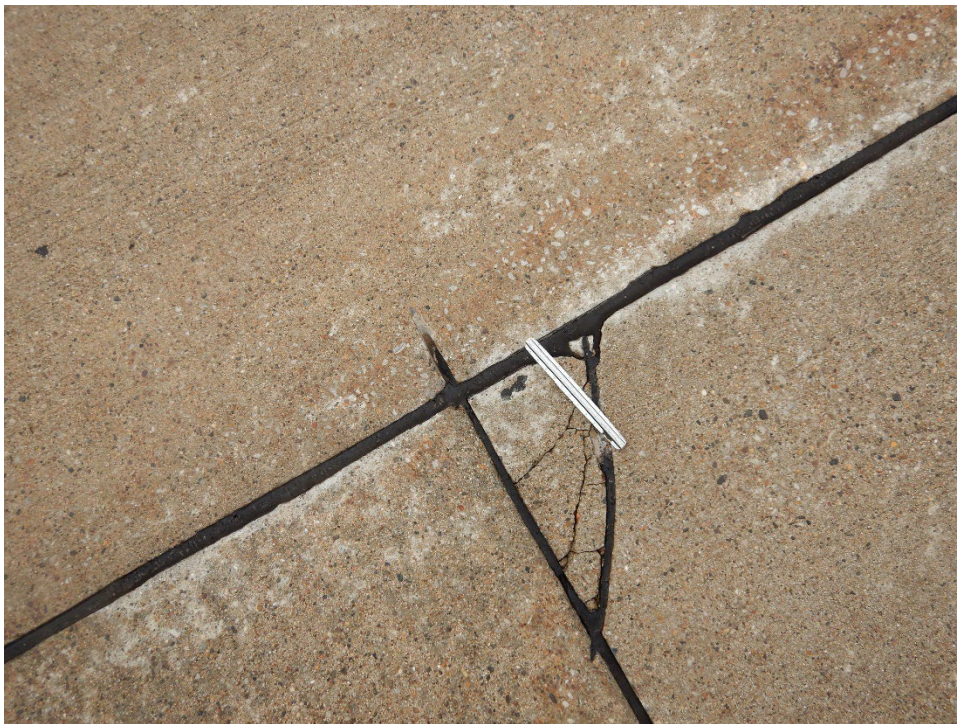
R16PE-07. Corner Spalling (Sample Unit No. 04).

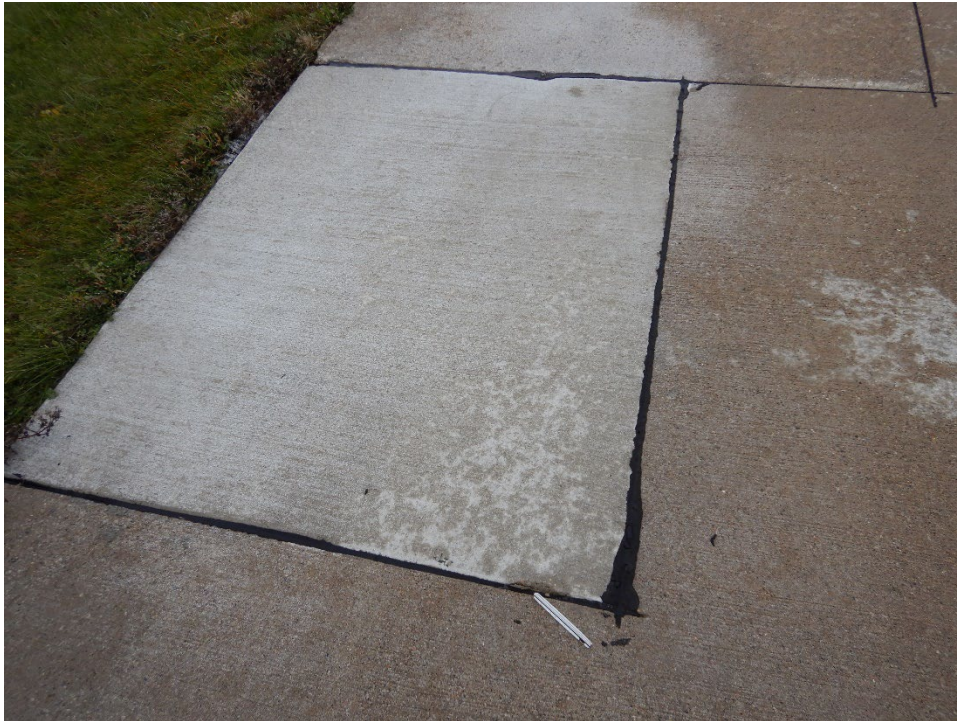
R16PE-07. Large Patching (Sample Unit No. 04).

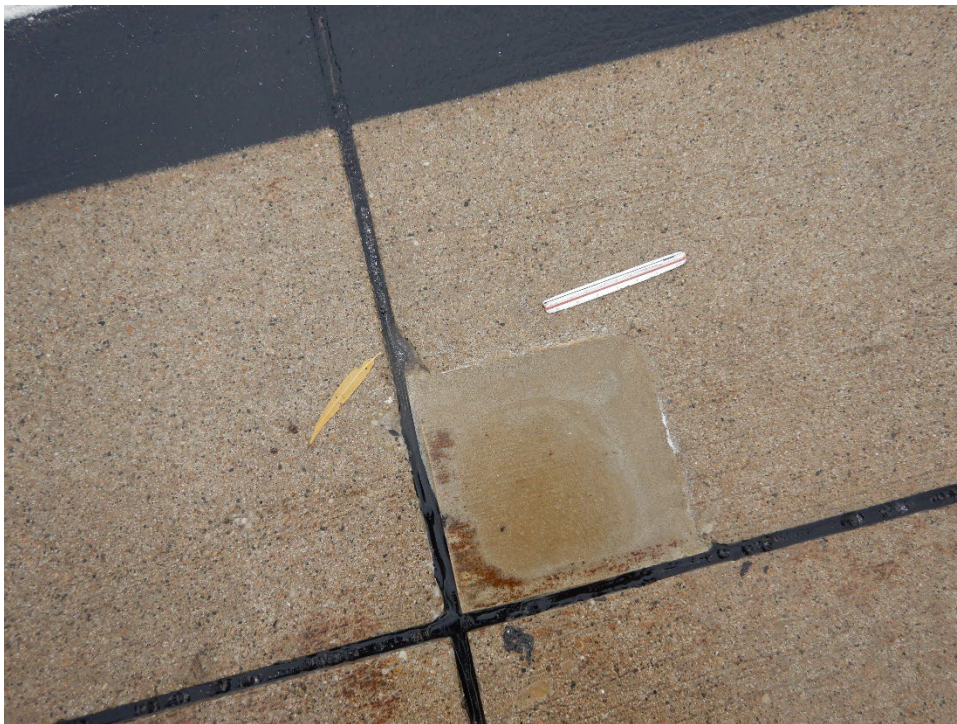
R16PE-07. Small Patching (Sample Unit No. 12).

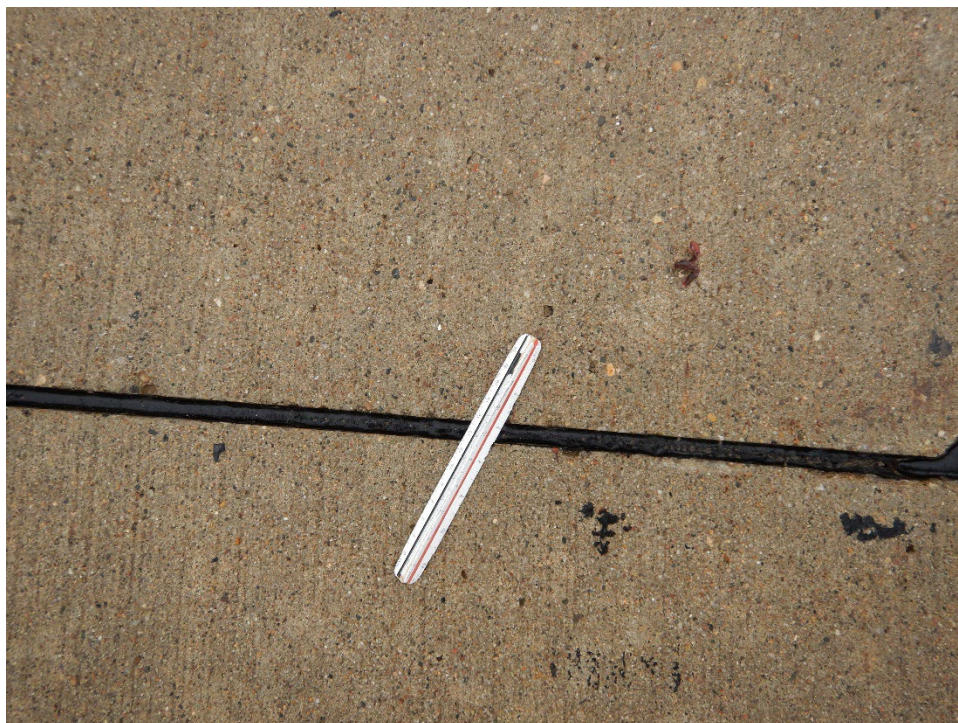
R16PE-08. Joint Seal Damage (Sample Unit No. 01).

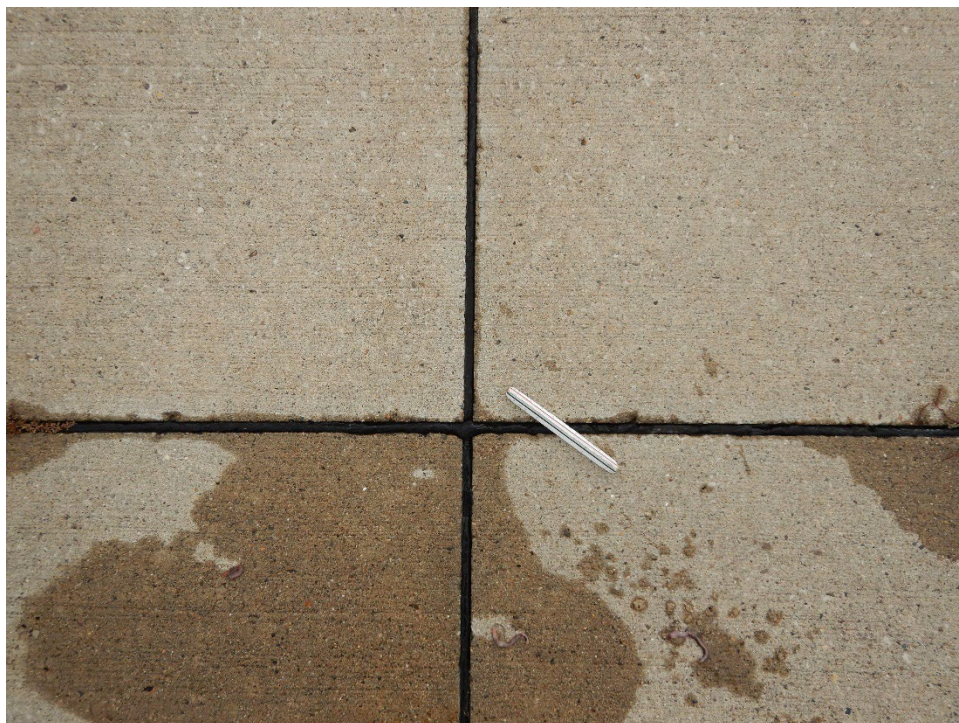
R16PE-09. Joint Seal Damage (Sample Unit No. 01).

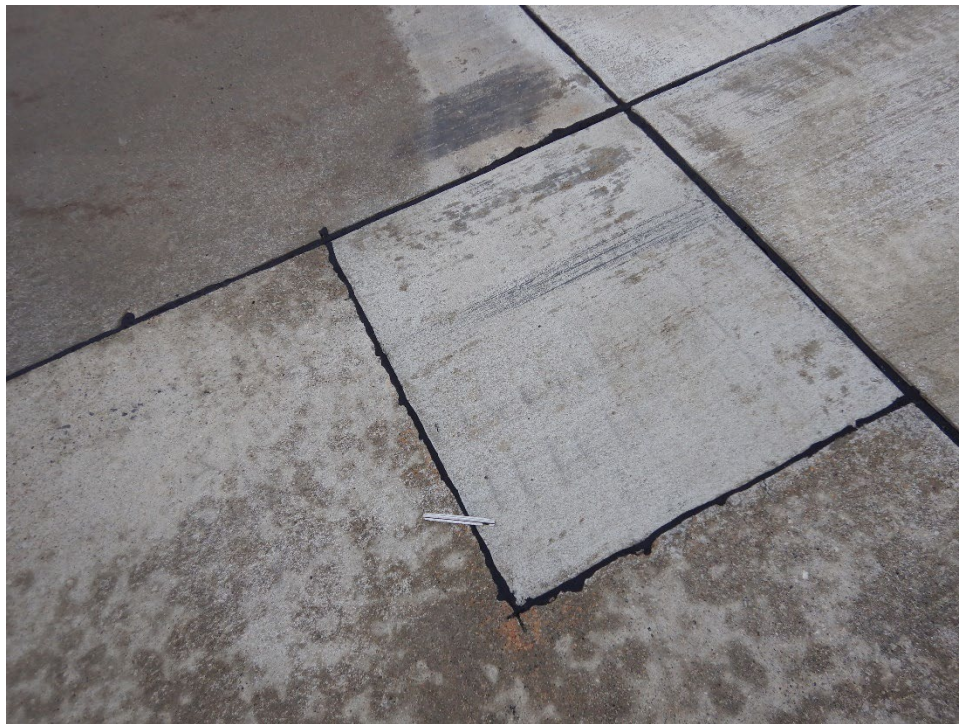
R16PE-10. Large Patching (Sample Unit No. 02).

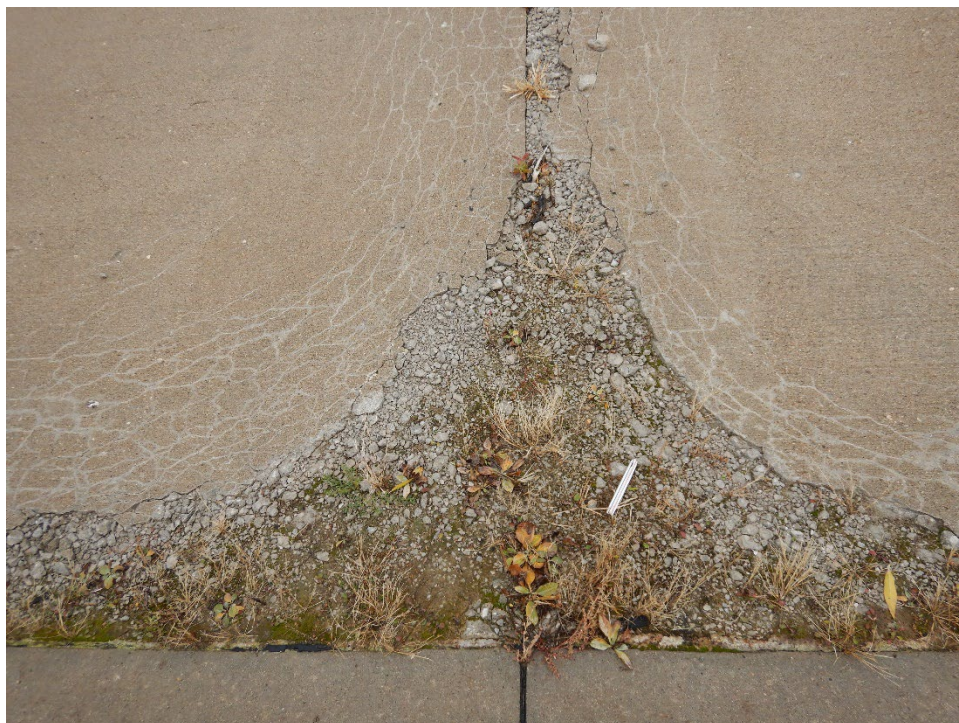
R16PE-11. ASR (Sample Unit No. 02) (1).

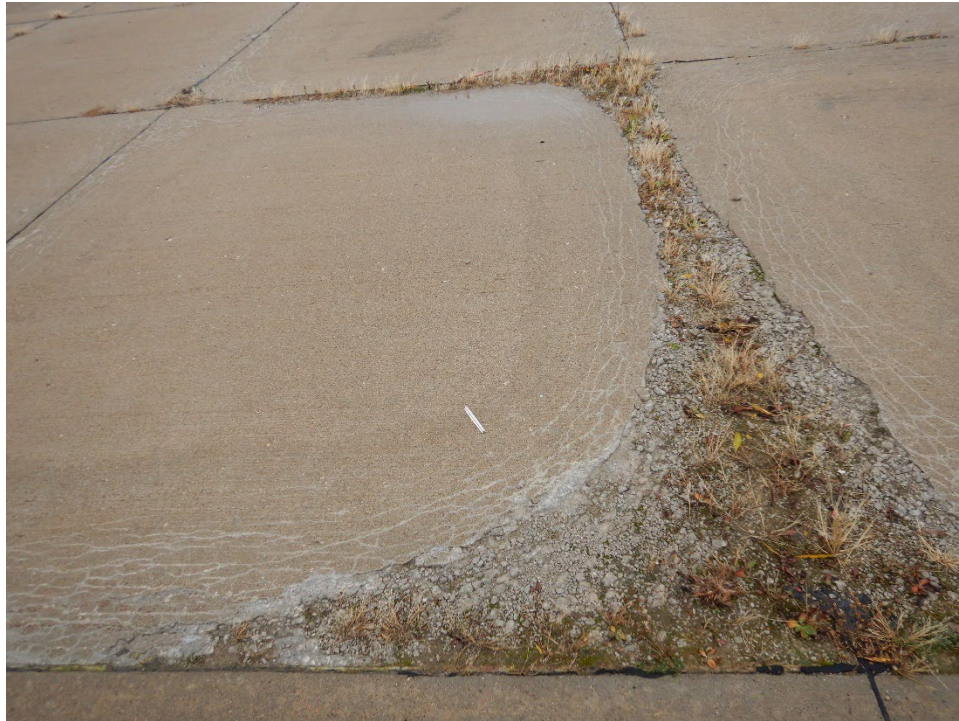
R16PE-11. ASR (Sample Unit No. 02) (2).

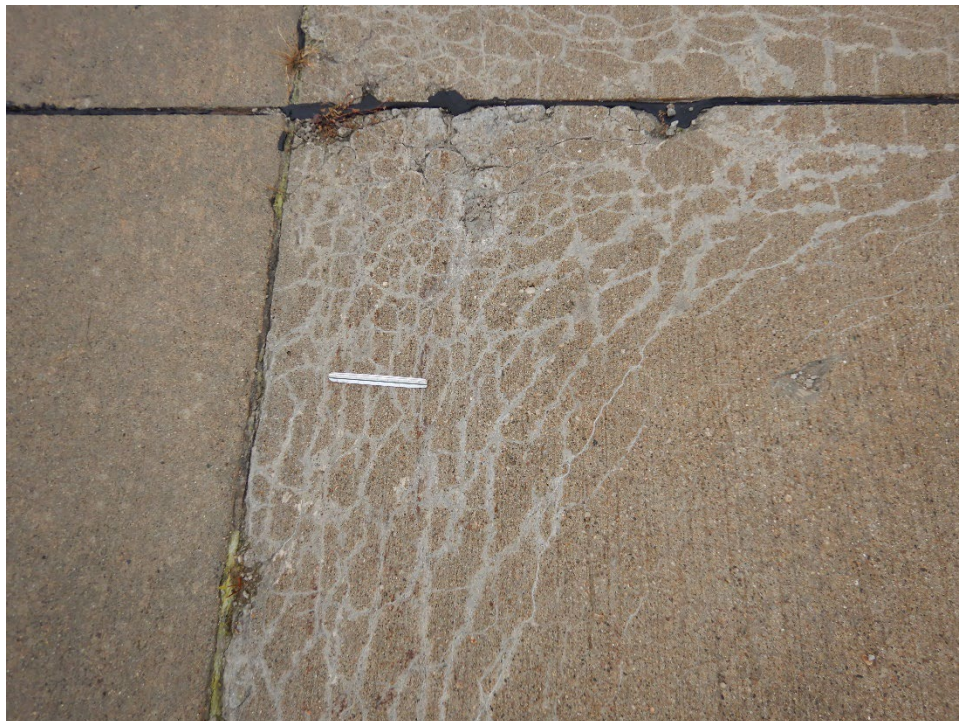
R16PE-11. ASR (Sample Unit No. 02) (3).

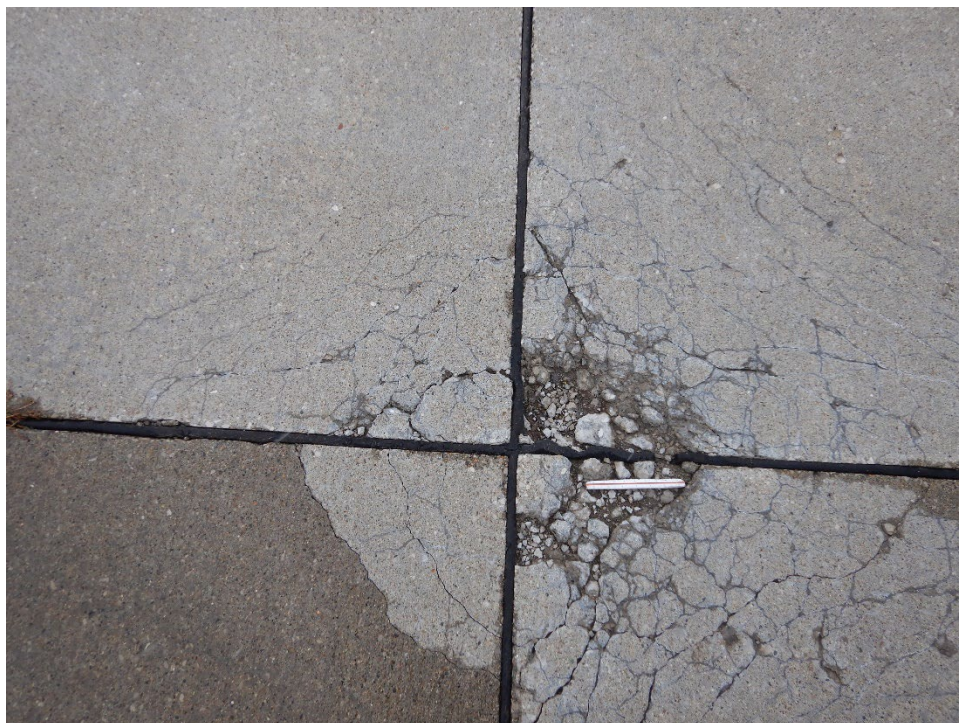
T01PE-01. ASR (Sample Unit No. 02).

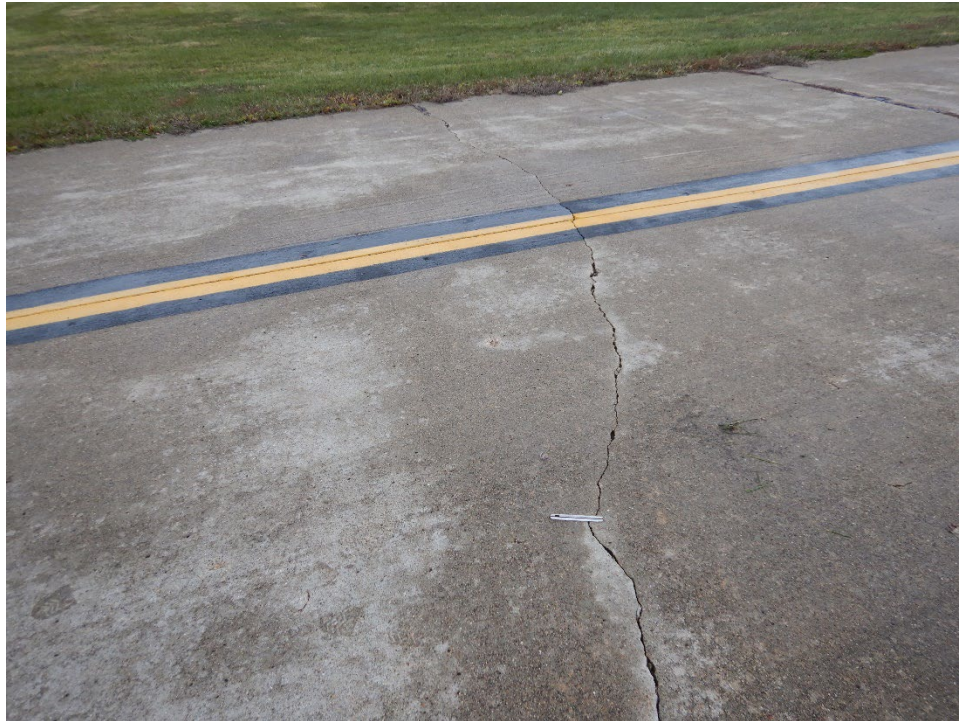
TH01PE-01. LTD Cracking (Sample Unit No. 01).

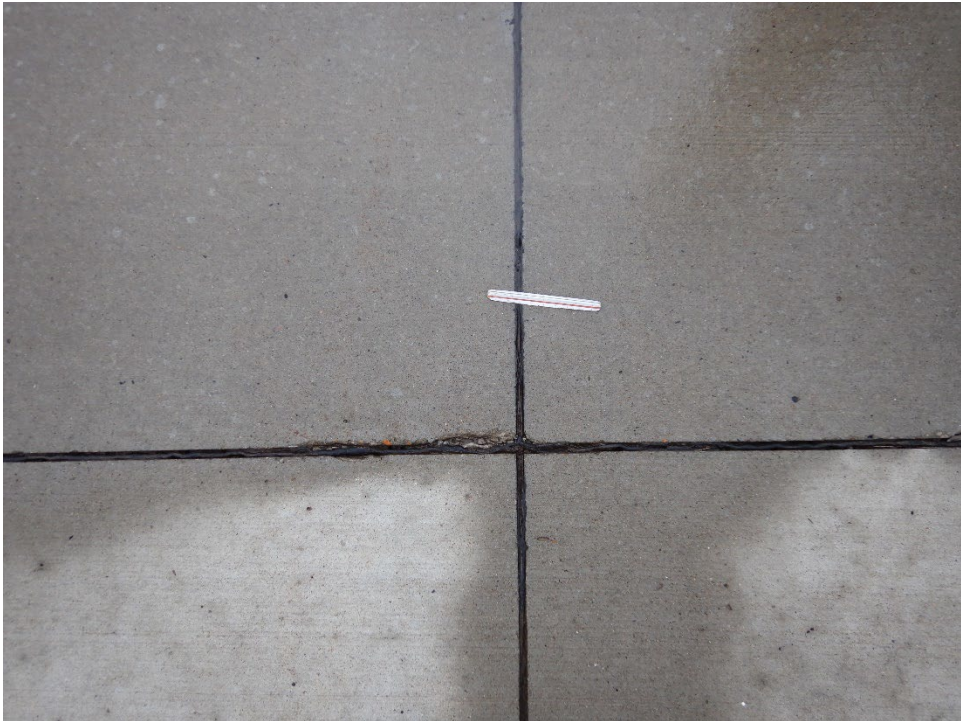
TH01PE-02. Joint Seal Damage (Sample Unit No. 02).
