# Perry Municipal Airport

## PAVEMENT MANAGEMENT REPORT

**JULY 2021**

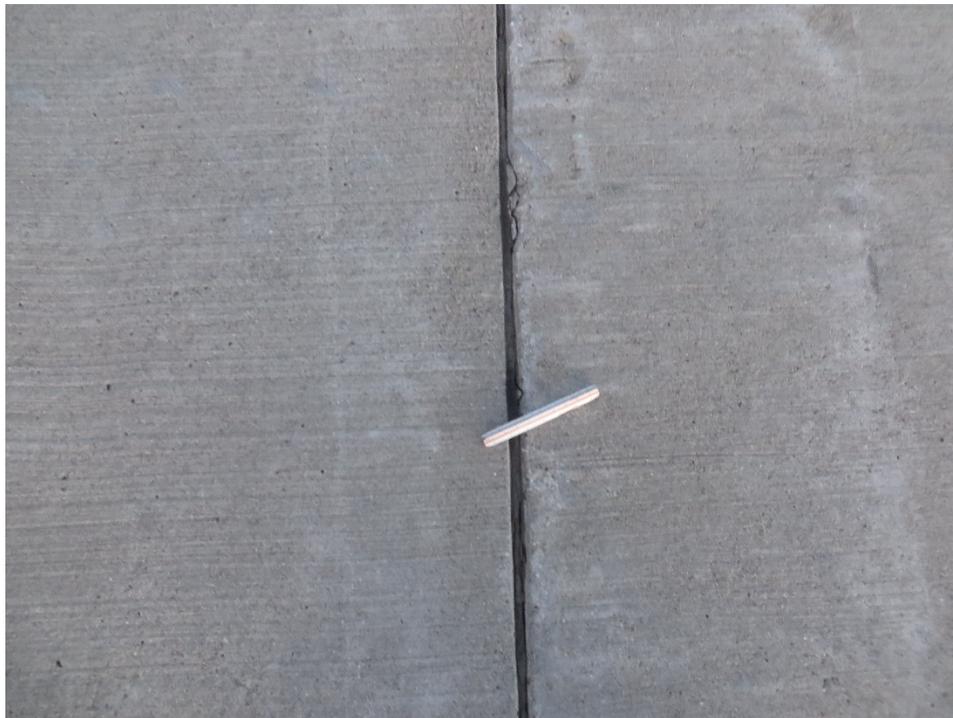
A01PR-01. Joint Seal Damage (Sample Unit No. 02).

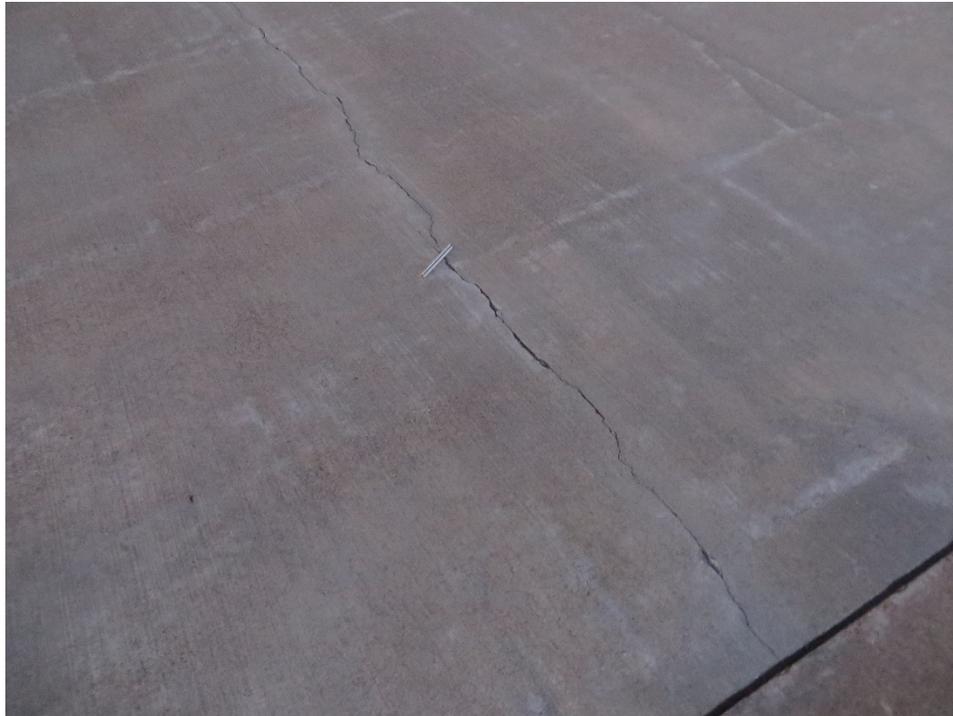
A01PR-01. LTD Cracking (Sample Unit No. 05).

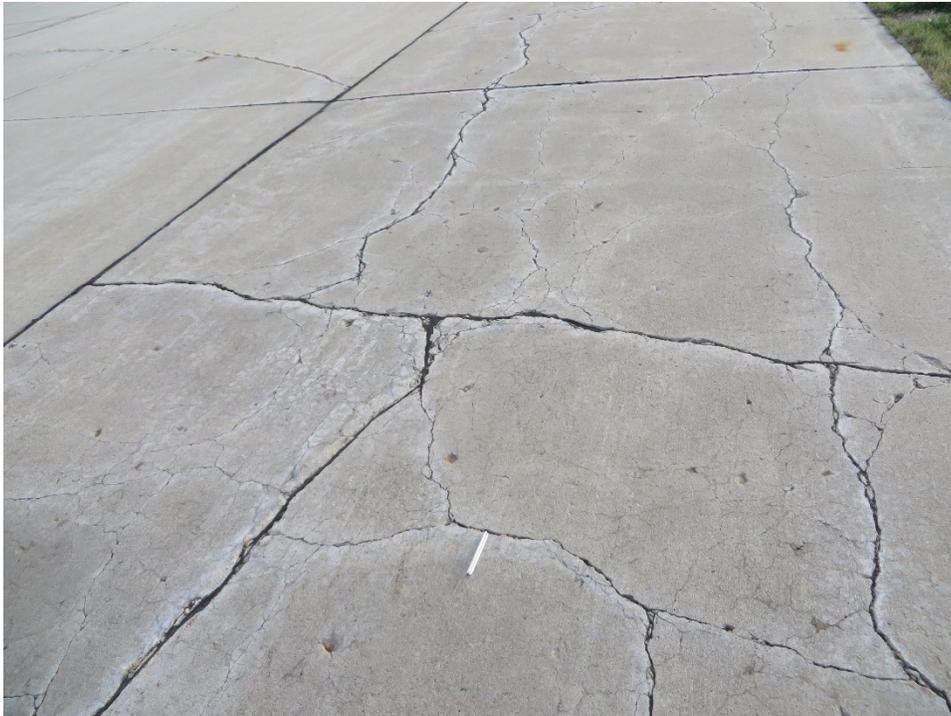
A01PR-03. ASR (Sample Unit No. 04).

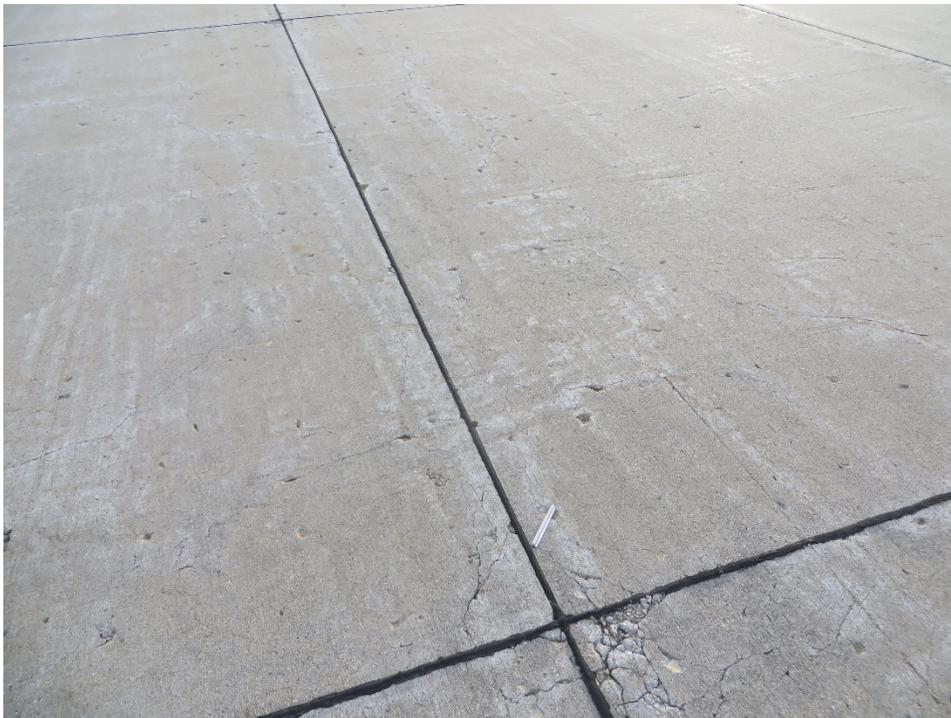
A01PR-03. ASR (Sample Unit No. 09).

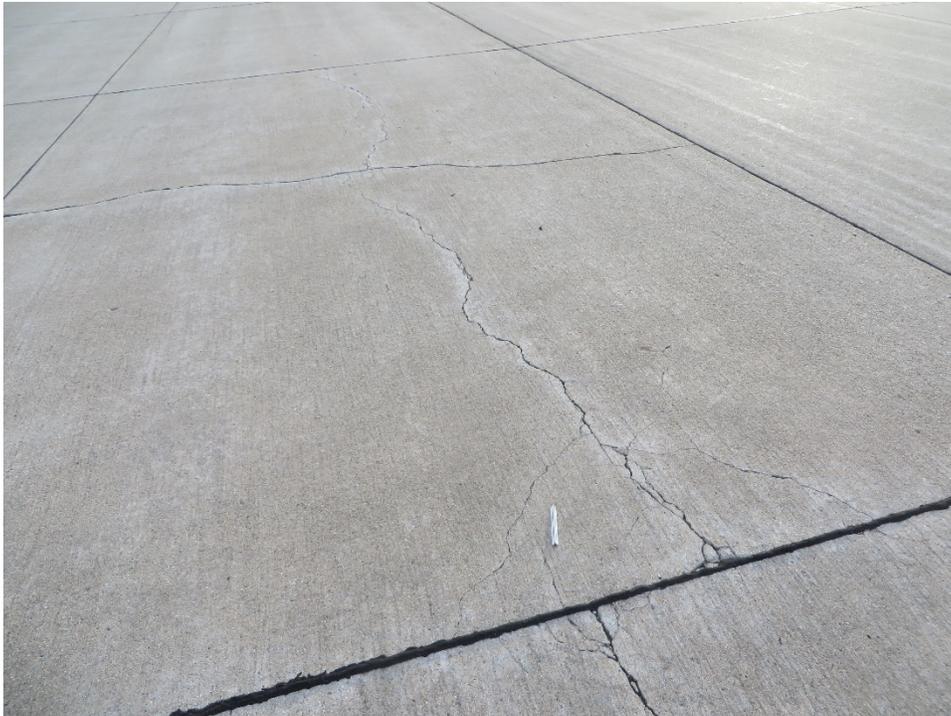
A01PR-03. Shattered Slab (Sample Unit No. 11).

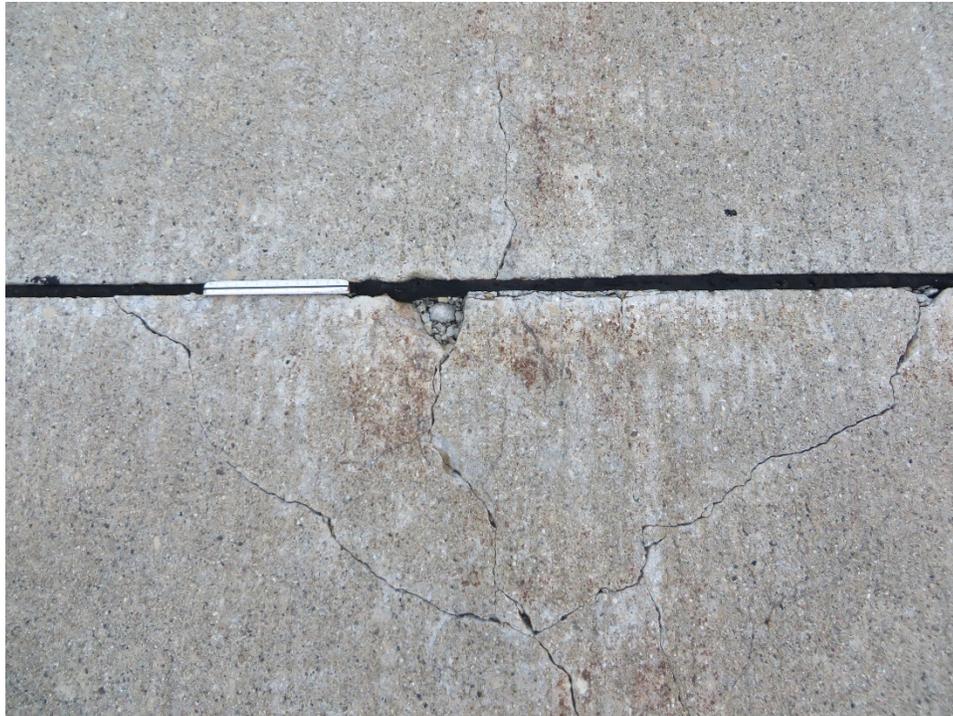
R14PR-01. ASR (Sample Unit No. 22).

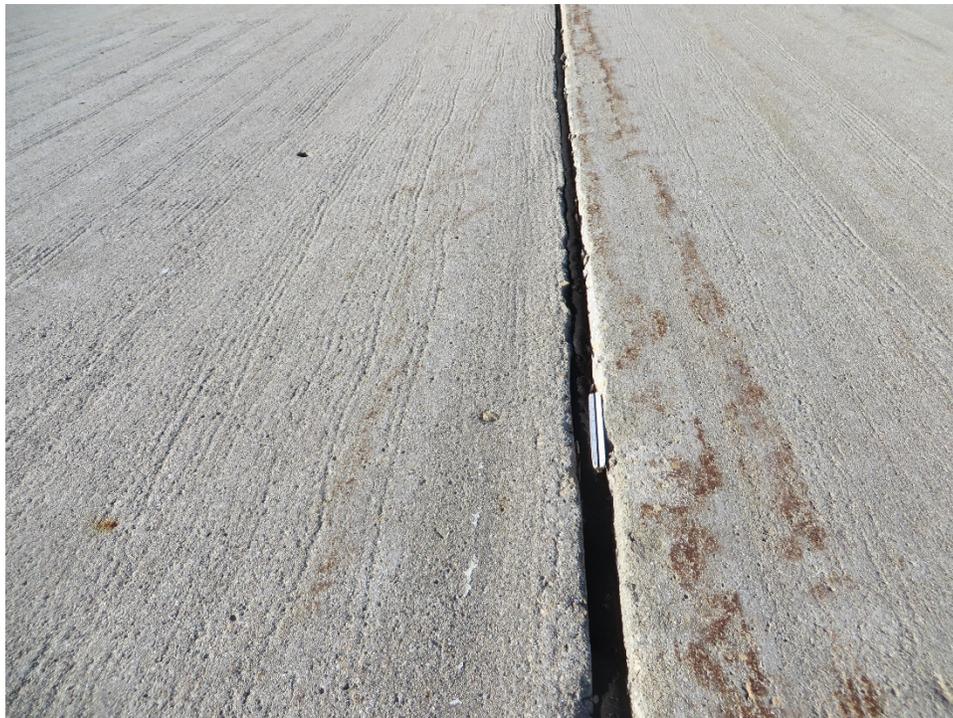
R14PR-01. Faulting (Sample Unit No. 04).

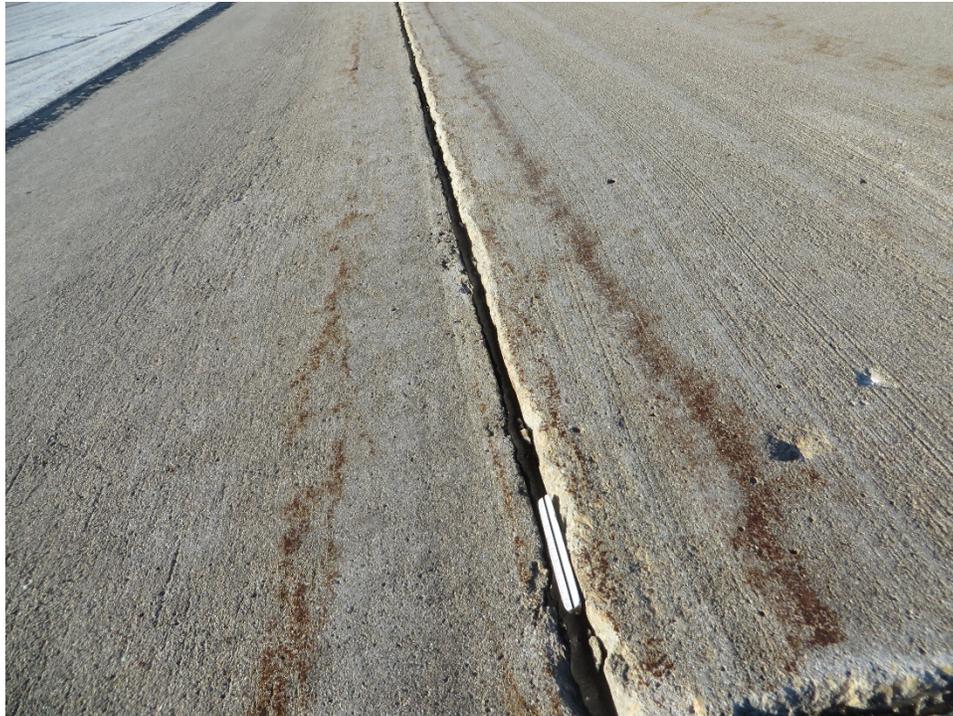
R14PR-01. Faulting (Sample Unit No. 15).

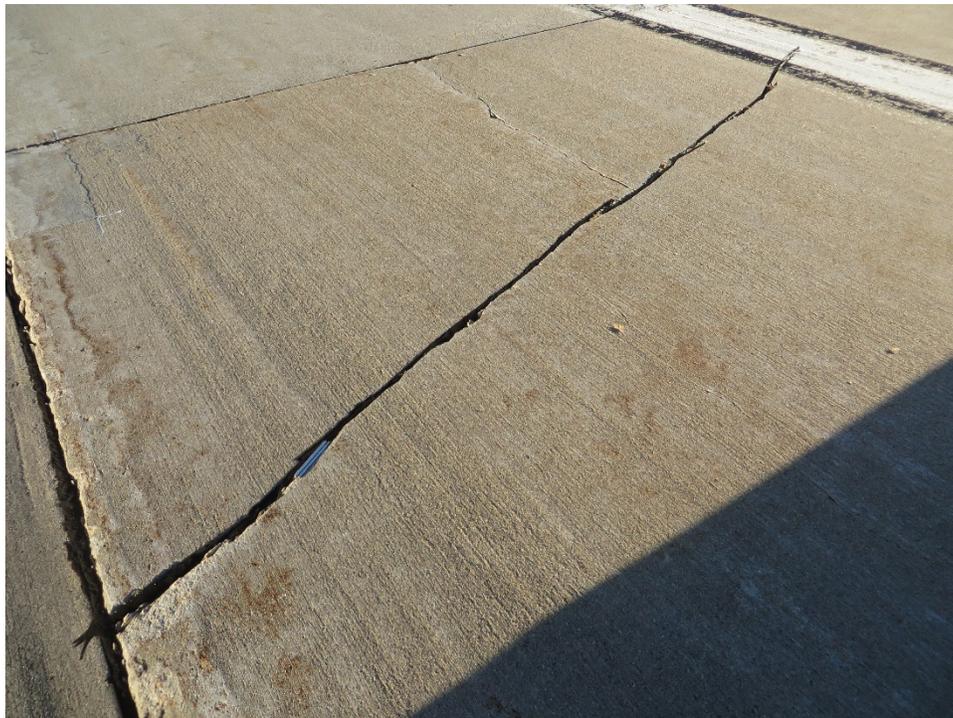
R14PR-01. Shattered Slab (Sample Unit No. 22).

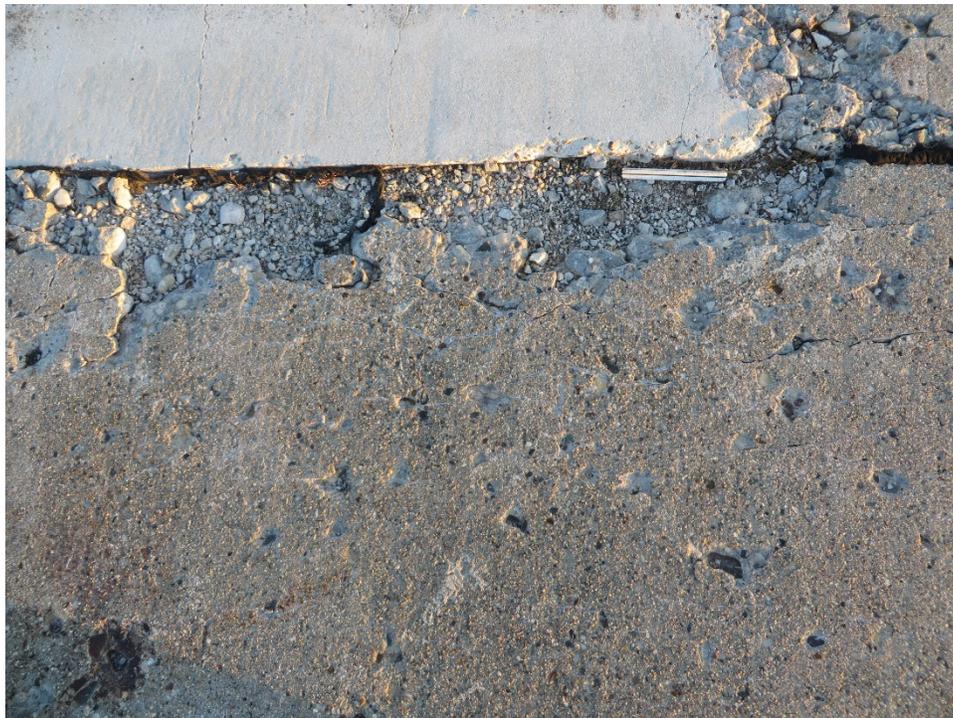
R14PR-02. ASR (Sample Unit No. 04).

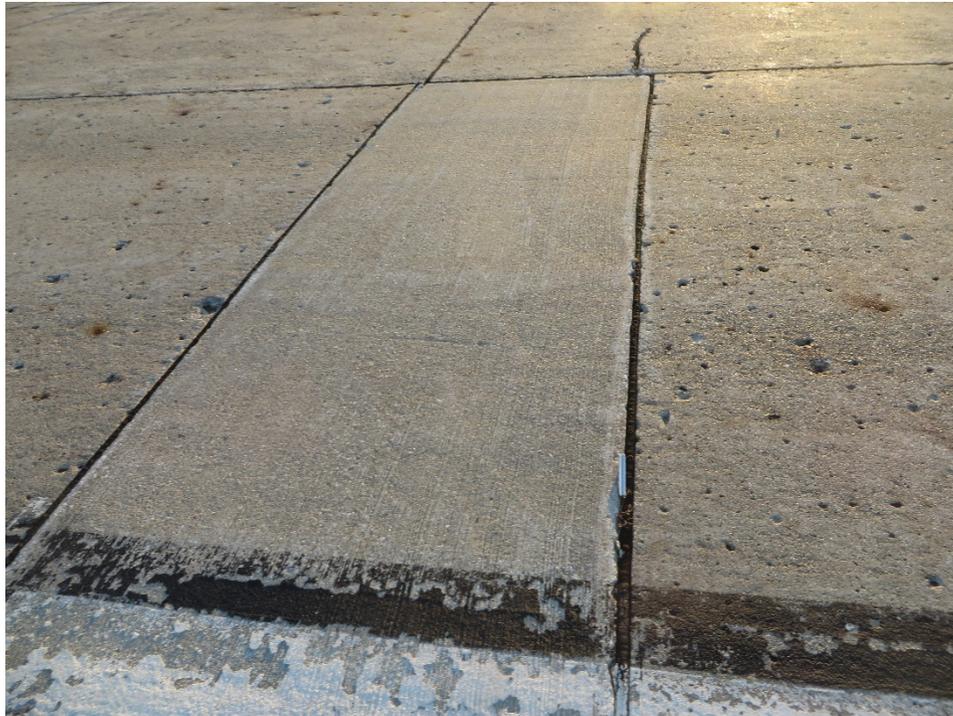
R14PR-02. Large Patching (Sample Unit No. 01).

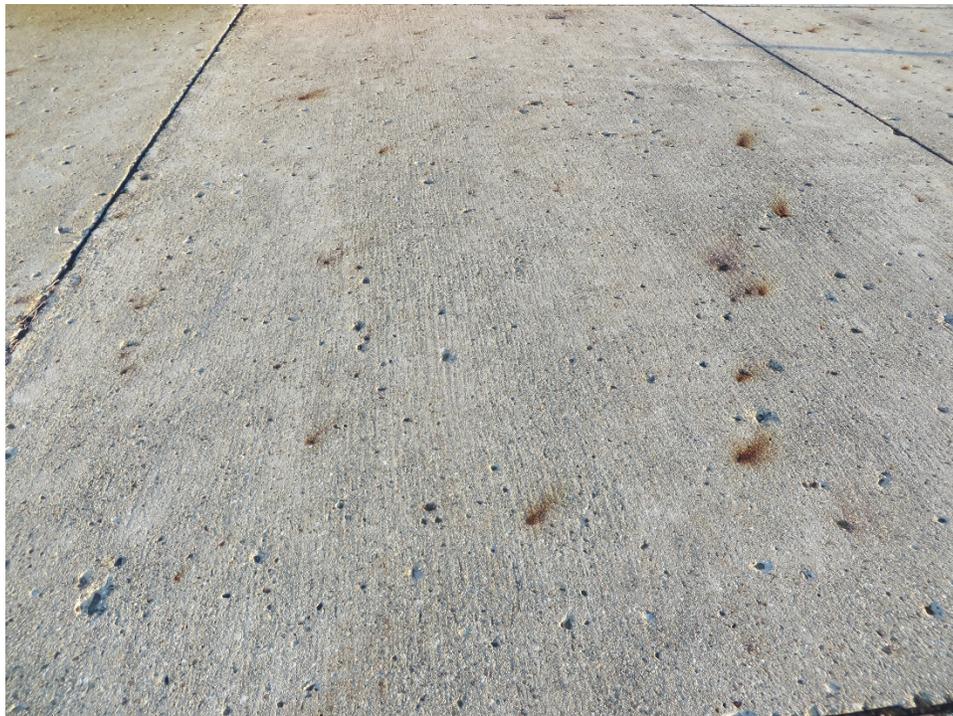
R14PR-02. Popouts (Sample Unit No. 01).

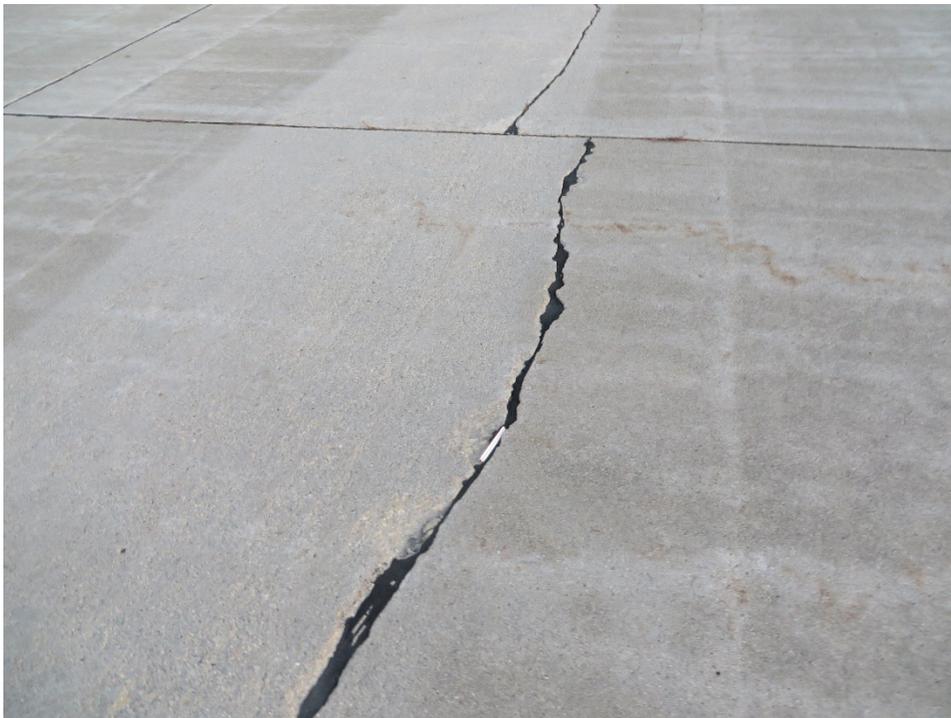
T01PR-01. LTD Cracking (Sample Unit No. 02).

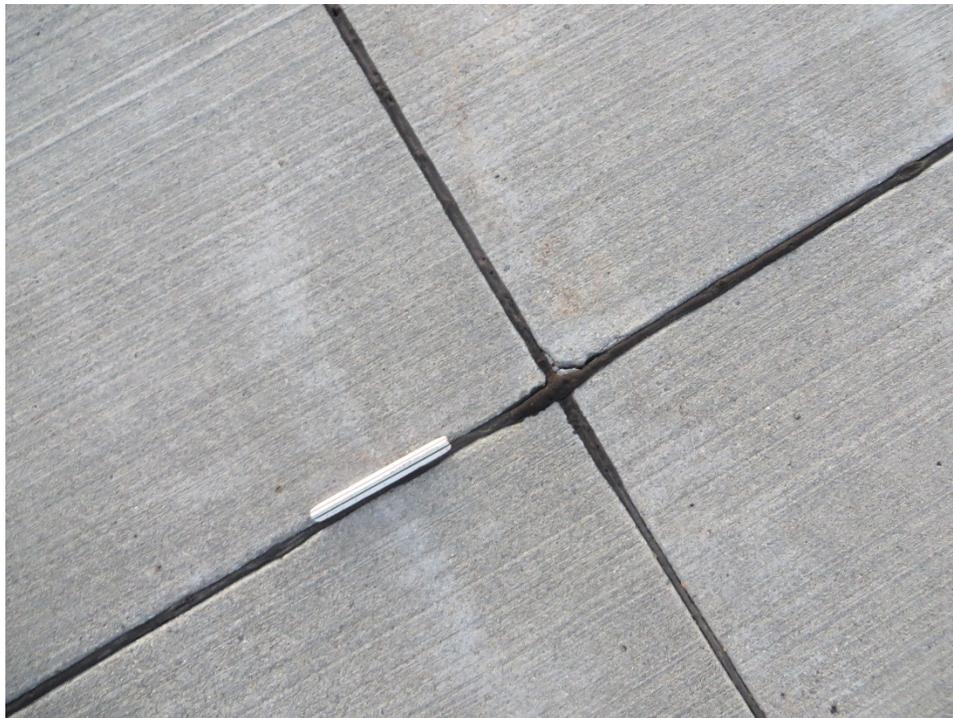
T01PR-02. Joint Seal Damage (Sample Unit No. 01).

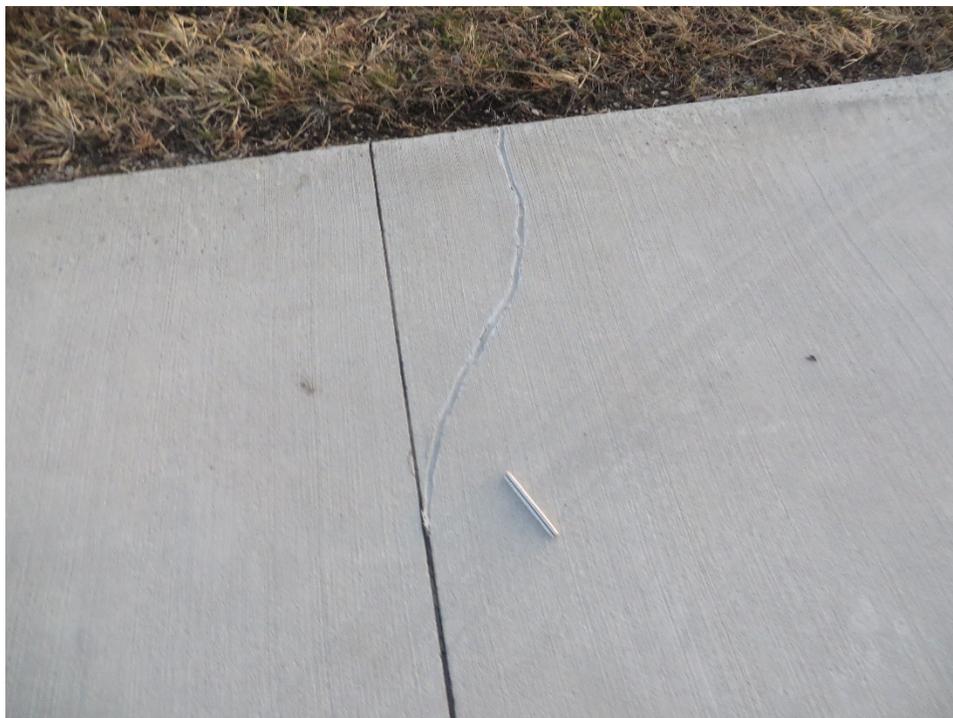
TH01PR-01. Corner Spalling (Sample Unit No. 04).

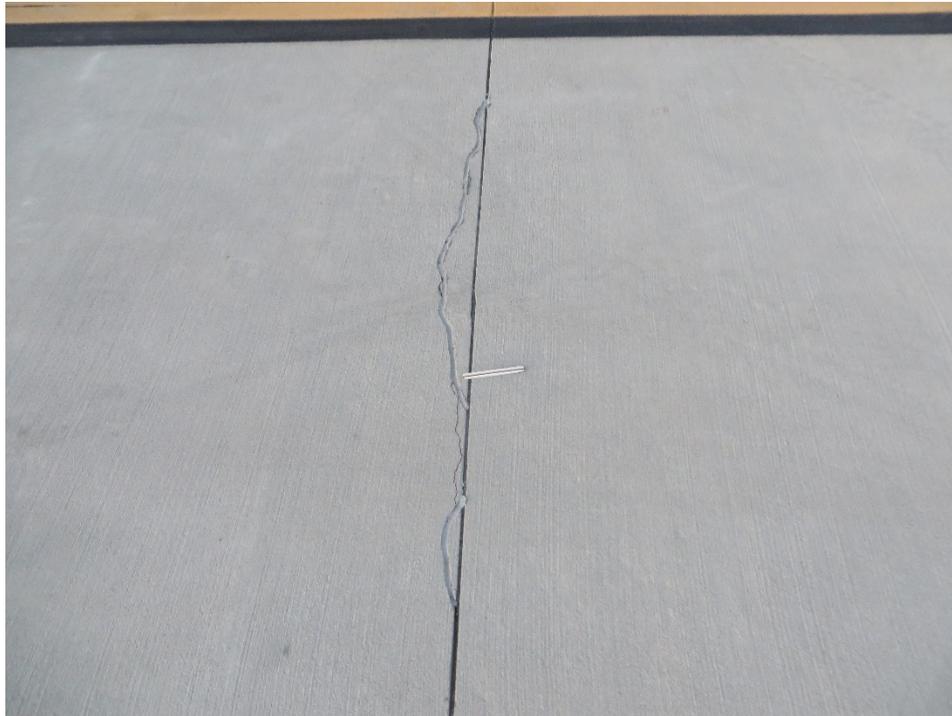
TH01PR-01. Joint Spalling (Sample Unit No. 04).

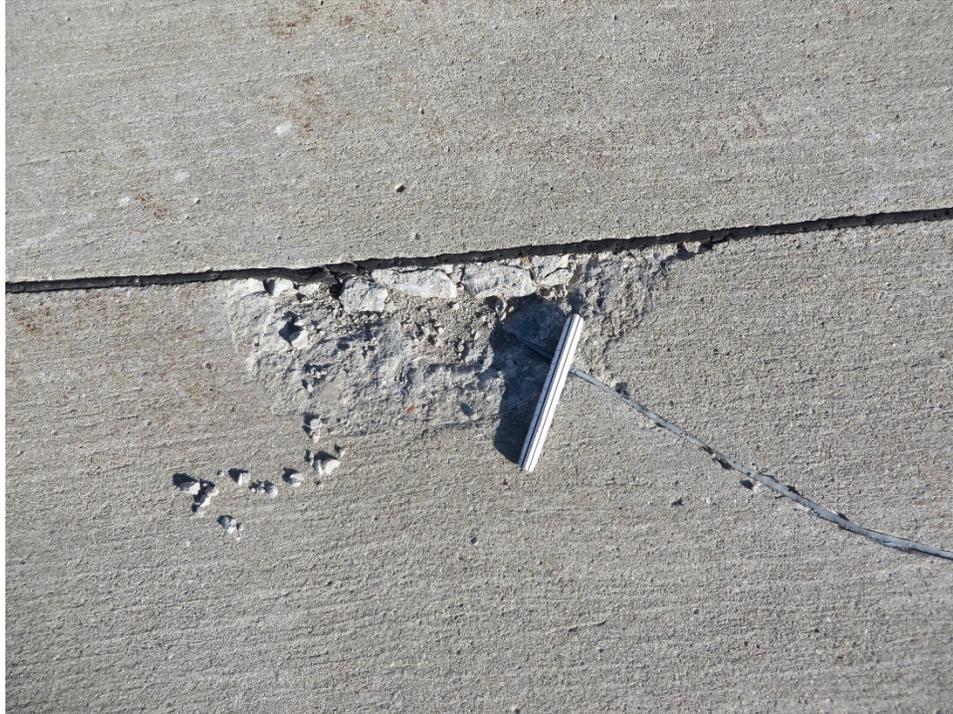
TH01PR-02. Joint Spalling (Sample Unit No. 01).

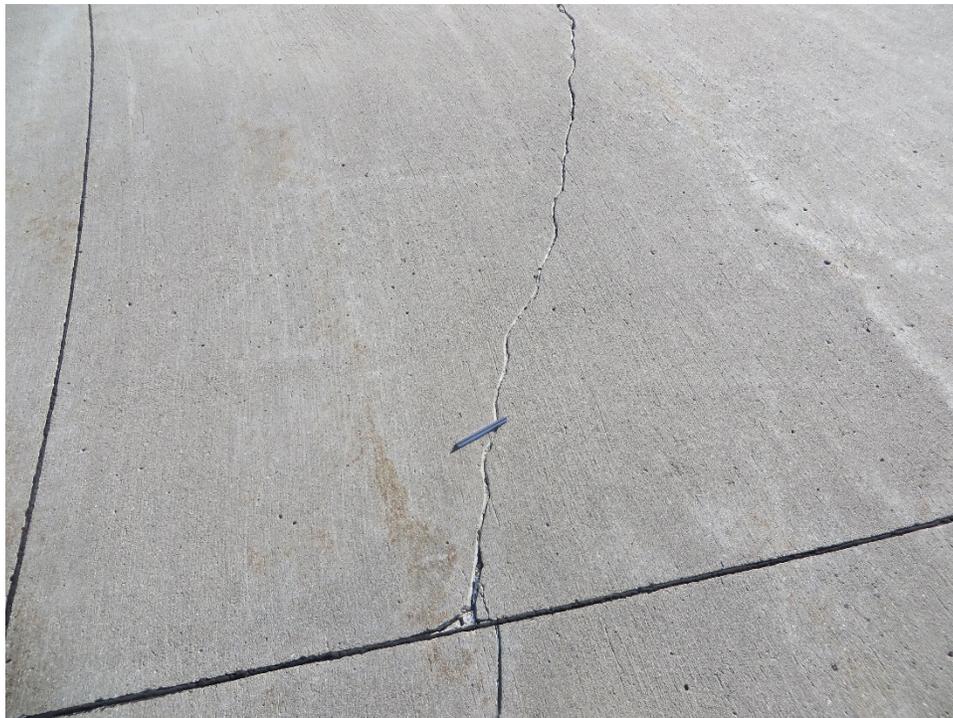
TH01PR-02. LTD Cracking (Sample Unit No. 01).

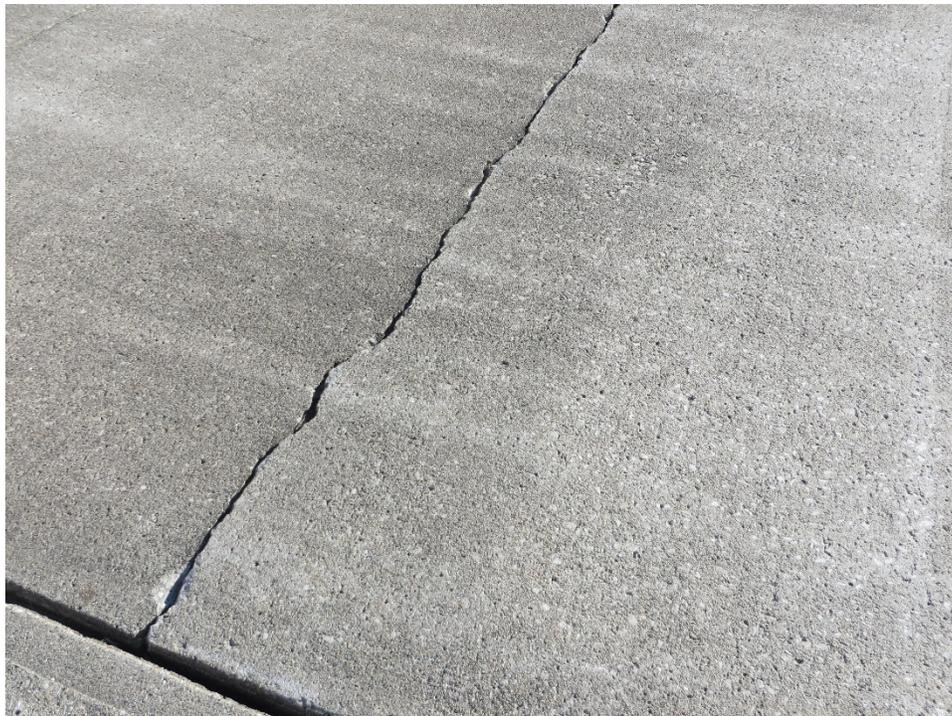
TH02PR-01. LTD Cracking (Sample Unit No. 01).

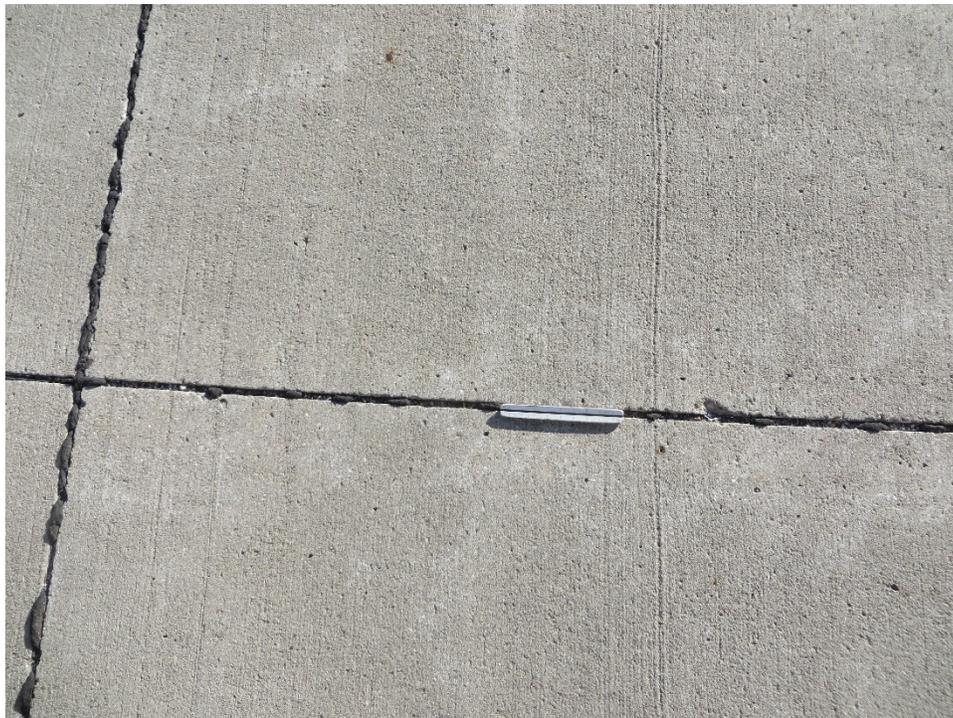
TH02PR-02. Joint Seal Damage (Sample Unit No. 01).

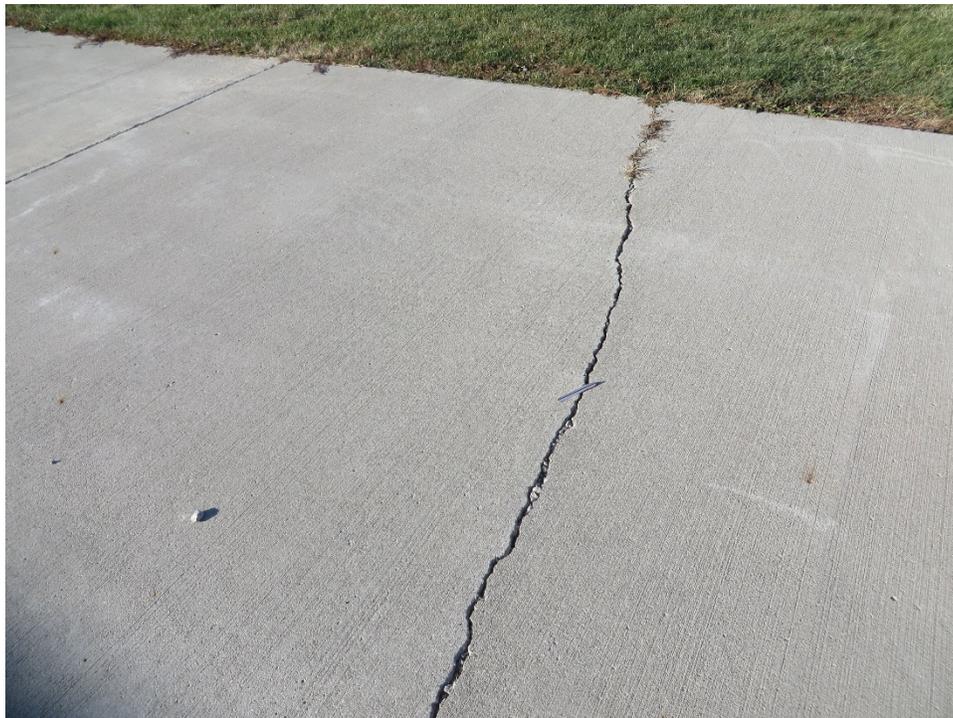
TH02PR-03. LTD Cracking (Sample Unit No. 01).
