Pocahontas Municipal Airport

Pavement Management Report

JULY 2023

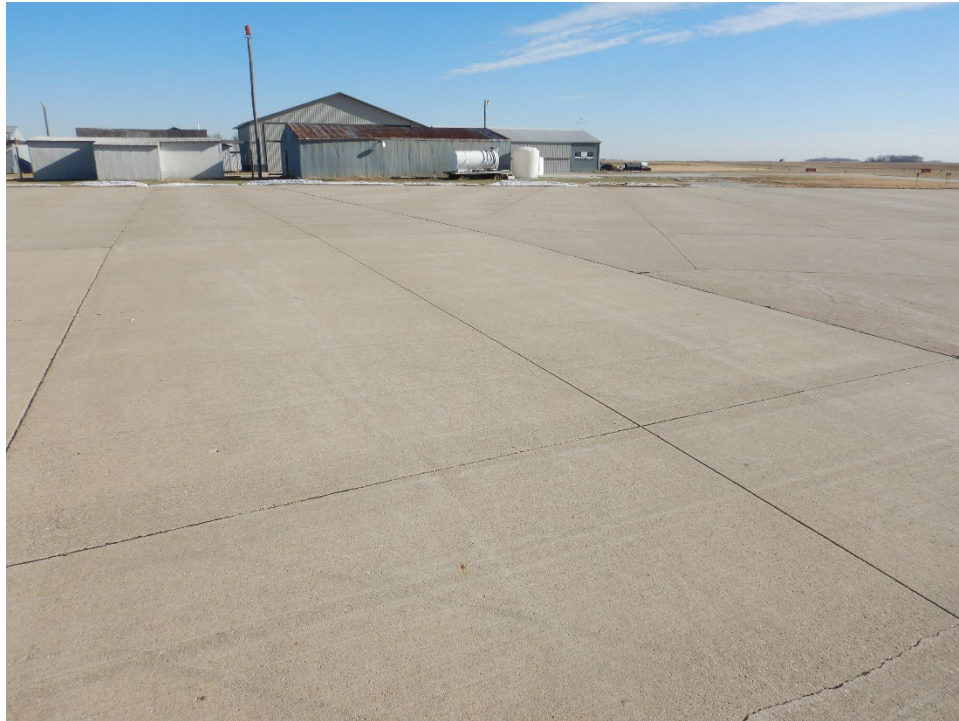
A01PO-01. Overview.

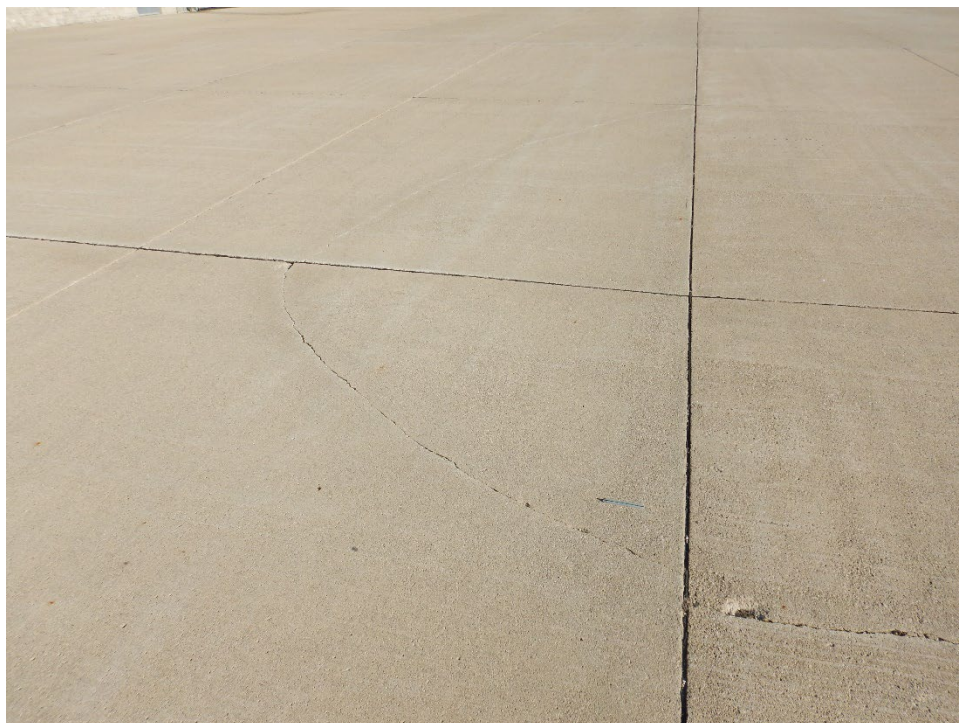
A01PO-01. LTD Cracking (Sample Unit No. 15).

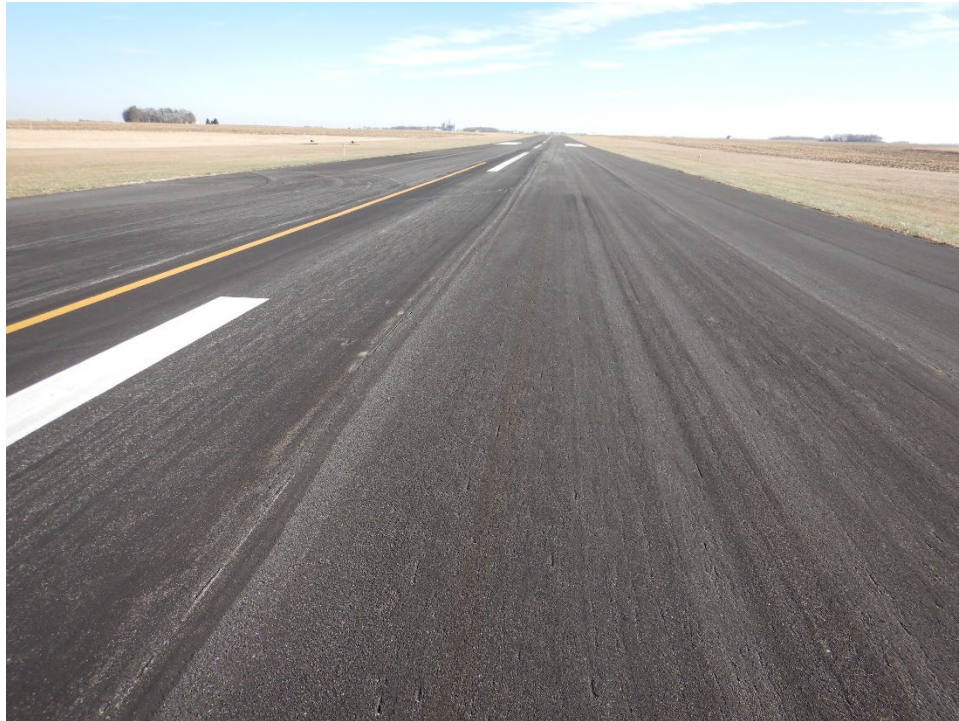
R12PO-01. Overview.

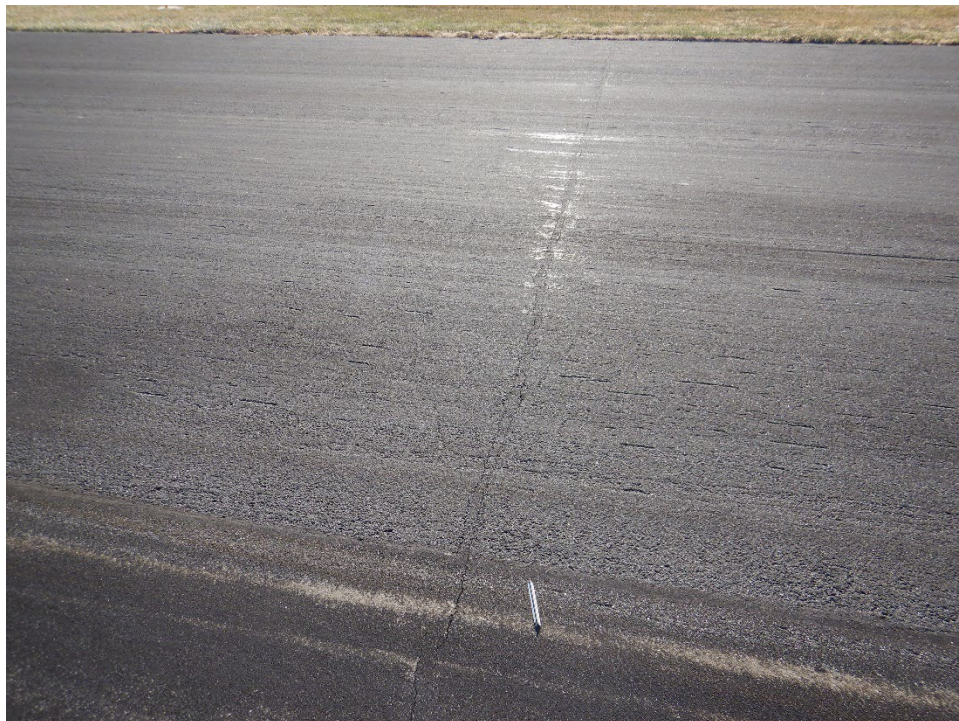
R12PO-01. L&T Cracking (Sample Unit No. 04).

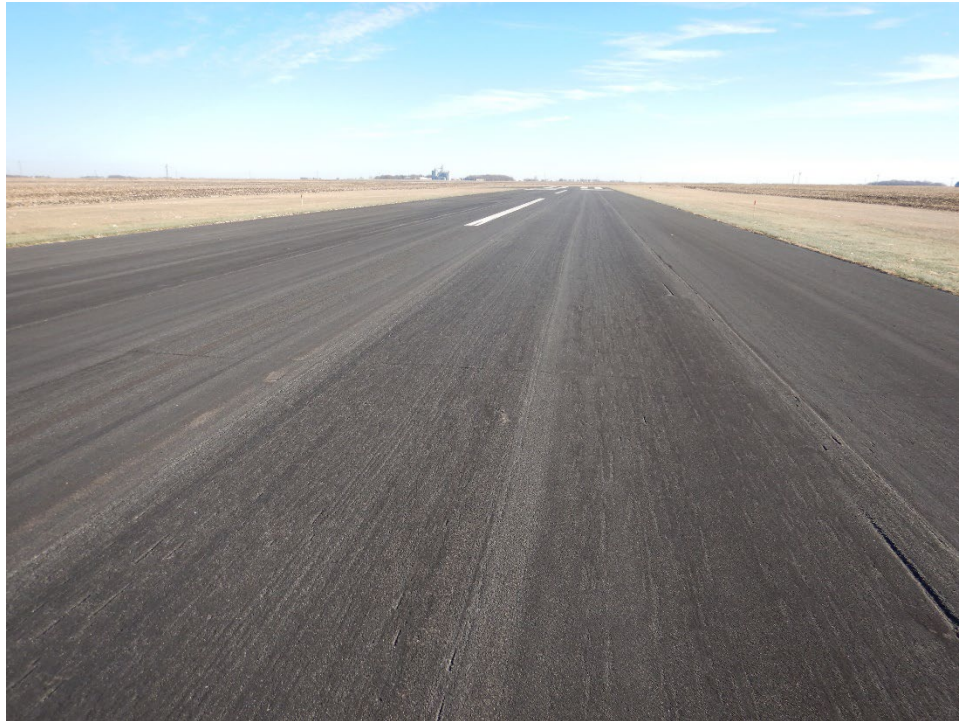
R12PO-02. Overview.

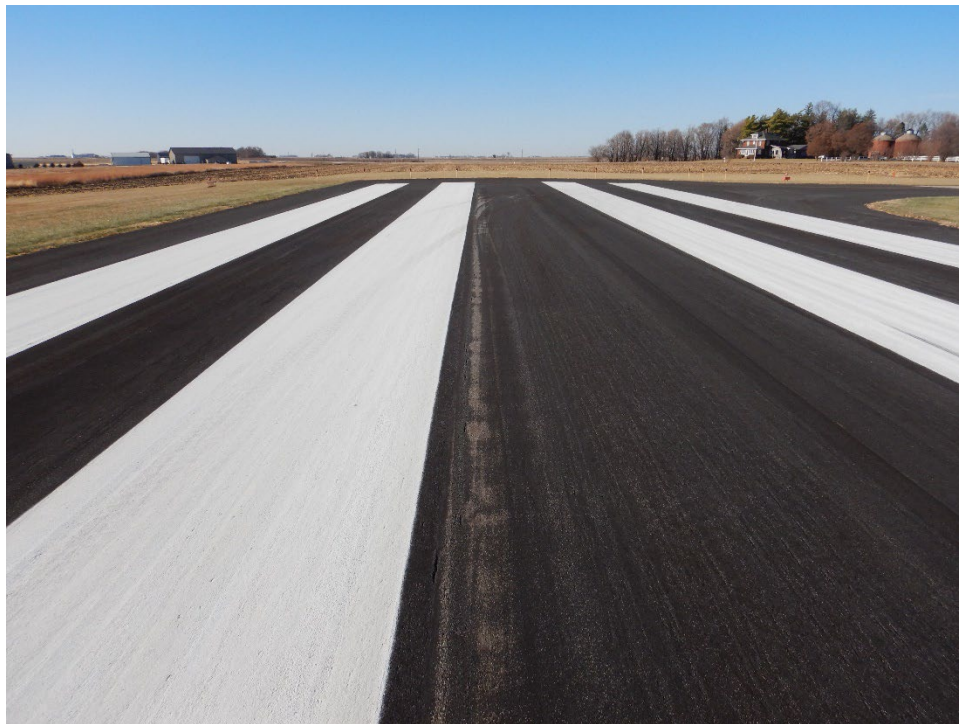
R12PO-03. Overview.

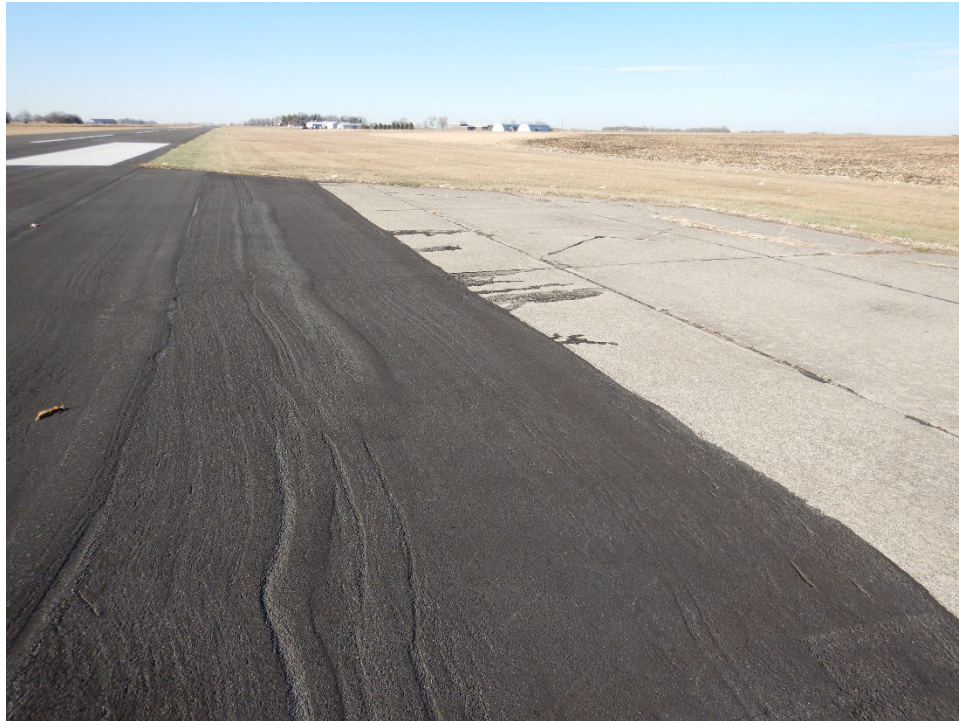
R12PO-04. Overview.

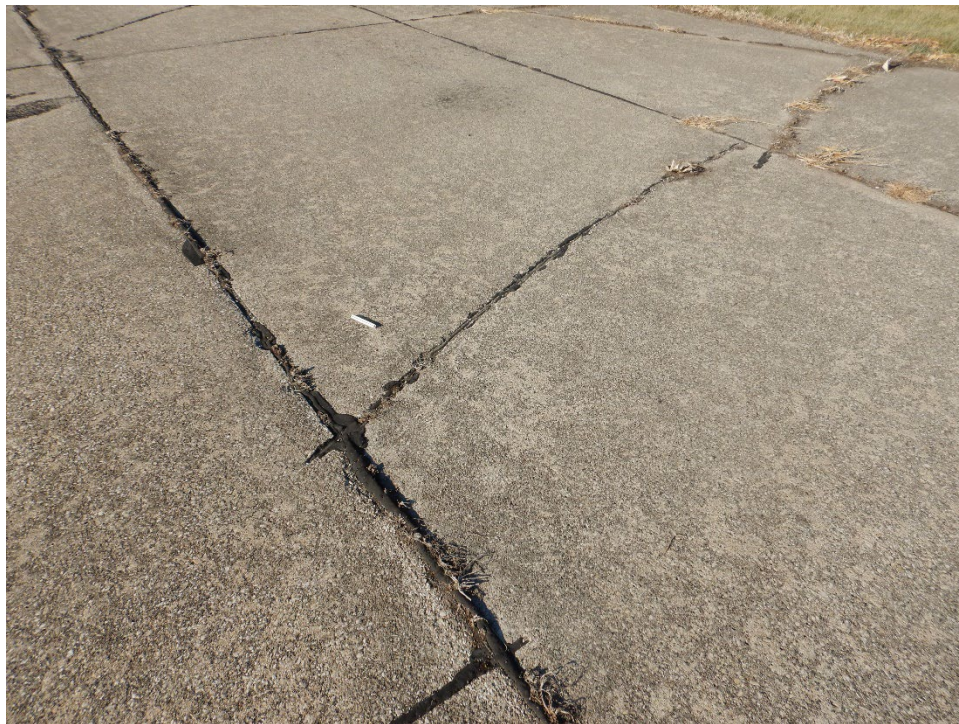
R12PO-04. LTD Cracking (Sample Unit No. 01).

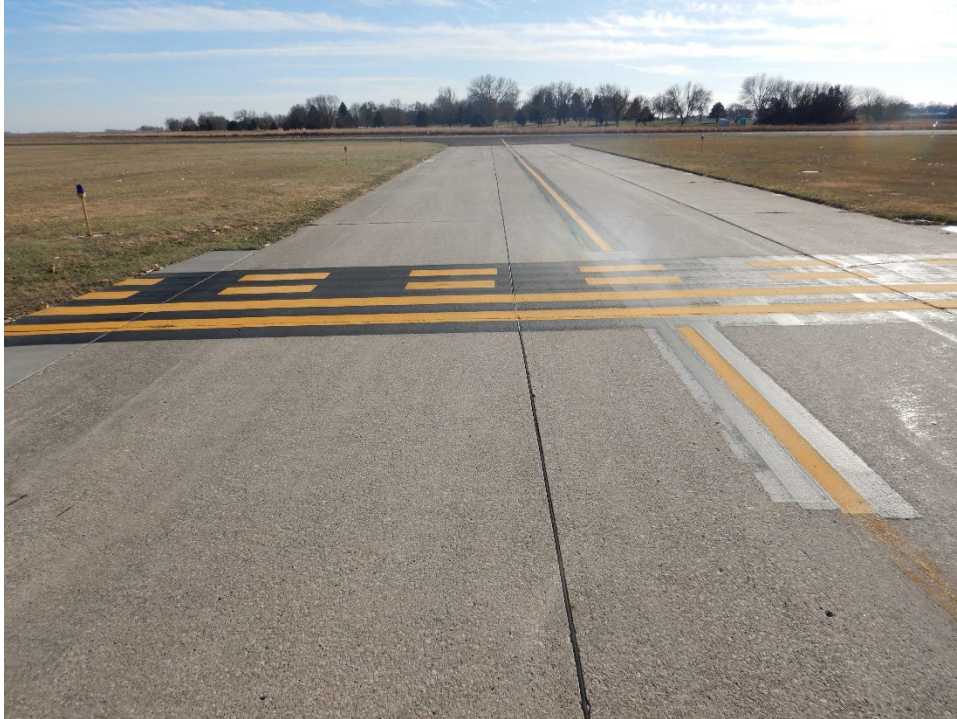
T01PO-01. Overview.

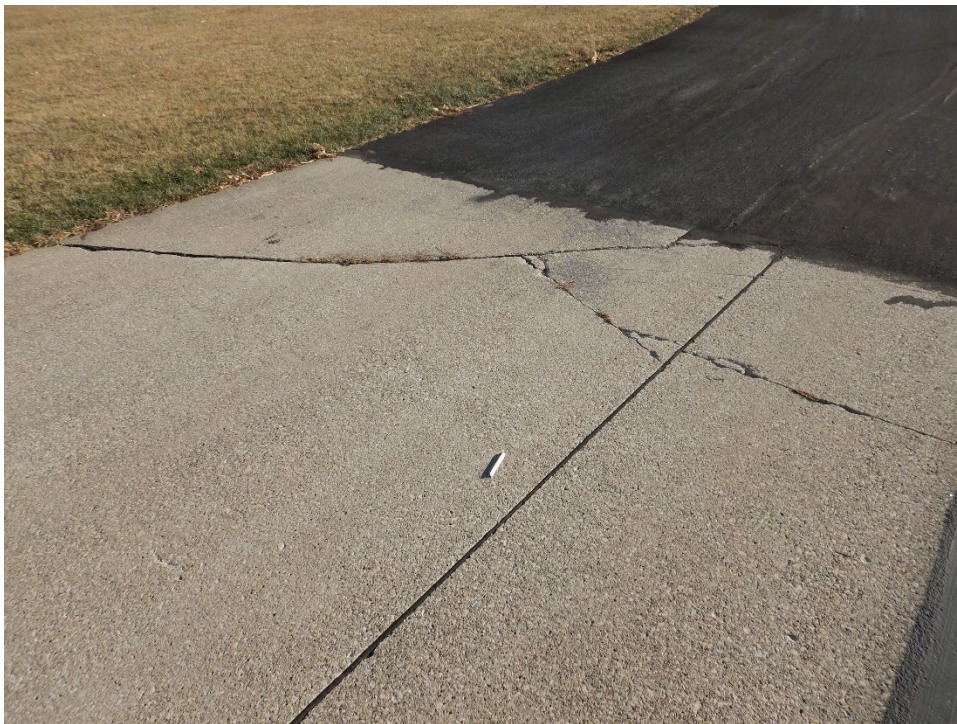
T01PO-01. Shattered Slab (Sample Unit No. 01).

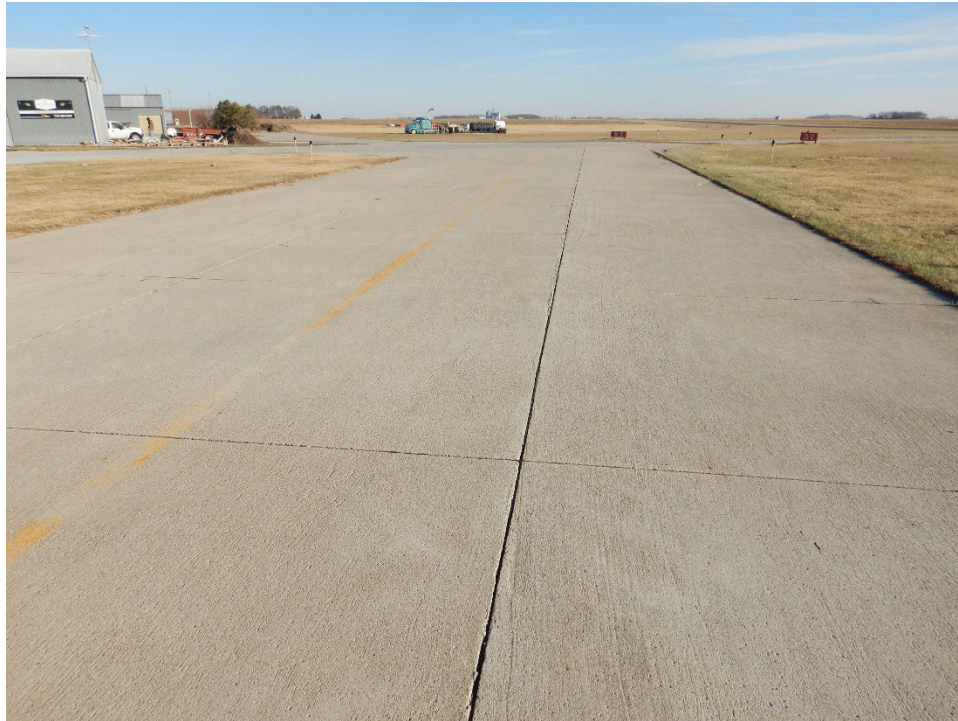
T01PO-02. Overview.

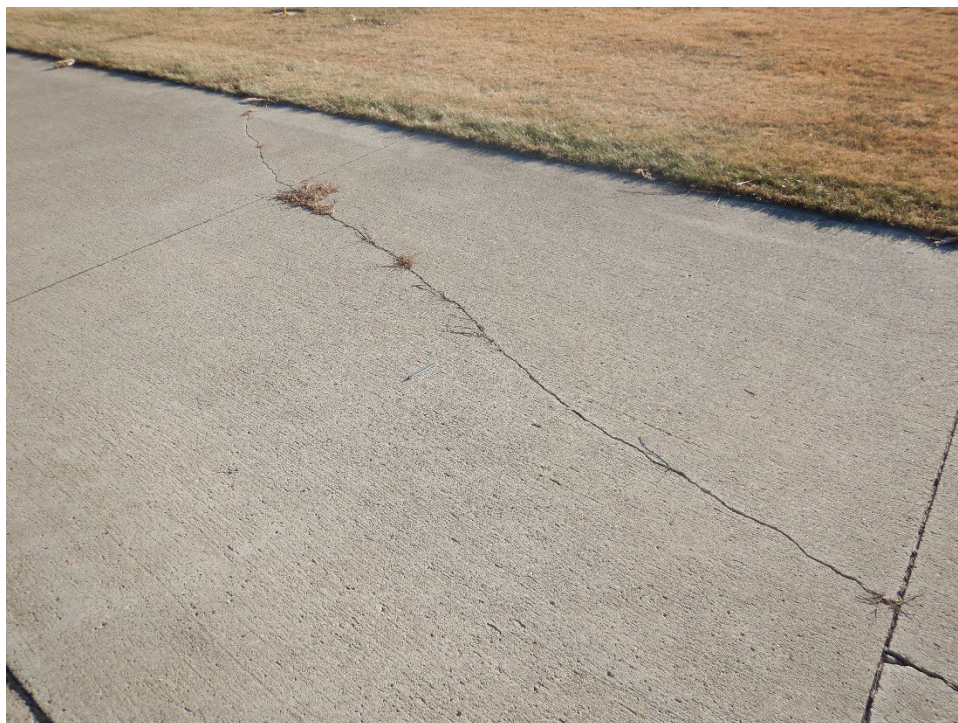
T01PO-02. LTD Cracking (Sample Unit No. 04).

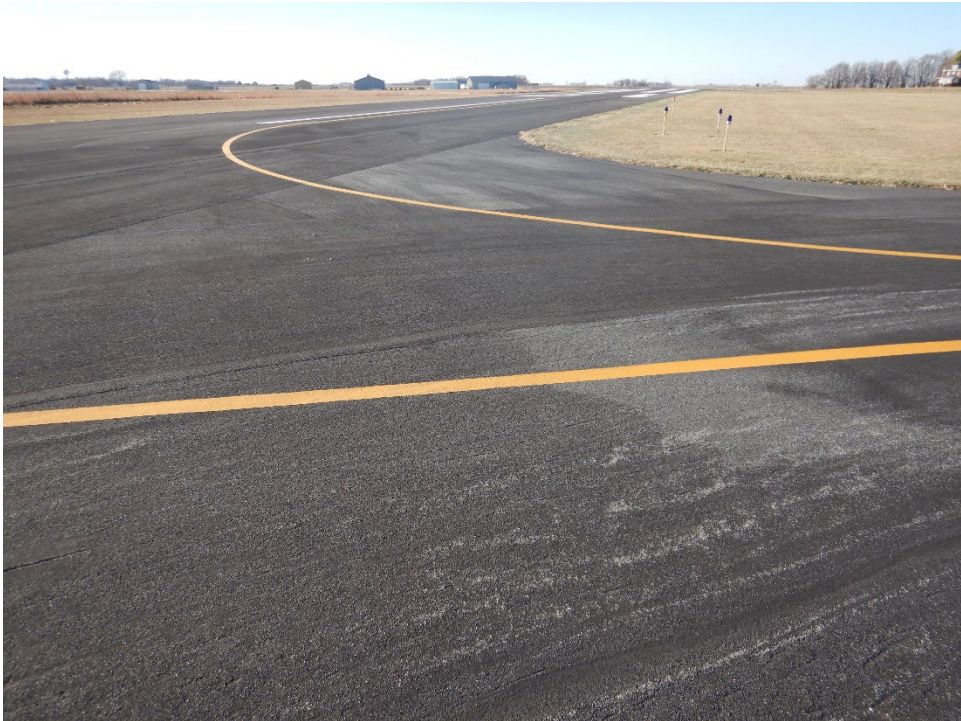
T01PO-03. Overview.

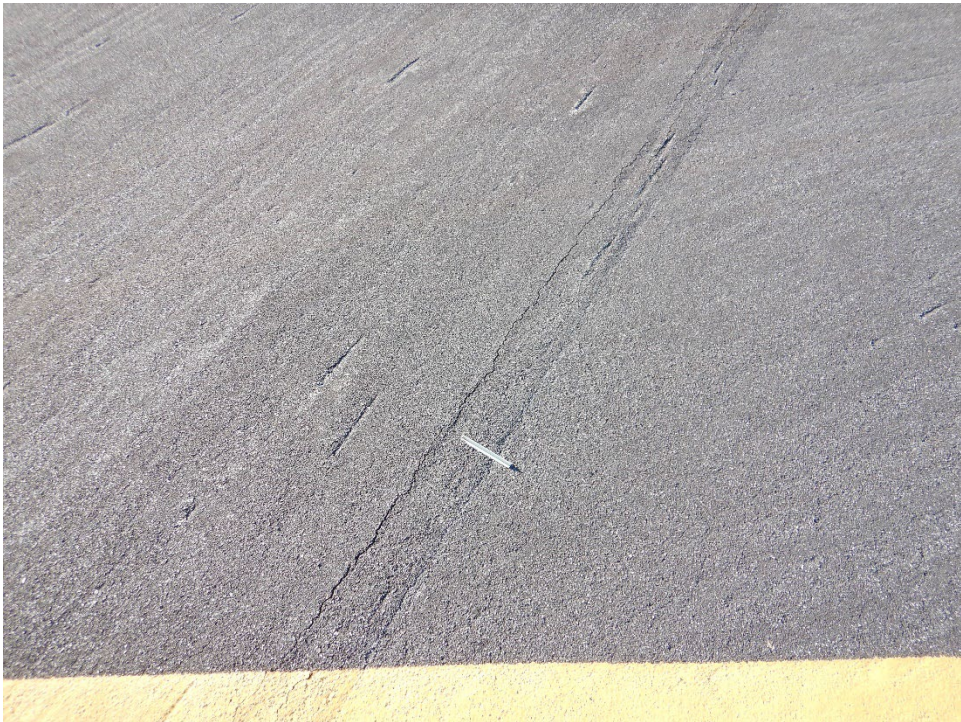
T01PO-03. L&T Cracking (Sample Unit No. 01).

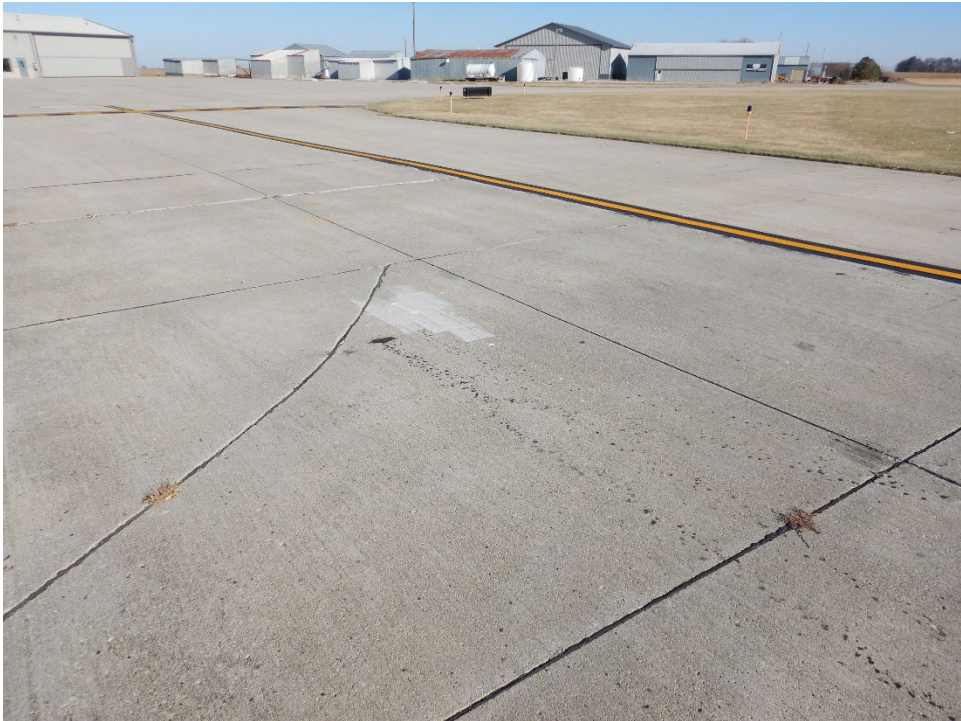
T02PO-01. Overview.

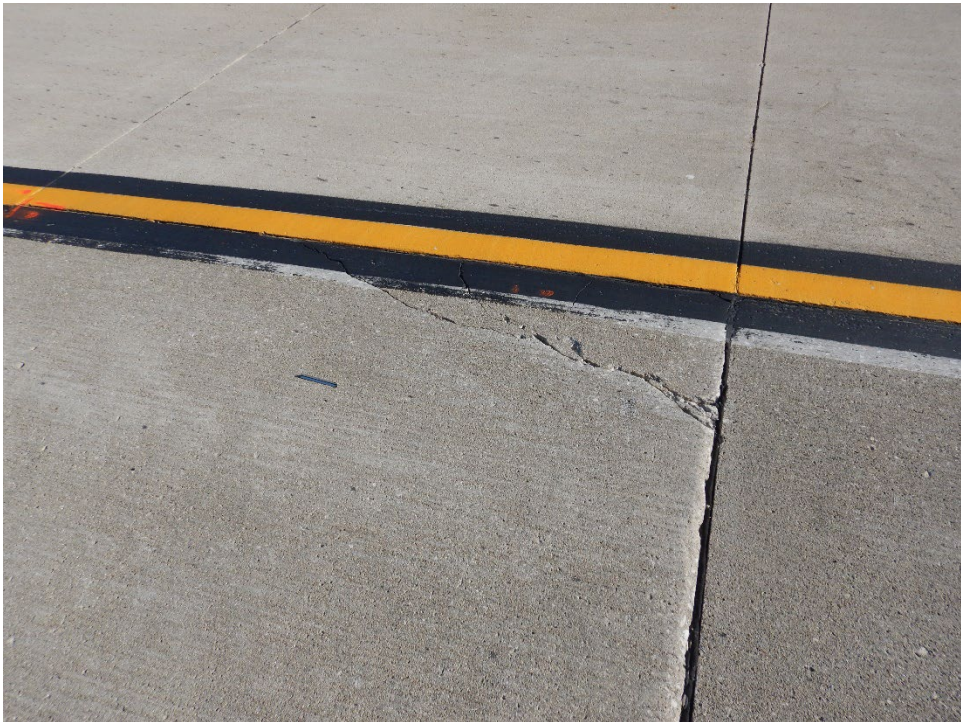
T02PO-01. Joint Spalling (Sample Unit No. 01).

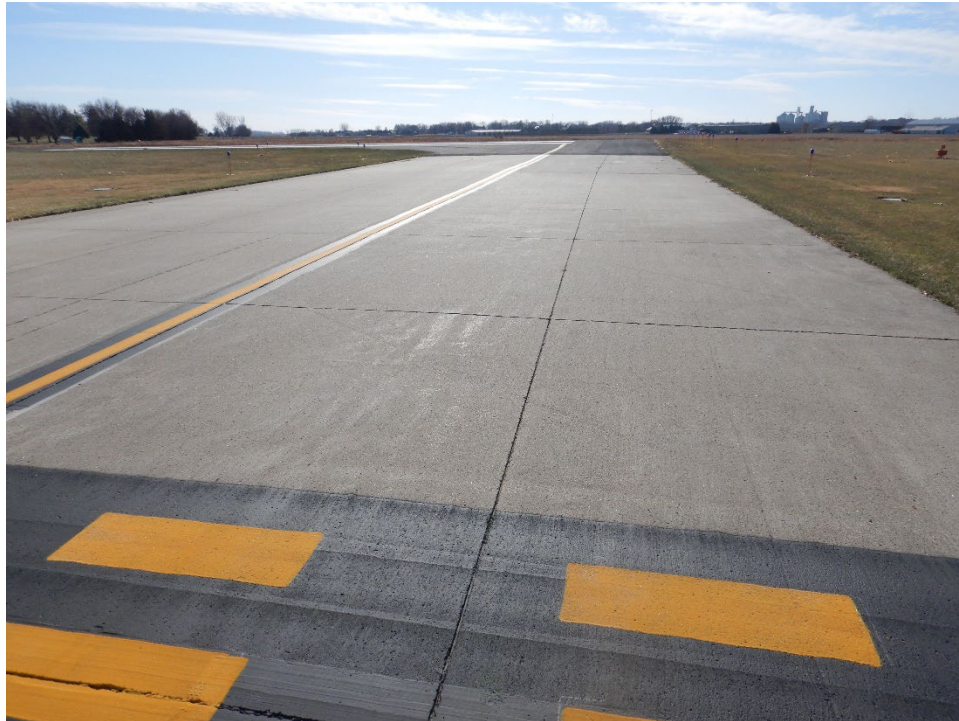
T02PO-02. Overview.

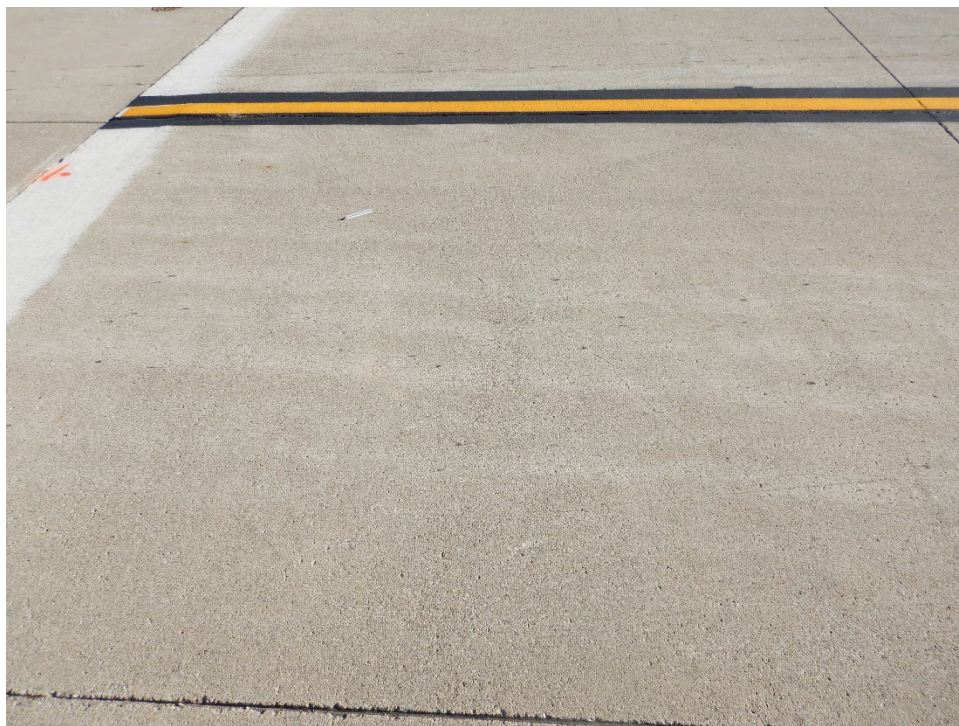
T02PO-02. LTD Cracking (Sample Unit No. 03).

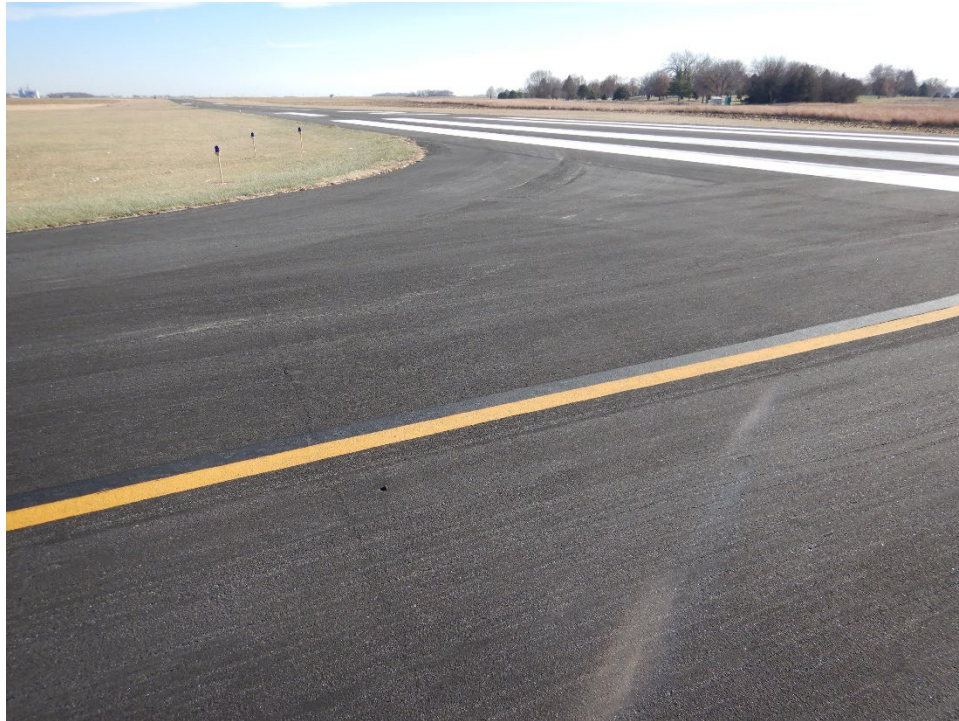
T02PO-03. Overview.

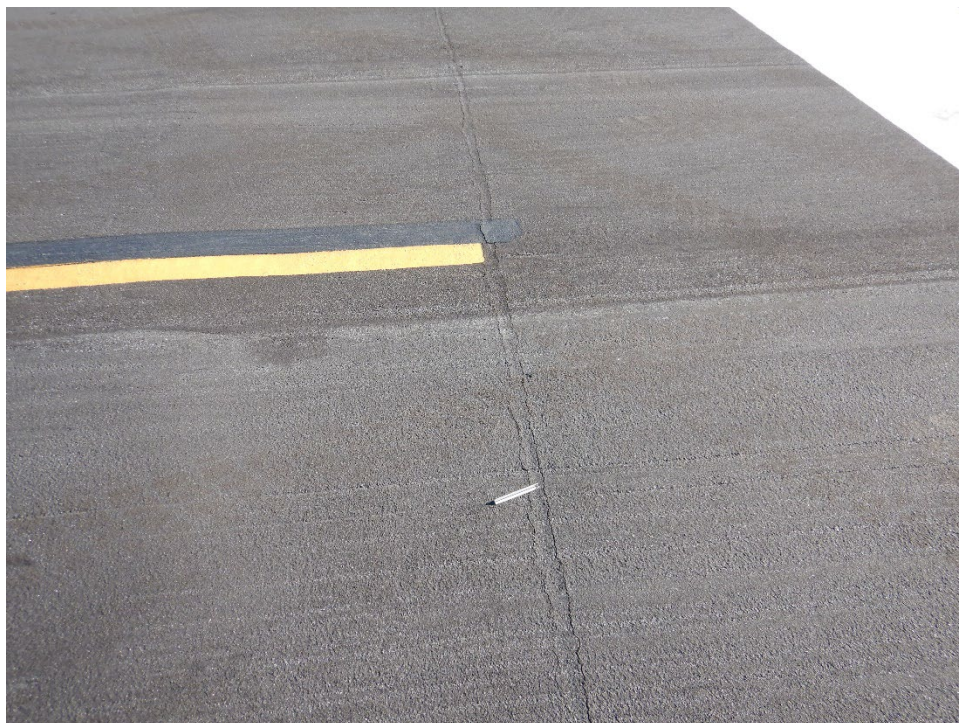
T02PO-03. Joint Reflection Cracking (Sample Unit No. 01).

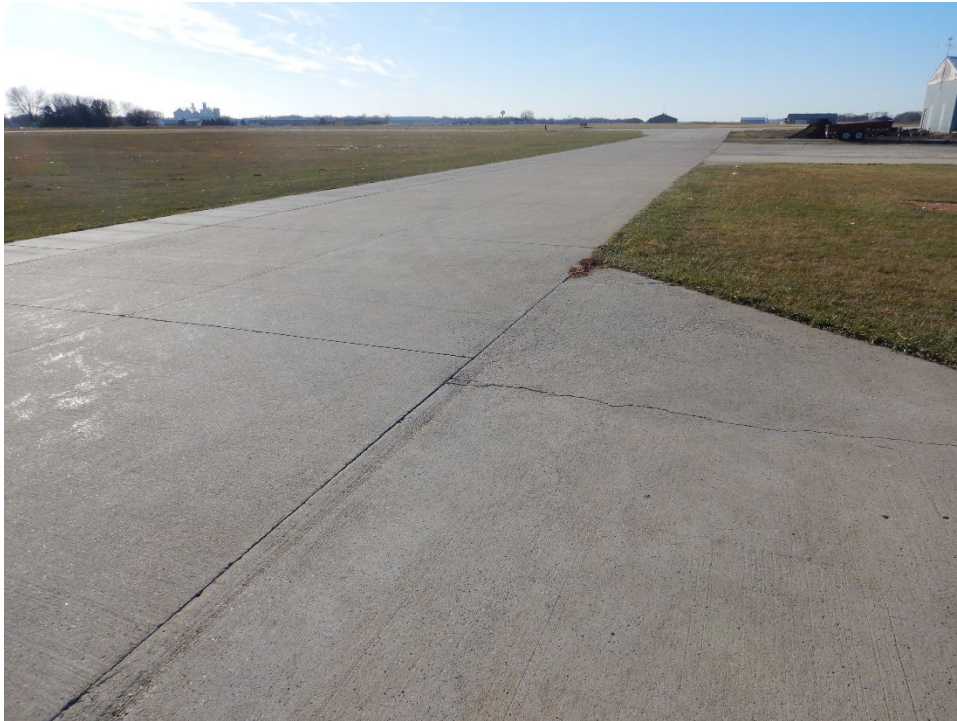
TH01PO-01. Overview.

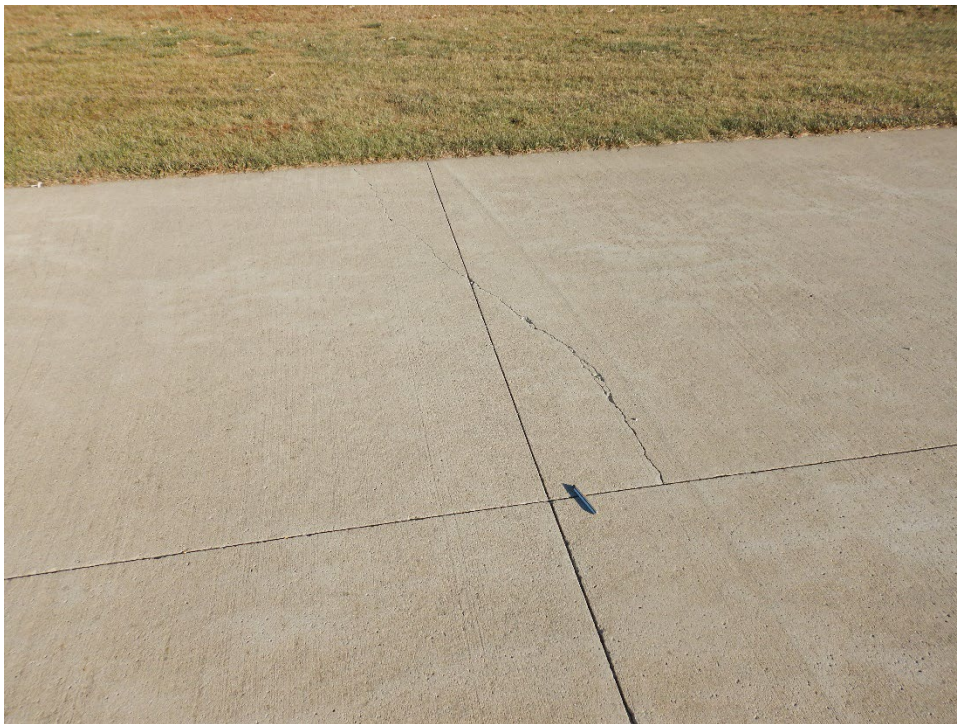
TH01PO-01. Corner Break (Sample Unit No. 03).

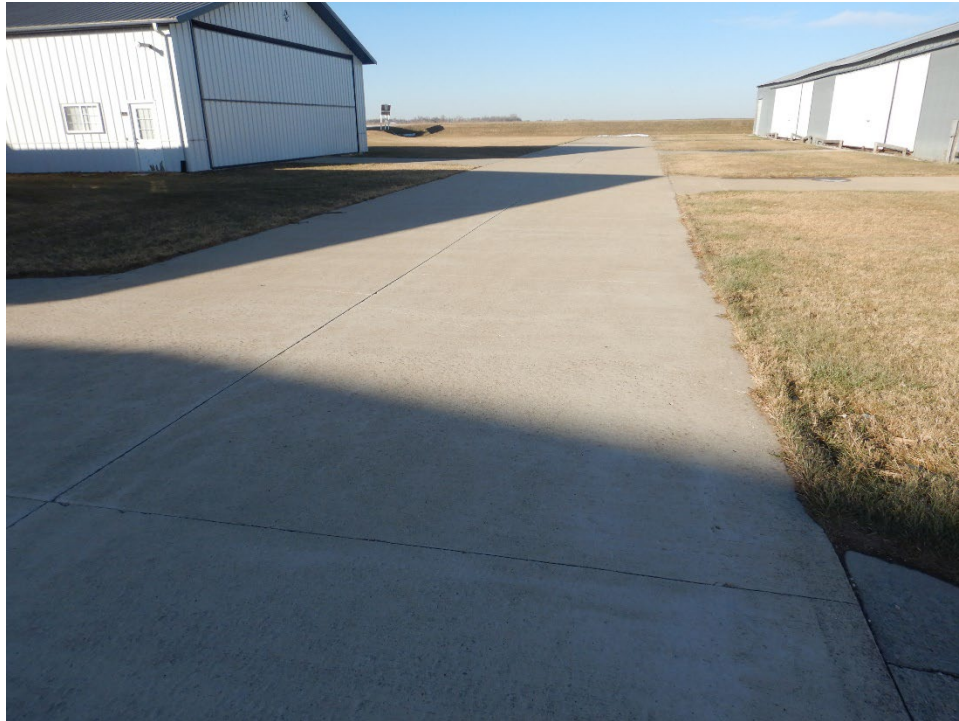
TH01PO-02. Overview.

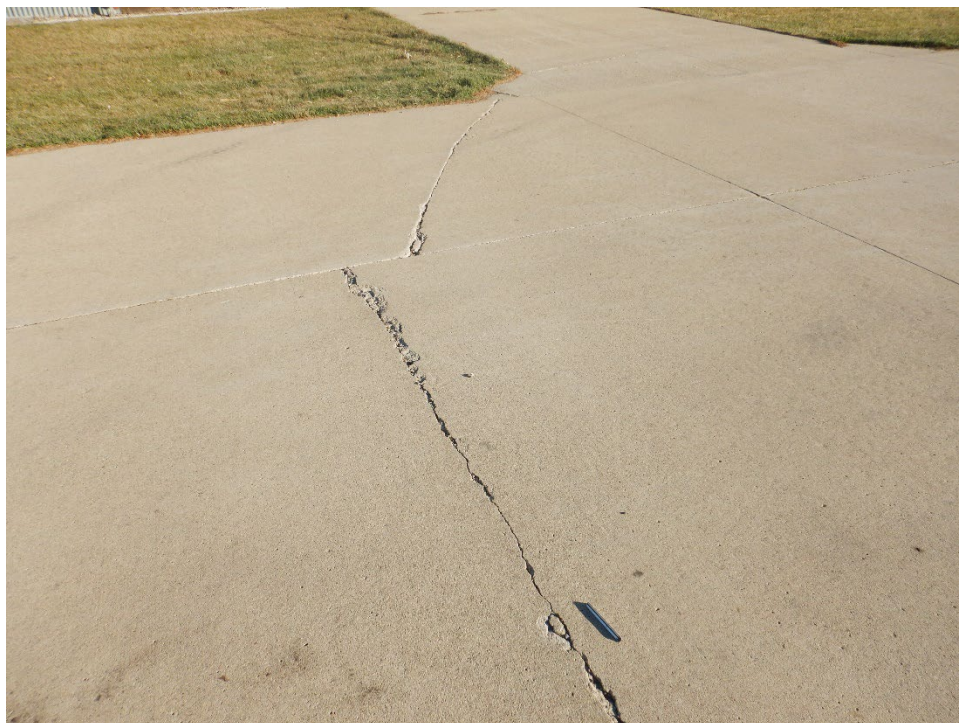
TH01PO-02. LTD Cracking (Sample Unit No. 01).

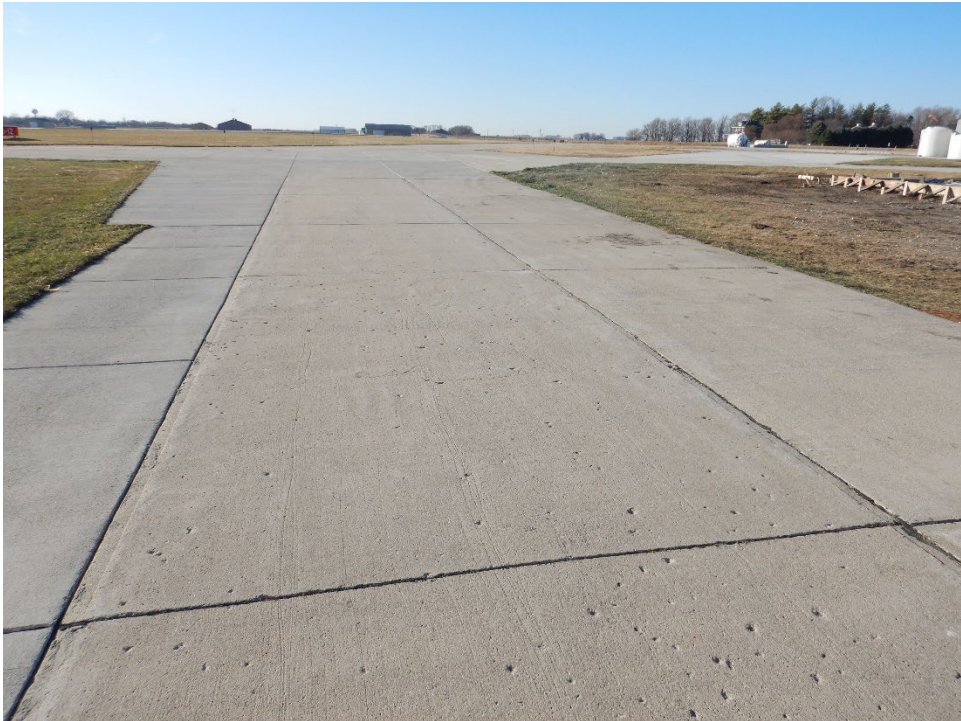
TH01PO-03. Overview.

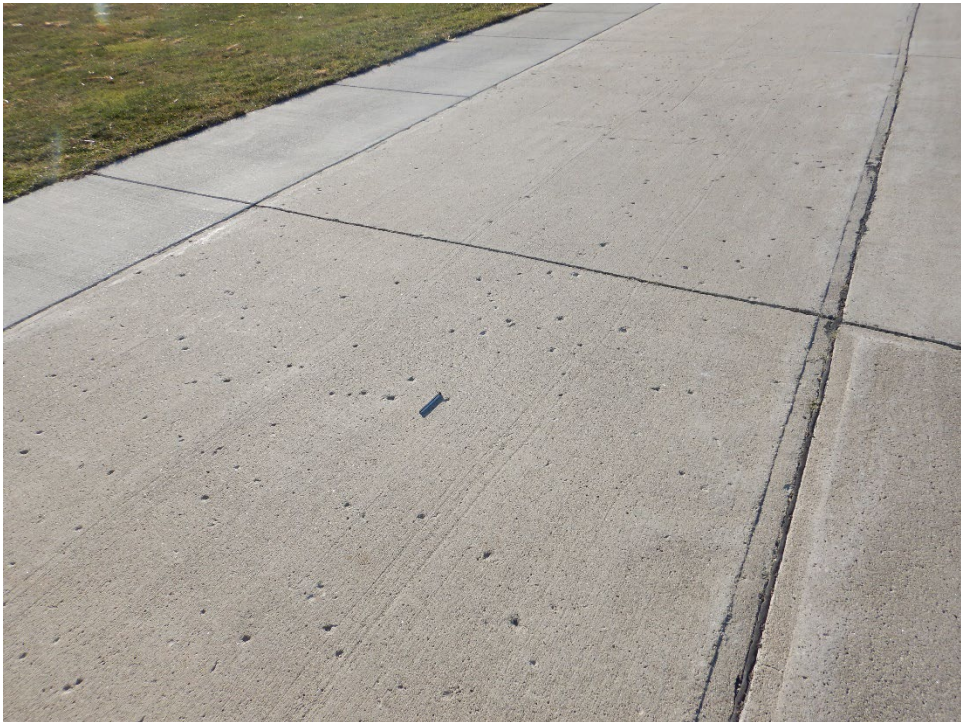
TH01PO-03. Popouts (Sample Unit No. 01).

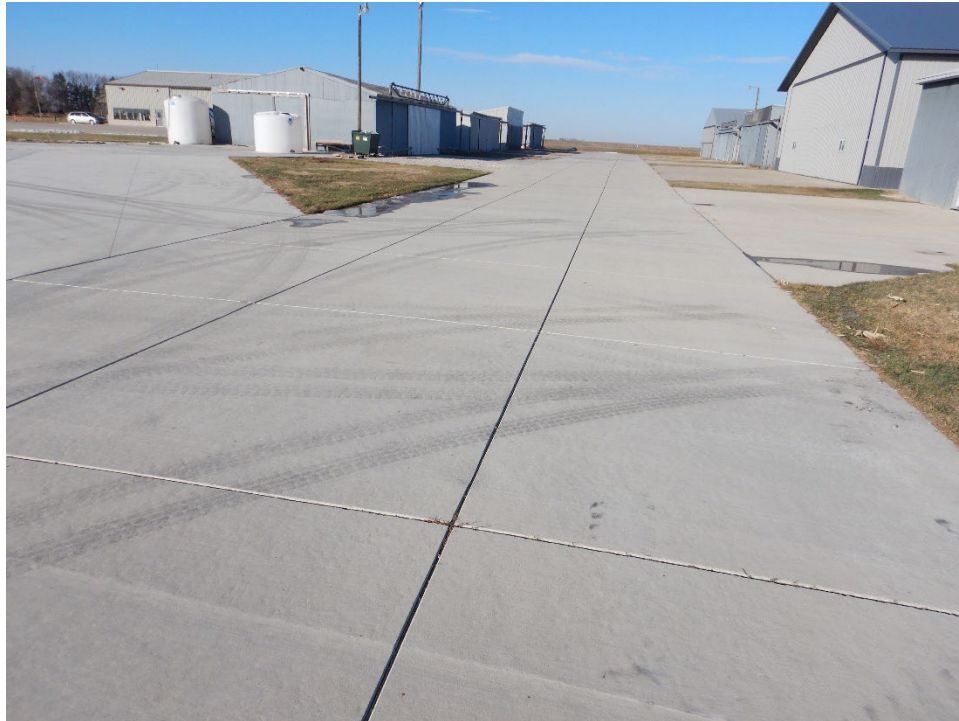
TH01PO-04. Overview.

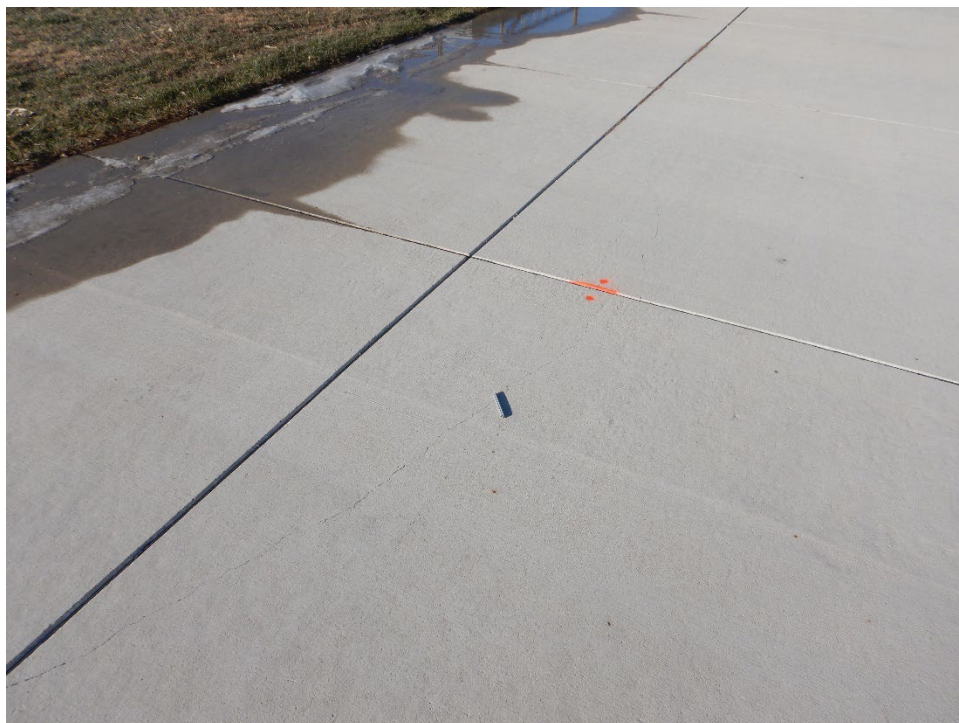
TH01PO-04. LTD Cracking (Sample Unit No. 05).
