Red Oak Municipal Airport

PAVEMENT MANAGEMENT REPORT

JULY 2022

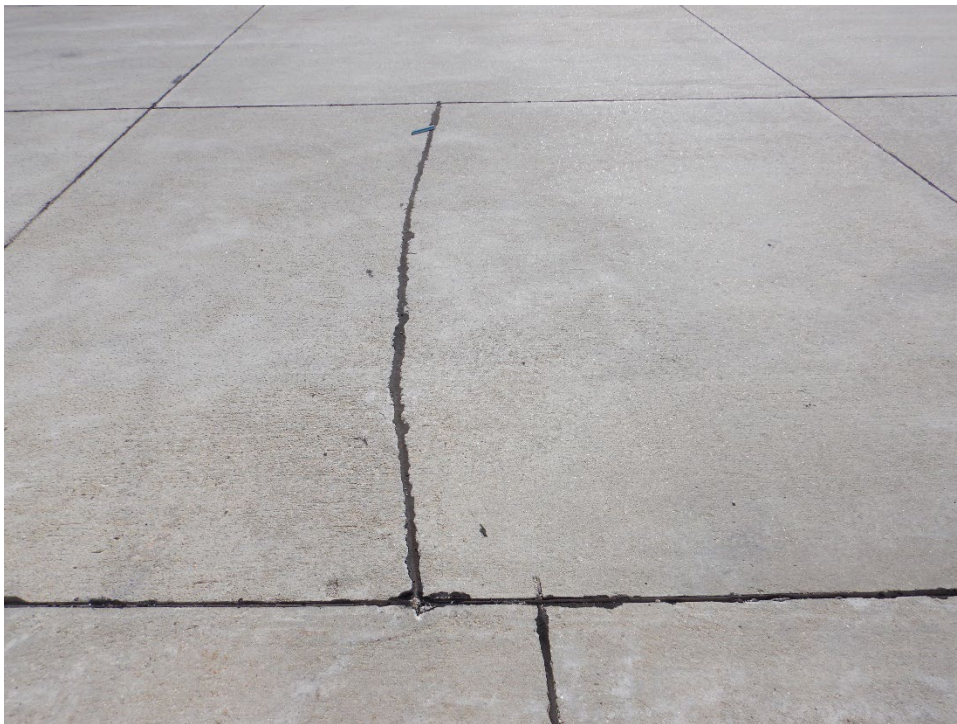
A01RO-01. LTD Cracking (Sample Unit No. 05).

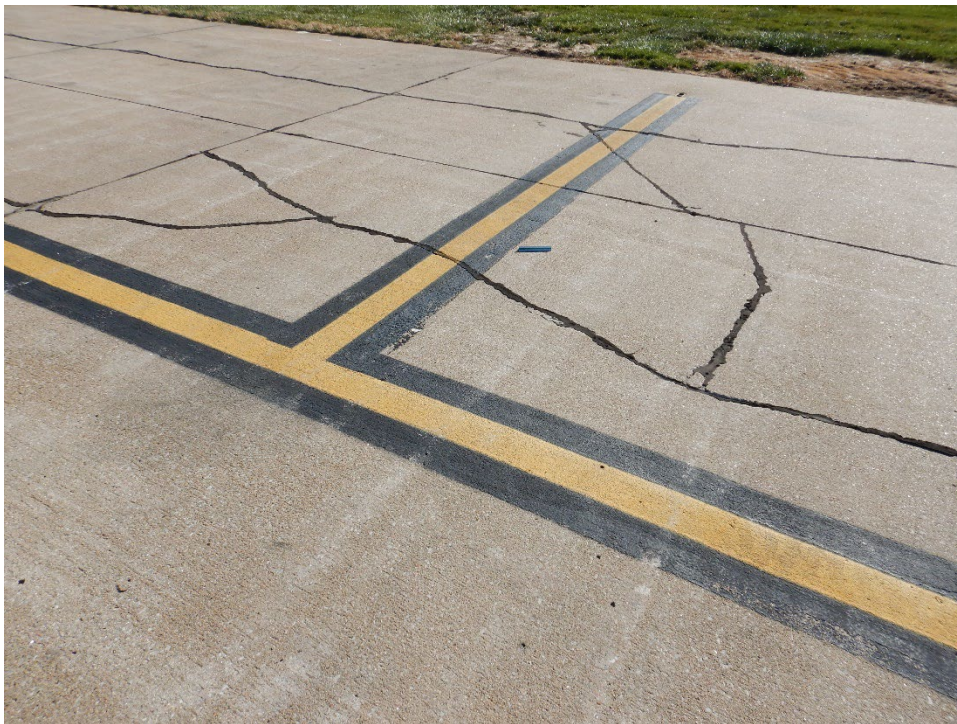
Apron 02 was defined by one section with areas of low-severity corner break, joint seal damage, large patching, and shattered slab recorded at the time of inspection, as well as low- and medium-severity corner spalling, faulting, joint spalling, and LTD cracking.

A02RO-01. Shattered Slab (Sample Unit No. 06).

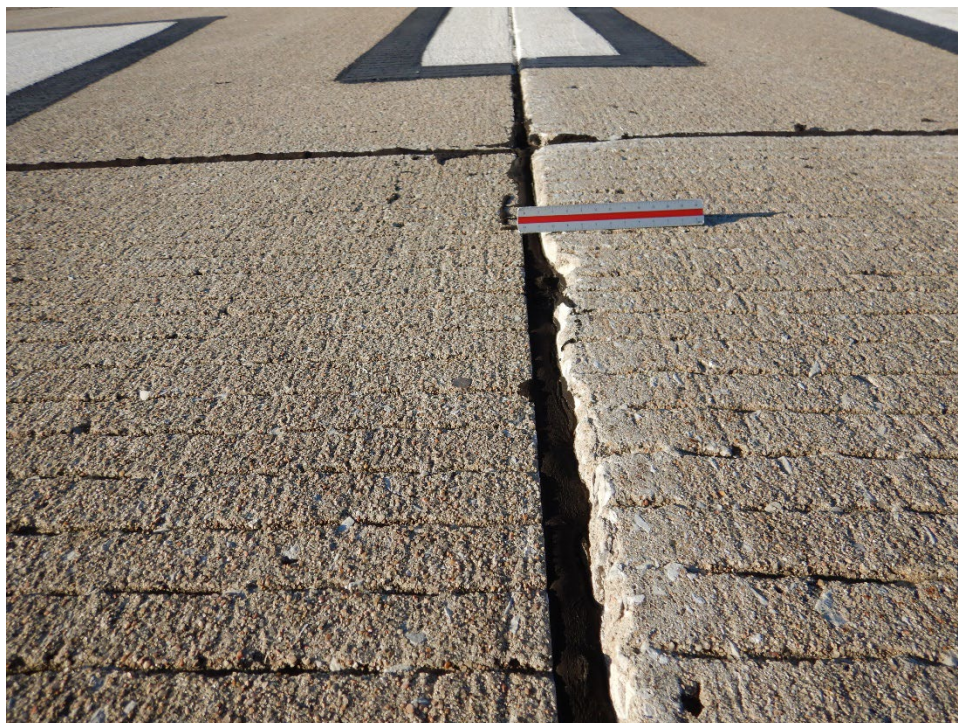
Runway 05/23 was defined by two sections. Section 01 contained areas of low-severity large patching and low- and medium-severity ASR, corner spalling, faulting, joint spalling, and longitudinal, transverse, and diagonal (LTD) cracking. Low-severity joint seal damage and corner spalling, low- and medium-severity faulting, medium-severity joint spalling, and shrinkage cracking were recorded in Section 02.

R05RO-01. Faulting (Sample Unit No. 16).

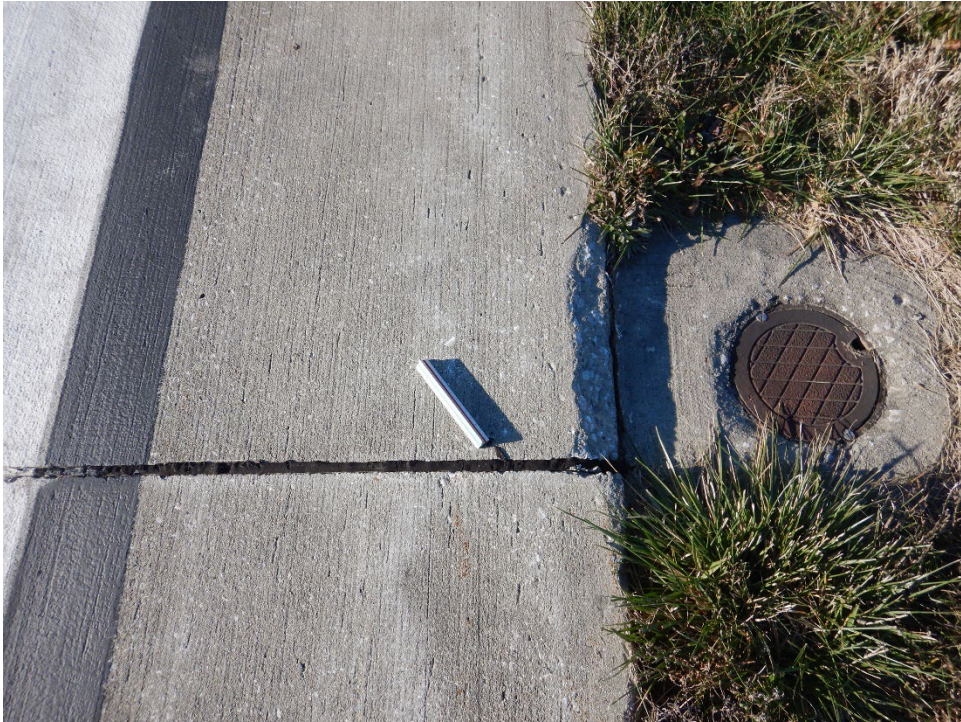
R05RO-02. Joint Spalling (Sample Unit No. 19).

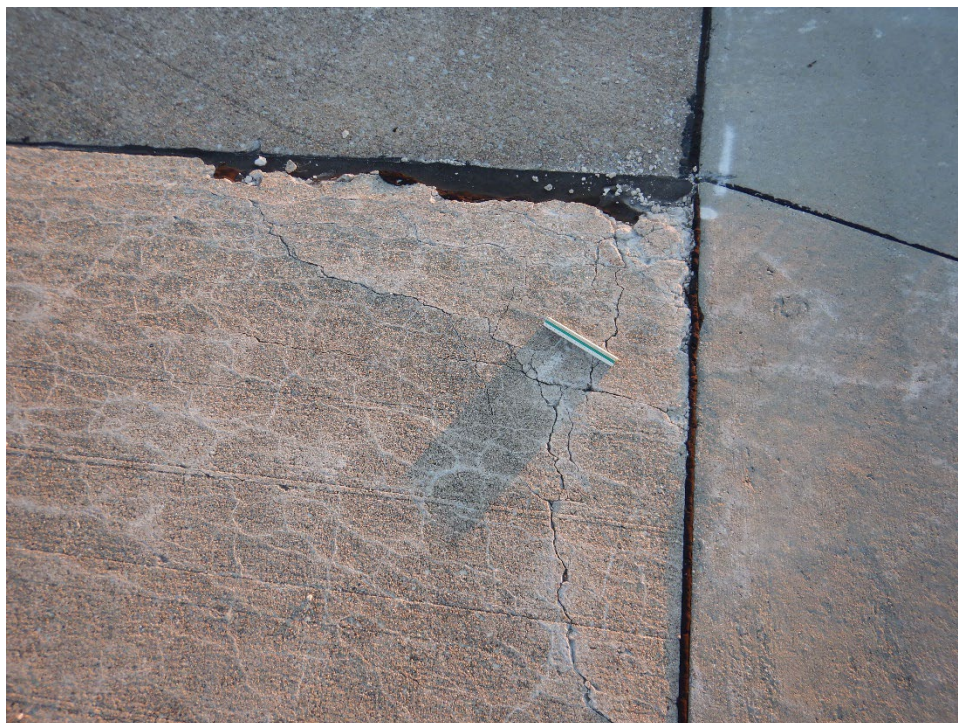
Runway 17/35 consisted of four sections. Section 02 contained low- and medium-severity corner spalling, scaling, joint seal damage, large patching, joint spalling, and ASR; medium-severity shattered slab and corner break; all severities LTD cracking; shrinkage cracking; and low- and high-severity small patching. Medium-severity corner break, corner spalling, and joint spalling; low- and medium-severity faulting, LTD cracking, and joint seal damage; low-severity large patching; and shrinkage cracking were observed in Section 03. Section 04 had areas of low-severity ASR and corner break; low- and medium-severity faulting; medium-severity joint seal damage and joint spalling; and shrinkage cracking noted. Section 05 was in excellent condition with areas of medium-severity corner spalling; low-severity joint seal damage, joint spalling, and small patching; and shrinkage cracking identified at the time of inspection.

R17RO-02. ASR (Sample Unit No. 02).

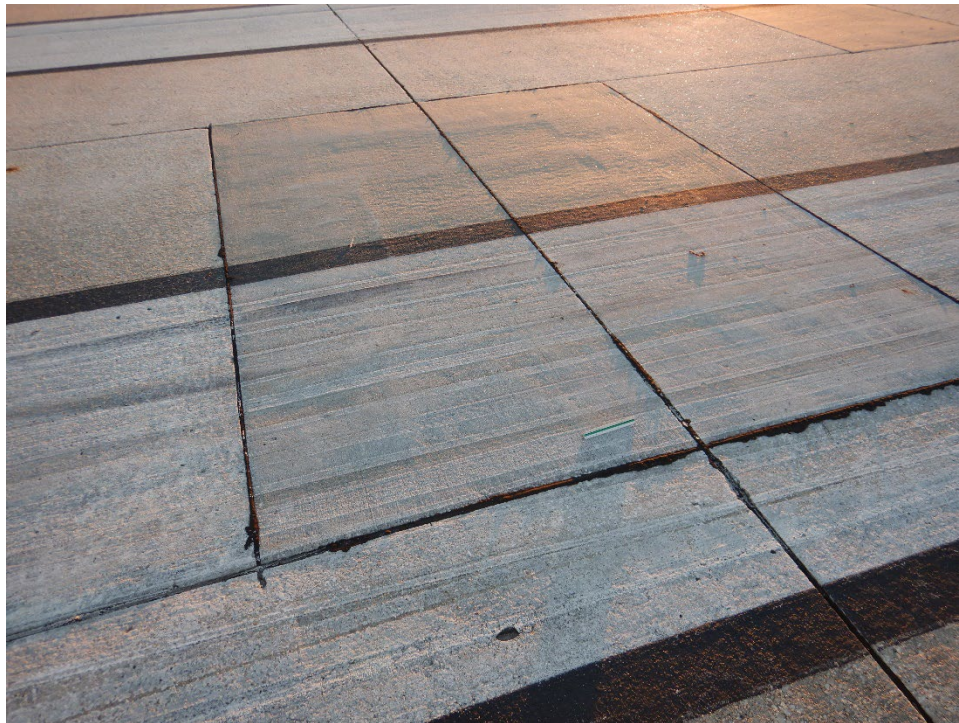
R17RO-02. Large Patching (Sample Unit No. 02).

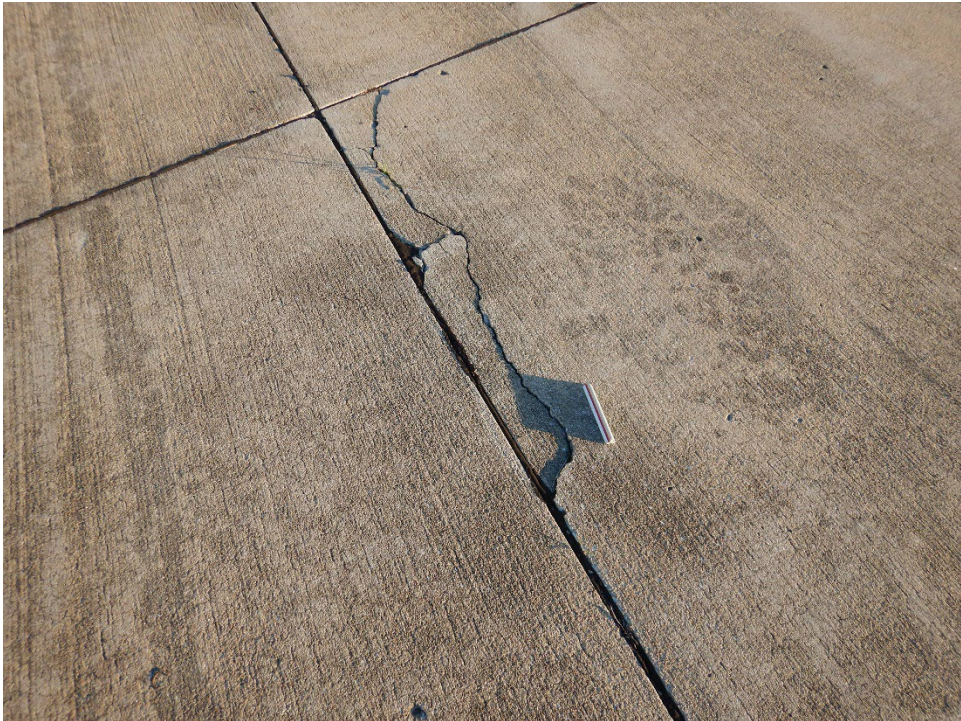
R17RO-03. Joint Spalling (Sample Unit No. 02).

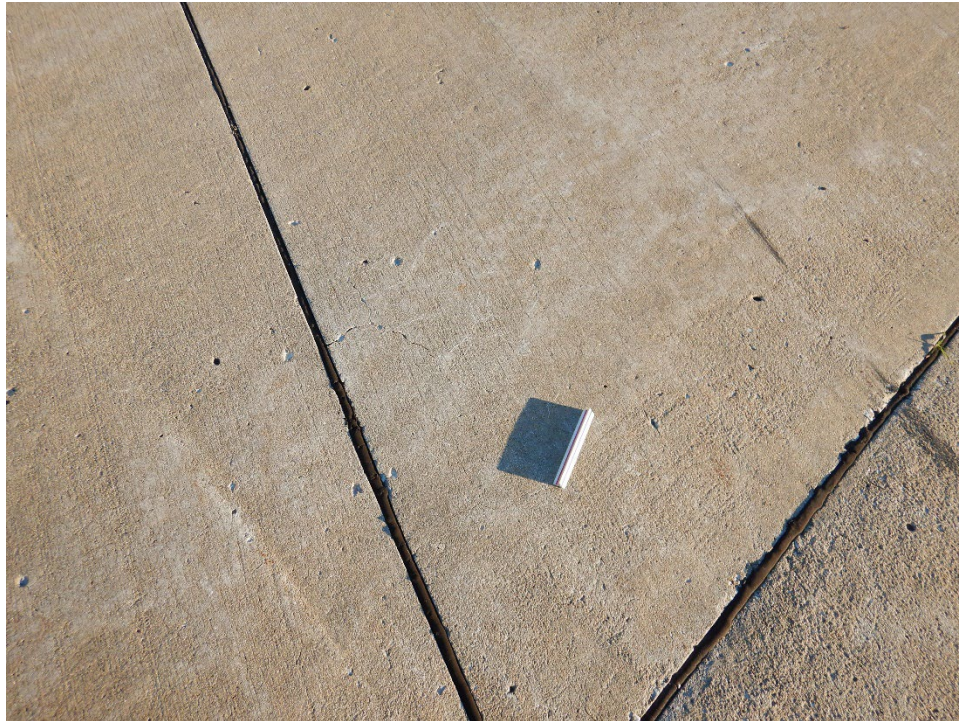
R17RO-04. ASR (Sample Unit No. 02).

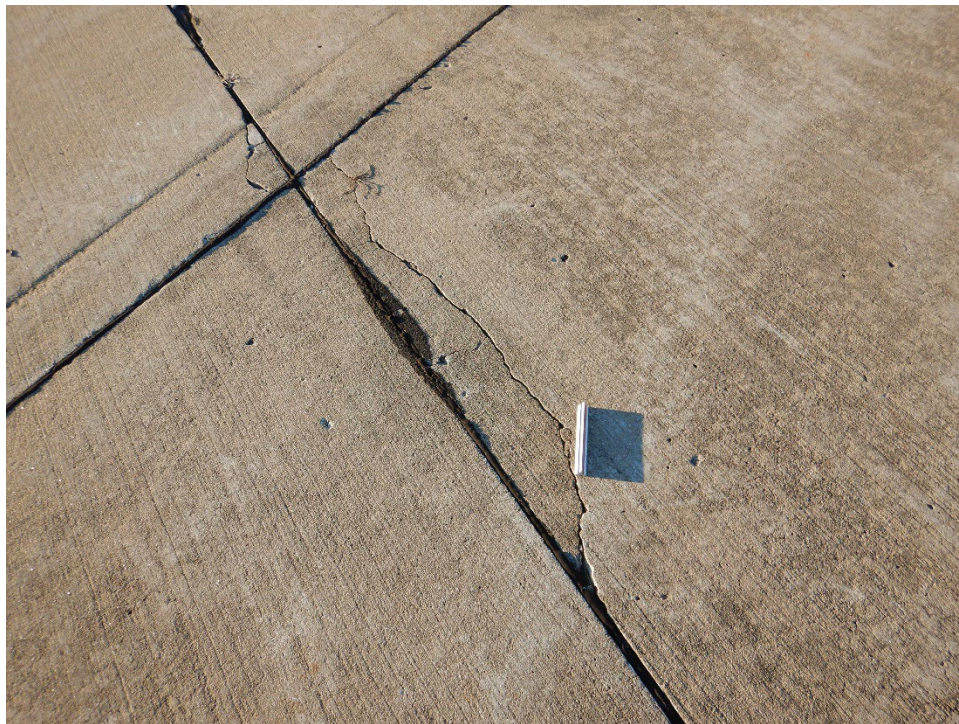
R17RO-04. Joint Spalling (Sample Unit No. 02).

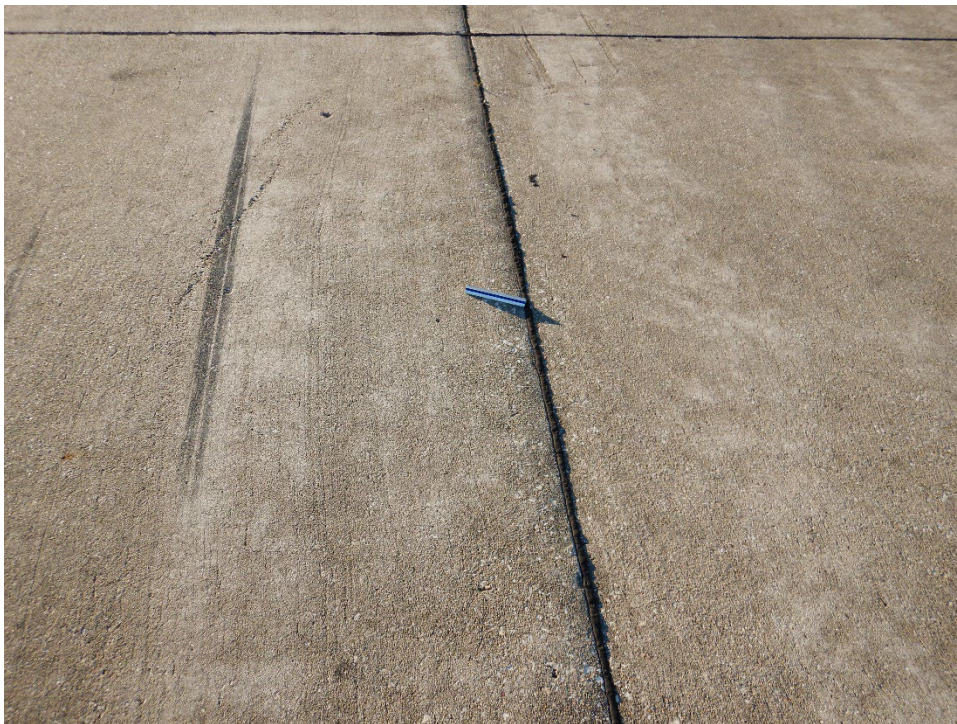
R17RO-05. Joint Seal Damage (Sample Unit No. 08).

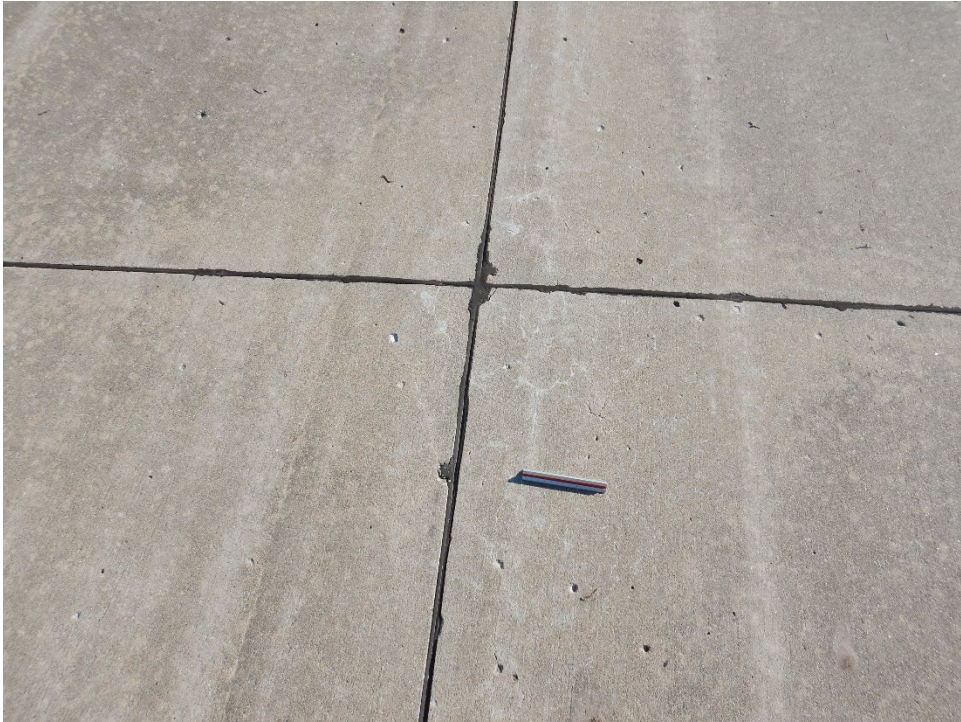
Taxiway 01 connected Runway 05/23 with the apron area and contained one section. Low- and medium-severity corner spalling and low-severity faulting, ASR, and joint seal damage were recorded in Section 01.

T01RO-01. ASR (Sample Unit No. 17).

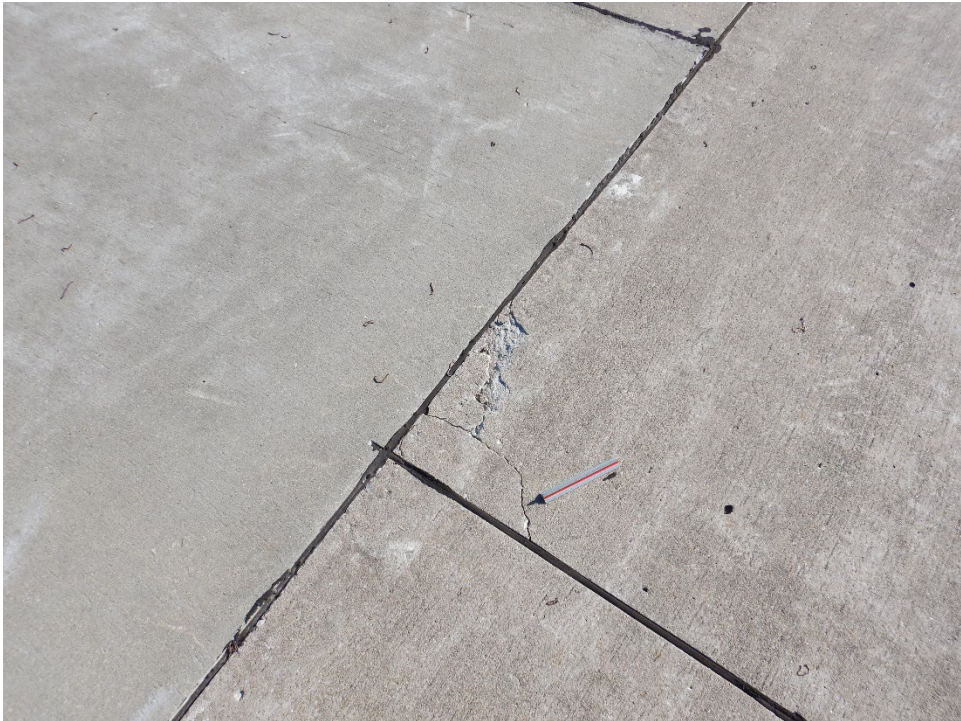
T01RO-01. Corner Spalling (Sample Unit No. 06).

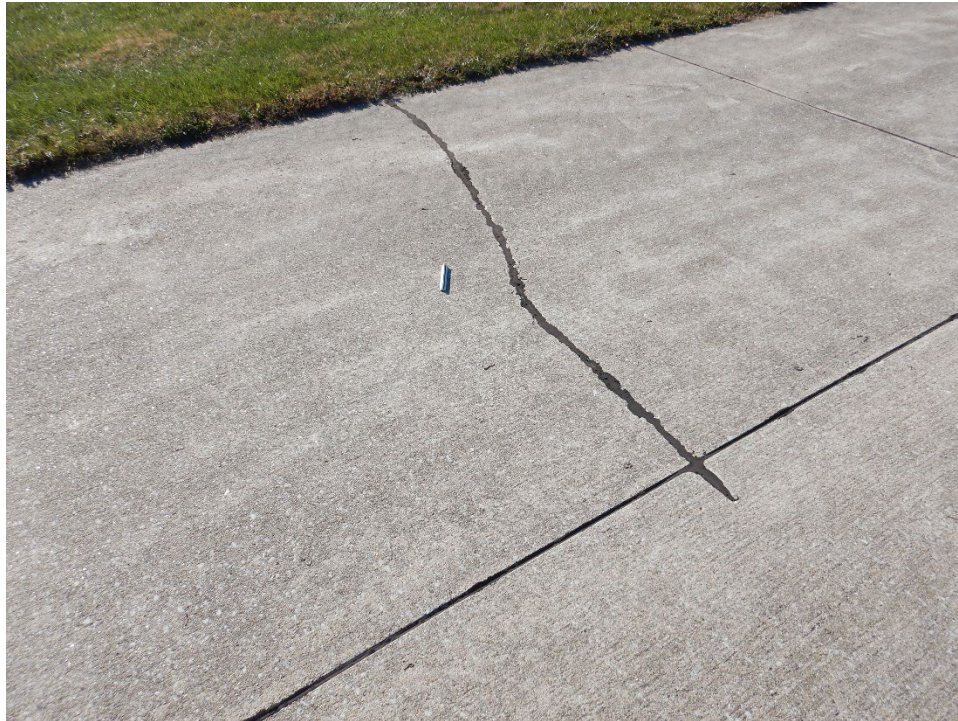
Taxiway 02 connected the Runway 17 approach with the apron area and was defined by one section. Section 01 contained areas of low- and medium-severity corner spalling, joint spalling, and LTD cracking; low-severity joint seal damage; and shrinkage cracking.

T02RO-01. LTD Cracking (Sample Unit No. 09).

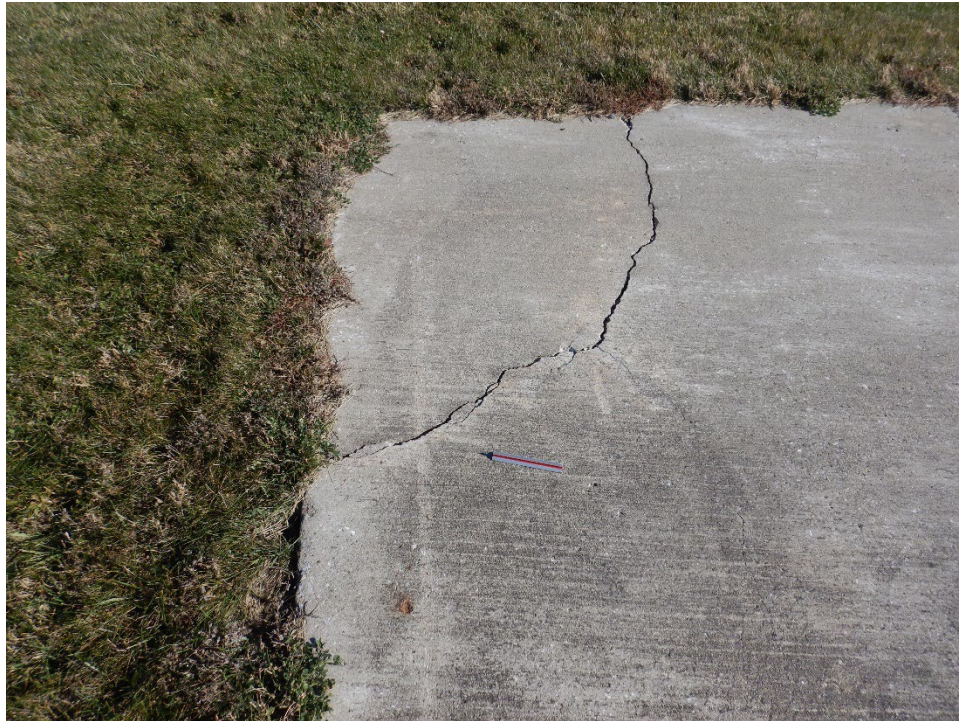
Taxiway 03 consisted of one section located at the Runway 23 approach. Low-severity ASR and faulting; high-severity corner break; all severities of joint seal damage; and medium-severity LTD cracking. An atypical area of medium-severity faulting was also identified and recorded as an additional sample unit, according to ASTM D5340-20.

T03RO-01. Corner Break (Sample Unit No. 02).

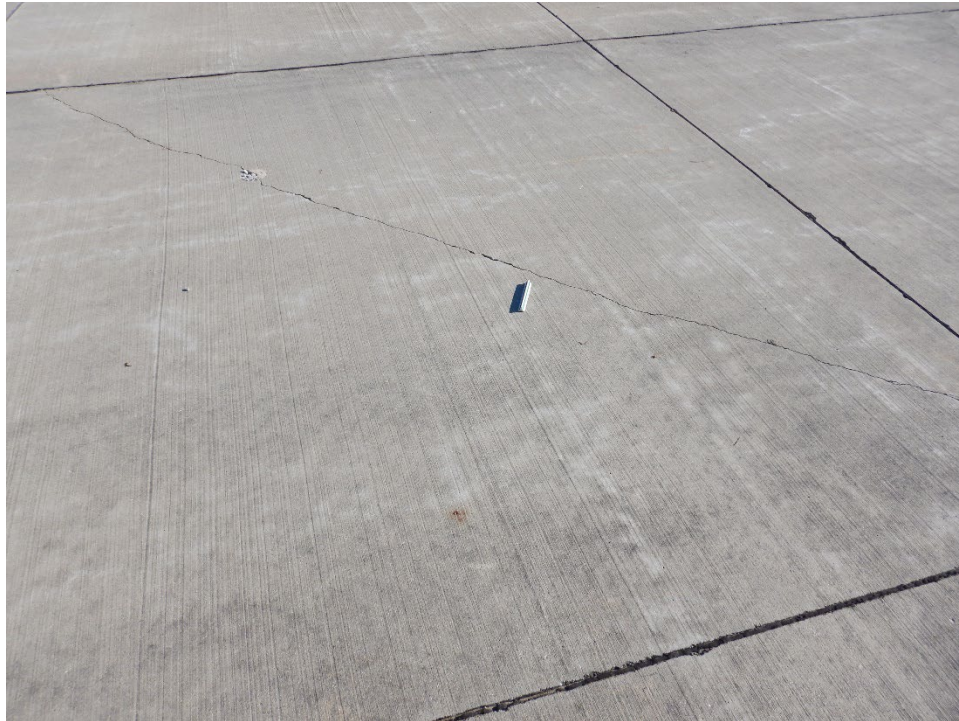
Taxiway 04 contained one section, located at the Runway 05 approach, that had areas of low-severity ASR, low- and medium-severity joint seal damage, and low-severity LTD cracking noted throughout.

T04RO-01. LTD Cracking (Sample Unit No. 03).

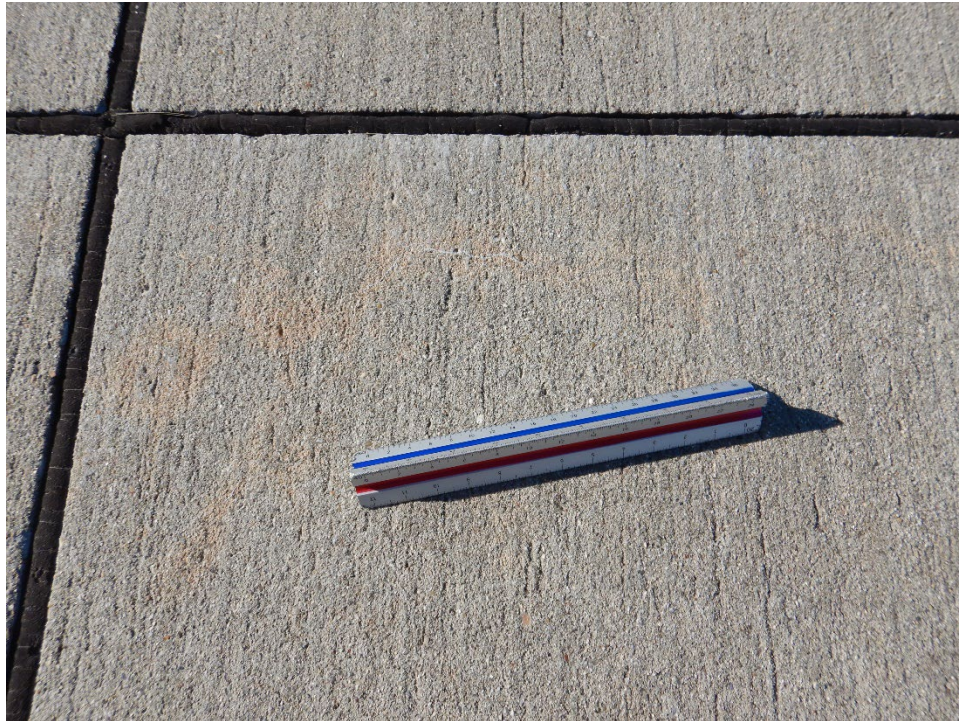
Taxiway 05 was defined by one section. Section 01 had areas of low-severity ASR, corner spalling, and faulting; low- and medium-severity joint seal damage; and high-severity small patching.

T05RO-01. ASR (Sample Unit No. 28).

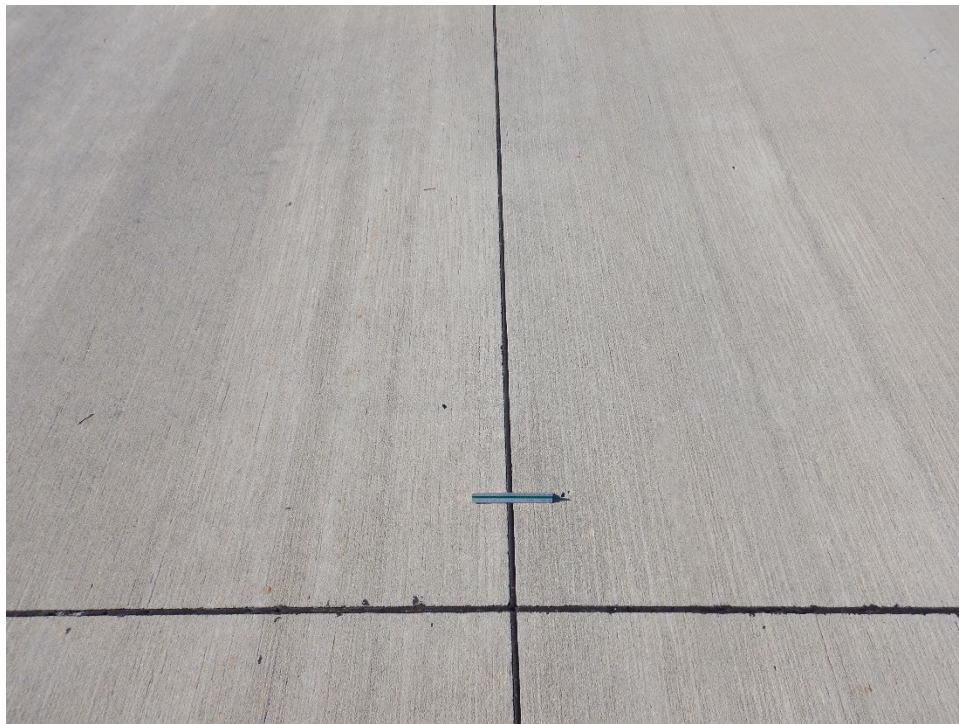
T05RO-01. Joint Seal Damage (Sample Unit No. 08).

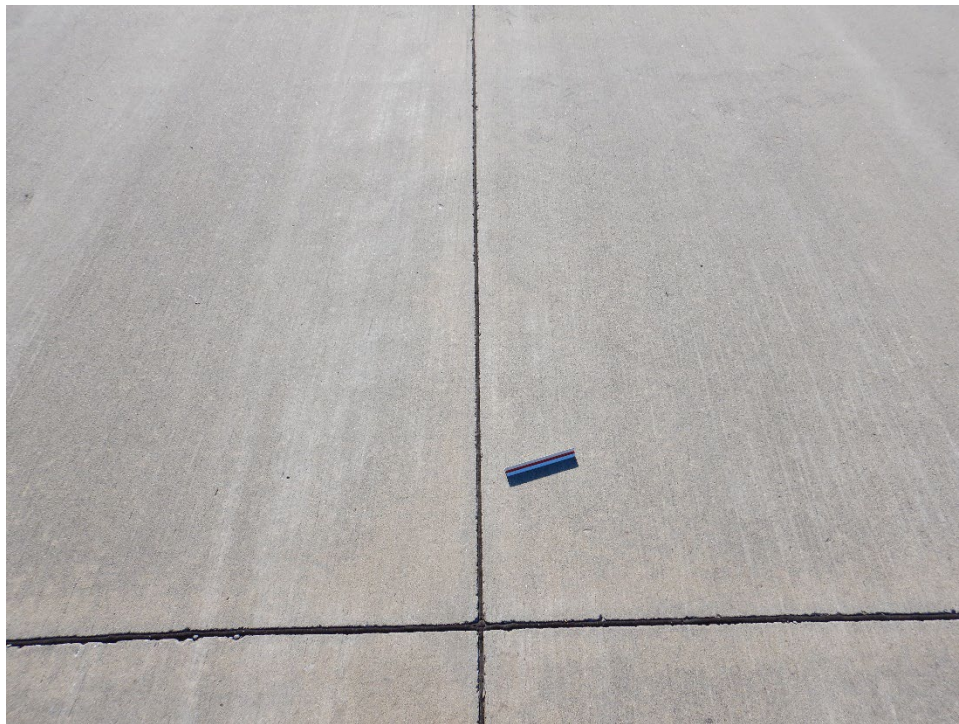
Taxiway 06 consisted of one section. Low-severity faulting and LTD cracking, low- and medium-severity joint seal damage, and all severities of joint spalling were recorded in Section 01.

T06RO-01. Joint Seal Damage (Sample Unit No. 13).

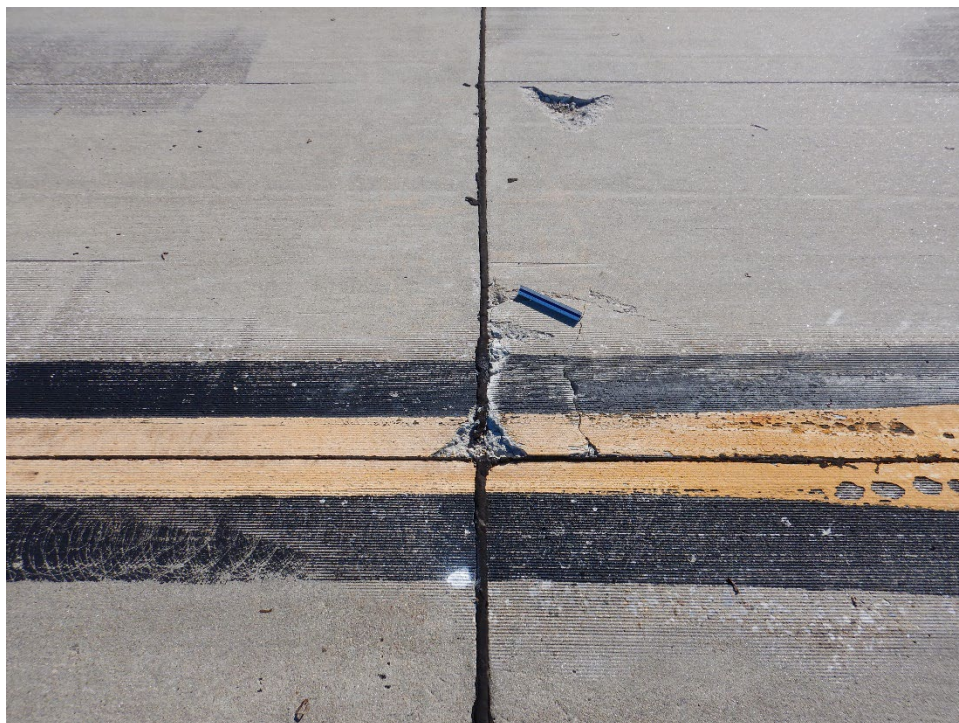
Taxiway 07 connected the Runway 23 approach with Taxiway 01 and contained one section with areas of low-severity ASR and faulting; low- and medium-severity corner spalling, LTD cracking, and joint seal damage; medium-severity joint spalling and scaling; and shrinkage cracking. Two atypical areas of low-severity blow-up and high-severity joint spalling, corner spalling, and corner break were identified and recorded as additional sample units, according to ASTM D5340-20.

T07RO-01. Blow-Up (Additional Sample Unit No. 01).

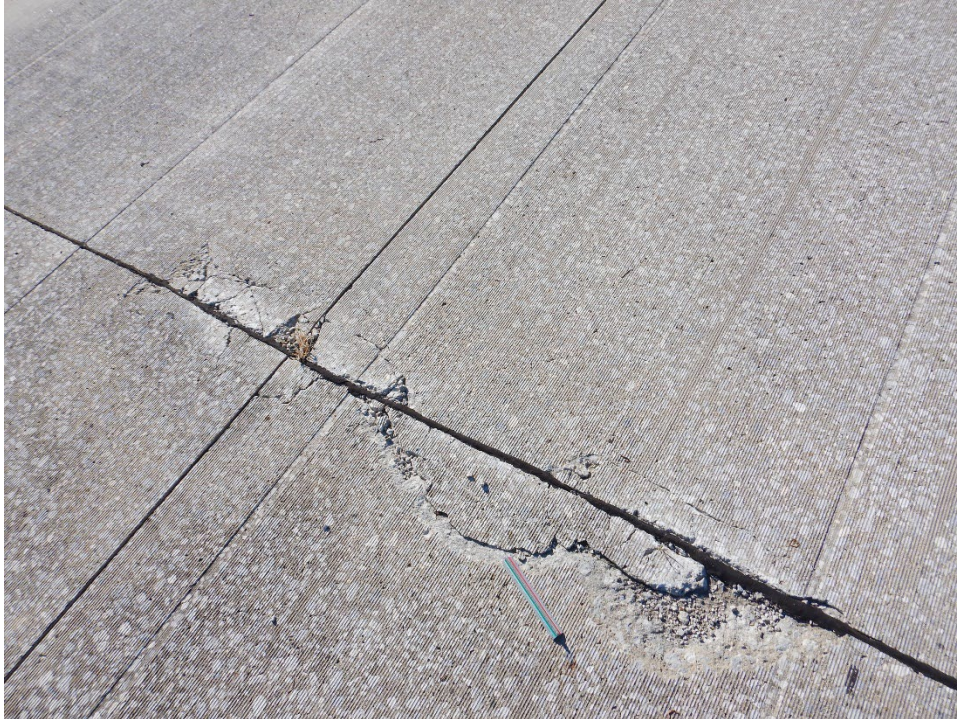
T07RO-01. Joint Spalling (Additional Sample Unit No. 16).

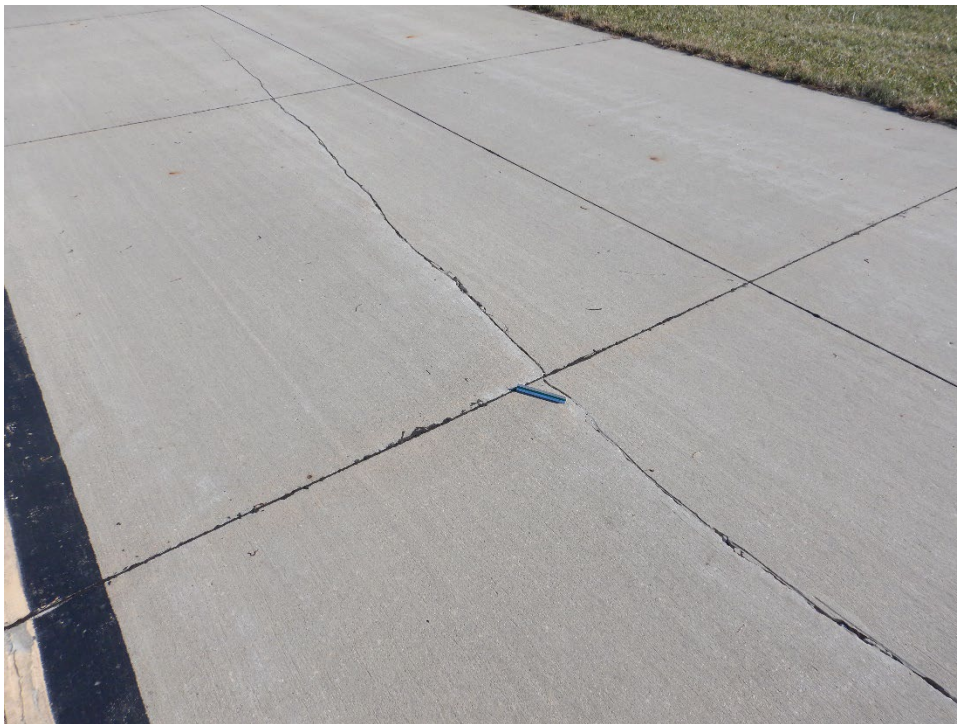
T07RO-01. LTD Cracking (Sample Unit No. 09).

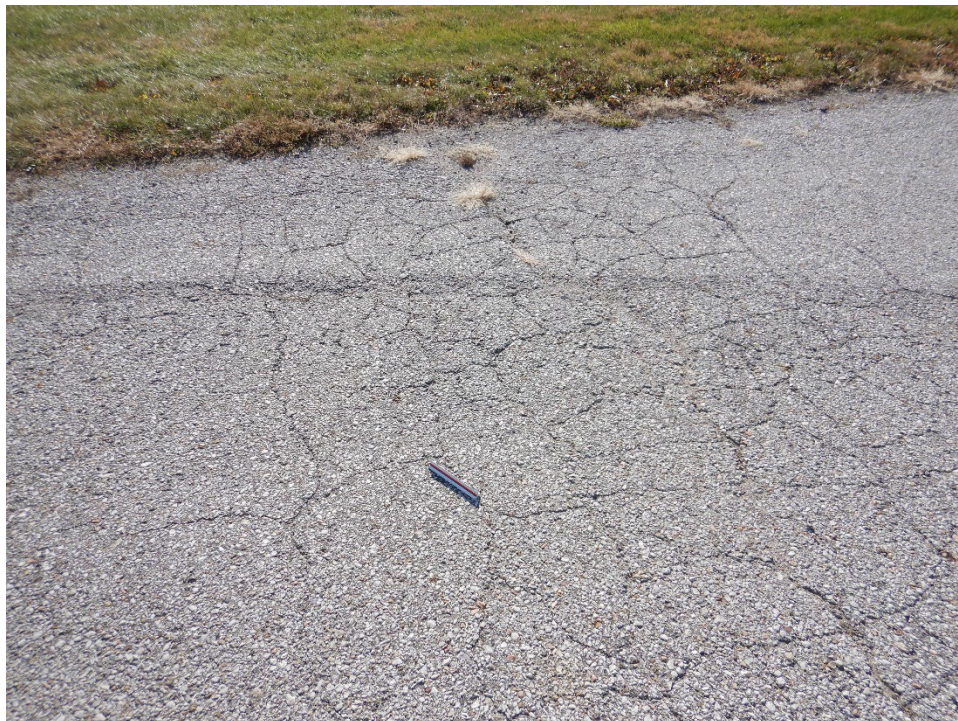
The T-hangar 01 area was divided into three sections. Section 01 was in poor condition with areas of medium- and high-severity alligator cracking and L&T cracking, low-severity patching and rutting, medium-severity shoving, and high-severity weathering noted at the time of inspection. The medium-severity L&T cracking was unsealed with crack widths exceeding $\frac{1}{4}$ in, while the high-severity L&T cracking was noted where crack widths were greater than 3 in. Medium-severity corner spalling and joint spalling, low-severity joint seal damage, and low- and medium-severity LTD cracking were recorded in Section 02. Section 03 contained medium-severity corner spalling and joint spalling, high-severity joint seal damage, and low- and medium-severity LTD cracking.

TH01RO-01. Alligator Cracking (Sample Unit No. 02).

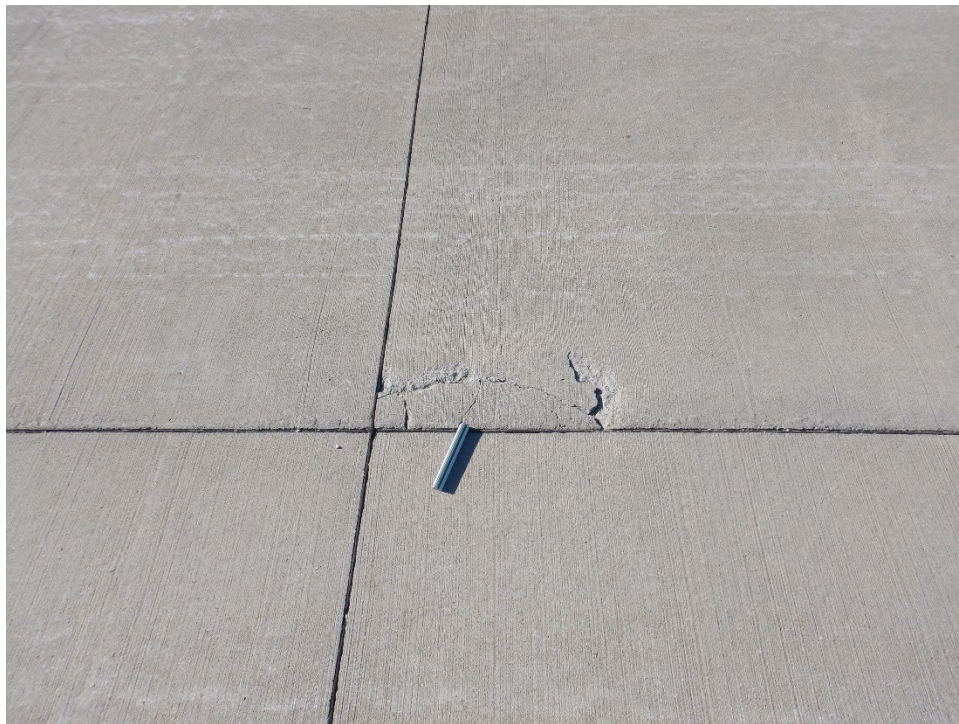
TH01RO-02. Joint Spalling (Sample Unit No. 01).

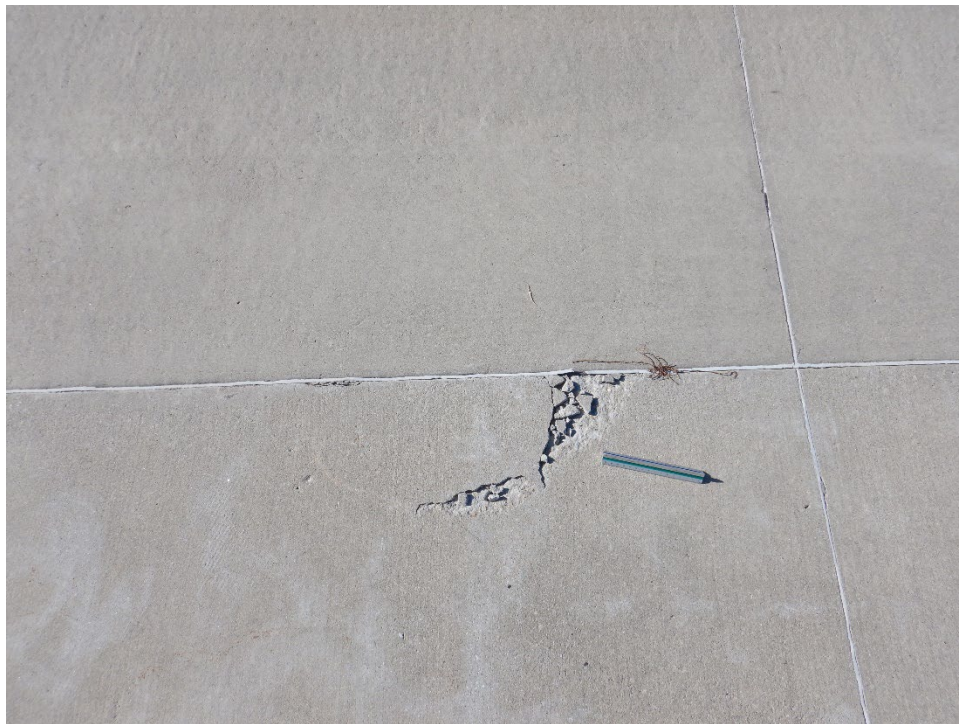
TH01RO-03. Joint Spalling (Sample Unit No. 01).

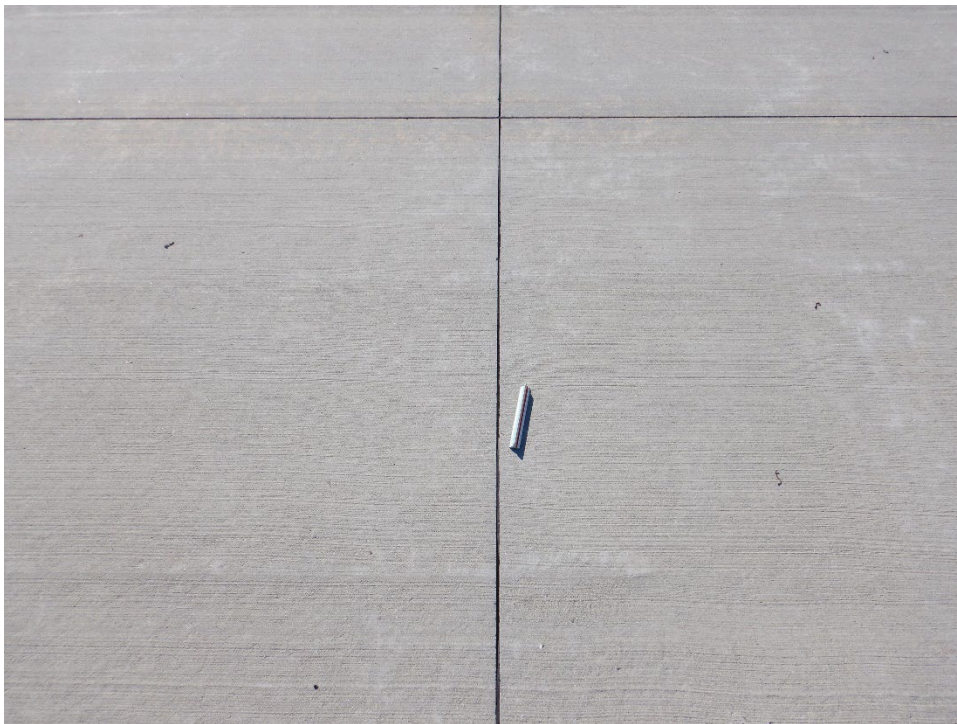
The T-hangar 02 area consisted of one section in excellent condition with only low severity joint seal damage recorded throughout.

TH02RO-01. Joint Seal Damage (Sample Unit No. 08).
