# Rockwell City Municipal Airport

## PAVEMENT MANAGEMENT REPORT

**JULY 2021**

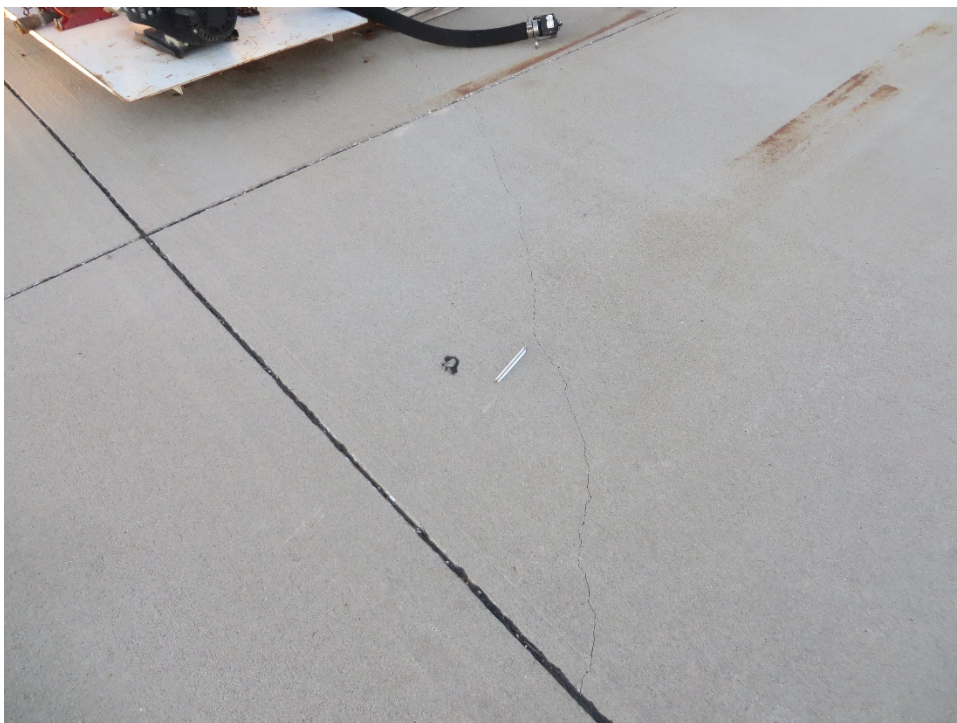
A01RC-01. Corner Break (Sample Unit No. 04).

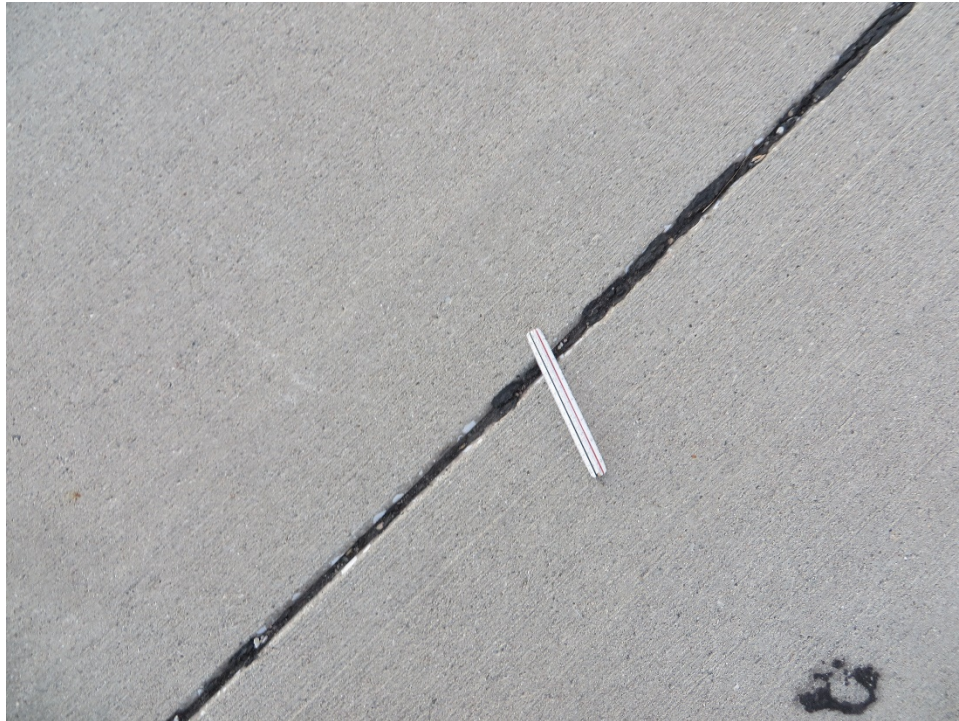
A01RC-01. Joint Seal Damage (Sample Unit No. 04).

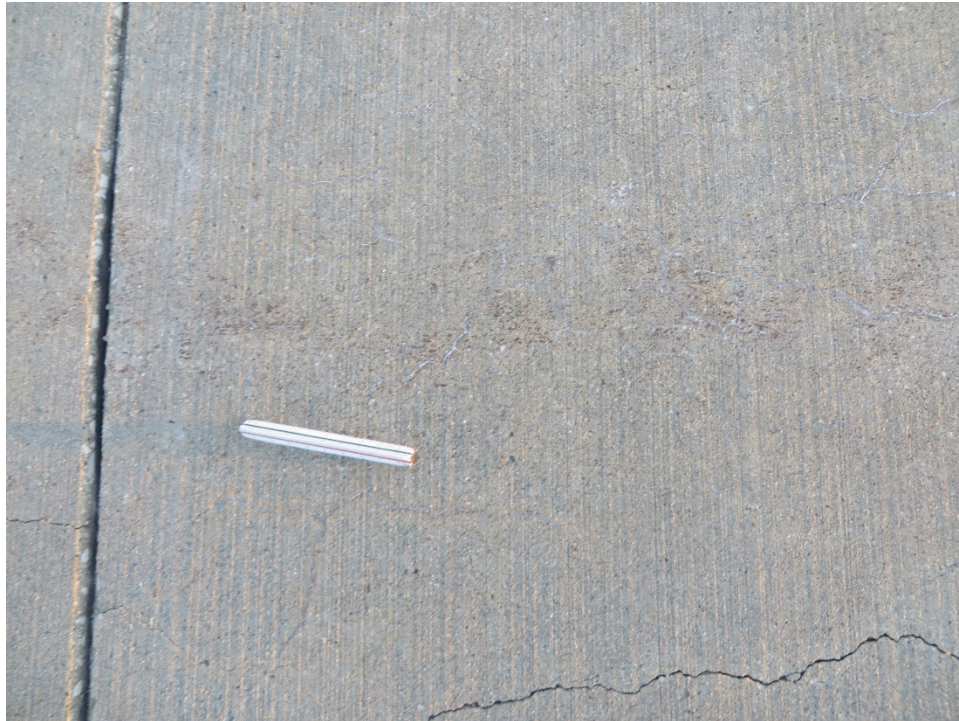
Apron 01 consisted of two sections. Section 01 had high-severity joint seal damage noted throughout, along with areas of low-severity corner break and LTD cracking and medium-severity joint spalling. In Section 02, areas of low-severity corner break and shattered slab; low- and medium-severity joint spalling and LTD cracking; medium-severity corner spalling; and high-severity joint seal damage were recorded during the inspection. Additionally, low-severity alkali-silica reaction (ASR) was recorded in accordance with ASTM D5340-20 where evidence of a precipitate was observed within some of the cracking in the PCC surface. It should be noted that laboratory testing in the form of petrographic analysis is the only definitive way to validate the presence of ASR; however, the formation of a precipitate is evidence of a reaction consistent with this type of materials-related distress.

A01RC-02. ASR (Sample Unit No. 04).

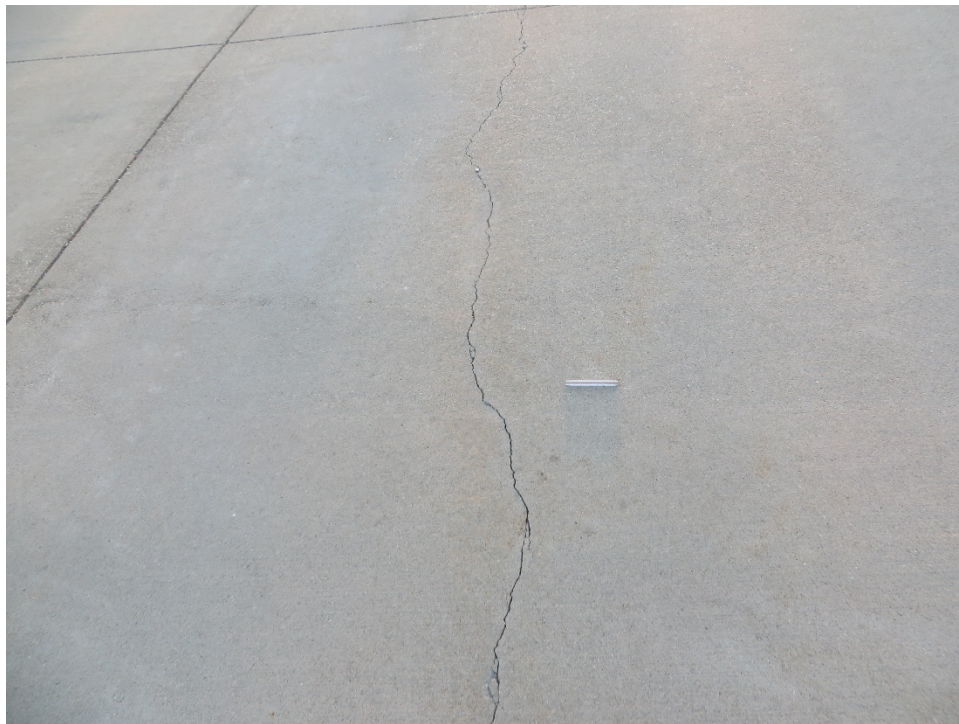
A01RC-02. LTD Cracking (Sample Unit No. 03).

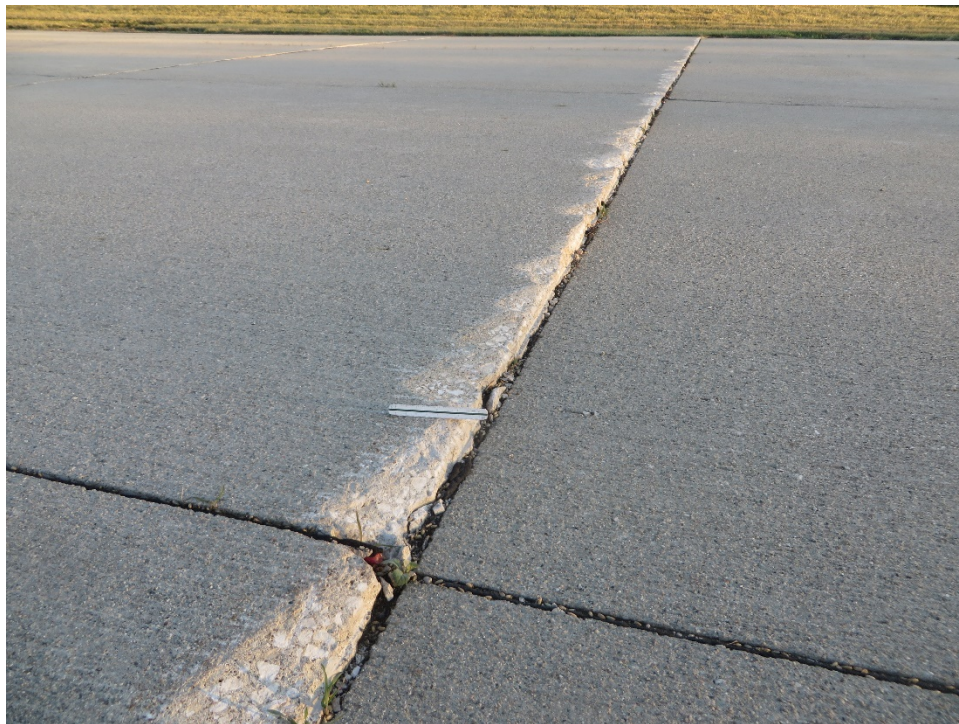
Apron 02 was defined by one section. Low-severity corner break, joint spalling, large patching, and LTD cracking; medium- and high-severity faulting; and high-severity joint seal damage were observed in Section 01 during the inspection.

A02RC-01. Faulting (Sample Unit No. 11).

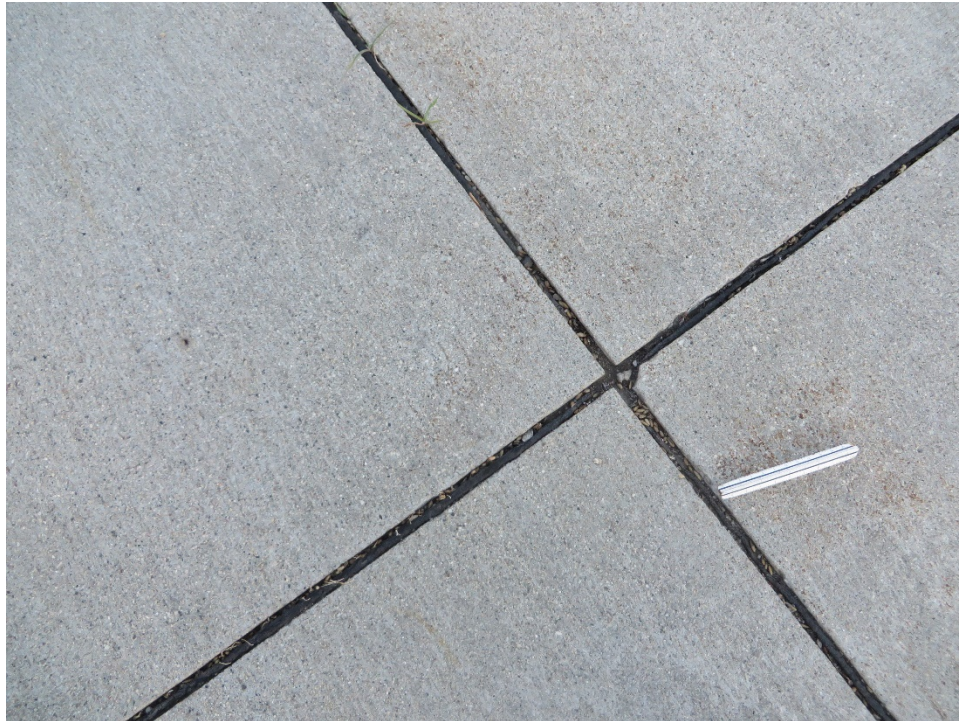
A02RC-01. Joint Seal Damage (Sample Unit No. 14).

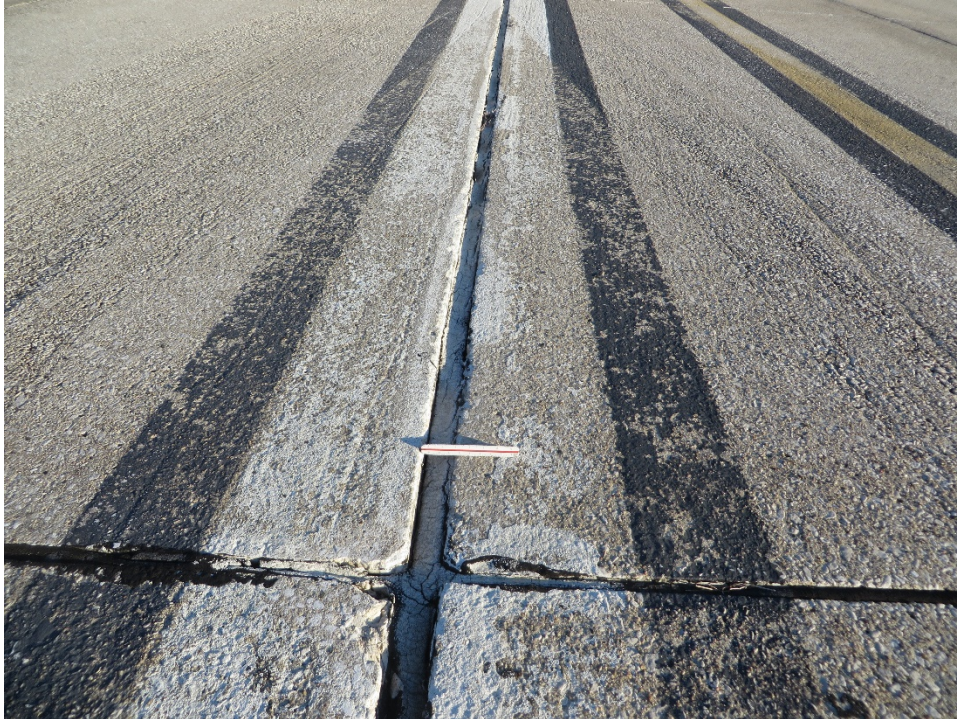
Runway 12/30 was defined by one section. Section 01 had low-severity corner spalling, joint seal damage, and small patching and low- and medium-severity corner break, faulting, joint spalling, shattered slab, and longitudinal, transverse, and diagonal (LTD) cracking recorded during the inspection.

R12RC-01. Faulting (Sample Unit No. 05).

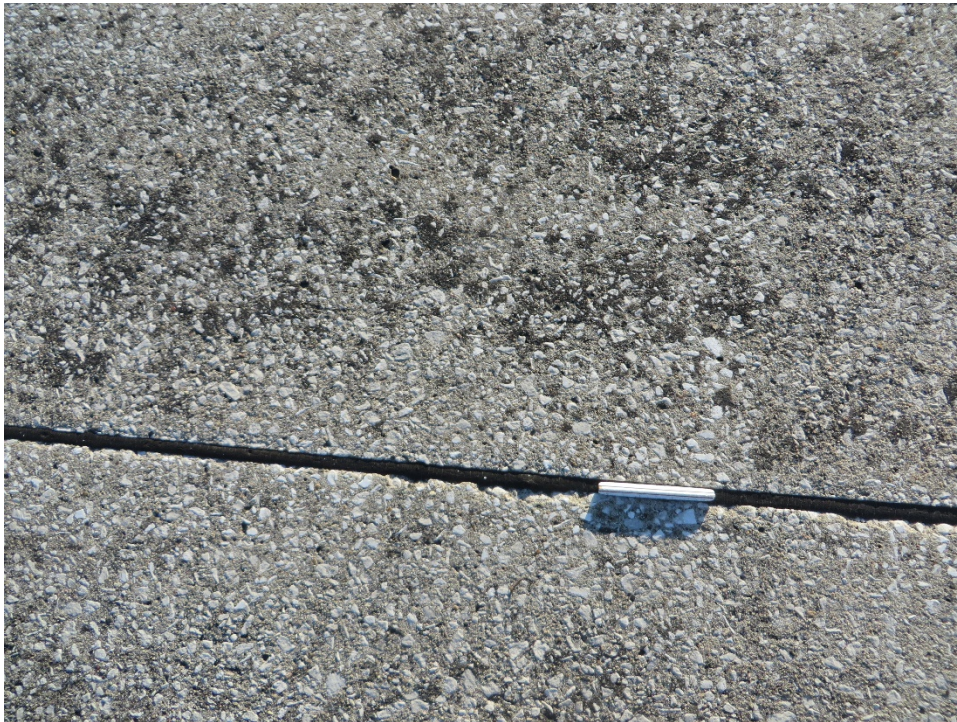
R12RC-01. Joint Seal Damage (Sample Unit No. 51).

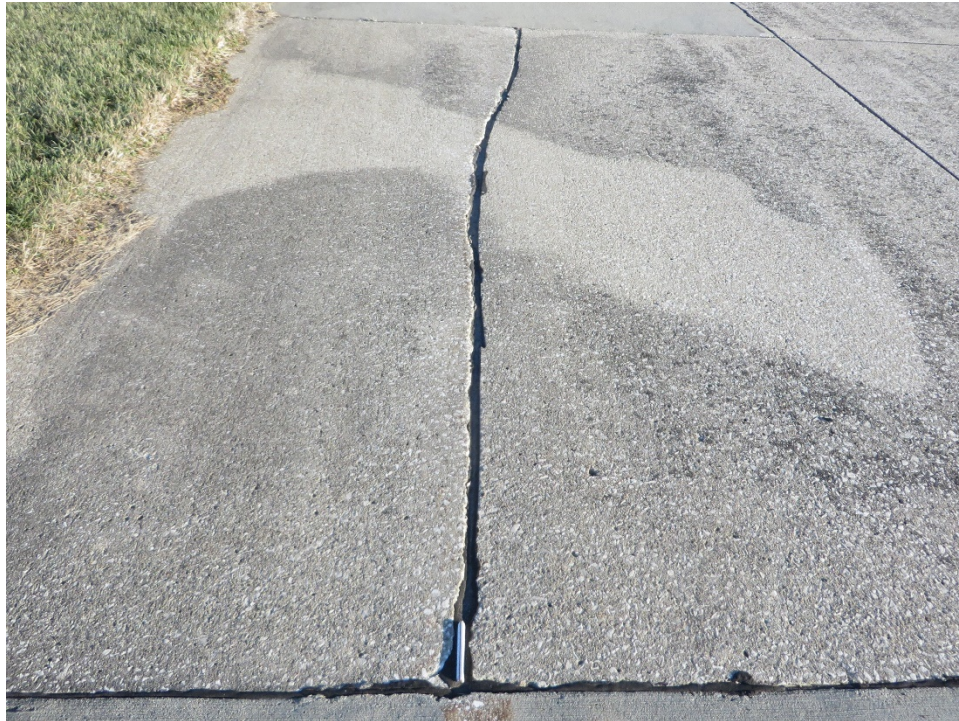
R12RC-01. LTD Cracking (Sample Unit No. 51).

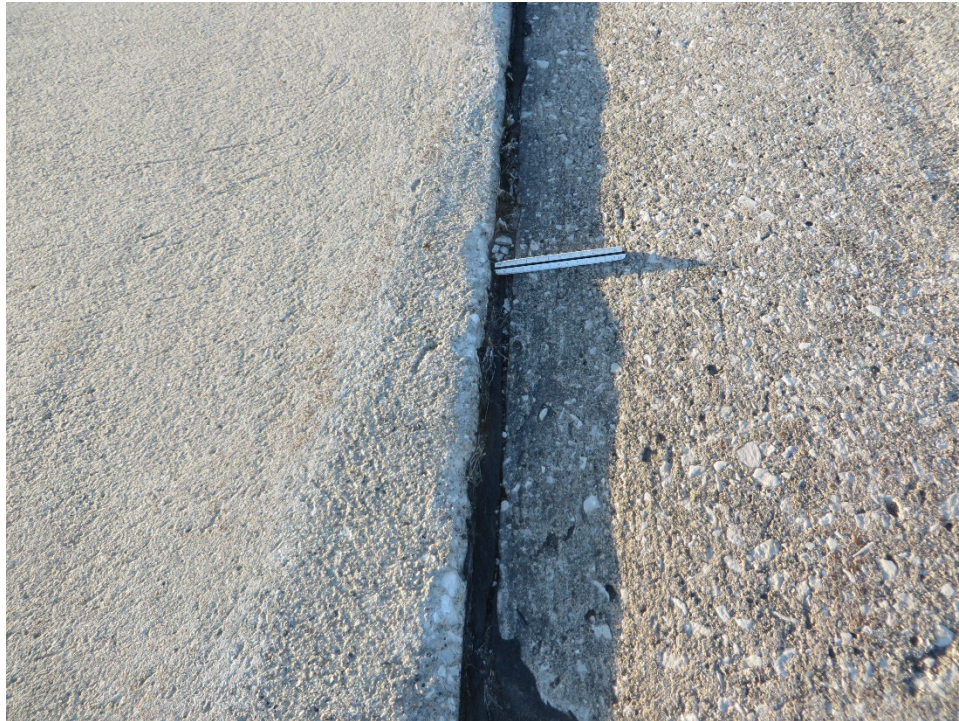
Taxiway 01 consisted of two sections. Low-severity corner break and large patching; low- and medium-severity corner spalling, faulting, joint seal damage, joint spalling, LTD cracking, and shattered slab; and shrinkage cracking were identified in Section 01. Section 02 had areas of low-severity LTD cracking and joint seal damage; low- and medium-severity corner break; and medium-severity joint spalling recorded at the time of the inspection.

T01RC-01. Faulting (Sample Unit No. 02).

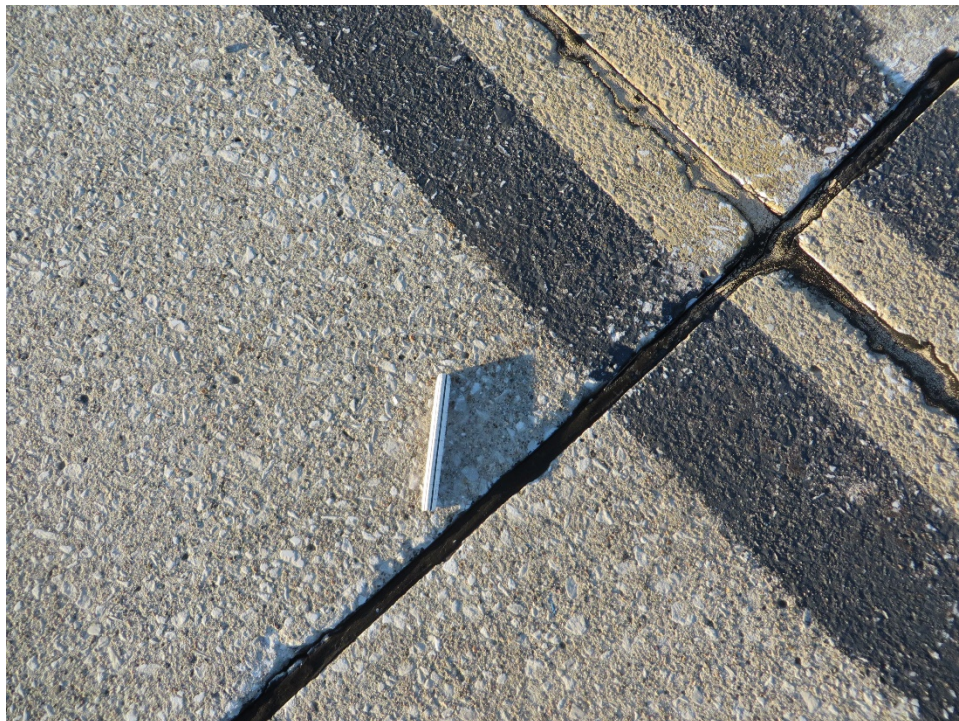
T01RC-01. Joint Seal Damage (Sample Unit No. 03).

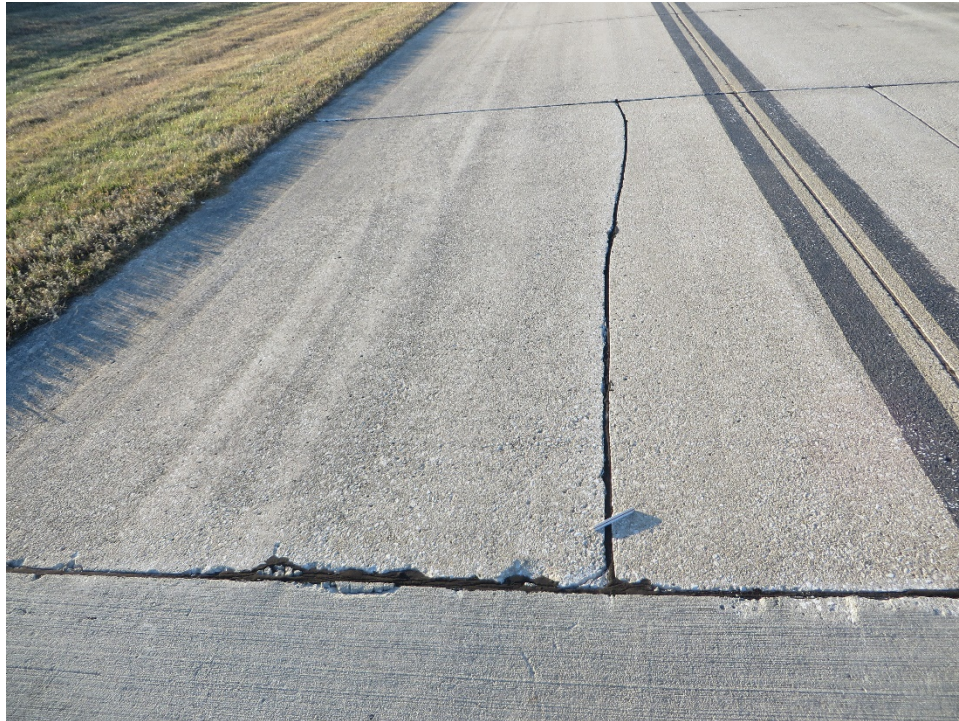
T01RC-01. LTD Cracking (Sample Unit No. 03).

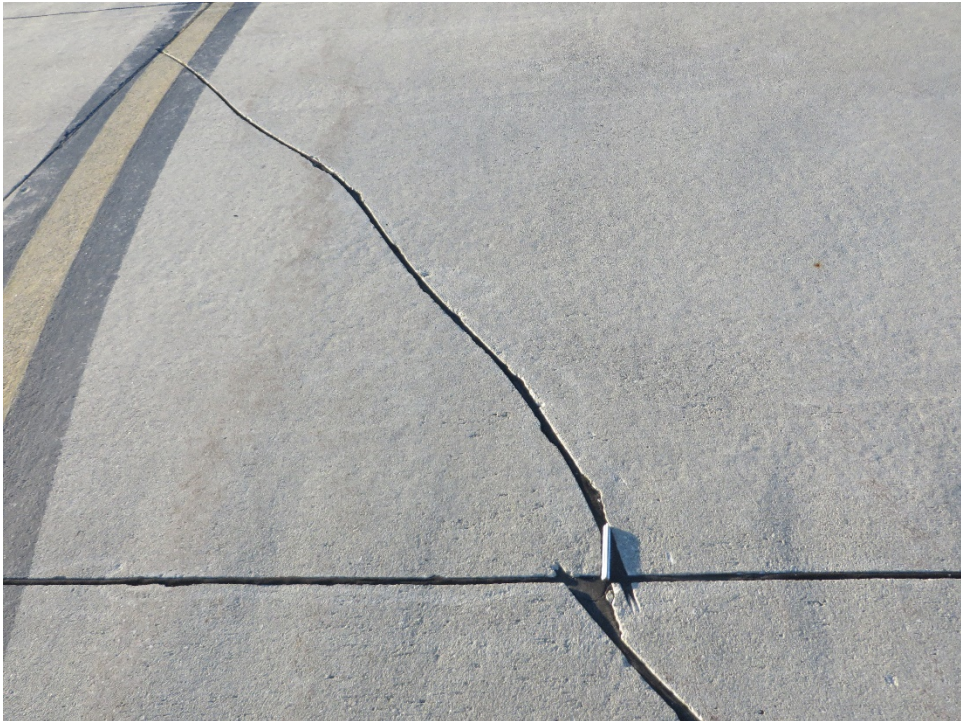
T01RC-02. LTD Cracking (Sample Unit No. 03).

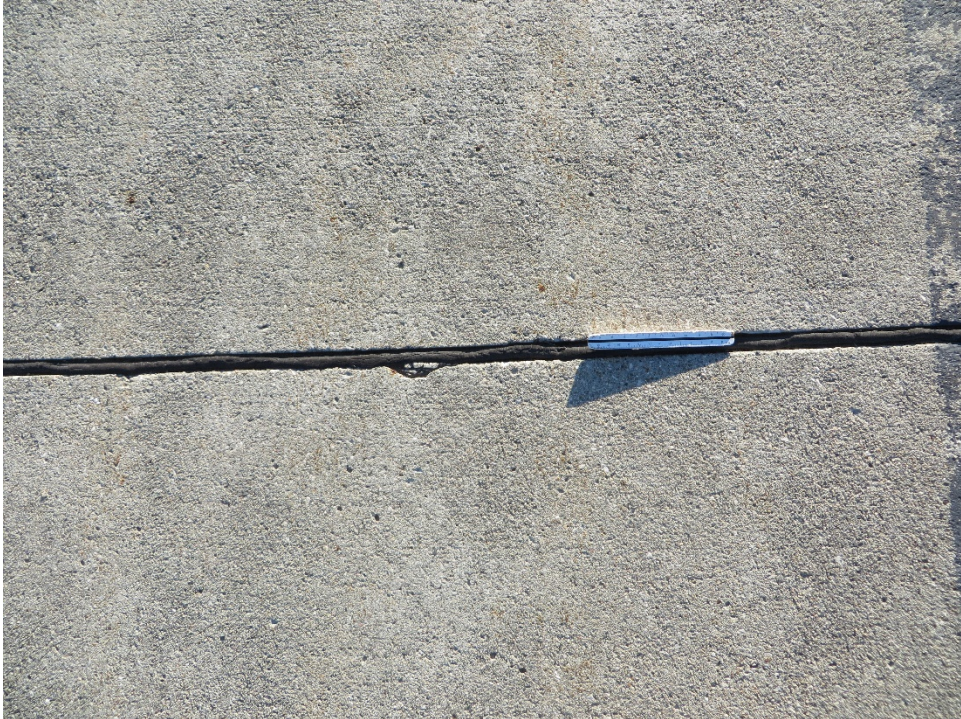
Taxiway 02 contained one section. Low-severity faulting and joint seal damage were observed in Section 01.

T02RC-01. Joint Seal Damage (Sample Unit No. 01).
