# Rockwell City Municipal Airport

## Pavement Management Report

**JULY 2024**

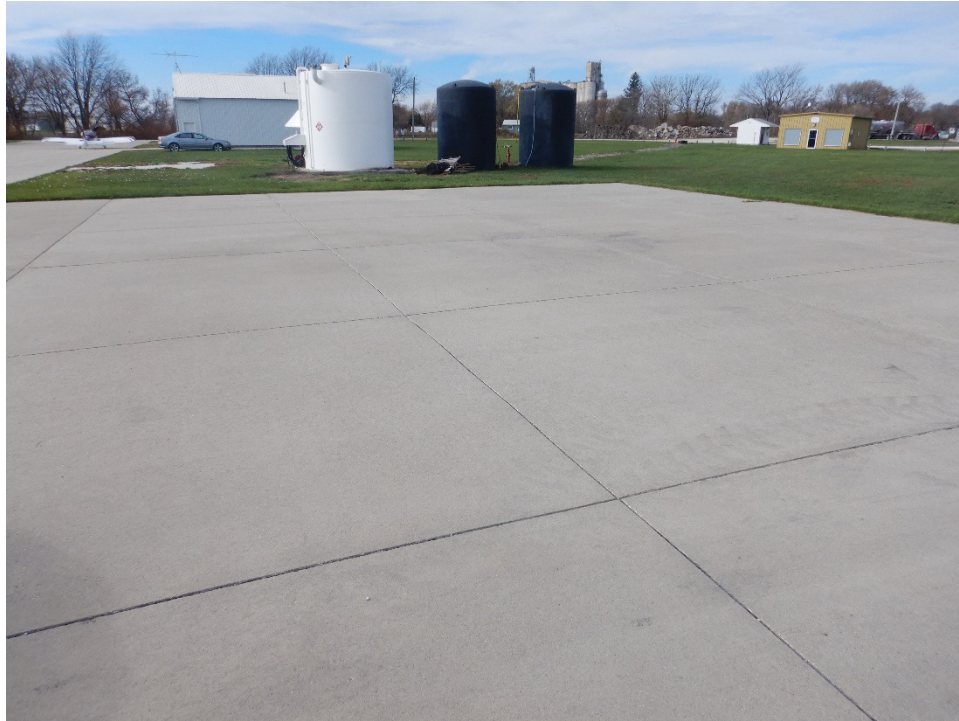
Apron 01 consisted of two sections. Section 01 contained areas of low-severity ASR and corner break, low- and medium-severity LTD cracking, high-severity joint seal damage, and shrinkage cracking. Areas of low-severity ASR and shattered slab; low- and medium-severity LTD cracking; medium-severity corner break, corner spalling, and joint spalling; high-severity joint seal damage; and shrinkage cracking were identified in Section 02.

A01RC-01. Overview.

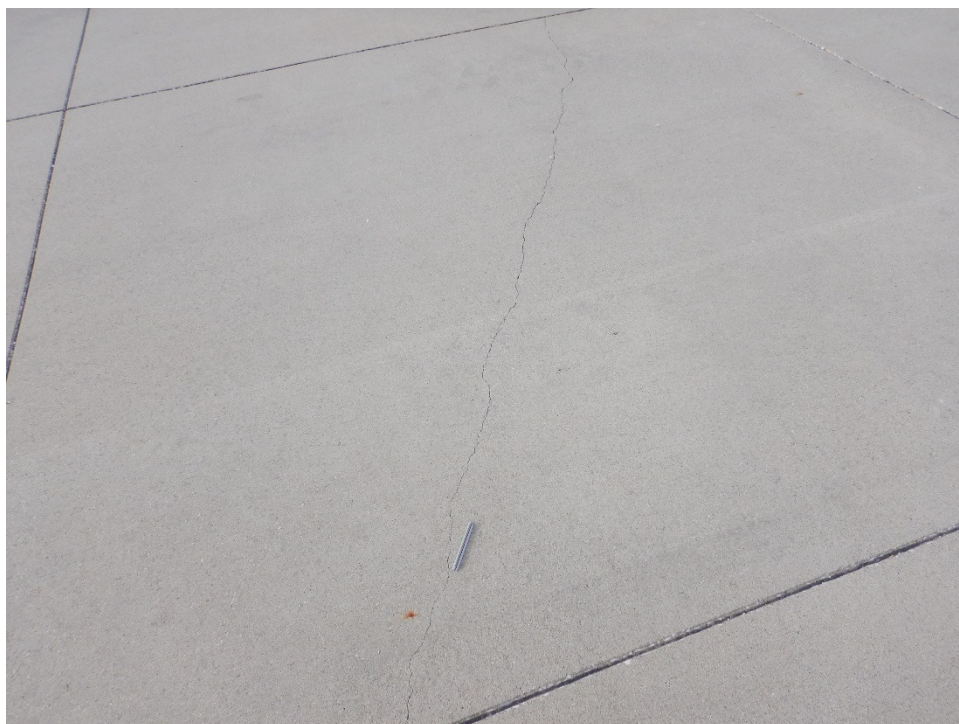
A01RC-01. LTD Cracking (Sample Unit No. 04).

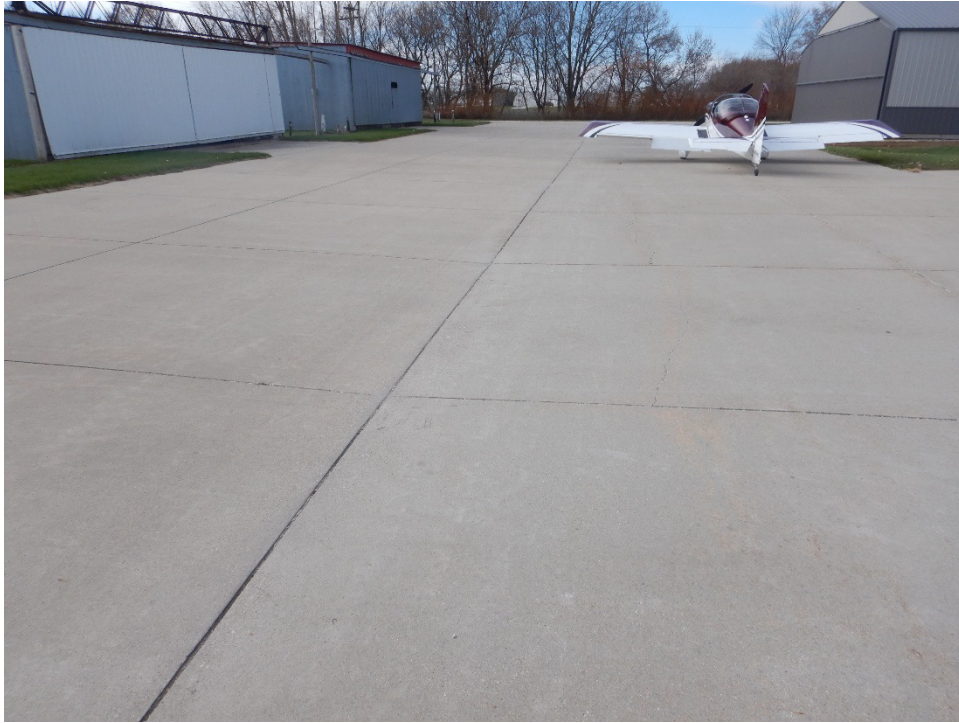
A01RC-02. Overview.

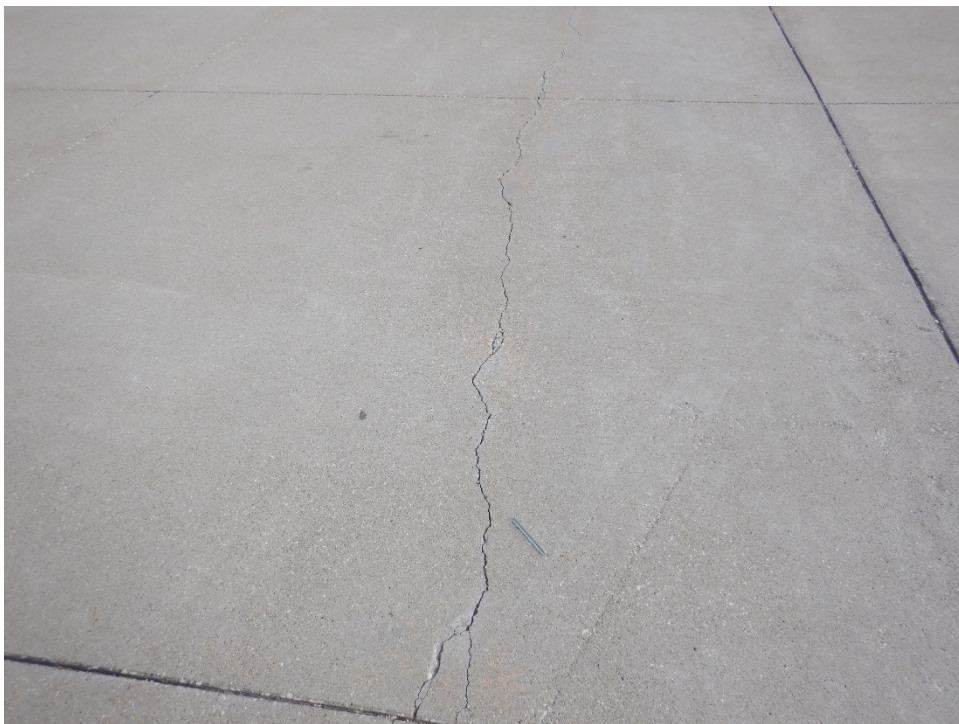
A01RC-02. LTD Cracking (Sample Unit No. 03).

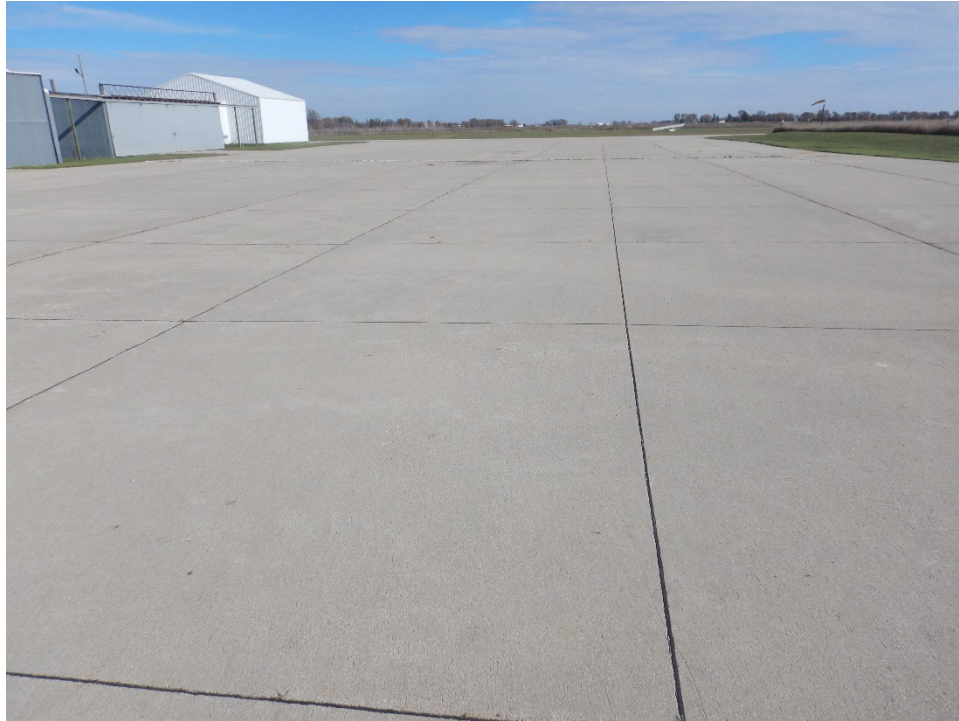
Apron 02 was defined by one section. Areas of low-severity corner break, joint spalling, and large patching; low- and medium-severity LTD cracking; medium- and high-severity faulting; and shrinkage cracking were recorded in Section 01.

A02RC-01. Overview.

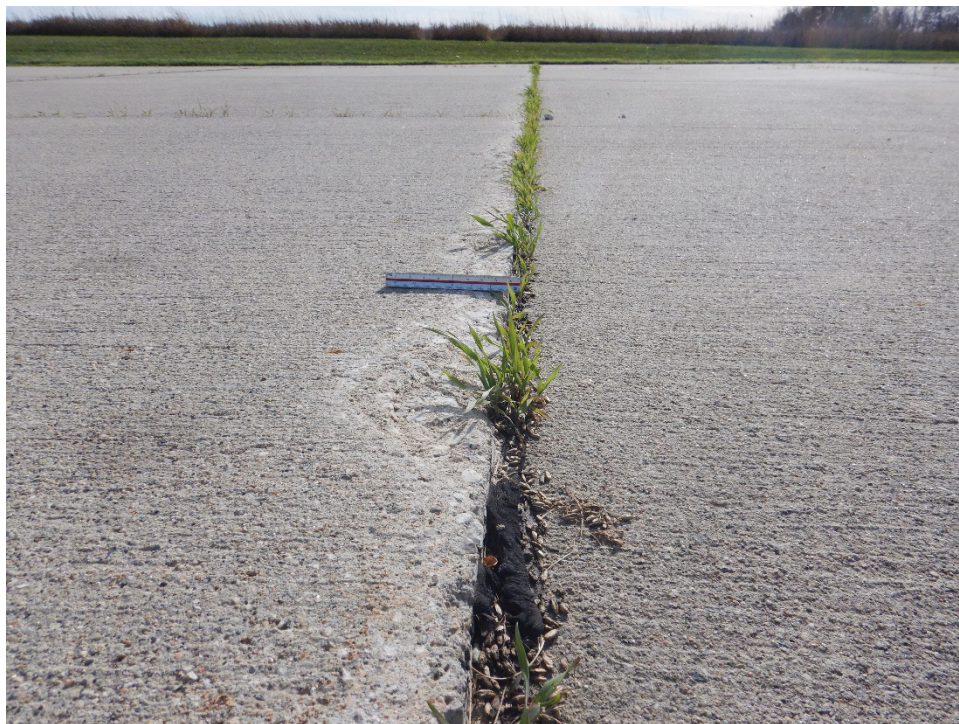
A02RC-01. Faulting (Sample Unit No. 11).

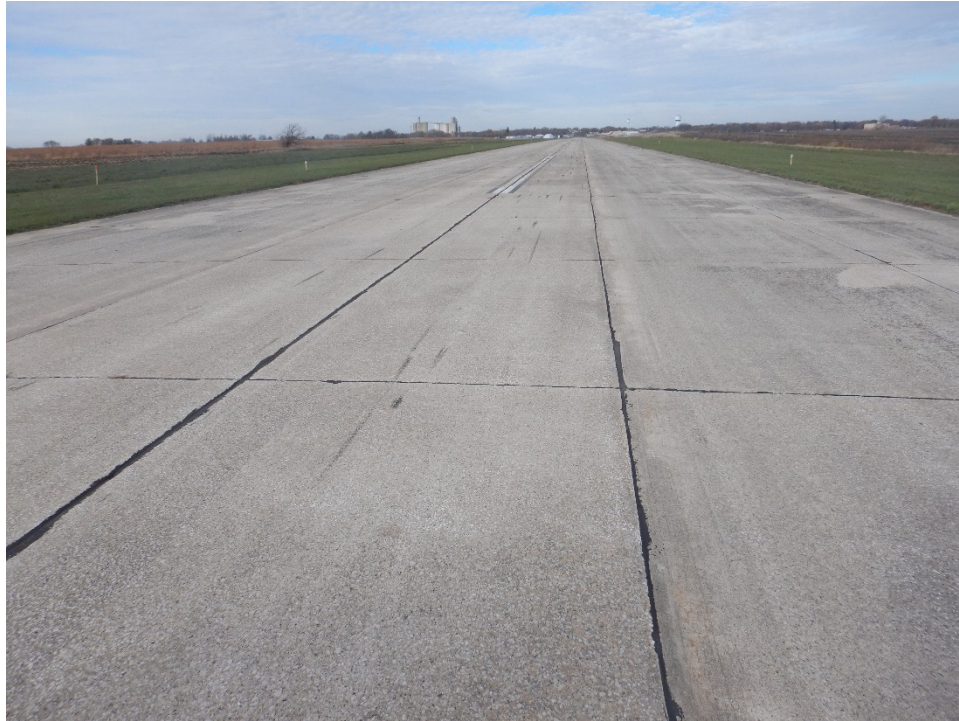
Runway 12/30 was defined by one section. Section 01 contained areas of low-severity scaling and small patching; low- and medium-severity corner spalling, faulting, joint spalling, shattered slab, and longitudinal, transverse, and diagonal (LTD) cracking; medium-severity corner break and joint seal damage; and shrinkage cracking.

R12RC-01. Overview.

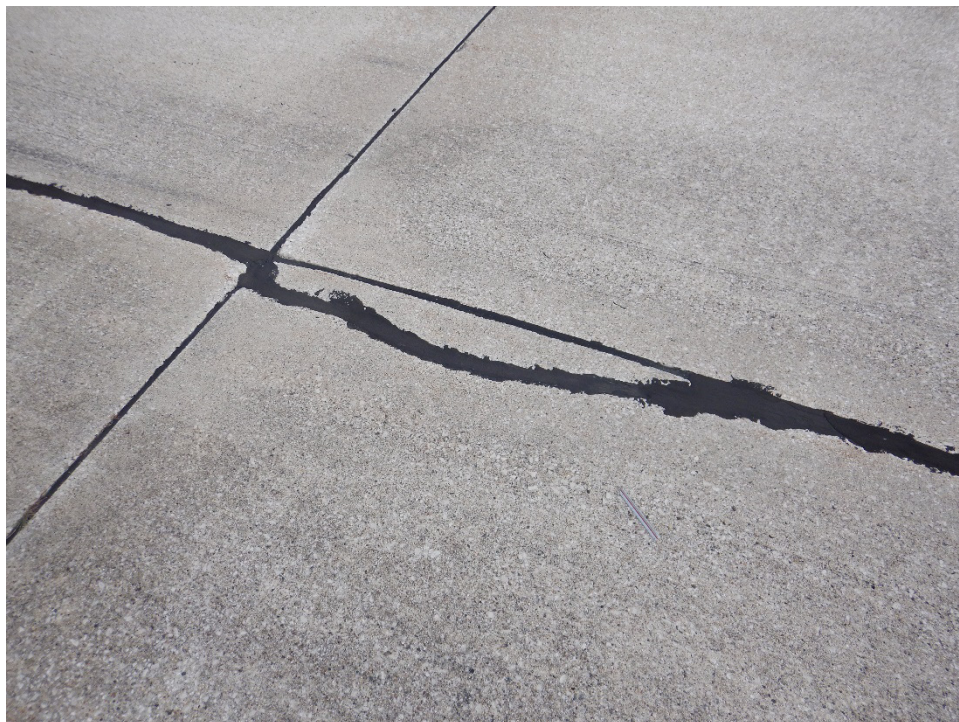
R12RC-01. Joint Spalling (Sample Unit No. 25).

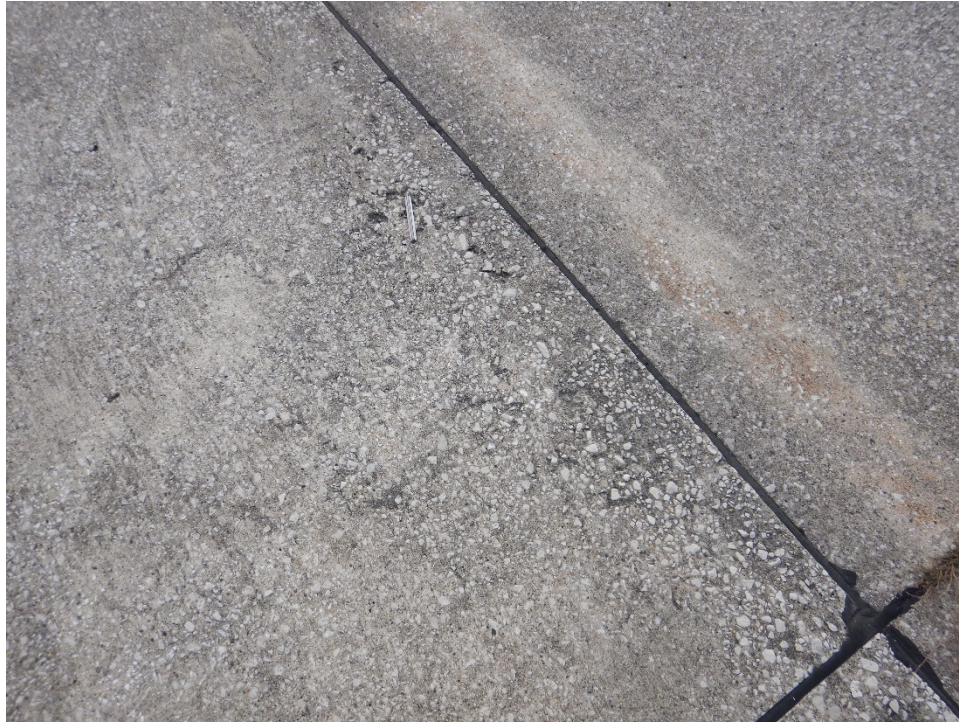
R12RC-01. Scaling (Sample Unit No. 15).

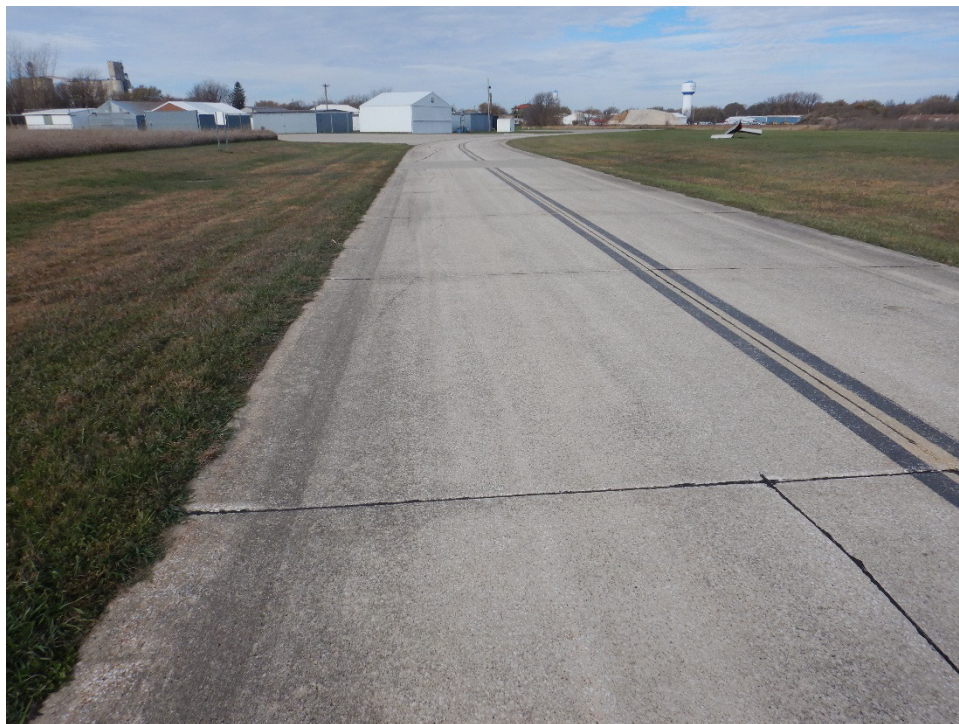
Taxiway 01 consisted of two sections that connected the apron area to Runway 12/30. Section 01 was in poor condition with areas with low-severity large patching, scaling, and small patching; low- and medium-severity faulting, joint spalling, and LTD cracking; medium-severity corner break, corner spalling, and shattered slab; medium- and high-severity joint seal damage; and shrinkage cracking. Low-severity LTD cracking and medium-severity corner break, joint seal damage, and joint spalling were observed in Section 02.

T01RC-01. Overview.

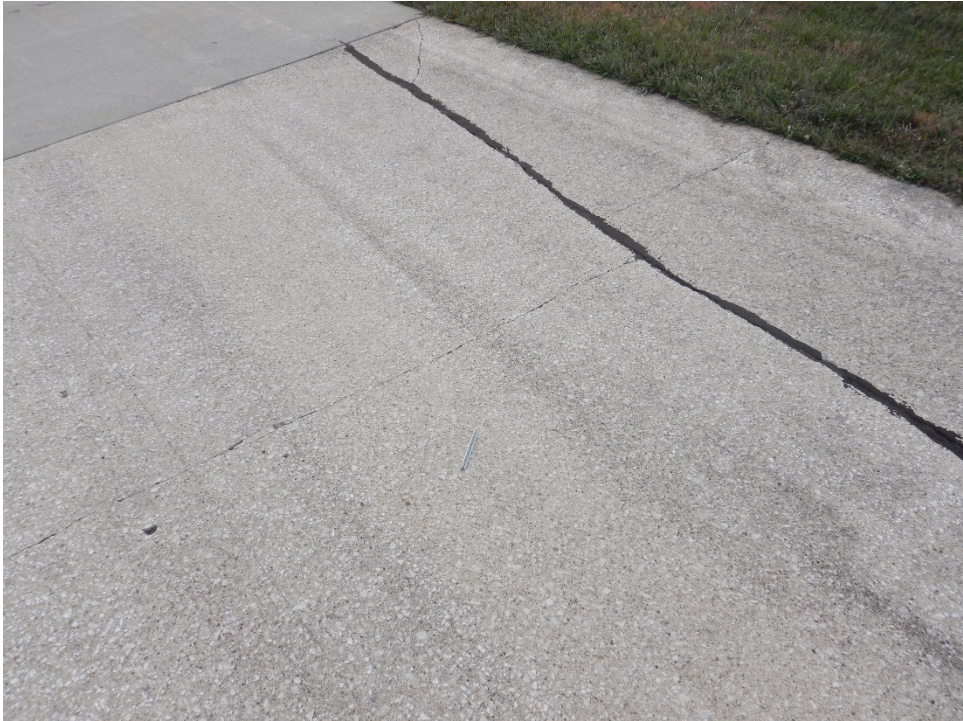
T01RC-01. Shattered Slab (Sample Unit No. 03).

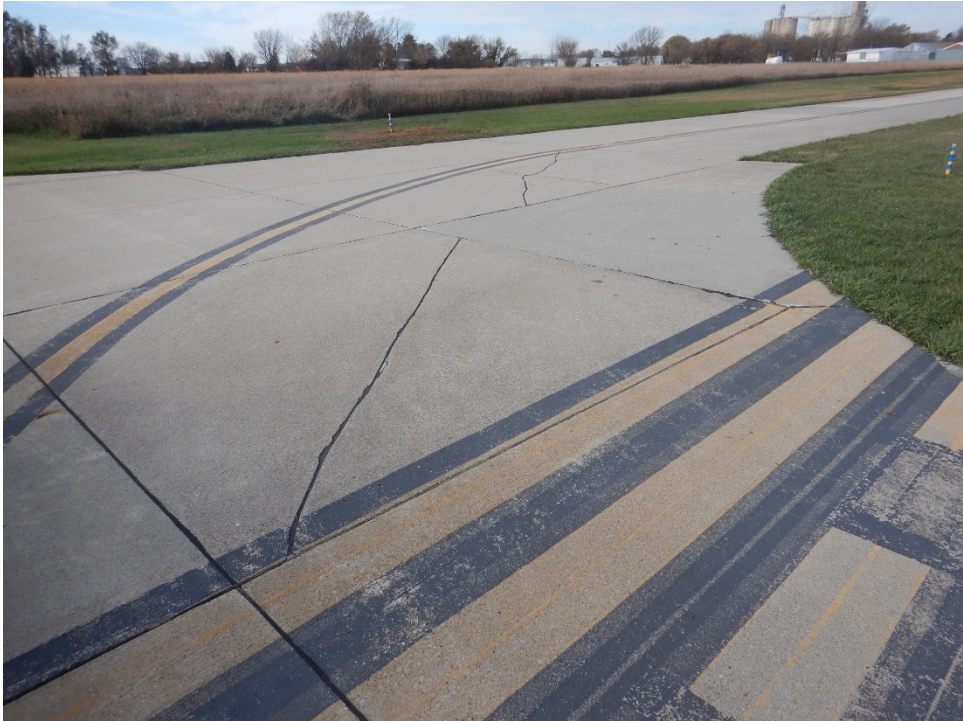
T01RC-02. Overview.

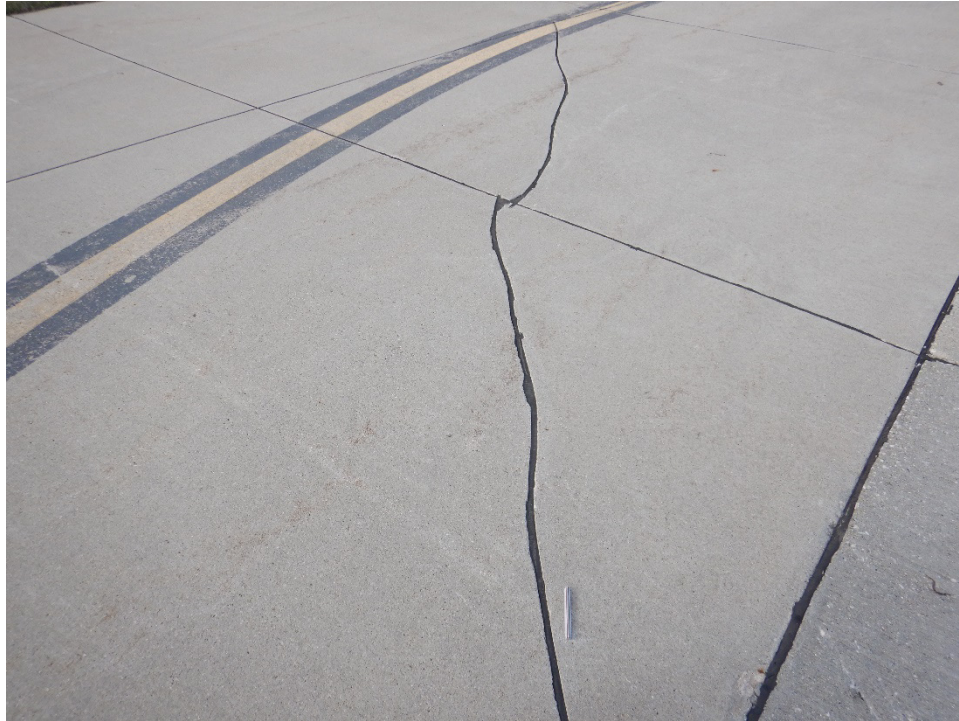
T01RC-02. LTD Cracking (Sample Unit No. 03).

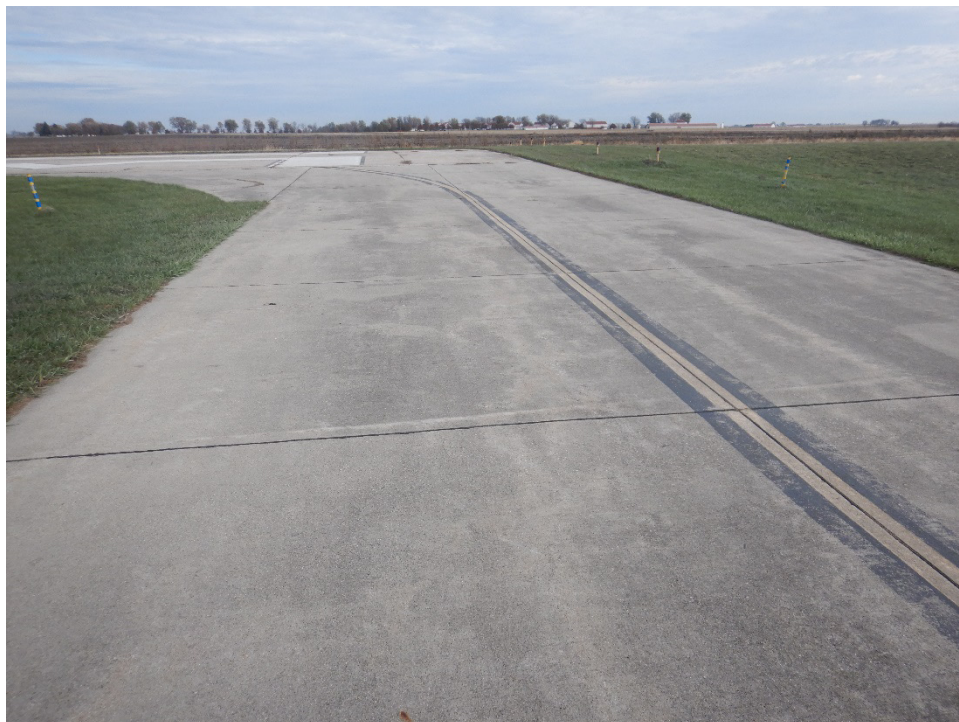
Taxiway 02 was defined by one section, located at the Runway 30 approach. Low-severity faulting, medium-severity LTD cracking, and high-severity joint seal damage were recorded in Section 01.

T02RC-01. Overview.

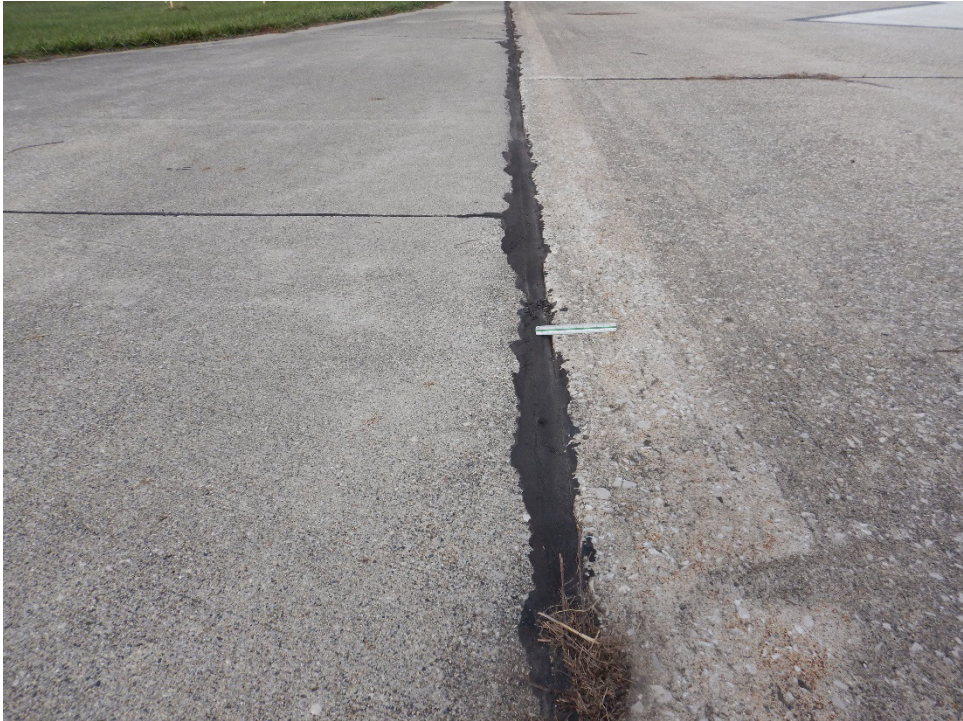
T02RC-01. Faulting (Sample Unit No. 01).
