# Shenandoah Municipal Airport

## PAVEMENT MANAGEMENT REPORT

**JULY 2021**

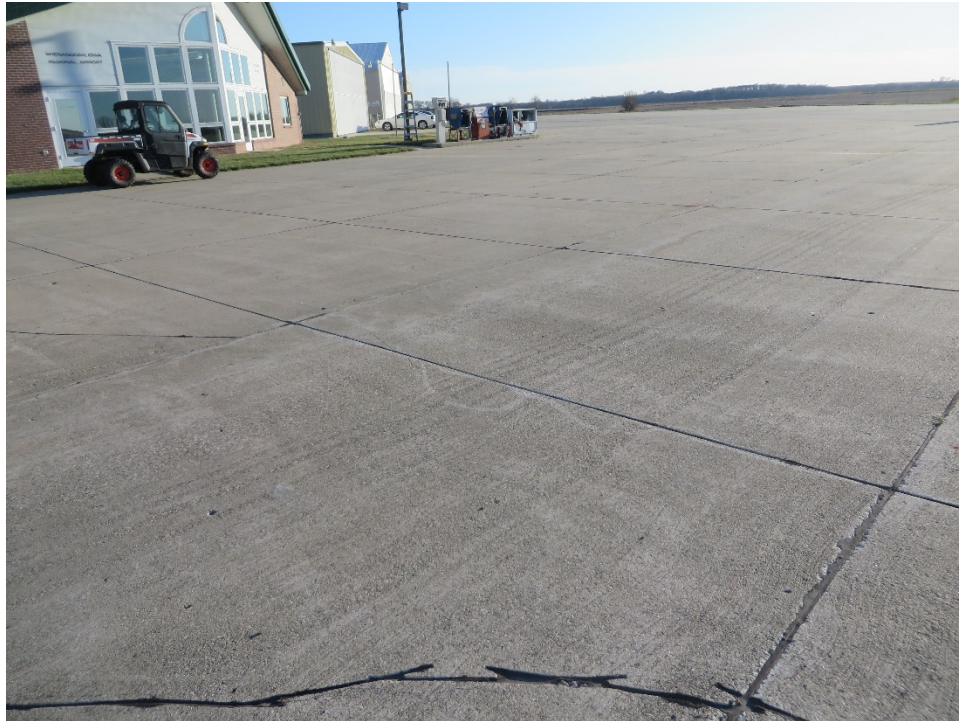
A02SH-01. Overview.

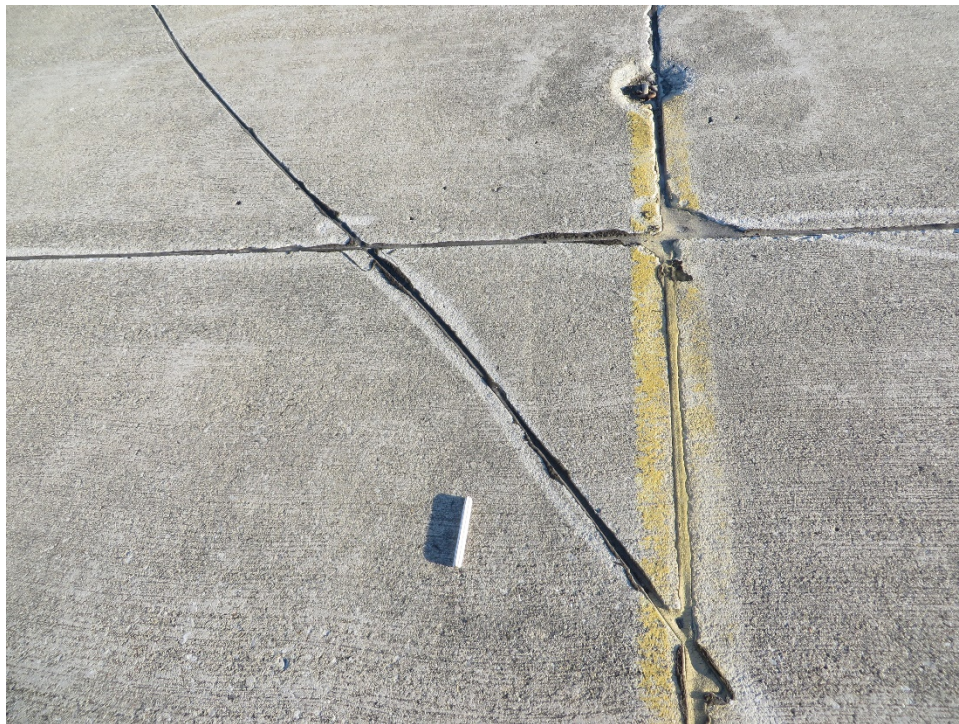
A02SH-01. Corner Break (Sample Unit No. 03).

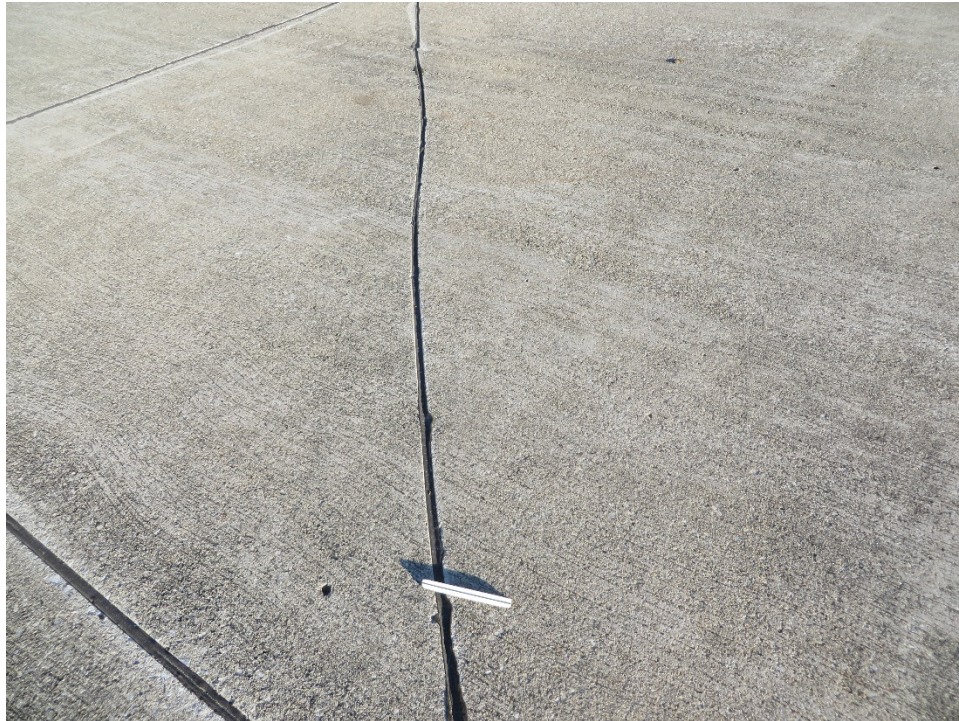
A02SH-01. LTD Cracking (Sample Unit No. 03).

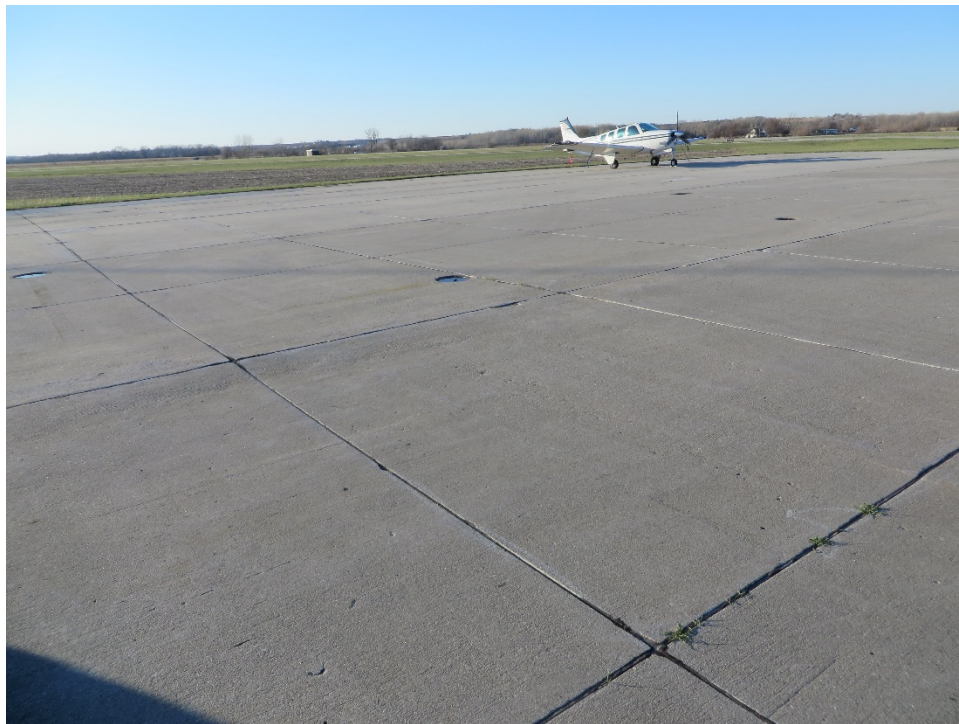
A02SH-02. Overview.

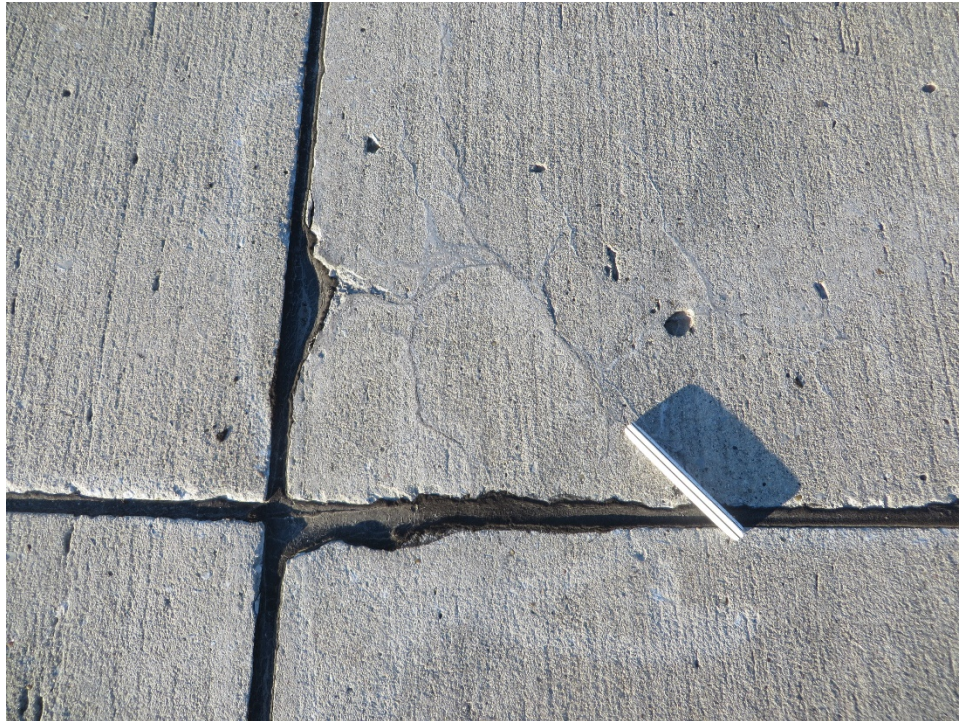
A02SH-02. ASR (Sample Unit No. 04).

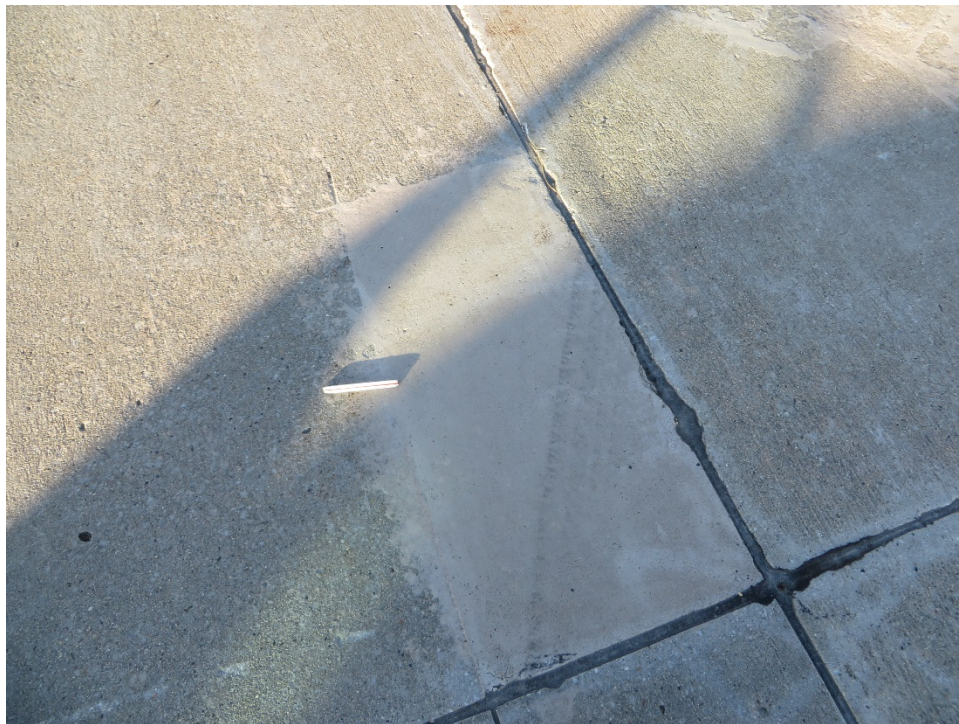
A02SH-02. Small Patching (Sample Unit No. 01).

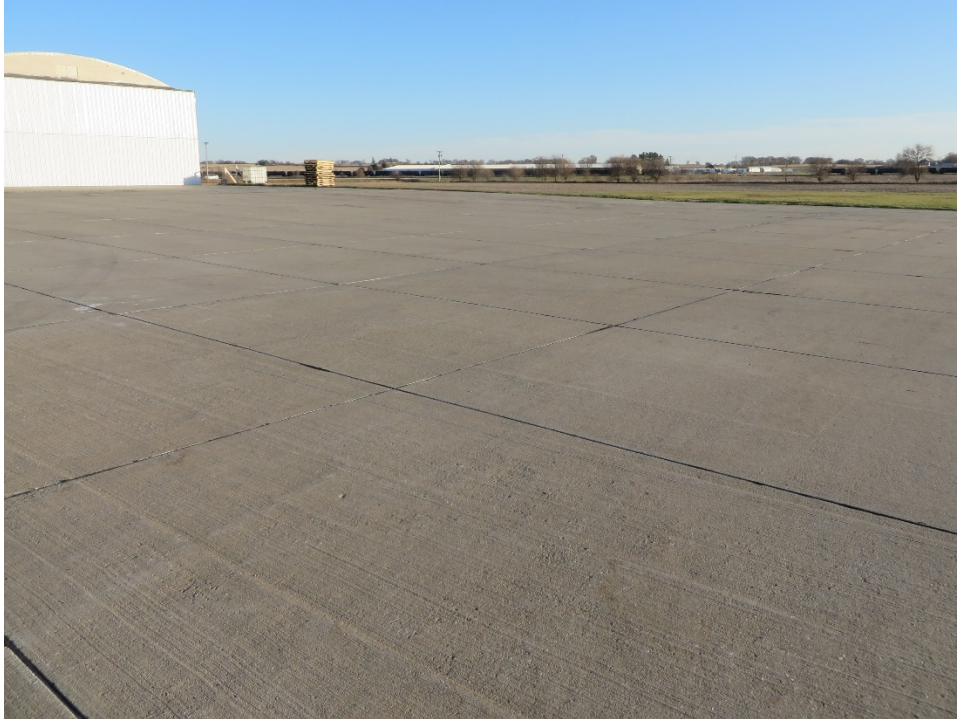
A02SH-03. Overview.

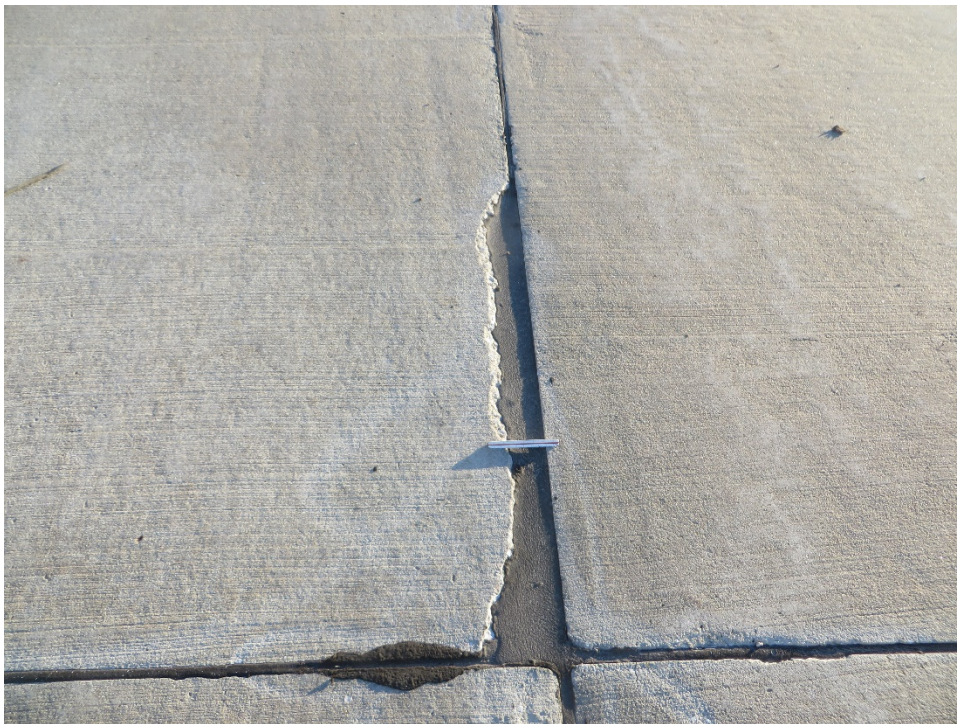
A02SH-03. Joint Spalling (Sample Unit No. 07).

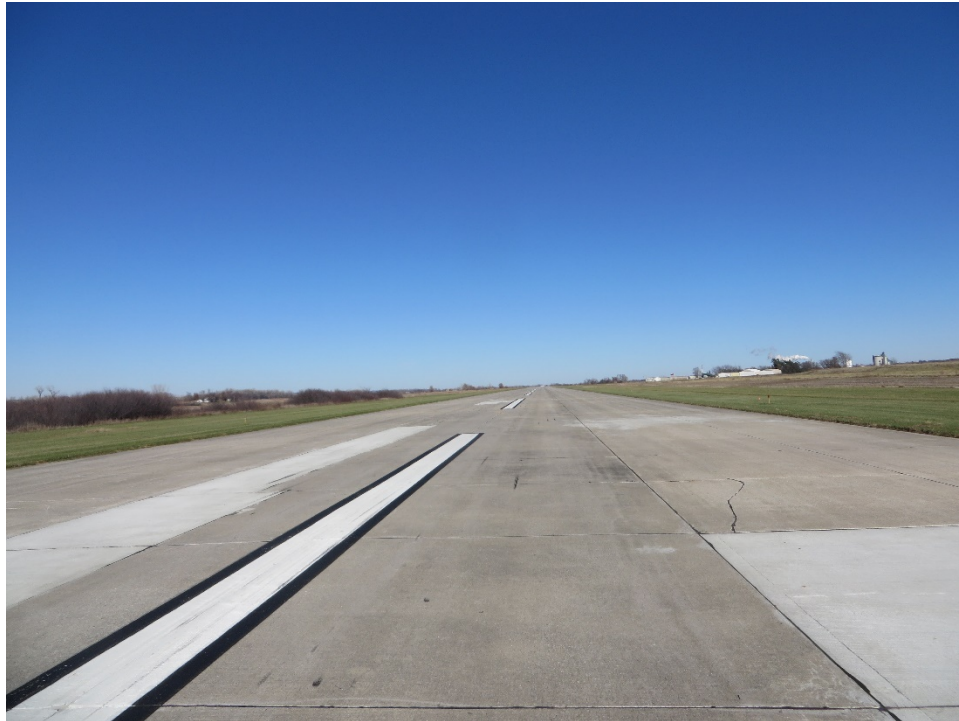
Runway 04/22 consisted of two sections. Low-severity ASR, corner spalling, joint spalling, large patching, and longitudinal, transverse, and diagonal (LTD) cracking; low- and medium-severity faulting; low- and high-severity small patching; and shrinkage cracking were identified in Section 01. In Section 02, areas of low-severity corner spalling, faulting, joint spalling, LTD cracking, and shattered slab; low- and medium-severity ASR; and shrinkage cracking were recorded during the inspection.

R04SH-01. Overview.

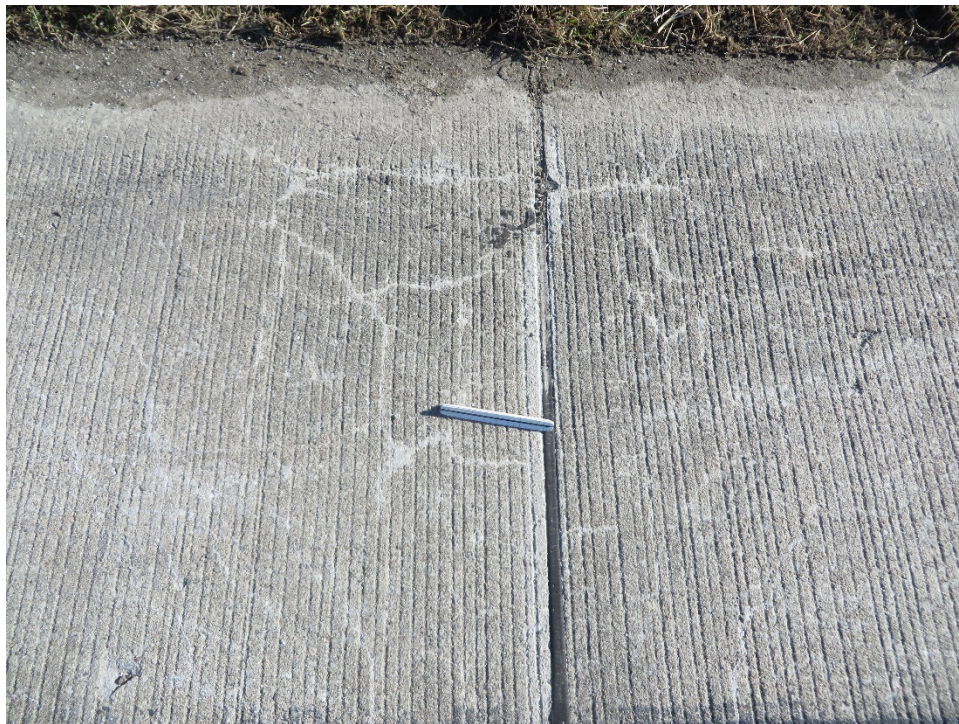
R04SH-01. ASR (Sample Unit No. 07).

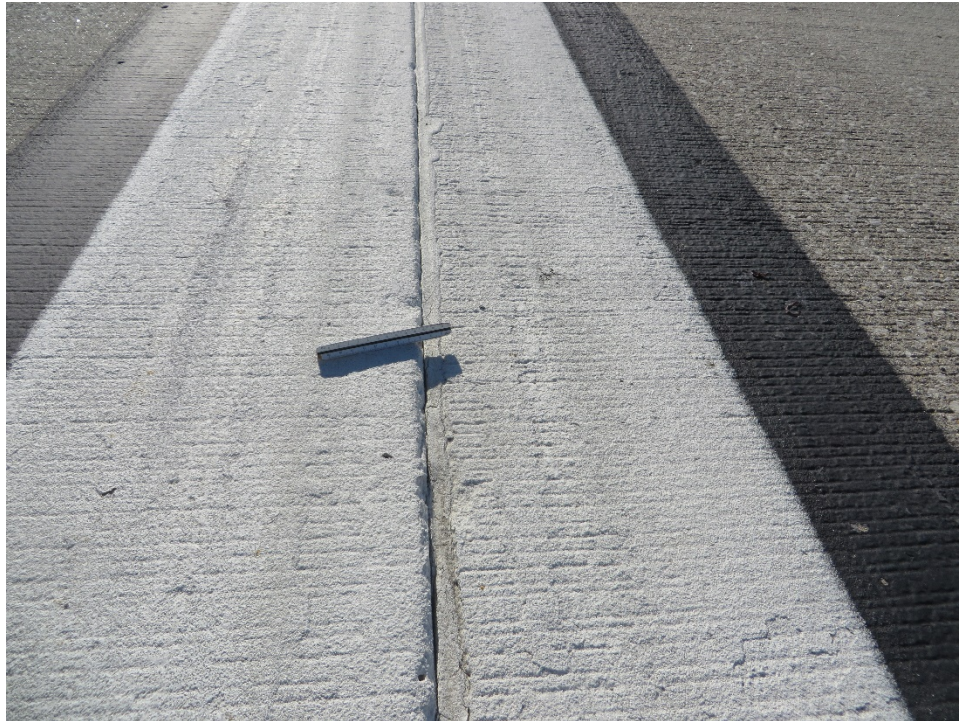
R04SH-01. Faulting (Sample Unit No. 07).

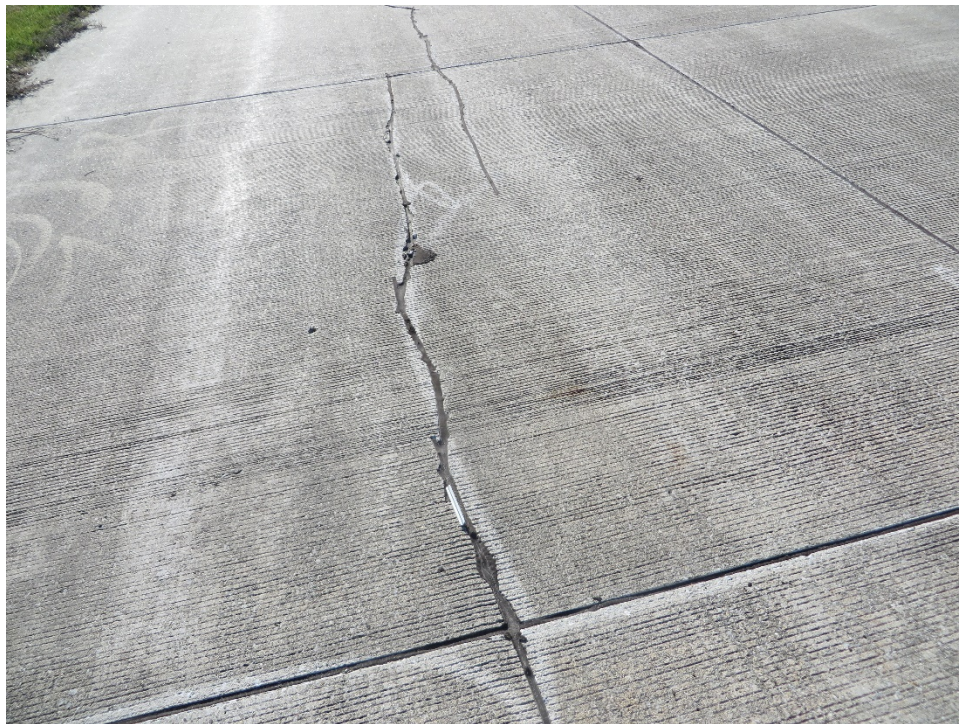
R04SH-01. LTD Cracking (Sample Unit No. 51).

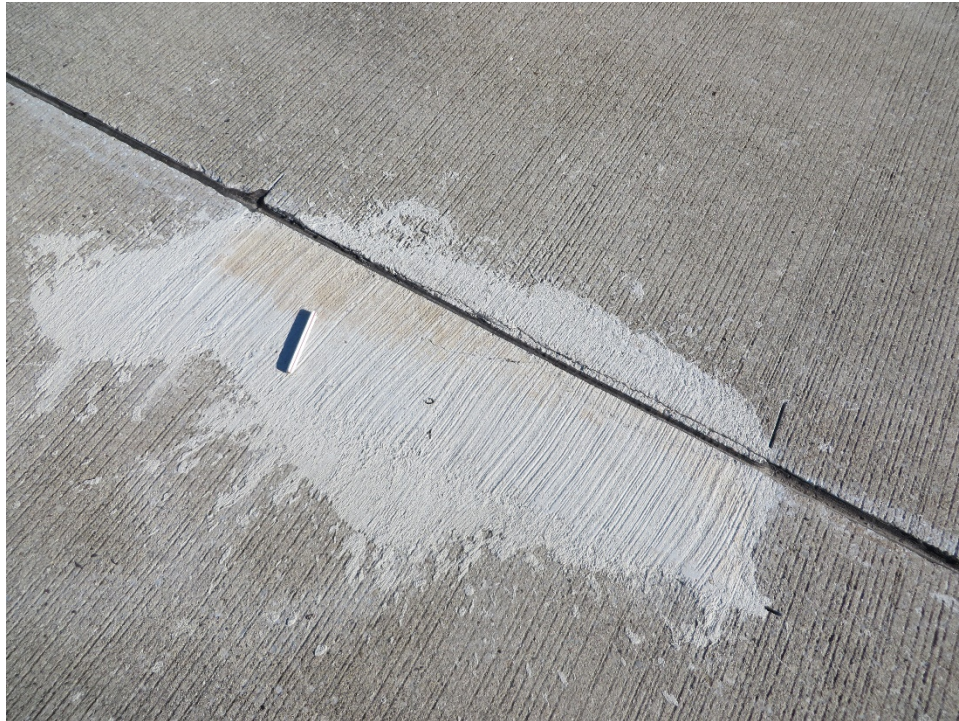
R04SH-01. Small Patching (Sample Unit No. 51).

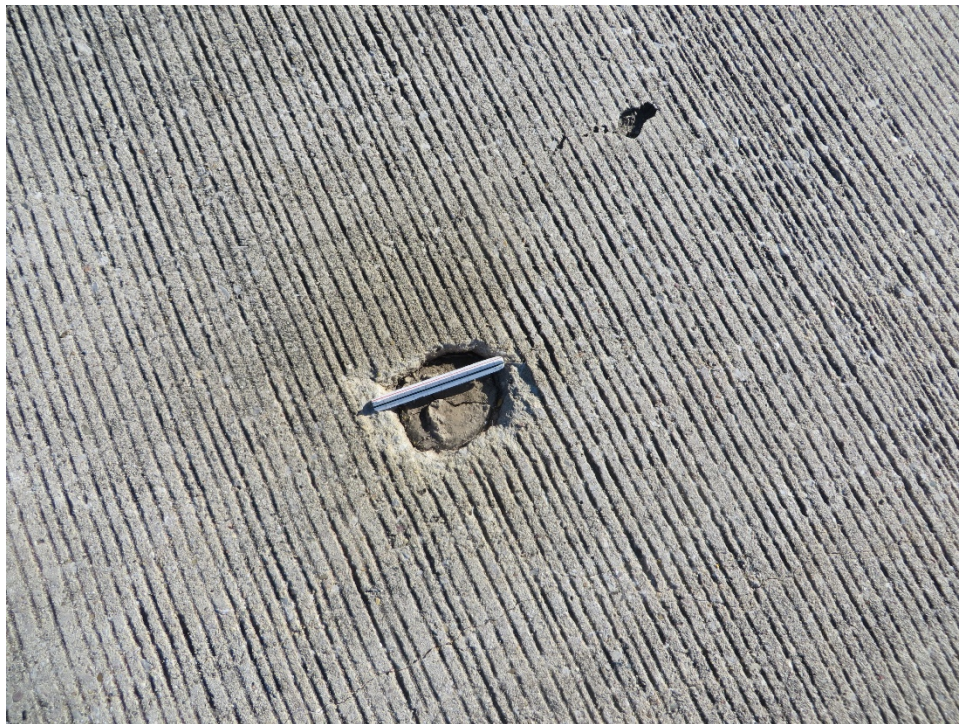
R04SH-01. Small Patching (Sample Unit No. 70).

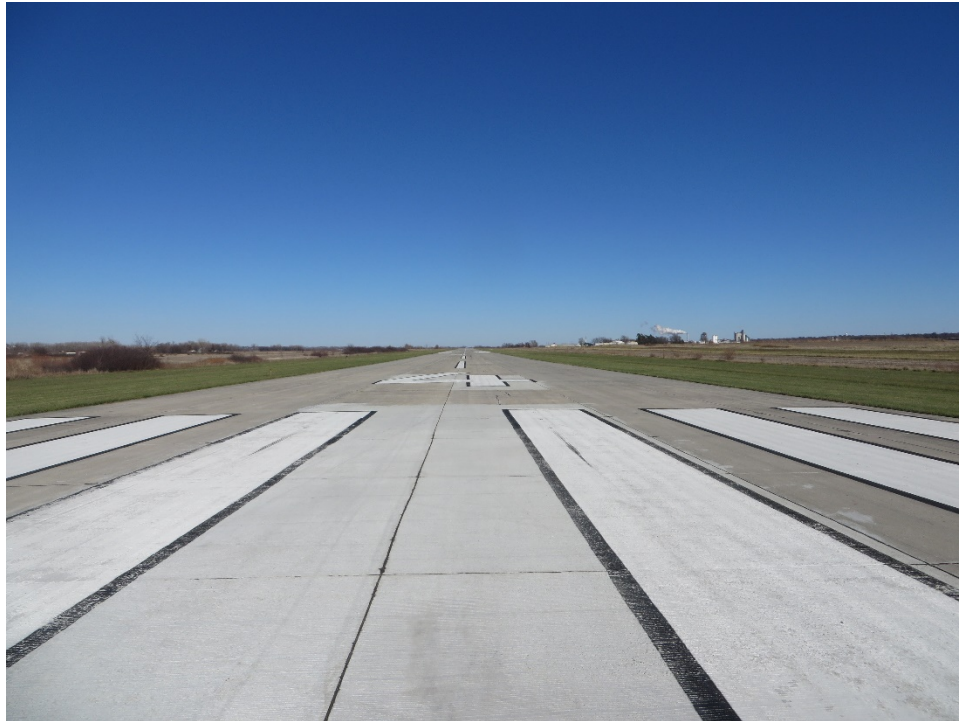
R04SH-02. Overview.

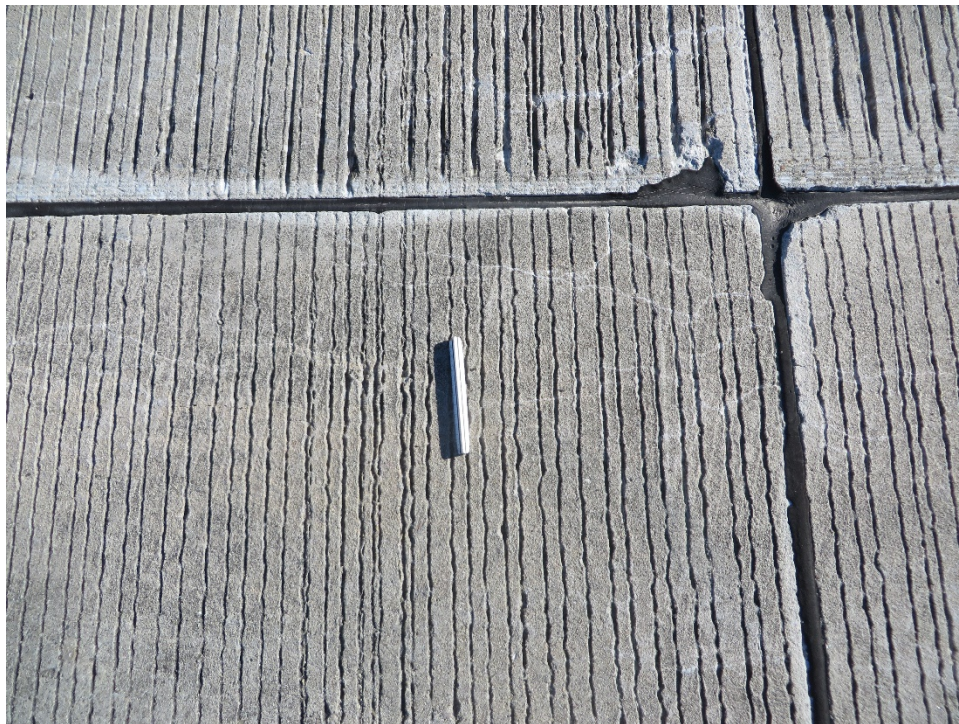
R04SH-02. ASR (Sample Unit No. 08).

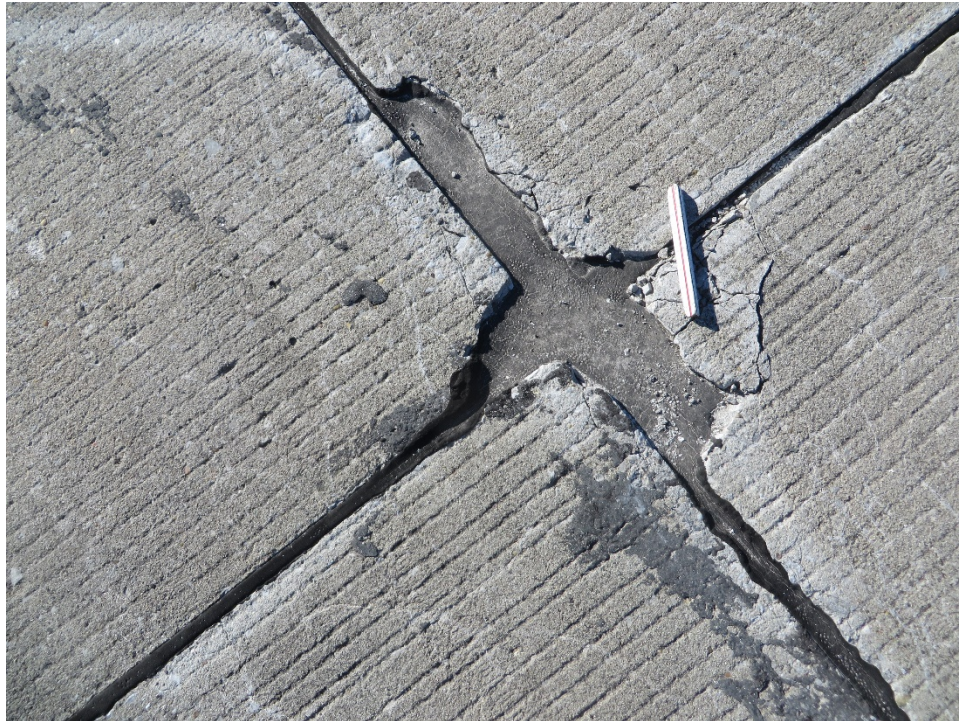
R04SH-02. ASR (Sample Unit No. 17).

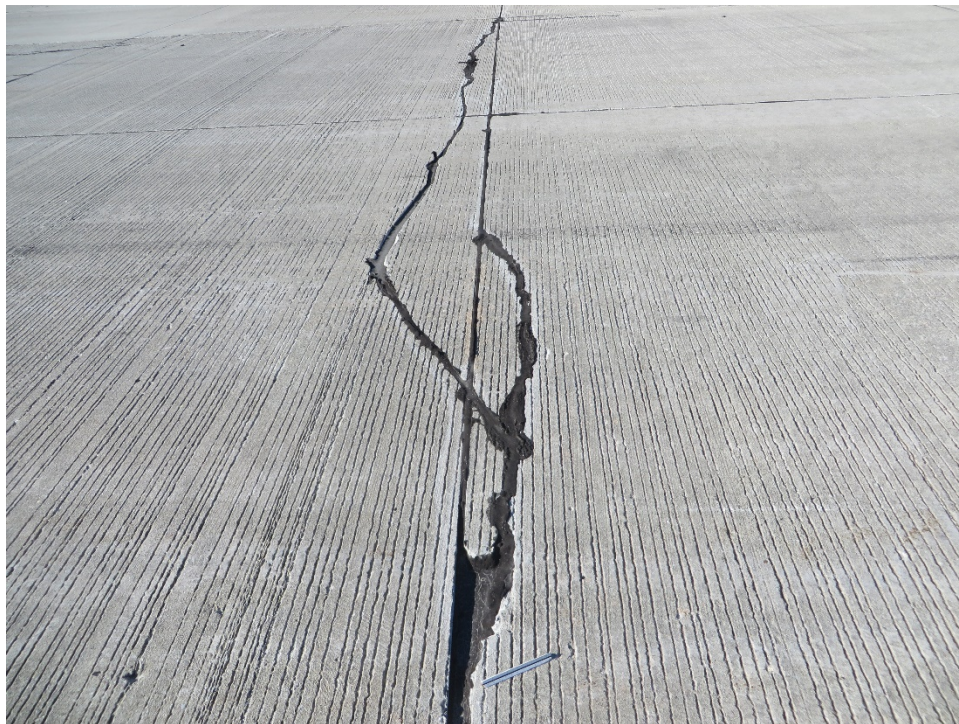
R04SH-02. Joint Spalling (Sample Unit No. 05).

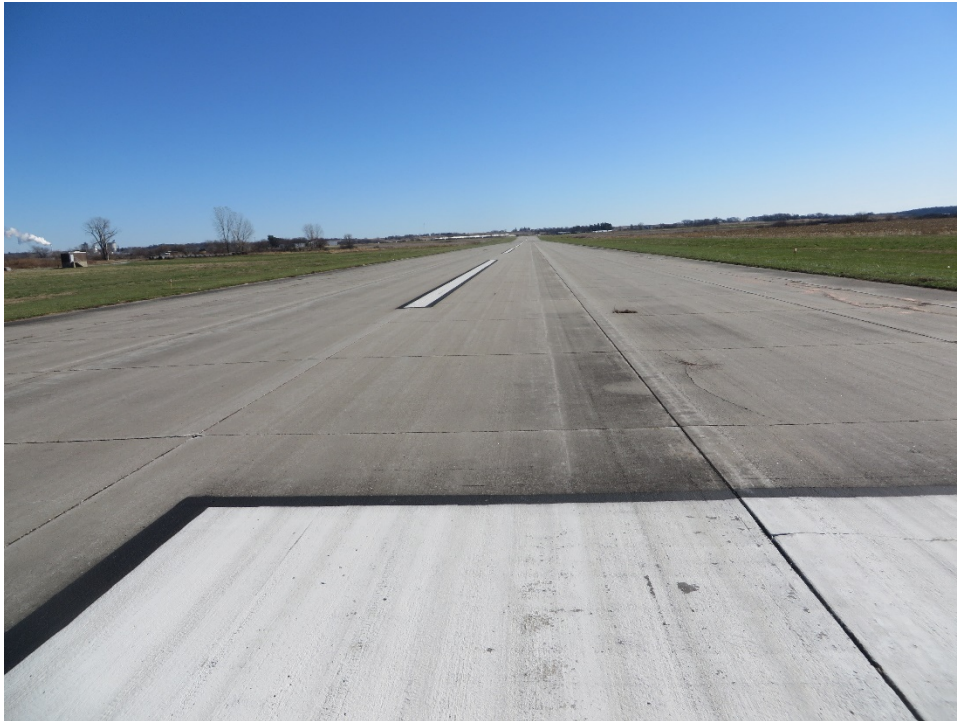
Runway 12/30 contained four sections. In Section 01, low-severity ASR, corner break, corner spalling, faulting, and scaling; low- and medium-severity LTD cracking; high-severity joint seal damage; and shrinkage cracking were recorded. Section 02 had low-severity ASR, corner spalling, and scaling identified along with low- and medium-severity joint spalling and LTD cracking. Medium-severity joint spalling and low-severity corner break, corner spalling, faulting, LTD cracking, and scaling were recorded in Section 03. Low-severity corner break, corner spalling, and LTD cracking and low- and medium-severity joint spalling were observed in Section 04.

R12SH-01. Overview.

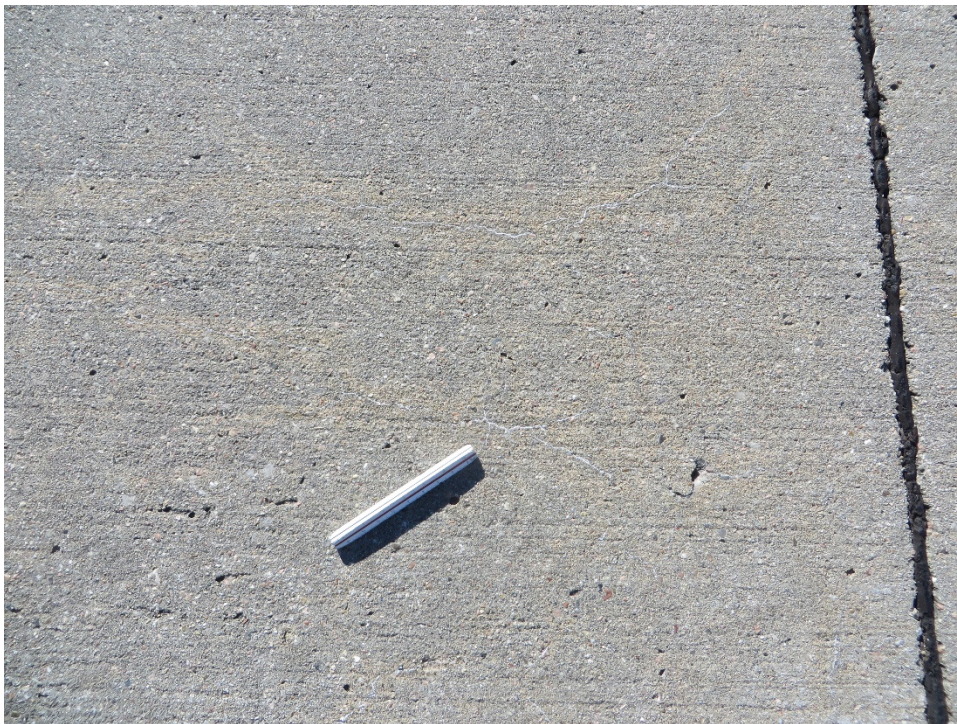
R12SH-01. ASR (Sample Unit No. 15).

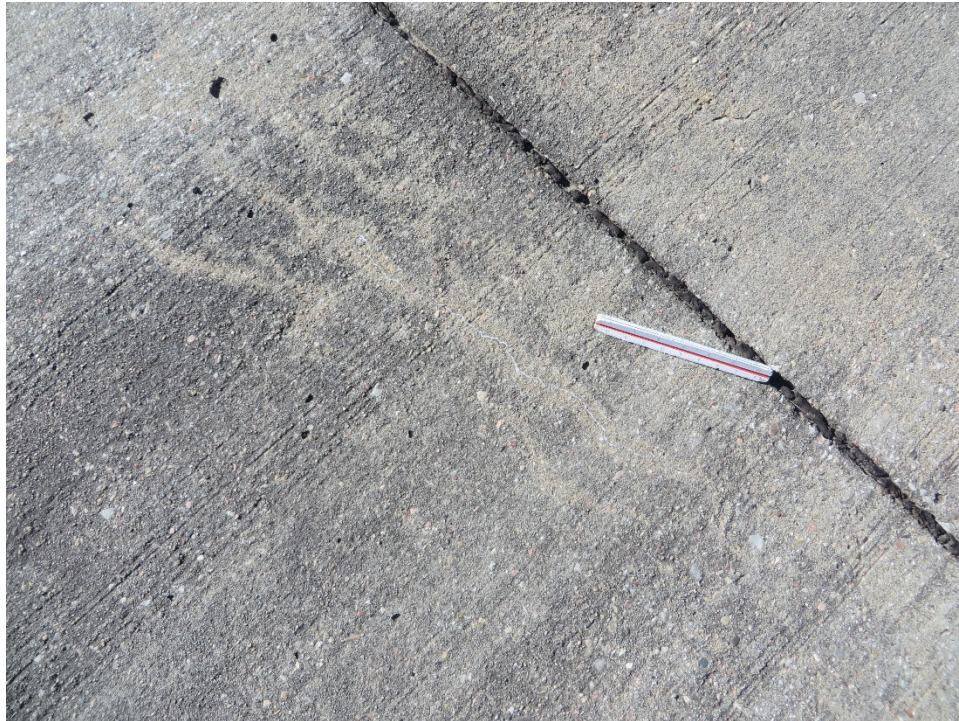
R12SH-01. ASR (Sample Unit No. 55).

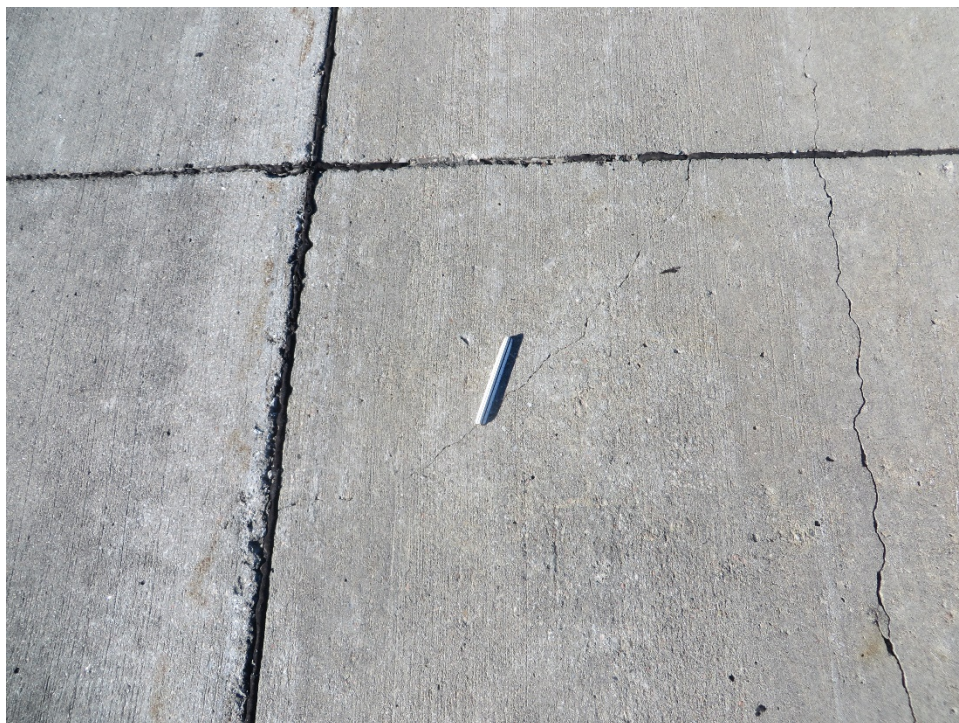
R12SH-01. Corner Break (Sample Unit No. 55).

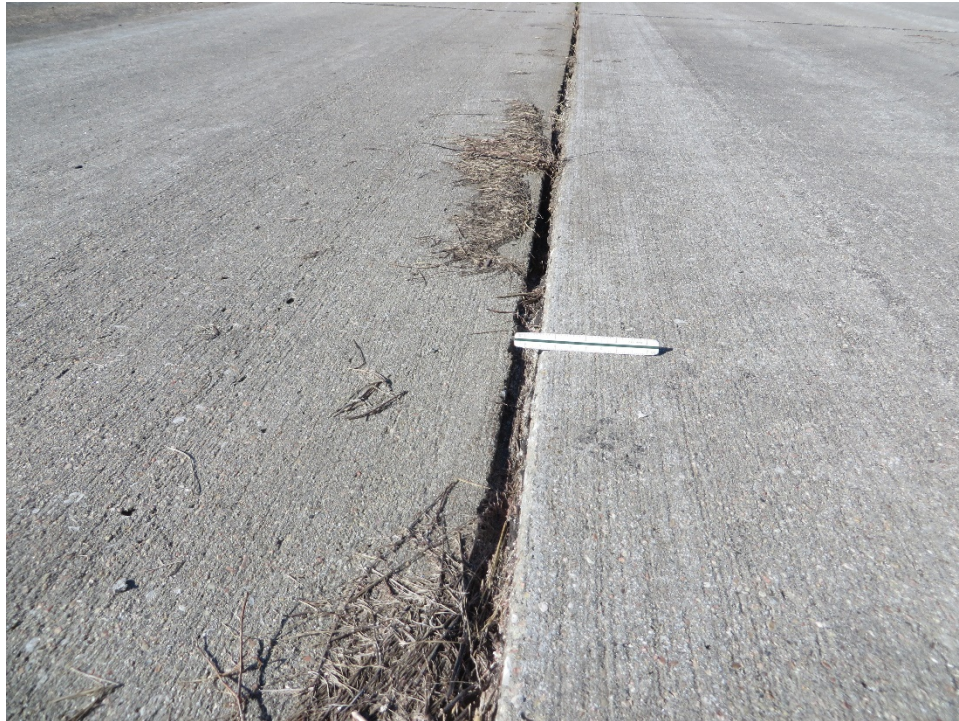
R12SH-01. Faulting (Sample Unit No. 05).

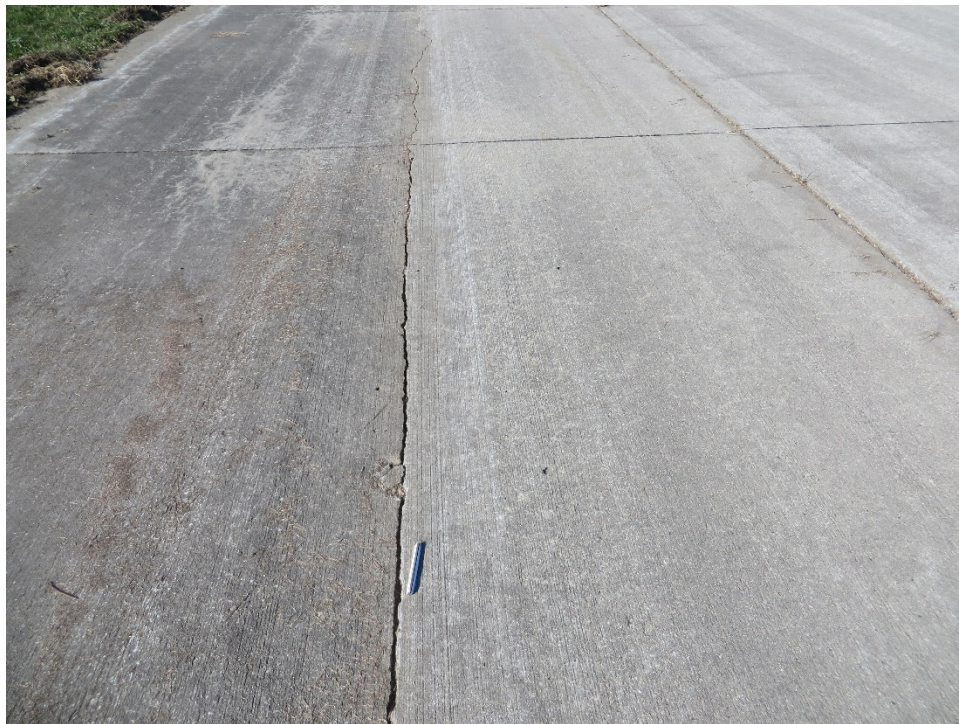
R12SH-01. LTD Cracking (Sample Unit No. 05).

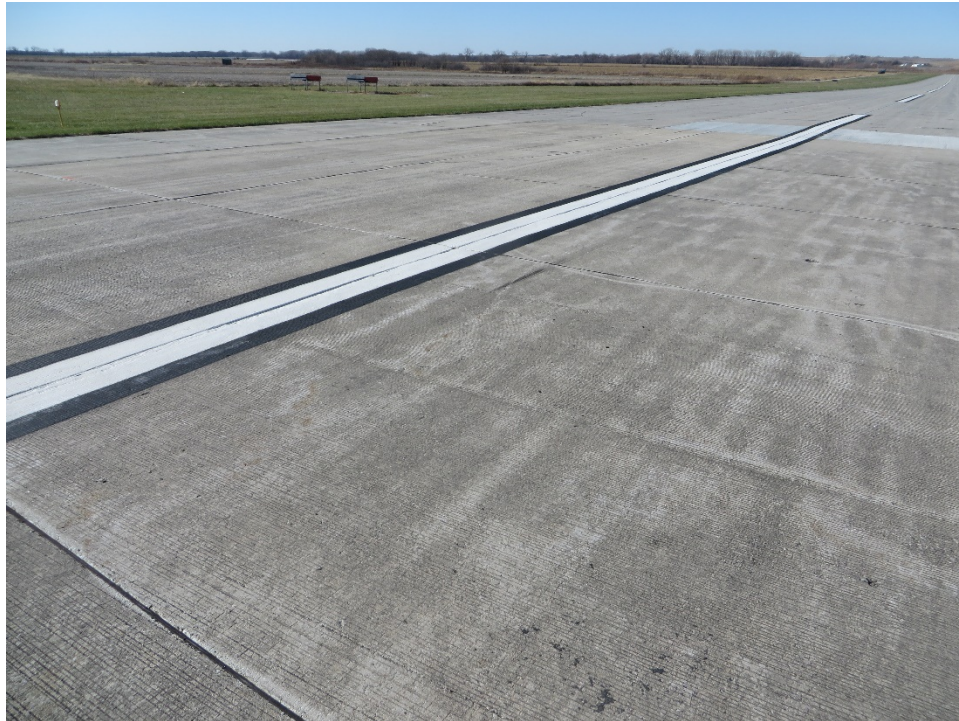
R12SH-02. Overview.

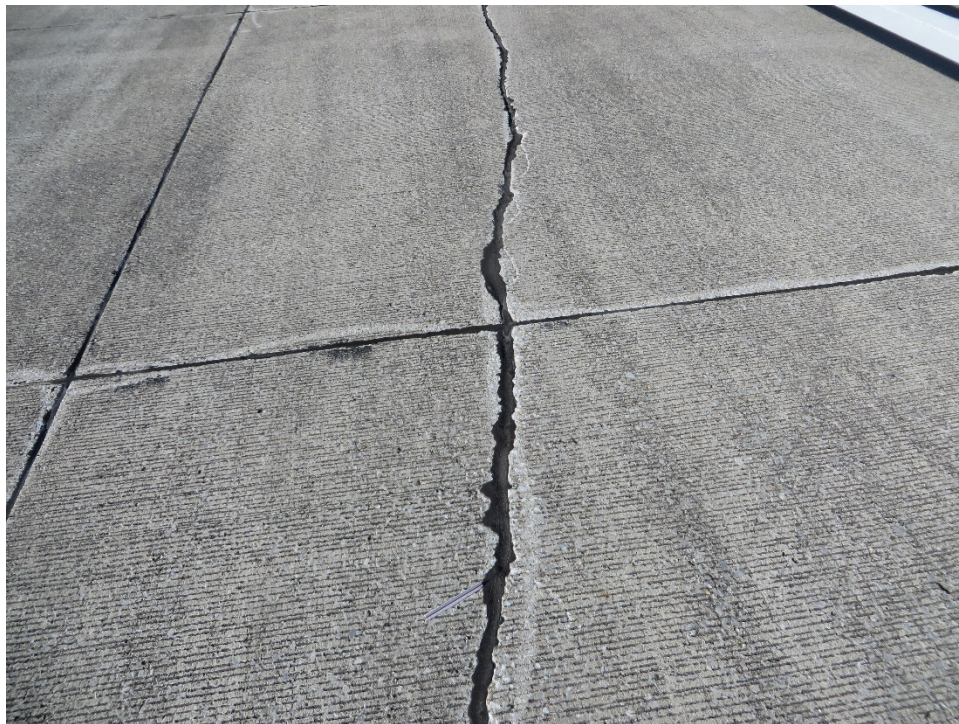
R12SH-02. LTD Cracking (Sample Unit No. 01).

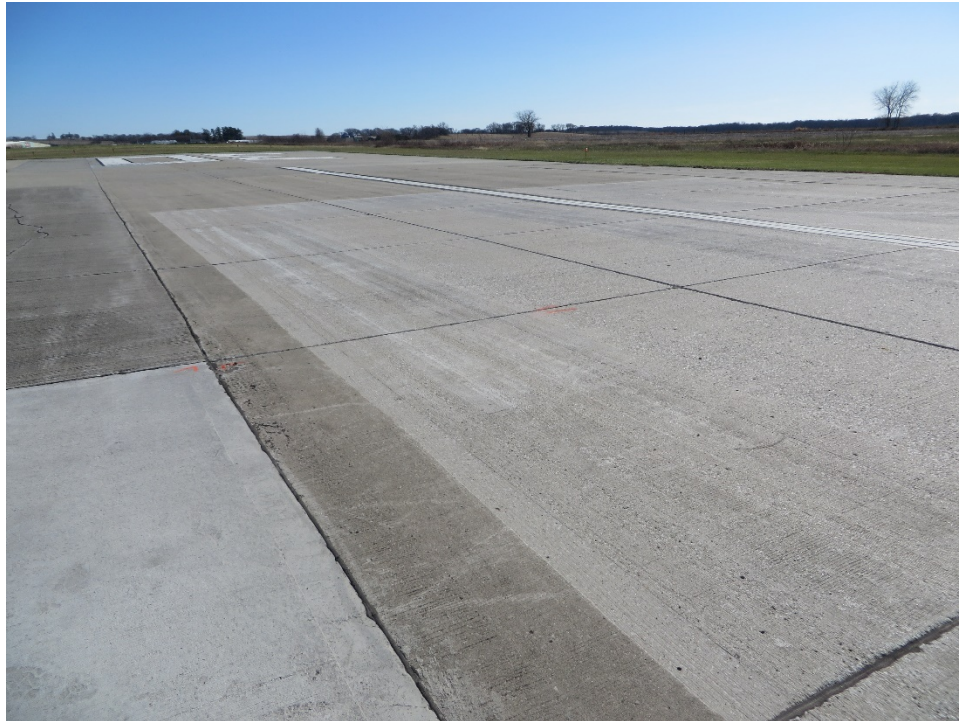
R12SH-03. Overview.

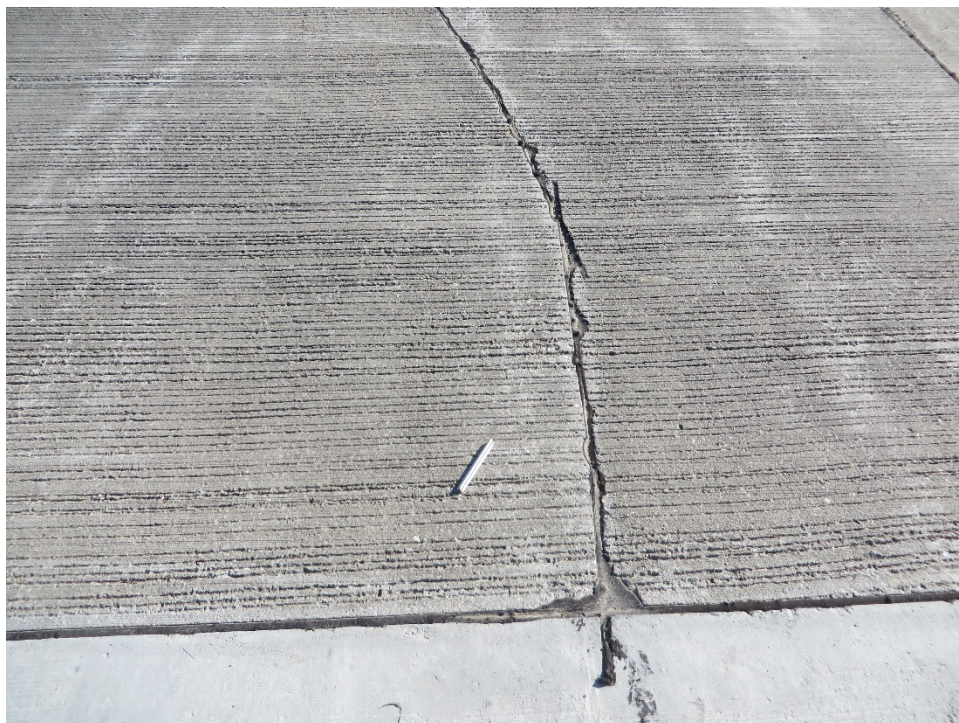
R12SH-03. LTD Cracking (Sample Unit No. 02).

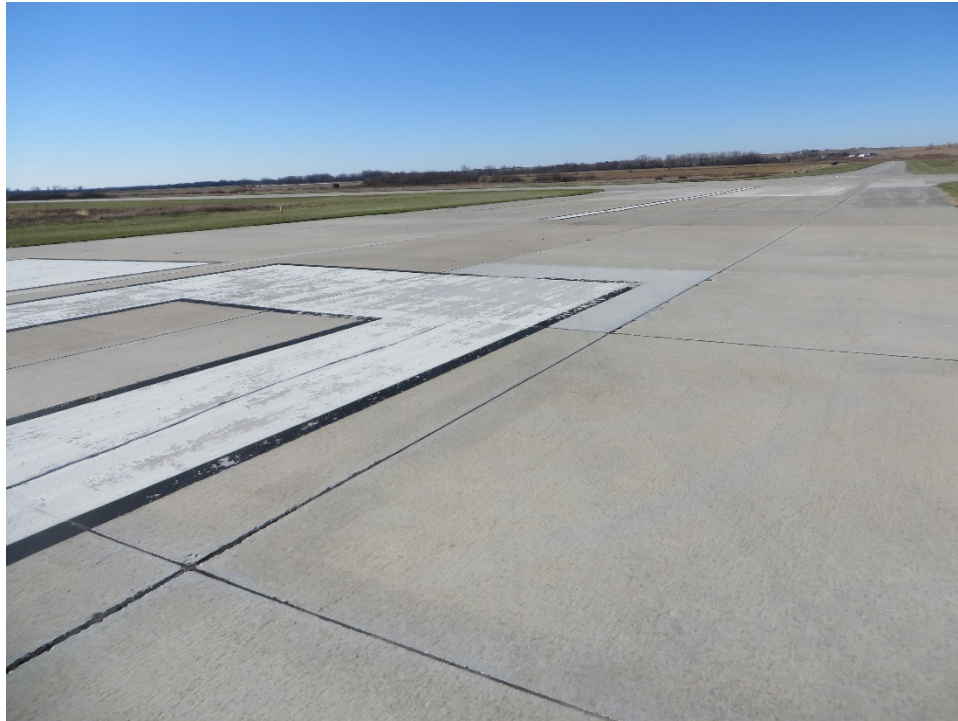
R12SH-04. Overview.

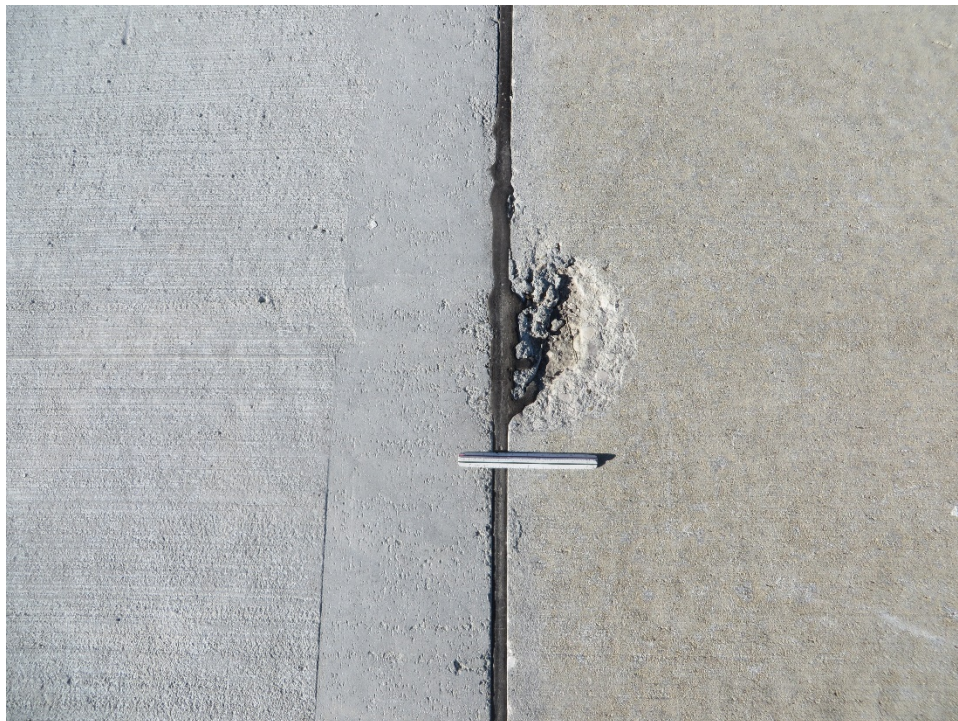
R12SH-04. Joint Spalling (Sample Unit No. 01).

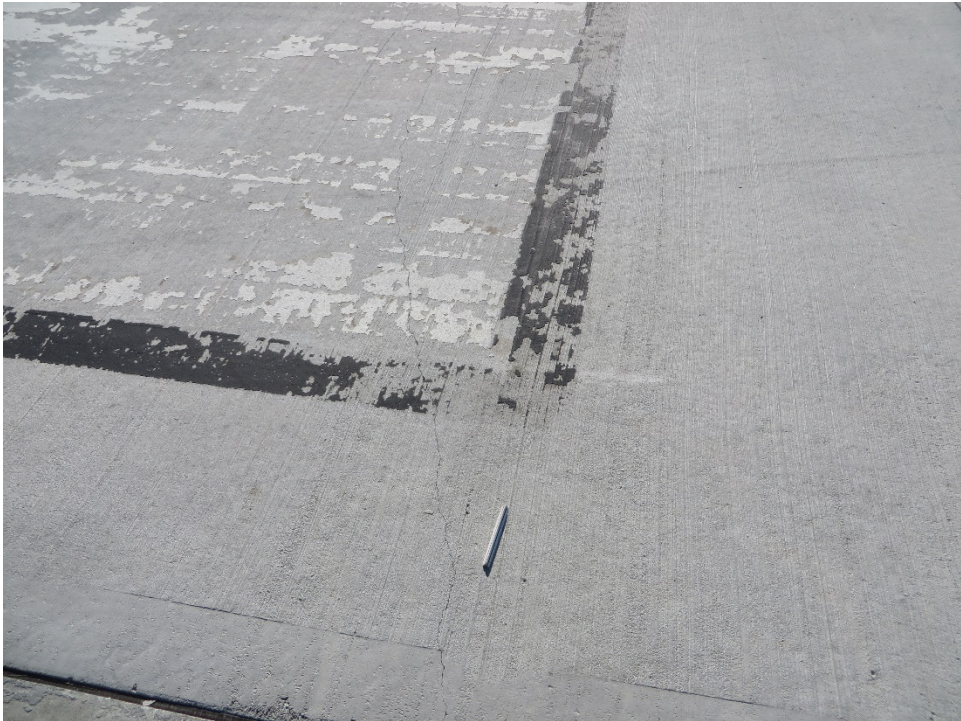
R12SH-04. LTD Cracking (Sample Unit No. 02).

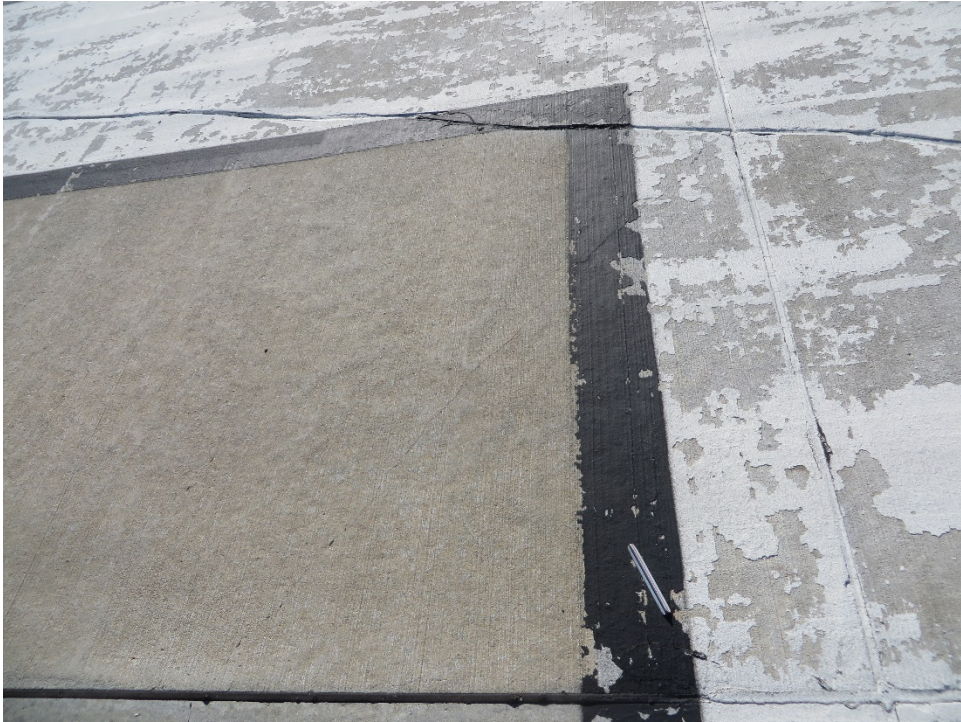
R12SH-04. LTD Cracking (Sample Unit No. 03).
