# Shenandoah Municipal Airport

## PAVEMENT MANAGEMENT REPORT

**JULY 2021**

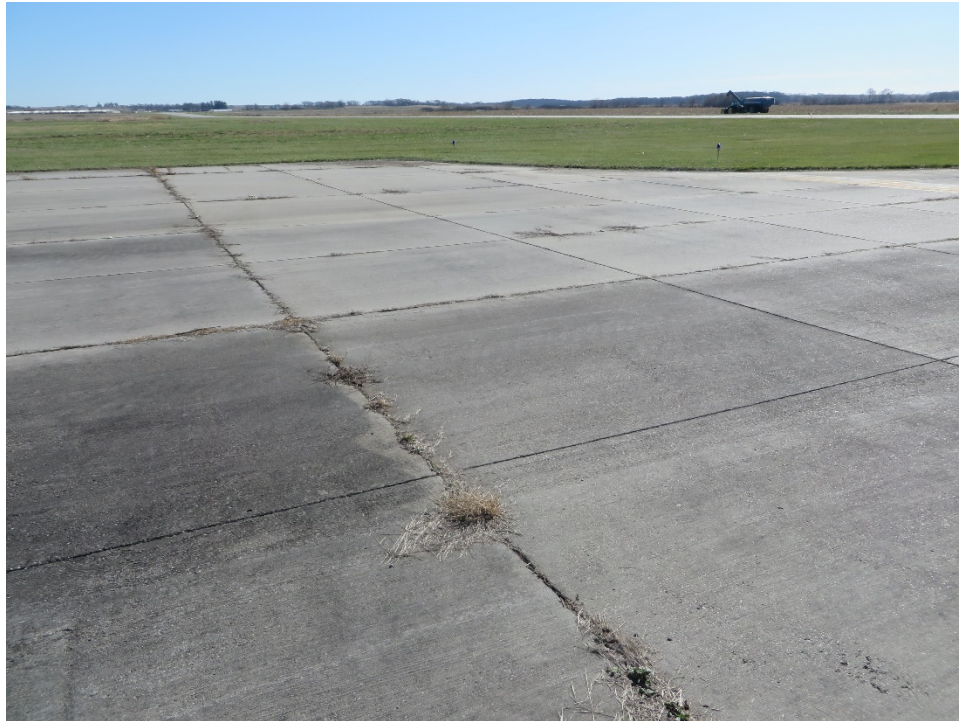
Taxiway 01 was defined by one section. High-severity joint seal damage was recorded throughout Section 01, along with smaller amounts of low-severity corner spalling and medium-severity joint spalling.

T01SH-01. Overview.

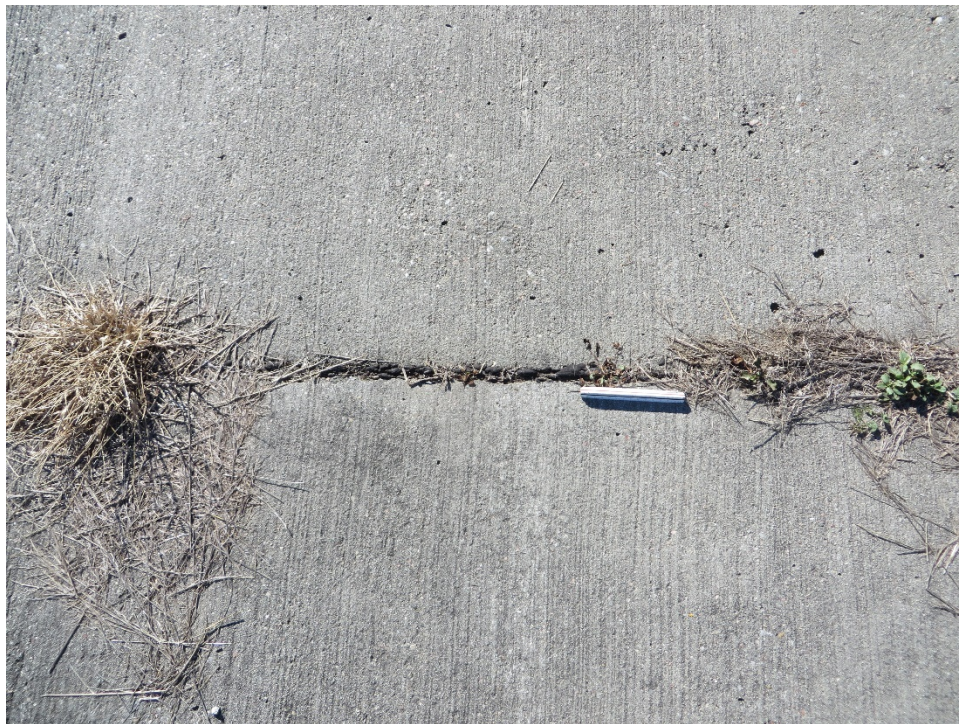
T01SH-01. Joint Seal Damage (Sample Unit No. 04).

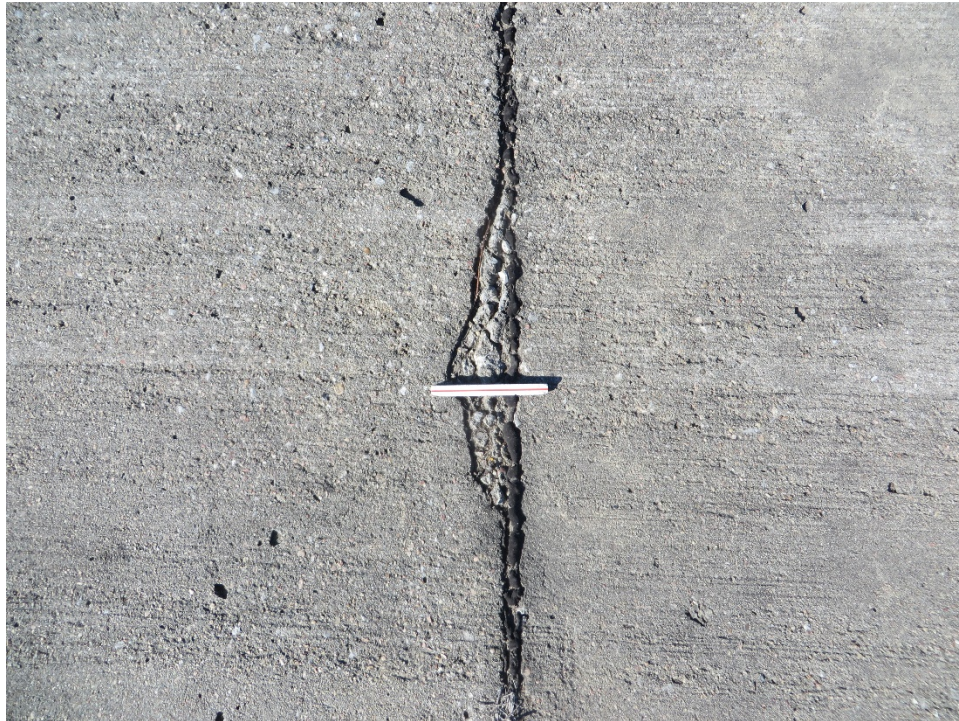
T01SH-01. Joint Spalling (Sample Unit No. 05).

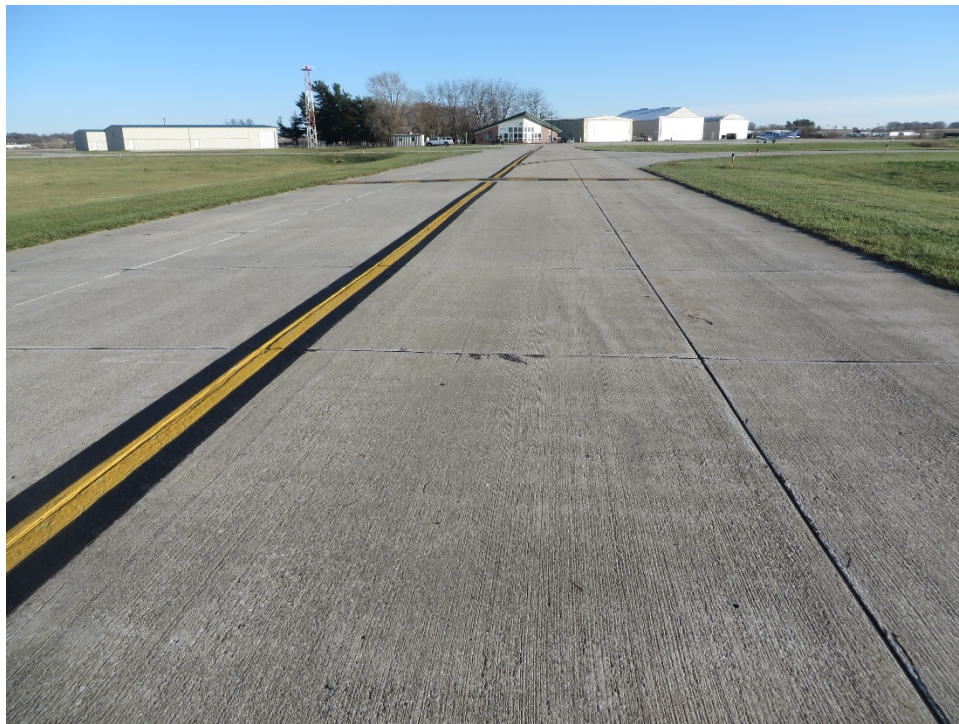
Taxiway 02 consisted of one section. Low- and medium-severity ASR and low-severity faulting, joint spalling, and small patching were identified in Section 01.

T02SH-01. Overview.

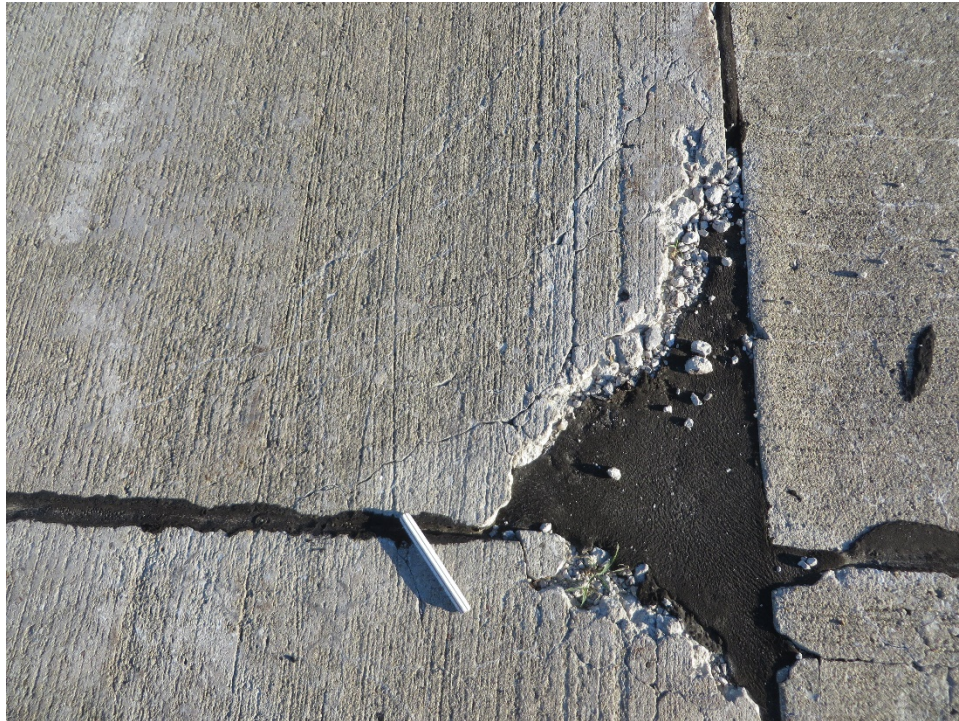
T02SH-01. ASR (Sample Unit No. 03).

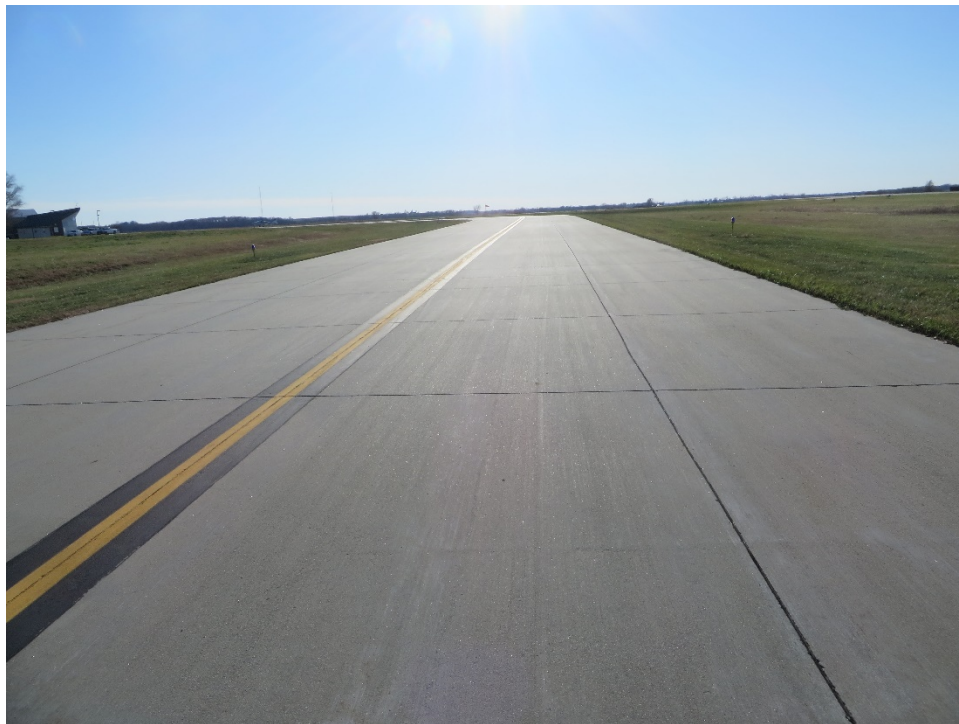
T03SH-01. Overview.

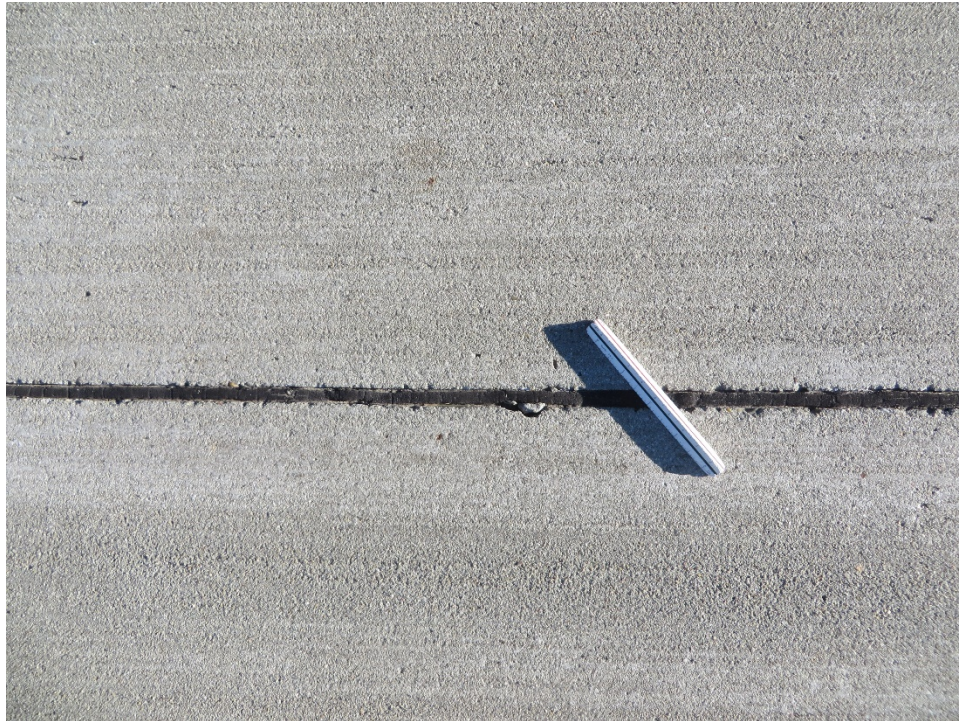
T03SH-01. Joint Seal Damage (Sample Unit No. 14).

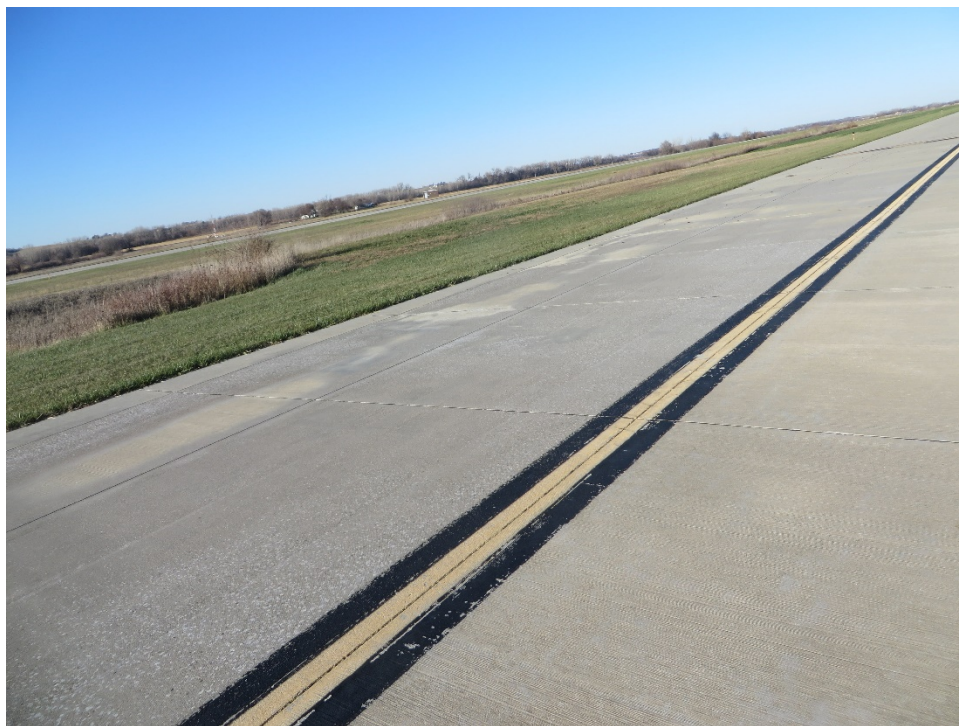
T03SH-02. Overview.

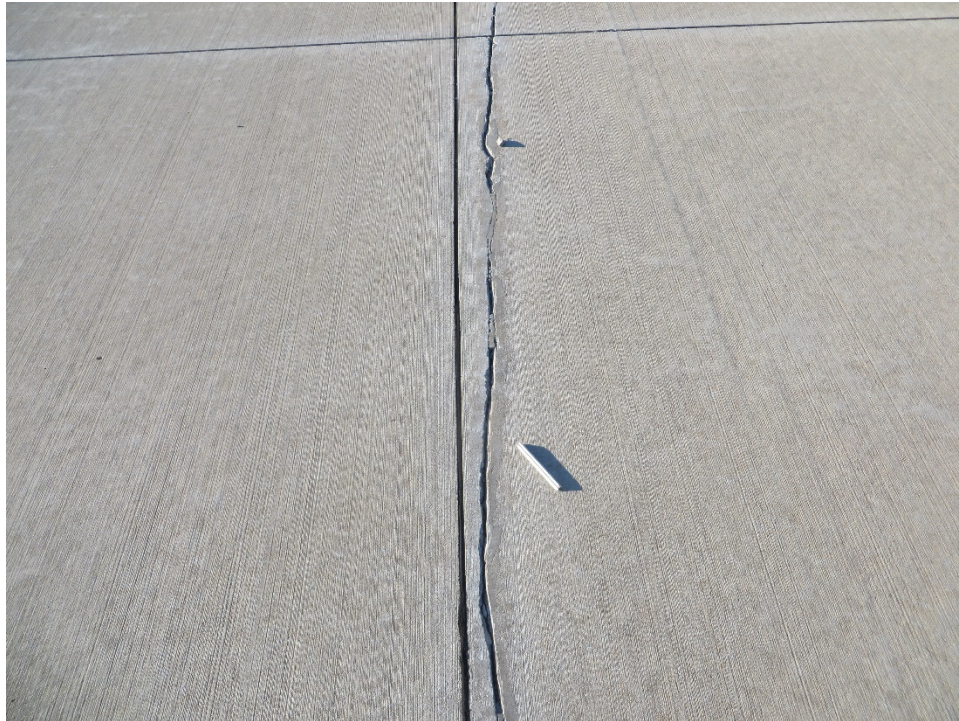
T03SH-02. Joint Spalling (Sample Unit No. 26).

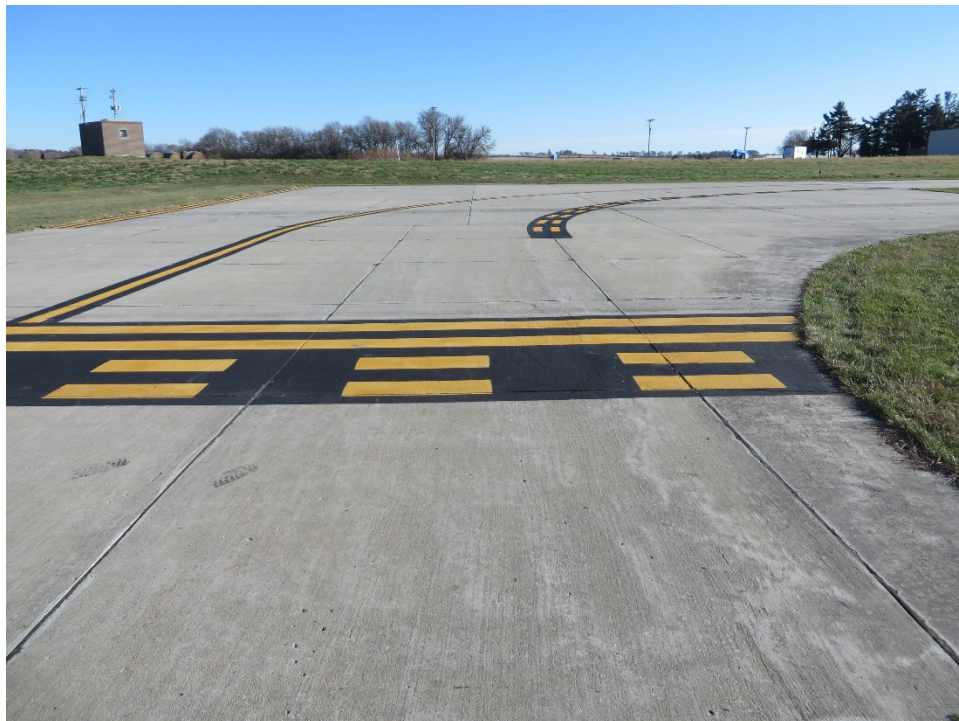
T03SH-03. Overview.

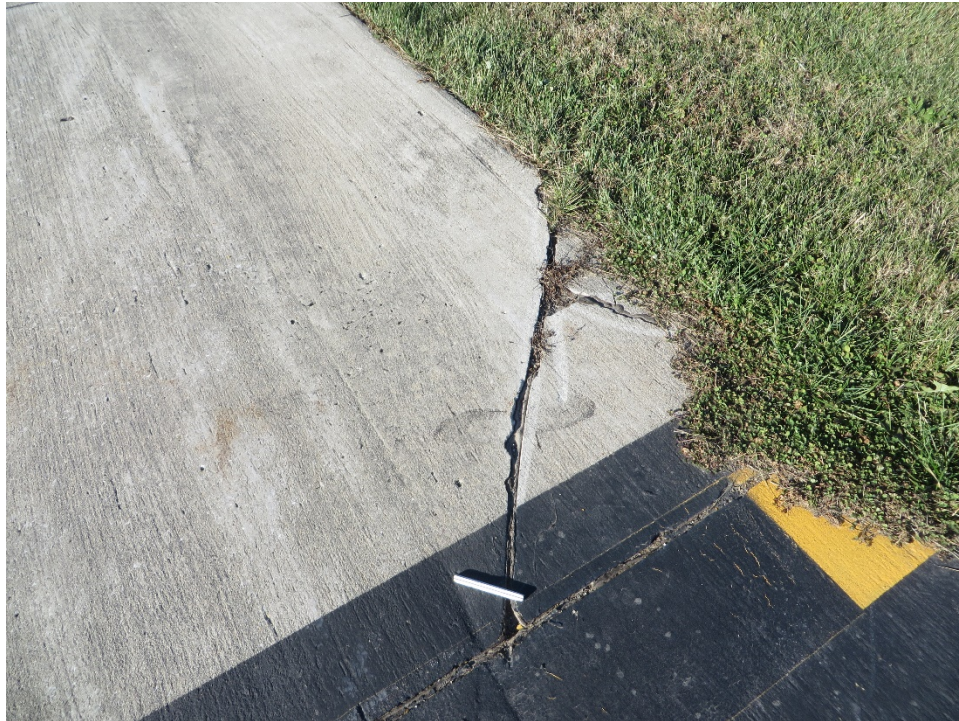
T03SH-03. Corner Break (Sample Unit No. 02).

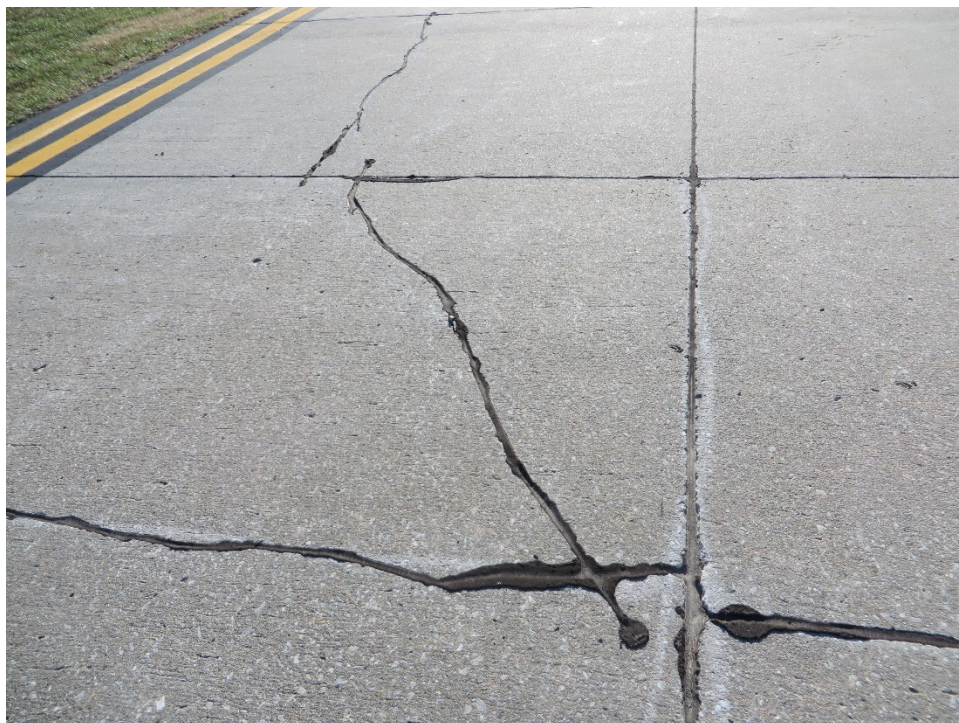
T03SH-03. LTD Cracking (Sample Unit No. 06).

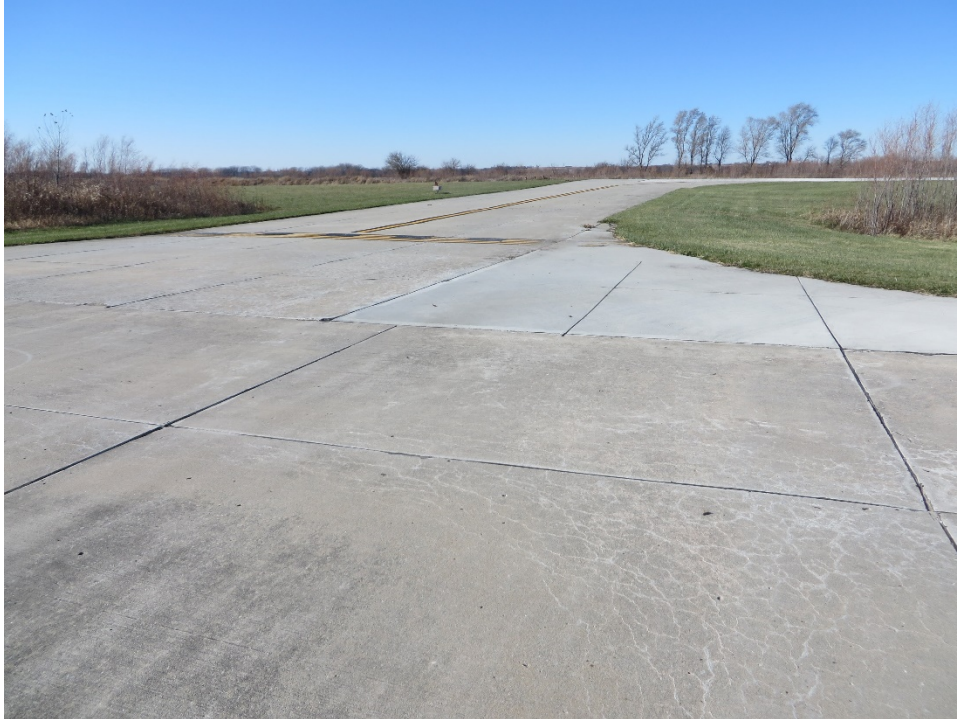
Taxiway 04 was defined by one section. Low-severity ASR, corner break, corner spalling, and faulting; low- and medium-severity LTD cracking; medium-severity large patching; and low- and high-severity small patching were identified in Section 01.

T04SH-01. Overview.

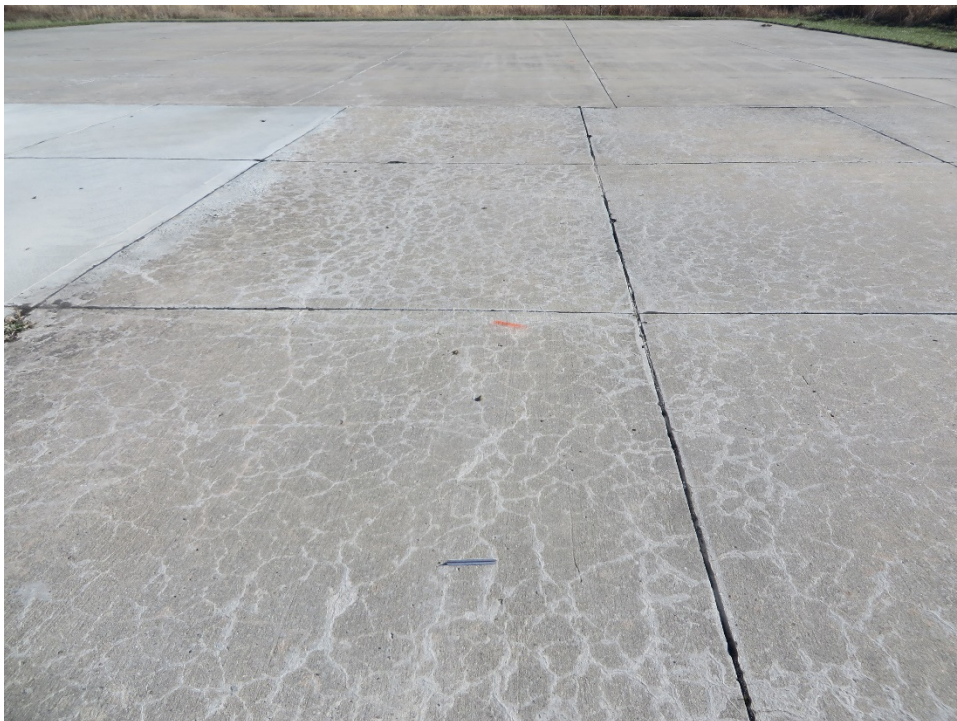
T04SH-01. ASR (Sample Unit No. 03).

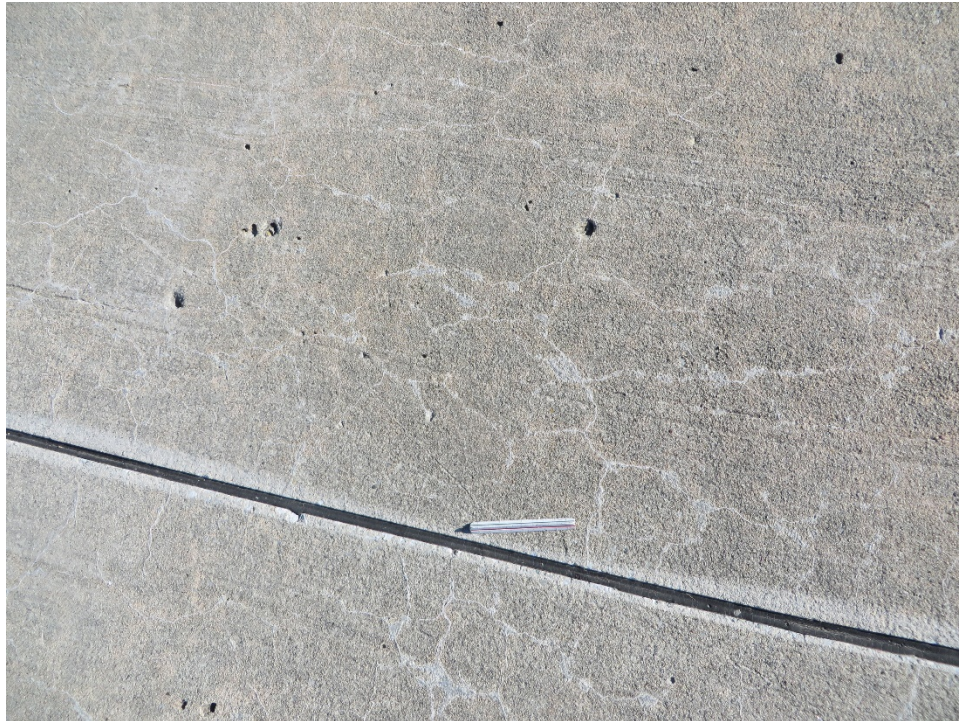
T04SH-01. ASR (Sample Unit No. 07).

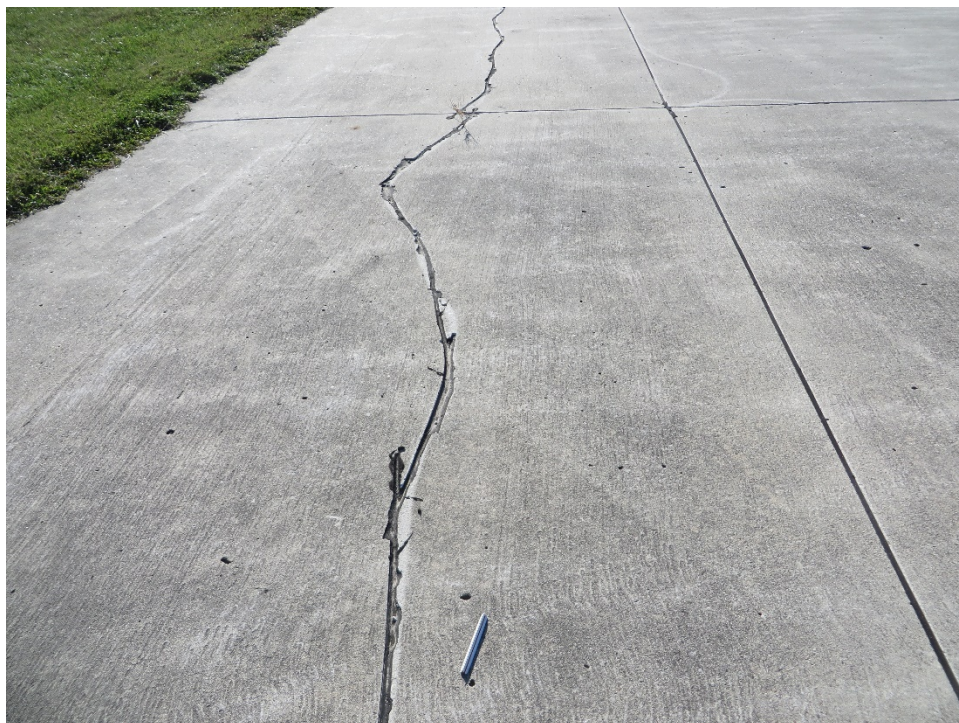
T04SH-01. LTD Cracking (Sample Unit No. 08).

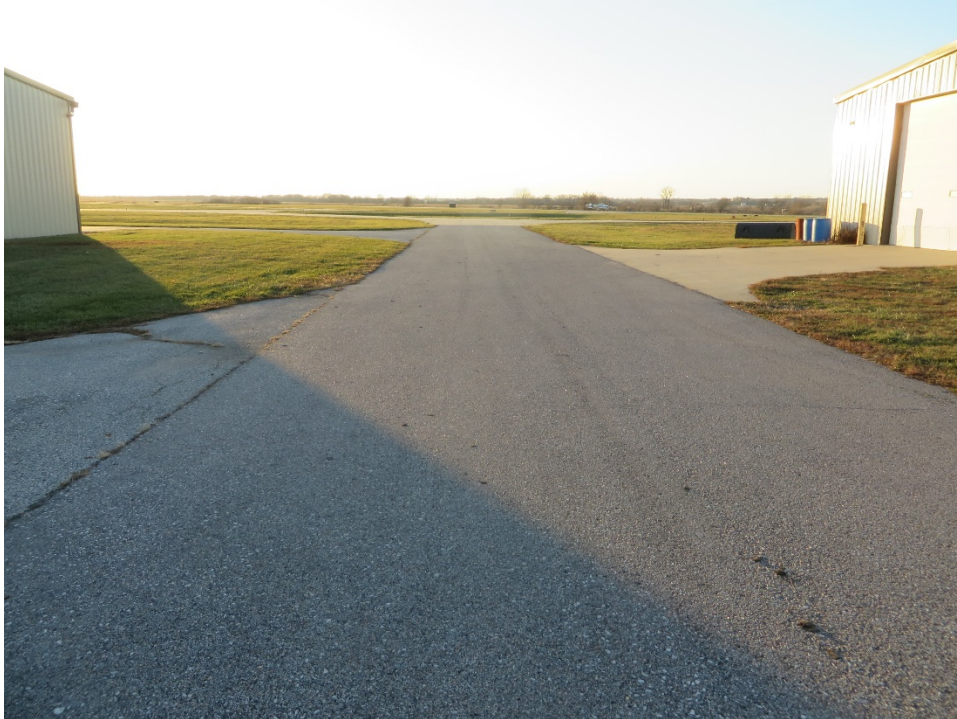
The T-Hangar was defined by four sections. Areas of low-severity alligator cracking and depression, all severities of longitudinal and transverse (L&T) cracking, and medium-severity weathering were observed in Section 01. The low-severity L&T cracking was unsealed, the medium-severity L&T cracking was identified where unsealed crack widths were greater than  $\frac{1}{4}$  in, and the high-severity L&T cracking was recorded where crack widths exceeded 3 in. In Section 02, low-severity joint spalling, low- and medium-severity LTD cracking, shrinkage cracking, and high-severity joint seal damage were identified. Areas of low- and medium-severity L&T cracking and medium-severity alligator cracking and weathering were recorded in Section 03. The low-severity L&T cracking was unsealed while the medium-severity L&T cracking was recorded where unsealed crack widths exceeded  $\frac{1}{4}$  in or the crack sealant no longer prevented water from penetrating the pavement surface. In Section 04, low-severity alligator cracking, low- and medium-severity L&T cracking and weathering, and high-severity raveling were observed. The low-severity L&T cracking was unsealed and the medium-severity L&T cracking was noted where the crack sealant was no longer satisfactorily preventing water from penetrating the pavement surface or secondary cracking had developed.

TH01SH-01. Overview.

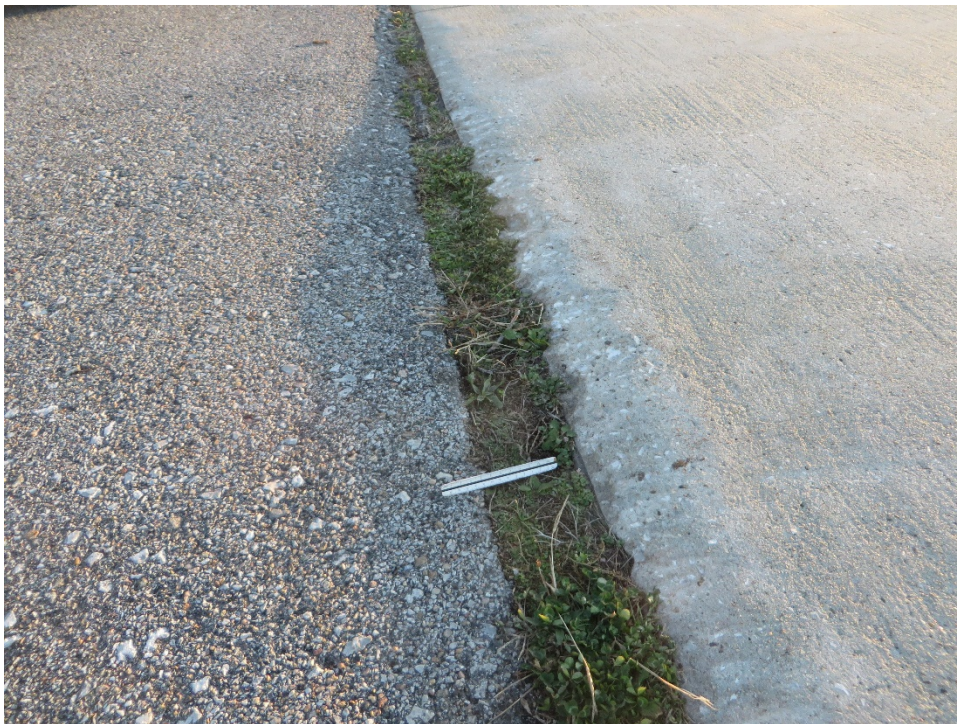
TH01SH-01. Depression (Sample Unit No. 01).

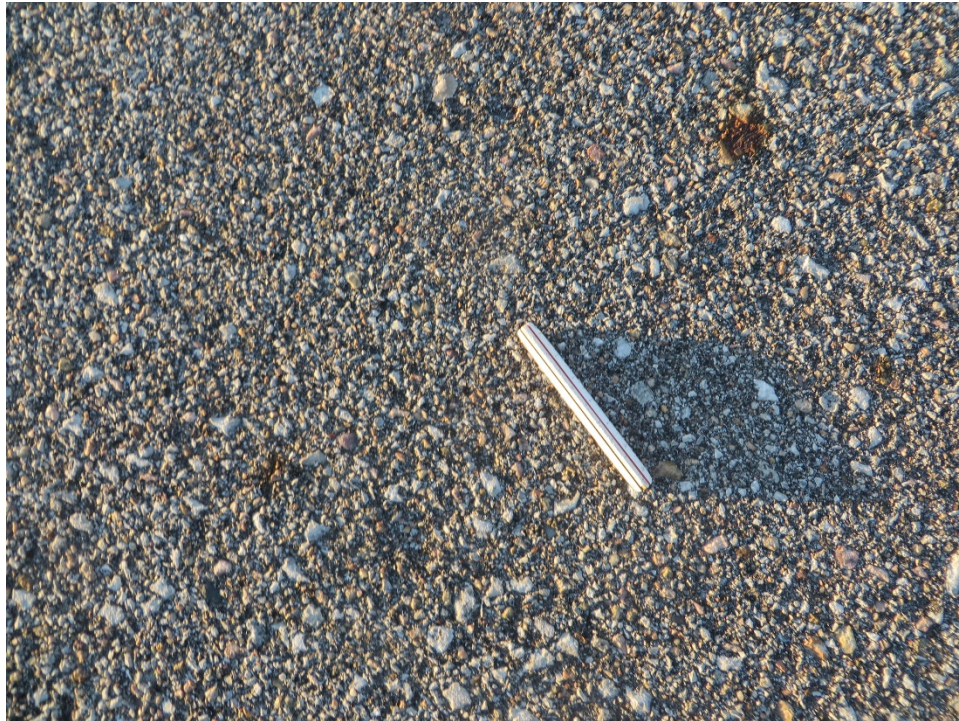
TH01SH-01. Weathering (Sample Unit No. 01).

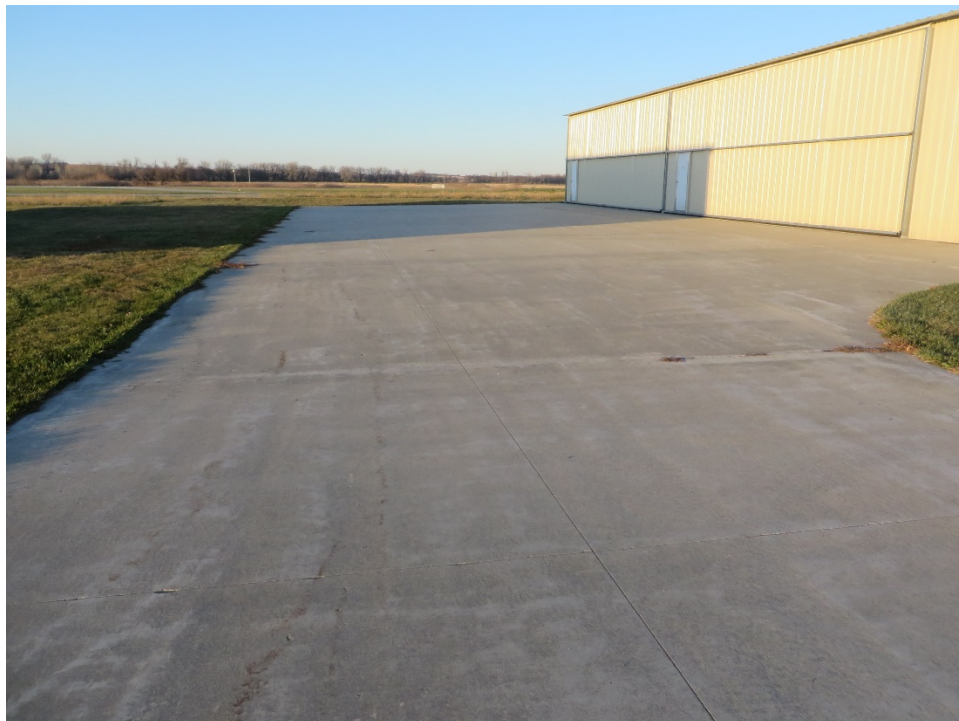
TH01SH-02. Overview.

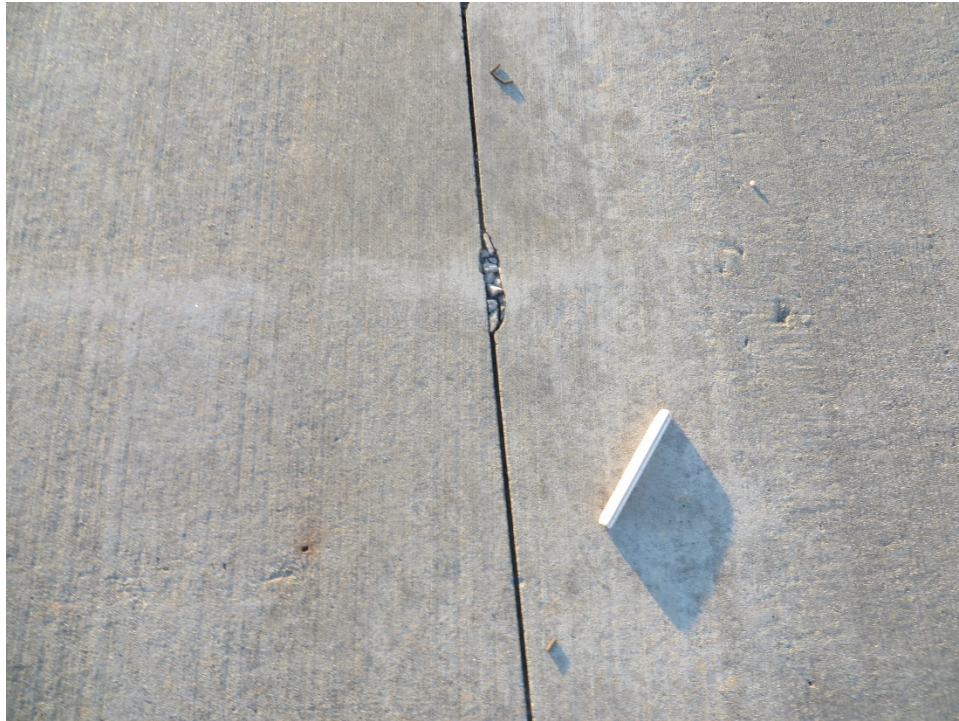
TH01SH-02. Joint Seal Damage (Sample Unit No. 01).

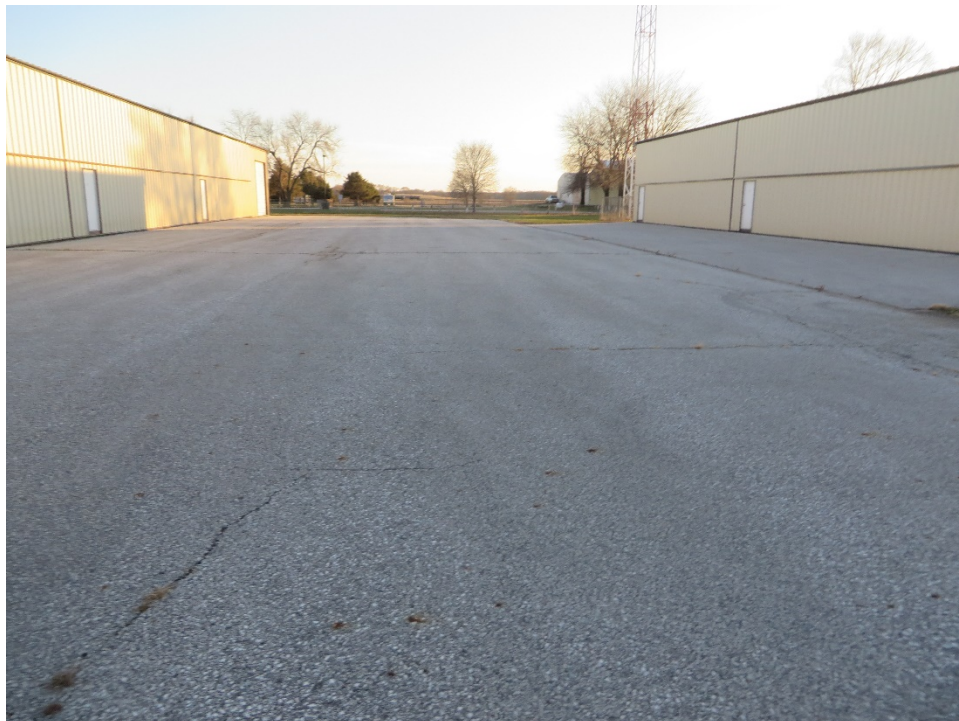
TH01SH-03. Overview.

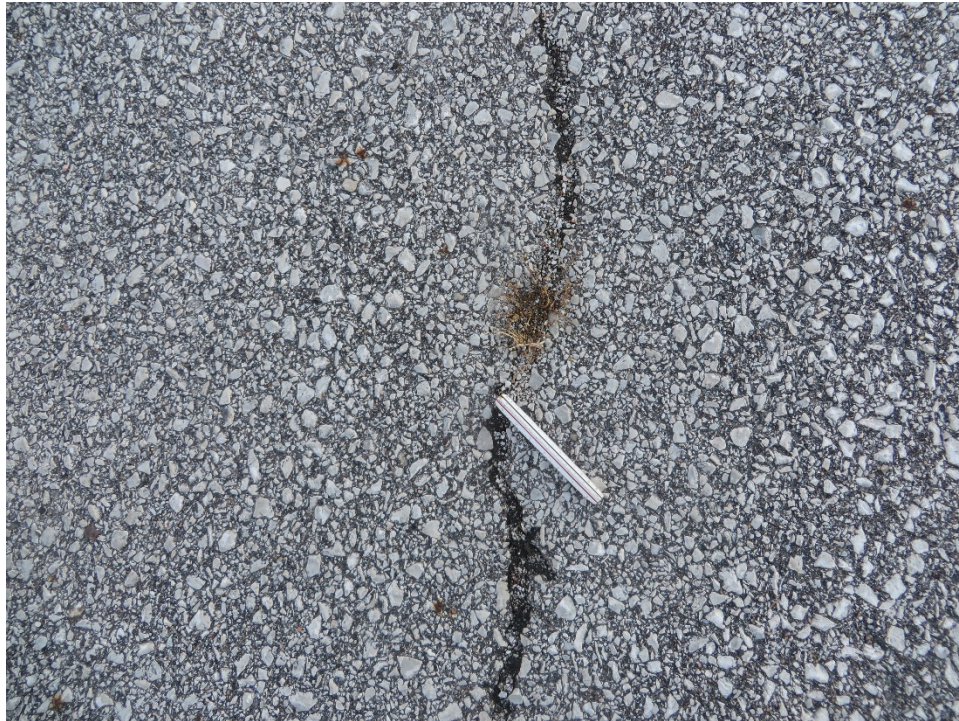
TH01SH-03. L&T Cracking (Sample Unit No. 01).

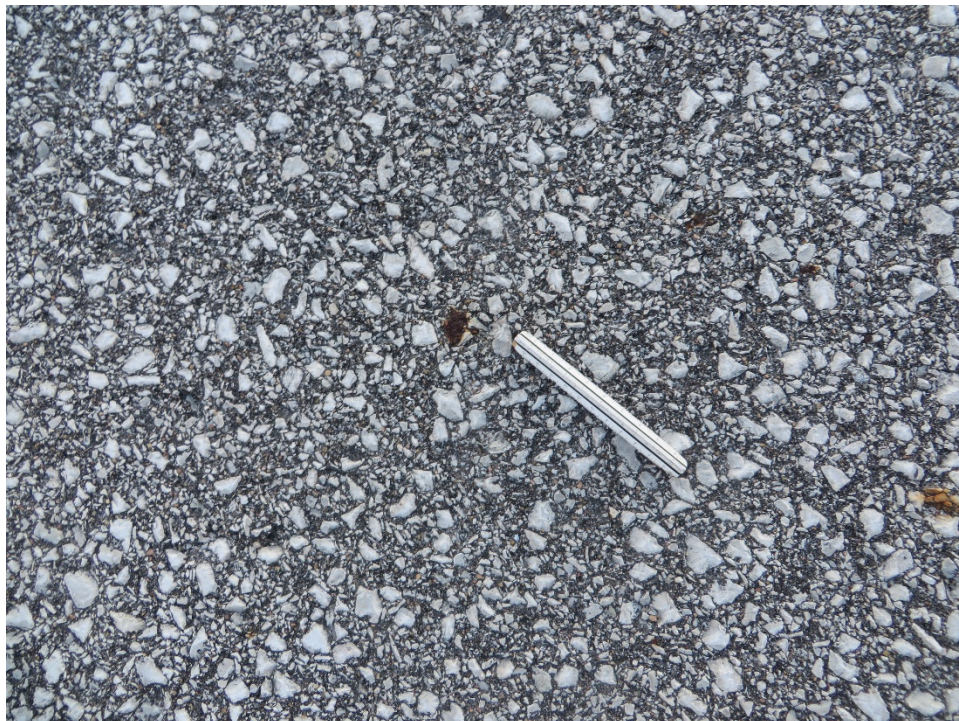
TH01SH-03. Weathering (Sample Unit No. 01).

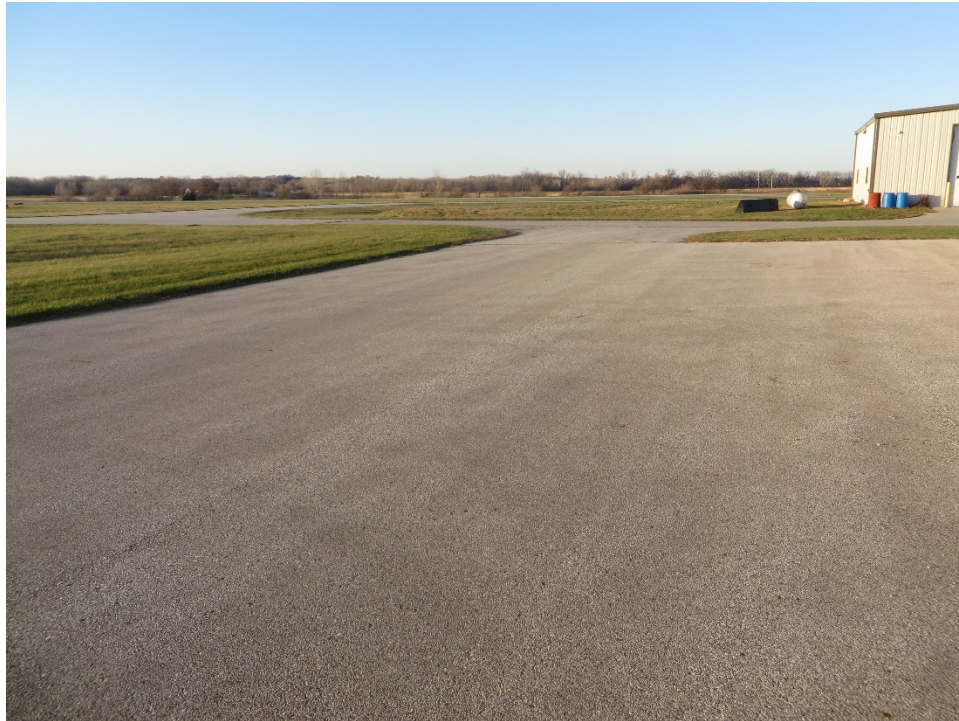
TH01SH-04. Overview.

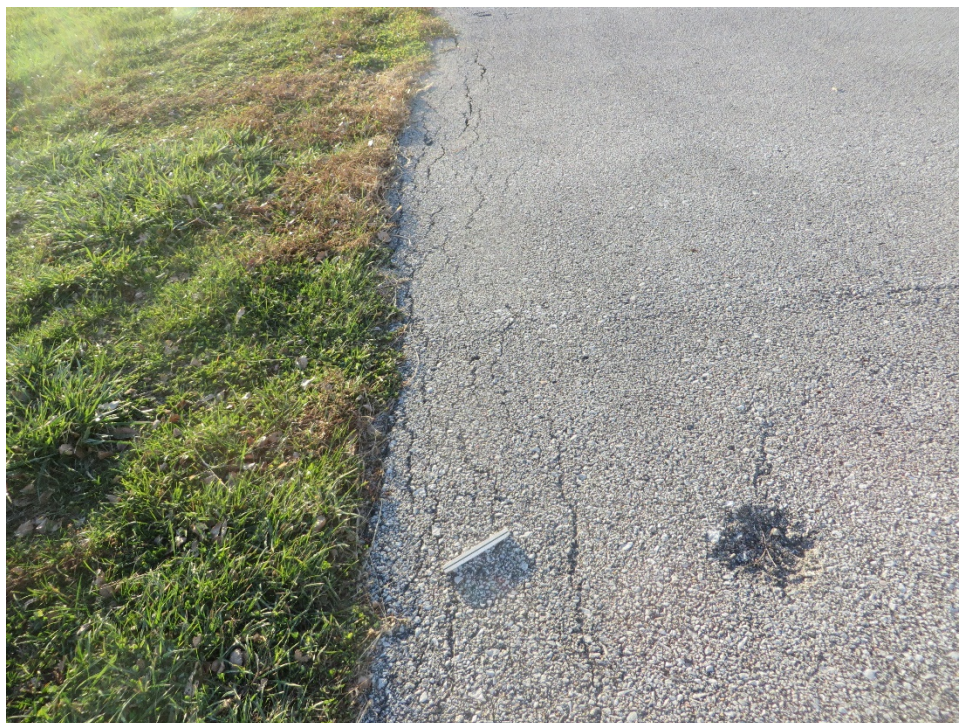
TH01SH-04. Alligator Cracking (Sample Unit No. 01).

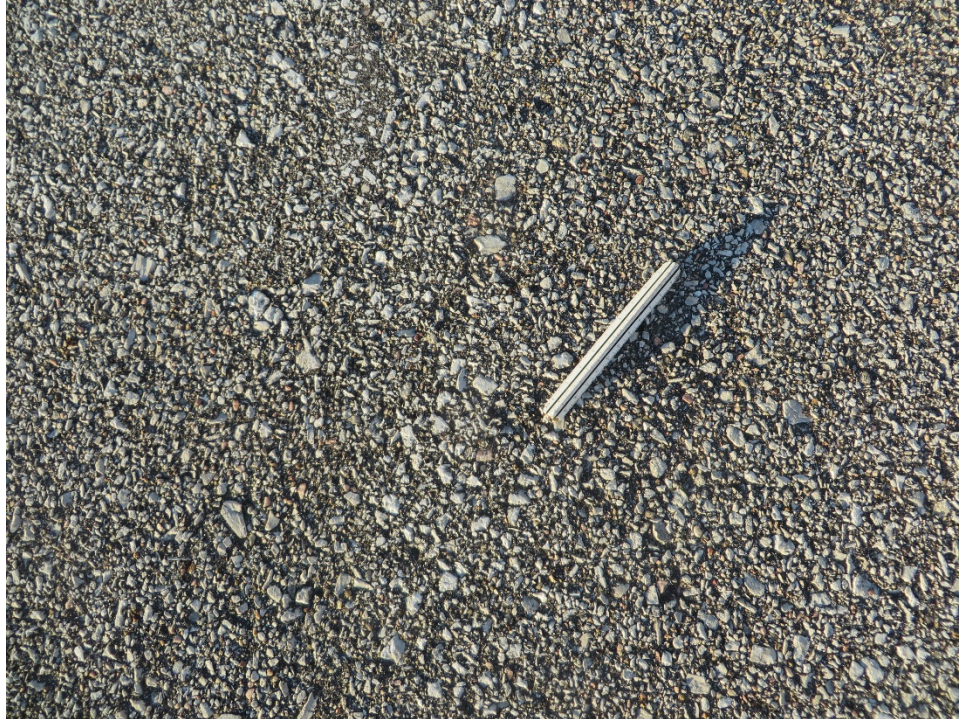
TH01SH-04. Weathering (Sample Unit No. 01).
