# Sibley Municipal Airport

**PAVEMENT MANAGEMENT REPORT**

**AUGUST 2019**

**IOWA DEPARTMENT OF TRANSPORTATION  
AVIATION BUREAU**

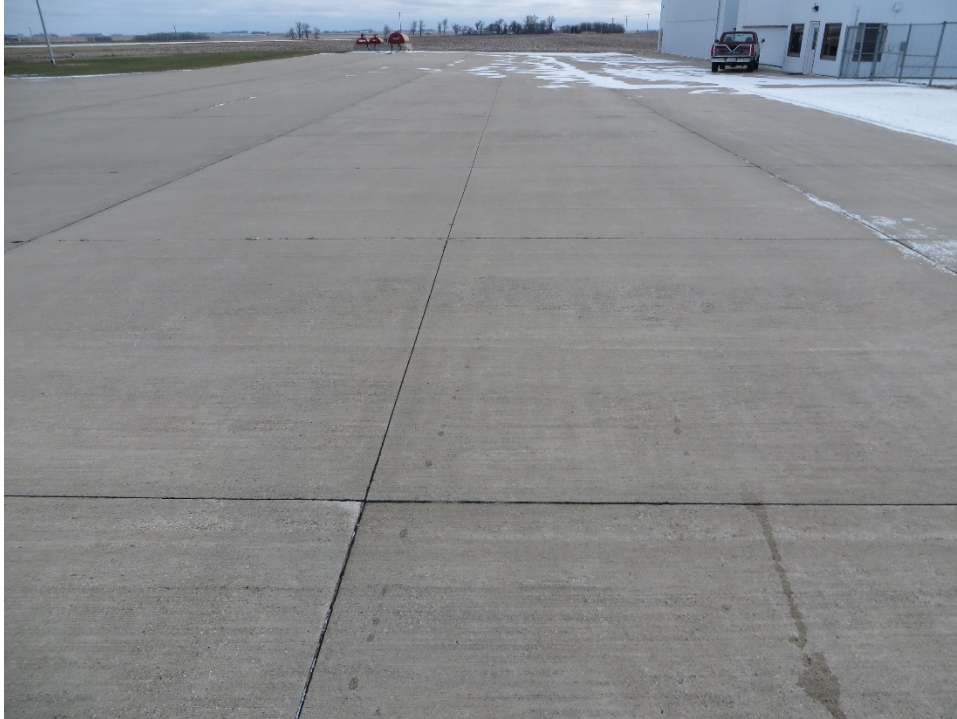
The apron area contained one section with medium-severity corner break and LTD cracking, low-severity corner spalling and faulting, low- and medium-severity joint seal damage, and all severities of joint spalling noted at the time of inspection.

A01IS-01. Overview.

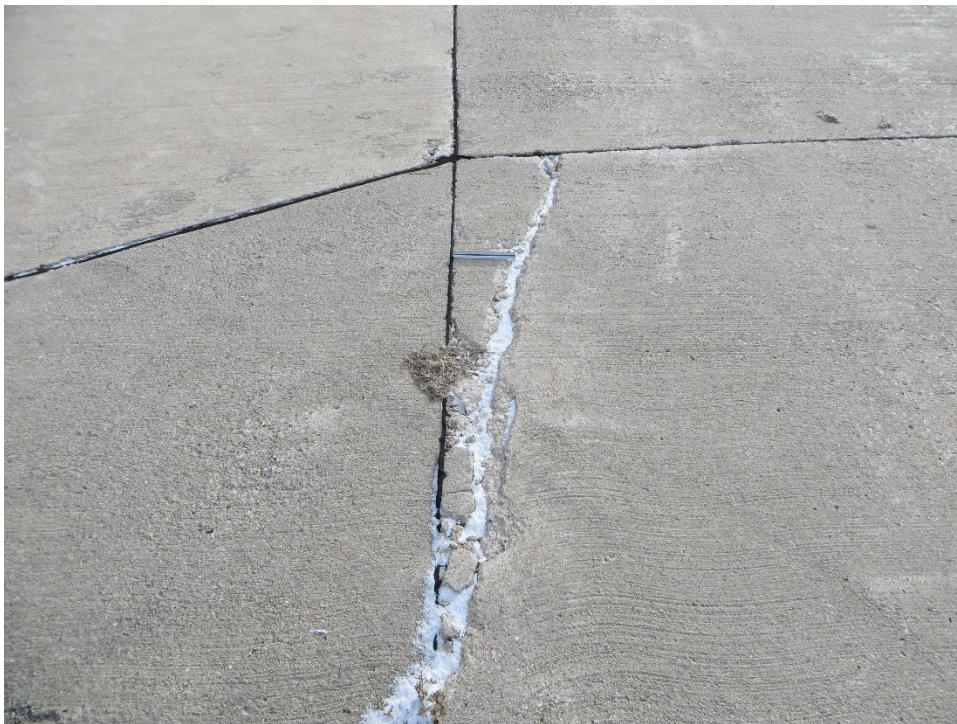
A01IS-01. Joint Spalling (Sample Unit No. 05).

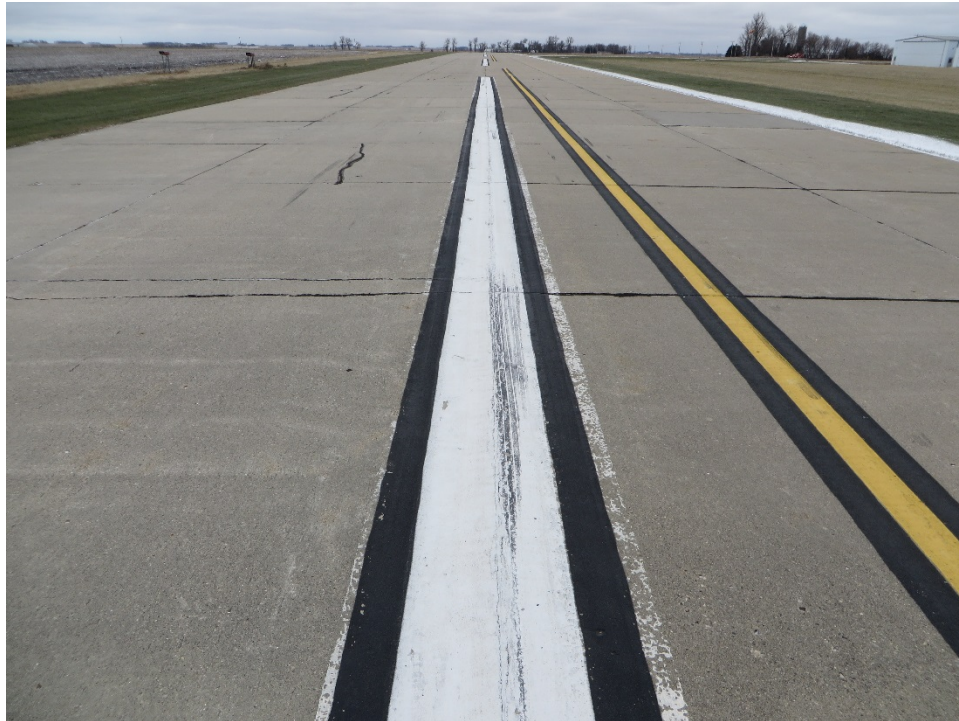
Runway 17/35 consisted of one section. Low-severity ASR, large patching, and corner break; low- and medium-severity longitudinal, transverse, and diagonal (LTD) cracking, corner spalling, faulting, and joint spalling; medium-severity joint seal damage; and popouts were recorded in Section 01.

R17IS-01. Overview.

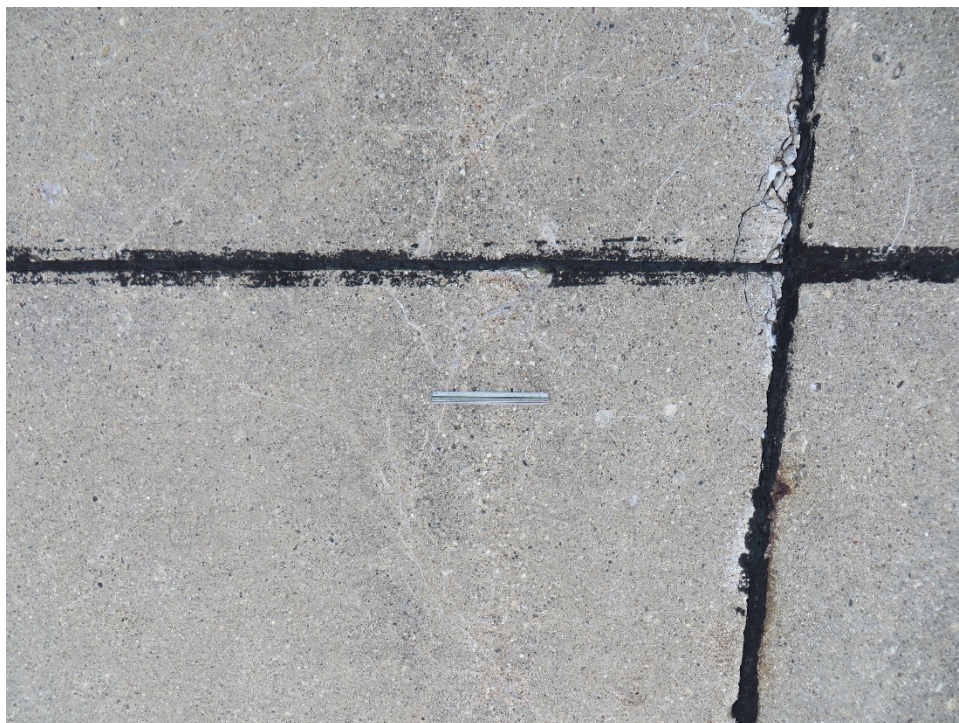
R17IS-01. ASR (Sample Unit No. 04).

Sample Number: 004 Type: R Area: 24.00Slabs PCI = 58  
Sample Comments:  
76 ASR L 8.00 Slabs Comments:  
75 CORNER SPALLING L 1.00 Slabs Comments:  
63 LINEAR CRACKING M 4.00 Slabs Comments:  
75 CORNER SPALLING L 2.00 Slabs Comments:  
65 JOINT SEAL DAMAGE M 24.00 Slabs Comments:

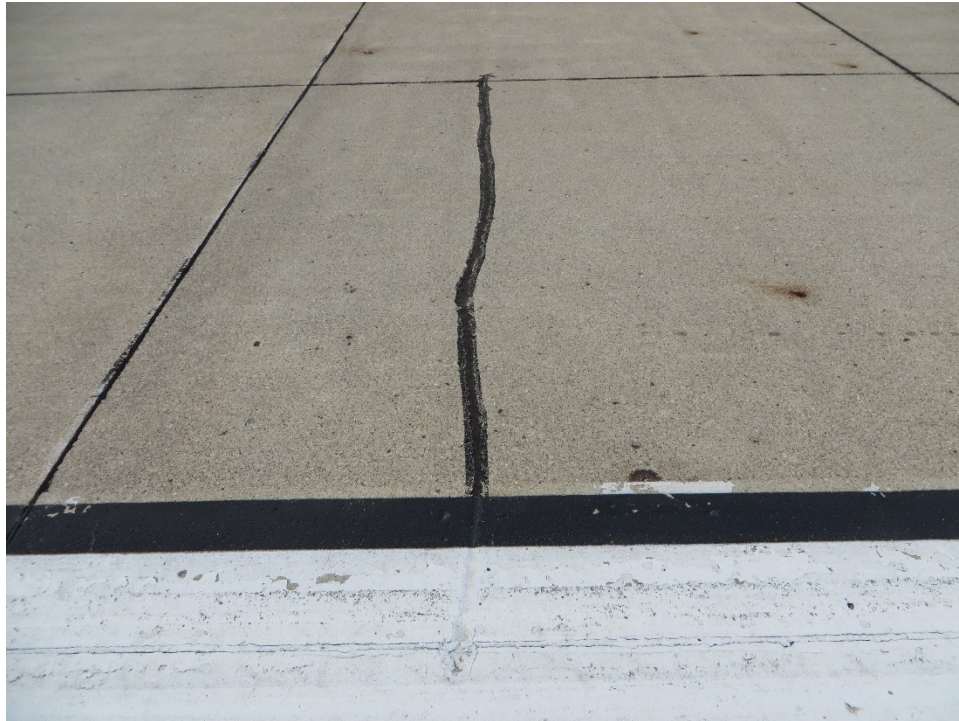
R17IS-01. LTD Cracking (Sample Unit No. 32).

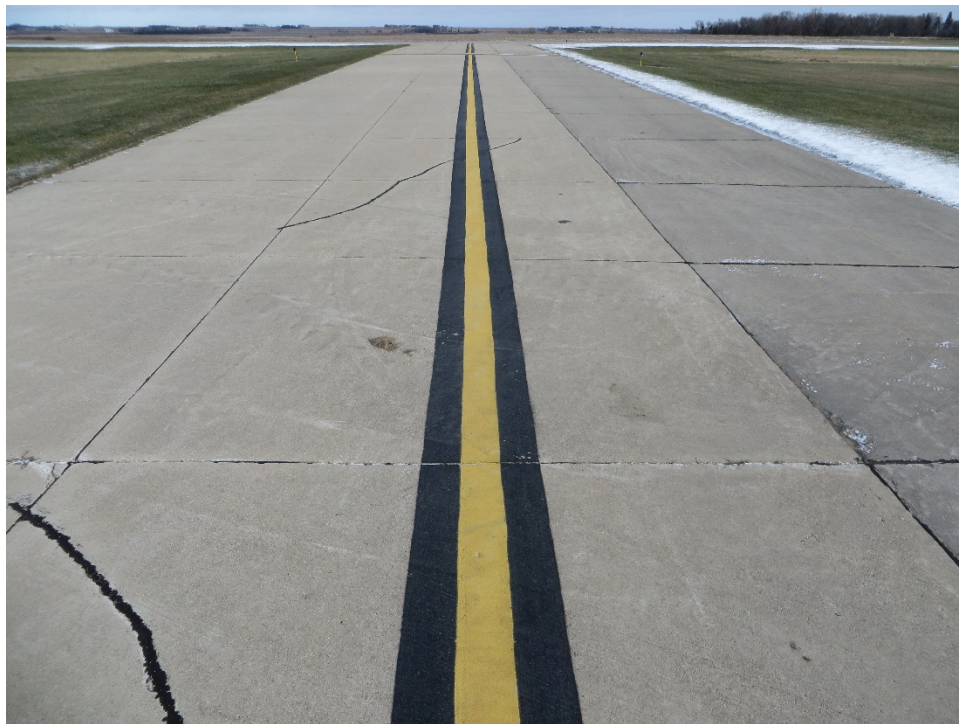
Taxiway 01 was defined by one section that connected the apron area with Runway 17/35. Medium- and high-severity corner spalling, low-severity faulting and large patching, and low- and medium-severity joint seal damage, joint spalling, and LTD cracking were observed in Section 01.

T01IS-01. Overview.

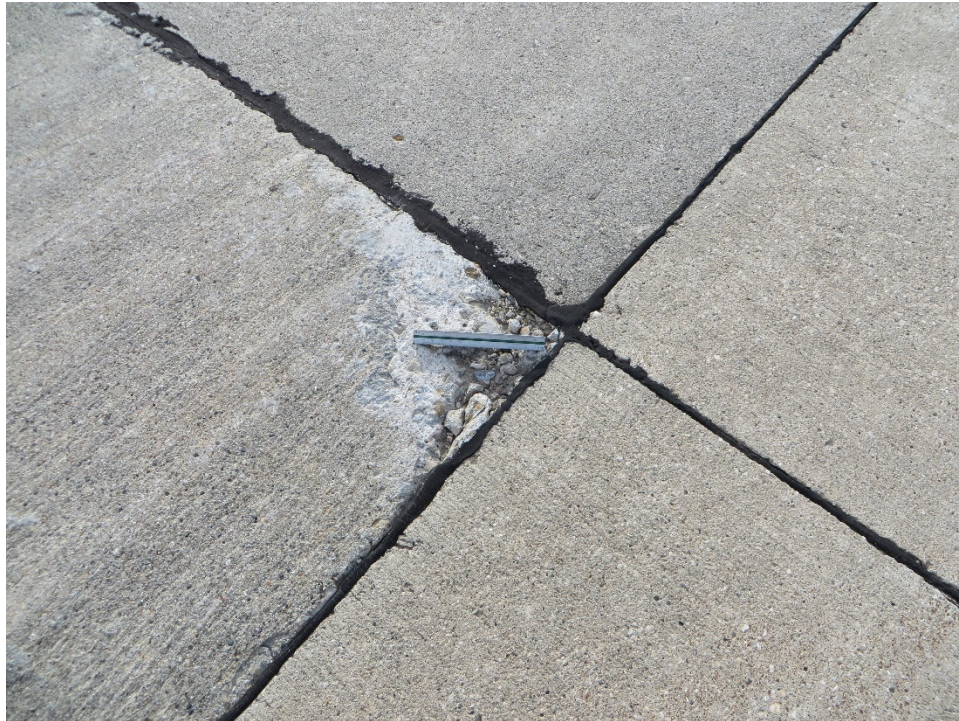
T01IS-01. Corner Spalling (Sample Unit No. 01).

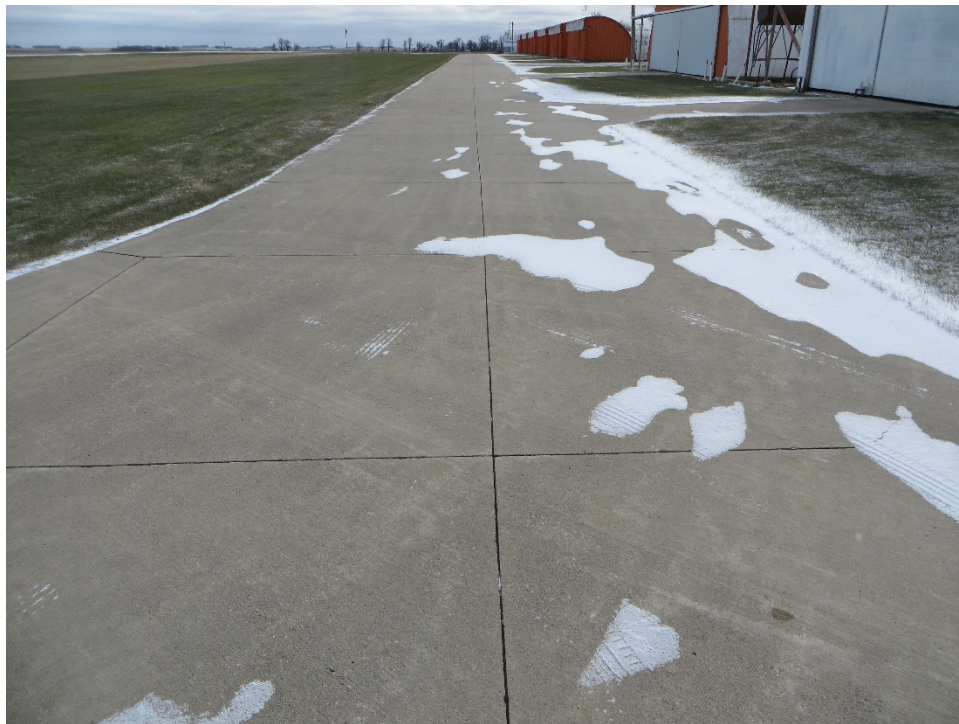
Taxiway 02 contained one section that was located between the apron area and Taxiway 03. Low-severity corner break, corner spalling, and faulting and low- and medium-severity joint seal damage, joint spalling, and LTD cracking were identified at the time of inspection.

T02IS-01. Overview.

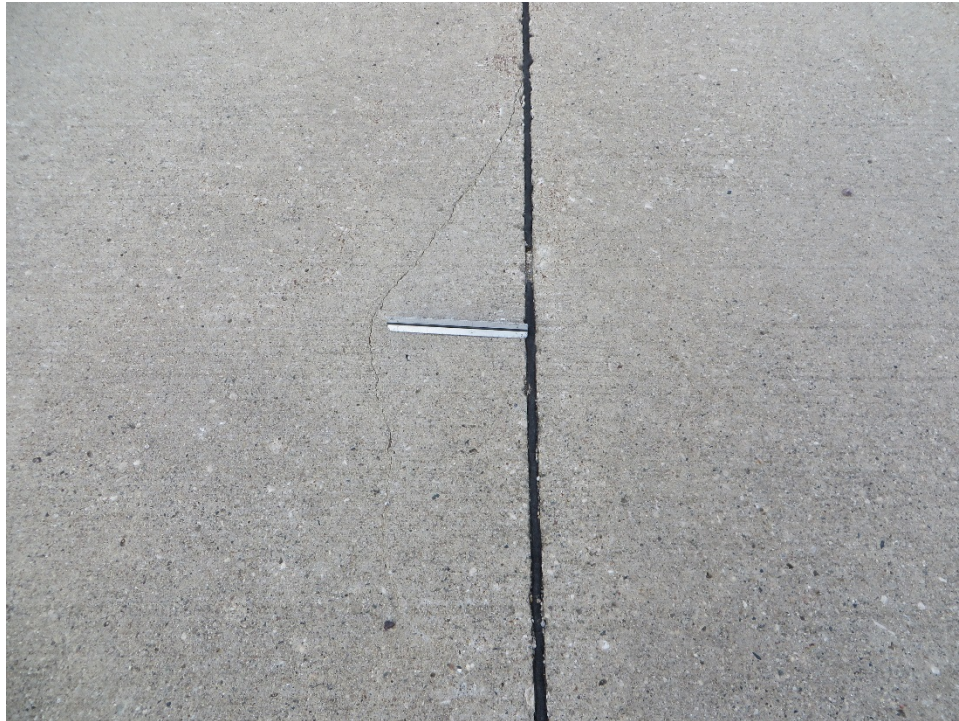
T02IS-01. Joint Spalling (Sample Unit No. 03).

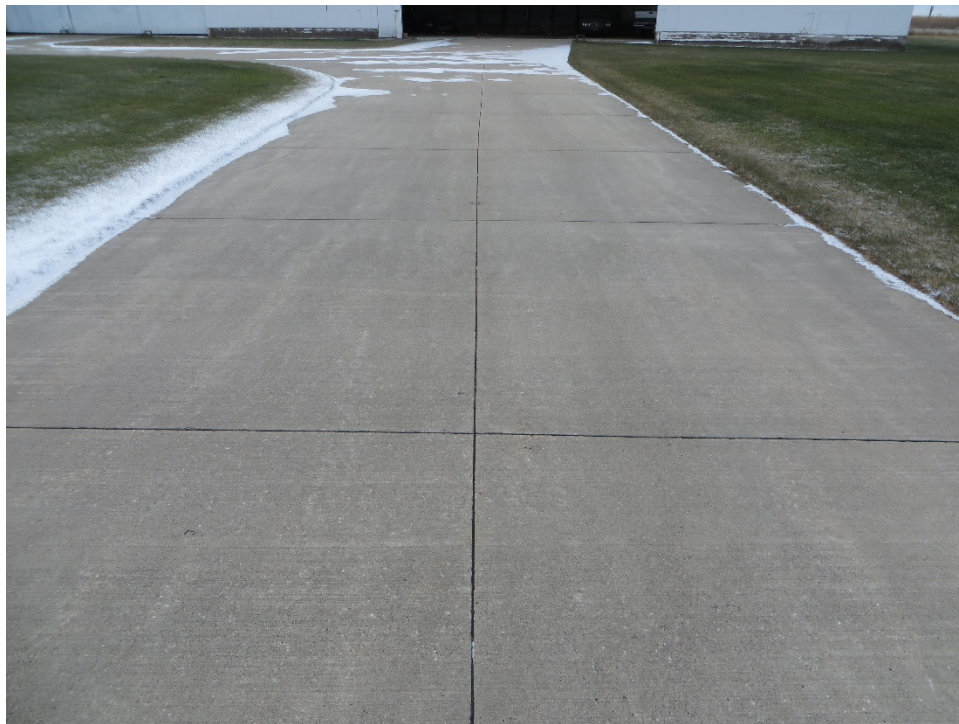
Taxiway 03 consisted of four sections that connected Taxiway 02 with the Runway 17 approach. Low-severity joint seal damage was recorded throughout Section 01 along with isolated amounts of low- and medium-severity joint spalling. Section 02 was in poor condition with low-severity corner break, low- and medium-severity LTD cracking and faulting, medium-severity joint seal damage and joint spalling, low-severity small and large patching, and popouts observed at the time of inspection. Low-severity ASR, joint spalling, large patching, and corner break; all severities of corner spalling; low- and medium-severity faulting; medium-severity joint seal damage and LTD cracking; and popouts were identified in Section 03. Section 04 was in poor condition with medium-severity faulting and joint spalling and low- and medium-severity ASR, LTD cracking, joint seal damage, shattered slab, and corner break recorded throughout.

T03IS-01. Overview.

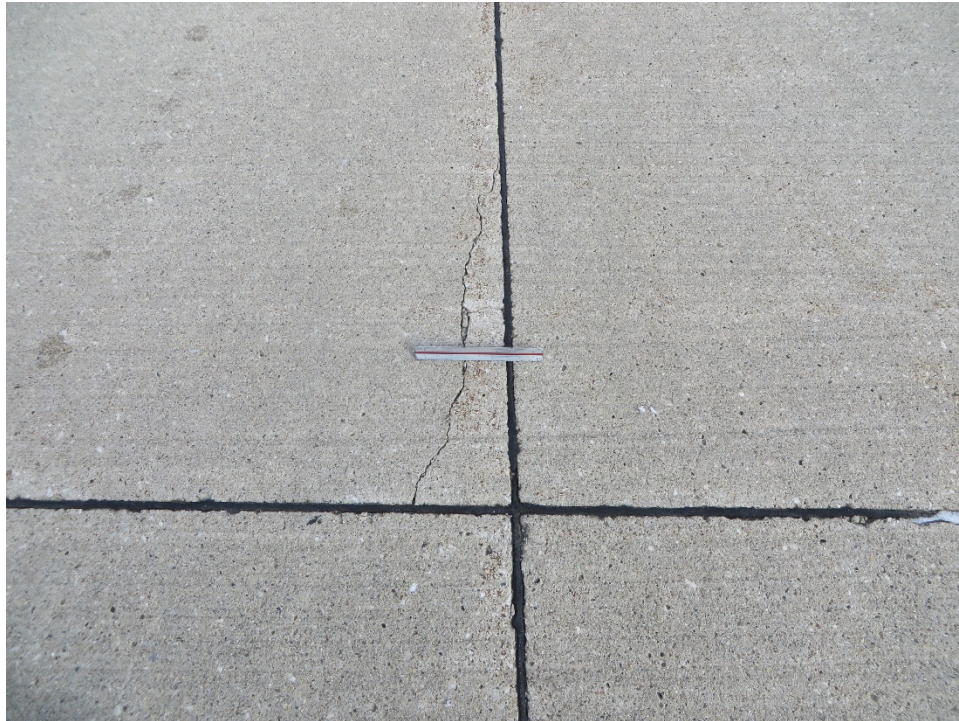
T03IS-01. Joint Spalling (Sample Unit No. 01).

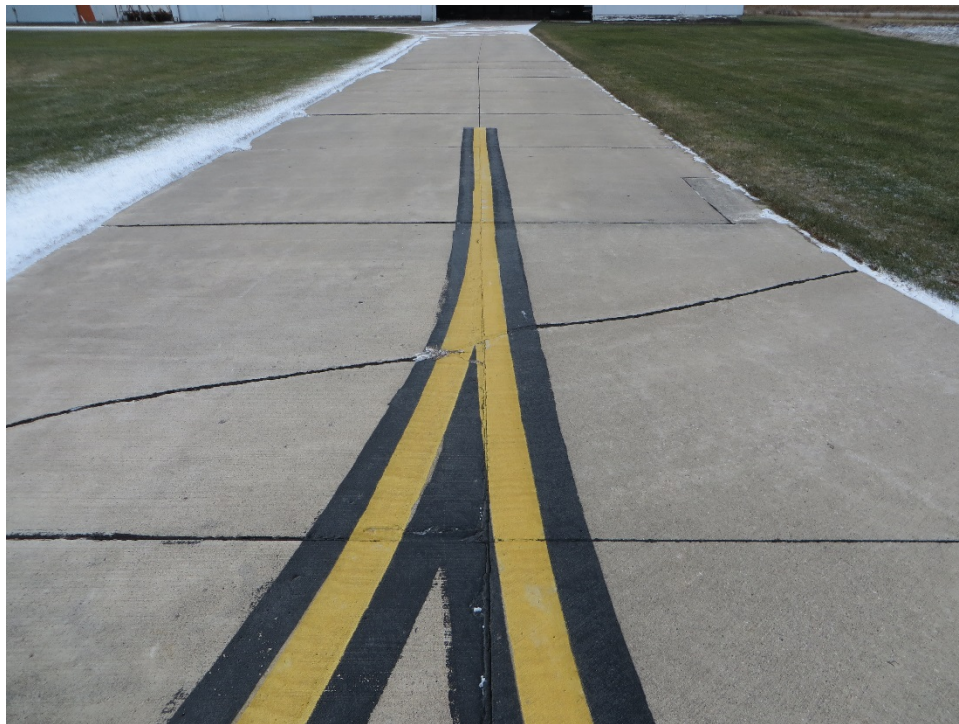
T03IS-02. Overview.

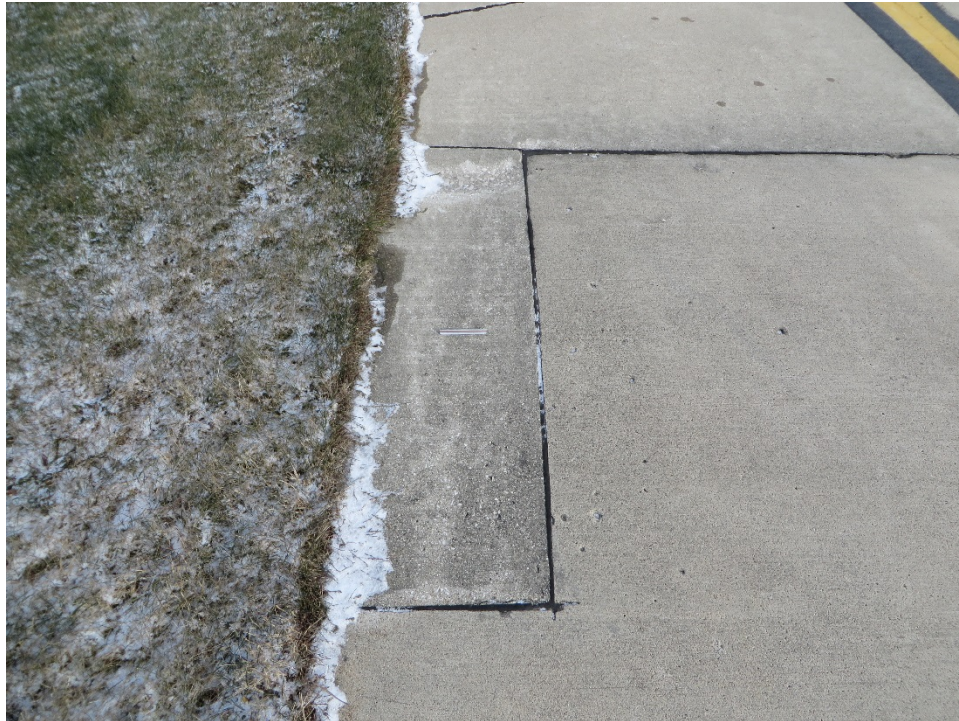
T03IS-02. Large Patching (Sample Unit No. 01).

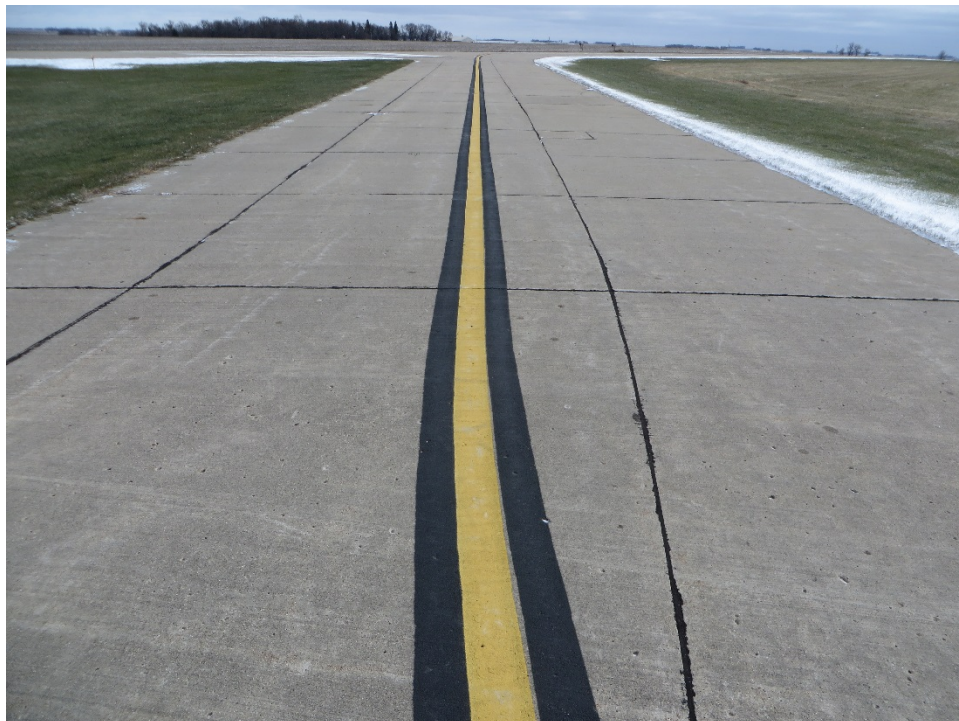
T03IS-03. Overview.

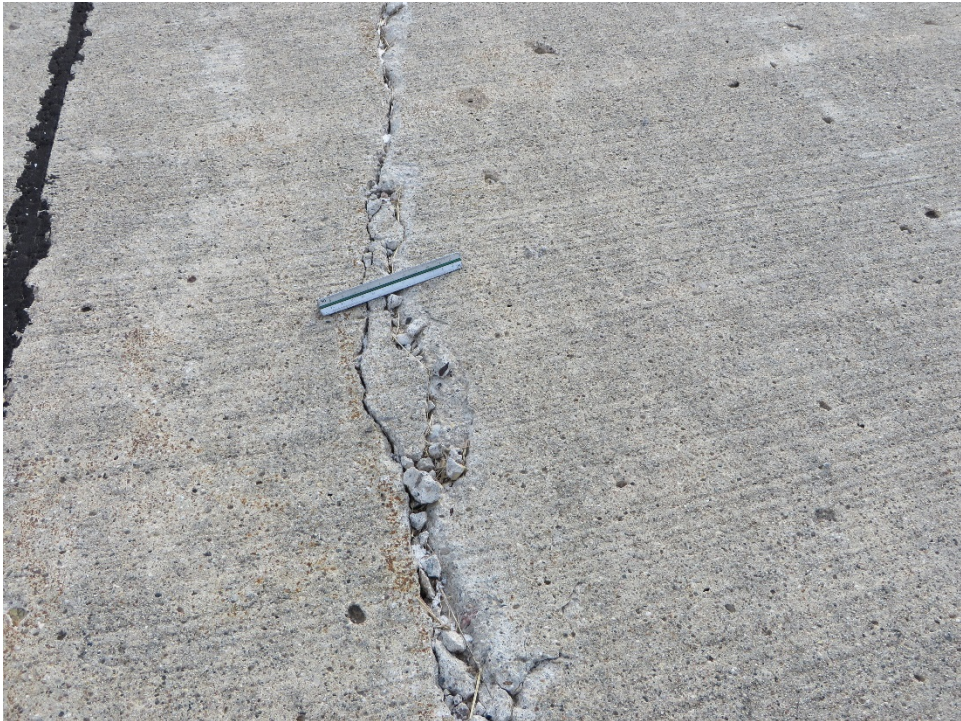
T03IS-03. LTD Cracking (Sample Unit No. 03).

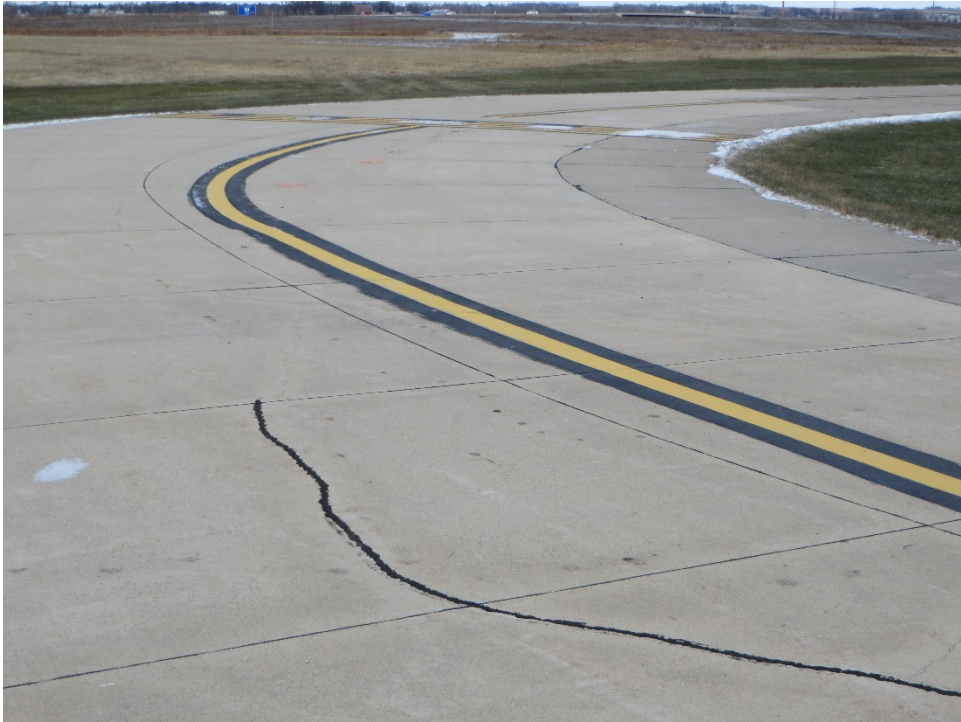
T03IS-04. Overview.

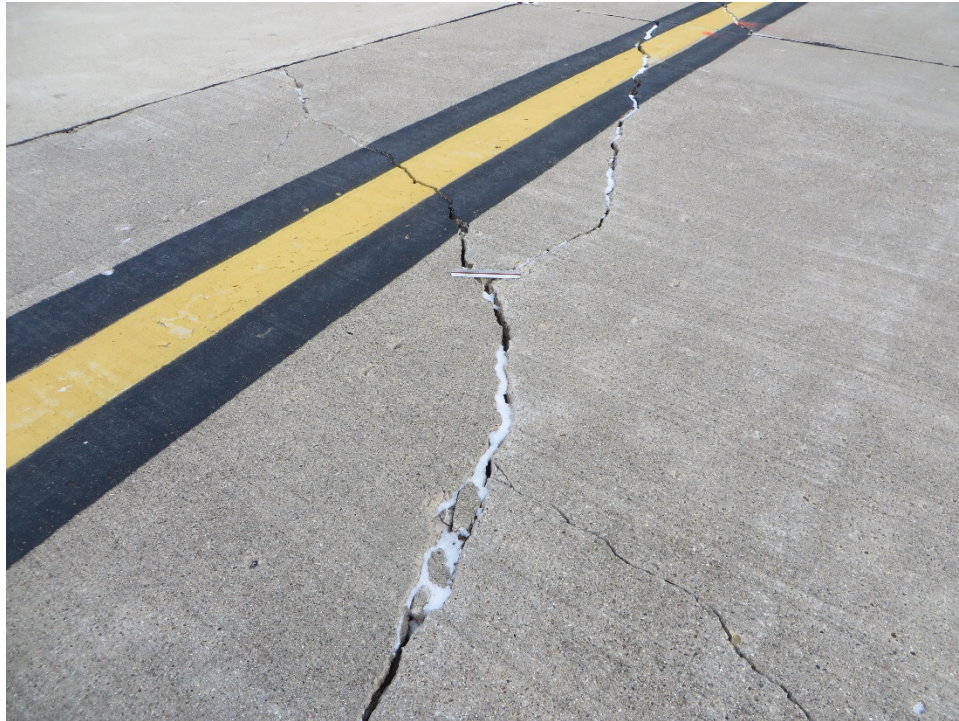
T03IS-04. Shattered Slab (Sample Unit No. 03).

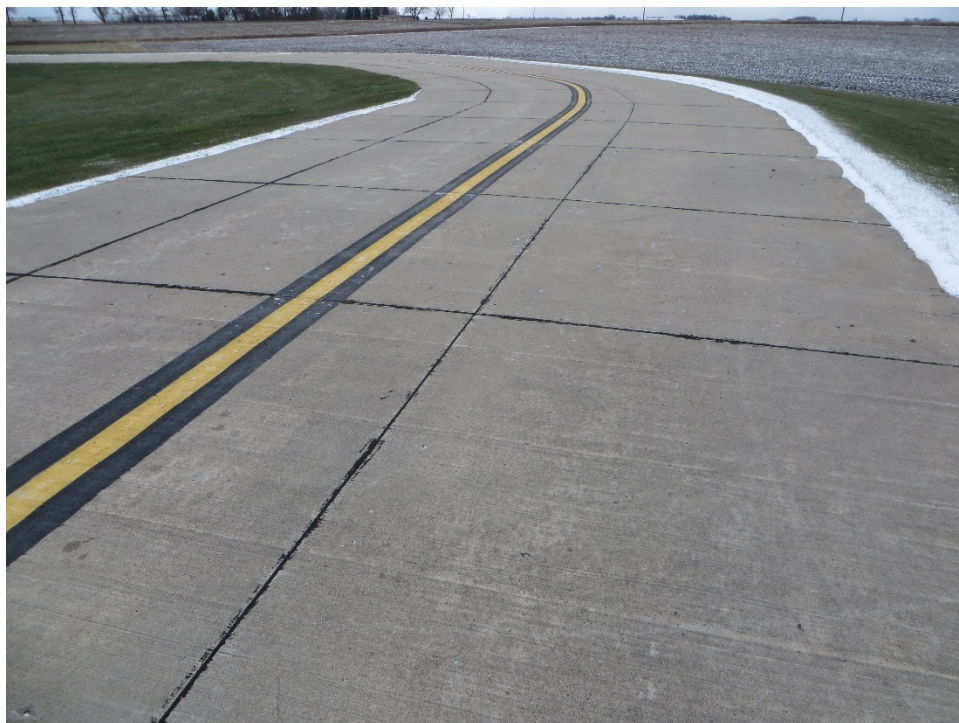
Taxiway 04, a taxiway turnaround located at the Runway 35 approach, was defined by one section. Low- and medium-severity ASR and corner spalling; low-severity corner break, joint spalling, faulting, and LTD cracking; medium-severity joint seal damage; popouts; and shrinkage cracking were observed in Section 01.

T04IS-01. Overview.

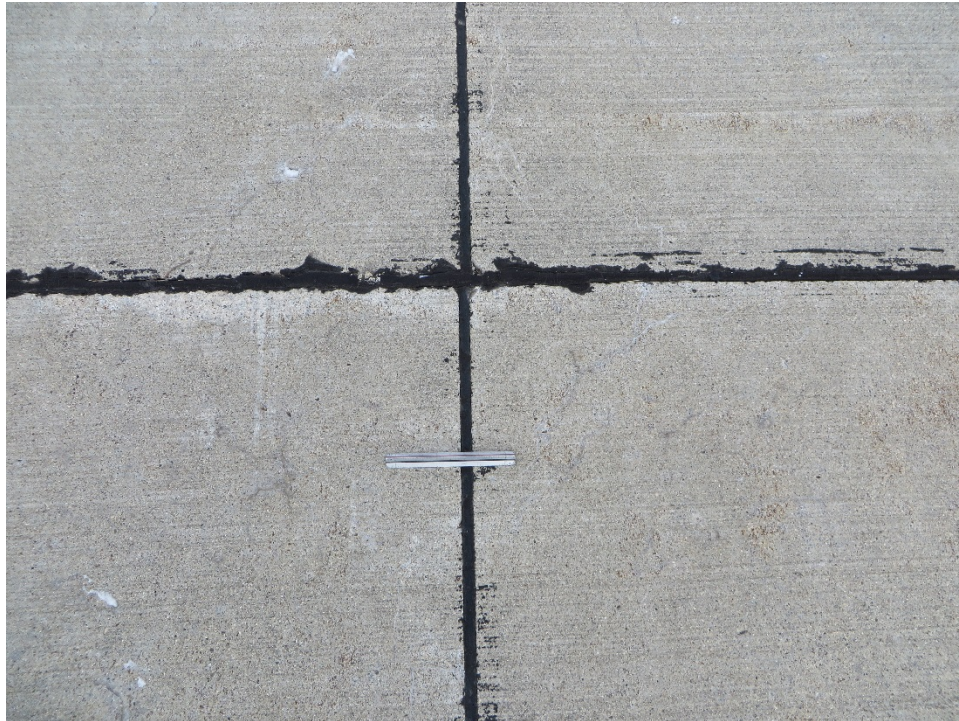
T04IS-01. ASR (Sample Unit No. 04).

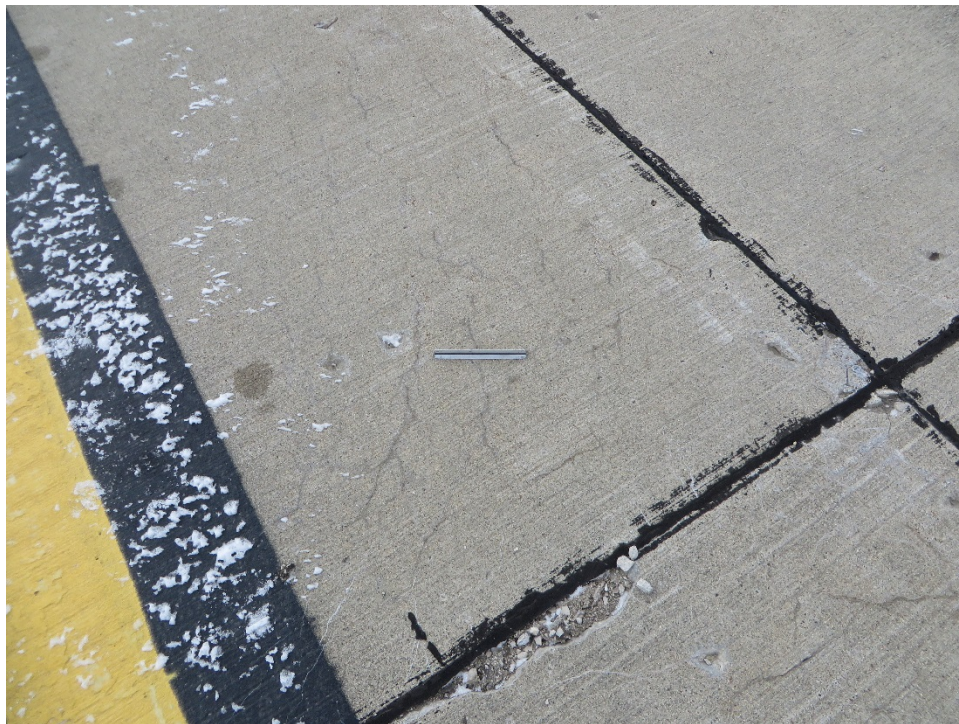
T04IS-01. ASR (Sample Unit No. 05).
