Tipton – Mathews Memorial Airport

PAVEMENT MANAGEMENT REPORT

JULY 2021

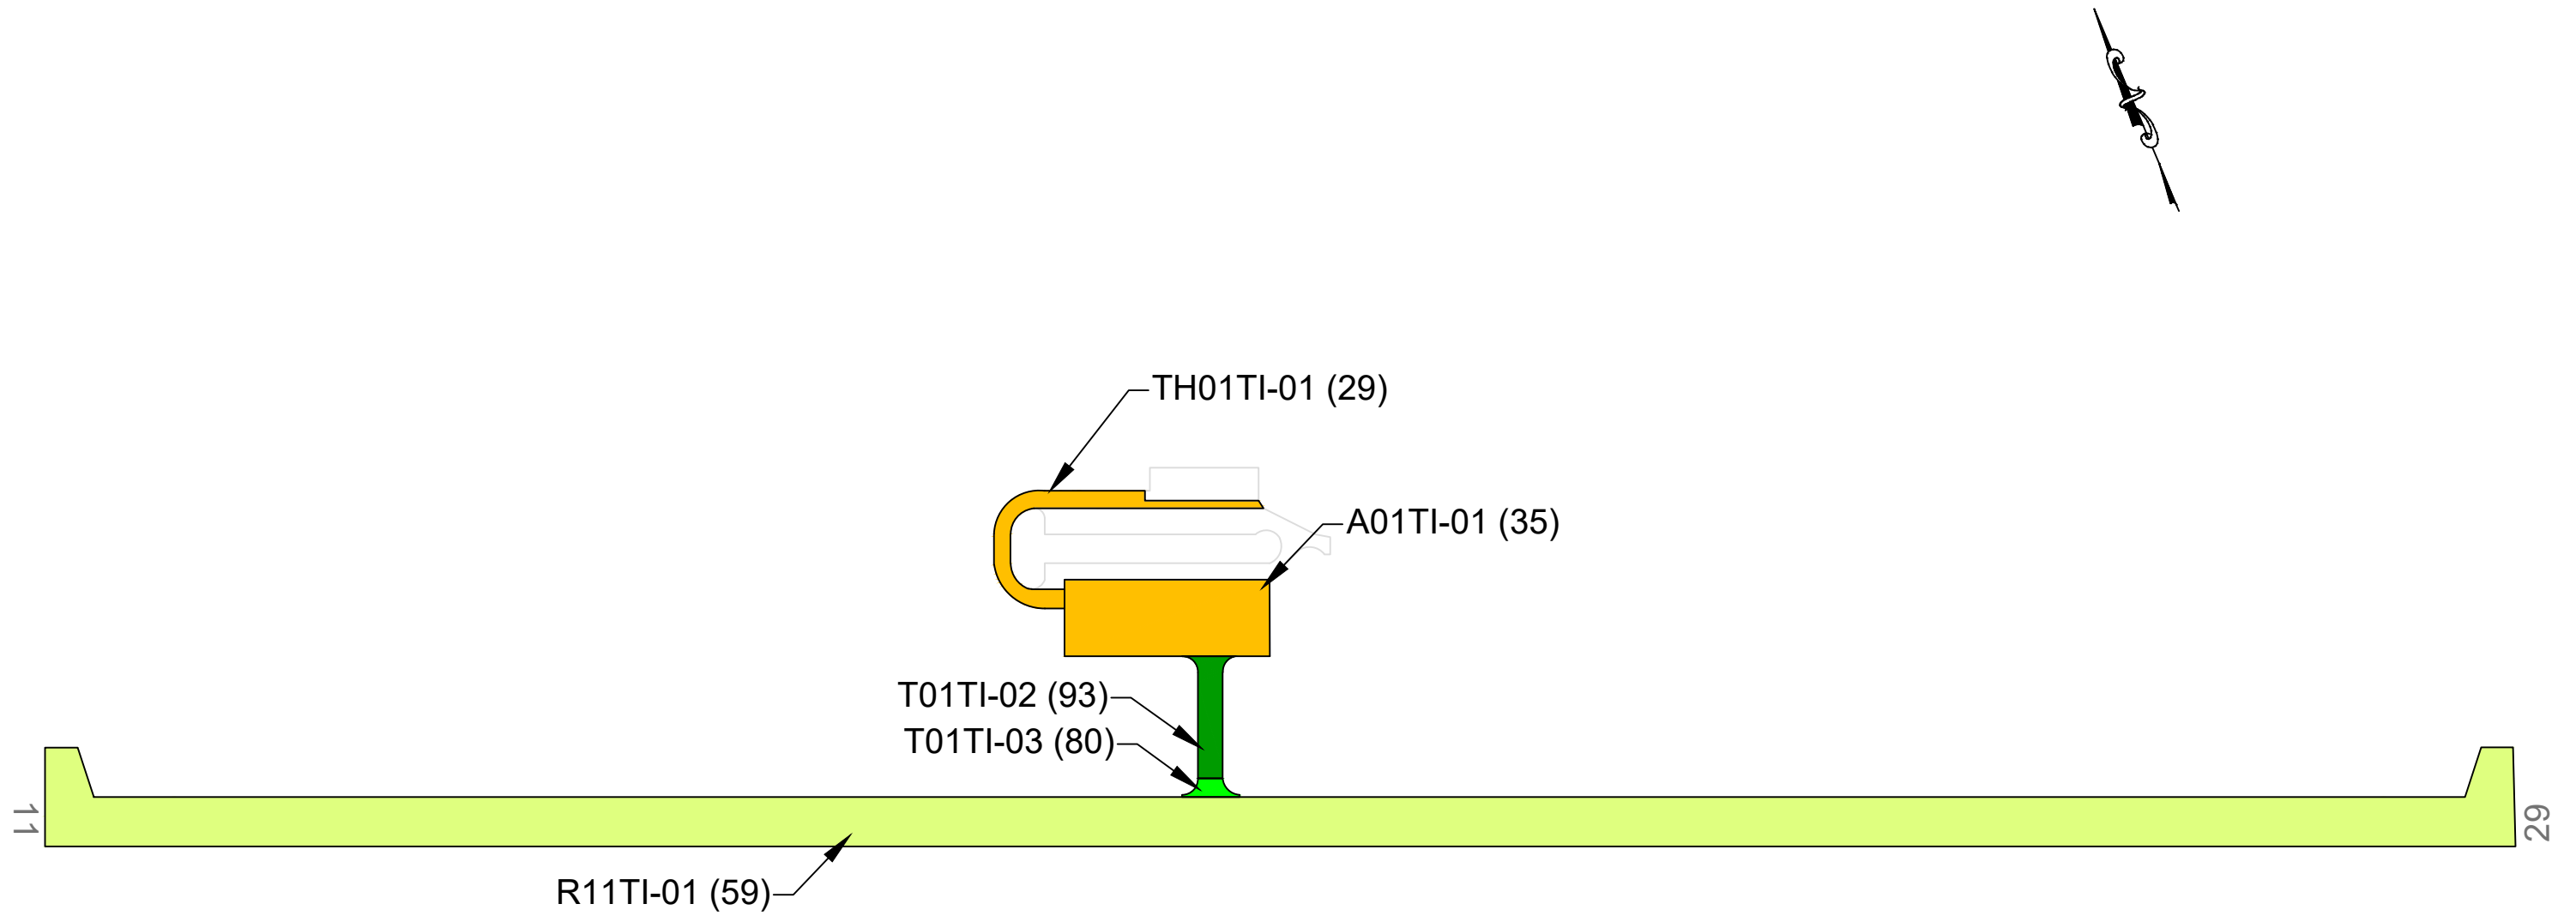
FIGURE 8. PCI MAP.

The pavements at Tipton - Mathews Memorial Airport were inspected in November 2020. The 2020 area-weighted condition of Tipton - Mathews Memorial Airport is 56, with conditions ranging from 29 to 93 (on a scale of 0 [failed] to 100 [excellent]). During the previous pavement inspection in 2017, the area-weighted PCI of the airport was 67.

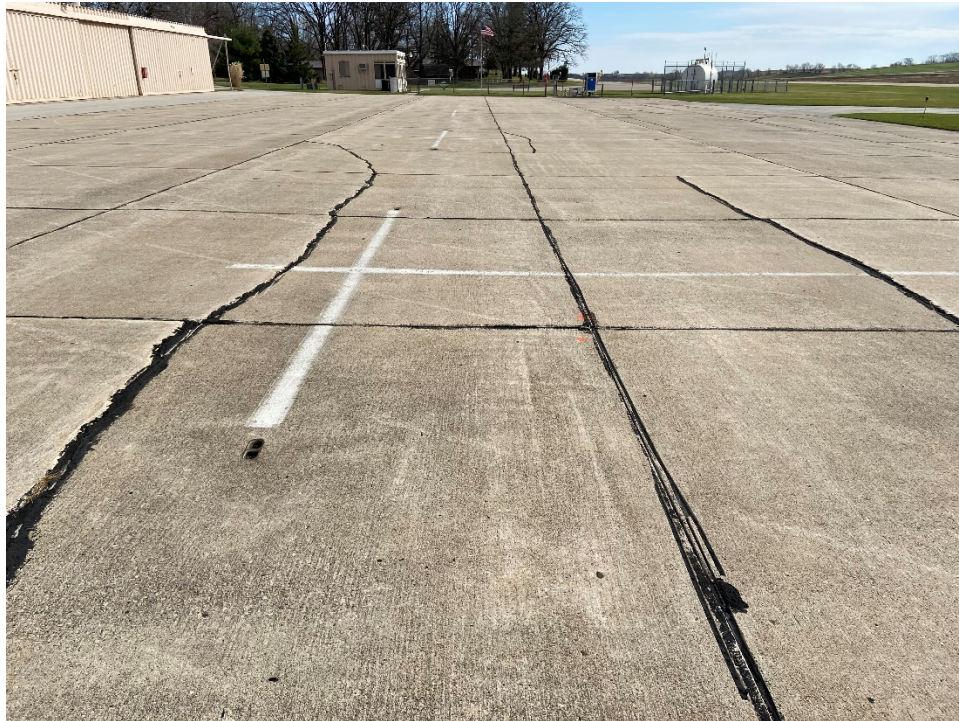
The apron area was defined by one section that was in poor condition. Low-severity scaling and large patching; low- and medium-severity corner break, faulting, joint spalling, and LTD cracking; and medium-severity joint seal damage and shattered slab were identified in Section 01 at the time of the inspection.

A01TI-01. Overview.

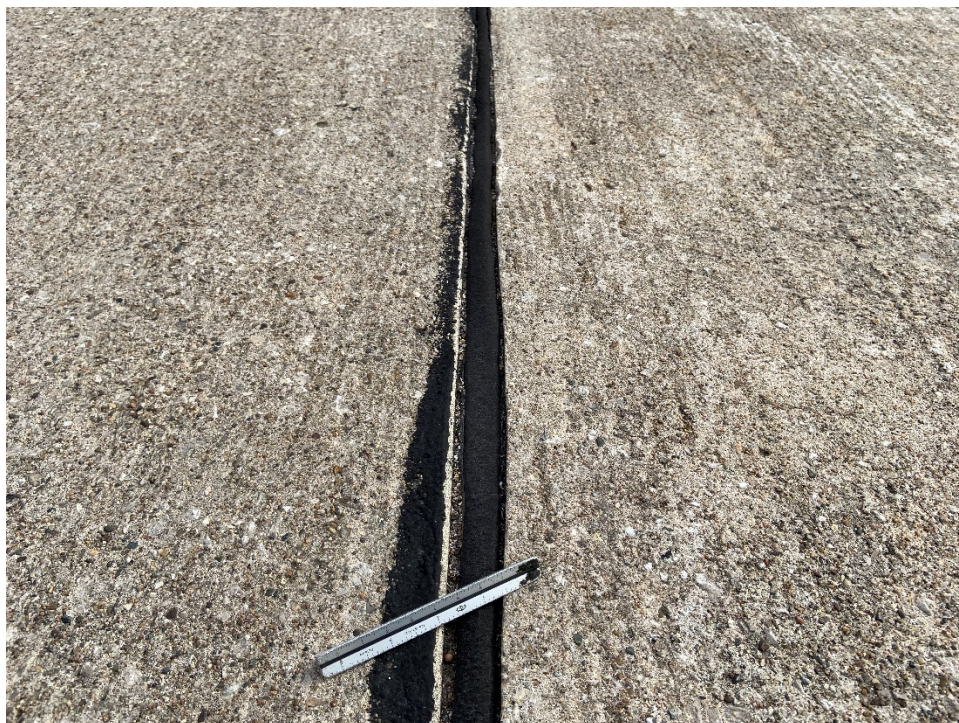
A01TI-01. Joint Seal Damage (Sample Unit No. 03).

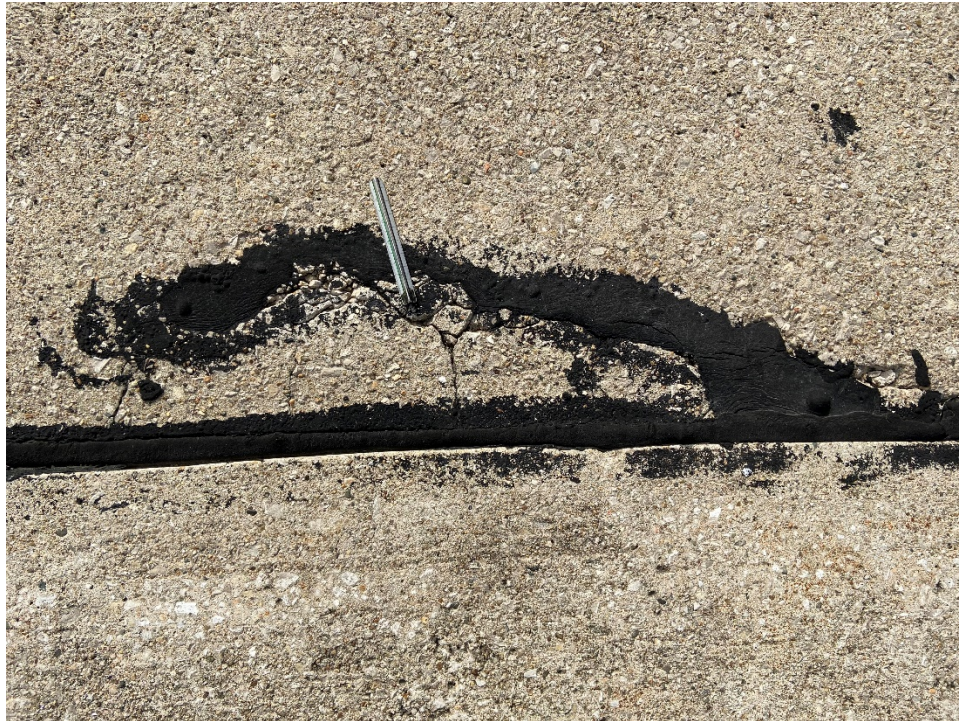
A01TI-01. Joint Spalling (Sample Unit No. 02).

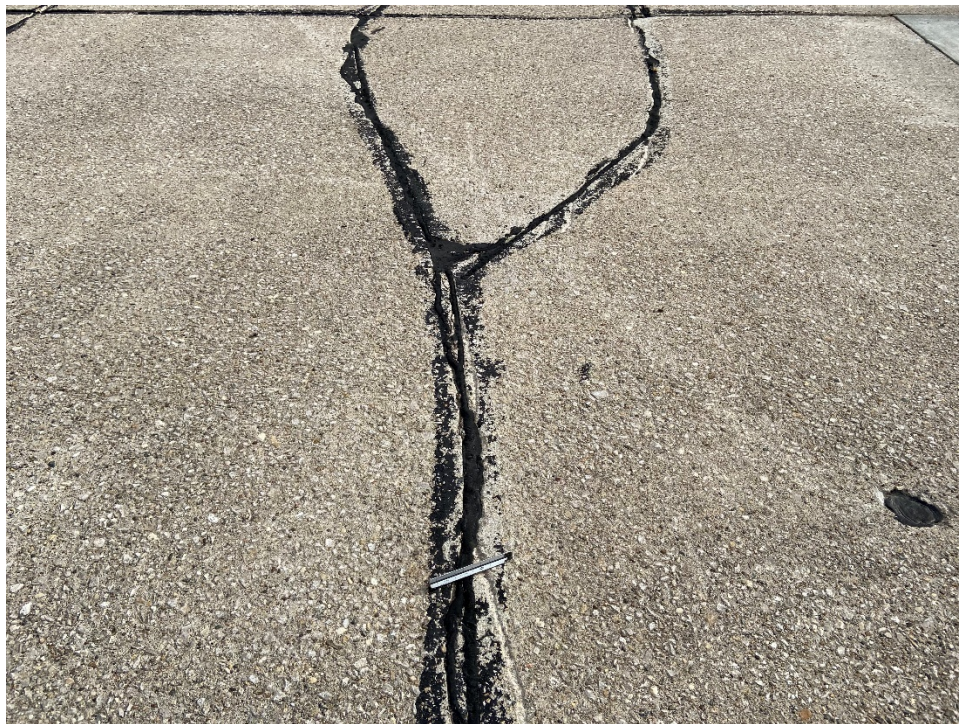
A01TI-01. LTD Cracking (Sample Unit No. 02).

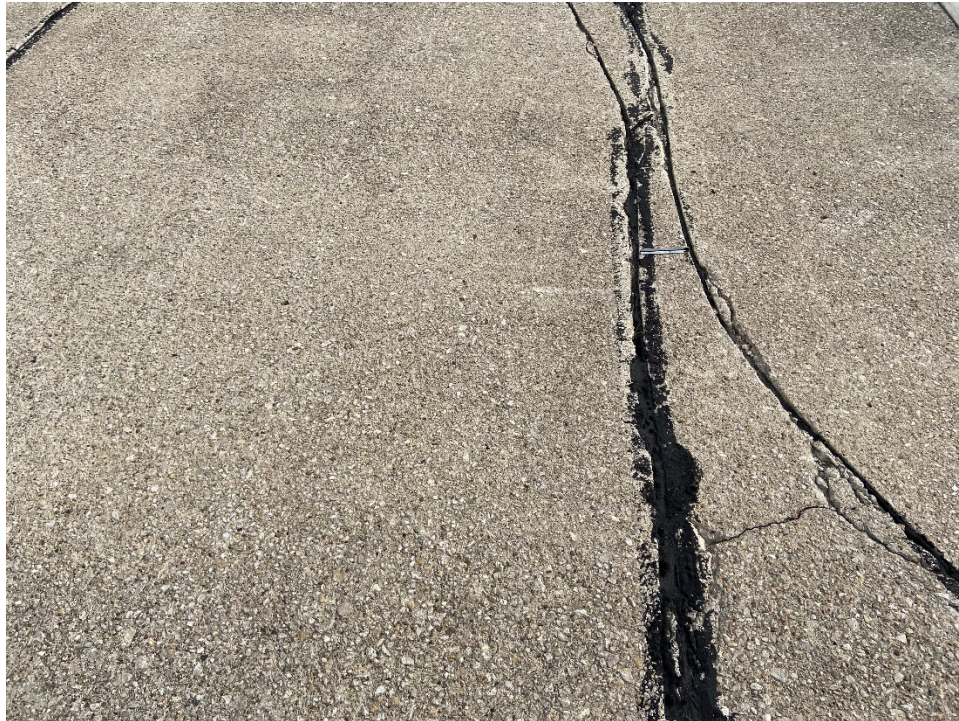
A01TI-01. Shattered Slab (Sample Unit No. 02).

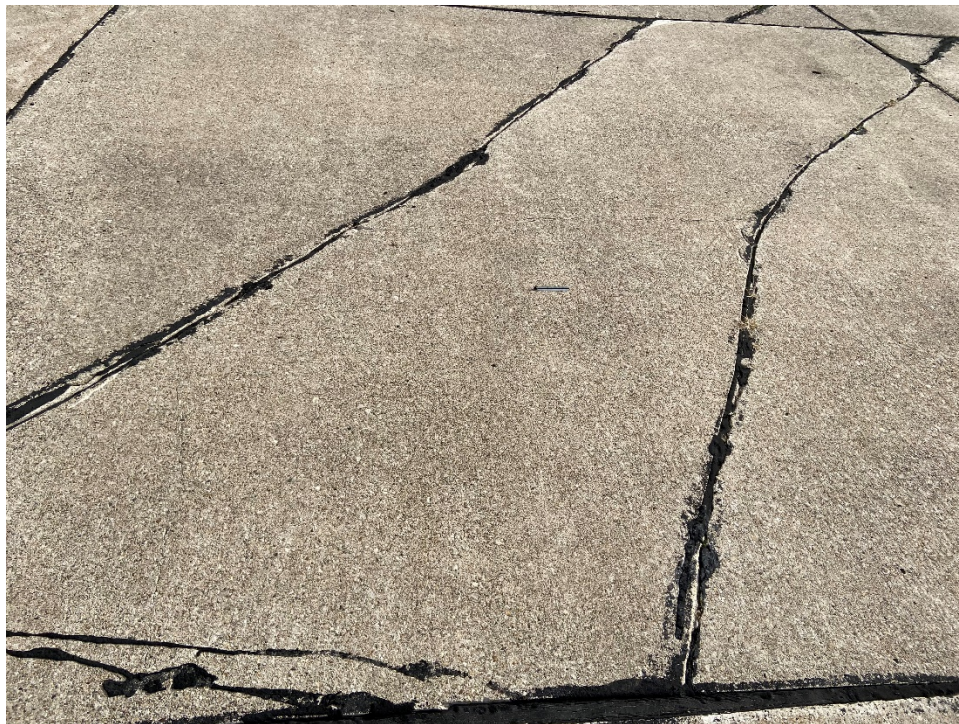
A01TI-01. Shattered Slab (Sample Unit No. 05).

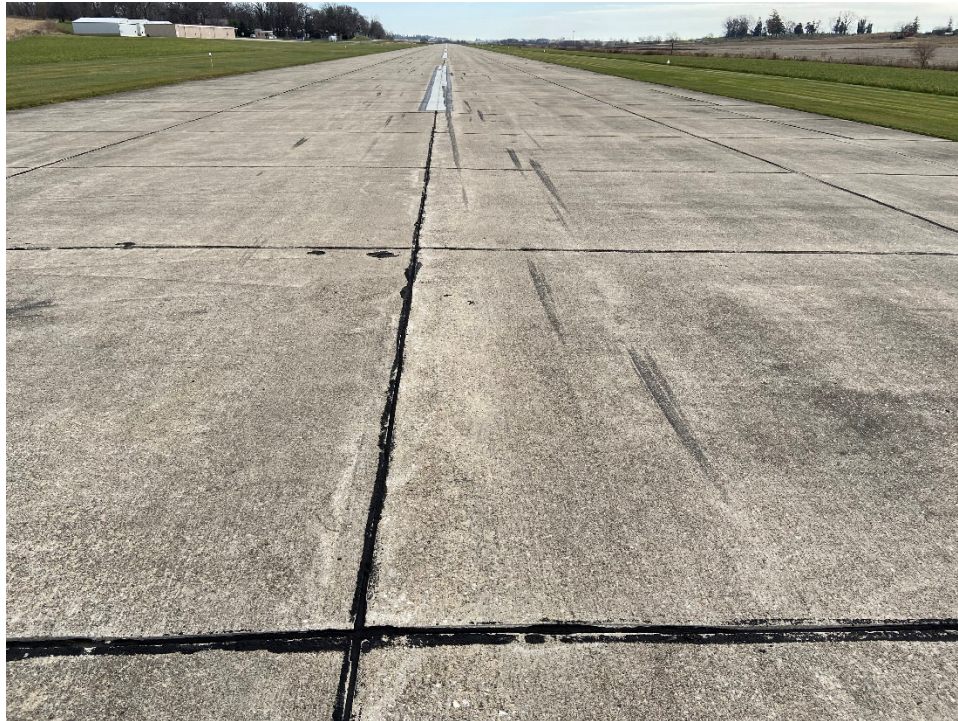
Runway 11/29 was defined by one section. Section 01 had areas of low-severity corner break and small patching; low- and medium-severity joint spalling and longitudinal, transverse, and diagonal (LTD) cracking; and medium-severity corner spalling, large patching, and joint seal damage recorded during the inspection.

R11TI-01. Overview.

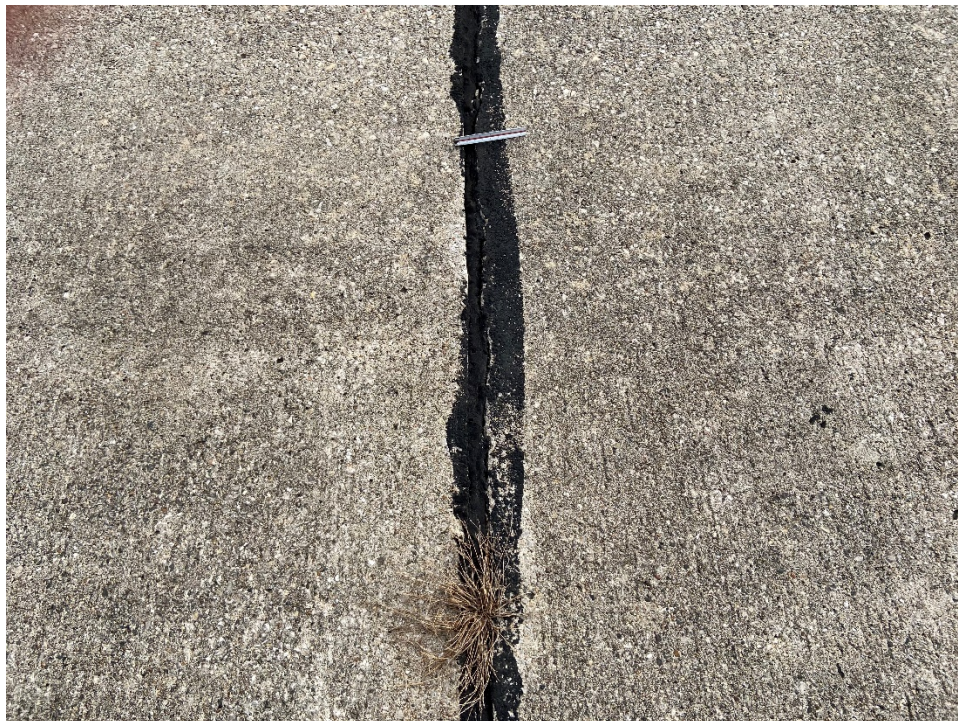
R11TI-01. LTD Cracking (Sample Unit No. 05).

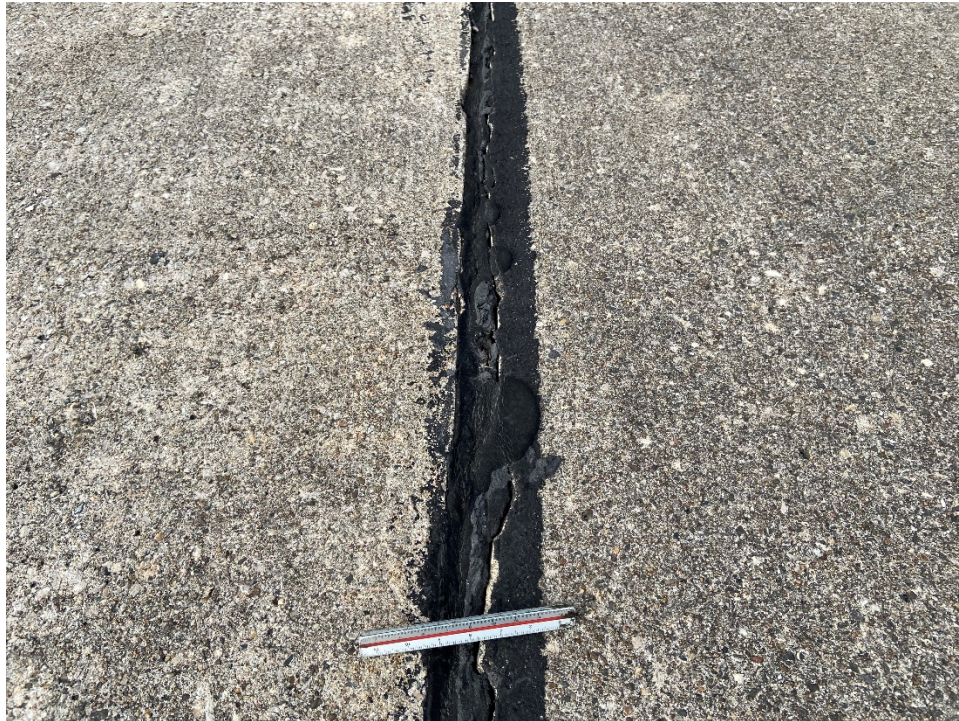
R11TI-01. LTD Cracking (Sample Unit No. 30).

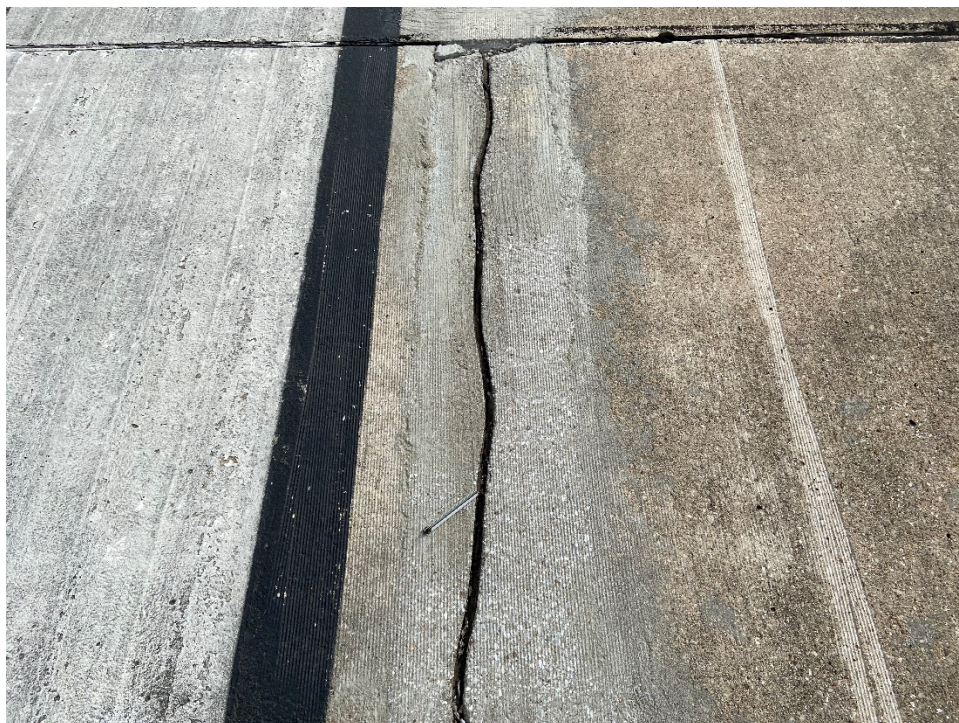
R11TI-01. Large Patching (Sample Unit No. 05).

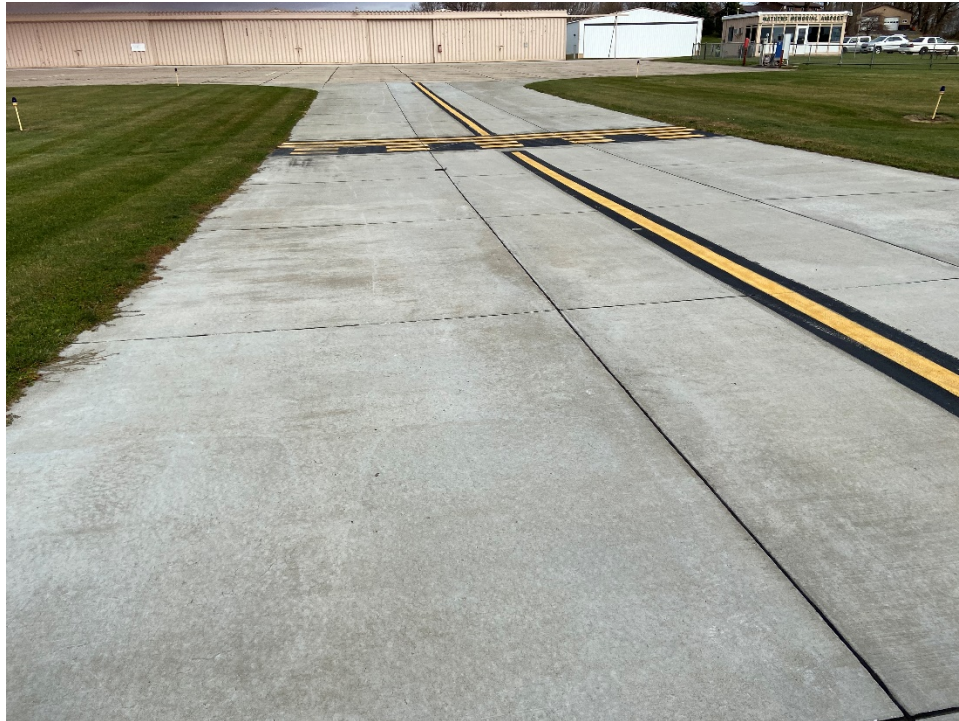
T01TI-02. Overview.

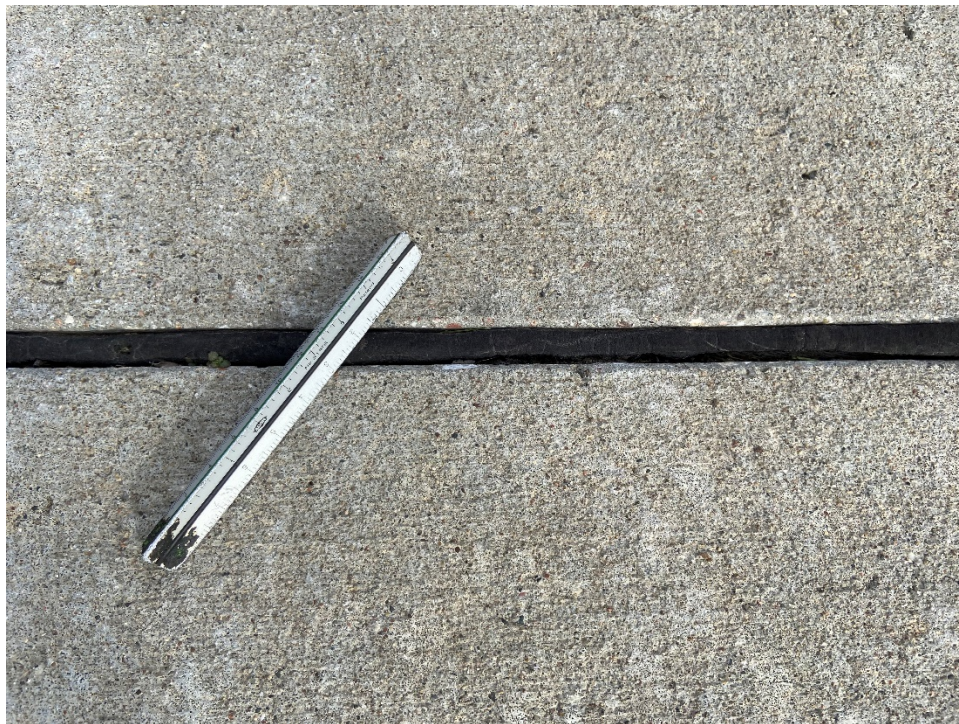
T01TI-02. Joint Seal Damage (Sample Unit No. 01).

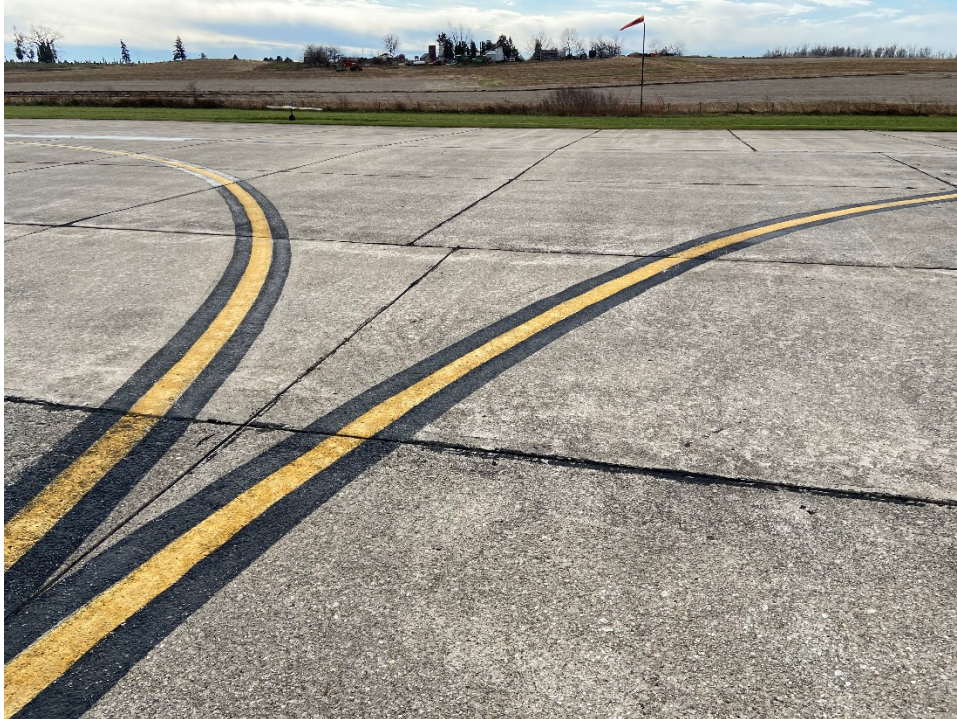
T01TI-03. Overview.

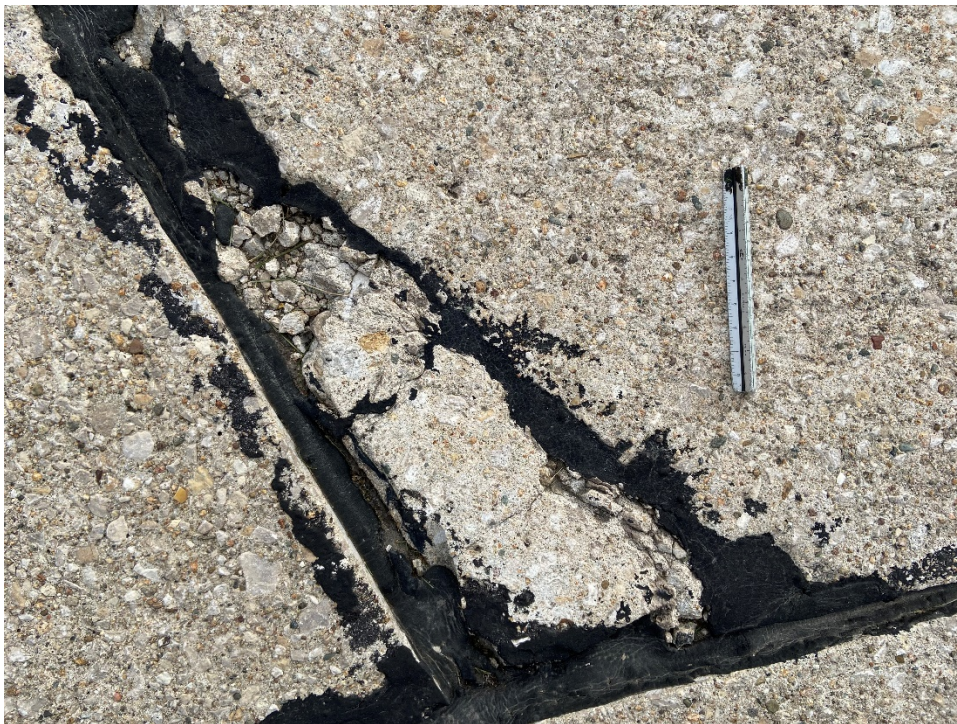
T01TI-03. Joint Spalling (Sample Unit No. 01) (1).

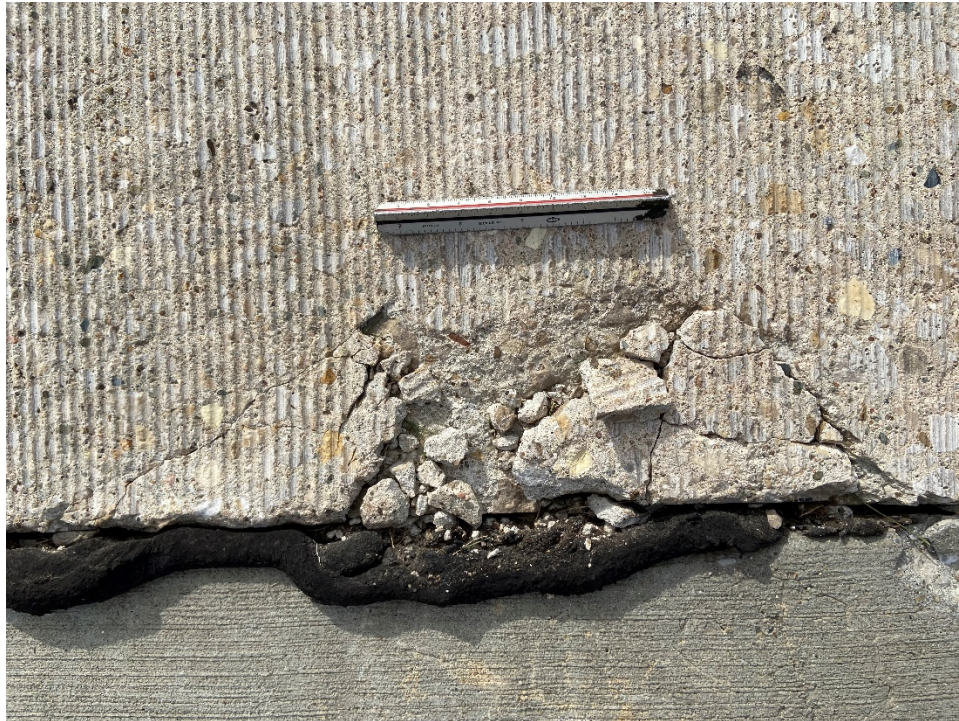
T01TI-03. Joint Spalling (Sample Unit No. 01) (2).

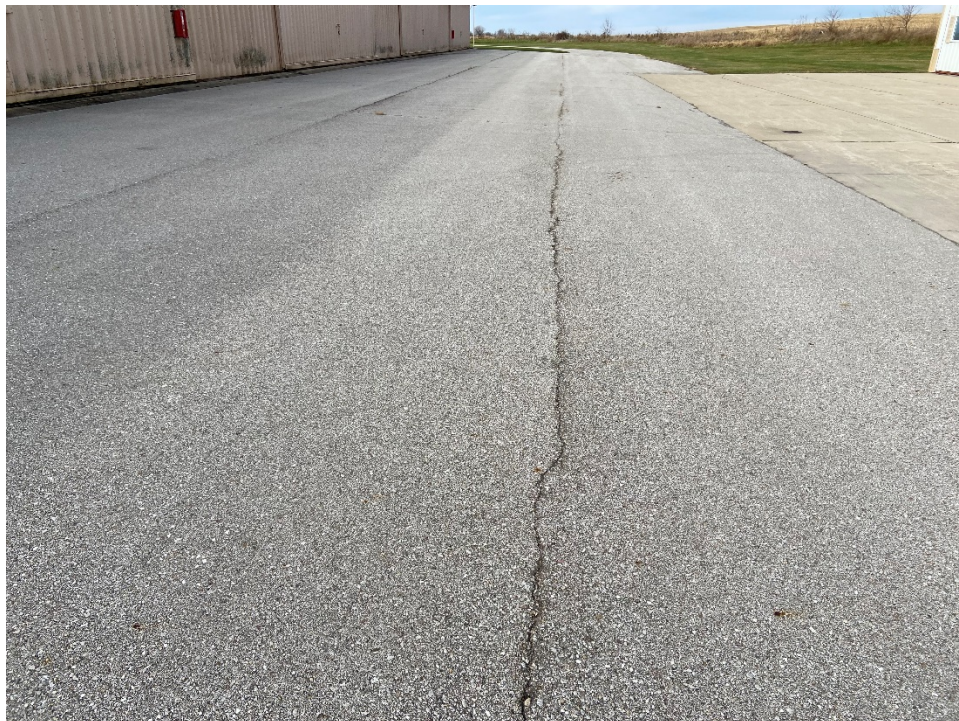
The T-Hangar area contained one section in poor condition. Low-severity, unsealed longitudinal and transverse (L&T) cracking was recorded in Section 01, along with medium-severity L&T cracking that was due to either unsealed crack widths that exceeded $\frac{1}{4}$ in or to the development of secondary cracking. Additionally, low-severity weathering and medium- and high-severity alligator cracking were observed.

TH01TI-01. Overview.

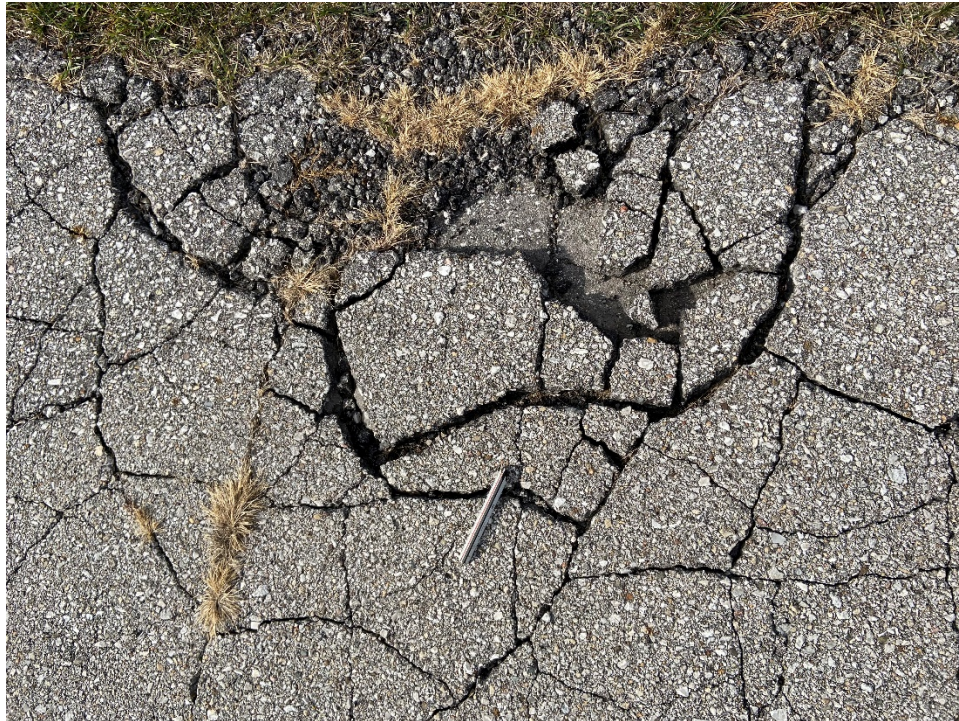
TH01TI-01. Alligator Cracking (Sample Unit No. 01).

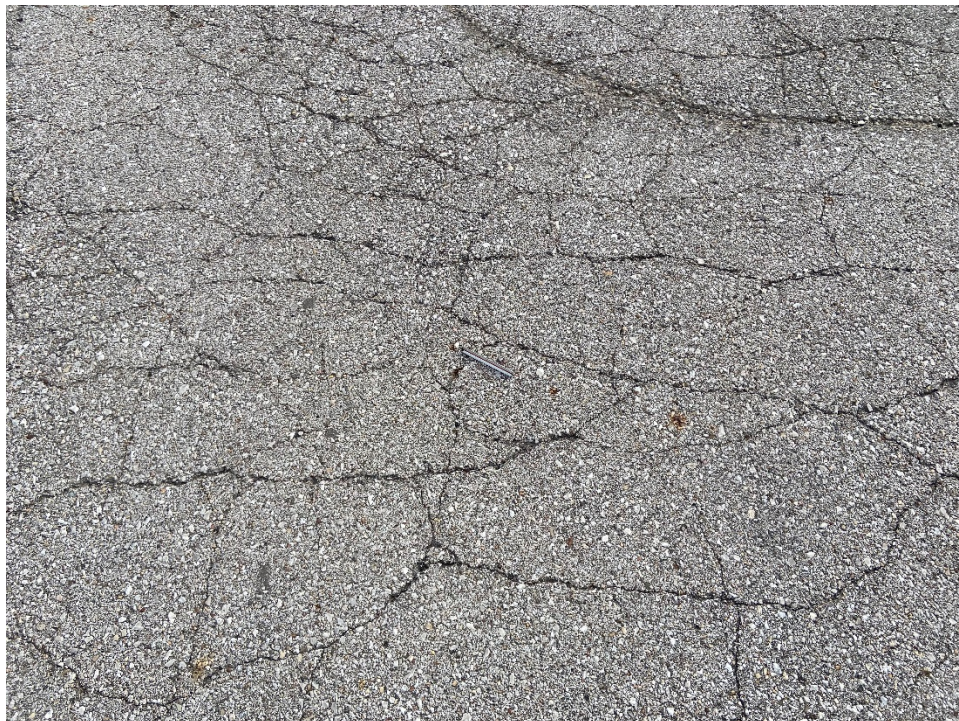
TH01TI-01. Alligator Cracking (Sample Unit No. 02).
