# West Union – George L. Scott Airport

## PAVEMENT MANAGEMENT REPORT

**JULY 2021**

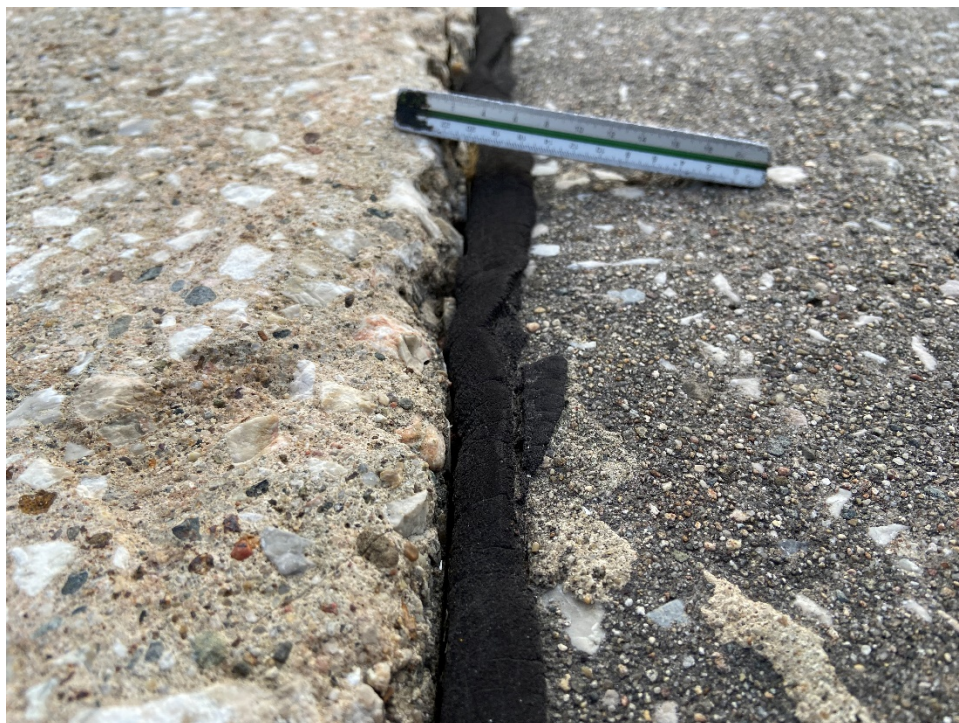
A01WU-01. Faulting (Sample Unit No. 02).

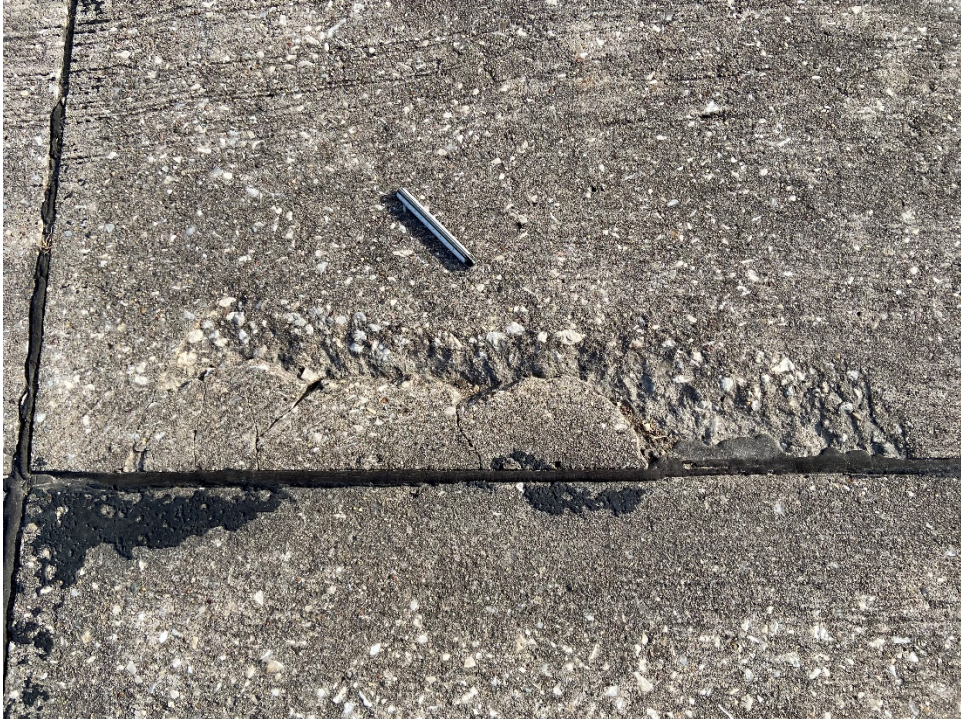
A01WU-01. Joint Spalling (Sample Unit No. 01).

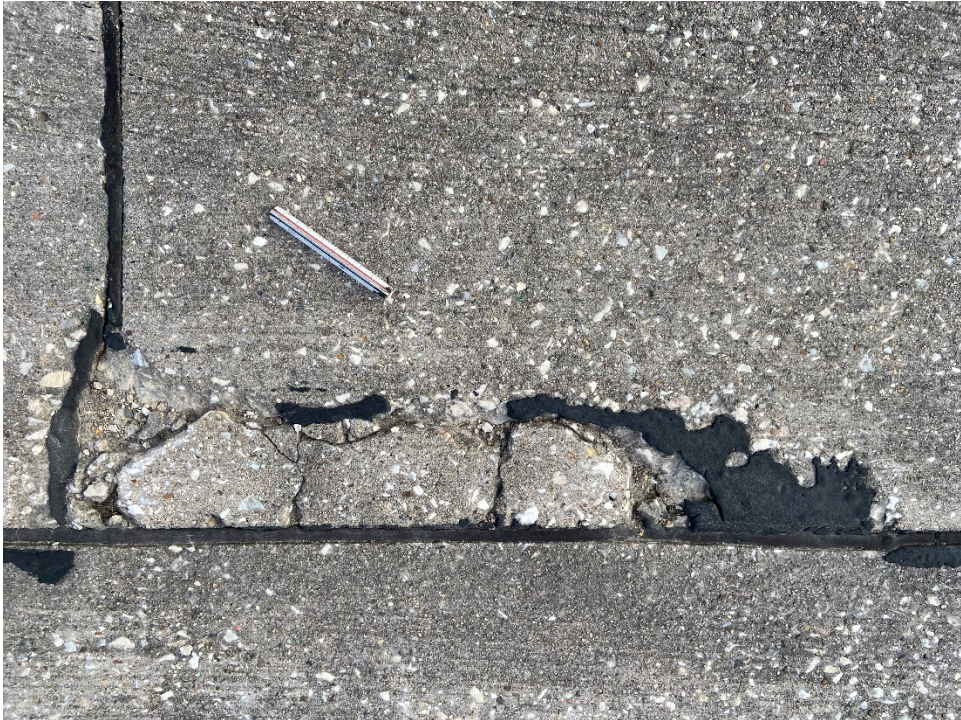
A01WU-01. Joint Spalling (Sample Unit No. 02) (1).

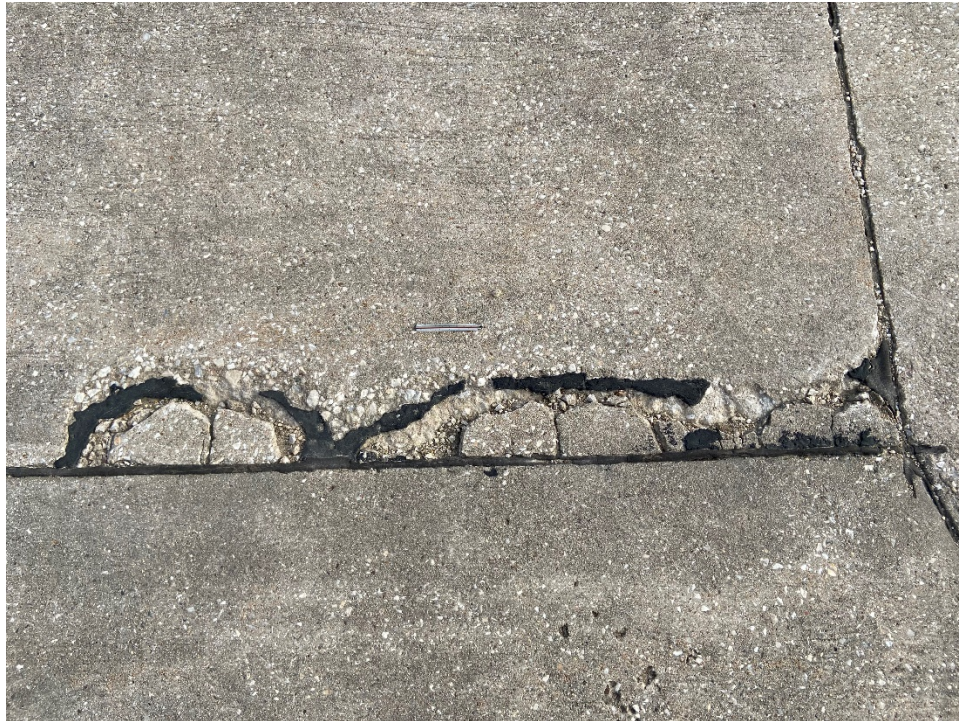
A01WU-01. Joint Spalling (Sample Unit No. 02) (2).

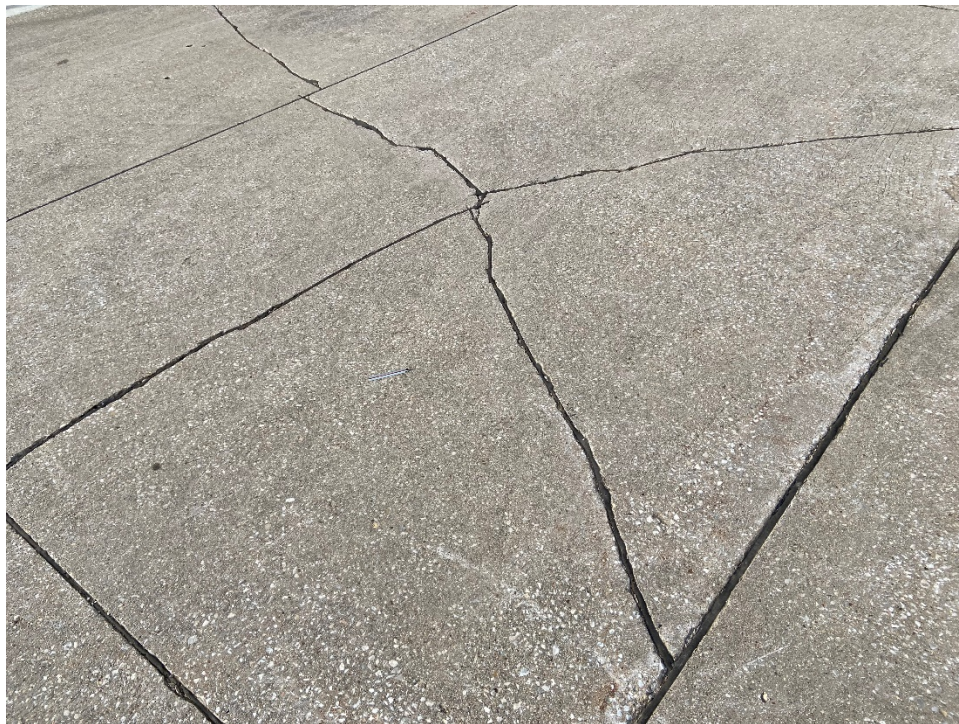
A01WU-01. Shattered Slab (Sample Unit No. 02).

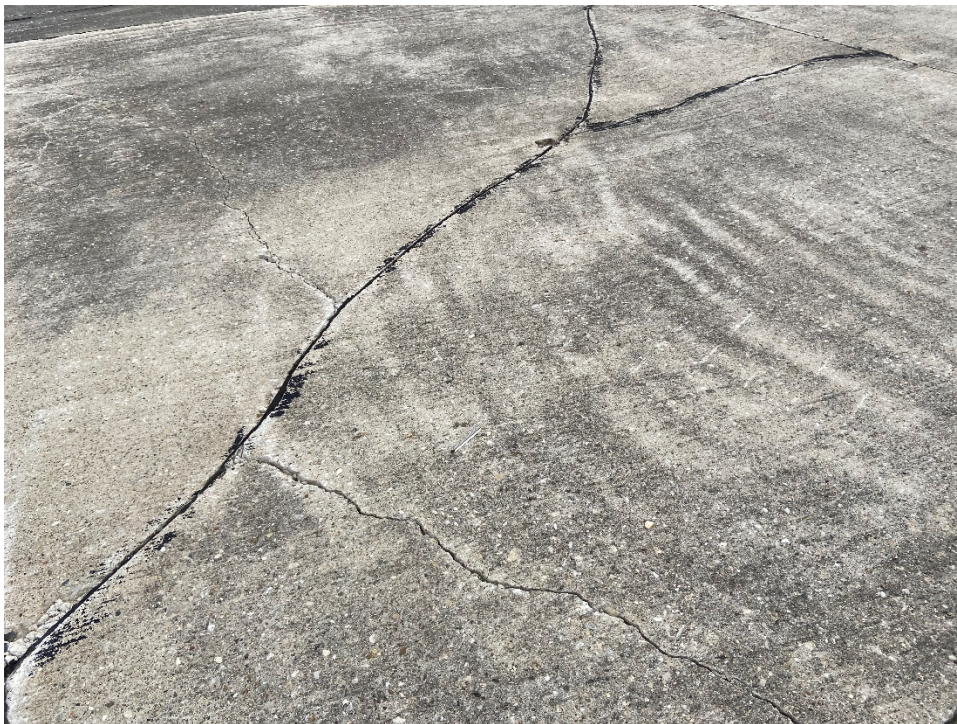
A01WU-02. Shattered Slab (Sample Unit No. 01).

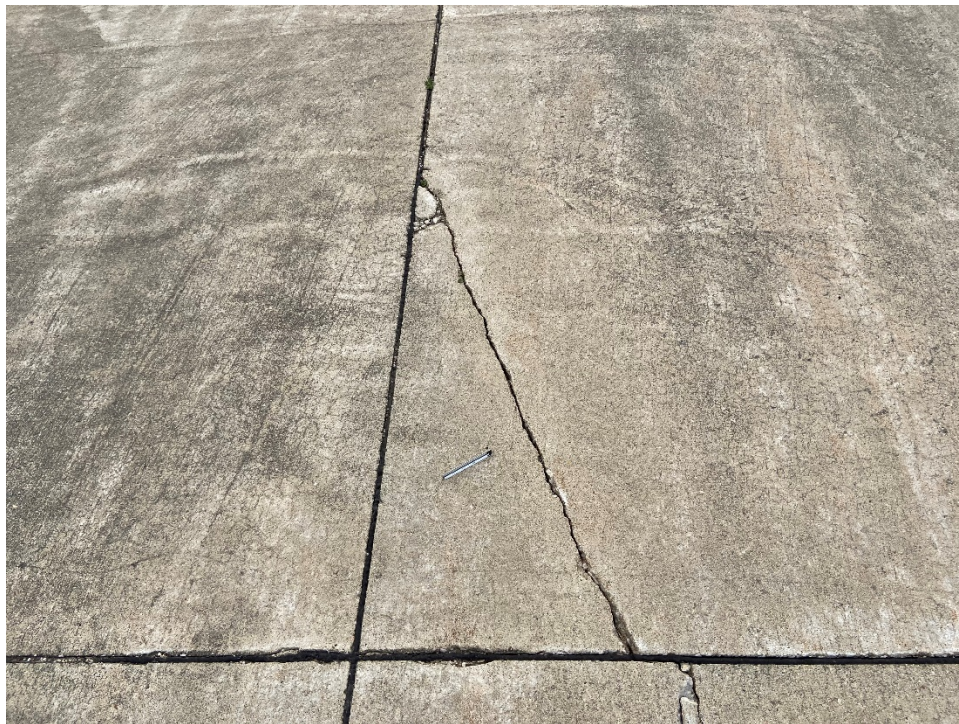
A01WU-03. Corner Break (Sample Unit No. 01).

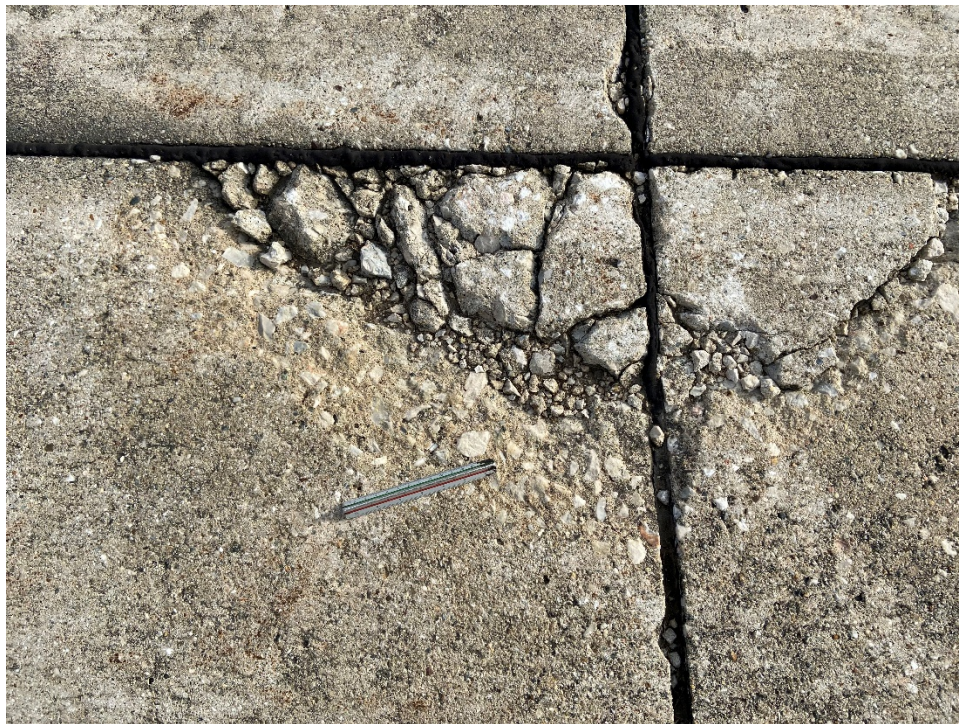
A01WU-04. Corner Spalling (Sample Unit No. 05).

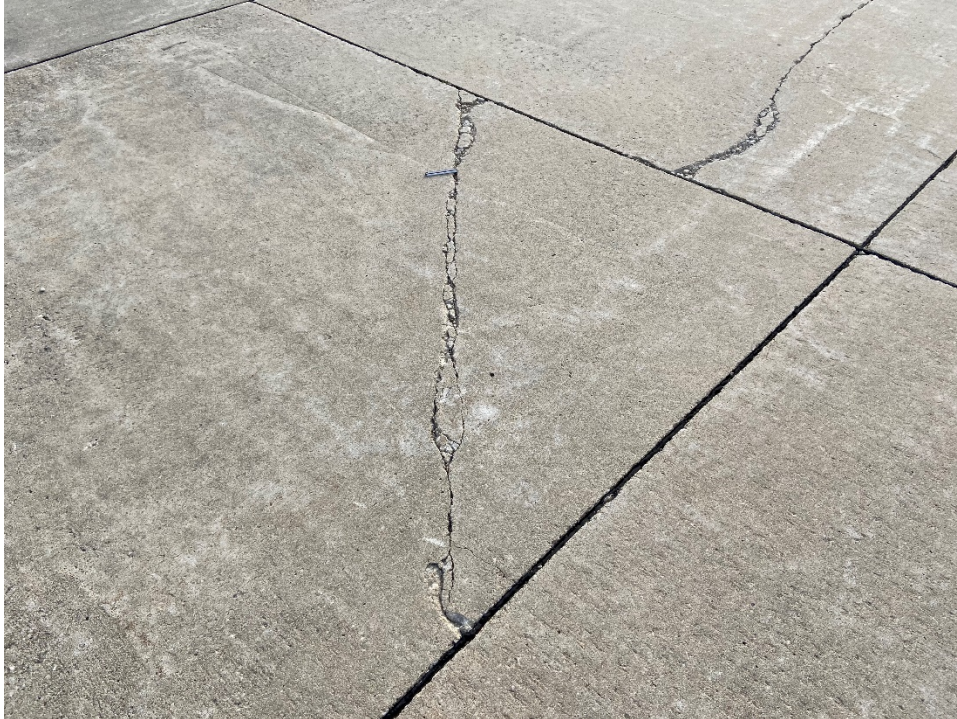
A01WU-04. LTD Cracking (Sample Unit No. 01).

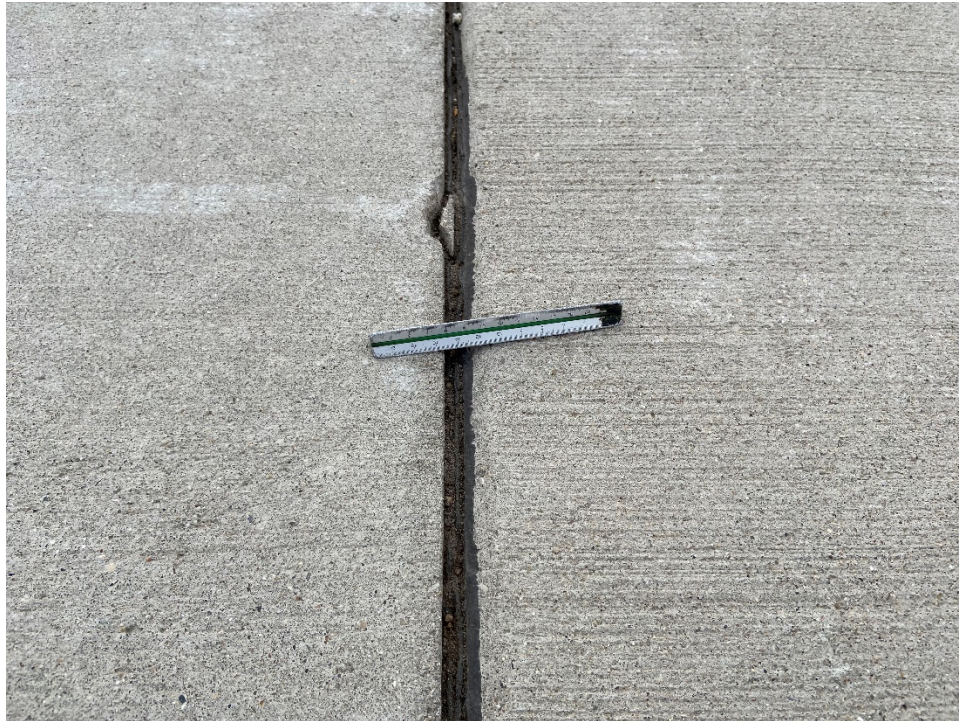
A01WU-05. Joint Seal Damage (Sample Unit No. 01).

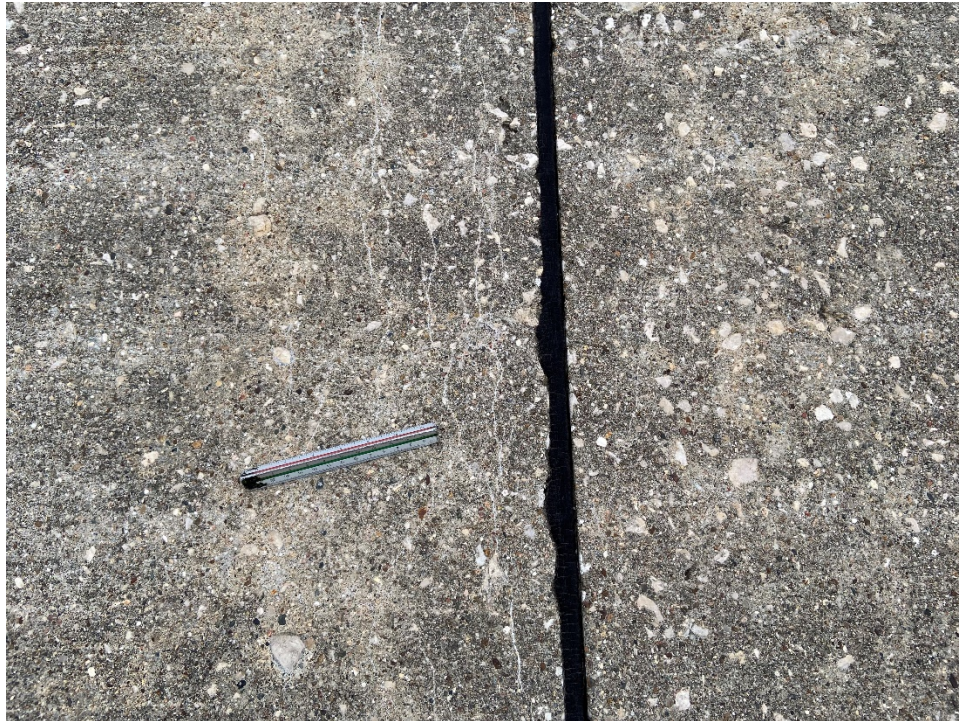
R17WU-01. ASR (Sample Unit No. 09).

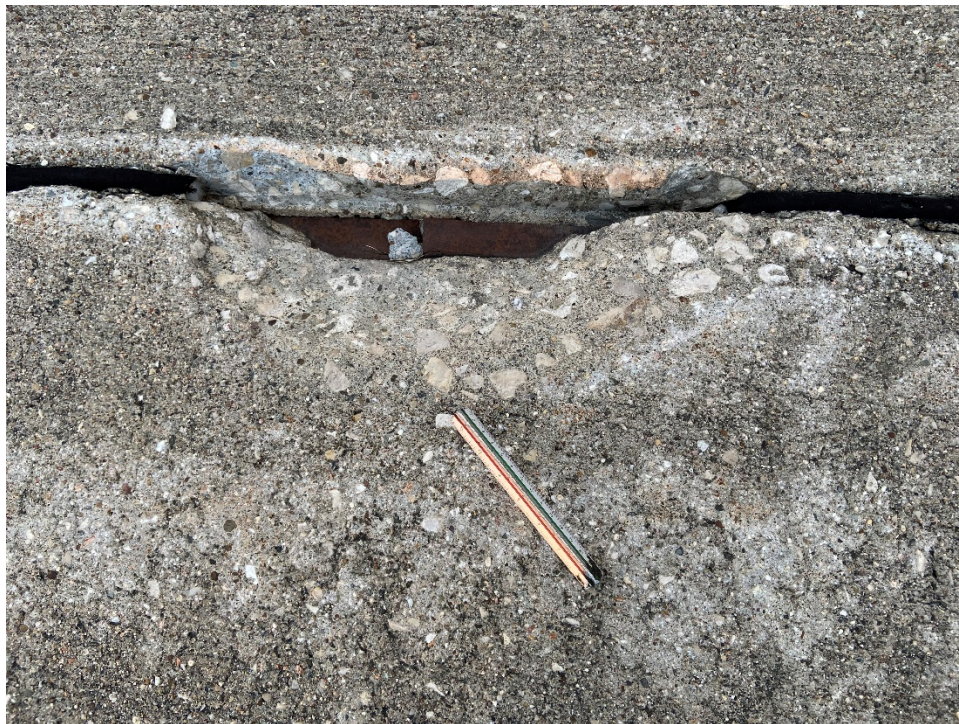
R17WU-01. Joint Spalling (Sample Unit No. 04).

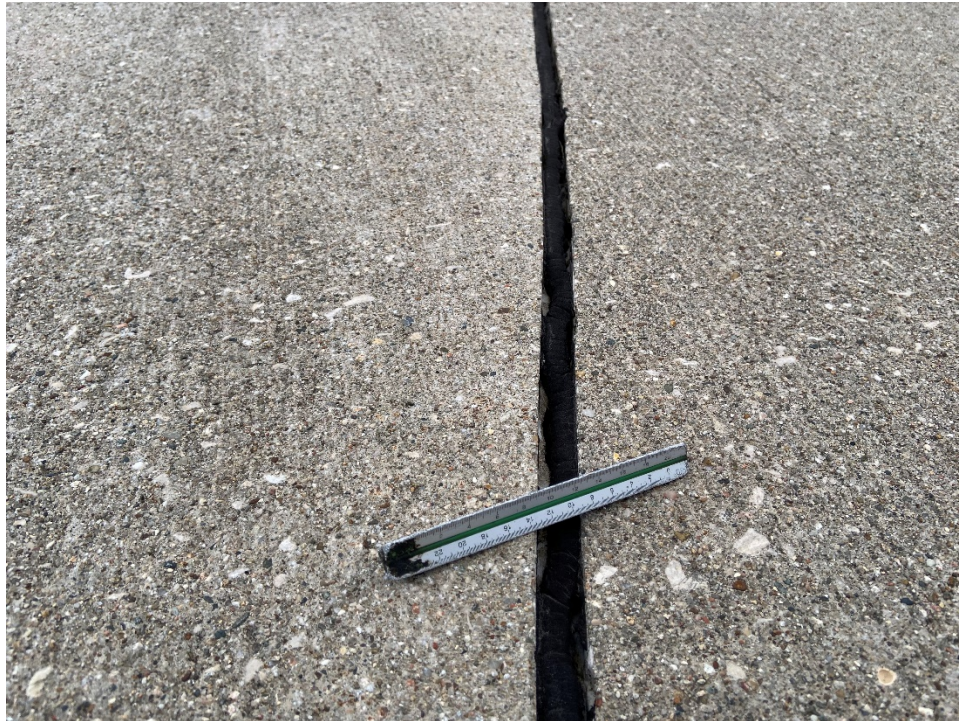
R17WU-01. LTD Cracking (Sample Unit No. 09).

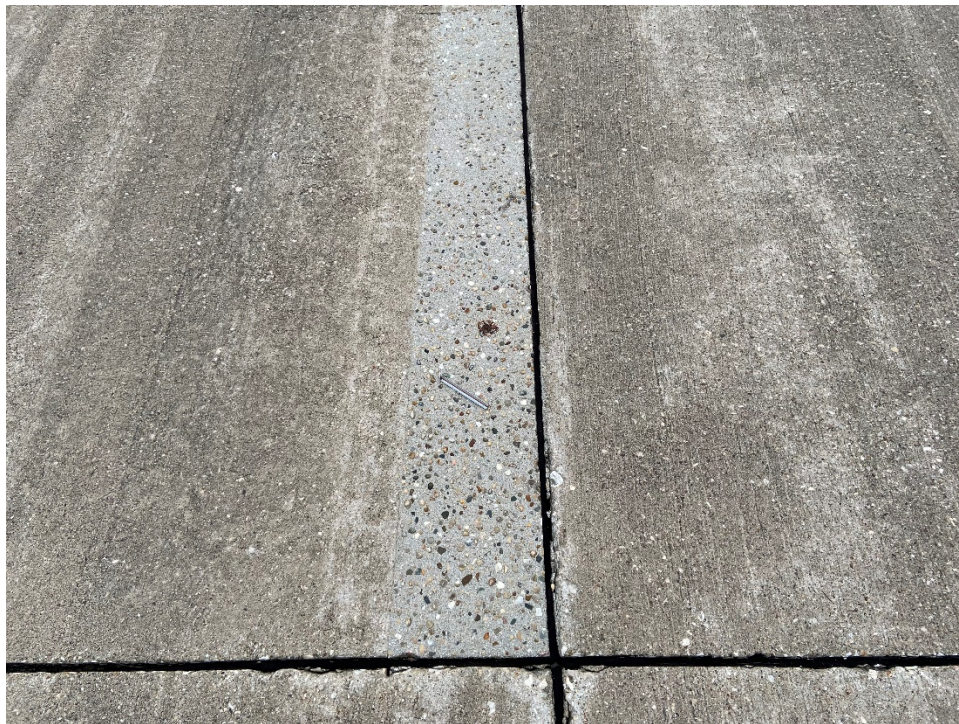
R17WU-01. Large Patching (Sample Unit No. 04).

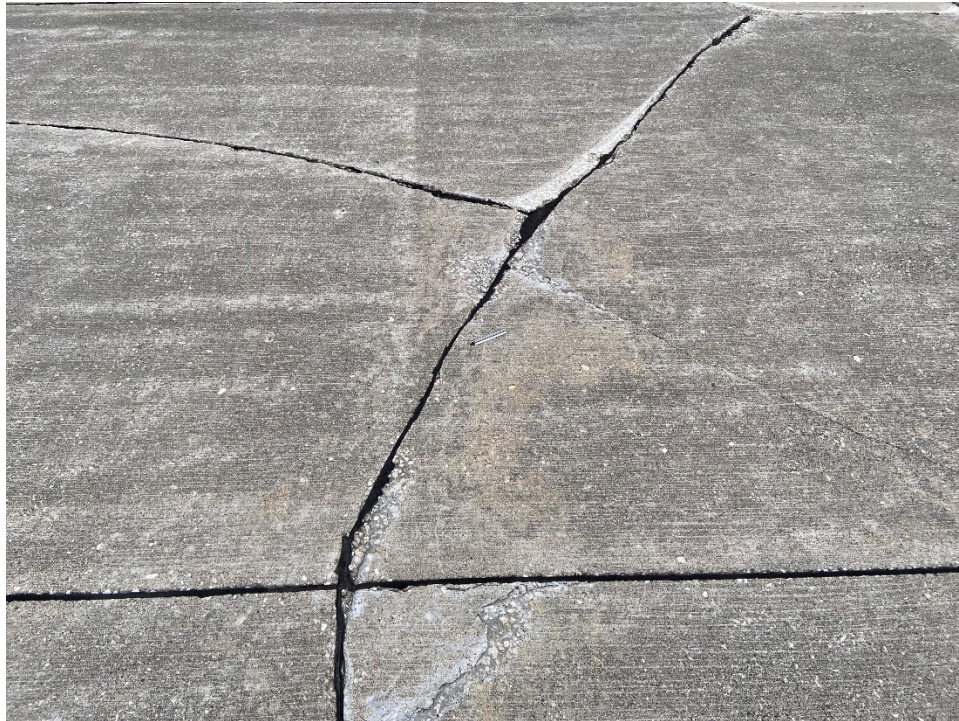
R17WU-01. Shattered Slab (Sample Unit No. 13).

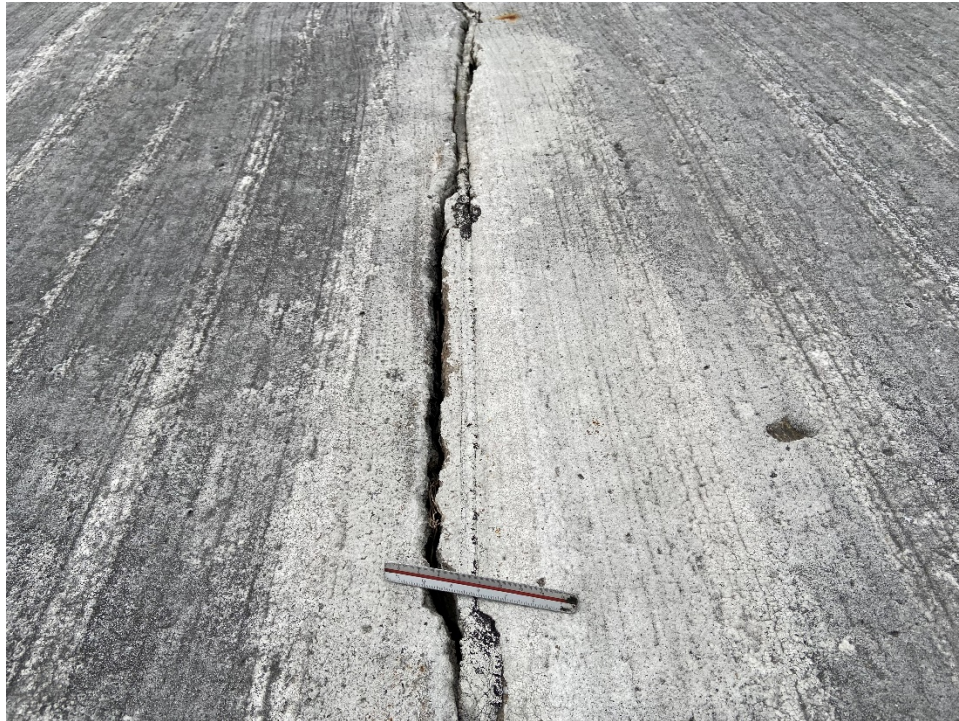
R17WU-02. LTD Cracking (Sample Unit No. 03).

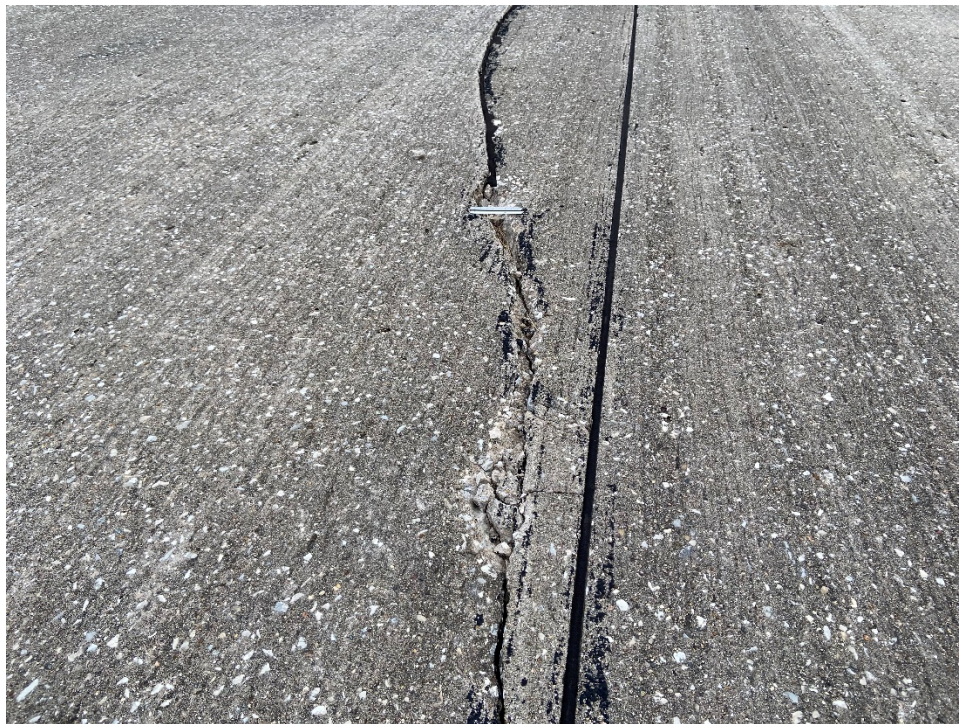
R17WU-02. LTD Cracking (Sample Unit No. 16).

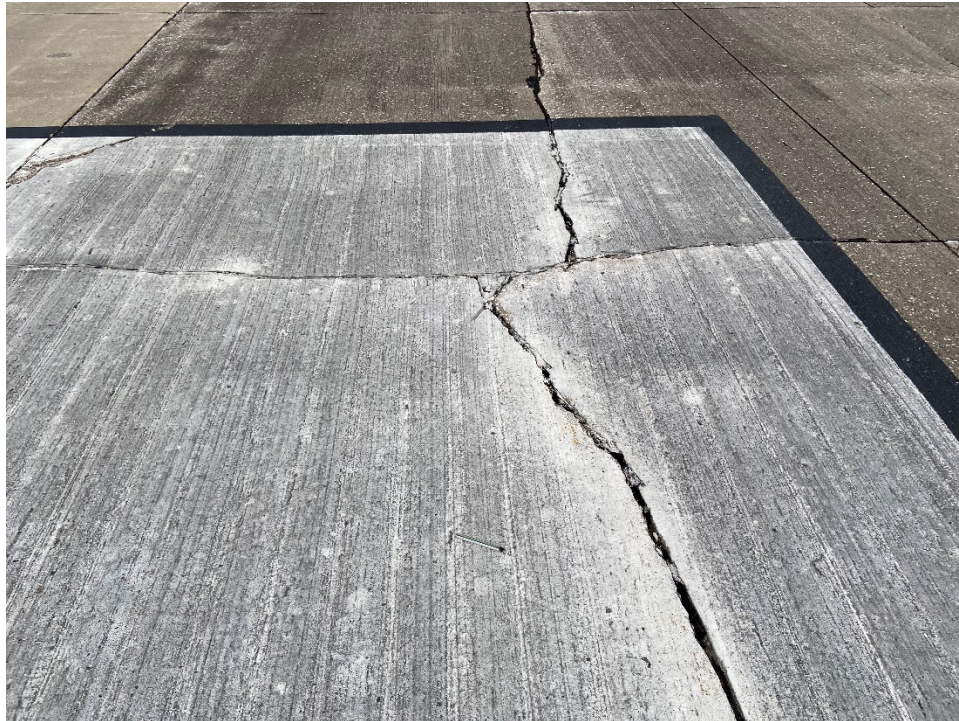
R17WU-02. Shattered Slab (Sample Unit No. 03).

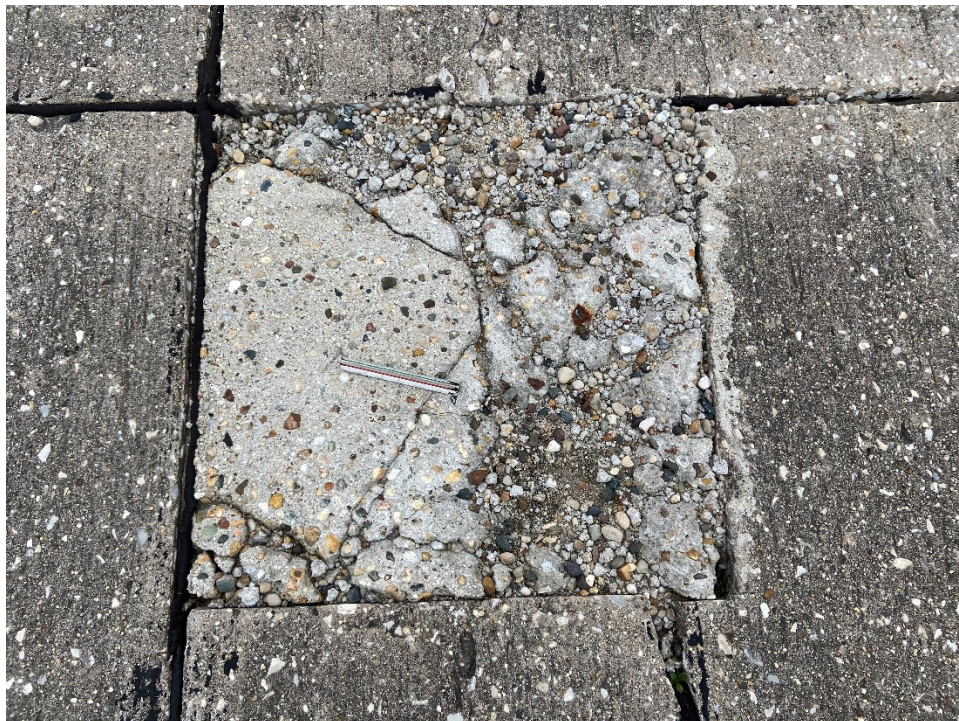
R17WU-02. Small Patching (Sample Unit No. 12).

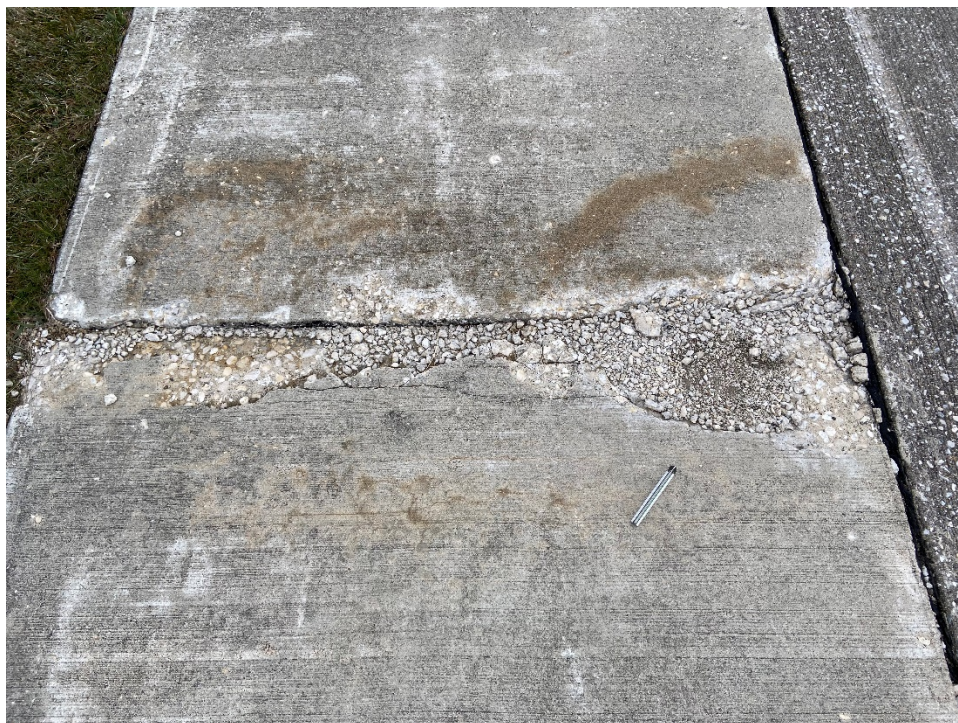
R17WU-03. ASR (Additional Sample Unit No. 14).

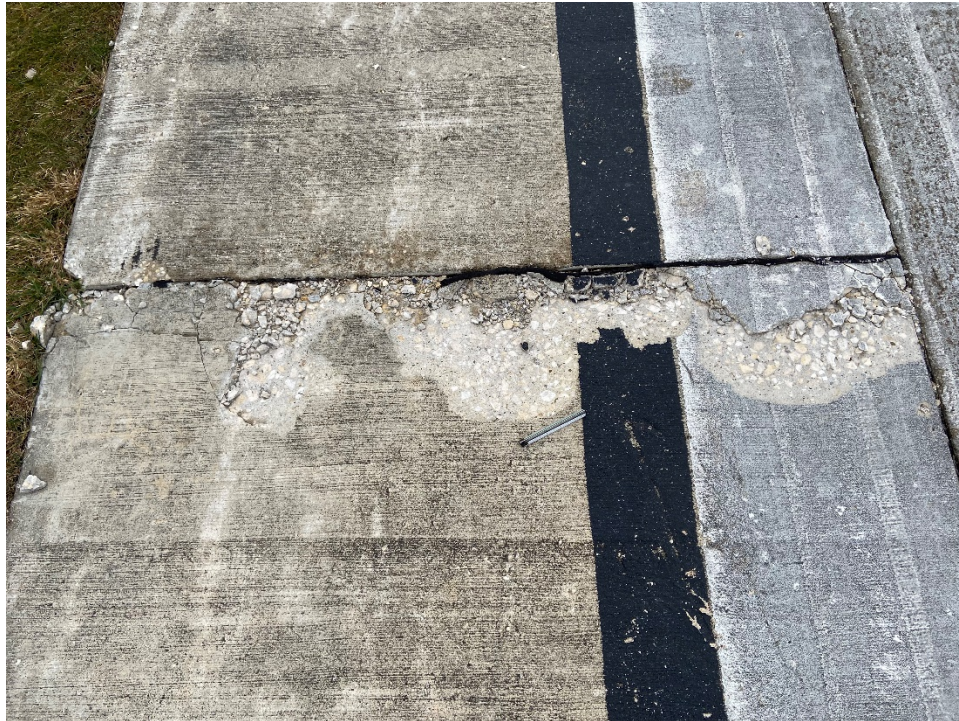
R17WU-03. ASR (Additional Sample Unit No. 30).

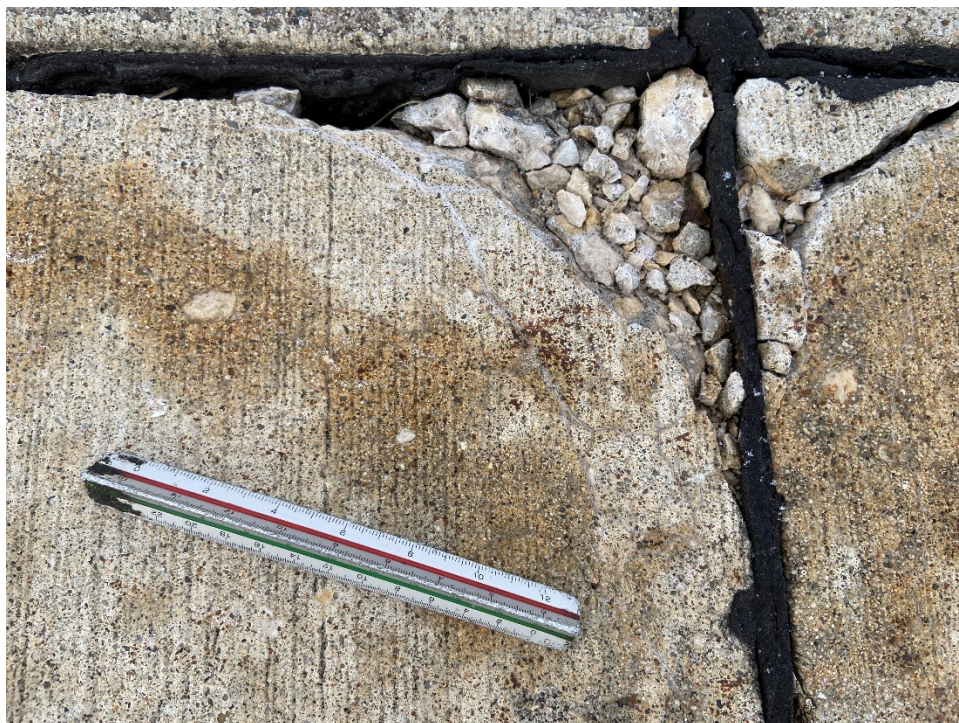
R17WU-03. ASR (Sample Unit No. 17).

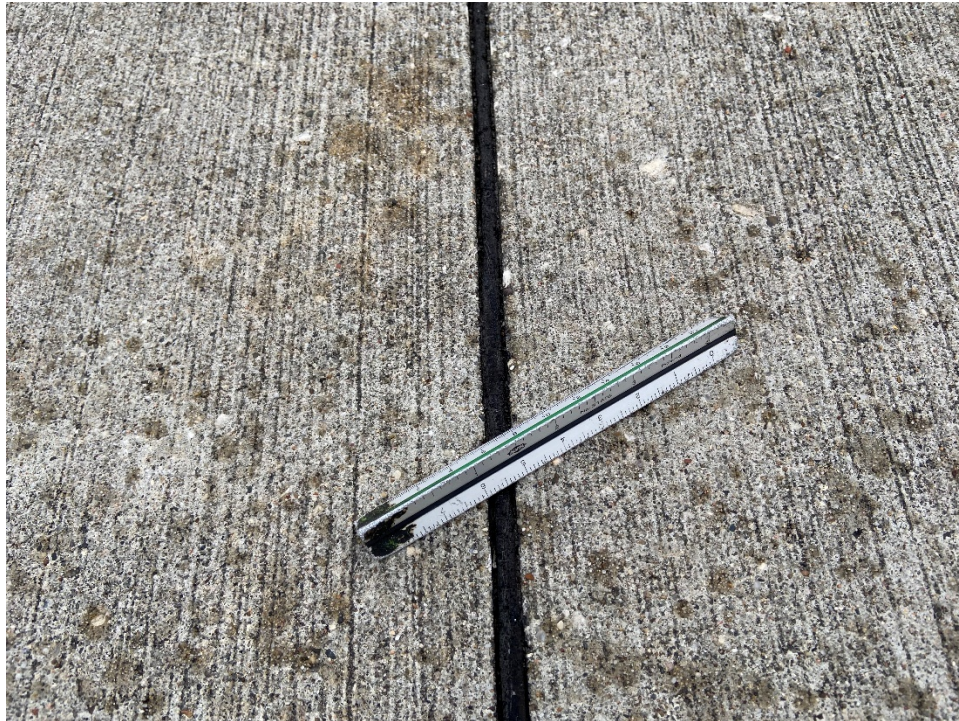
R17WU-03. Joint Seal Damage (Sample Unit No. 39).

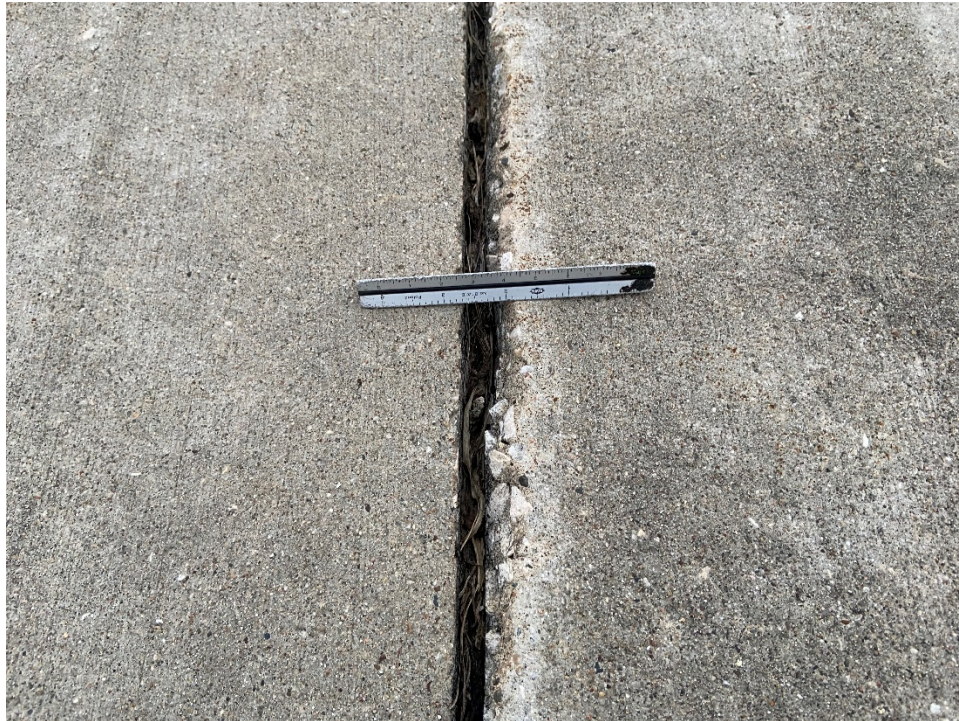
R17WU-04. Joint Seal Damage (Sample Unit No. 01).

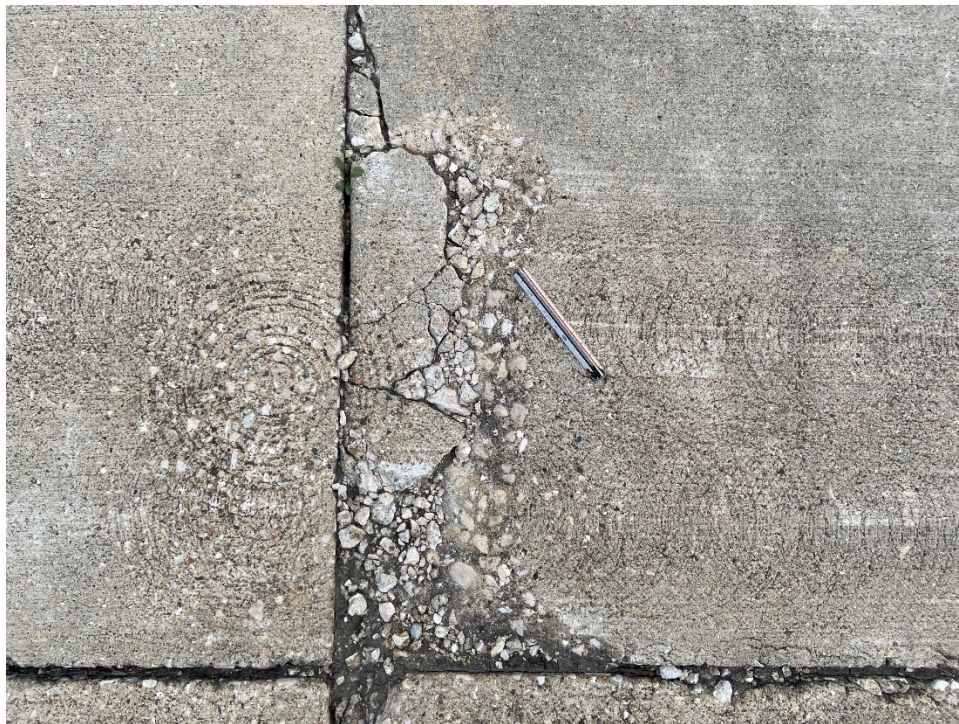
R17WU-04. Joint Spalling (Sample Unit No. 02).

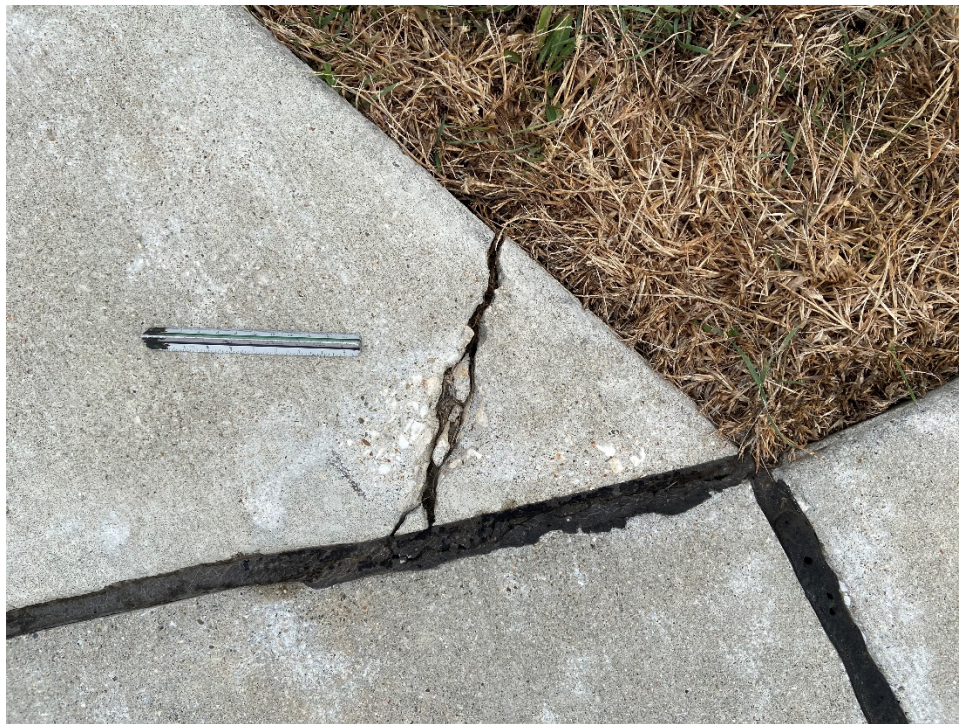
T01WU-01. Corner Break (Sample Unit No. 01).

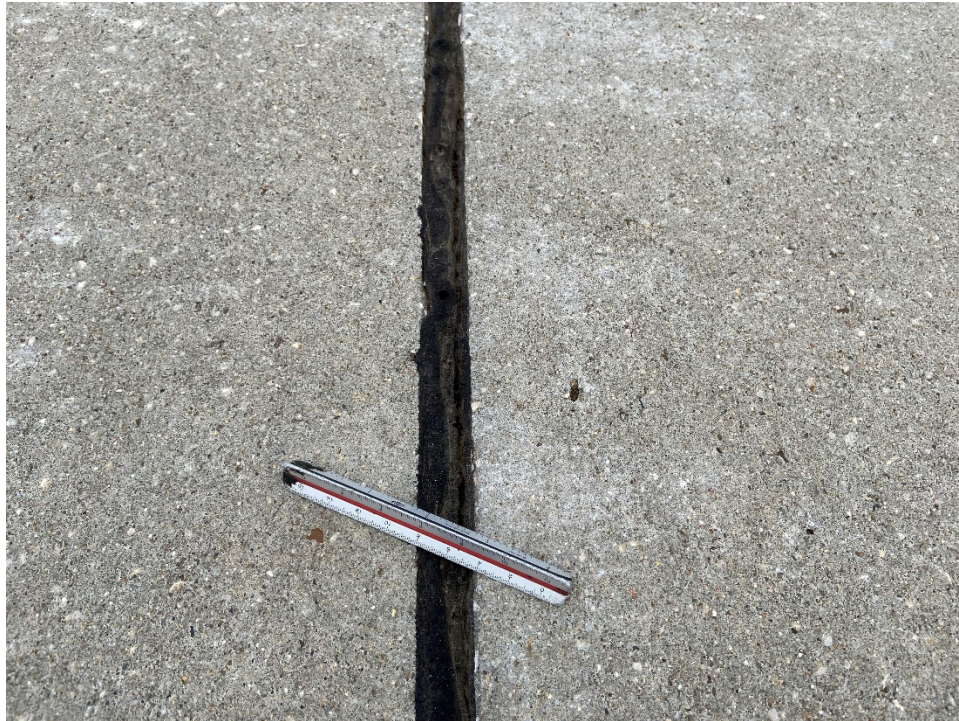
T01WU-01. Joint Seal Damage (Sample Unit No. 01).

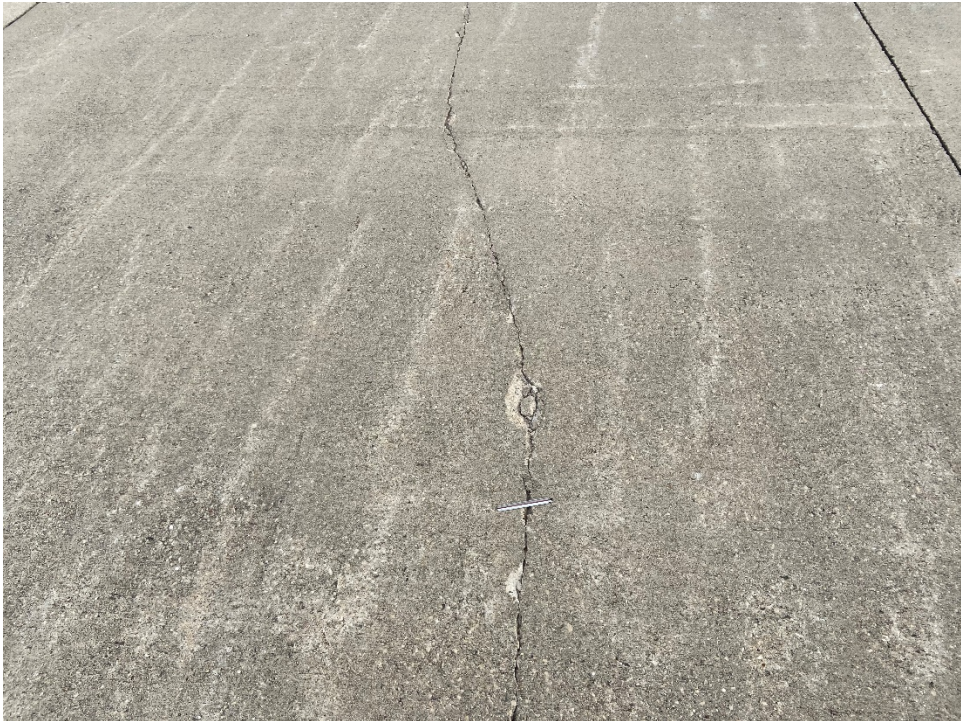
TH01WU-01. LTD Cracking (Sample Unit No. 01).
