West Union-George L Scott Municipal Airport

Pavement Management Report

JULY 2024

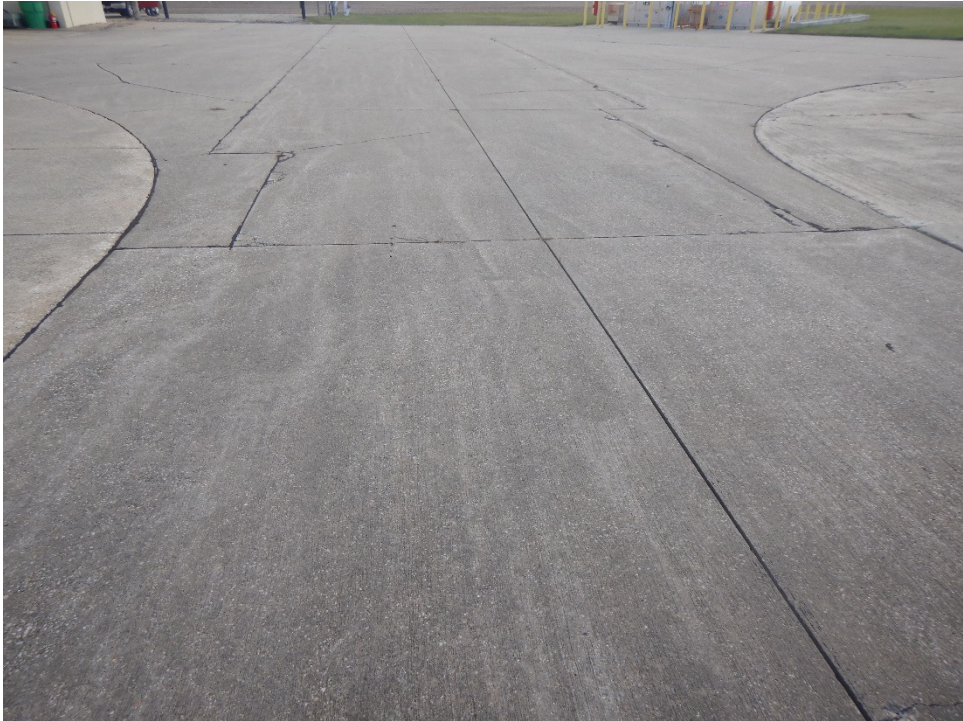
A01WU-01. Overview.

The apron area was defined by five sections. Section 01 was in poor condition with low- and medium-severity corner break, faulting, and LTD cracking; medium-severity corner spalling and shattered slab; high-severity joint seal damage; and all severities of joint spalling. Section 02 was also in poor condition and contained medium-severity corner break and LTD cracking, medium- and high-severity shattered slab, and high-severity joint seal damage. Low- and medium-severity joint spalling, medium-severity corner break and LTD cracking, and high-severity joint seal damage were recorded in Section 03. Areas of low-severity corner break and scaling, medium-severity LTD cracking, high-severity corner spalling and joint seal damage, and all severities of joint spalling were identified in Section 04. Low-severity corner spalling and joint spalling and medium-severity joint seal damage were recorded in Section 05.

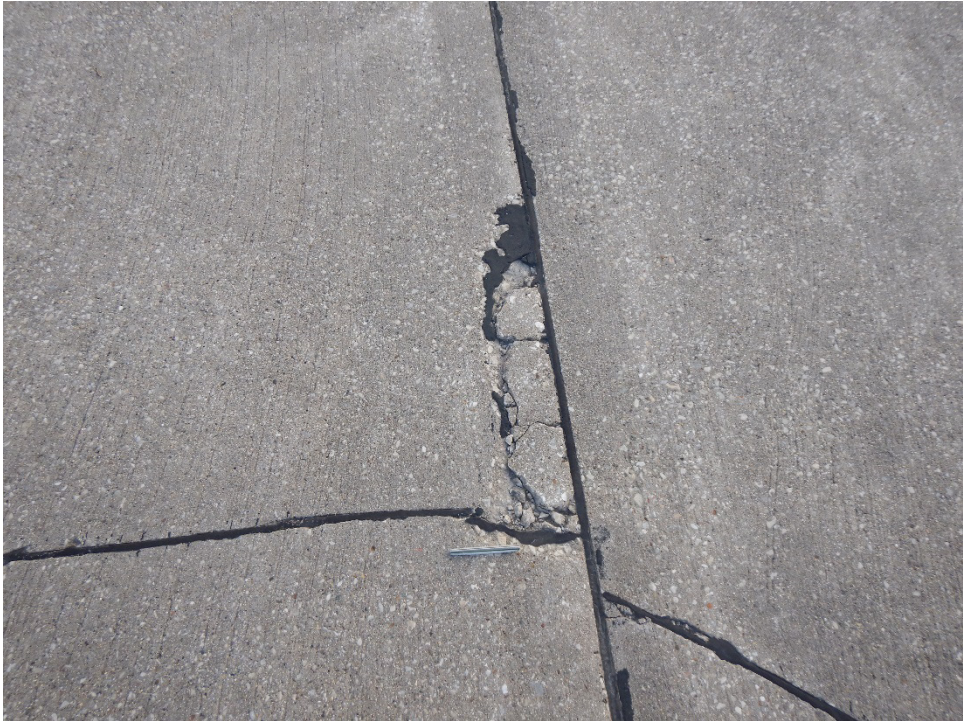
A01WU-01. Joint Spalling (Sample Unit No. 01).

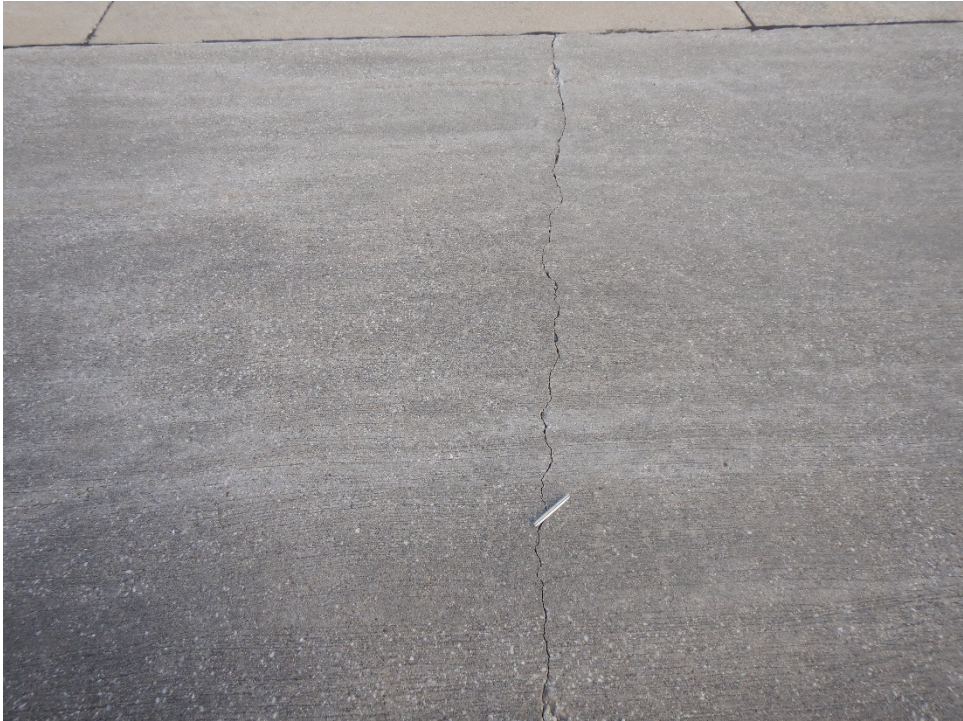
A01WU-01. LTD Cracking (Sample Unit No. 01).

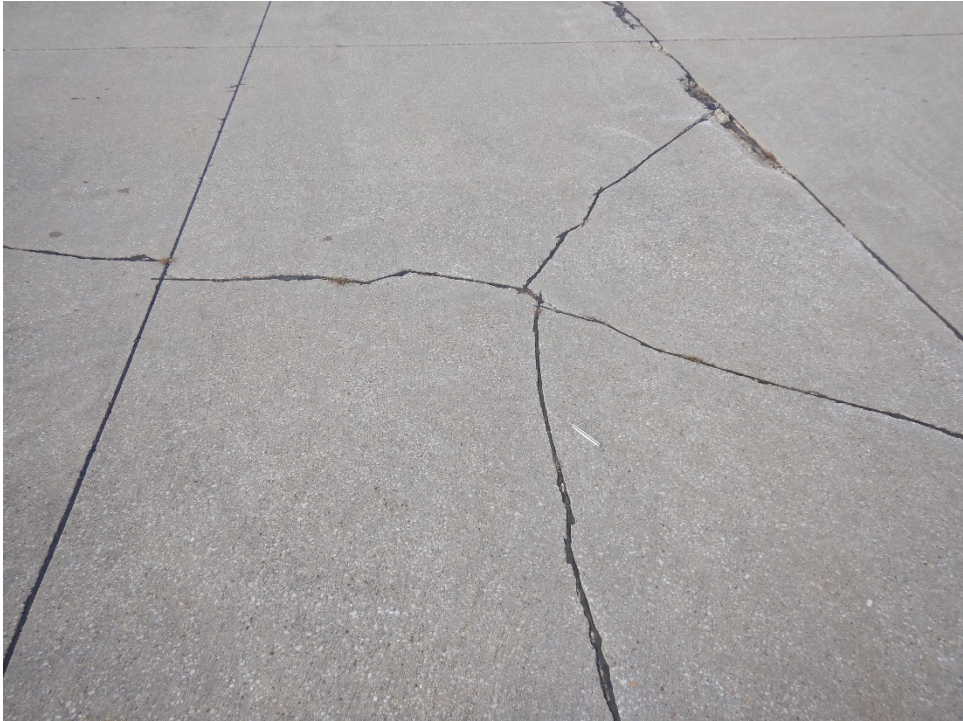
A01WU-01. Shattered Slab (Sample Unit No. 02).

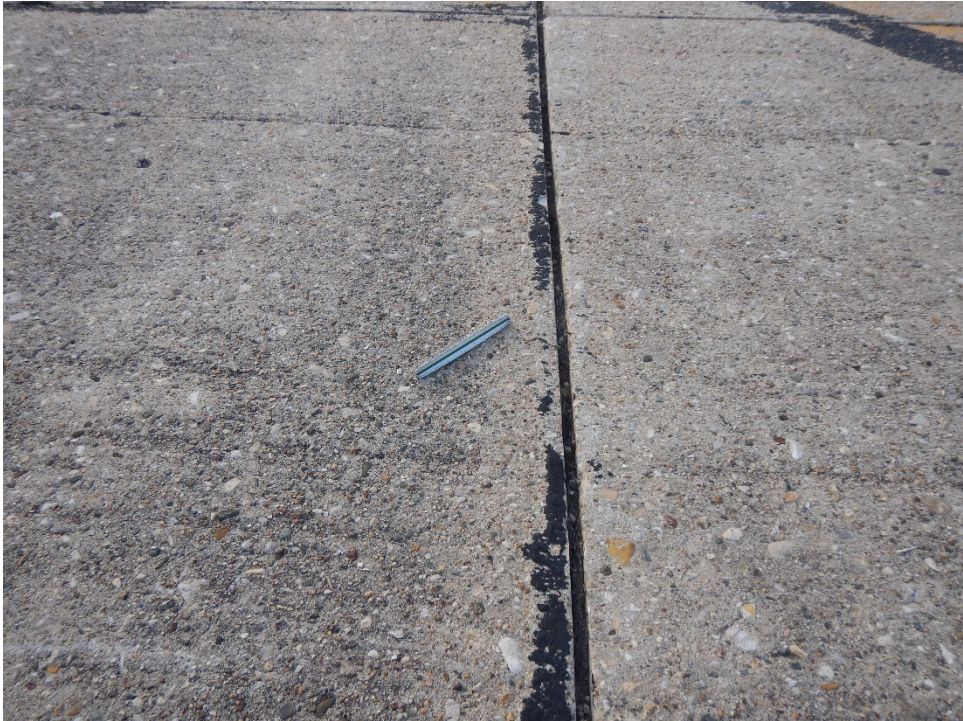
A01WU-02. Joint Seal Damage (Sample Unit No. 01).

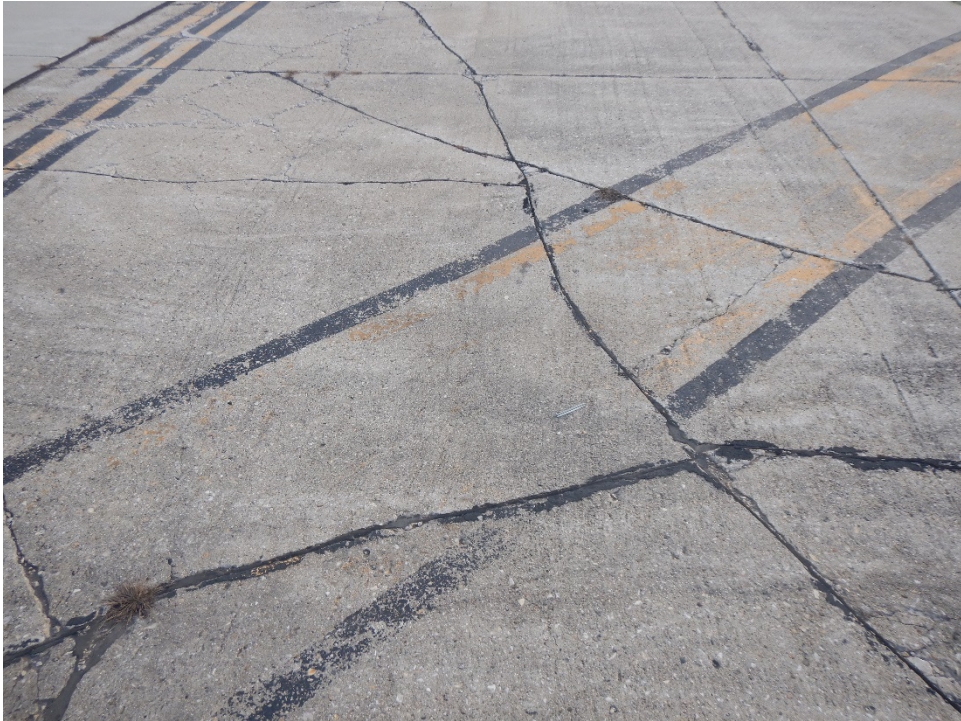
A01WU-02. Shattered Slab (Sample Unit No. 01).

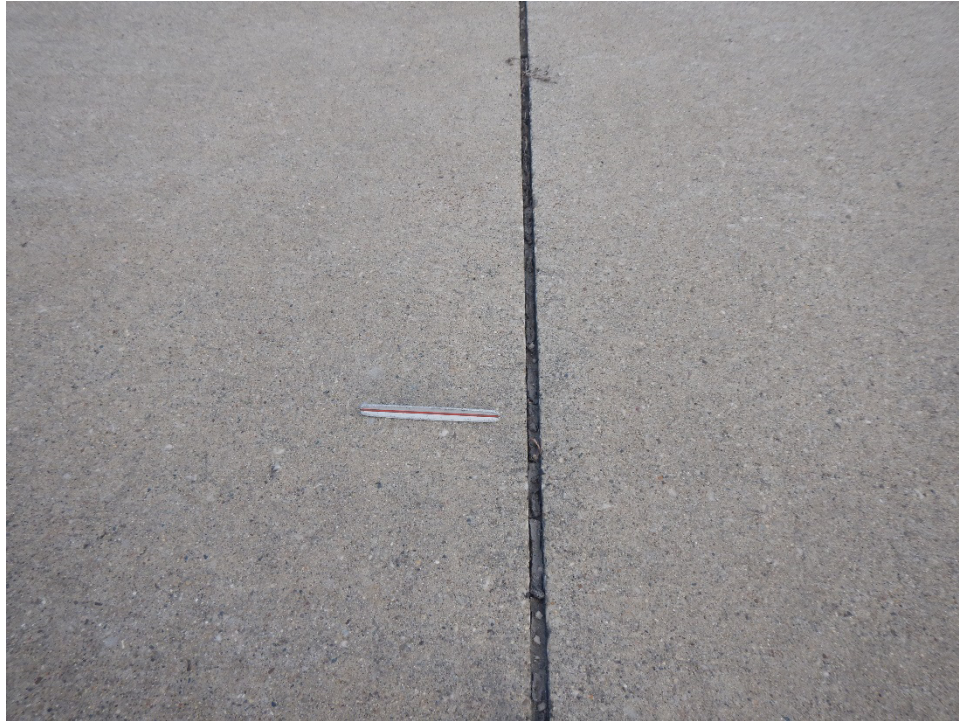
A01WU-03. Joint Seal Damage (Sample Unit No. 02).

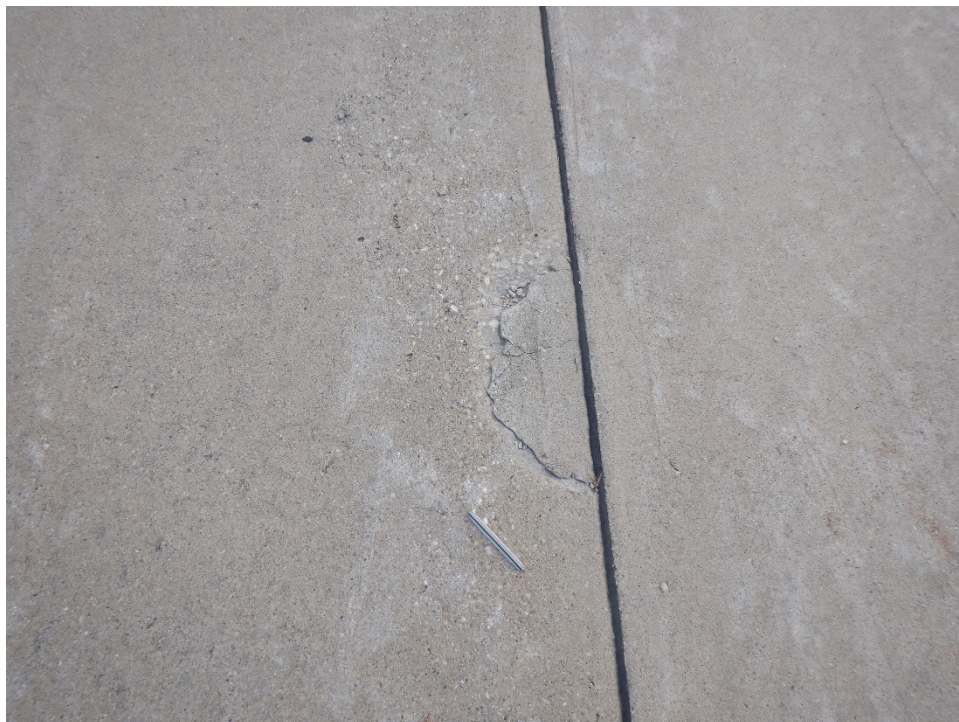
A01WU-03. Joint Spalling (Sample Unit No. 02).

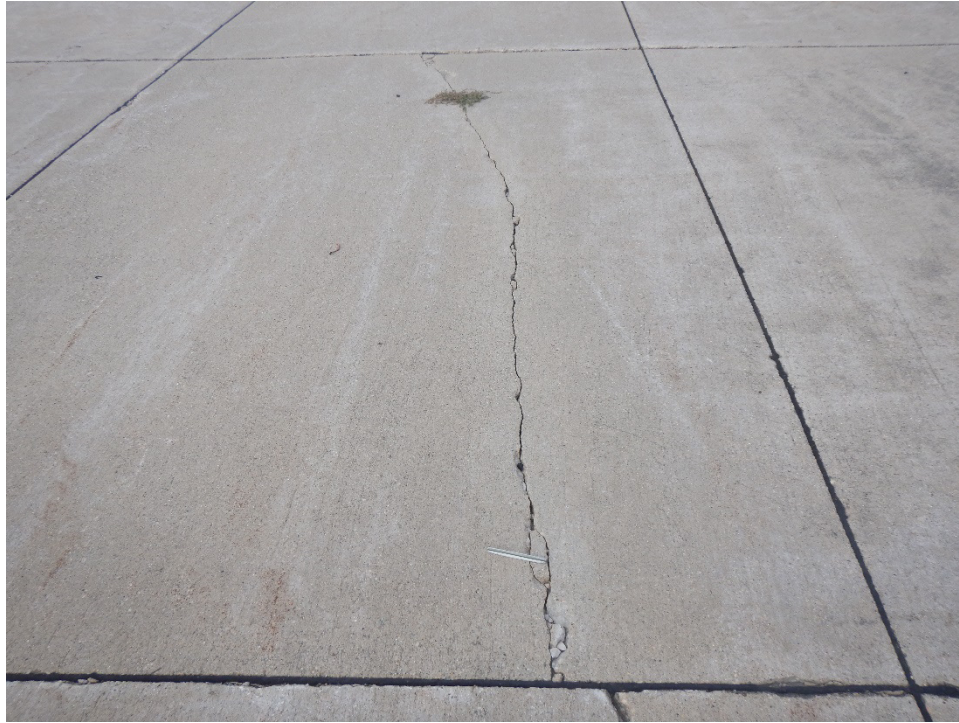
A01WU-03. LTD Cracking (Sample Unit No. 01).

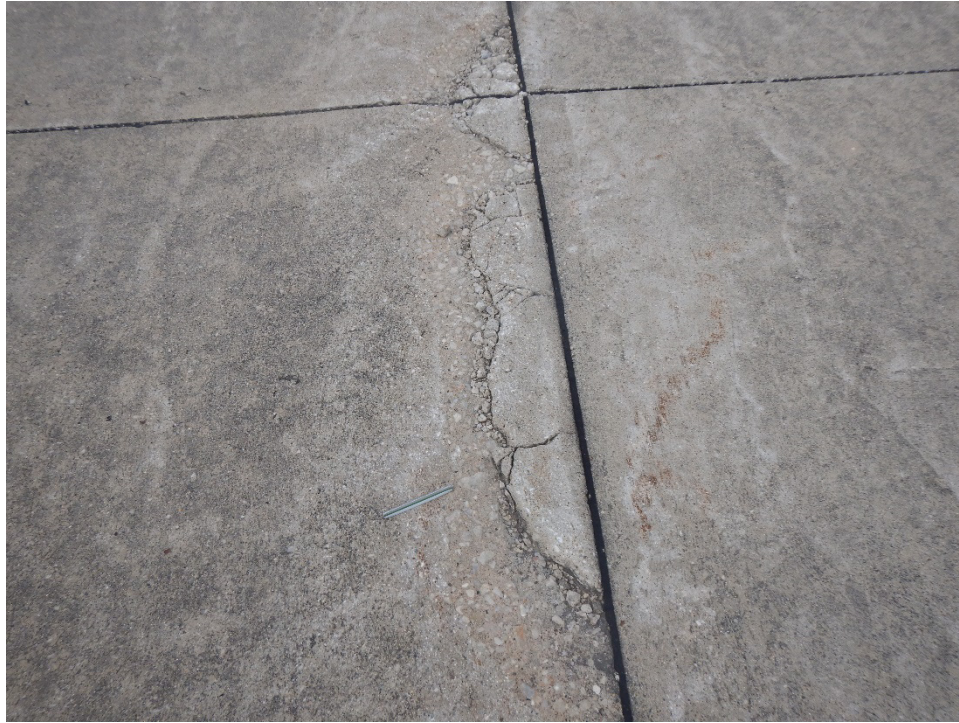
A01WU-04. Joint Spalling (Sample Unit No. 05).

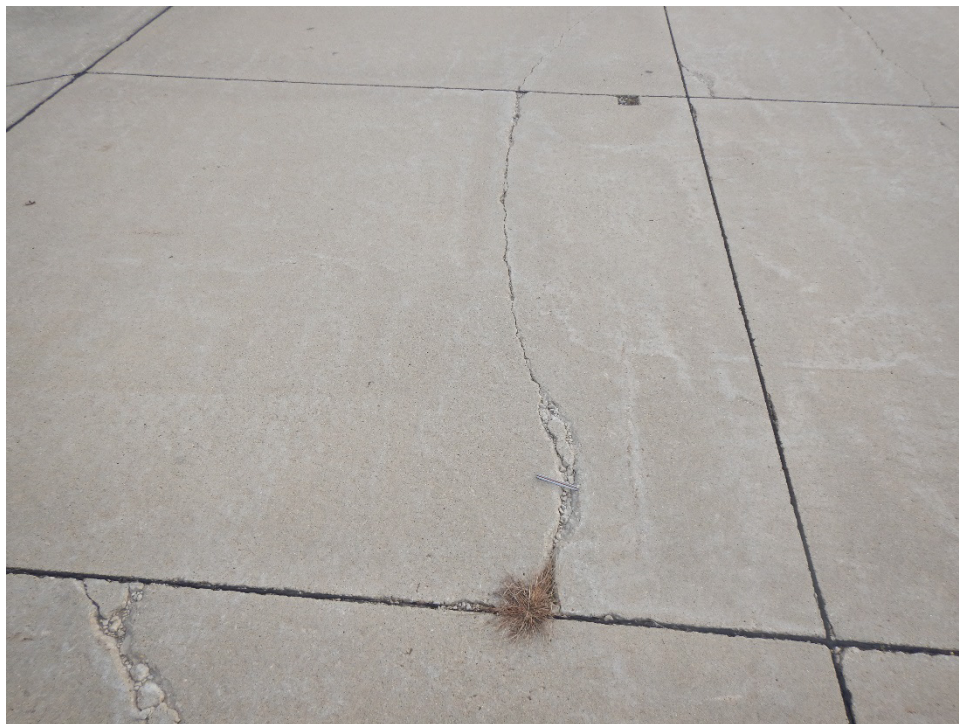
A01WU-04. LTD Cracking (Sample Unit No. 01).

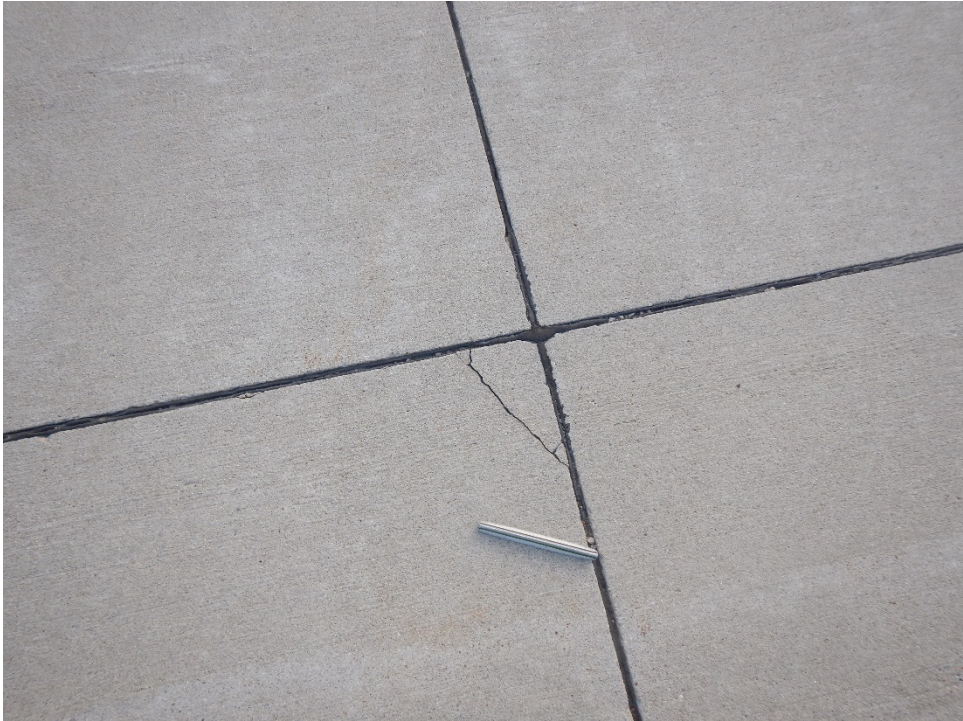
A01WU-05. Corner Spalling (Sample Unit No. 01).

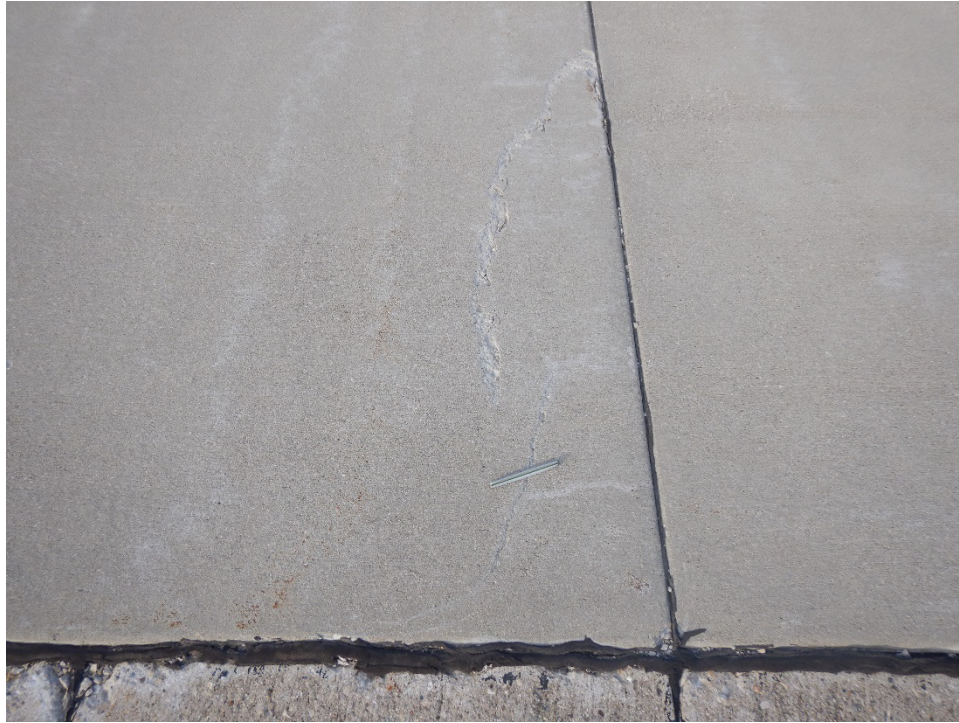
A01WU-05. Joint Spalling (Sample Unit No. 03).

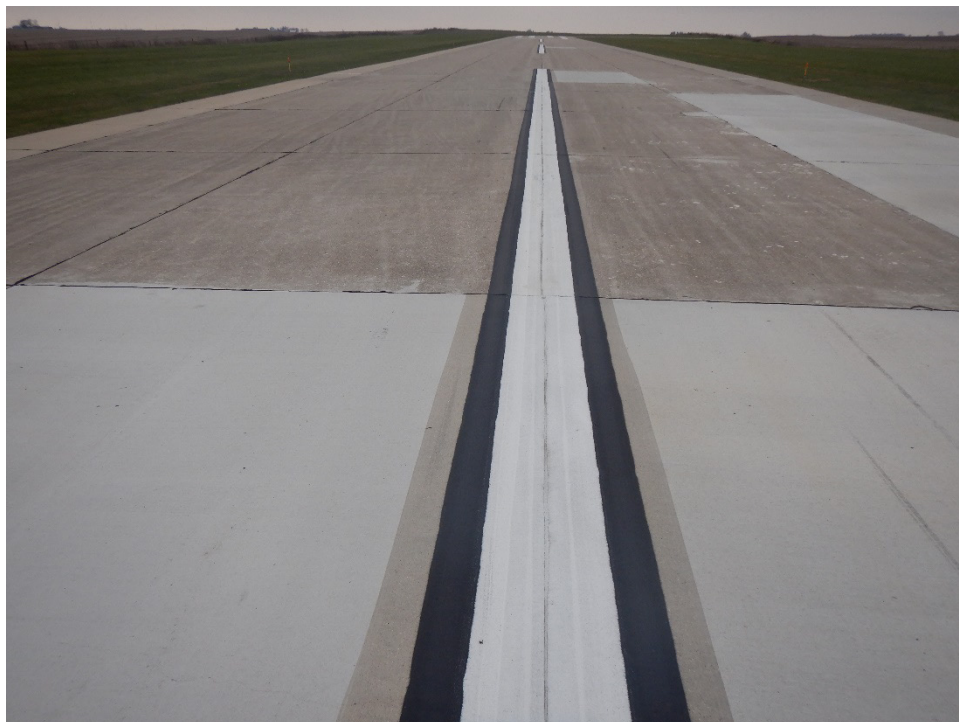
R17WU-01. Overview.

Runway 17/35 was defined by four sections. Section 01 was located at the Runway 35 approach. Areas of low-severity ASR, large patching, small patching, and longitudinal, transverse, and diagonal (LTD) cracking were recorded. Section 02 comprised the majority of Runway 17/35. Low-severity corner break, corner spalling, joint spalling, large patching, and small patching; low- and medium-severity LTD cracking; and shrinkage cracking were observed in this section. Section 03 was located along the edges of Runway 17/35. It contained areas of low- and medium-severity ASR and low-severity large patching, LTD cracking, and small patching. Section 04 was connected to the Runway 35 approach with areas of low-severity faulting, joint spalling, LTD cracking, and small patching recorded during the inspection.

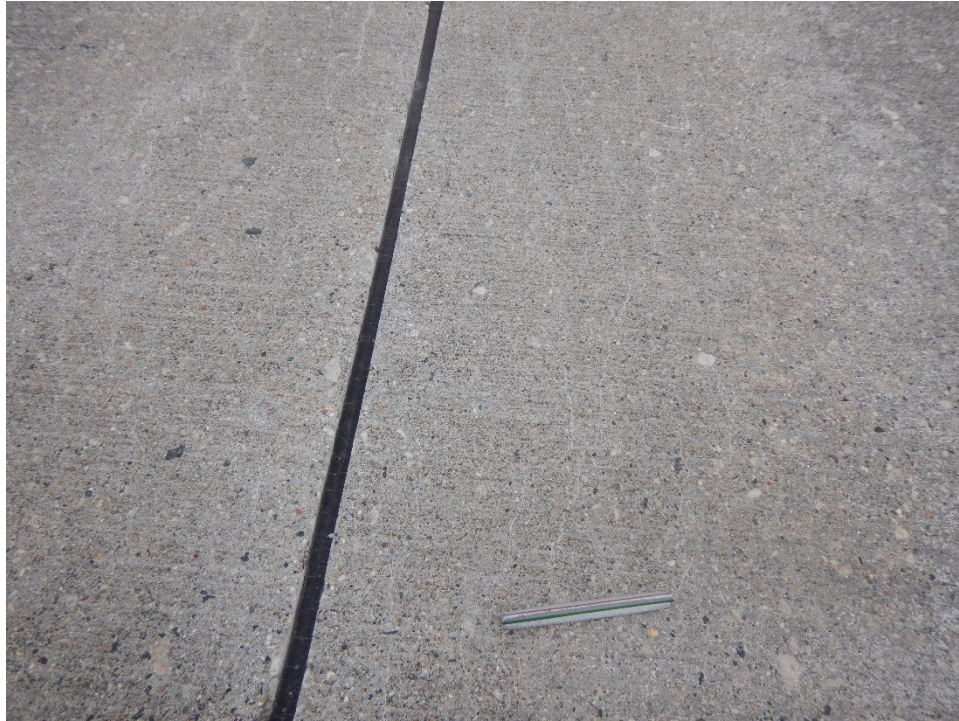
R17WU-01. ASR (Sample Unit No. 11).

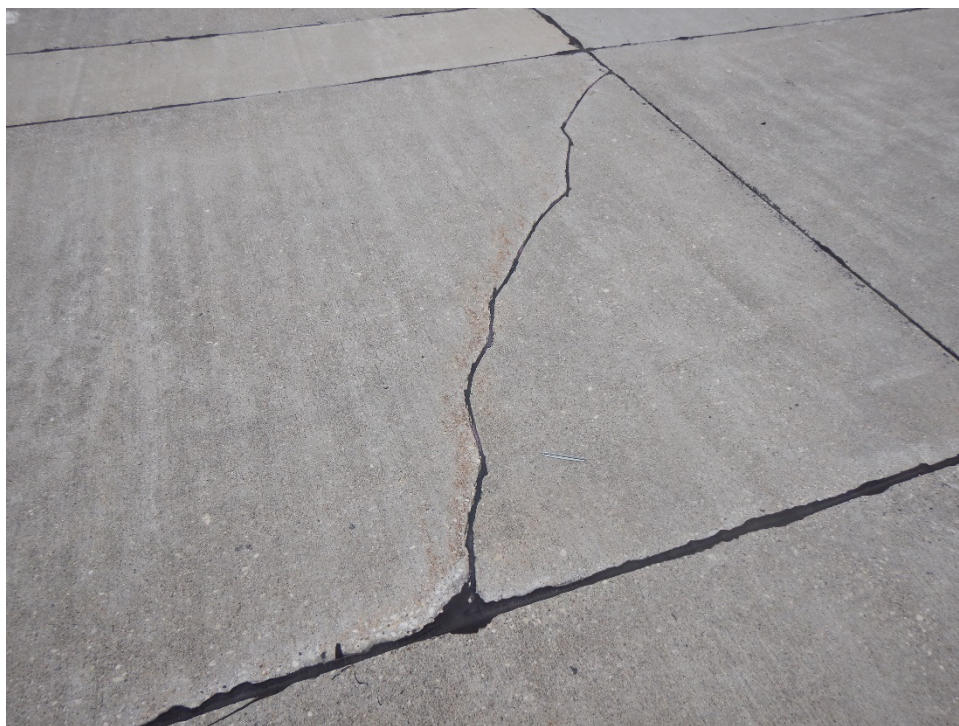
R17WU-01. LTD Cracking (Sample Unit No. 13).

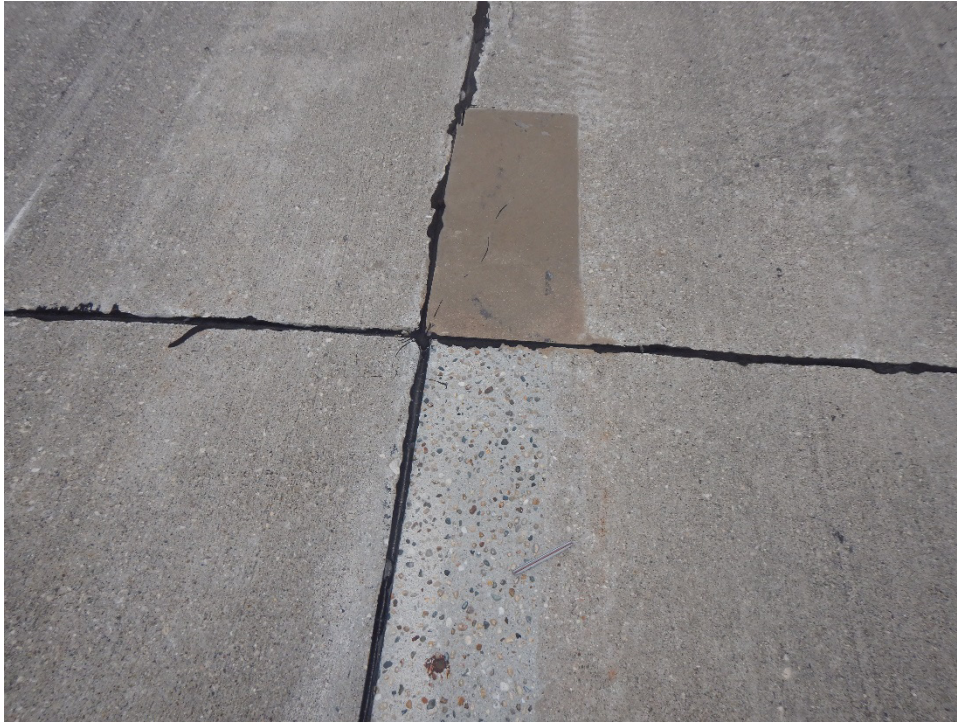
R17WU-01. Small Patching (Sample Unit No. 04).

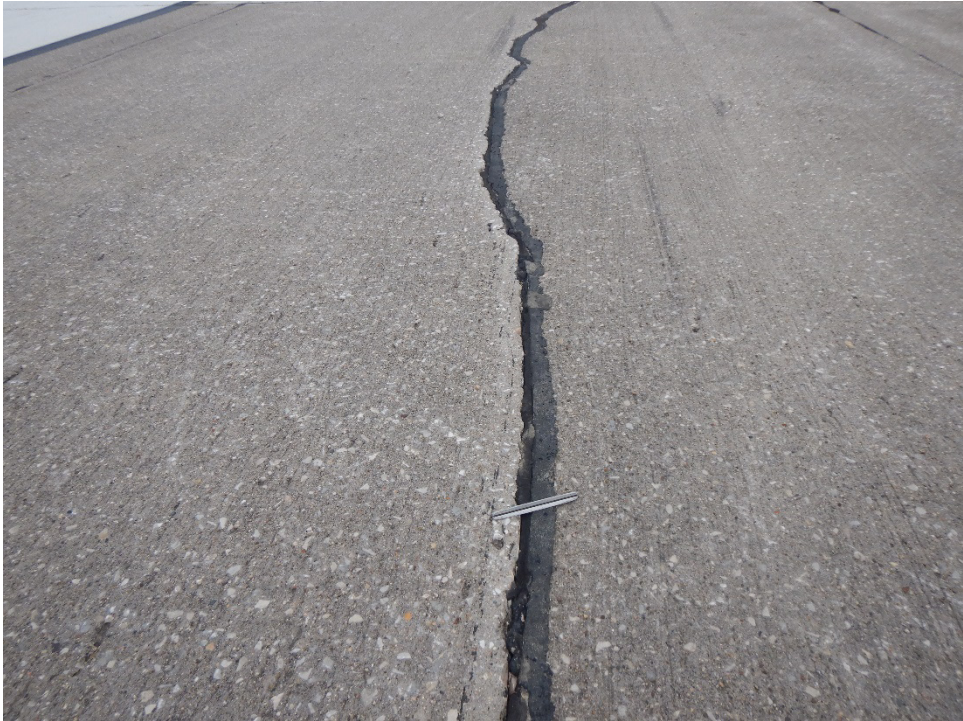
R17WU-02. LTD Cracking (Sample Unit No. 03).

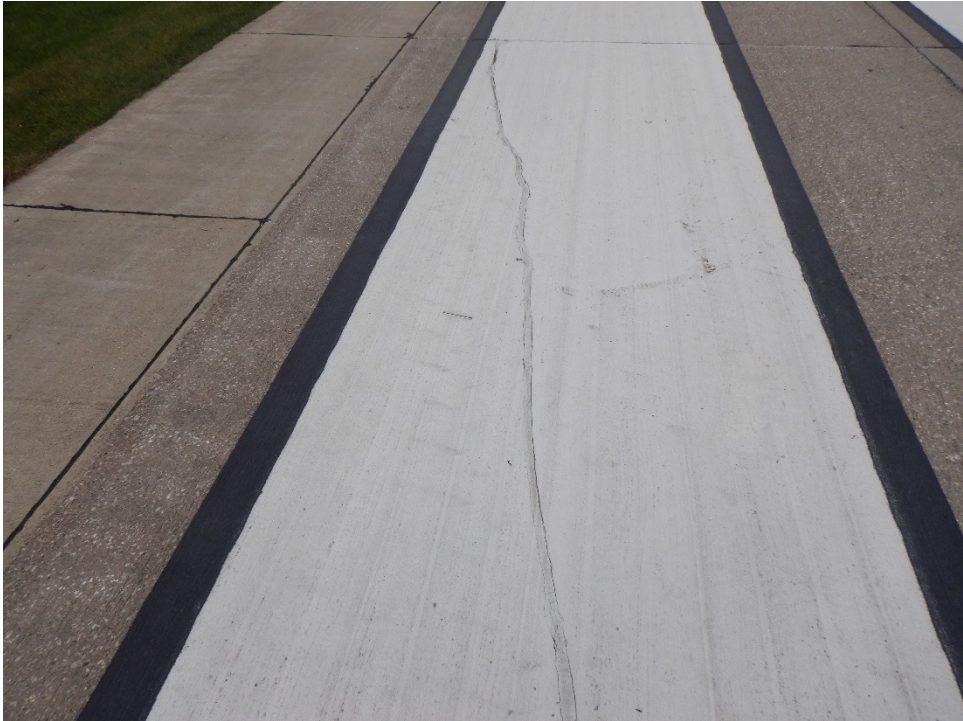
R17WU-02. LTD Cracking (Sample Unit No. 33).

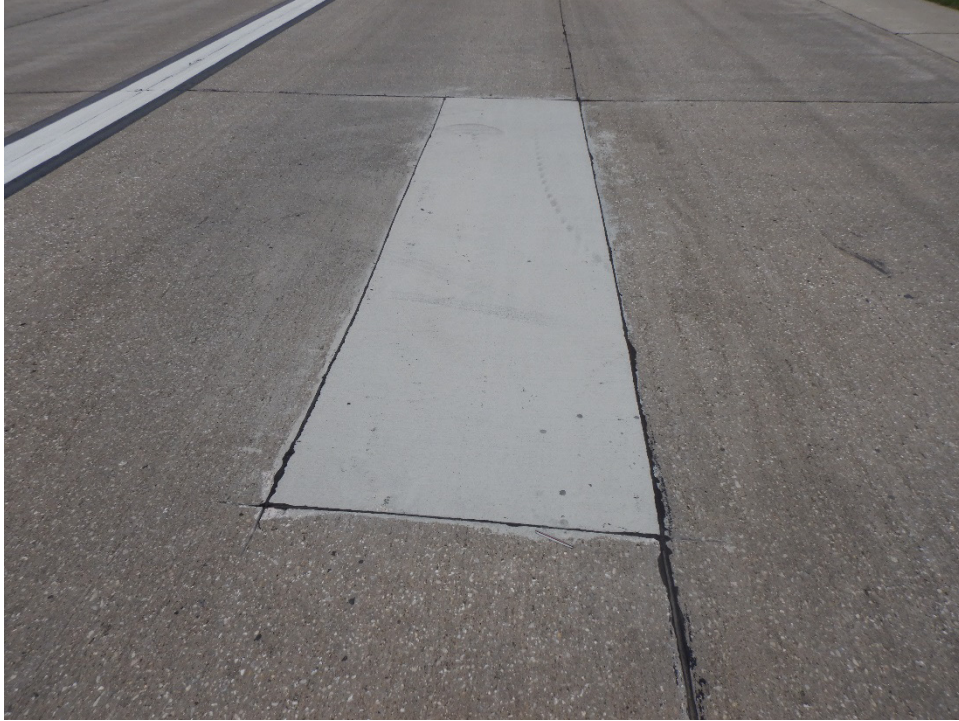
R17WU-02. Large Patching (Sample Unit No. 16).

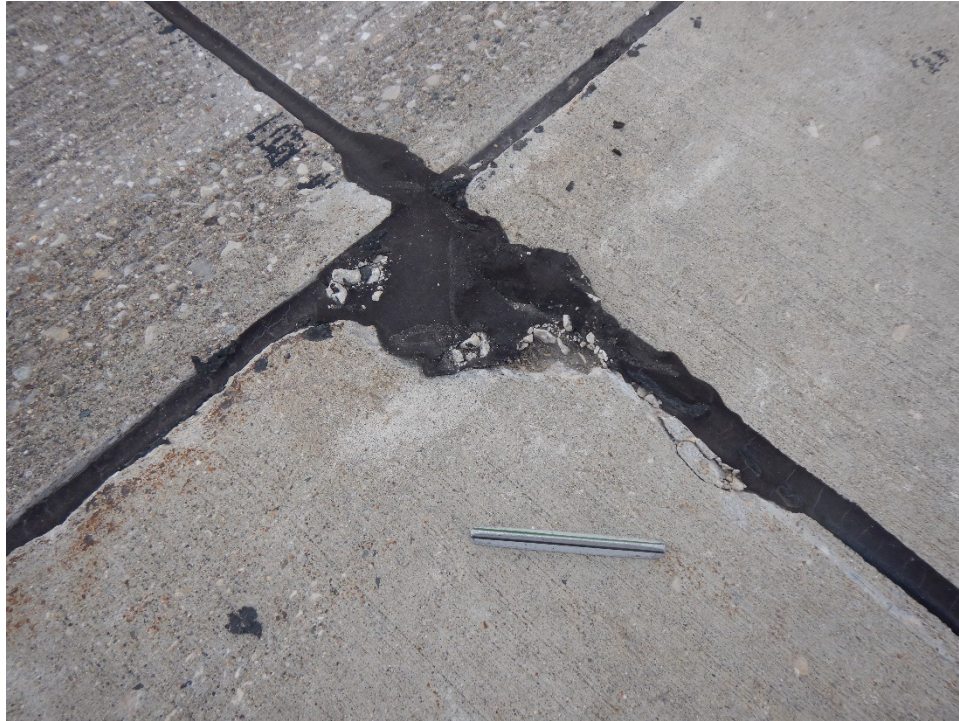
R17WU-03. ASR (Sample Unit No. 10).

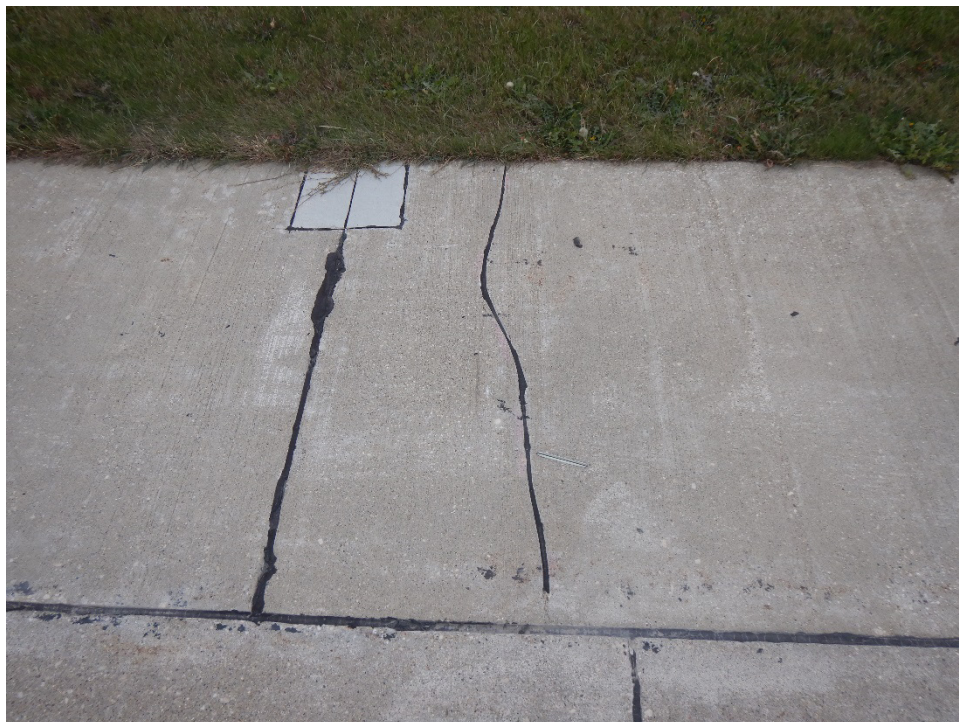
R17WU-03. LTD Cracking (Sample Unit No. 03).

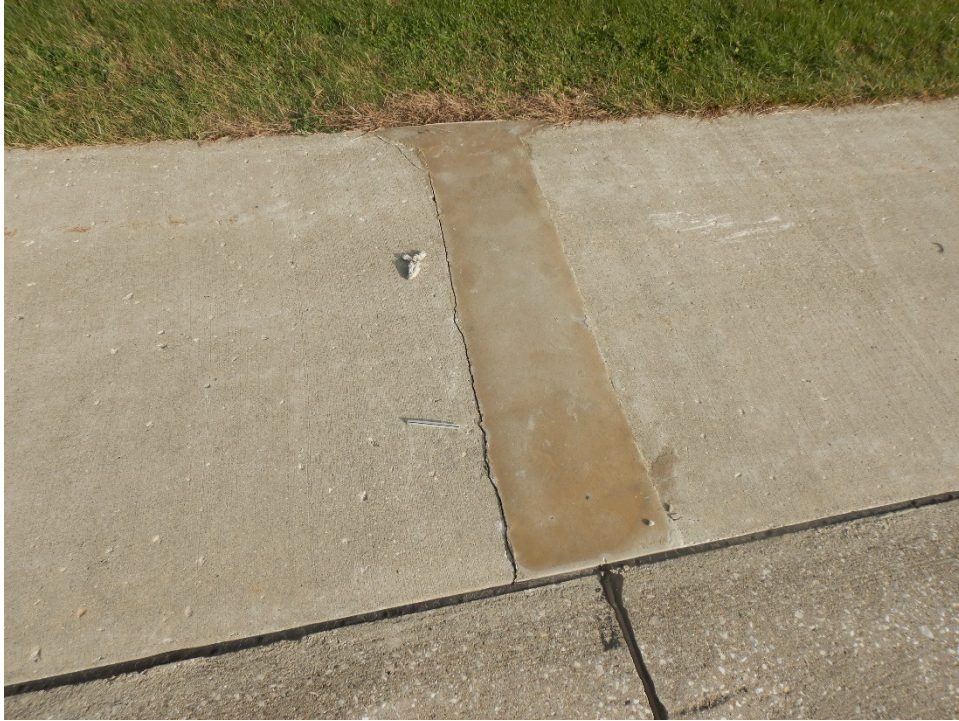
R17WU-03. Large Patching (Sample Unit No. 22).

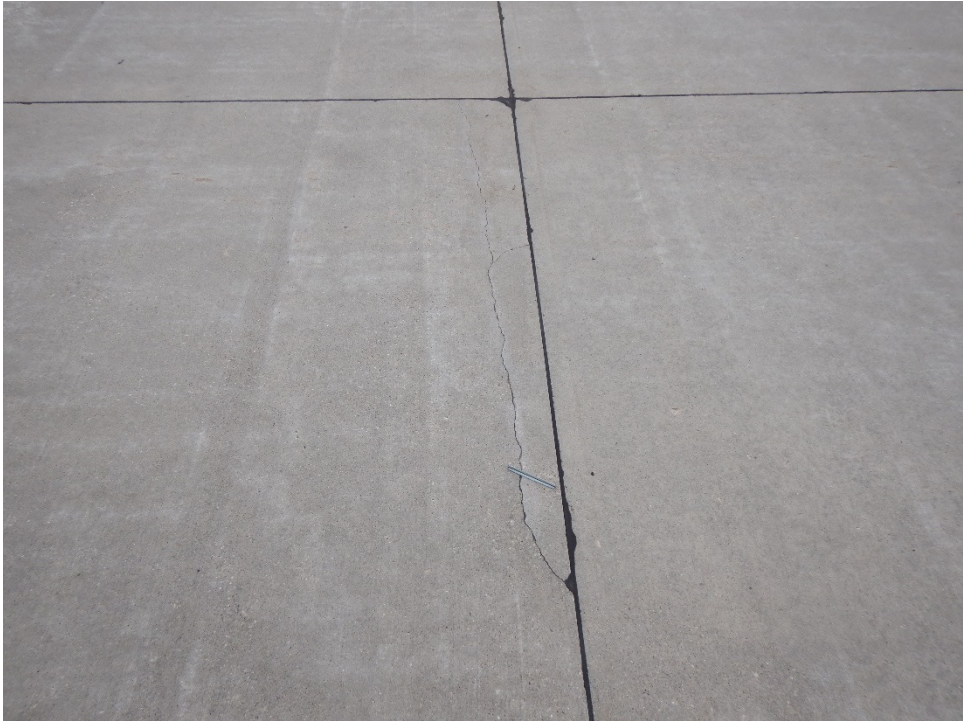
R17WU-04. Joint Spalling (Sample Unit No. 01).

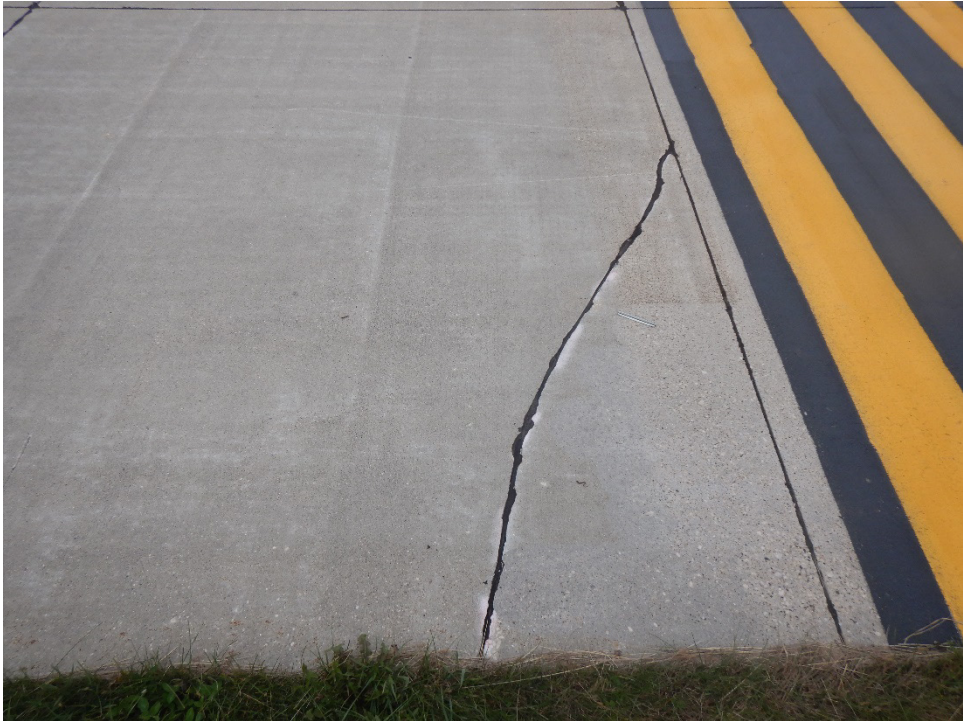
R17WU-04. LTD Cracking (Sample Unit No. 01).

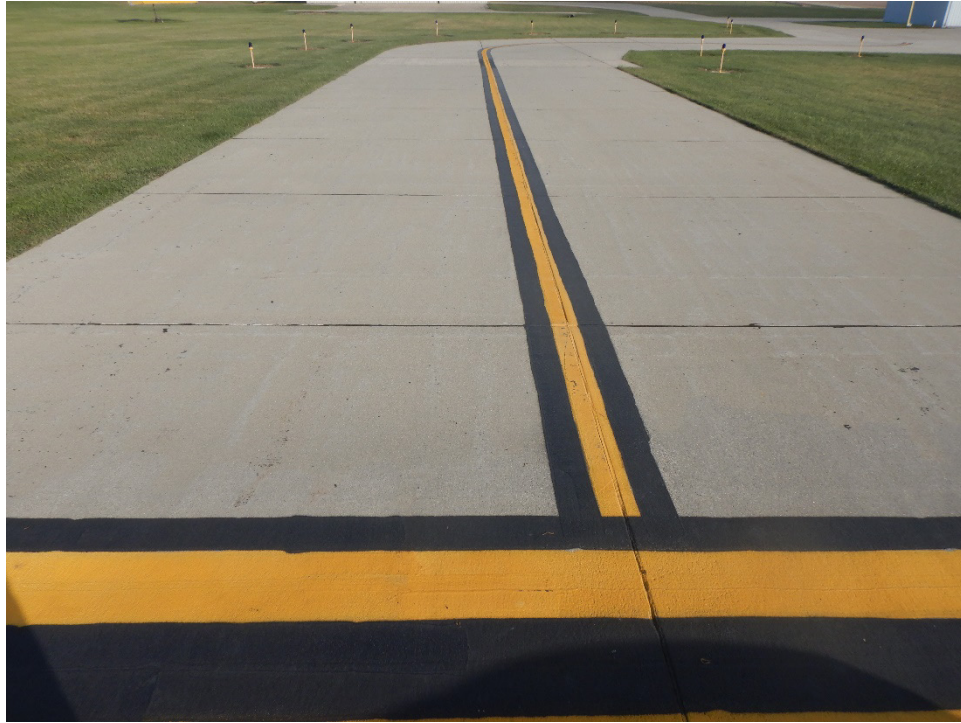
T01WU-01. Overview.

Taxiway 01 consisted of one section in excellent condition. It connected Runway 17/35 to the apron area and contained only low-severity corner break.

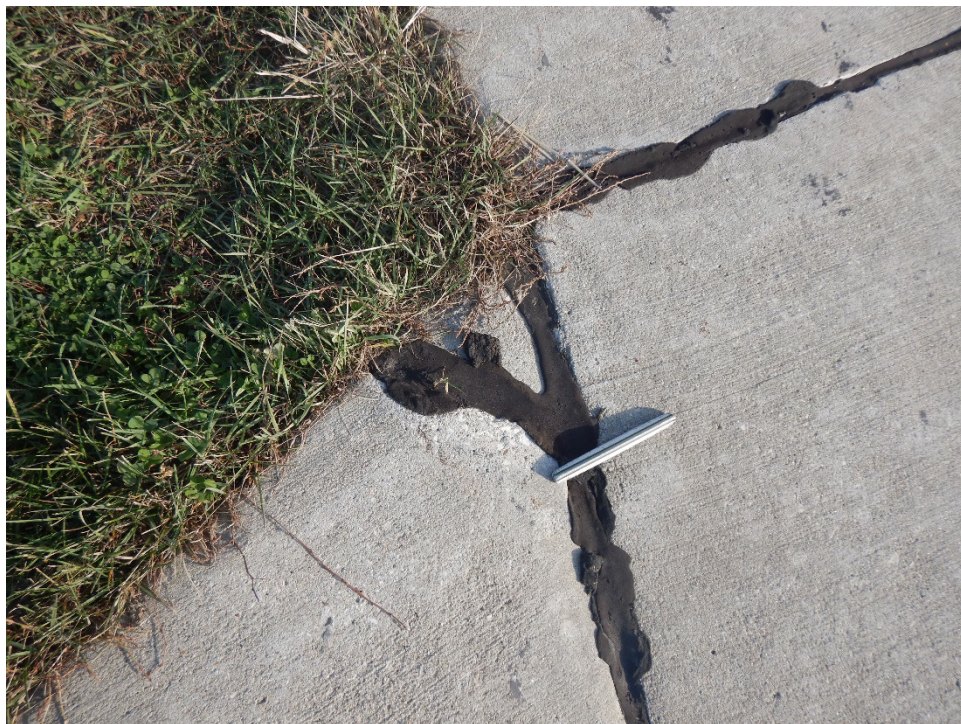
T01WU-01. Corner Break (Sample Unit No. 01).

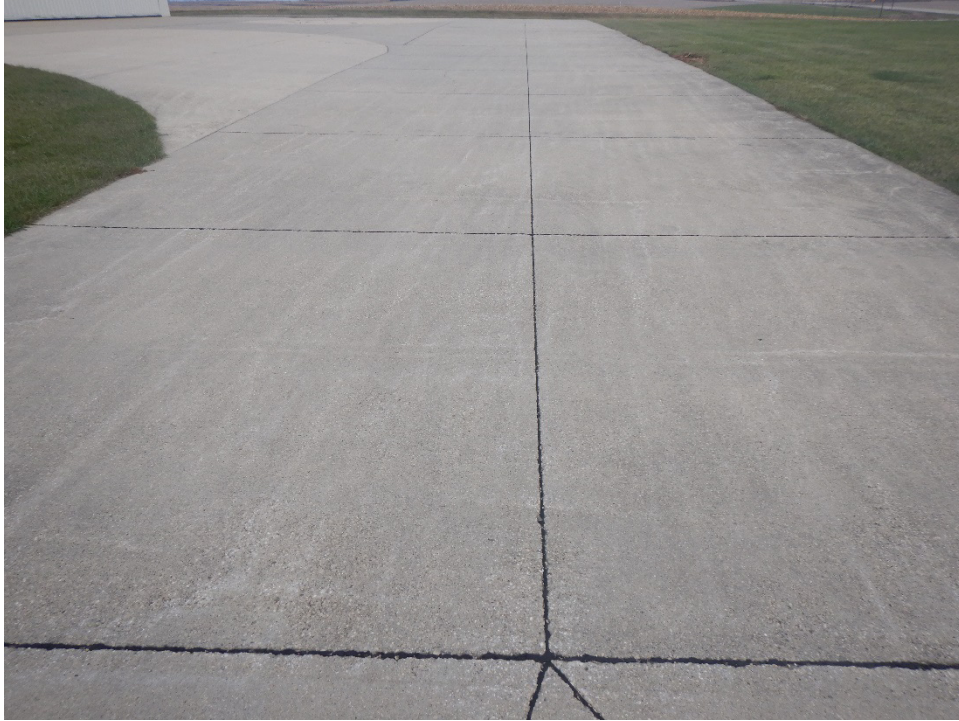
TH01WU-01. Overview.

The T-hangar area contained one section. Low-severity scaling, low- and medium-severity LTD cracking, high-severity joint seal damage, and shrinkage cracking were identified in Section 01.

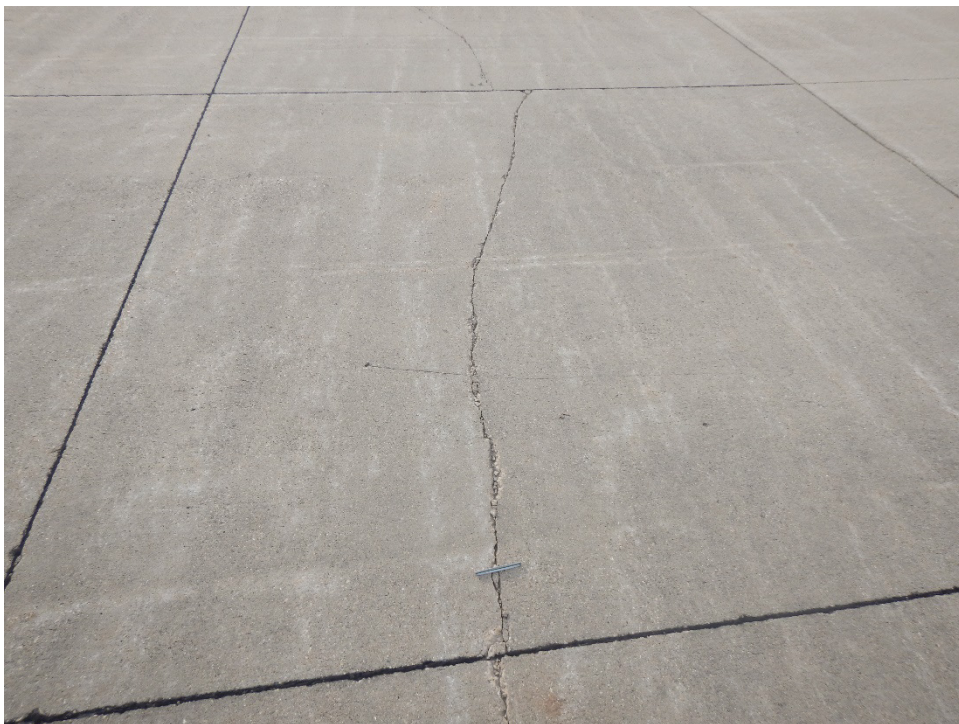
TH01WU-01. LTD Cracking (Sample Unit No. 01).

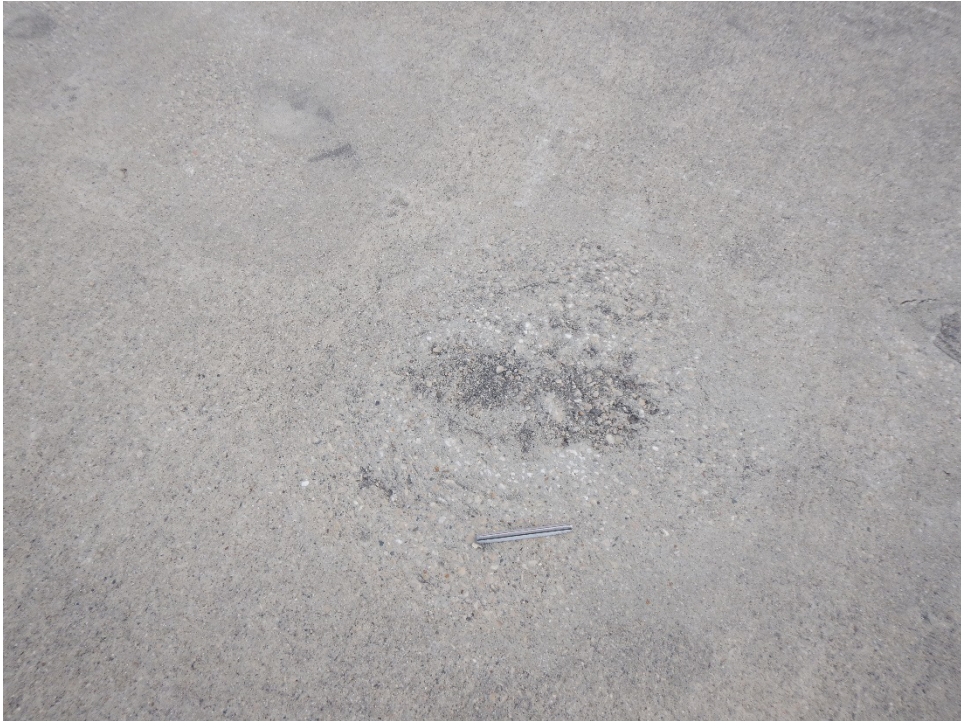
TH01WU-01. Scaling (Sample Unit No. 01).
