Winterset Municipal Airport

PAVEMENT MANAGEMENT REPORT

JUNE 2018

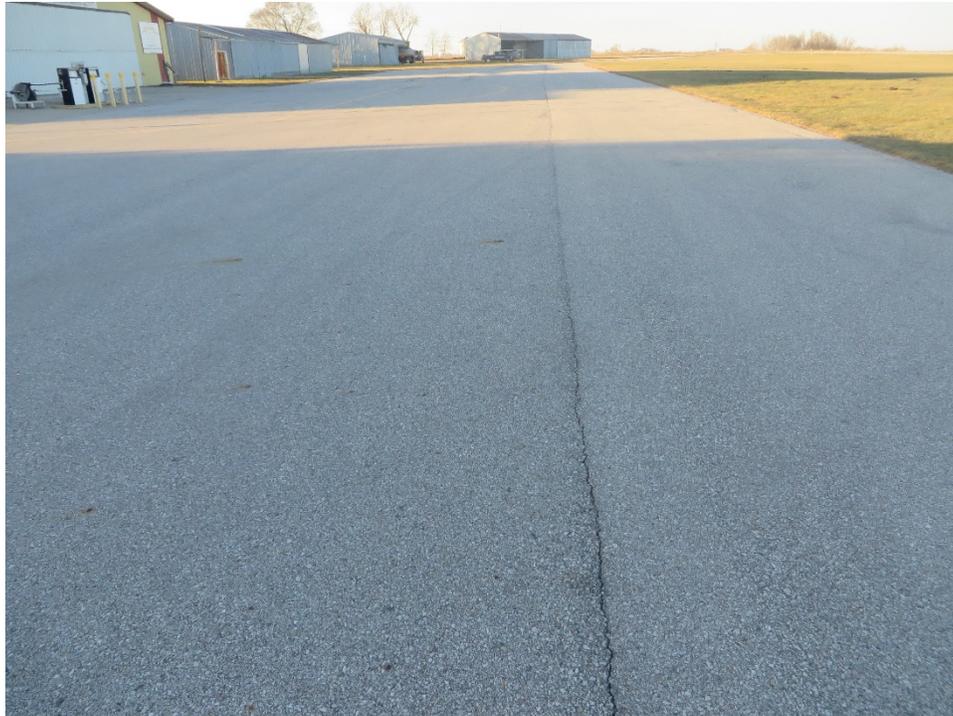
A01WI-01. Overview.

| Branch ¹ | Section ¹ | Surface Type ² | Section Area (sf) | LCD ³ | 2017 PCI | % Distress due to Load ⁴ | % Distress due to Climate/Durability ⁵ | % Distress due to Other ⁶ | Type of Distresses ⁷ |
|---|---|---|---|---|---|---|---|---|---|
| A01WI | 01 | AC | 37,013 | 6/4/2009 | 75 | 0 | 100 | 0 | L&T Cracking, Raveling, Weathering |

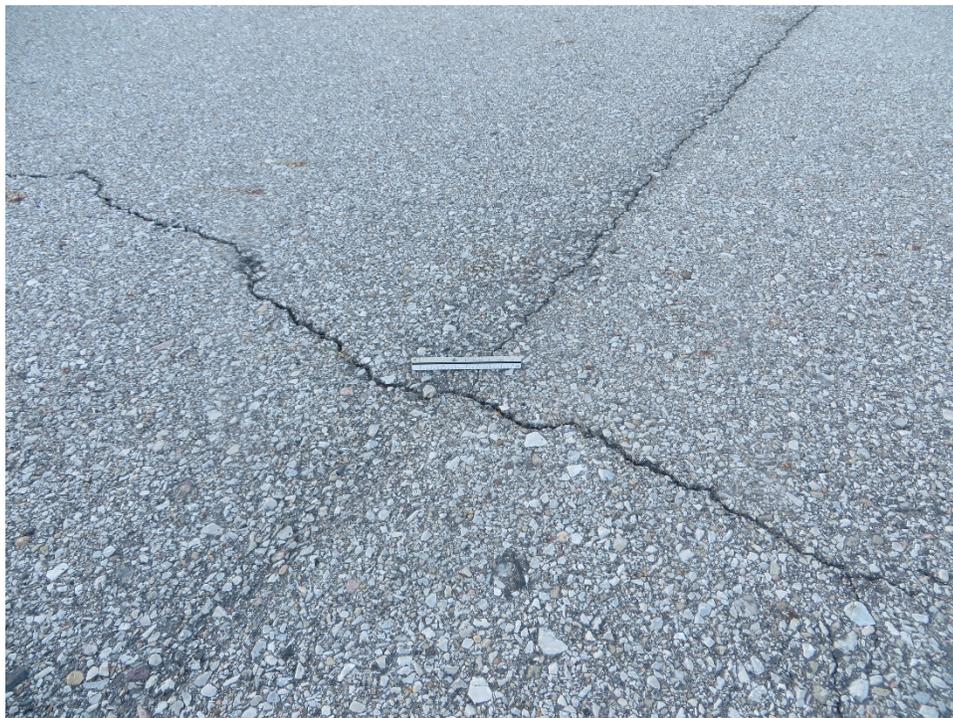
A01WI-01. L&T Cracking (Sample Unit No. 05).

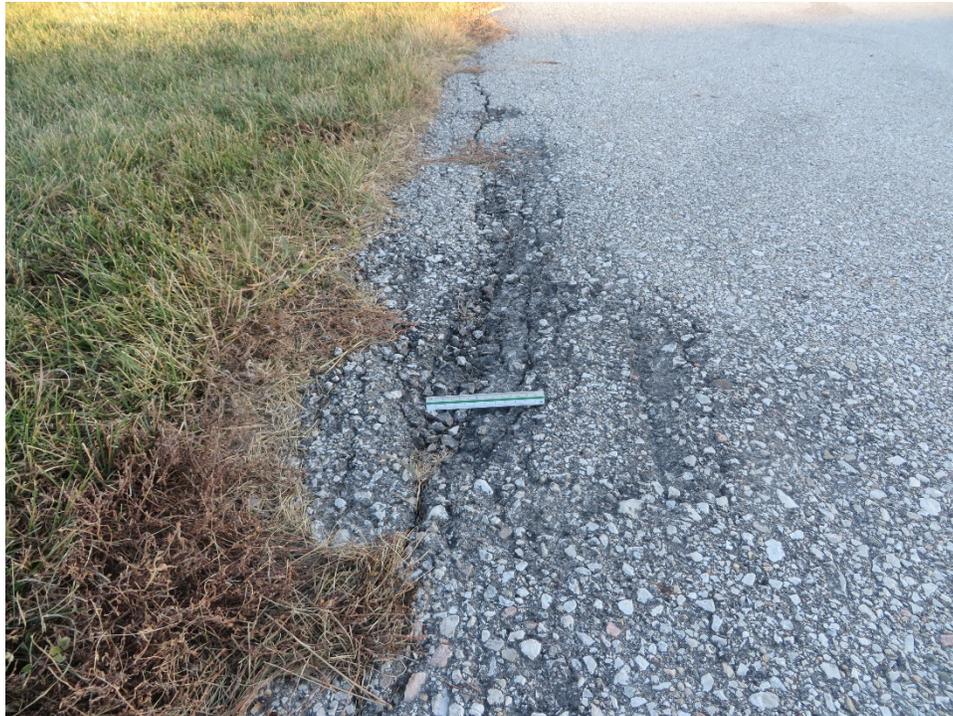
A01WI-01. Raveling (Sample Unit No. 05).

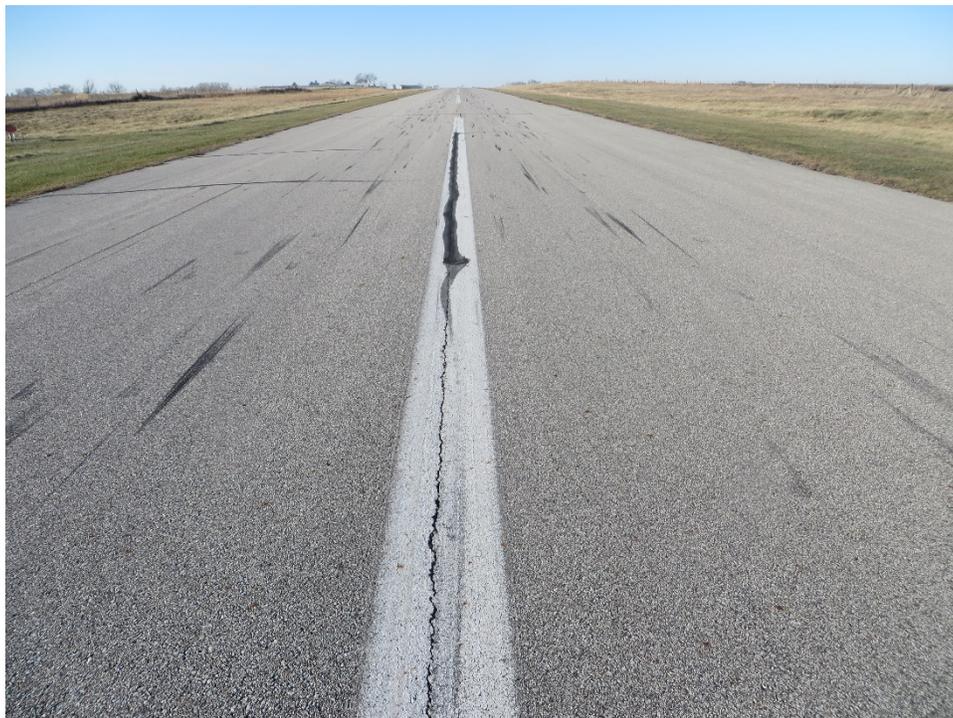
R14WI-01. Overview.

Runway 14-32 was defined by one section. Low- and medium-severity alligator cracking and longitudinal and transverse (L&T) cracking and low-severity swelling and weathering were observed in Section 01. The low-severity alligator cracking was recorded at the edge of the pavement. The low-severity L&T cracking was identified in both the sealed and unsealed conditions while the medium-severity L&T cracking was recorded due to either the development of secondary cracking, unsealed crack widths greater than ¼ inch, or crack sealant no longer performing satisfactorily.

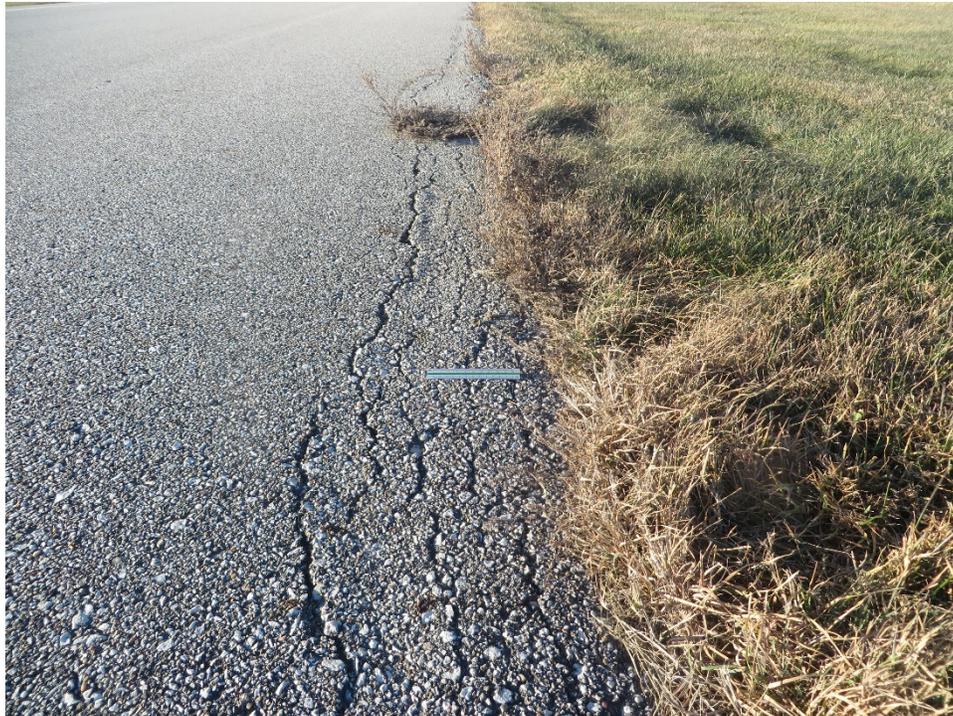
R14WI-01. Alligator Cracking (Sample Unit No. 12).

Sample Number: 12 Type: R Area: 5,000.00SqFt PCI = 63
Sample Comments:
41 ALLIGATOR CRACKING L 160.00 SqFt Comments:@ EDGE
57 WEATHERING L 5,000.00 SqFt Comments:

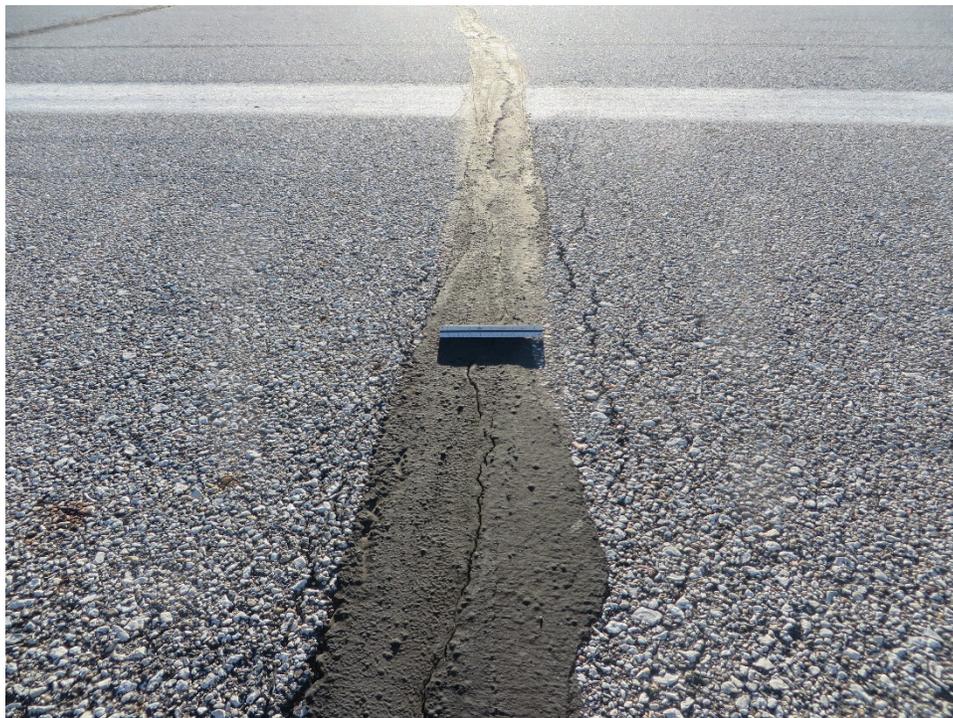
R14WI-01. L&T Cracking (Sample Unit No. 16).

Sample Number: 16 Type: R Area: 5,000.00SqFt PCI = 54
Sample Comments:
57 WEATHERING L 5,000.00 SqFt Comments:
41 ALLIGATOR CRACKING L 105.00 SqFt Comments:@ EDGE
48 LONGITUDINAL/TRANSVERSE CRACKING L 12.00 Ft Comments:LS
48 LONGITUDINAL/TRANSVERSE CRACKING M 97.00 Ft Comments:FS; 2NDY; W
41 ALLIGATOR CRACKING M 7.00 SqFt Comments:

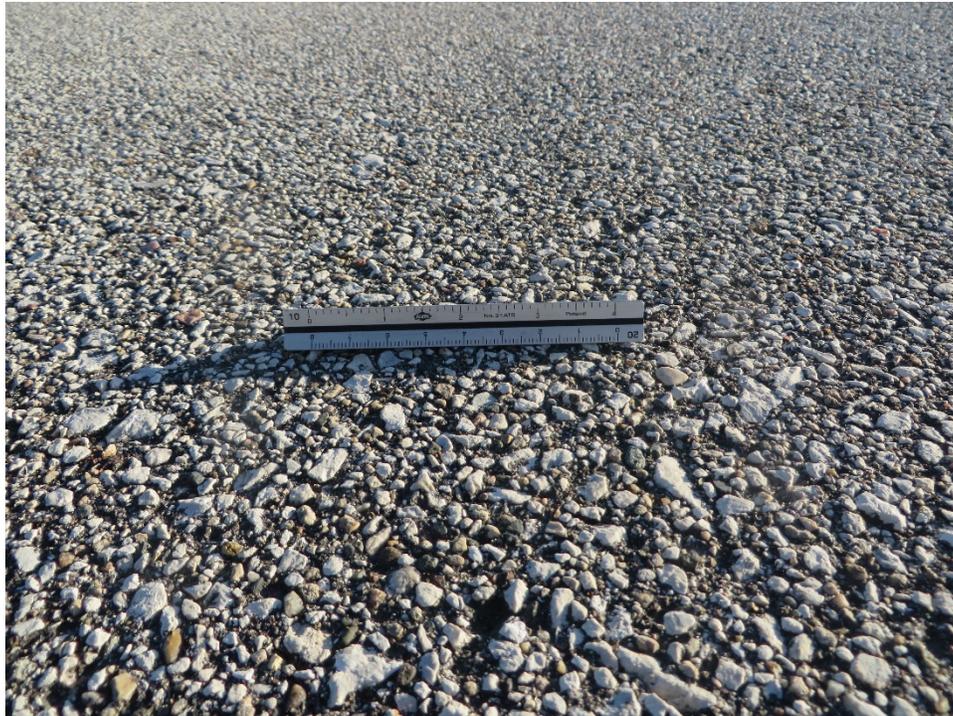
R14WI-01. Weathering (Sample Unit No. 16).

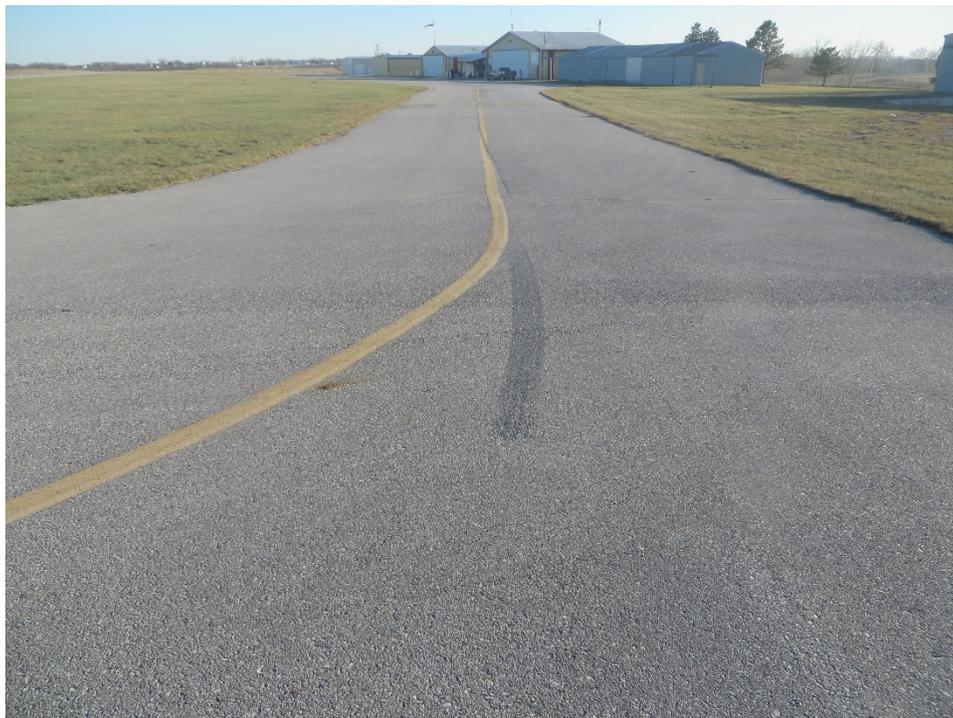
T01WI-01. Overview.

Taxiway 01 consisted of one section, located between the Runway 14 approach and the apron area. Low-severity weathering, swelling and alligator cracking and low- and medium-severity L&T cracking were identified. The low-severity L&T cracking was identified in an unsealed condition while the medium-severity L&T cracking was recorded where either crack sealant was no longer performing satisfactorily, unsealed crack widths exceeded ¼ in, or secondary cracking associated with the primary cracking was observed. The low-severity alligator cracking was observed at the edge of the pavement.

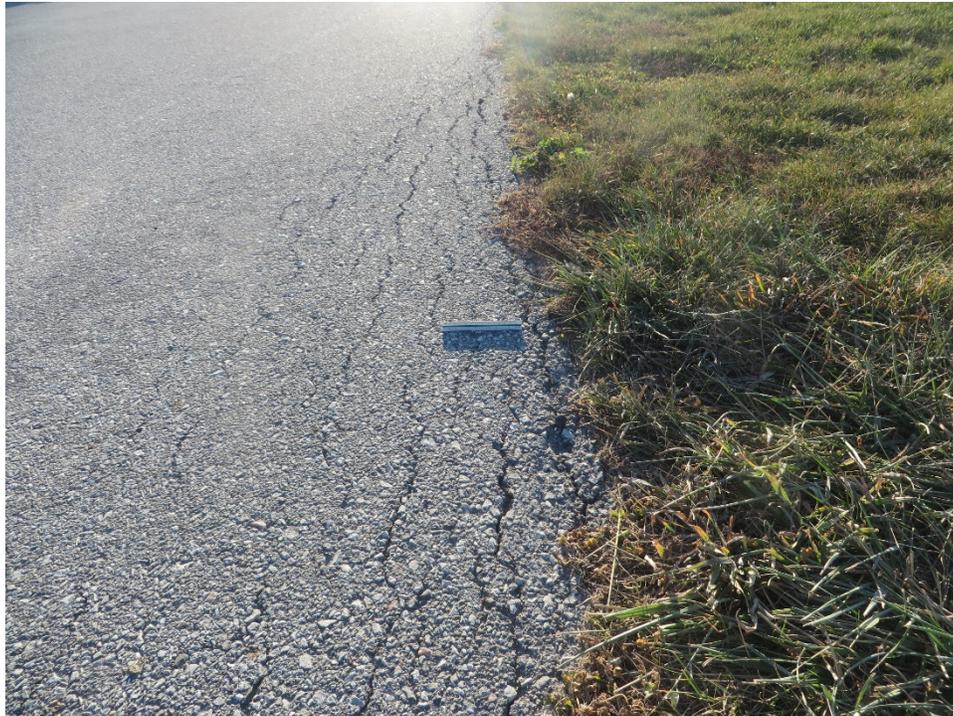
T01WI-01. Alligator Cracking (Sample Unit No. 01).

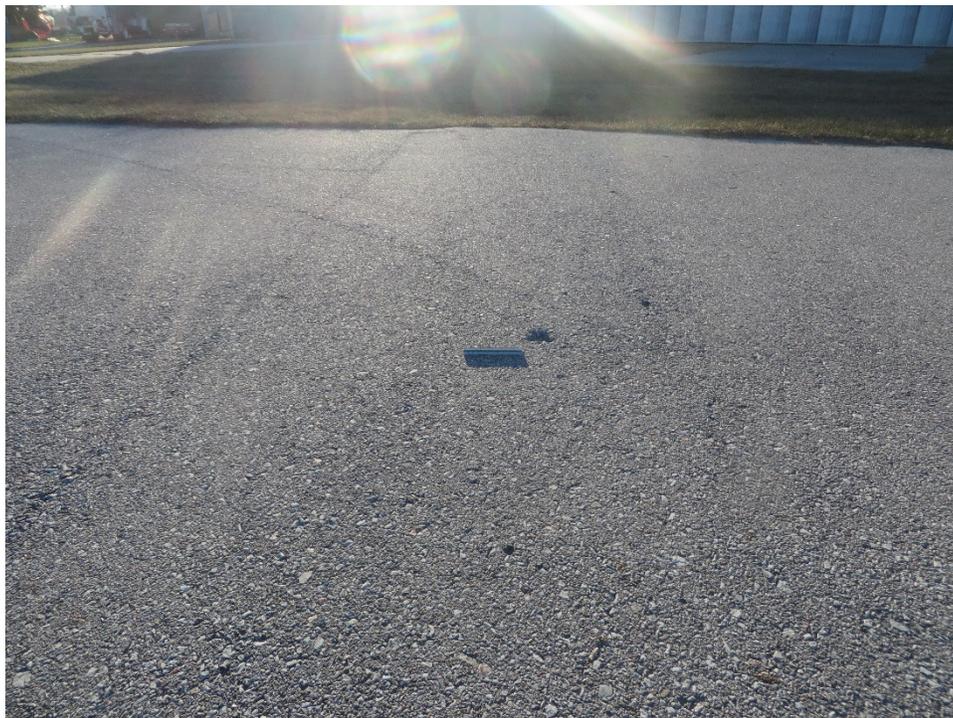
T01WI-01. Swelling (Sample Unit No. 02).

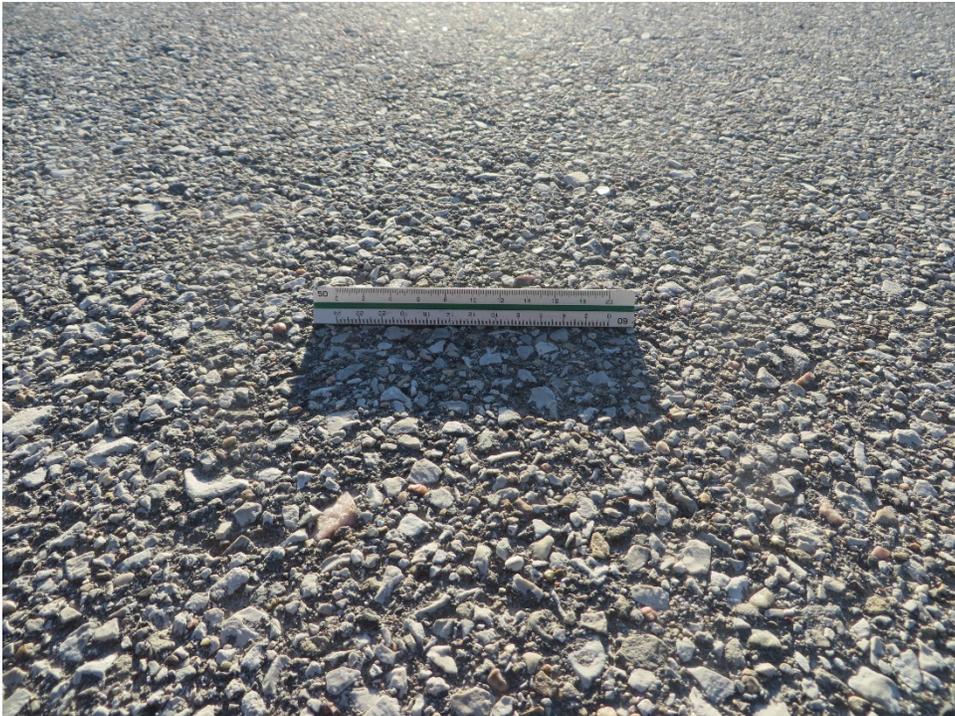
T01WI-01. Weathering (Sample Unit No. 01).

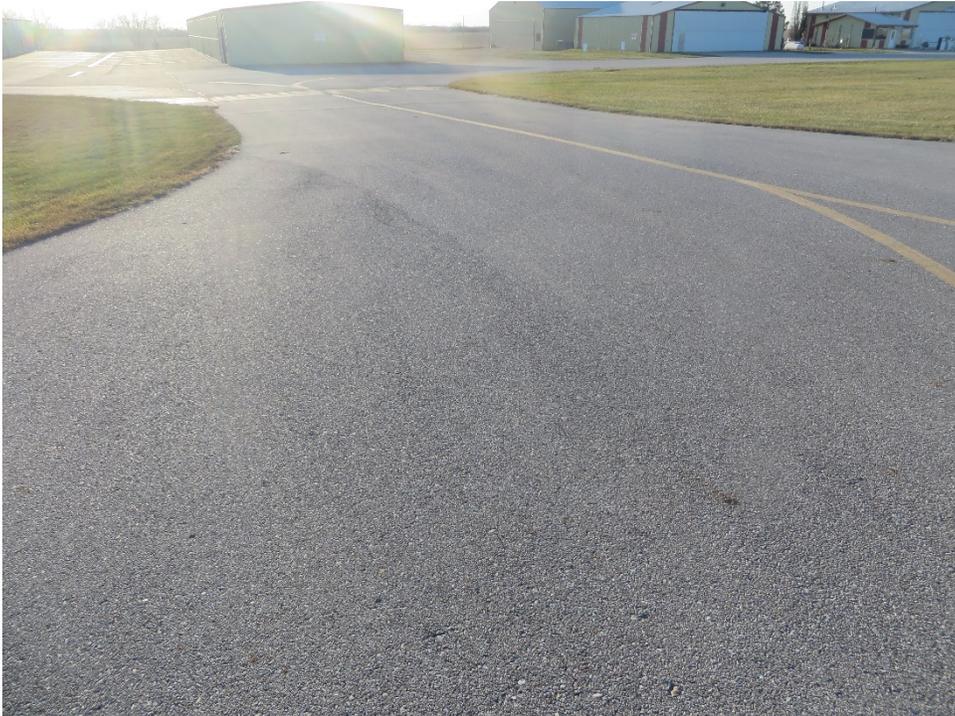
T02WI-01. Overview.

Taxiway 02 contained one section, located between Runway 14-32 and the apron area. Low-severity L&T cracking was observed in Section 01 in both the sealed and unsealed conditions along with medium-severity L&T cracking that was due to the development of secondary cracking. Low-severity weathering was also recorded along with low-severity alligator cracking where secondary cracking was greater than 1 foot wide.

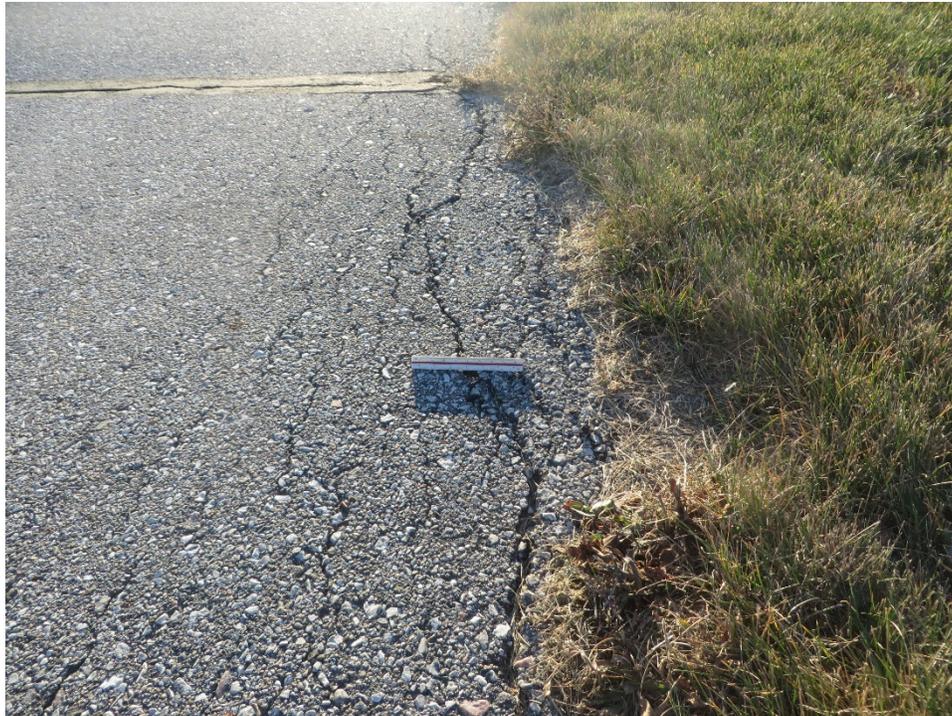
T02WI-01. Alligator Cracking (Sample Unit No. 01).

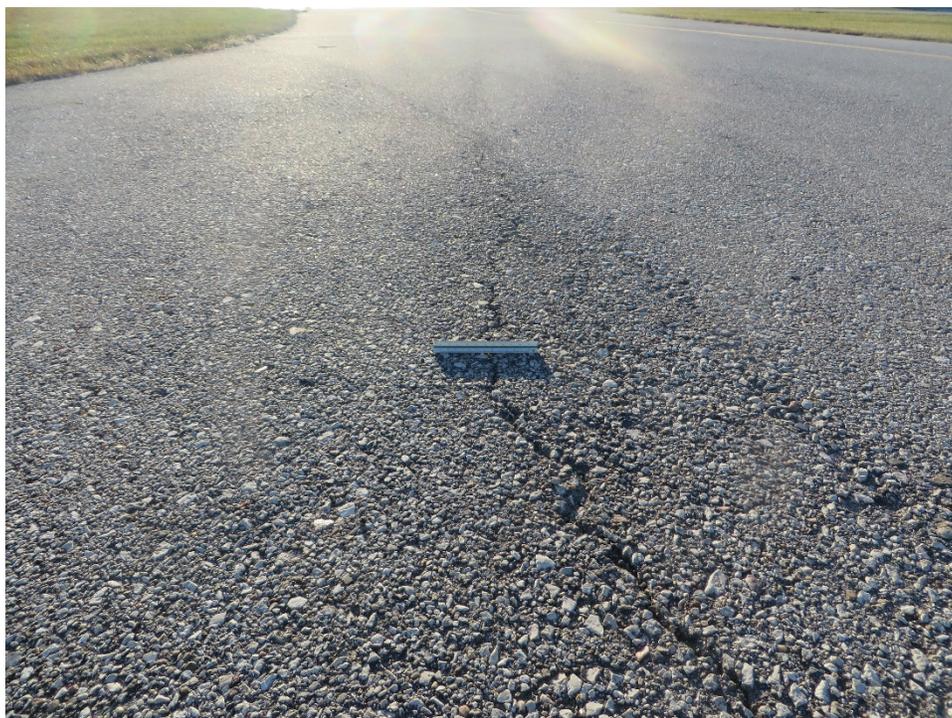
T02WI-01. L&T Cracking (Sample Unit No. 01).

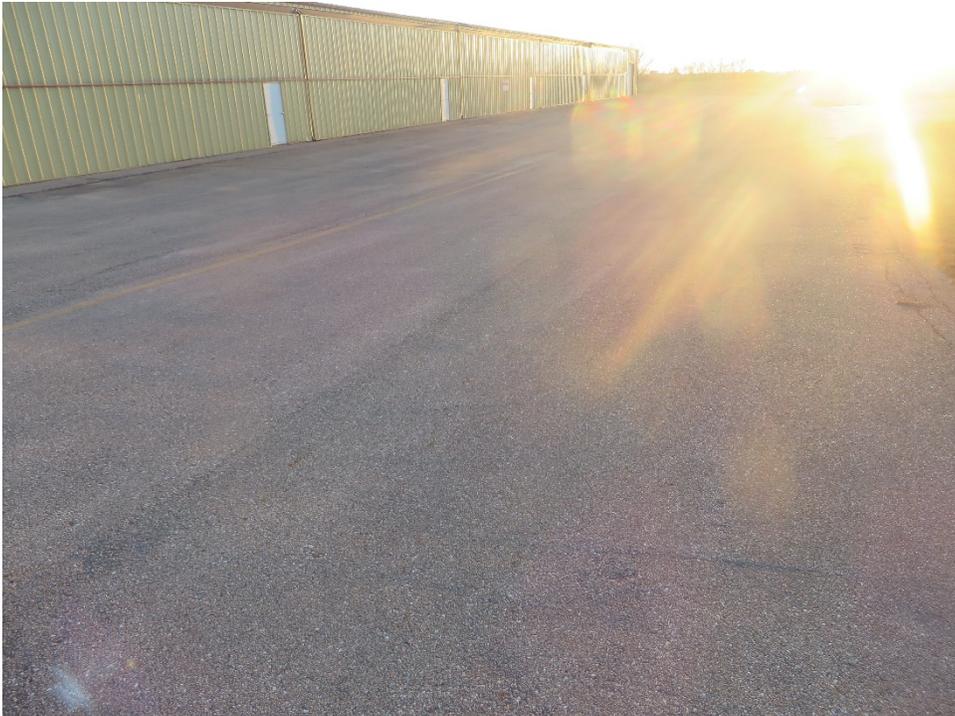
TH01WI-01. Overview.

The T-Hangar area was defined by two sections. Section 01 was observed with low-severity alligator cracking, rutting, weathering, and depression; low- and medium-severity L&T cracking; and medium- and high-severity raveling were recorded. The low-severity alligator cracking was located at the edge of the pavement. Low-severity L&T cracking was recorded in both the sealed and unsealed conditions, while the medium-severity L&T cracking was observed where either crack sealant was no longer performing satisfactorily, unsealed crack widths exceeded ¼ inch, or secondary cracking associated with the primary cracking was identified. Isolated amounts of low-severity swelling were observed at the L&T cracking and at a drainage structure. Section 02 was identified with low-severity L&T cracking in both the sealed and unsealed conditions, along with medium-severity L&T cracking that was due to either unsatisfactory crack sealant or unsealed crack widths greater than ¼ inch. Much of the cracking in this section was filled with vegetation. Low-severity swelling and weathering were also identified.

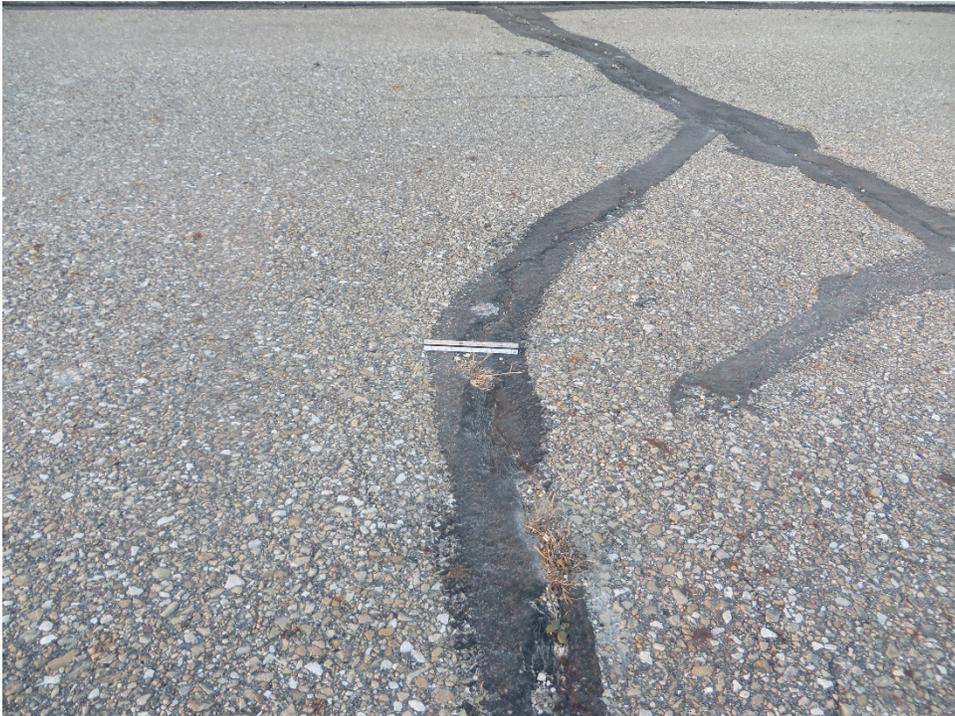
TH01WI-01. L&T Cracking (Sample Unit No. 05).

Sample Number: 05 Type: R Area: 4,025.00SqFt PCI = 55
Sample Comments:
48 LONGITUDINAL/TRANSVERSE CRACKING M 190.00 Ft Comments:FS W 2NDY
48 LONGITUDINAL/TRANSVERSE CRACKING L 97.00 Ft Comments:LU
52 RAVELING H 10.00 SqFt Comments:
53 RUTTING L 50.00 SqFt Comments:
57 WEATHERING L 4,015.00 SqFt Comments:

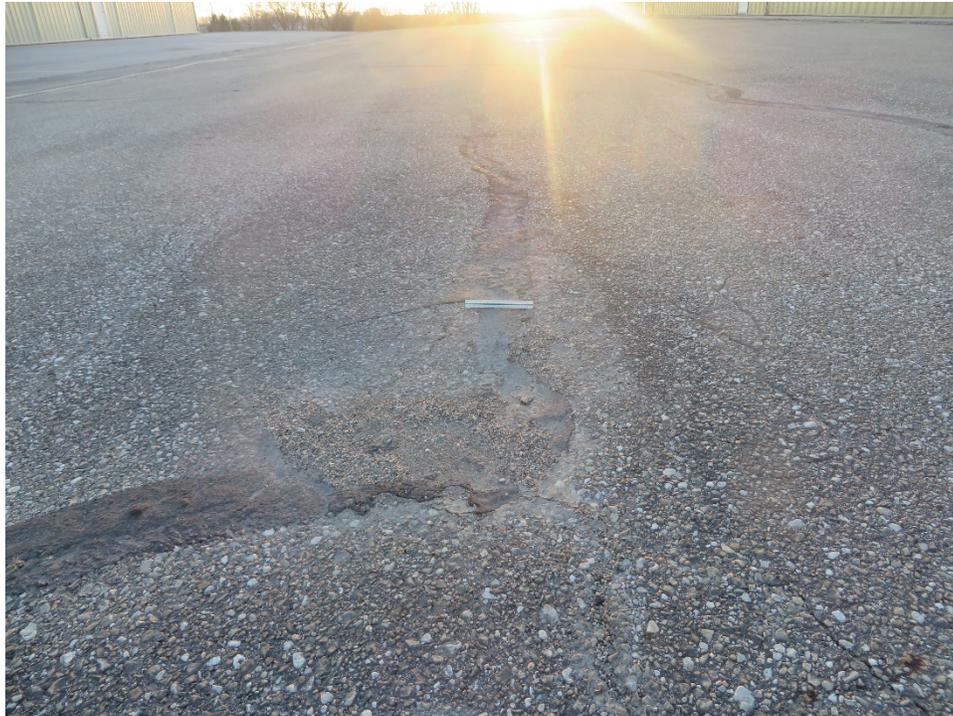
TH01WI-01. Rutting (Sample Unit No. 05).

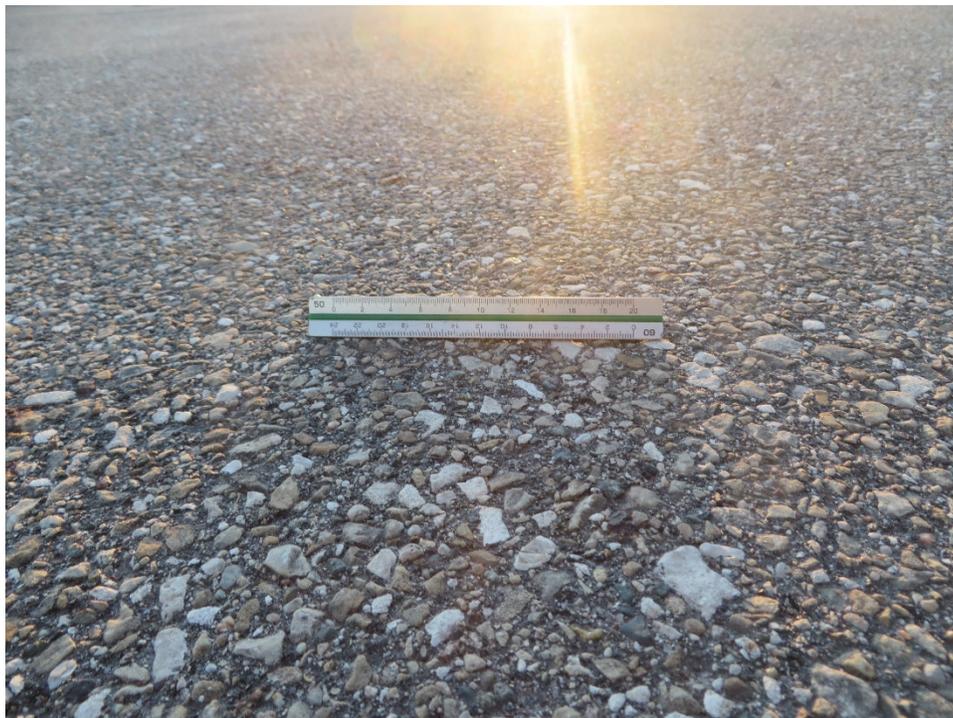
TH01WI-01. Weathering (Sample Unit No. 05).

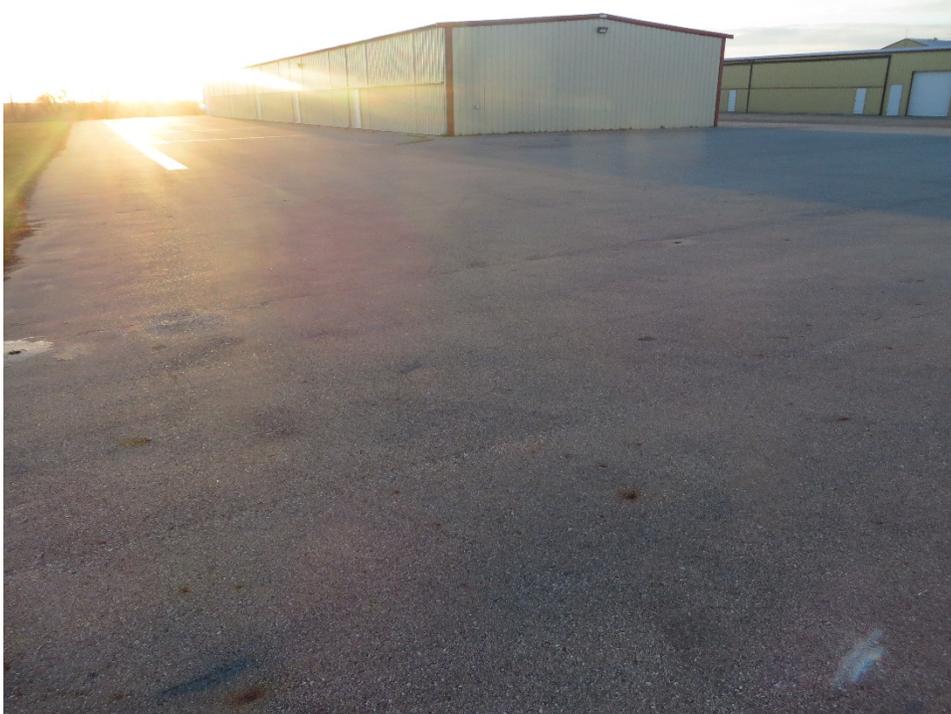
TH01WI-02. Overview.

| Branch ¹ | Section ¹ | Surface Type ² | Section Area (sf) | LCD ³ | 2017 PCI | % Distress due to Load ⁴ | % Distress due to Climate/Durability ⁵ | % Distress due to Other ⁶ | Type of Distresses ⁷ |
|---|---|---|---|---|---|---|---|---|---|
| TH01WI | 02 | AC | 30,294 | 1/1/2013 | 82 | 0 | 74 | 26 | L&T Cracking, Swelling, Weathering |

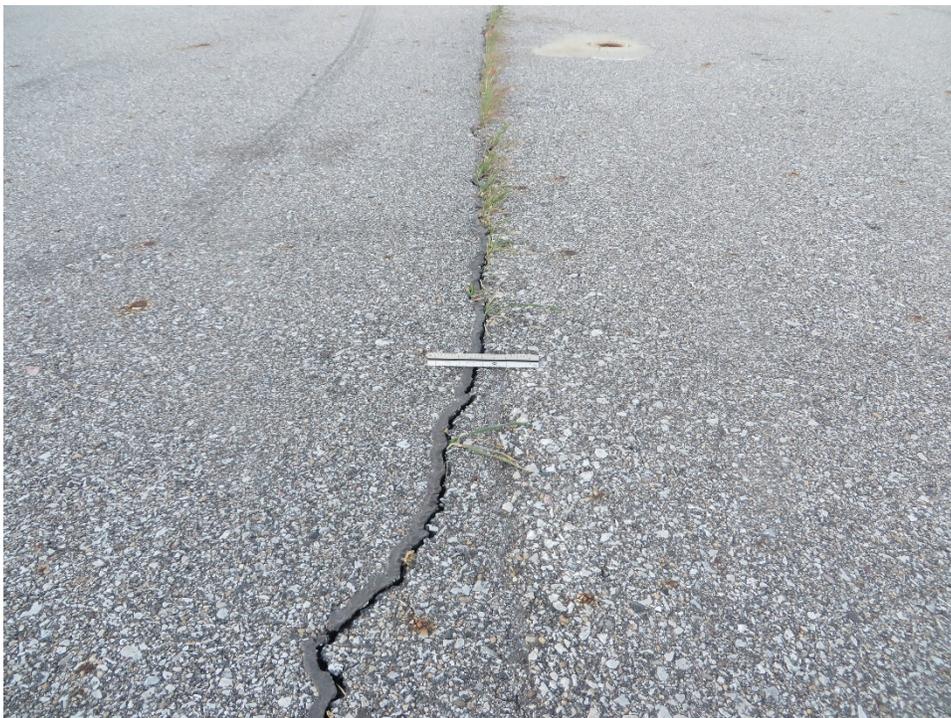
TH01WI-02. L&T Cracking (Sample Unit No. 02).

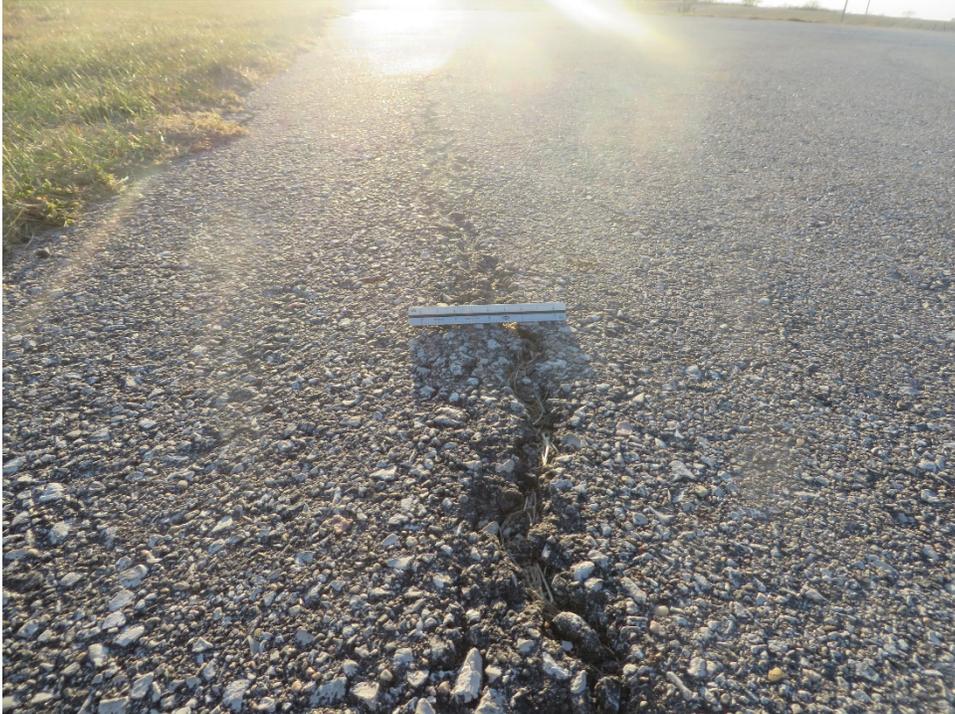
TH01 WI-02. Swelling (Sample Unit No. 06).
