Winterset Municipal Airport

Pavement Management Report

JULY 2024

WINTERSET MUNICIPAL AIRPORT PAVEMENT MANAGEMENT REPORT

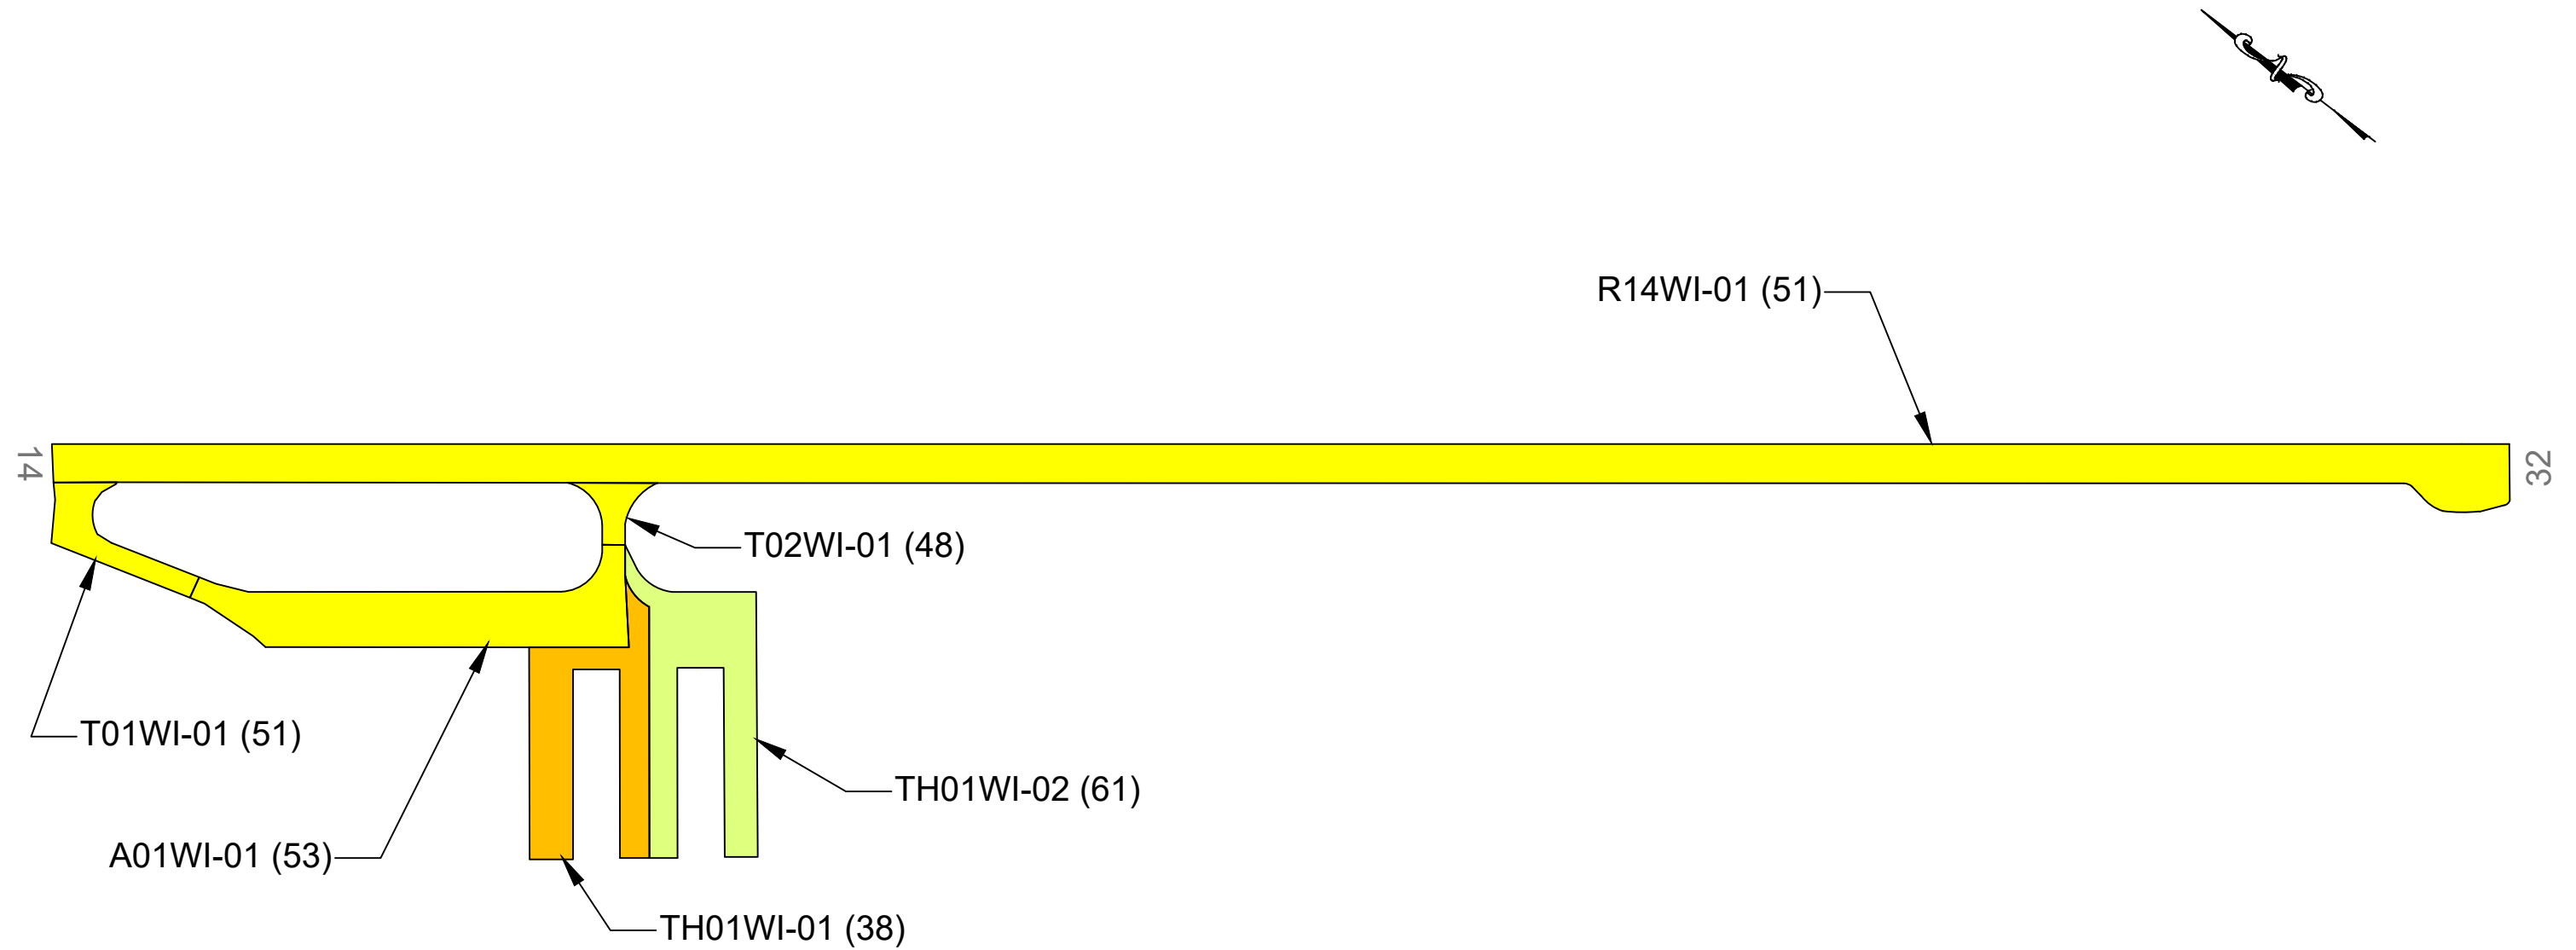
FIGURE 8. PCI MAP.

The pavements at Winterset Municipal Airport were inspected in November 2023. The 2023 area-weighted condition of Winterset Municipal Airport is 51, with conditions ranging from 38 to 61 (on a scale of 0 [failed] to 100 [excellent]). During the previous pavement inspection in 2020, the area-weighted PCI of the airport was 57.

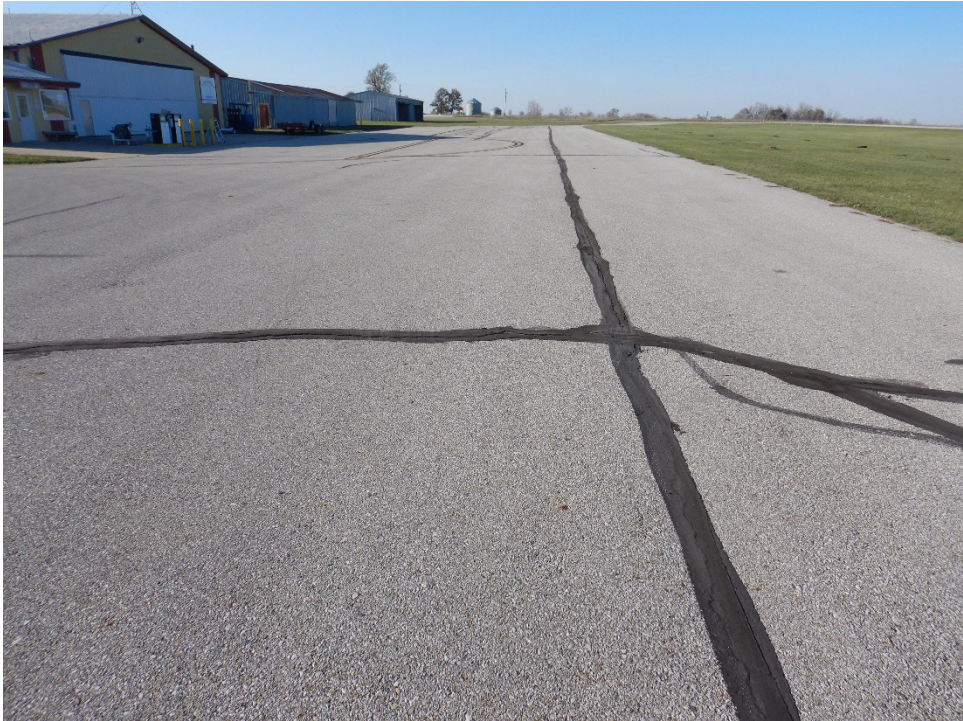
A01WI-01. Overview.

The apron area consisted of one section. Section 01 was identified with low- and medium-severity alligator cracking and L&T cracking, medium- and high-severity weathering, and high-severity raveling. The low-severity L&T cracking was either sealed or unsealed while the medium-severity L&T cracking was identified where either the crack sealant was no longer satisfactory or secondary cracking had developed.

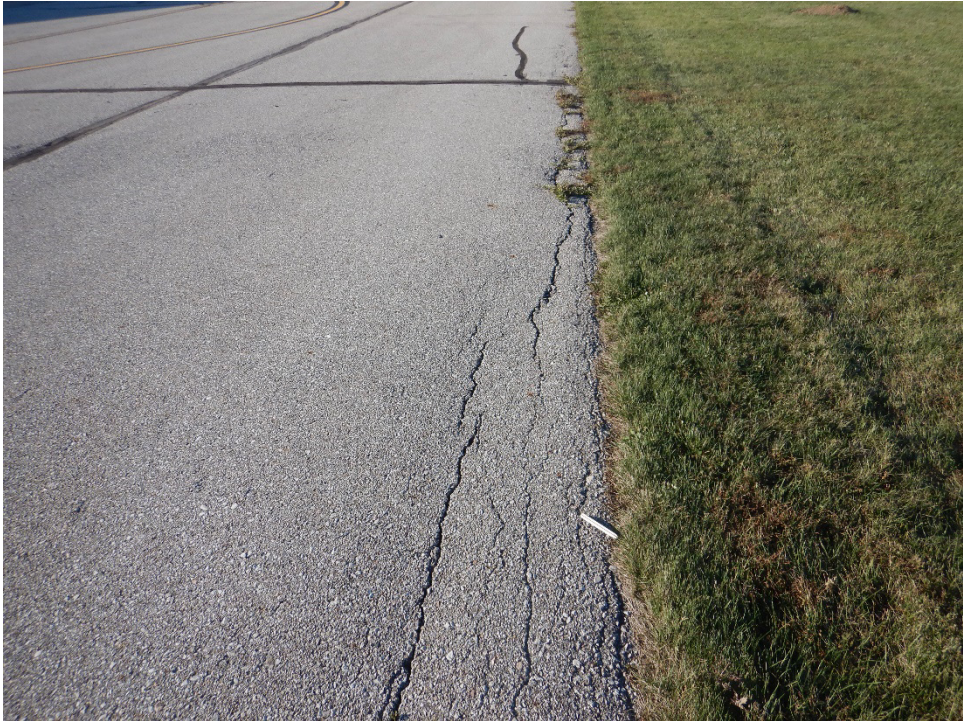
A01WI-01. Alligator Cracking (Sample Unit No. 06).

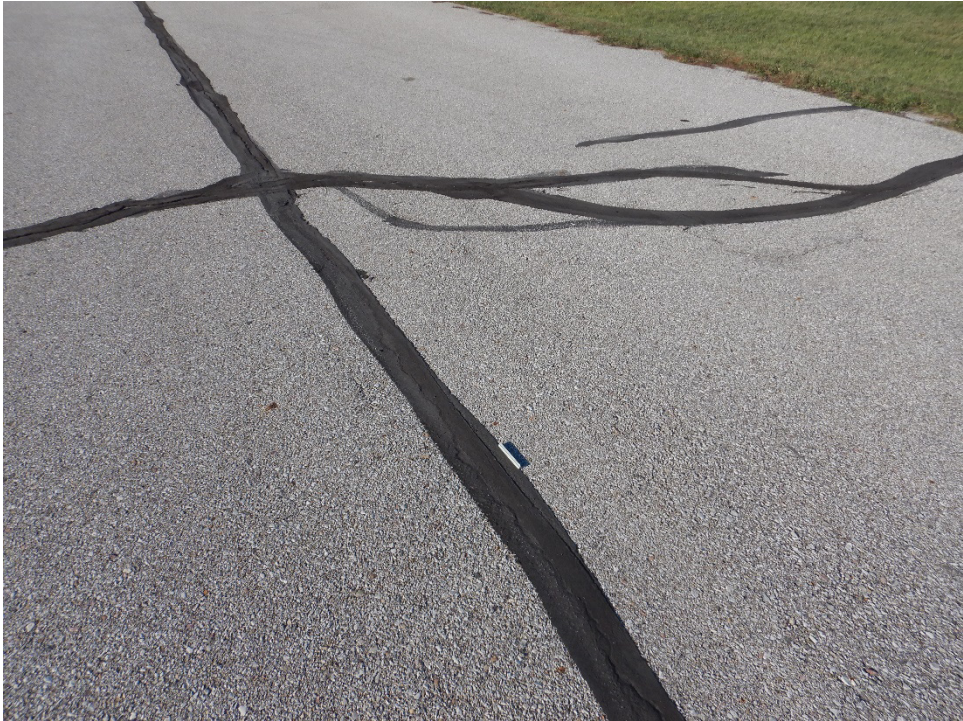
A01WI-01. L&T Cracking (Sample Unit No. 05).

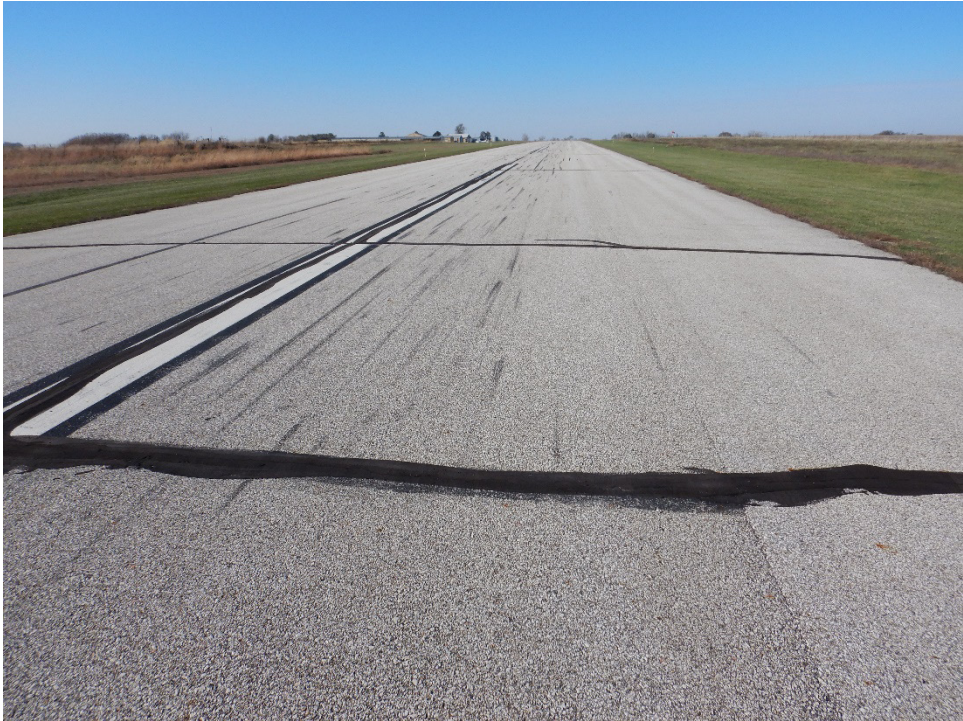
R14WI-01. Overview.

Runway 14/32 was defined by one section. Low- and medium-severity longitudinal and transverse (L&T) cracking and alligator cracking, medium-severity weathering, and high-severity raveling were identified in Section 01. The low-severity L&T cracking was either sealed or unsealed. The medium-severity L&T cracking was identified where either the crack sealant was no longer satisfactory or secondary cracking had developed.

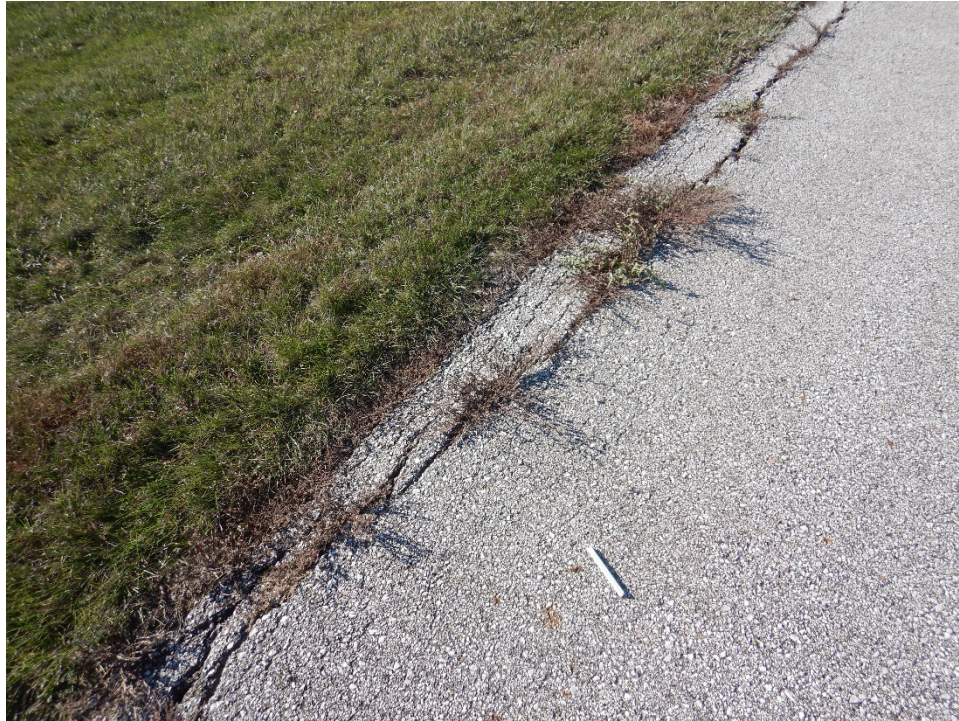
R14WI-01. Alligator Cracking (Sample Unit No. 16).

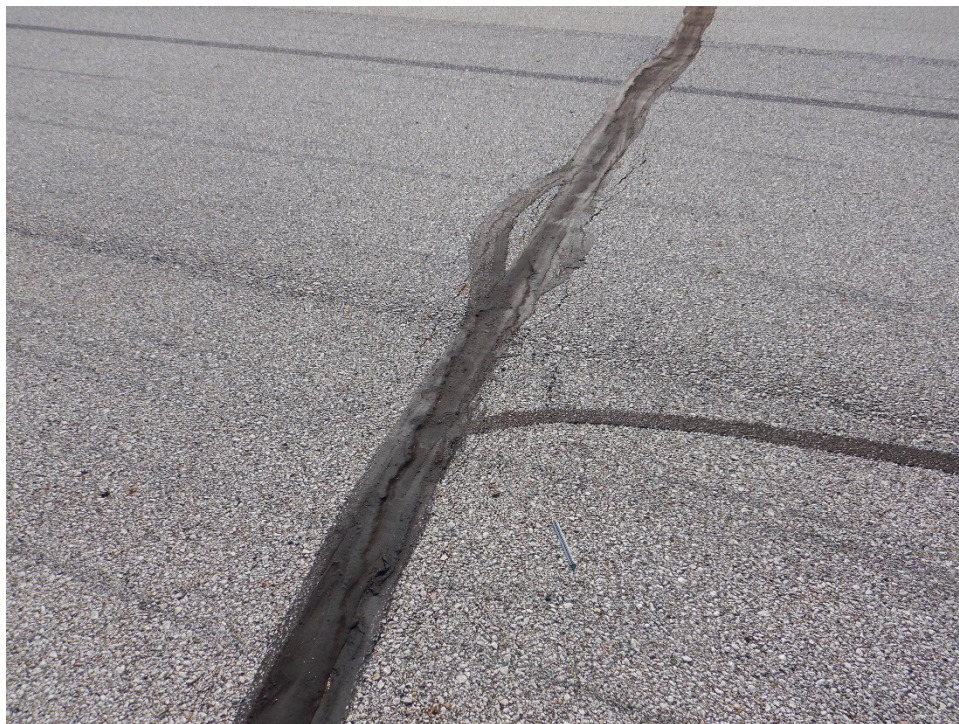
R14WI-01. L&T Cracking (Sample Unit No. 24).

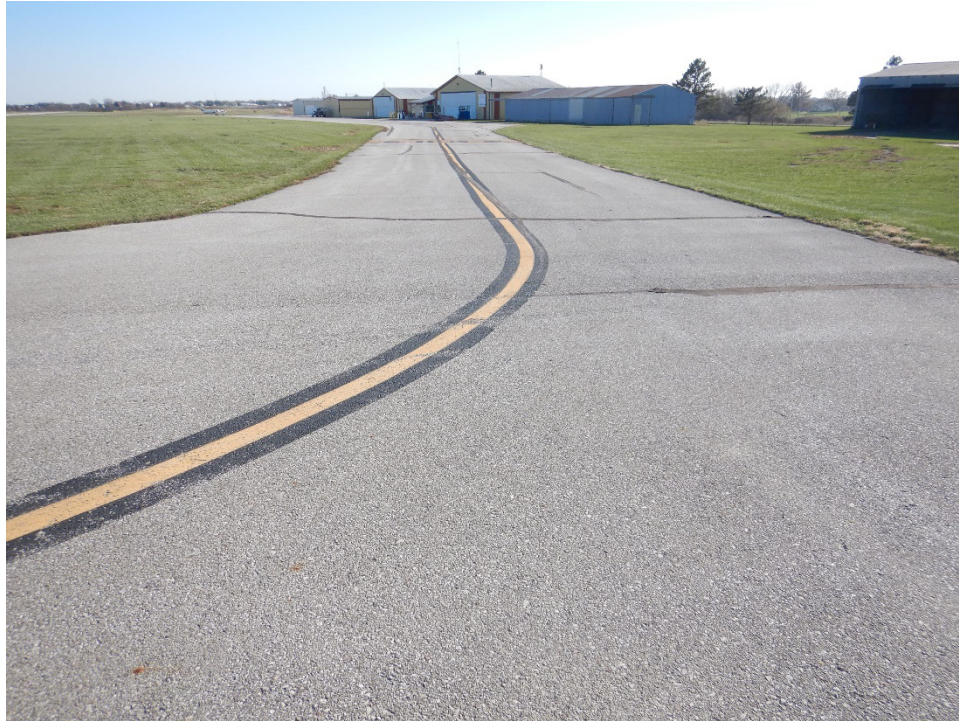
T01WI-01. Overview.

Taxiway 01 contained one section. Medium-severity weathering and low- and medium-severity alligator cracking and L&T cracking were identified in Section 01. The low-severity L&T cracking was either sealed or unsealed and the medium-severity L&T cracking was due to the development of secondary cracking.

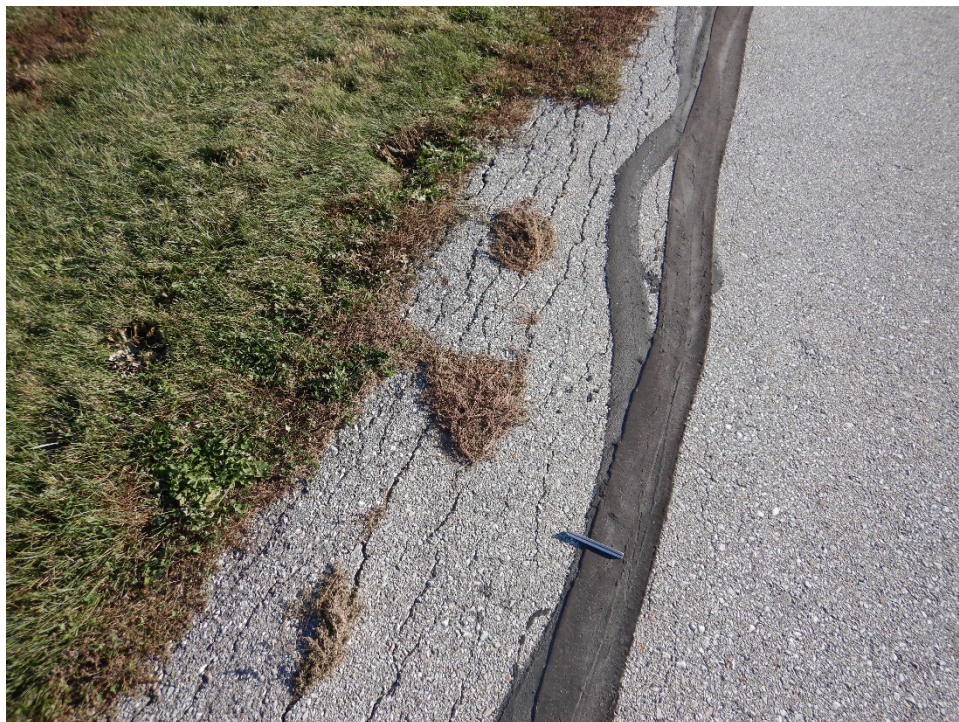
T01WI-01. Alligator Cracking (Sample Unit No. 01).

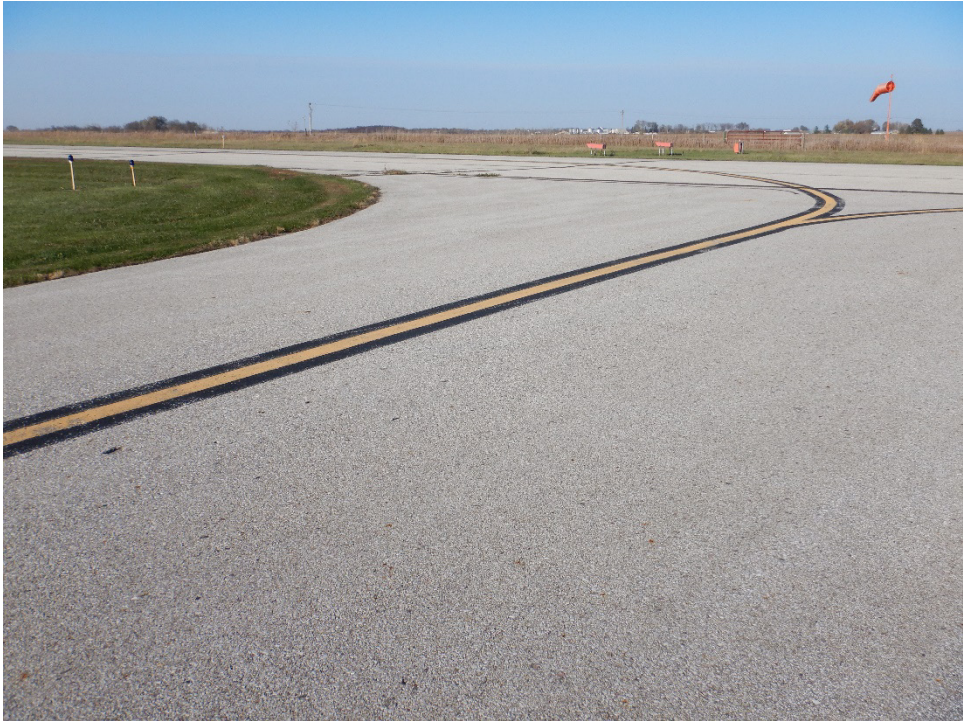
T02WI-01. Overview.

Taxiway 02 was defined by one section. In Section 01, areas of low-severity alligator cracking and raveling, low- and medium-severity L&T cracking, and medium-severity weathering were observed. The low-severity L&T cracking was sealed while the medium-severity L&T cracking was identified where either crack sealant unsatisfactory or secondary cracking had developed.

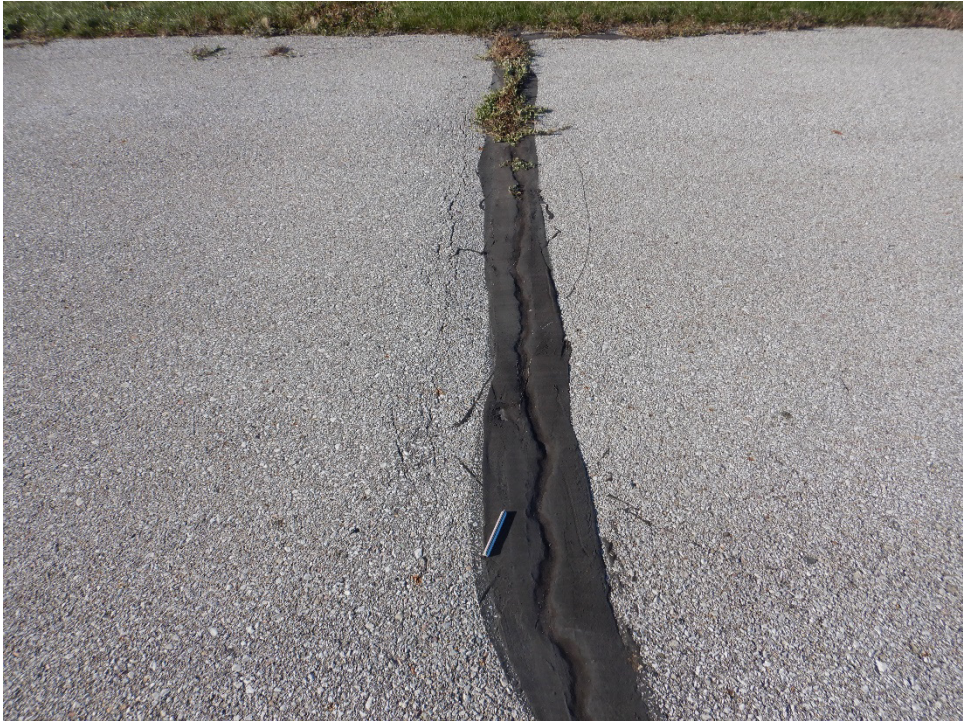
T02WI-01. L&T Cracking (Sample Unit No. 01).

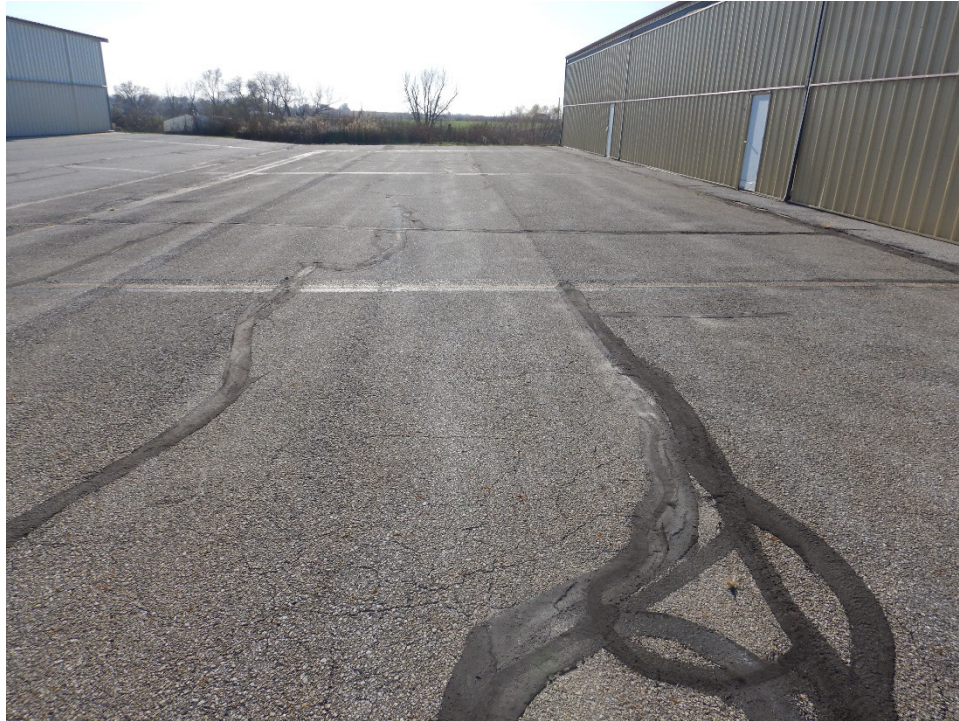
TH01WI-01. Overview.

The T-Hangar area was defined by two sections. Section 01 was in poor condition and with areas of low-severity depression and swelling; low- and medium-severity alligator cracking, L&T cracking, and rutting; medium-severity weathering; and medium- and high-severity raveling. The low-severity L&T cracking was primarily sealed. The medium-severity L&T cracking was due to either unsatisfactory crack sealant or the development of secondary cracking. Low-severity depression, rutting, and swelling; low- and medium-severity alligator cracking and L&T cracking; and medium-severity weathering were identified in Section 02. The low-severity L&T cracking was mostly sealed while the medium-severity L&T cracking was identified where secondary cracking had developed.

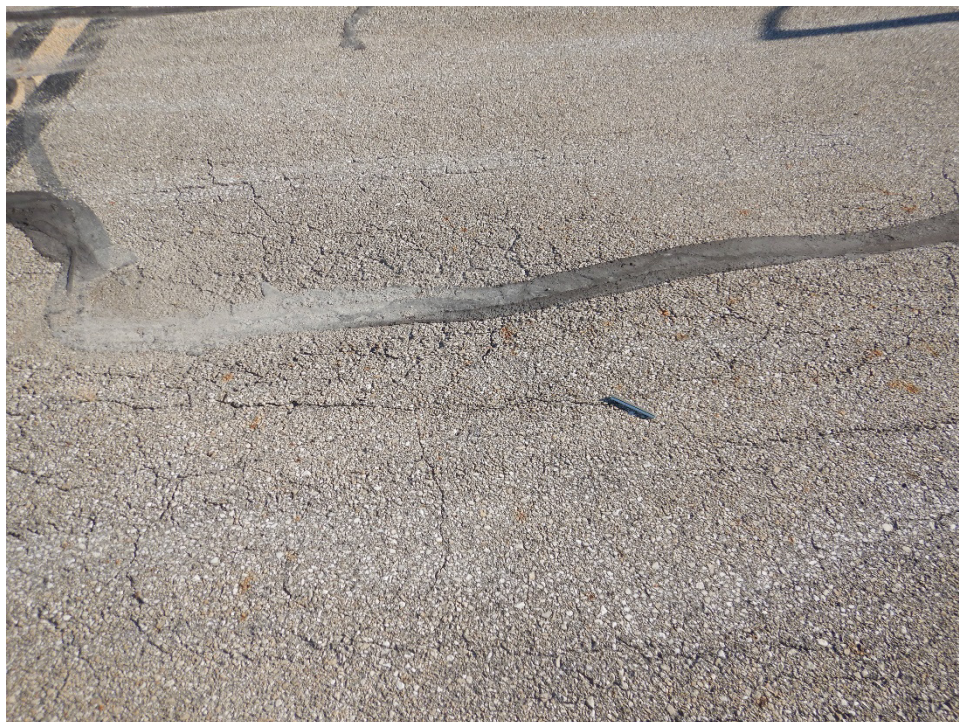
TH01WI-01. Alligator Cracking (Sample Unit No. 05).

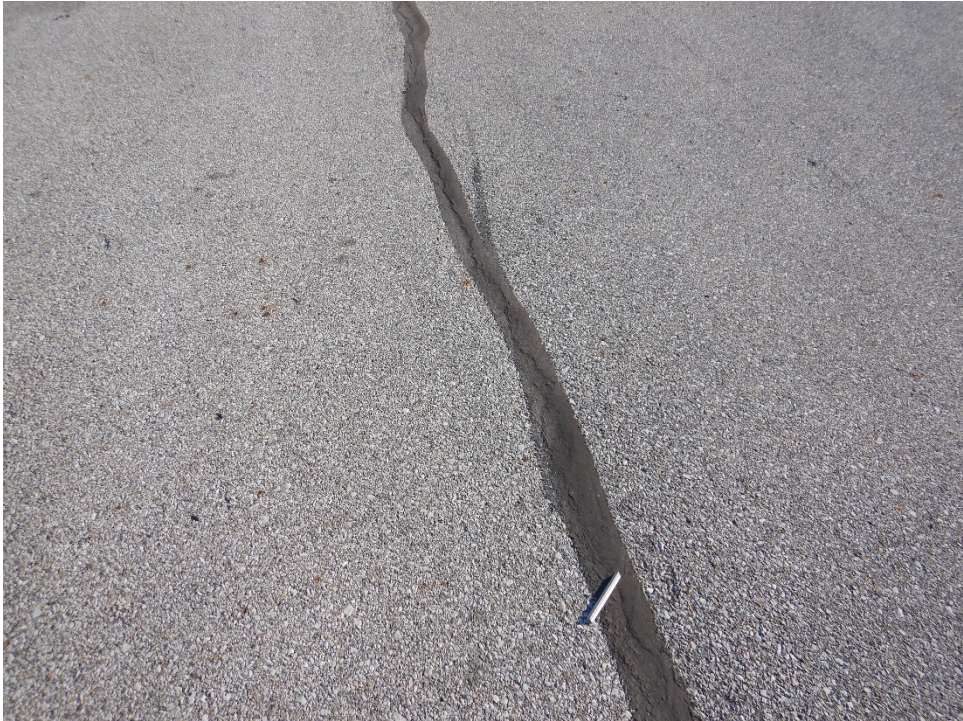
TH01WI-02. L&T Cracking (Sample Unit No. 02).
