# EVALUATION OF A STEEL GIRDER BRIDGE STRENGTHENED USING FRP PLATES

CTRE Project

**Final Report • November 2005**

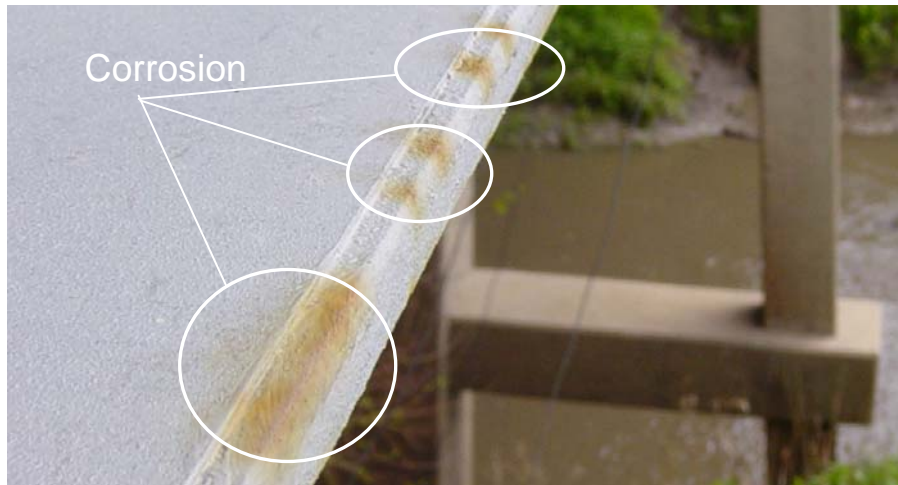
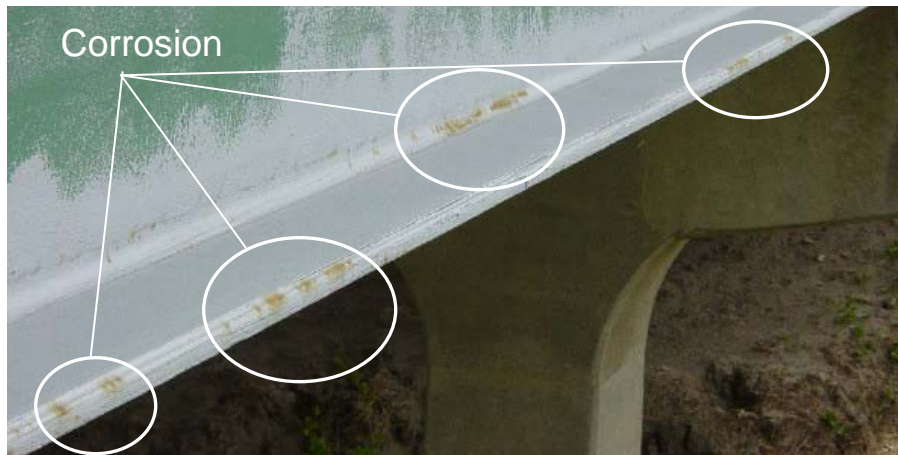
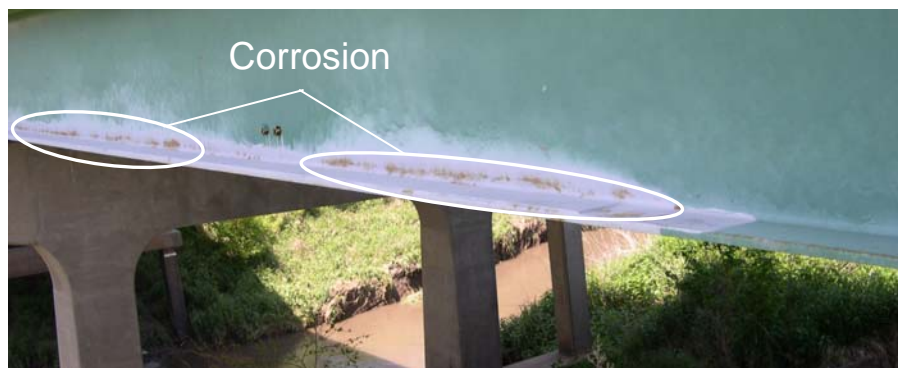
**Figure 36. Corrosion on the top of the bottom flange of Girder 6.**

some corrosion was observed on the top of the bottom flange of Girder 6 in all three spans. It was initially expected that the coating of paint applied after the installation of CFRP plates would be good enough for corrosion protection. After the visual inspections, however, it was speculated that the applied paint was too thin or had some defects and that rain or snow might have penetrated the protective coating. Therefore, it is recommended that thicker or a proper coatings of paint or other water-proof material be applied to prevent the weather-induced corrosion and, thereby, protect the integrity of the strengthening system.

All CFRP plates installed on both the exterior and interior girders were visually inspected approximately one and two years after installation (May 2004 and 2005, respectively) to observe any degradation or other changes that may have an influence on the integrity of the strengthening system. In general, no obvious debonding was observed and the condition of the CFRP plates seemed intact. However, some corrosion in the steel girders was observed, as shown in Fig. 36, on the top of the bottom flange of Girder 6 in all three spans. It was initially expected that the coating of paint applied after the installation of CFRP plates would be adequate for corrosion protection. After the visual inspections, however, it is speculated that the applied paint was too thin or had defects and that rain or snow might have penetrated the protective coating. Therefore, it is recommended that thicker or more coatings of paint or other water-proof material be applied to prevent weather-induced corrosion and, thereby, protect the integrity of the strengthening system.

- Paint coating applied after the installation may not have been sufficient enough to protect the strengthening system from direct environmental exposure (e.g., rain, snow, etc.); minimal to moderate corrosion had occurred on the top of the bottom flange on the top of the bottom flange on Girder 6 and the CFRP plates. Therefore, it is recommended that thicker or more coatings of paint or other water-proof coating be applied to prevent the weather-induced corrosion and, thereby, protect the integrity of the strengthening system.
