1. Report No.	2. Government Accession No.	3. Recipient's Catalog No.	
4. Title and Subtitle Testing and Evaluation of the Iowa DOT FRP Temporary Bypass Bridge		5. Report Date March 2008

Testing and Evaluation of the Iowa DOT FRP Temporary Bypass Bridge

Bridge Engineering Center

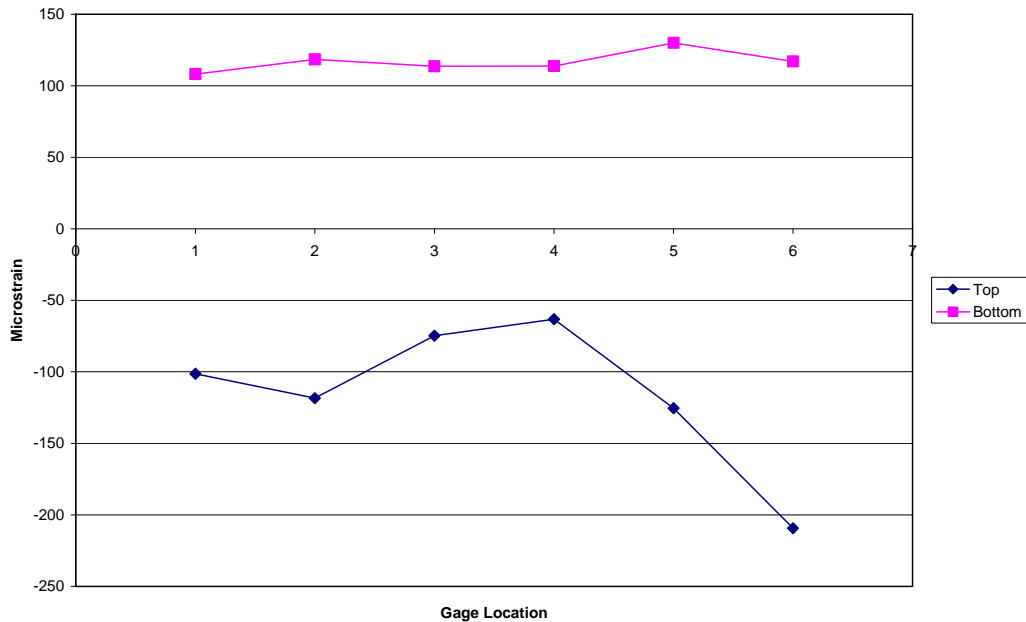
Illustrated in Fig. 24 is the strain profile for the top and bottom gages at mid-span for load case 2 (LC2) for Test 1, which is a symmetrical transverse truck position, and is generally representative of all three load cases for Test 1. Figure 24 indicates that there may be some discrepancy at gage location SG6 (T). Illustrated in Figs. 25 and 26 are panel strain readings from Test 1 and Test 2, respectively, in the area around gage SG6. Based on these two figures, it would appear that the strain measured at SG6 (T) for Test 1 is suspect. It is unclear whether this is due to localized effects from the close proximity of the rear axles, gage bonding issues, or other effects.

Figure 24. Top and Bottom strain profile at mid-span, LC2.

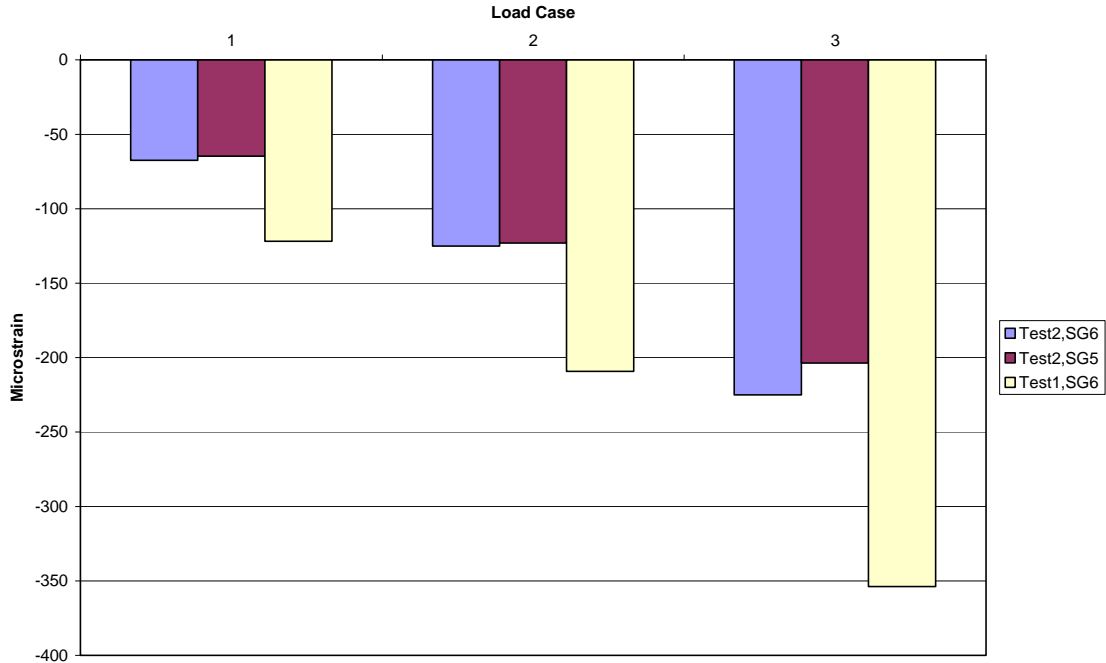
Figure 26. Strain comparison near SG6, Tests 1 and 2.

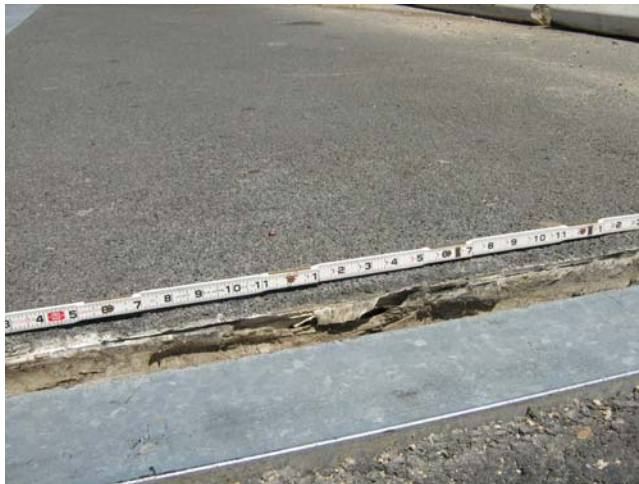
For several reasons, traffic over the FRP bridge was restricted to one lane by the use of portable jersey barriers, as shown in Fig. 33. Shortly after traffic was allowed on the bridge, Iowa DOT inspectors noticed that the transverse edge at the end of one of the panels was showing signs of significant damage at the approach end of the bridge, see Fig. 34. Investigation of the area found that the contact between the backwall and the panel was not necessarily the problem. Rather, the elevation of the top of the backwall was approximately an inch lower than the elevation of the top of the panel, this left the leading edge of the panel exposed to the full force of oncoming traffic loads. Due to time constraints and the need to keep traffic uninterrupted, steel plates (shown in Fig. 33) were used to span from the approach roadway section to the bridge deck across the abutment joint in an attempt to stop the progression of the deck deterioration. At the same time, traffic was reduced from two lanes to one lane across the bridge.

Figure 34. Damage at edge of deck panel at approach abutment.

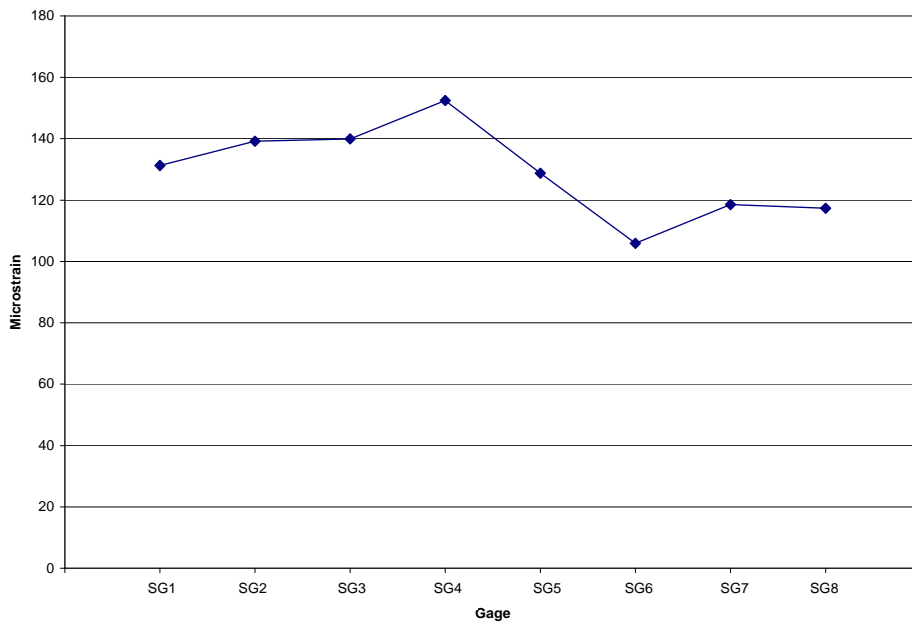
Figure 37. Transverse strain distribution at midspan, on site load test, 8/15/07.

A brief load test at the time of this inspection resulted in measured tensile strains at midspan that were similar to with those measured prior to installation. Although these test results indicated that the bridge showed no signs of reduced stiffness and was adequately distributing the loads, the structure was immediately removed.
