EVALUATION OF THE BETTENDORF BRIDGE, IOWA

**Final Report
July 2006**

A report from
Center for Transportation Research and Education

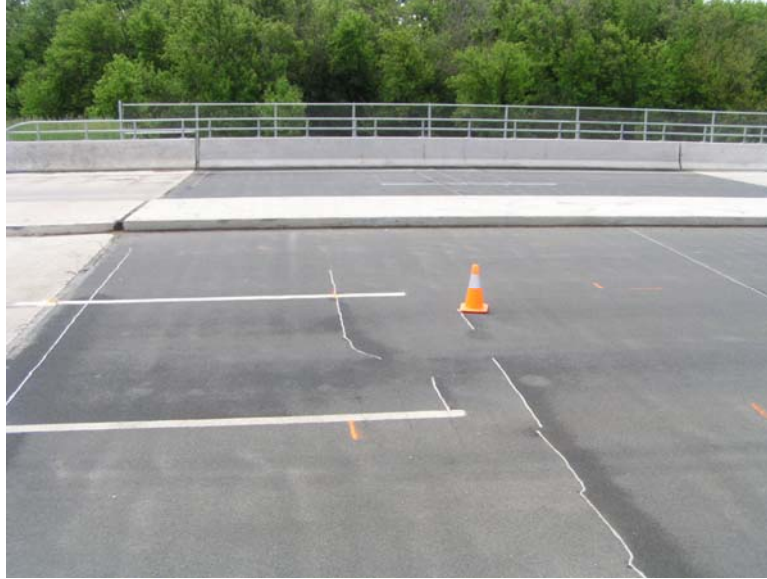
A walk-through inspection of the FRP deck, in 2004, revealed clear signs of cracking in the transverse direction. These cracks were found to be regular and are likely resulting from differential displacements between panels resulting from failed panel-to-panel connections.

During a walk-through inspection of the FRP deck in 2004, clear signs of cracking in the transverse direction of the traffic were found (see Figure 54 and Figure 55). Even though the joints cracked, the measured responses over time indicate that there was no significant loss of stiffness in the FRP deck. Thus, it is unclear what impact this cracking will have on the long-term bridge behavior.

Figure 54. Transverse Cracks in North Traffic

- After one year of service, clear signs of cracking in the transverse direction to the traffic were observed. Those cracks run parallel with the FRP tube components of the panels.
- No damage of the girders was observed.

- It does not appear that any unusually large loads crossed the bridge during the two year monitoring period. Thus, the observed deterioration is likely due to structural behavior effects and not loading effects.

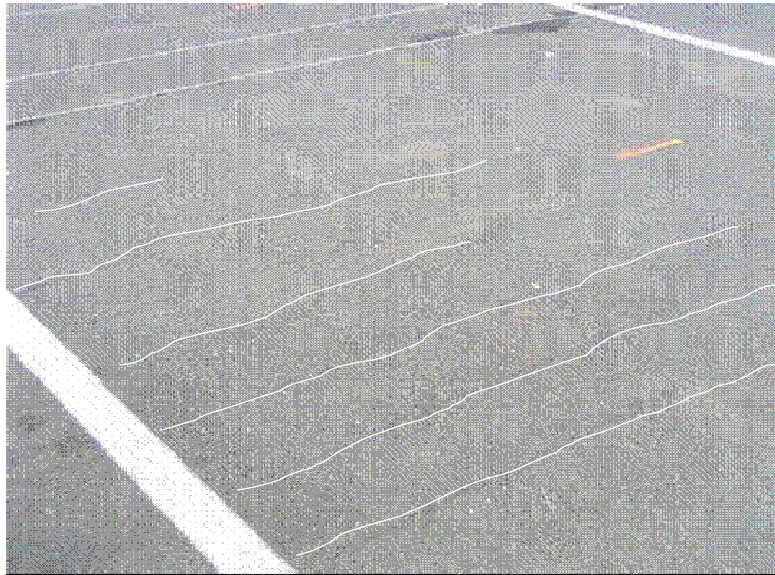
Figure 55. Transverse Cracks in South Traffic
