### Technical Report Documentation Page

# **Testing and Evaluation of the Iowa DOT FRP Temporary Bypass Bridge**

### **Bridge Engineering Center**

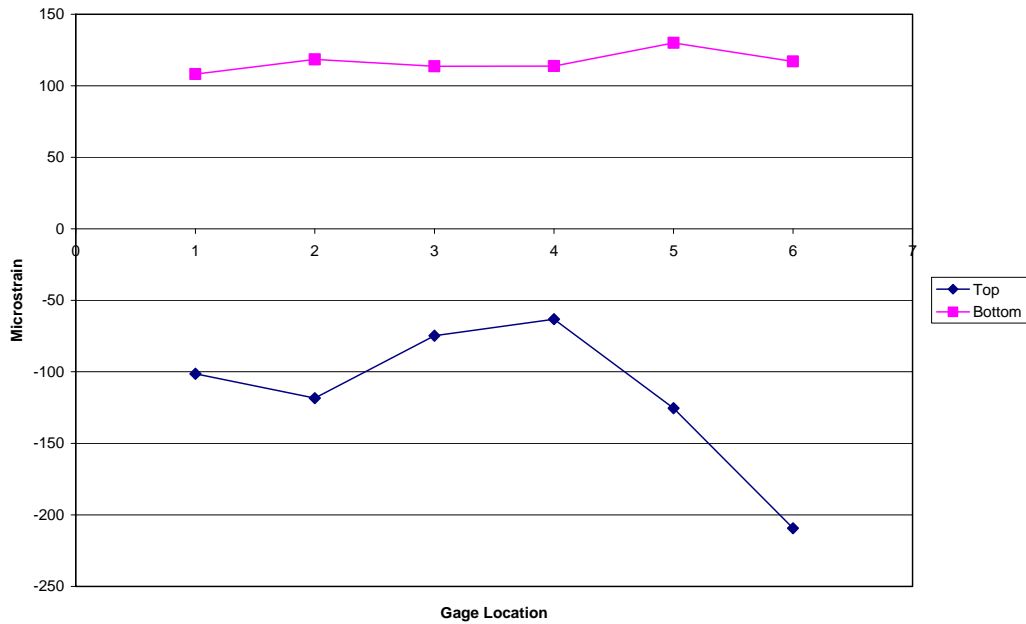
Illustrated in Fig. 24 is the strain profile for the top and bottom gages at mid-span for load case 2 (LC2) for Test 1, which is a symmetrical truck position, and is generally representative of all three load cases for Test 1. Figure 24 indicates that there may be some discrepancy at gage location SG6 (T). Illustrated in Figs. 25 and 26 are panel strain readings from Test 1 and Test 2, respectively, in the area around gage SG6. Based on these two figures, it would appear that the strain measured at SG6 (T) for Test 1 is suspect. It is unclear whether this is due to localized effects from the close proximity of the rear axles, gage bonding issues, or other effects.

Figure 24. Top and Bottom strain profile at mid-span, LC2.

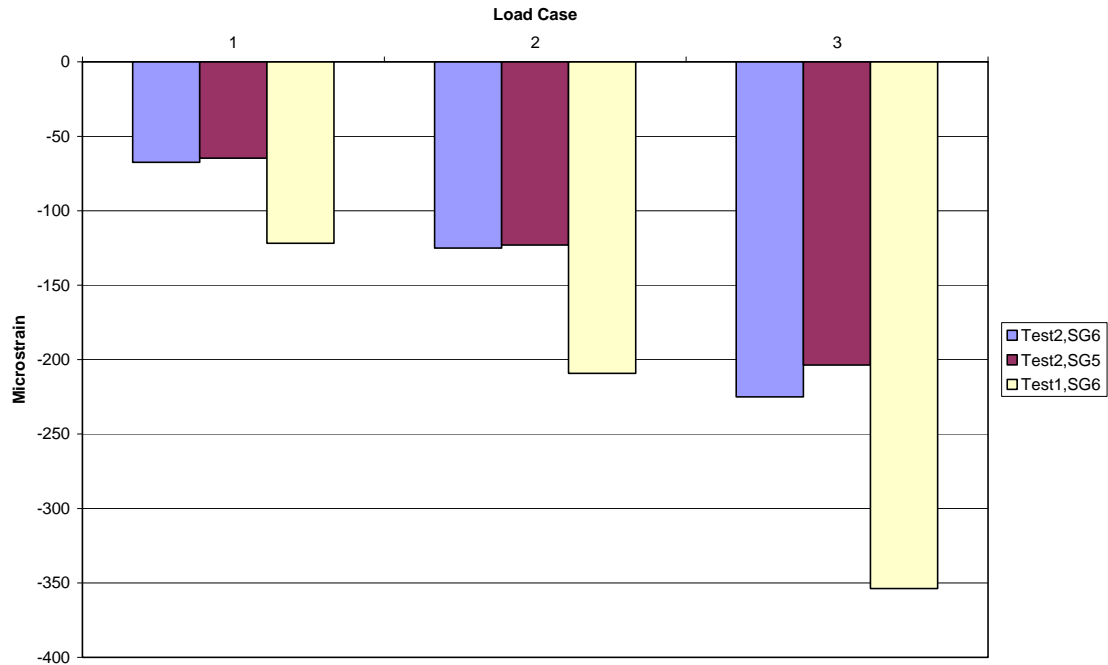
Figure 26. Strain comparison near SG6, Tests 1 and 2.

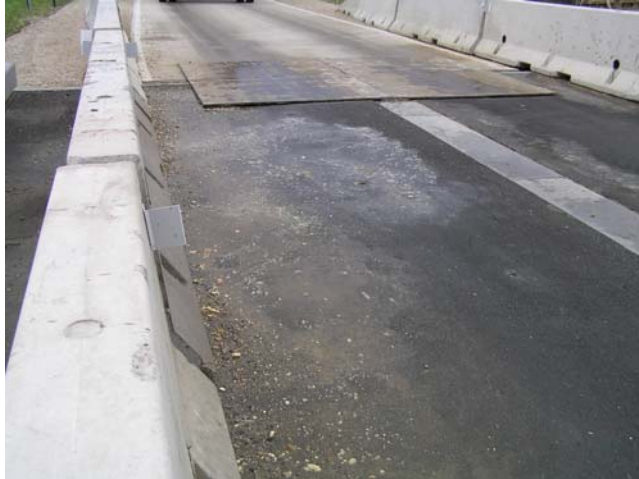
For several reasons, traffic over the FRP bridge was restricted to one lane by the use of portable jersey barriers, as shown in Fig. 33. Shortly after traffic was allowed on the bridge, Iowa DOT inspectors noticed that the transverse edge at the end of one of the panels was showing signs of significant damage at the approach end of the bridge, see Fig. 34. Investigation of the area found that the contact between the backwall and the panel was not necessarily the problem. Rather, the elevation of the top of the backwall was approximately an inch lower than the elevation of the top of the panel, this left the leading edge of the panel exposed to the full force of oncoming traffic loads. Due to time constraints and the need to keep traffic uninterrupted, steel plates (shown in Fig. 33) were used to span from the approach roadway section to the bridge deck across the abutment joint in an attempt to stop the progression of the deck deterioration. At the same time, traffic was reduced from two lanes to one lane across the bridge.

Figure 33. Jersey barrier and steel plate on FRP Bypass Bridge.
