### ***Visual, Sounding, and Half-Cell Potential Plans***

### ***Petrographic Examination***

**Project:** Iowa State Highway 92 Over Drainage Ditch #25  
WJE No. 2012.5759

***Laboratory Analysis of Reinforcing Bars***

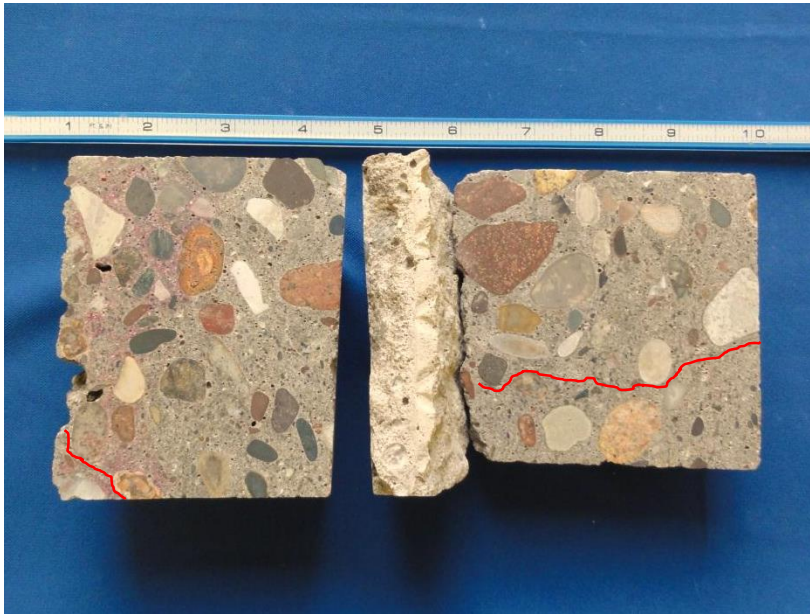
*Condition* - The top surface of the concrete exhibits rake marks. The top surface is slightly weathered and somewhat uneven. A few aggregate particles have been dislodged from the top surface of the concrete. The concrete mix appears uniform and well consolidated throughout the core sample. The lower section of the core contains an impression of a reinforcing bar. (Figure 1). Corrosion staining was not observed.

A few fine microcracks were detected on the lapped surfaces of the sample (Figures 1, 2, and 3). One microcrack slopes at an angle from the top surface and exits from the side of the core at the depth of 3/4 inch. It splits into a few finer microcracks just below the top surface. The second main microcrack is found in the bottom section of the core. This microcrack extends from the cut, bottom surface mostly through the section, terminating approximately 1/4 inch below the top of that section. The microcrack appears slightly wider near the cut (bottom) surface than near the fractured/cracked (top) surface. Both microcracks mainly pass around aggregate particles. Impression of a rebar is visible in the middle section

of the core. The widths of the microcracks are 1 mil or less. The microcrack in the top region of the concrete may be shrinkage/carbonation-related, and the microcrack in the lower region of the core could also be related to shrinkage or it could be due to flexural stress.

Figure 1. Sections of Core 8; top surface of the concrete is on the left of the photograph. The locations of the microcracks are outlined in red. Impression of a rebar is visible in the middle section of the core. Similar impression (not visible in photo) is also present at the top of the bottom section.

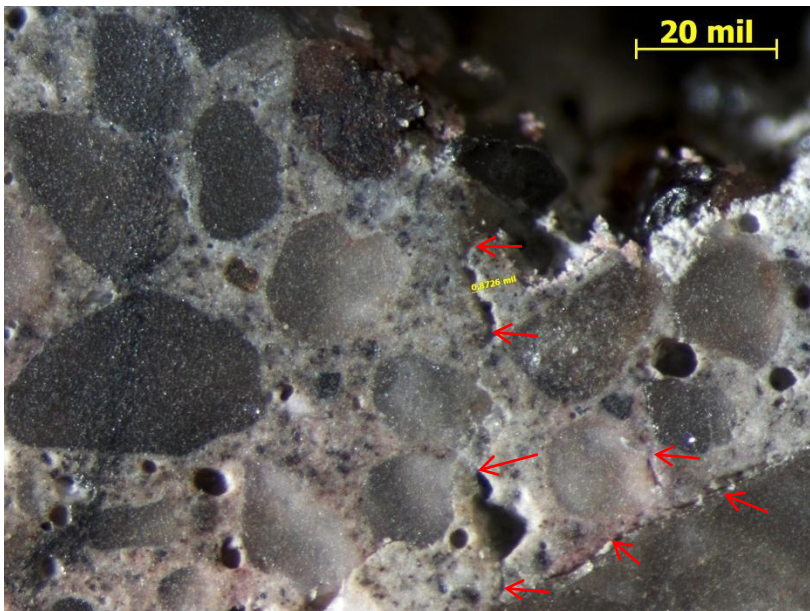
related to shrinkage and flexing of the slab. The tiny microcracks branching off the main microcracks near the very top of the core most likely are related to carbonation shrinkage of the cement paste.

Figure 2. Lapped surface of Core 8 just below the top. The main microcrack split into a few tiny microcracks (indicated by red arrows) just below the very top surface of the core.

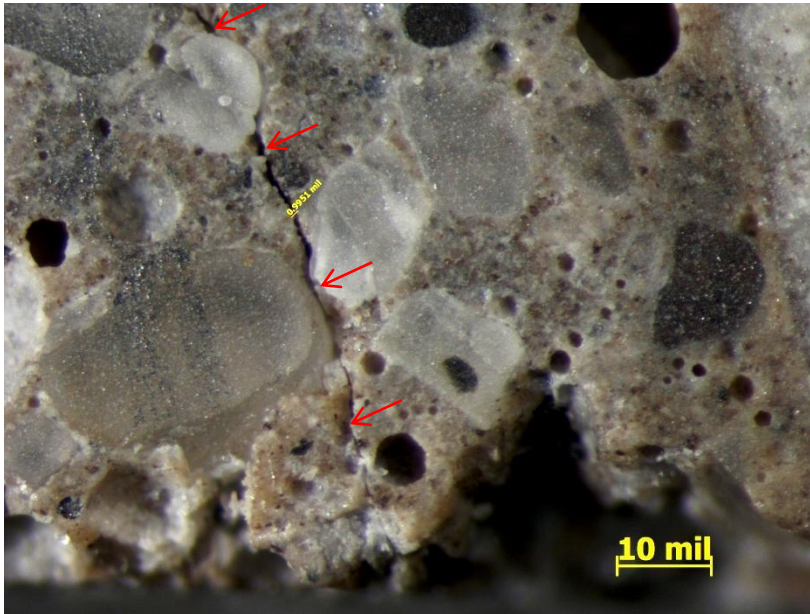
A few longitudinal microcracks were detected within the concrete. Two main microcracks included one in the top ¾ inch of the core and one in the bottom 3 inches of the core. The microcracks are very fine with widths measuring 1 mil or less, and mainly pass around aggregate particles. These microcracks may be

Figure 3. Shown is a microcrack (indicated by red arrows) on the lapped surface in bottom region of Core 8.

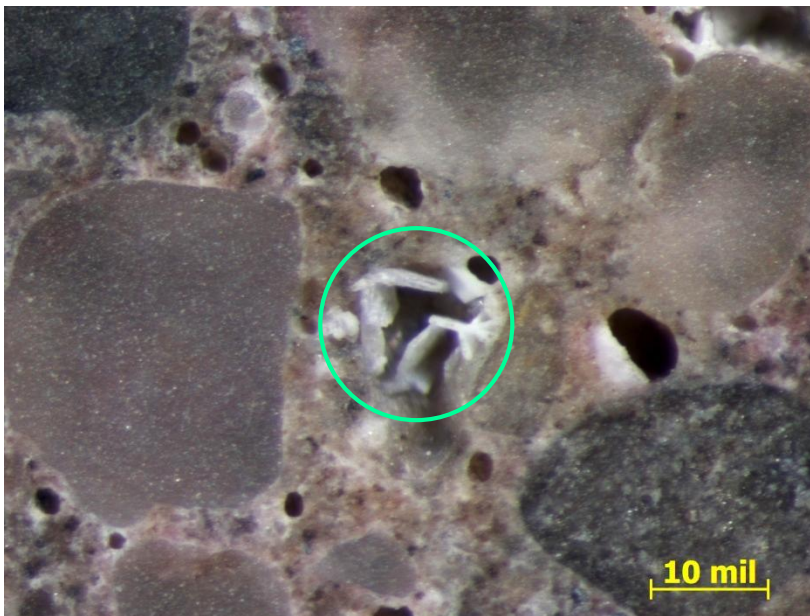
Small amounts of secondary mineral deposits, mainly calcium hydroxide, some ettringite, and possibly deicing salts, were detected inside some air-voids only in the top ¼ inch of the concrete (Fig.4). This suggests that the concrete from this particular area is moderately dense or was not subjected to a lot of moisture.

Small amounts of secondary mineral deposits were detected inside air voids along top surface of the concrete. The scarcity of the secondary deposits indicates that the concrete remained relatively dry or impermeable while in service. There was no evidence of ASR associated with chert particles present within the aggregate.

Figure 4. Lapped surface just below the top of Core 8 showing secondary deposits of calcium hydroxide inside an air void (encircled).

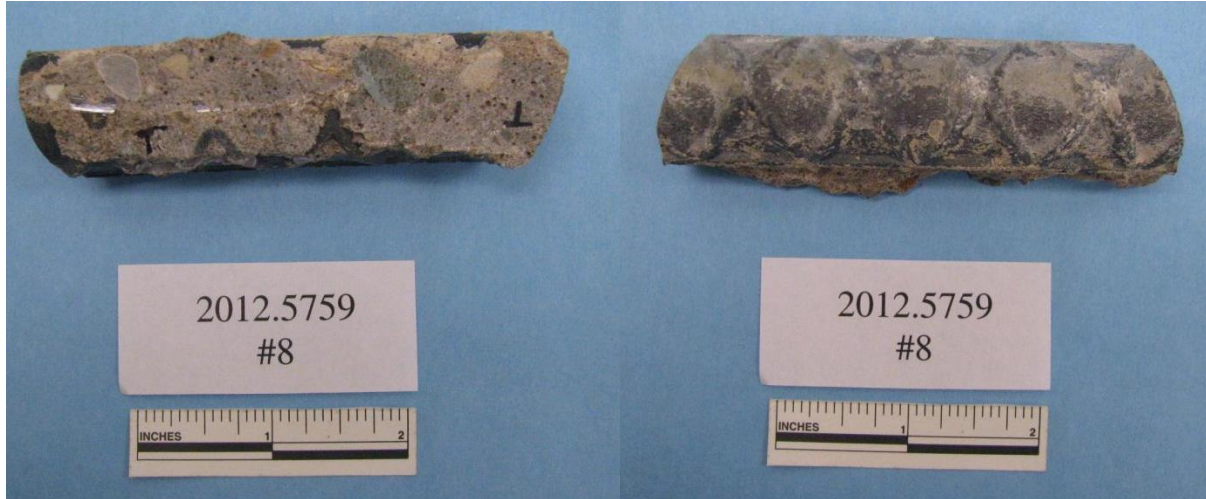
The bottom surface of Sample 8 has areas of both light green-gray shiny surface and dark gray surface. White deposits are present in limited areas. The top surface of the bar is uniform dark gray indicating the absence of corrosion. Light white discoloration may indicate minor surface corrosion of the bottom side of the bar. Photographs and micrographs of the sample are provided in Figure 1 through Figure 3.

*Figure 1. Sample 8. Top side (left) and bottom side (right).*

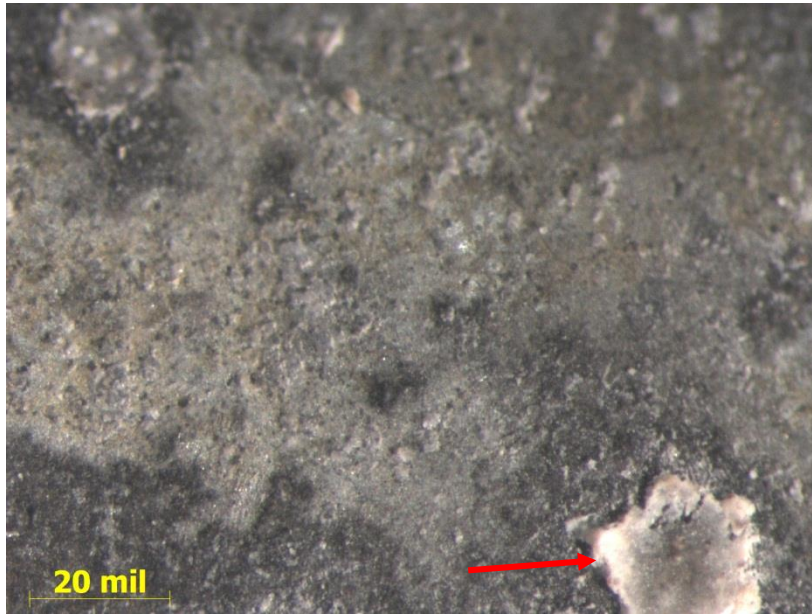
Figure 3. Micrograph of the bottom side of Sample 8. Note the dark to light coloration, with some white deposit indicated with an arrow.

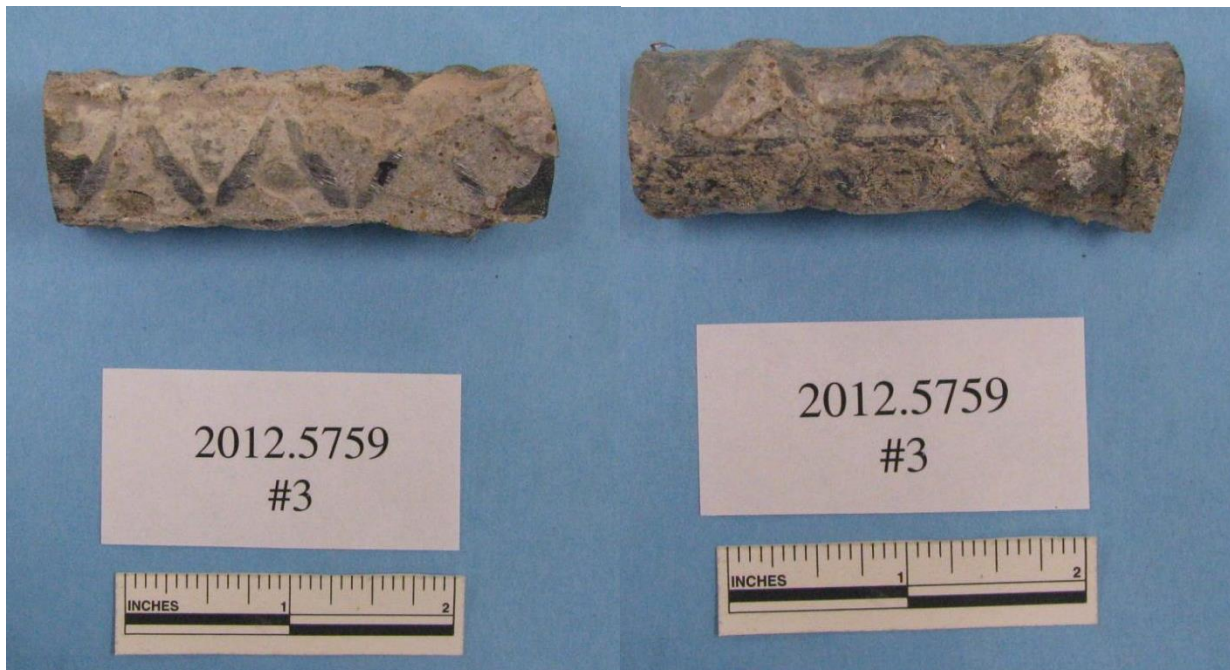
The surface of Sample 3, where not covered with adherent concrete, was light gray, shiny with a metallic appearance on the bottom of the bar. White deposits were present in one area of the bottom of the bar indicative of zinc surface corrosion. The top of the bar had a darker gray appearance with the absence of notable corrosion. Photographs and micrographs of the sample are provided in Figure 4 through Figure 7.

Figure 4. Sample 3. Top side (left) and bottom side (right).

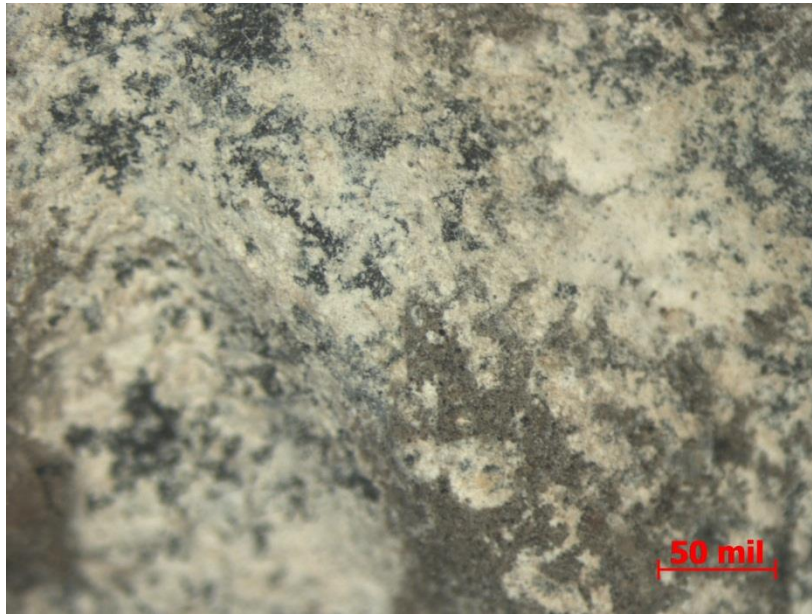
Figure 7. Micrograph of the top surface of Sample 3, showing white deposits.

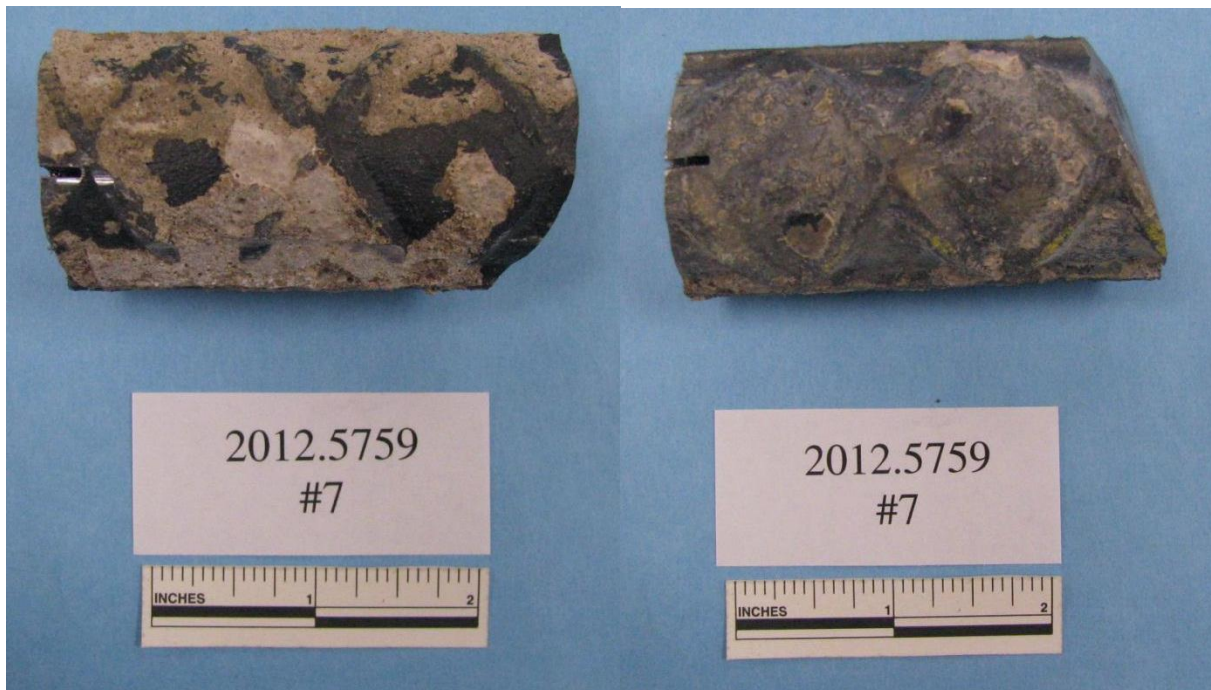
The bottom surface of Sample 7 was lighter in color than the top surface. The appearance ranged from light gray to slightly green and shiny, to spots of white deposit, and a few spots of yellow-green deposit. Surface corrosion of the zinc is likely along the bottom surface of the bar. The top surface had more adherent concrete, but where the bar was exposed, was a uniform dark gray and corrosion was absent. Photographs and micrographs of the sample are provided in Figure 8 through Figure 12.

Figure 8. Sample 7. Top side (left) and bottom side (right).

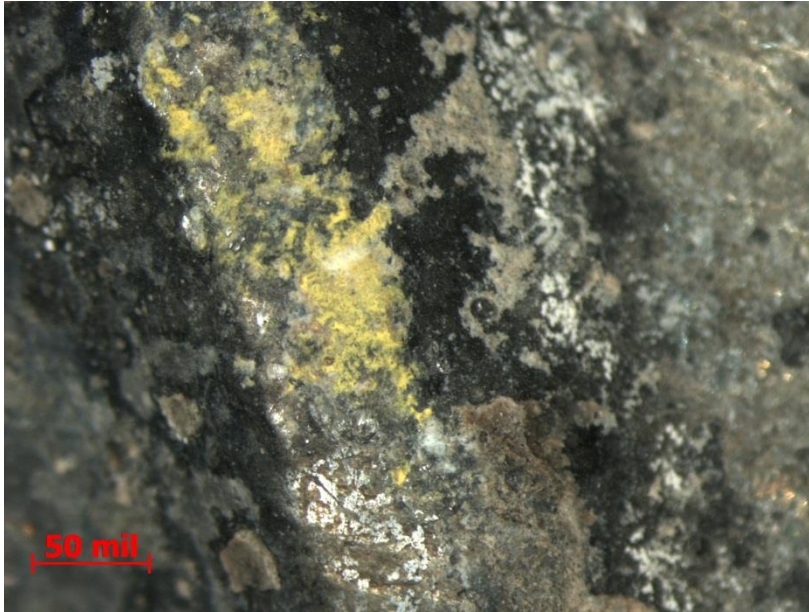
*Figure 11. Micrograph showing the yellow-green and white deposits on the bottom of Sample 7.*

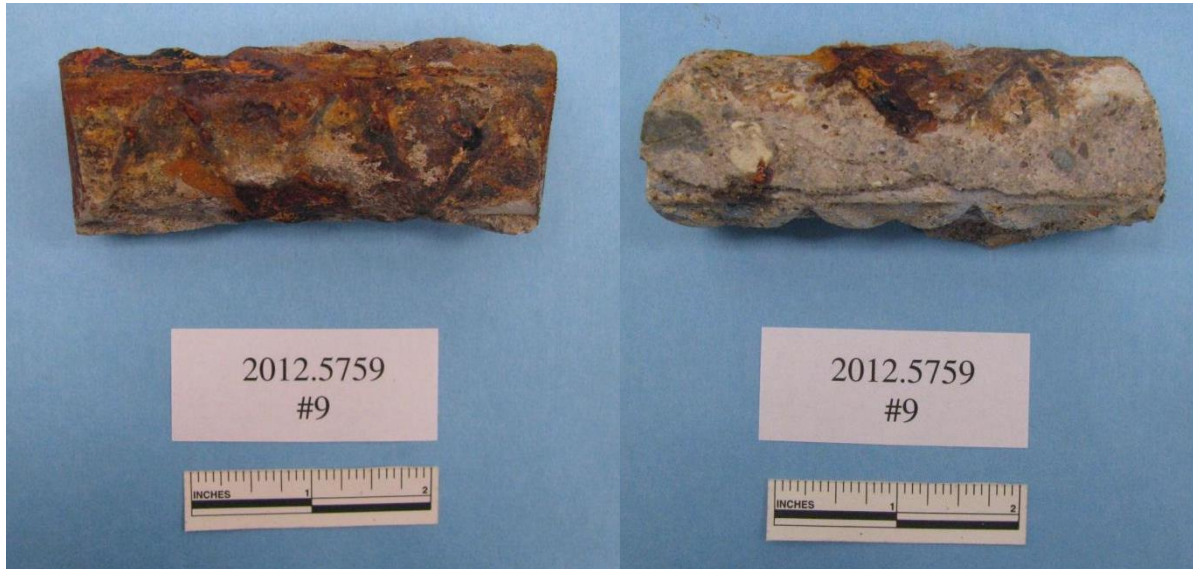
The bottom surface of Sample 9 is covered primarily in white corrosion deposits, although some localized areas have no apparent deposit. The top surface is primarily red corrosion product, with some white corrosion product present. This indicates that the zinc layer has been mostly consumed. Photographs and micrographs of the sample are provided in Figure 13 through Figure 15.

Figure 13. Sample 9. Top side (left) and bottom side (right).

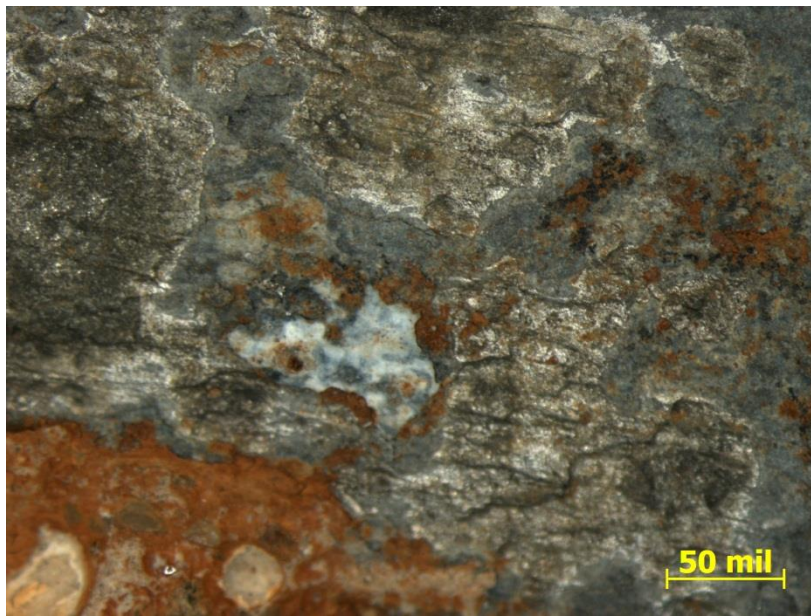
Figure 14. Micrograph of the bottom surface of Sample 9, showing localized areas with no deposits, nearby areas of white and red deposits.

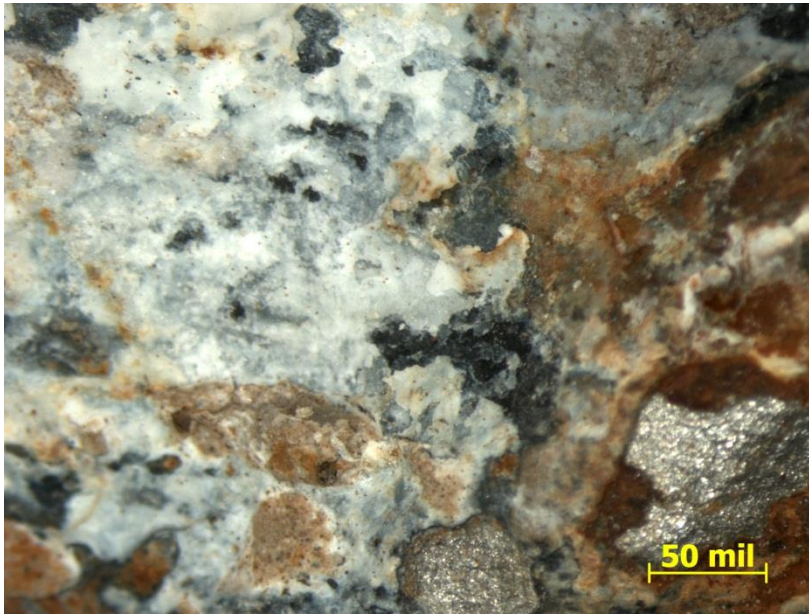
Figure 15. Micrograph of the bottom surface of Sample 9, showing white corrosion product.

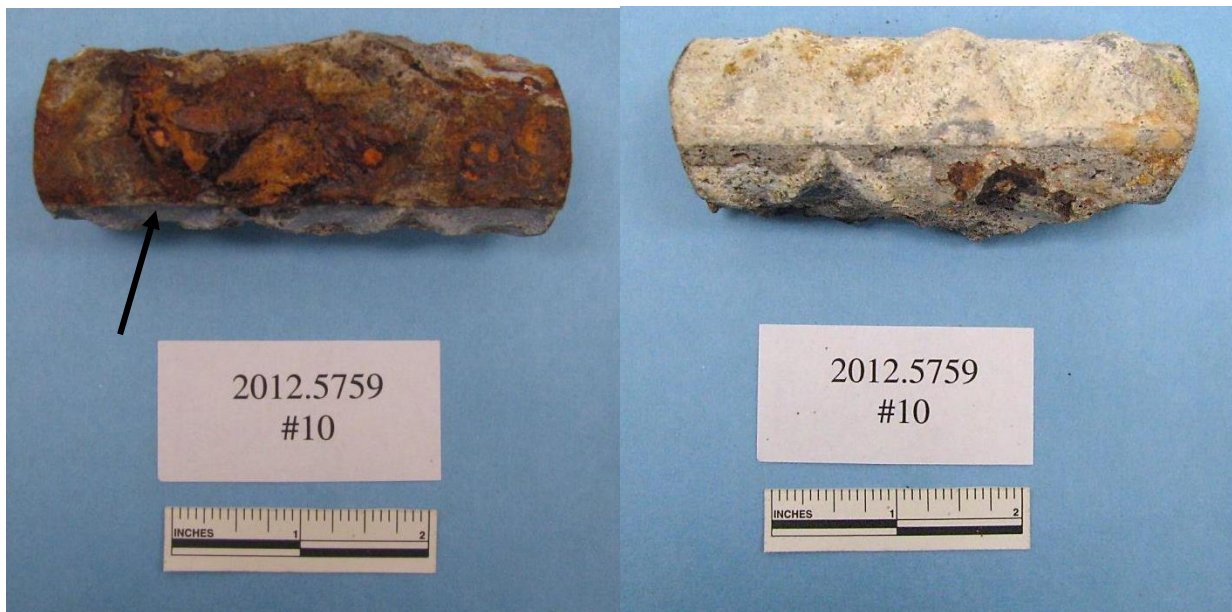
The bottom surface of Sample 10 consists primarily of white and red corrosion product, with some gray surface visible. The top surface consists primarily of red corrosion product, with a stripe of blue-gray deposit near the side of the bar. Corrosion is wide spread and the zinc has been consumed in areas. Photographs and micrographs of the sample are provided in Figure 16 through Figure 20.

Figure 16. Sample 10. Top side (left) and bottom side (right). The stripe of blue-gray deposit is indicated with an arrow.

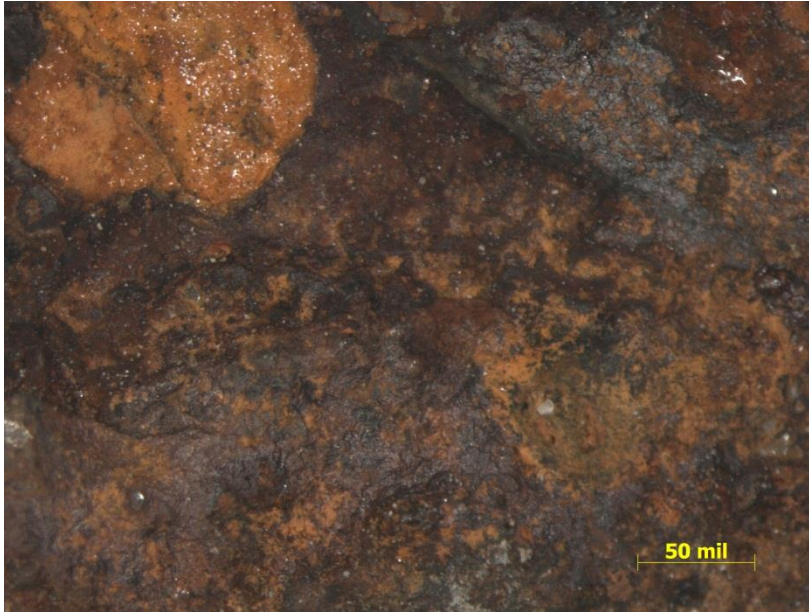
*Figure 17. Micrograph of the top surface of Sample 10, showing red corrosion product from the steel.*

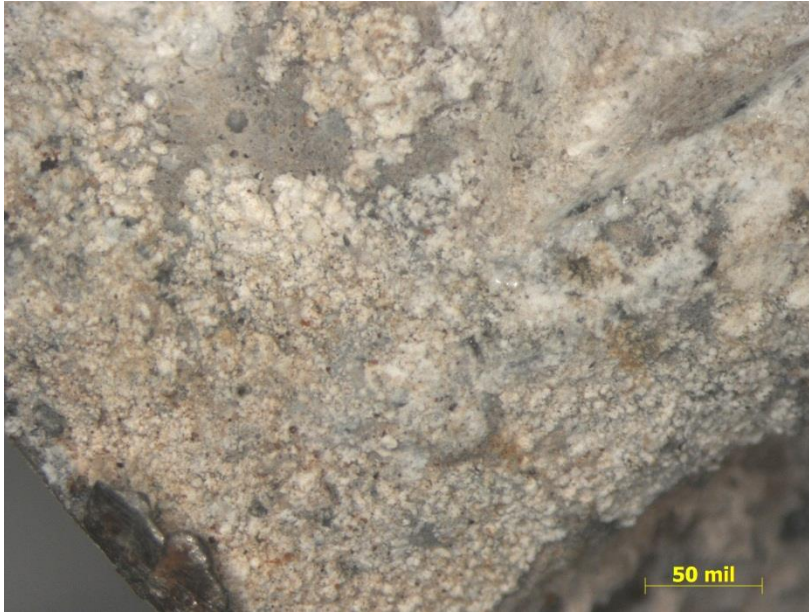
*Figure 19. Micrograph of the bottom surface of Sample 10, showing a white deposit.*

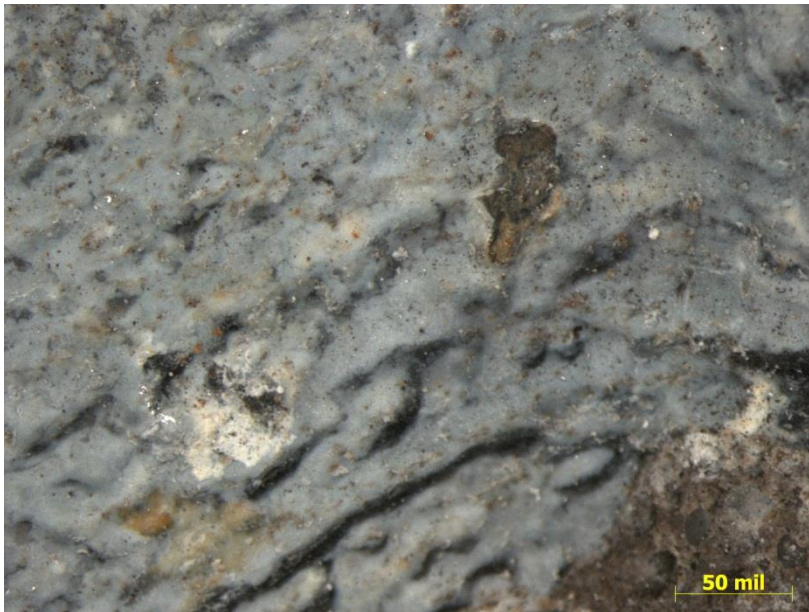
*Figure 20. Micrograph of the blue-gray deposit on the side of Sample 10.*

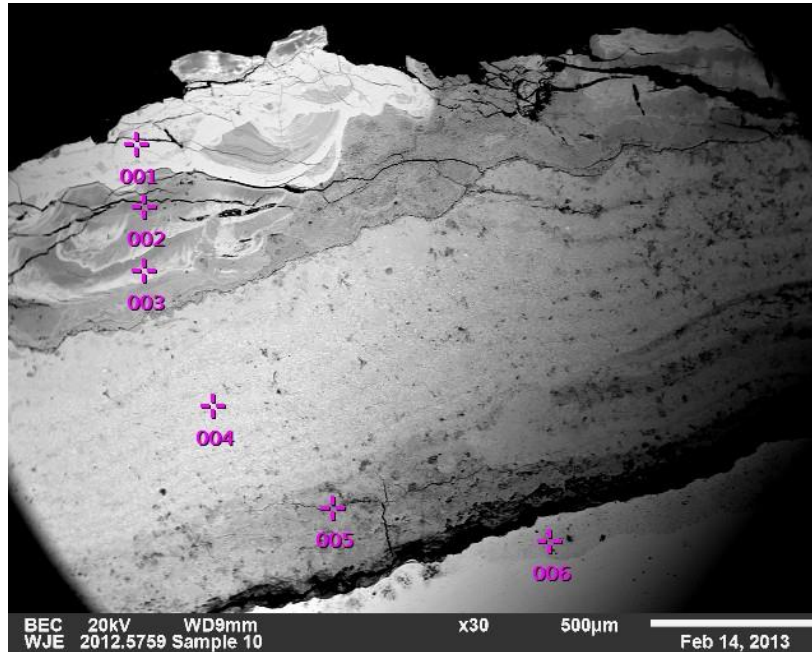
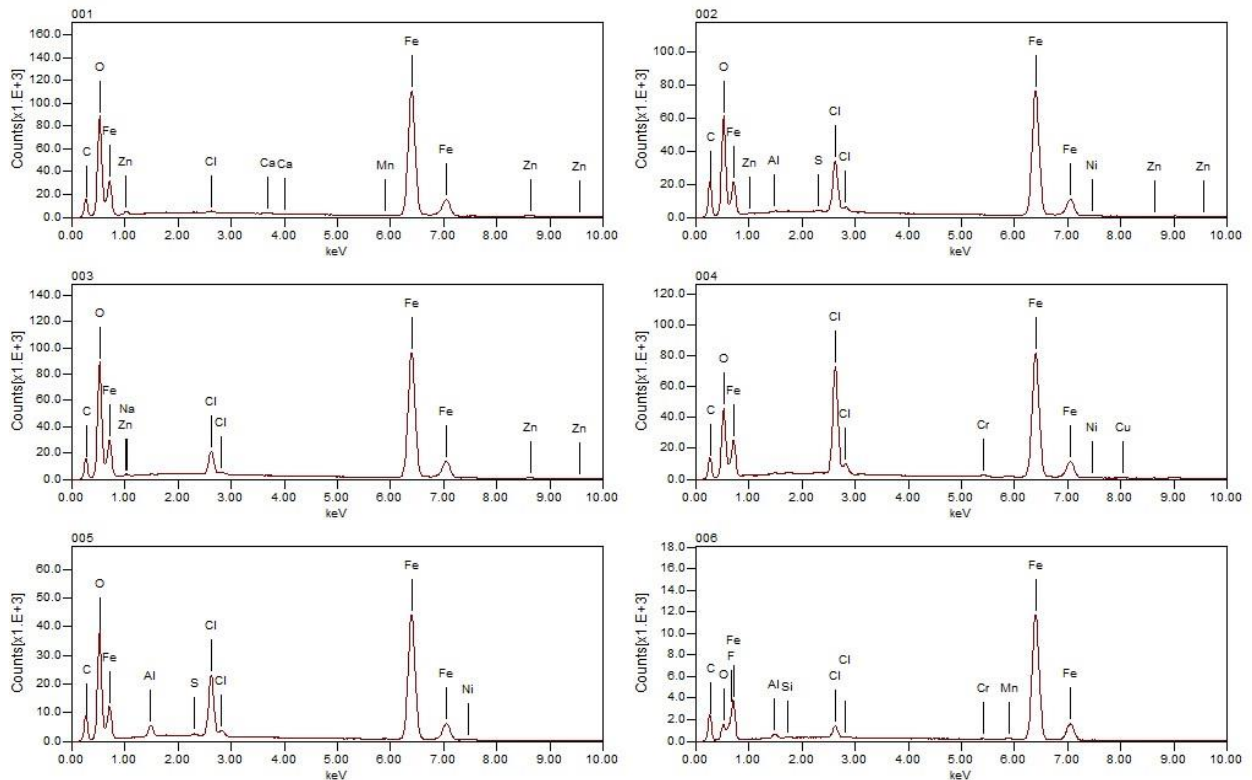
A cross-section of Sample 10 was examined using SEM/EDS to evaluate the composition of the corrosion product and zinc layer. A large pit filled with iron corrosion product was examined. Significant, but varying, amounts of chlorine were detected in different layers of the corrosion product (Figure 24). This confirms a chloride-induced pitting mechanism. Examination of the zinc layer indicated corrosion (oxidation) beginning at the exterior (Figure 25). Little to no chlorine (beyond the small amount present in the epoxy mounting medium) is present in the zinc layer that is beginning to corrode.

Analysis of Sample 10, chosen to represent a corroded bar in chloride contaminated concrete, indicated the presence of chloride-induced corrosion in the pits, but little chlorine present in the intact or lightly corroding zinc layer.

Figure 24. Cross-sectional BE image and point EDS spectra of a corroded pit on Sample 10, showing a significant amount of chlorine in the corrosion product. Each EDS spectrum has a number above the upper left corner which corresponds to the location indicated on the micrograph.

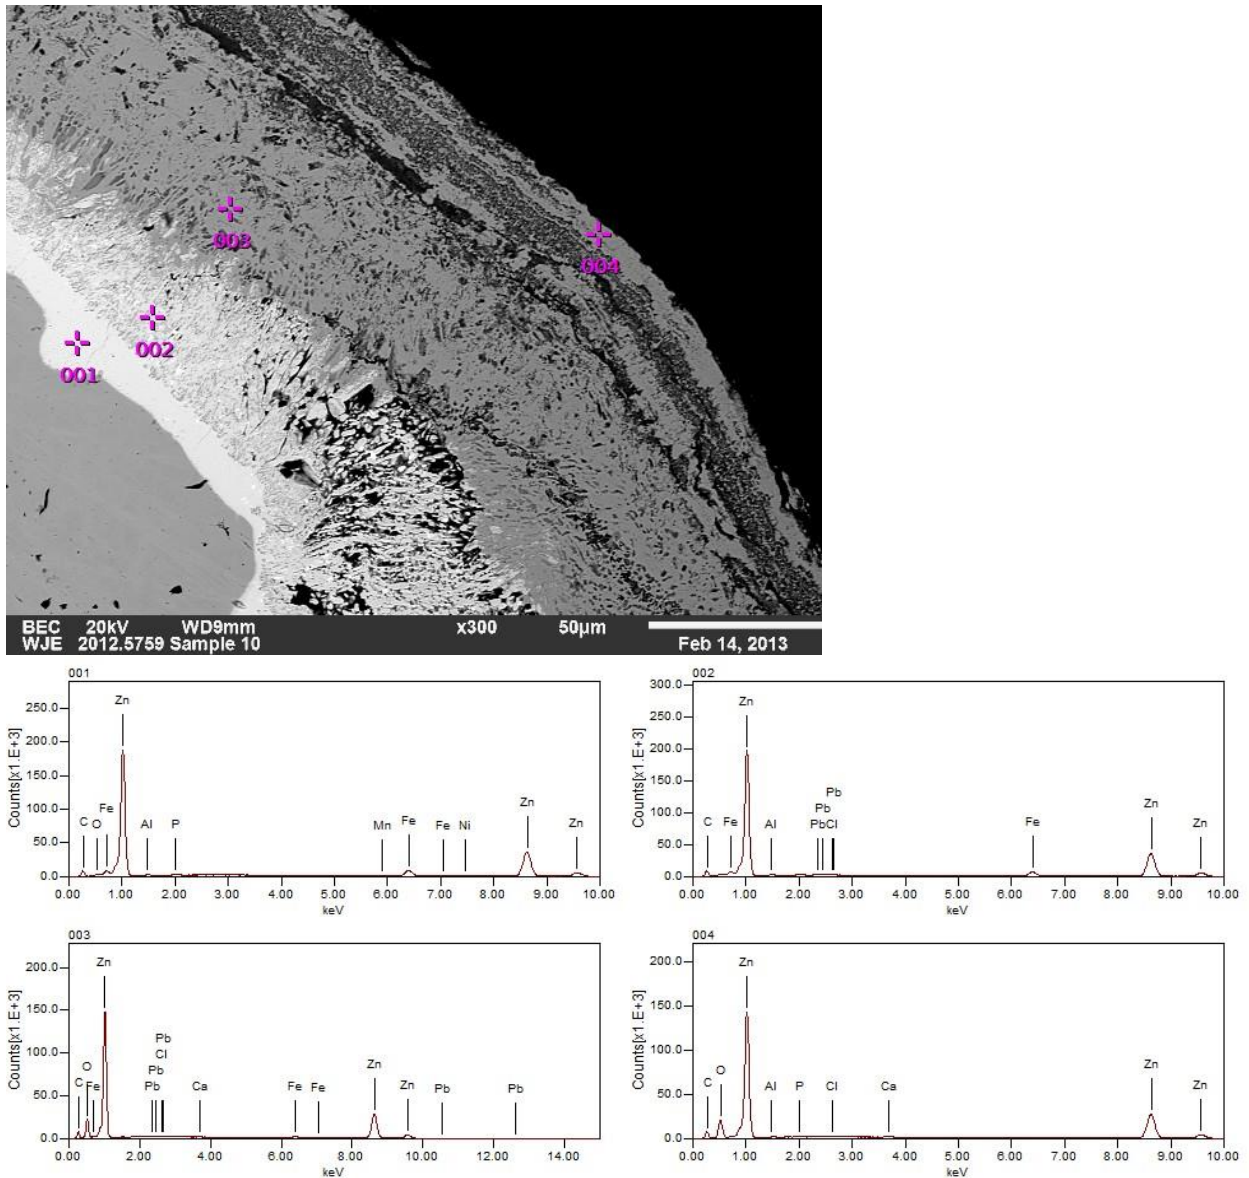
Figure 25. Cross-sectional BE image and point EDS spectra of the zinc layer Sample 10. Very little chlorine is incorporated into the zinc corrosion product (see EDS 004). Each EDS spectrum has a number above the upper left corner which corresponds to the location indicated on the micrograph. A minor amount of chlorine is present in the epoxy mounting medium.

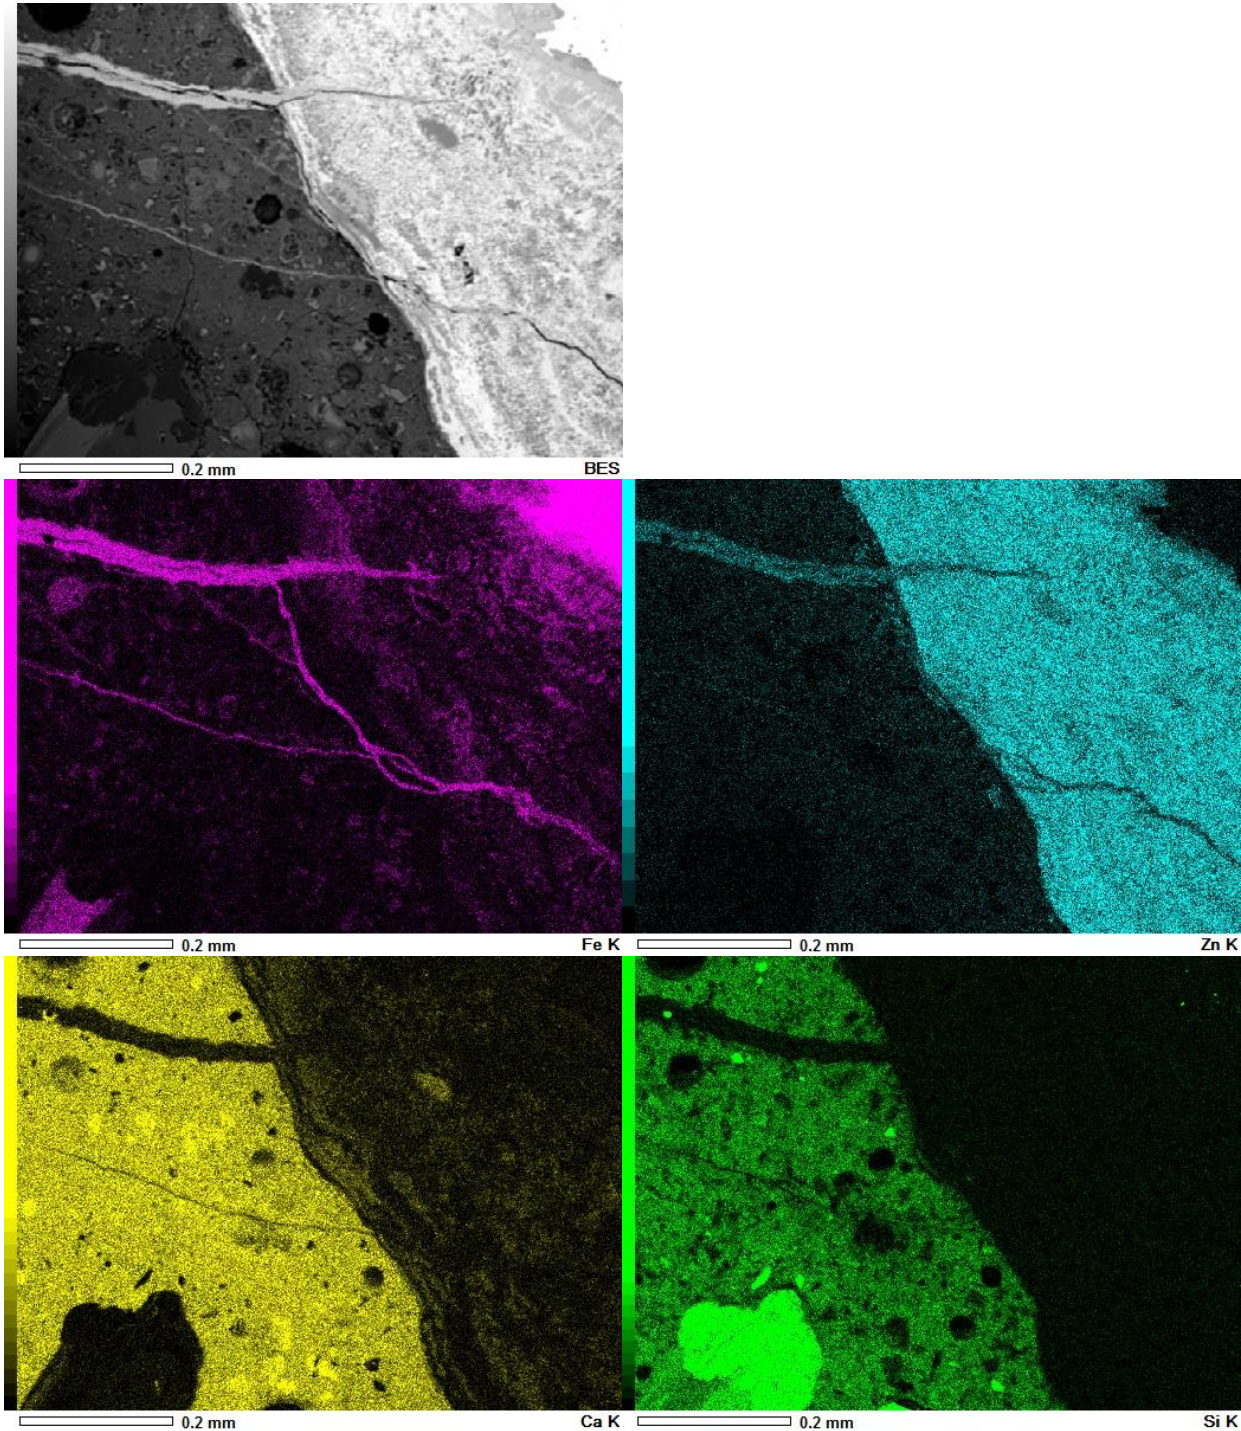
A small amount of concrete remained adhered to the rebar of Sample 10 in the location prepared for cross-sectional analysis. This portion was examined in detail to determine if the corrosion product diffused into the concrete. Dot map analysis indicated that iron and zinc corrosion product penetrated through cracks in the concrete, but do not appear to have diffused into the concrete itself (Figure 26). It is not known if the cracks existed prior to the corrosion of the reinforcing bar.

Figure 26. Dot map showing corrosion product/concrete interface of Sample 10. The corrosion product is on the right. The upper image is a BE micrograph. The elemental dot maps are, from left to right: purple -- iron, blue -- zinc, yellow -- calcium, green -- silicon. The iron and zinc can be seen penetrating the concrete along cracks, where calcium and silicon (constituents of cement paste) are not present.

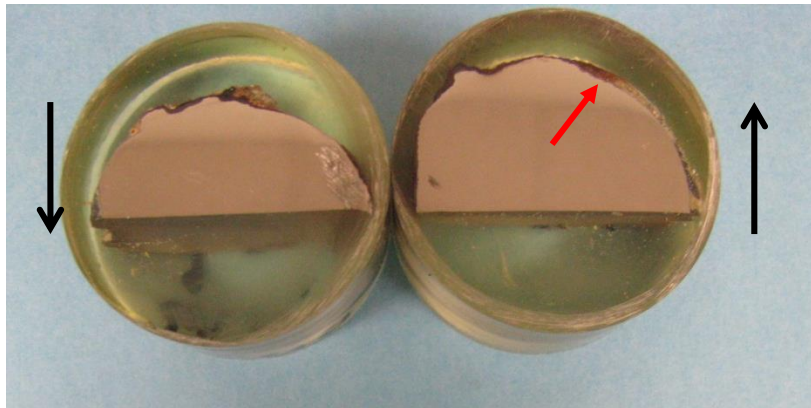
Significant loss of zinc thickness and underlying steel corrosion was observed in the two samples with chloride concentration greater than 0.193 percent by mass of chloride. Samples 9 and 10, from heavily chloride contaminated concrete, had intact zinc layers present only intermittently on the surface, and had pitting and red rust present on the surface. Sample 10, which had the highest chloride level, had the greatest amount of pitting present along the circumference studied.

*Figure 30. The polished cross-sections of Sample 9. The bar was cut in half so it could be placed into the epoxy molds. Arrows indicate which side was facing up in the slab. Some pitting can be seen on the top surface of the right-hand specimen (red arrow).*

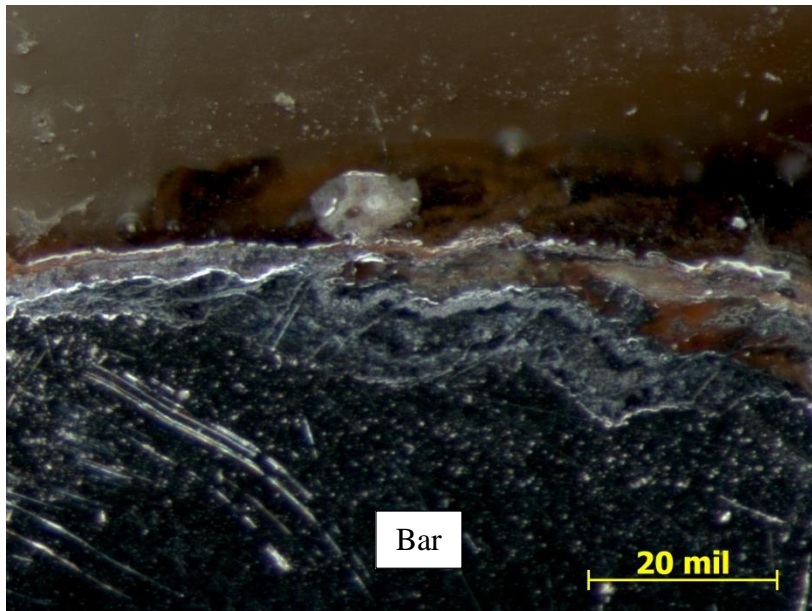
Figure 32. Cross-section of Sample 9, showing corroded bar.

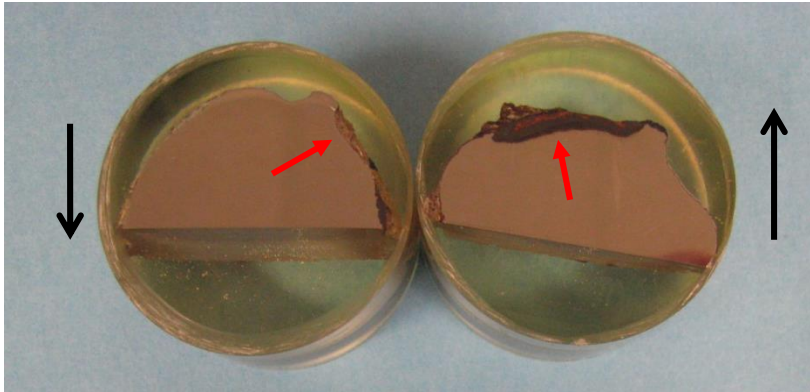
*Figure 33. The polished cross-sections of Sample 10. The bar was cut in half so it could be placed into the epoxy molds. Arrows indicate which side was facing up in the slab. Significant pitting can be seen on the top surface of the right-hand specimen, and minor pitting can be seen on the bottom surface (red arrows).*

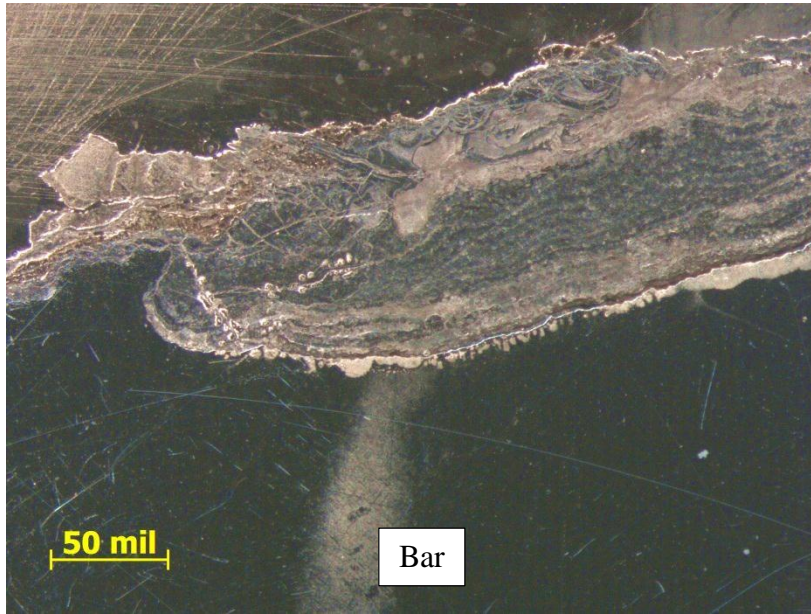
*Figure 35. Cross-section of Sample 10, showing the corroded bar and pitting corrosion.*

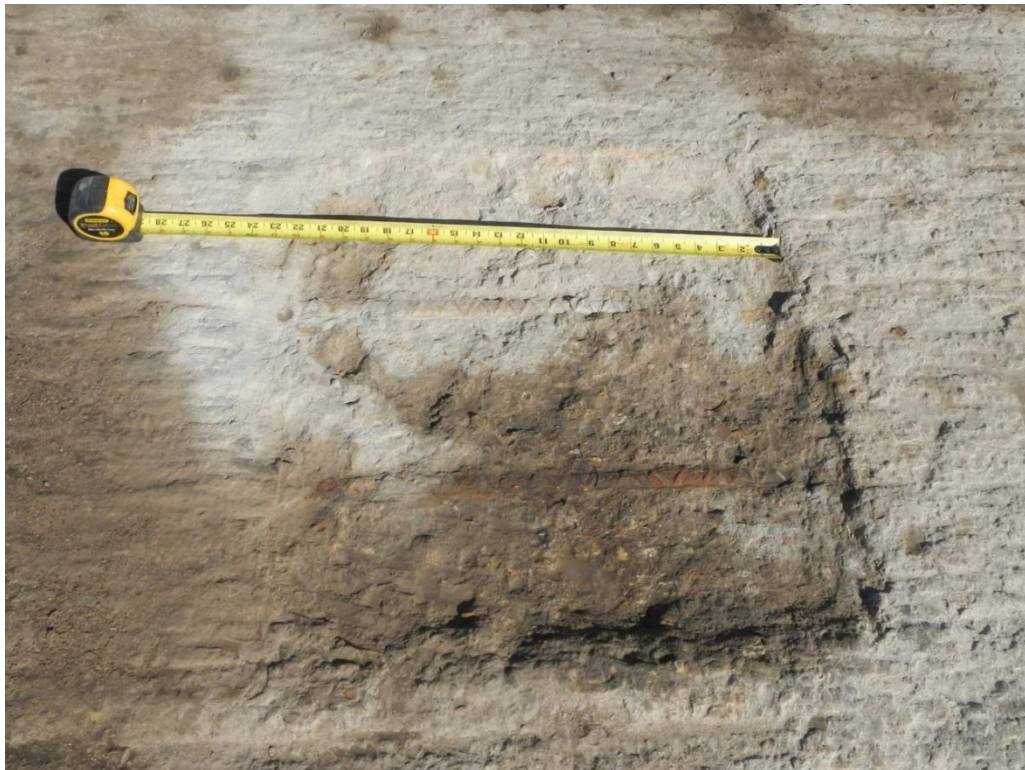
The repair excavations at corroding reinforcing bars generally extended only to the top surface of the exposed reinforcing bars, as can be seen in Figures E2, E3, E6, E7, and E8. This location defined the bottom of the delamination and the extent of the “unsound” concrete, so all delaminated concrete was being removed. We understand that the applicable IaDOT specifications give the bridge engineer the responsibility for establishing the depth of repair, stating the following: “Removal for Class A repair extends at least to the level of the top reinforcing bars, and deeper, as determined by the Engineer, to remove unsound concrete.” In addition, we understand that the general policy is that if more than half of the bar diameter is exposed, the entire bar should be exposed. Therefore, the amount of concrete removal we observed was consistent with IaDOT specifications and project requirements. Additionally, the extent of concrete removal was generally consistent with the extent of delaminated concrete identified by WJE during the 2012 field investigation.

*Figure E2. Close-up of typical repair location in IA92 deck, westbound lanes.*

While the observed repair openings at locations of reinforcing corrosion generally did not expose more than half the bar, we generally recommend that repair of concrete damage due to chloride-driven corrosion should include removal of concrete around the entire perimeter of the bar to at least 3/4 in. below the corroded bar section. This practice is discussed extensively in the literature, including in ICRI 310.1R-2008 *Guideline for Surface Preparation for the Repair of Deteriorated Concrete Resulting from Reinforcing Steel Corrosion*. While removal of concrete below the bars may include removing otherwise sound concrete, the intent is to remove concrete with elevated levels of chloride so as to re-establish passive conditions at the bar by encapsulating the bars in new, uncontaminated repair concrete. This will reduce the risk of corrosion initiating on the bar below the interface with the repair material and increase the life of the repair. Note that this does not address the potential for the ring-anode (or “halo”) effect, a process by which corrosion in bars adjacent to concrete repairs is accelerated by locally large differences in the internal concrete environment at the perimeter of patch repairs. However, coating the reinforcing bars exposed in a repair opening with an electrically insulating coating such as an epoxy would reduce the risk of ring-anode corrosion by increasing the resistance path within the repair.

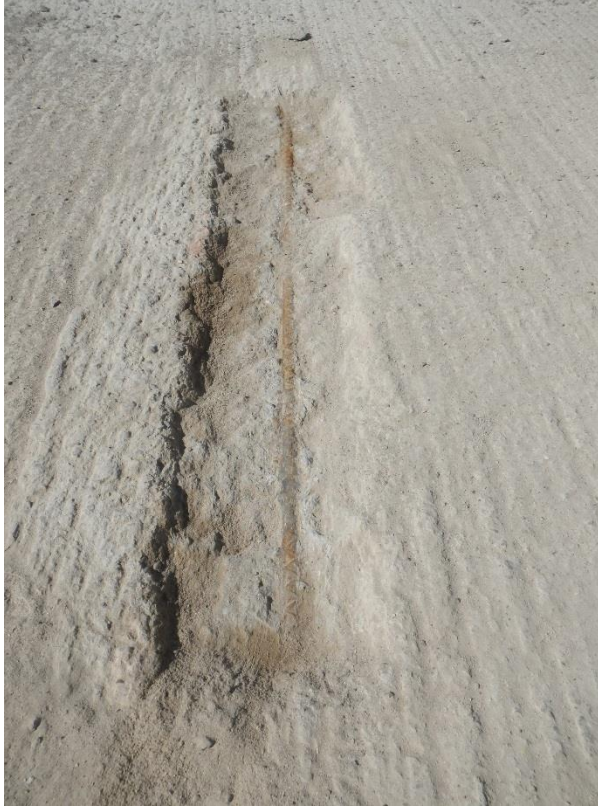
*Figure E3. Typical repair location in IA 92 deck, westbound lanes*

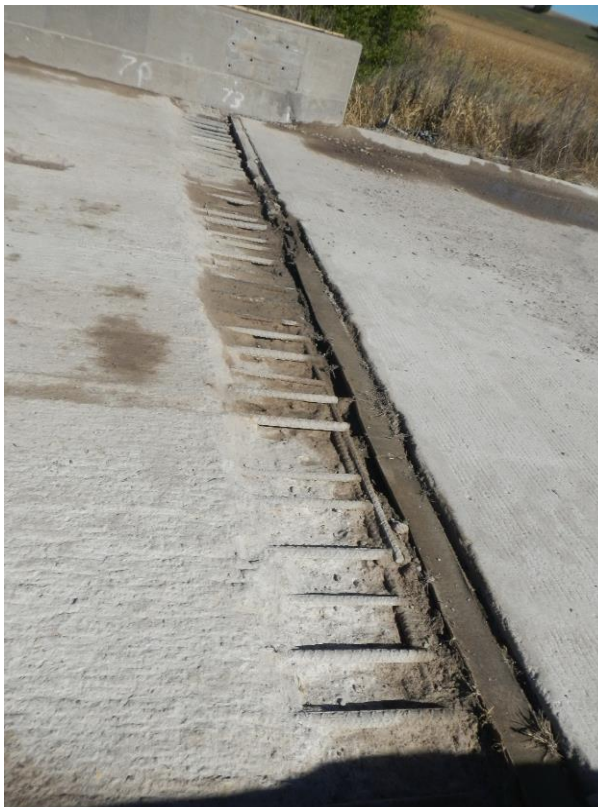
Concrete removal not directly related to corrosion damage had been performed at the ends of the decks and the west approach slab on the eastbound lane apparently to allow for the installation of a new joint seal system. The concrete removal at these repair openings was performed to a depth below the top layer of reinforcing steel, as can be seen in Figure E4. The epoxy coating on the reinforcing exposed in the approach slab was damaged as shown in Figure E10. The contractor indicated that a coating patch material would be applied to the bars prior to concrete installation, as required by IaDOT specifications. Even with this repair, it should be recognized that the protection afforded to the reinforcing steel by the original fusion-bonded epoxy coating has been reduced.

*Figure E4. Deeper removal along end joint at westbound lanes*
