### ***Visual, Sounding, and Half-Cell Potential Plans***

### ***Petrographic Examination***

**Project:** Iowa State Highway 92 Over Drainage Ditch #25  
WJE No. 2012.5759

***Laboratory Analysis of Reinforcing Bars***

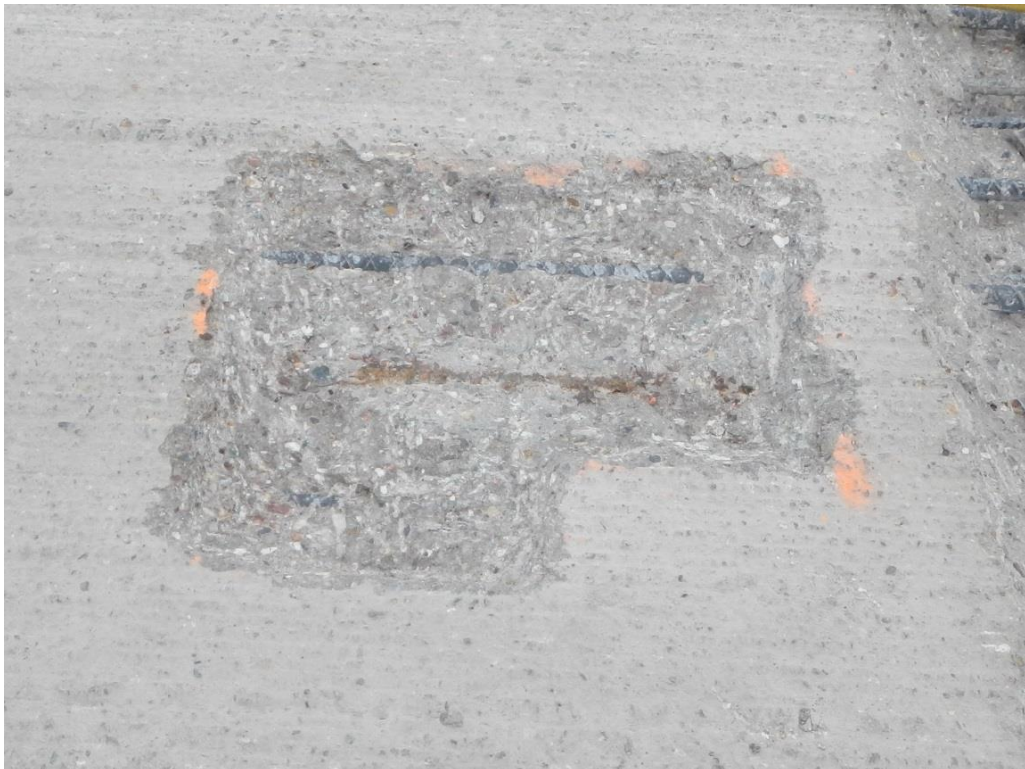
The repair excavations at corroding reinforcing bars generally extended only to the top surface of the exposed reinforcing bars, as can be seen in Figures E2, E3, E6, E7, and E8. This location defined the bottom of the delamination and the extent of the “unsound” concrete, so all delaminated concrete was being removed. We understand that the applicable IaDOT specifications give the bridge engineer the responsibility for establishing the depth of repair, stating the following: “Removal for Class A repair extends at least to the level of the top reinforcing bars, and deeper, as determined by the Engineer, to remove unsound concrete.” In addition, we understand that the general policy is that if more than half of the bar diameter is exposed, the entire bar should be exposed. Therefore, the amount of concrete removal we observed was consistent with IaDOT specifications and project requirements. Additionally, the extent of concrete removal was generally consistent with the extent of delaminated concrete identified by WJE during the 2012 field investigation.

*Figure E6. Close-up of repair location in IA92 deck, eastbound lanes.*

While the observed repair openings at locations of reinforcing corrosion generally did not expose more than half the bar, we generally recommend that repair of concrete damage due to chloride-driven corrosion should include removal of concrete around the entire perimeter of the bar to at least 3/4 in. below the corroded bar section. This practice is discussed extensively in the literature, including in ICRI 310.1R-2008 *Guideline for Surface Preparation for the Repair of Deteriorated Concrete Resulting from Reinforcing Steel Corrosion*. While removal of concrete below the bars may include removing otherwise sound concrete, the intent is to remove concrete with elevated levels of chloride so as to re-establish passive conditions at the bar by encapsulating the bars in new, uncontaminated repair concrete. This will reduce the risk of corrosion initiating on the bar below the interface with the repair material and increase the life of the repair. Note that this does not address the potential for the ring-anode (or “halo”) effect, a process by which corrosion in bars adjacent to concrete repairs is accelerated by locally large differences in the internal concrete environment at the perimeter of patch repairs. However, coating the reinforcing bars exposed in a repair opening with an electrically insulating coating such as an epoxy would reduce the risk of ring-anode corrosion by increasing the resistance path within the repair.

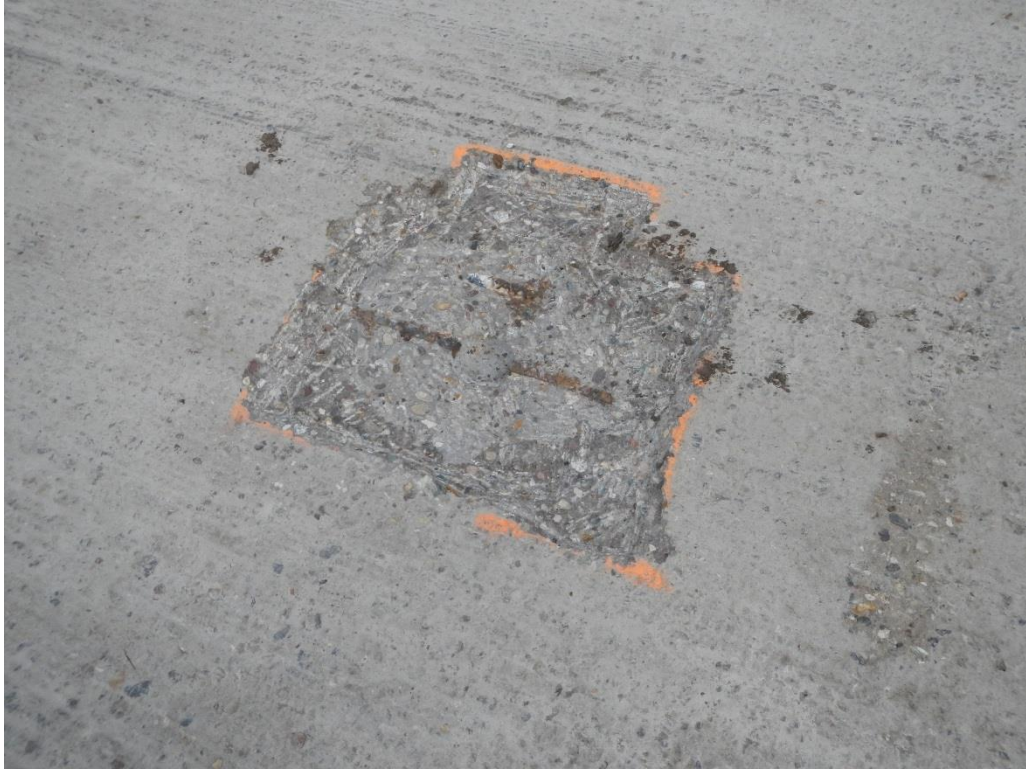
*Figure E7. Typical repair location in IA 92 deck, eastbound lanes.*

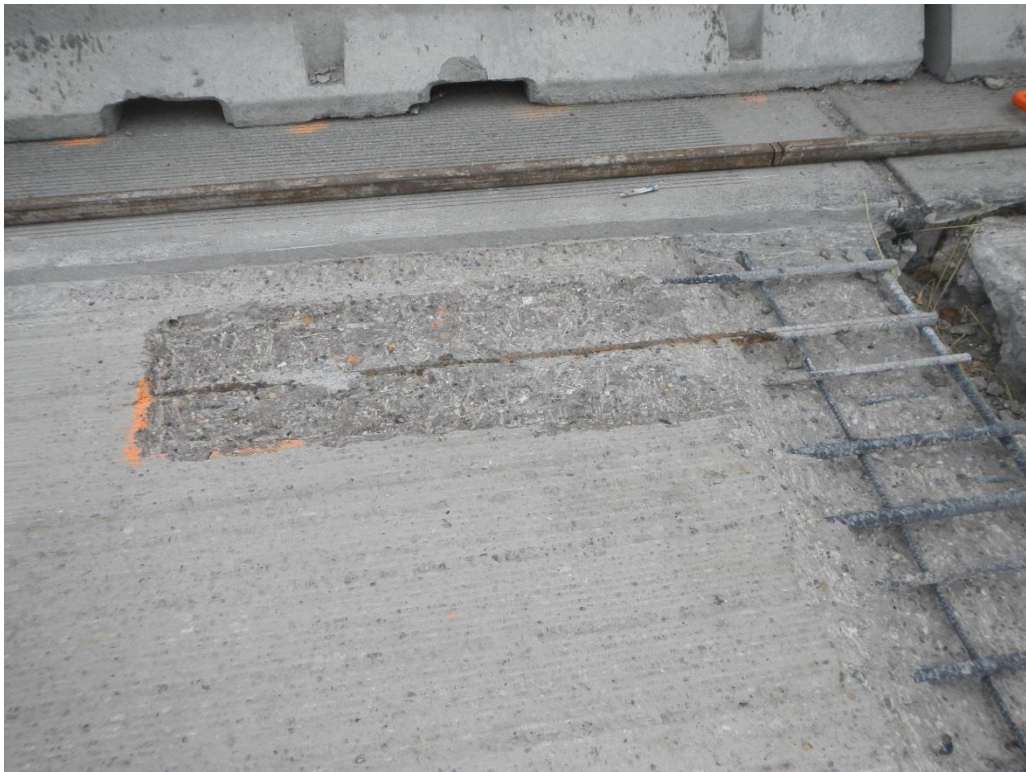
*Figure E8. Deck repair location extending from deeper repair at end joint in eastbound lanes of IA 92 deck.*

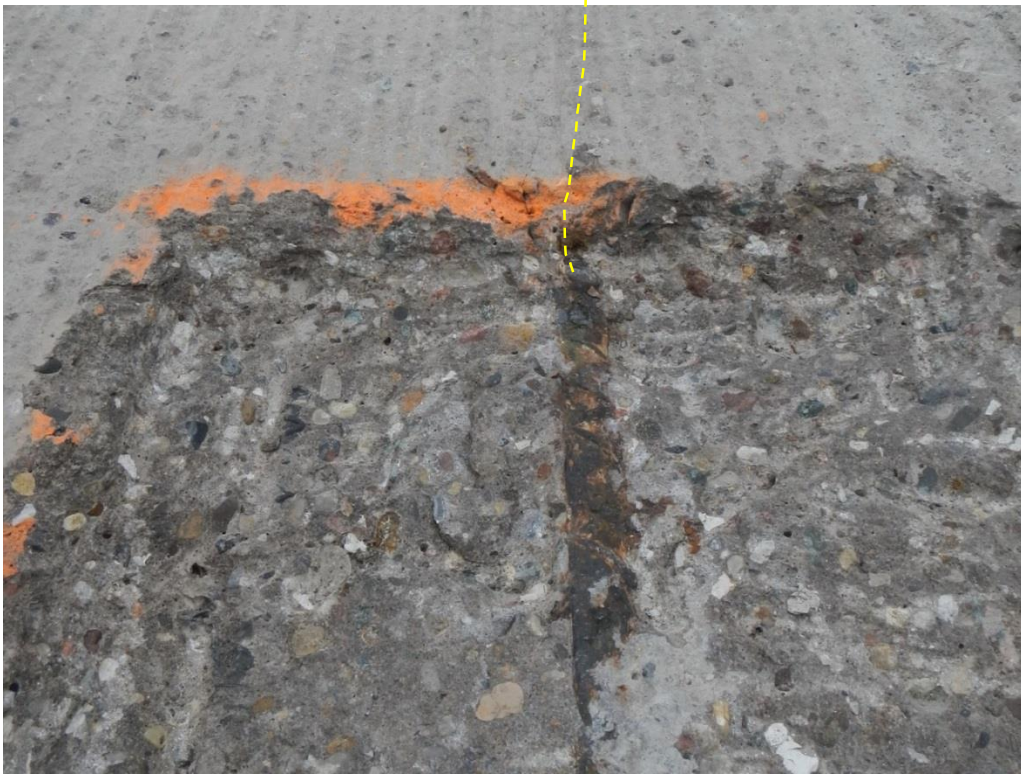
Most repair openings were generally localized and were directly associated with corrosion of a single reinforcing bar. In a number of cases where two reinforcing bars were exposed during excavation, only one appeared to be actively corroding (see Figure E6). The corrosion was generally associated with cracks that were in-line with the corroded bar (see Figure E9).

*Figure E9. Corroding bar at crack (yellow line) in eastbound lanes.*

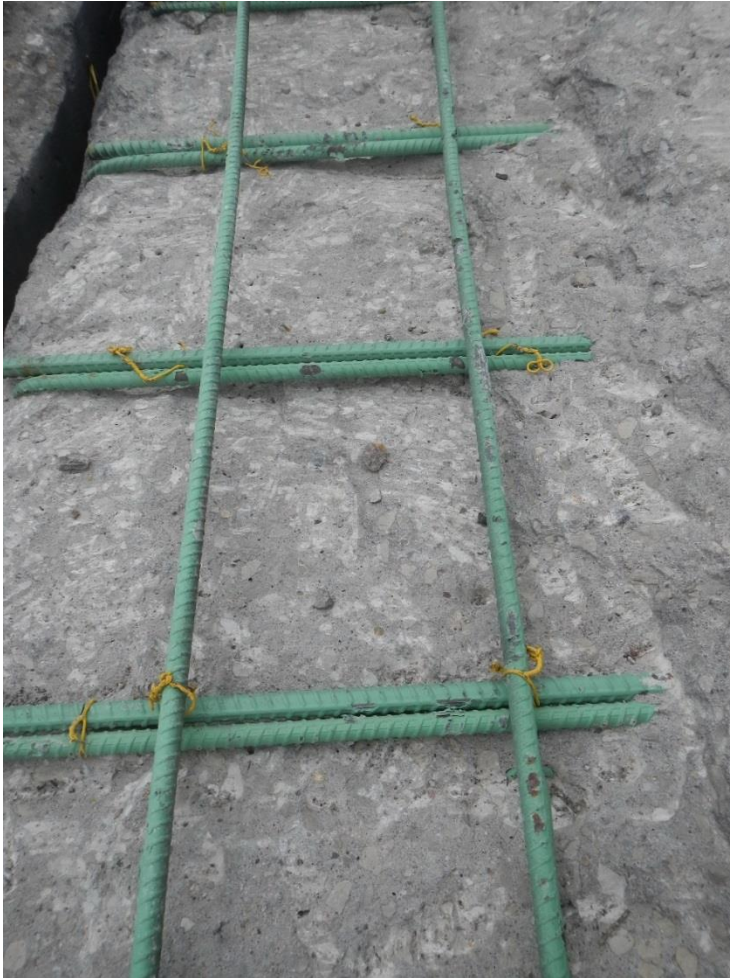
Concrete removal not directly related to corrosion damage had been performed at the ends of the decks and the west approach slab on the eastbound lane apparently to allow for the installation of a new joint seal system. The concrete removal at these repair openings was performed to a depth below the top layer of reinforcing steel, as can be seen in Figure E4. The epoxy coating on the reinforcing exposed in the approach slab was damaged as shown in Figure E10. The contractor indicated that a coating patch material would be applied to the bars prior to concrete installation, as required by IaDOT specifications. Even with this repair, it should be recognized that the protection afforded to the reinforcing steel by the original fusion-bonded epoxy coating has been reduced.

*Figure E10. Damage to epoxy coating on bars in west approach slab in eastbound lanes*

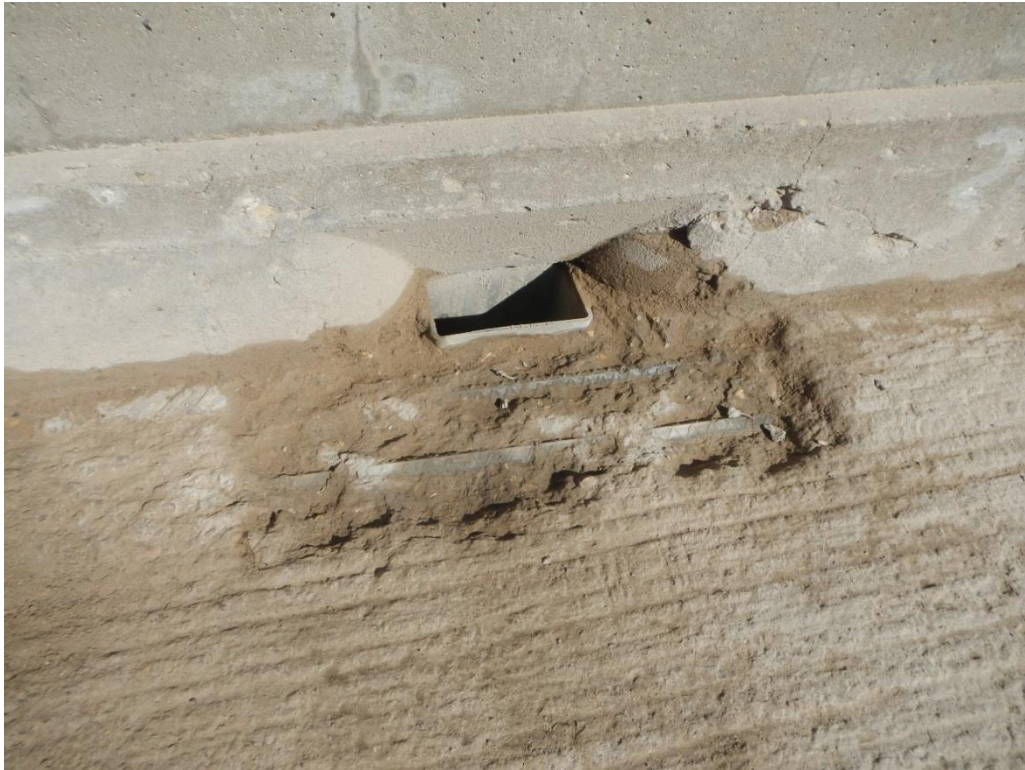
Finally, partial depth concrete removal had also been performed around the deck scuppers (Figure E11), reportedly to accommodate elevation modifications associated with the new overlay. The cover at the drains will be less, somewhat reducing the corrosion protection at this already vulnerable site.

*Figure E11. Concrete removal at scupper drain on westbound lane.*

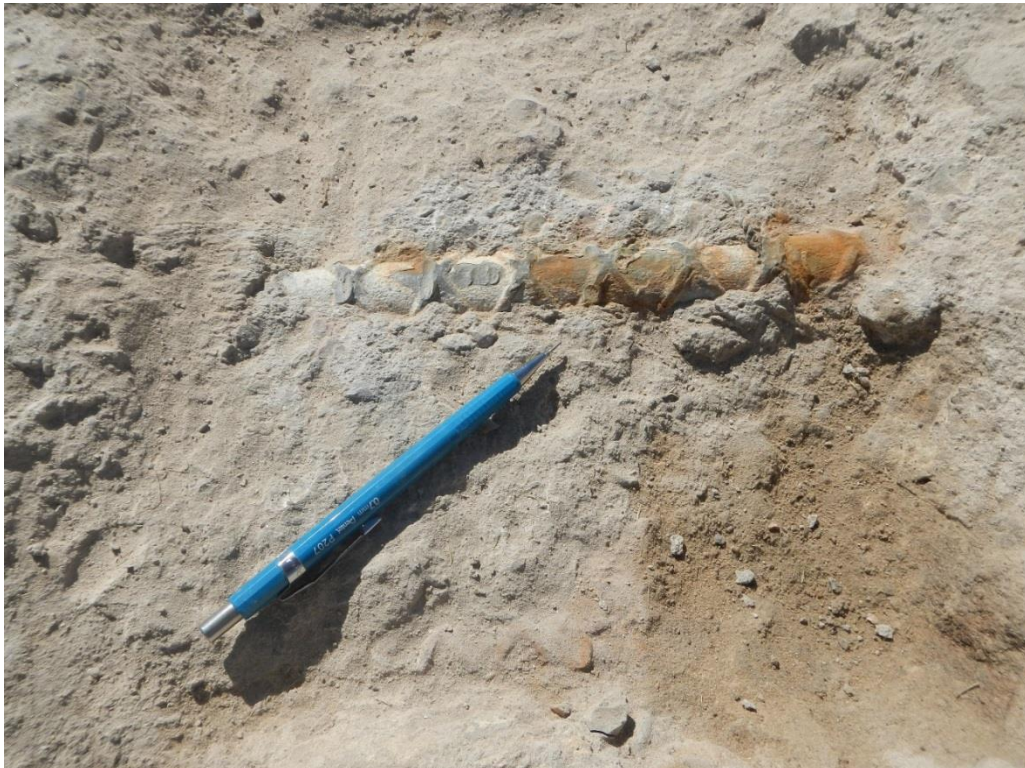
*Figure E12. Close-up of corroded bar in westbound lanes.*

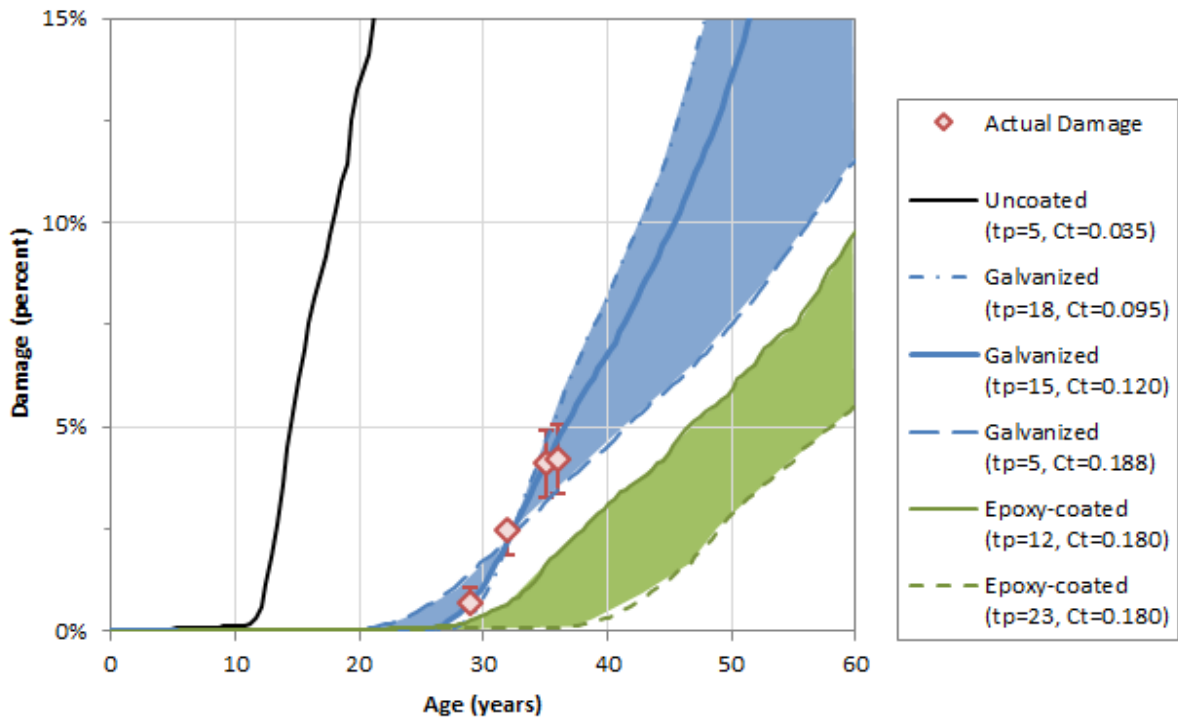
A primary component of WJE's 2012 investigation was quantifying the corrosion resistance of the galvanized reinforcing in terms of a corrosion threshold and propagation time, as implemented in a service life model, based on the observed rate of distress development calculated from information available from surveys or repair projects of the bridge deck conducted in 2006 and 2009, and the 2012 WJE survey. To assess the progression of damage between WJE's 2012 deck survey and the recent repairs, WJE identified new deterioration by comparing the repair areas with the results of the 2012 delamination survey of the deck. A combined total of 4.1 sq. ft. of additional delamination was observed during the October 2013 and Spring 2014 site visits, bringing the total estimate of distress up to 131.6 sq. ft., which corresponds to 4.2 percent of the total deck area. While additional damage was observed, the interval between measurements was only one year, so the fact that the increase in damage was small is not surprising.

In Figure E13, this percentage of damage is added to the prior observations of damage and the damage projected through service life modeling that was shown in Figure E13. This new data point falls well within the range of damage projected based on the range of assumed chloride thresholds and propagation times. Therefore, a modification to WJE's quantification of corrosion resistance (ranging from a chloride threshold of 0.095 percent by weight with a propagation time of 18 years to a chloride threshold of 0.188 percent by weight with a propagation time of 5 years) is not warranted based on this information.

*Figure E13. Results of service life model for bridge - updated to show additional distress through 2013/2014. (Propagation time ( $tp$ ) is given in years, and chloride threshold ( $Ct$ ) is given in percent by weight of concrete.)*
