IOWA STATE HIGHWAY 92 OVER DRAINAGE DITCH #25

Performance Evaluation Galvanized Reinforcing Bars

Louisa County, Iowa

Final Report

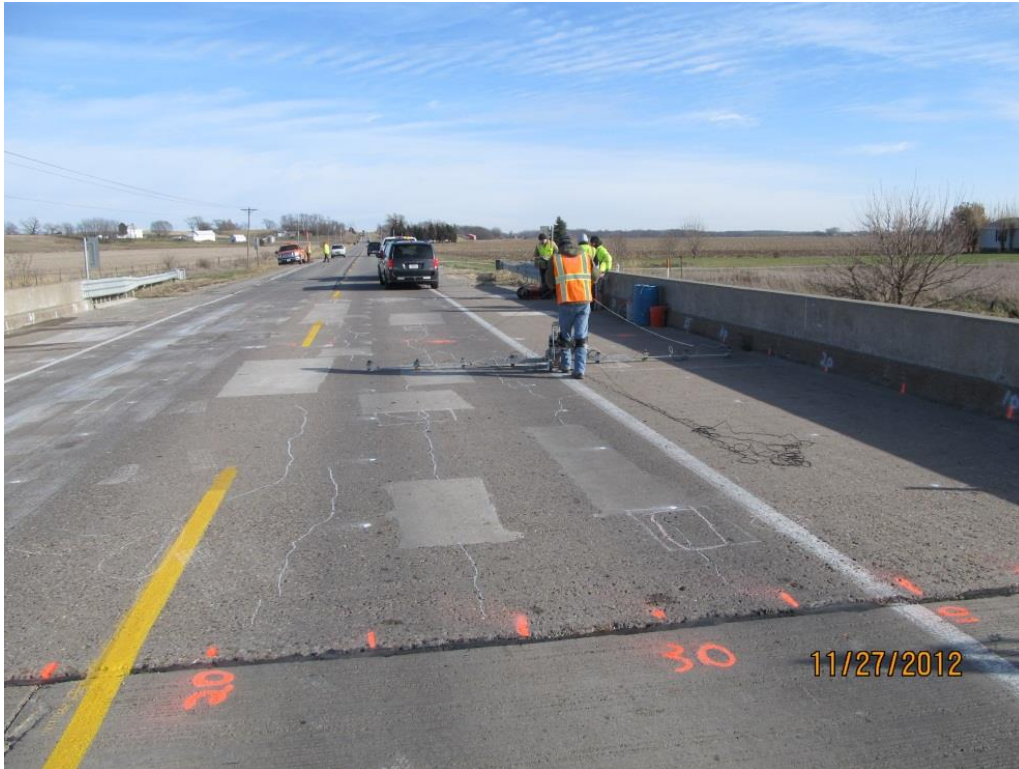
Overall photos of the deck top surface are shown in Figures 3.1 and 3.2. The deterioration noted during the visual and delamination surveys is presented on the plan drawings in Appendix A.

Figure 3.1. Overall view of eastbound lane of bridge, looking east. Chalk lines indicate cracks and delaminations identified by survey.

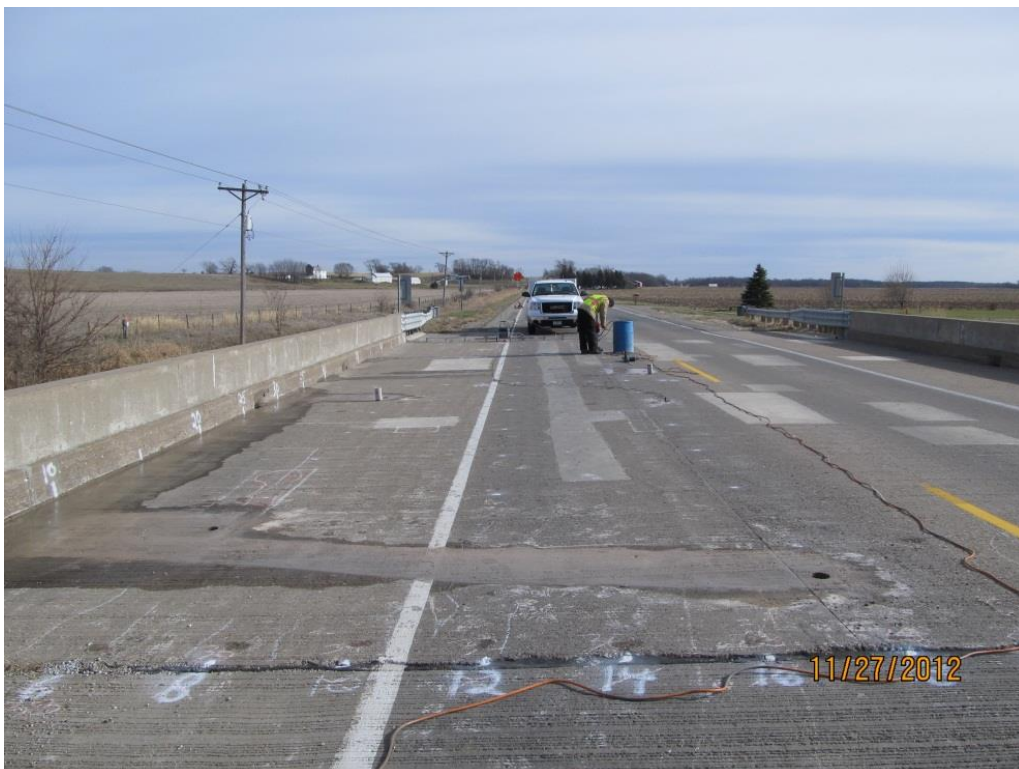
Figure 3.2. Overall view of westbound lane of bridge, looking east. Chalk lines indicate cracks and delaminations identified by survey.

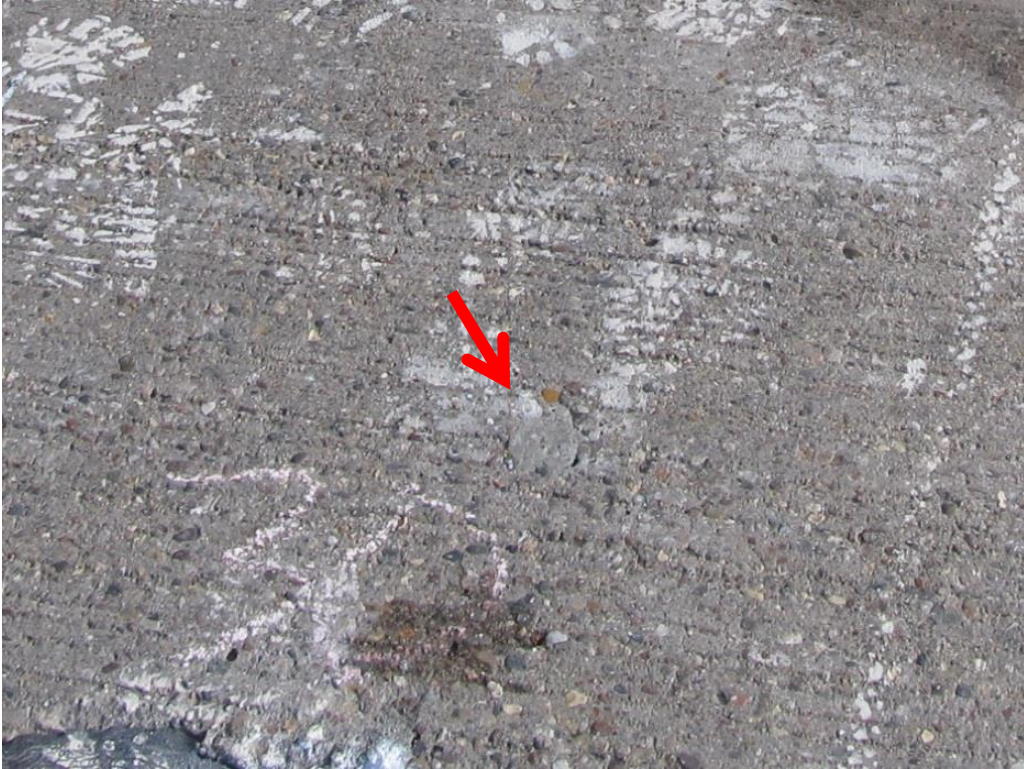
The patch repairs were generally distributed uniformly across the deck surface. One long, relatively narrow (approximately 24-inch wide) repair was present at the location where the temporary barrier rail had been installed during the original construction. It is unclear whether this repair was performed to address corrosion-related distress, but it is likely that the repair was prompted at least in part by the anchor holes for the barrier rail. These holes were partially filled with grout where they remained (see Figure 3.3).

Figure 3.3. Patched rail anchor hole at west end of westbound lanes.

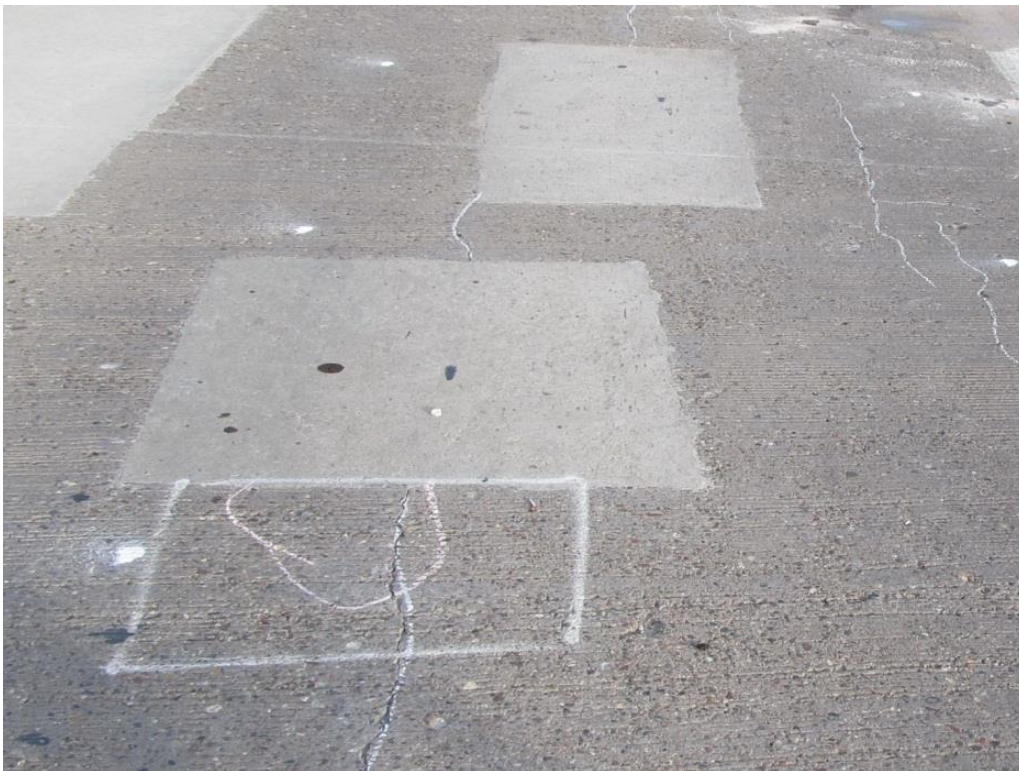
With one exception, the patch repairs were generally sound. Many of the new delaminations were located immediately adjacent to these repairs, and likely resulted from the “halo” or “ring anode” effect, a process by which corrosion of embedded reinforcing immediately adjacent to concrete repairs is accelerated by locally large differences in the internal concrete environment at the perimeter of the patch repairs. An example of a new delamination along a crack and adjacent to an existing repair is pictured in Figure 3.4.

Figure 3.4. Delamination marked in pink chalk and proposed repair location marked in white paint adjacent to previous patch repair.

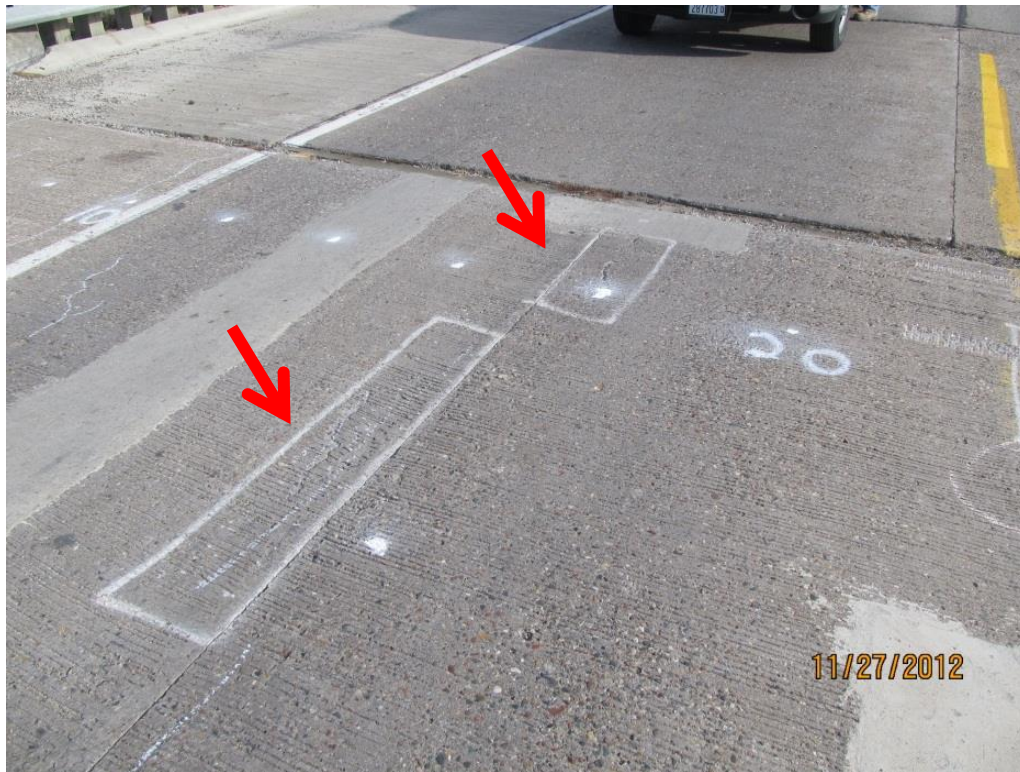
Three of the areas located adjacent to the construction joint marked by IaDOT for repair as part of the 2013 rehabilitation showed cracking distress (see Figure 3.5), but were not identified as delaminated during WJE’s survey. The cause of this distress is uncertain, but may be related to differential movement between the north and south portions of the deck, or freezing of water trapped in the construction joint.

Figure 3.5. Repair areas marked by IaDOT associated with cracking adjacent to construction joint, but not identified as delaminated.

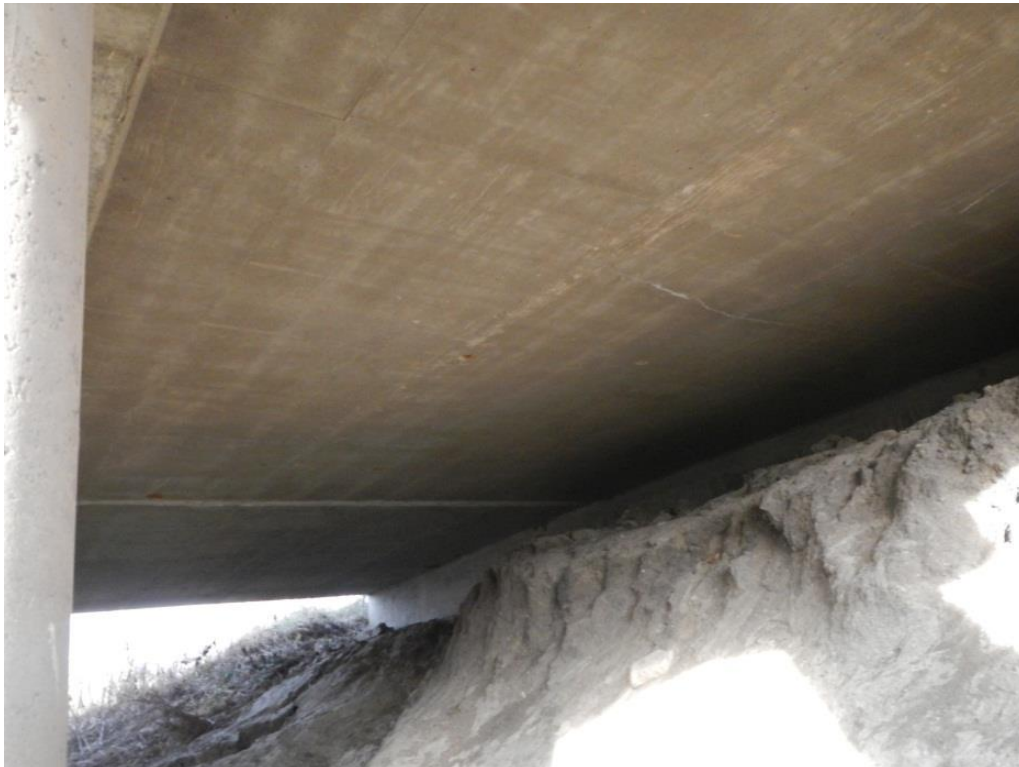
The underside of the deck is generally in very good condition, as can be seen in Figures 3.6 and 3.7. While some signs of efflorescence were present at the construction joint and at some other cracks, indicating moisture passing through the thickness of the deck, only a few through-deck cracks were observed. No underside spalls were identified, and the only moisture staining noted at the drain penetrations was limited to localized areas (see Figure 3.8).

Figure 3.6. Deck underside east span.

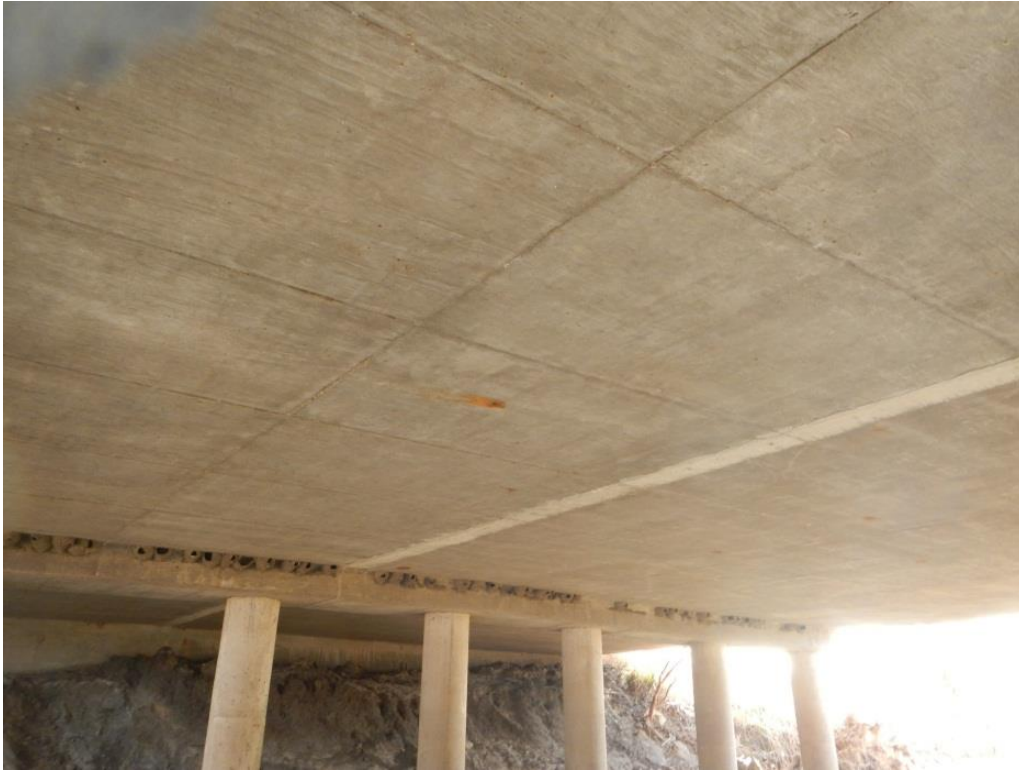
Figure 3.7. Deck underside center span.

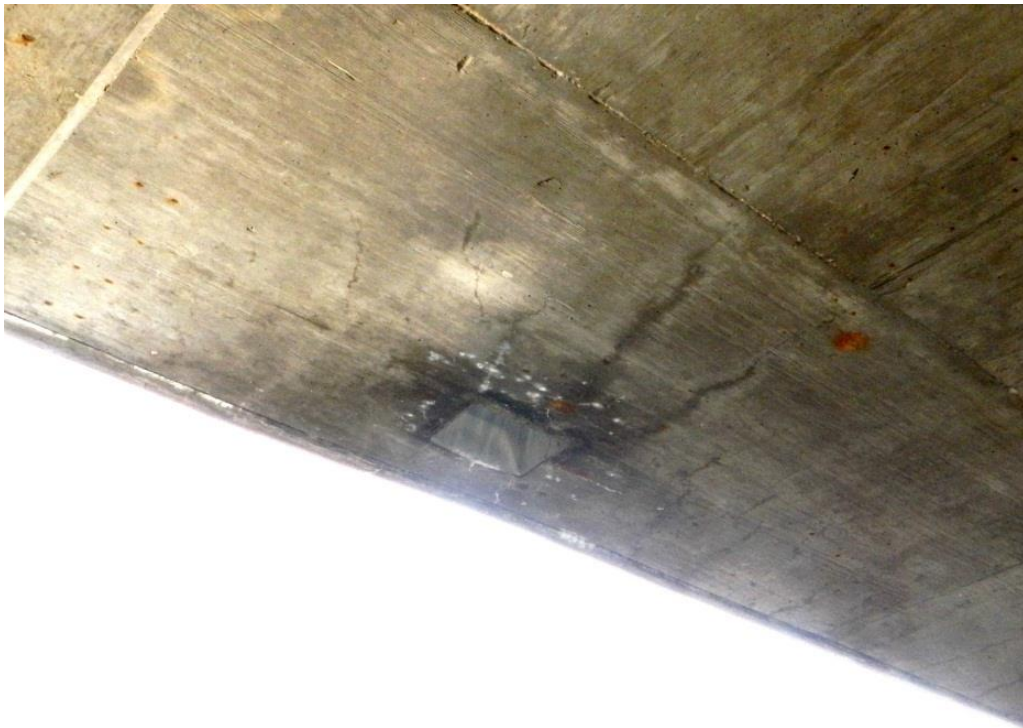
Figure 3.8. Moisture staining on deck underside surrounding drain penetration.

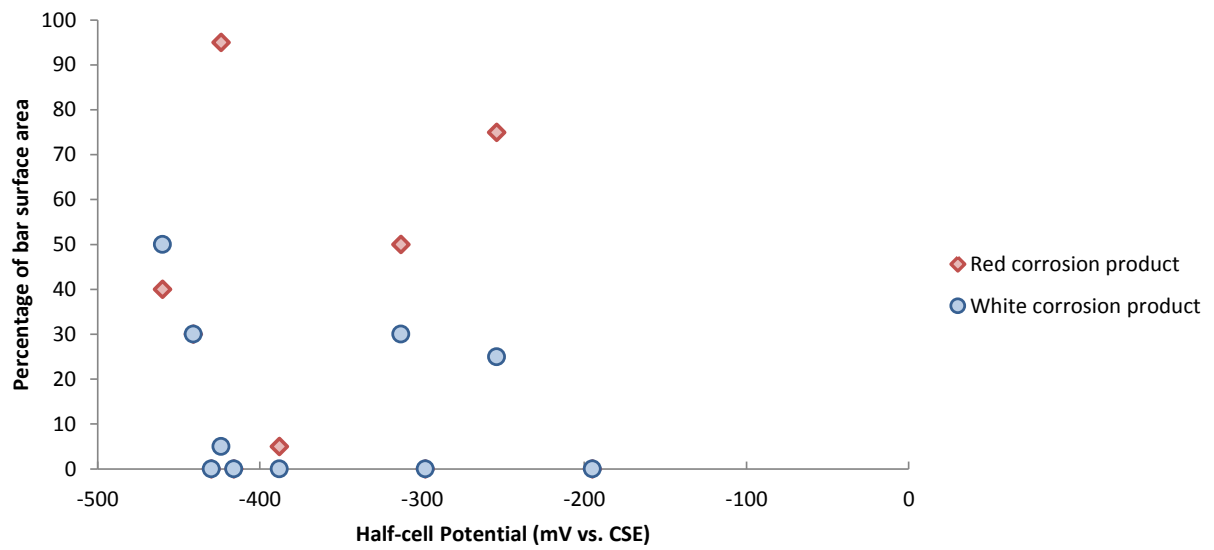
To determine if the half-cell potentials could be used to identify the condition of the galvanizing for the embedded reinforcing, the corrosion state for each core was plotted versus the measured potential at that location (see Figure 3.9), as determined by the rolling wheel contour map. The corrosion state was considered as the percentage of corrosion product on the bar for both white corrosion product (zinc corrosion) and red corrosion product (steel corrosion). The plot shows that no clear relationship was evident between the corrosion product on the bar and the measured half-cell potential.

Figure 3.9. Relationship of half-cell potential to corrosion product observed on extracted bar sample.

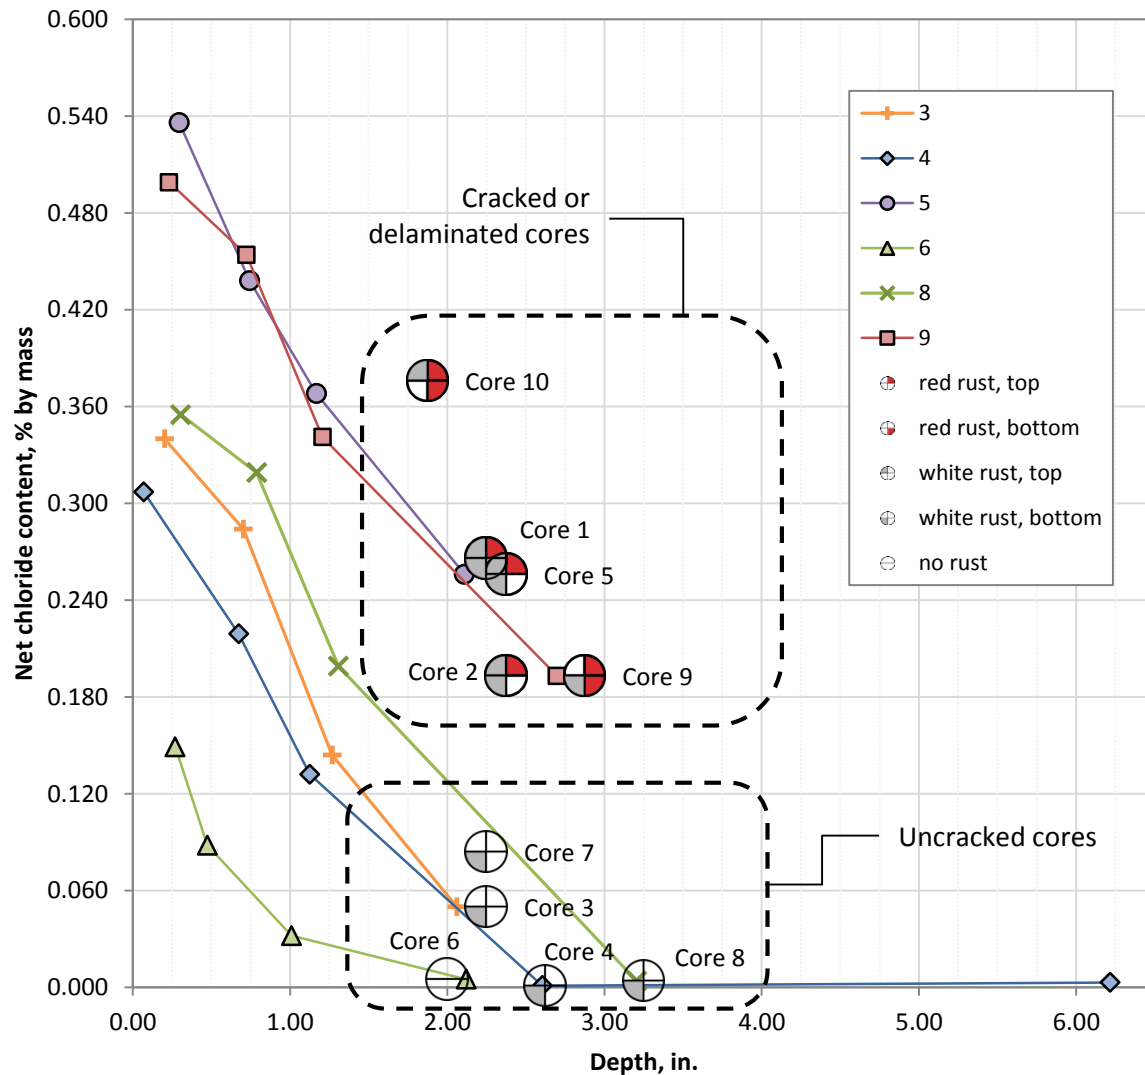
Acid-soluble chloride content test results are provided for each core in Table 3.5. Chloride content profiles versus depth are plotted in Figure 3.10; chloride contents at the bar depth are also indicated for all 10 cores. For comparison purposes, the corrosion state of the extracted bars, as described in Section 3.2.3 below, is indicated by the symbol shown for each core. Cores at cracked or delaminated locations are also identified.

The resulting chloride profiles can be grouped into three categories: cracked, uncracked, and sheltered. Observations from these profiles are as follows:

- Chloride profiles for cracked cores are represented by Cores 5 and 9, which had partial depth vertical cracks. The cores taken at cracked or delaminated locations had the highest chloride content at the bar depth, in excess of 0.180 percent by weight of concrete. These bar samples had red rust (steel corrosion) at least on the top surface of the bar and white rust (zinc corrosion) on the top and bottom surfaces of the bar.

- Chloride profiles for uncracked cores are represented by Cores 3, 4, and 8. These cores had chloride contents less than 0.060 percent by weight of concrete at the bar depth. The bars from these cores did not have any red rust (steel corrosion), but did have some white rust (zinc corrosion) evident on the bar underside.

- The sheltered core profile is represented by Core 6. This profile had the lowest surface concentration of chloride of all the cores. This core came from the shoulder of the north half of the deck near the barrier. Documentation from the 2006 inspection indicated that this area had a build-up of 2 inches of “gravel”. It is unclear whether the gravel build-up had a direct effect on the chloride exposure, or whether localized drainage patterns had resulted in lower chloride exposure than on other areas of the deck. The bar extracted from Core 6 did not have active zinc or steel corrosion.

Figure 3.10. Chloride content profiles with depth for 6 cores. Chloride content at bar depth is also shown for all 10 cores. The corrosion state of extracted bars is indicated by the symbol shown for each core, where a colored indication (grey or red) denotes that 10 percent or more of the bar exhibited white or red rust. Lines for the chloride profiles do not pass exactly through the bar designation for each core, because the actual position of the slice varied slightly relative to the top of the bar.
