## **Strengthening Steel Girder Bridges with CFRP Plates**

Based upon the laboratory results, a second project was undertaken in which an existing steel-girder bridge was strengthened using CFRP plates. This bridge is a 150 ft x 30 ft three-span continuous rolled I-beam bridge in southwestern Iowa. The original non-composite four beam bridge was widened in 1965 by adding two additional composite beams. A recent rating of this bridge determined that several of the original beams were understrength in the positive moment regions, thus CFRP was bonded to the positive moment regions of the bottom flanges of the two original interior beams and the “new” exterior beams. At some locations on the exterior beams, the plates were installed on the top surface of the bottom flange to investigate the performance and in-service durability under detrimental environmental conditions. This bridge has been load tested three times: before and after installation of the CFRP plates, and approximately one year later to determine the effectiveness of the strengthening system. Results are presented to illustrate this effectiveness.

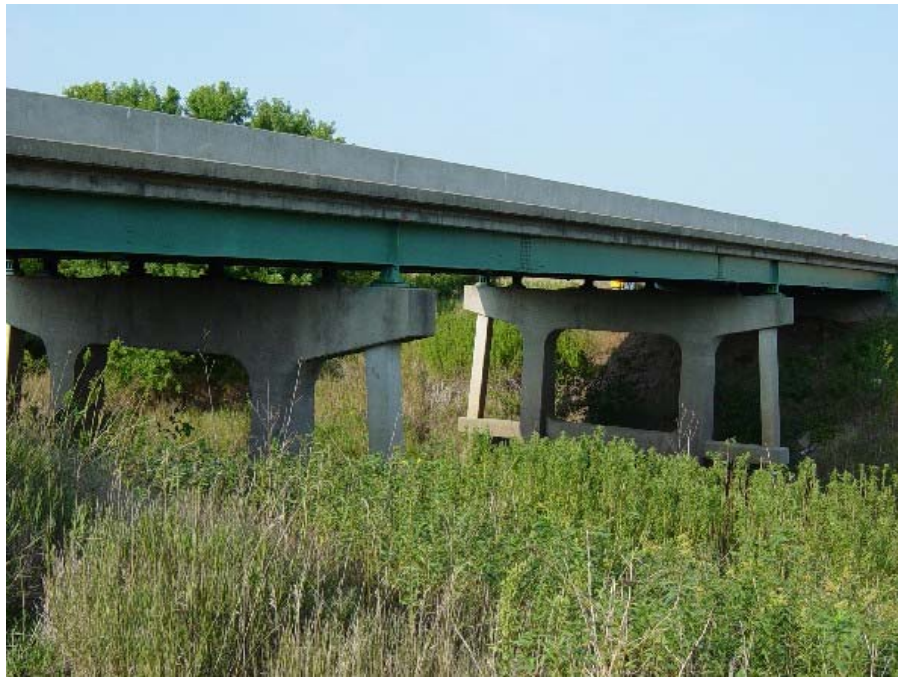
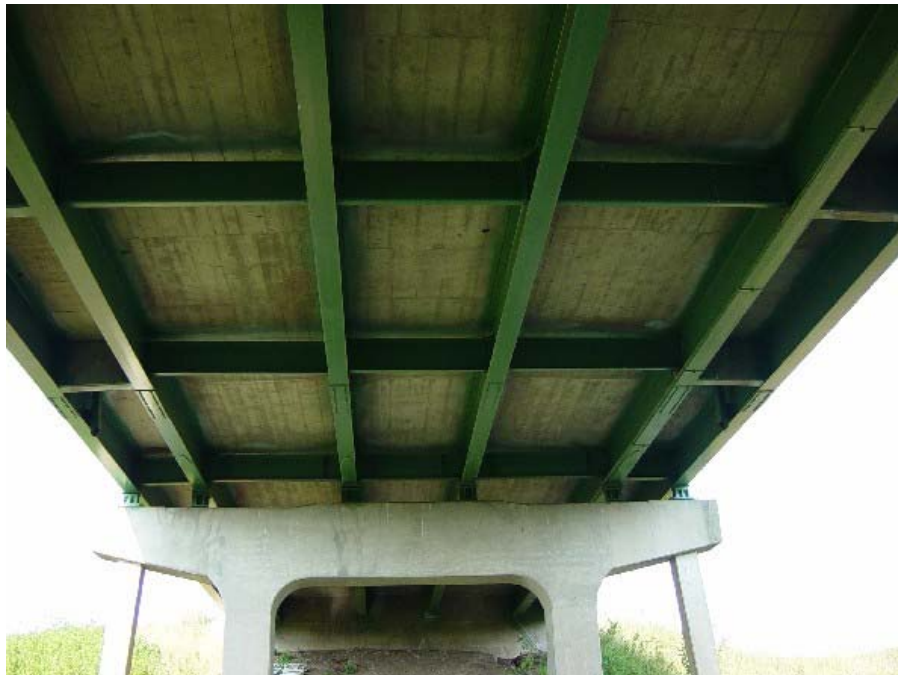
**FIGURE 5 Photographs of Bridge 7838.5S092.**

The bridge (Number 7838.5S092) selected for strengthening is the 150 ft x 30 ft three-span continuous I-beam bridge shown in Fig. 5. The bridge is located in southwest Iowa in Pottawattamie County on State Highway IA 92 over Walnut Creek. The bridge has two 45 ft - 6 in. end spans and a 59-ft center span. The original non-composite bridge was built in 1938 and was widened on both sides in 1967 by the addition of exterior girders that were constructed composite with the deck. The original bridge deck is a nominal 6.5-in. thick cast-in-place, reinforced concrete slab. The current average deck thickness is approximately 11 in. with 4 - 1/8 in. of crown from the edge of the roadway to the center of the roadway. The bridge deck is supported by two W27x84 exterior beams and four interior beams (two W27x91s and two W27x98s). As can be seen in Fig. 5, full depth 8-in. thick concrete diaphragms were cast between the W27x91 interior and W27x84 exterior beams when the bridge was widened in 1967. The bridge has no skew. Both abutments are integral concrete supported on treated wood friction piling, and the original piers are open-two-column concrete supported on untreated wood friction wood piling. The piers were also widened on both sides with the addition of a concrete pile at each end in 1967. The roadway width is 30 ft allowing for two traffic lanes and a shoulder on each side. The bridge has curbs integral with the deck with concrete guardrails connected to the curbs.

Both abutments have a few random vertical and horizontal hairline cracks with a small delaminated area at the top of one of the abutments. The top and bottom of the deck exhibit several hairline and narrow transverse cracks, and a few small delaminated areas. Both curbs have moderate hairline cracks through their length. The top of the deck has Portland Cement patches at several locations, and a few small spalls and delaminated areas along the construction joints.

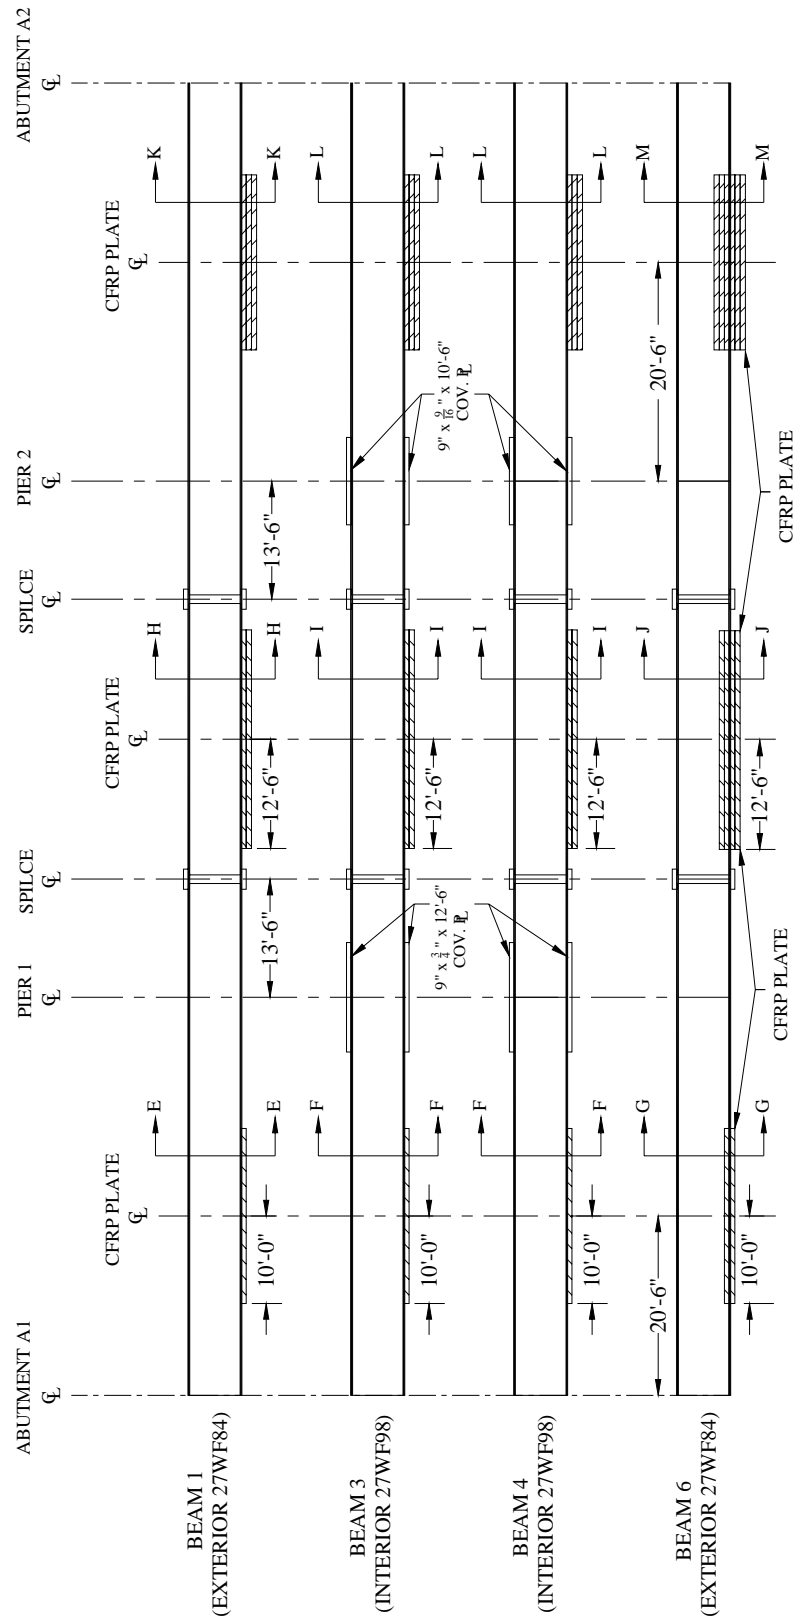
FIGURE 7 CFRP strengthening system layout.

Following the procedures outlined previously, it was found that the overstressed beams could be adequately strengthened by the addition of CFRP plates bonded to the bottom flange of the beams. The required amount of CFRP plate needed for strengthening the middle two beams was determined to be one layer in the end spans and two layers in the center span (each layer of CFRP plate measured 8 in. x 0.04 in.).

To this end, the following modifications were made with the final layout summarized in Fig. 7:

- The exterior beams were strengthened to investigate CFRP plate durability on exterior girders.
- All of the beams in the east end span had three layers (as opposed to the one layer required for strength) installed to evaluate performance and construction of multi layers.
- The south exterior beam in all three span had one-half of the CFRP plate installed on the bottom of the bottom flange and one-half on the top of the bottom flange (on the exterior side) to investigate durability under direct environmental exposure.
