## Test and Evaluation Report

### **Load Test to Assess Fatigue Detail Performance on Westbound I-80 Bridge over the Cedar River**

February 8, 2010

**Bridge Engineering Center**  
2901 South Loop Dr.  
Suite 3100  
Ames, IA 50010  
(515) 294-8103

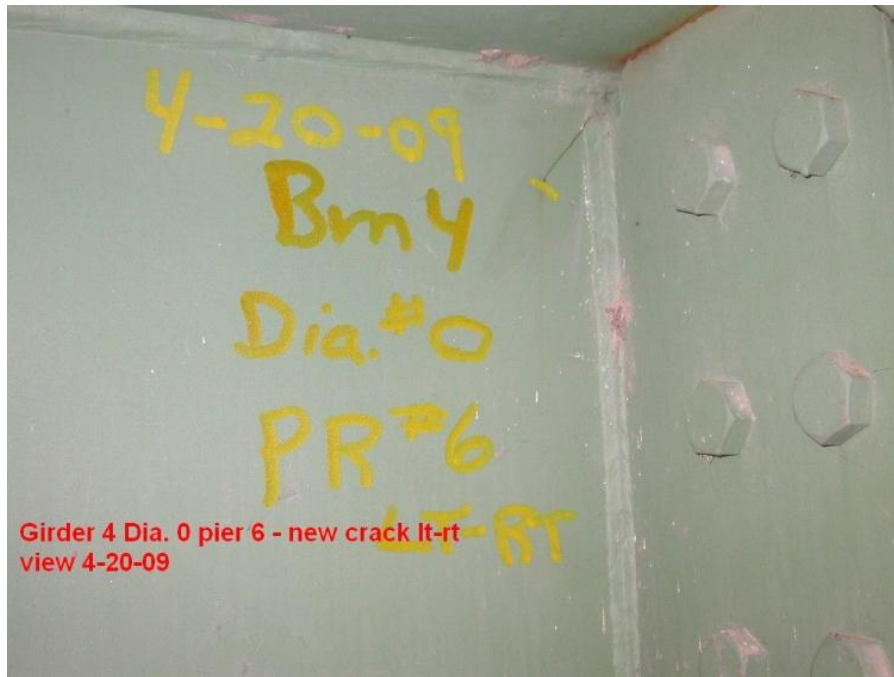
**Figure 5. Fatigue crack on Girder 4 at Pier 6 of westbound I-80 Bridge over the Cedar River. The 2 ½ in. crack was found in April 2009.**

Top Flange tipping (tilt) data only were collected at Girder 4 at Pier 6 on the westbound bridge. This is the location where the fatigue crack had occurred previously and where the drilled hole retrofit had been implemented (see Figure 5).

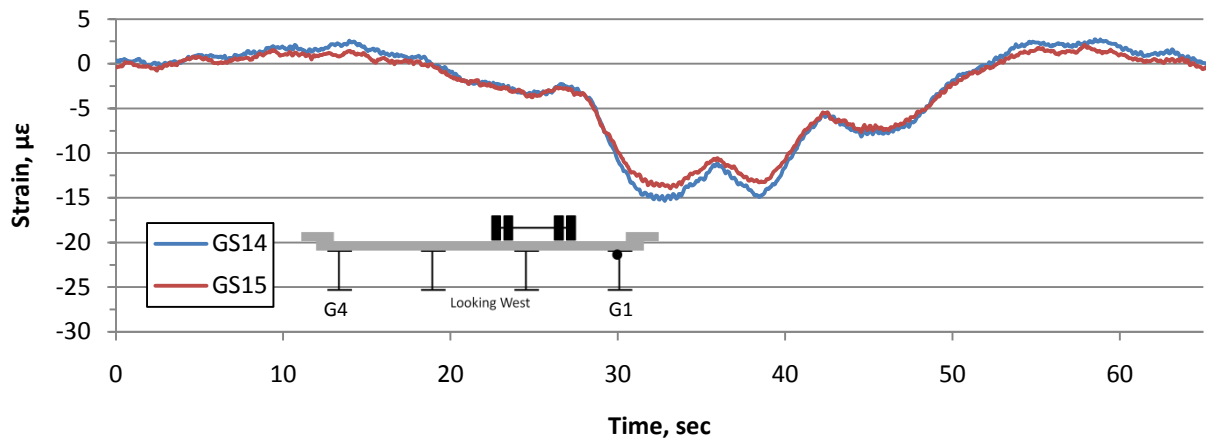
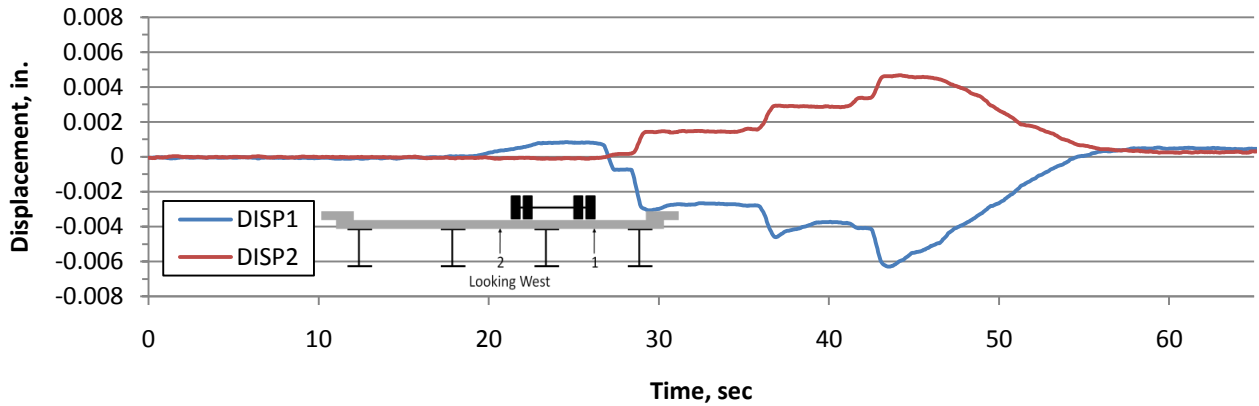
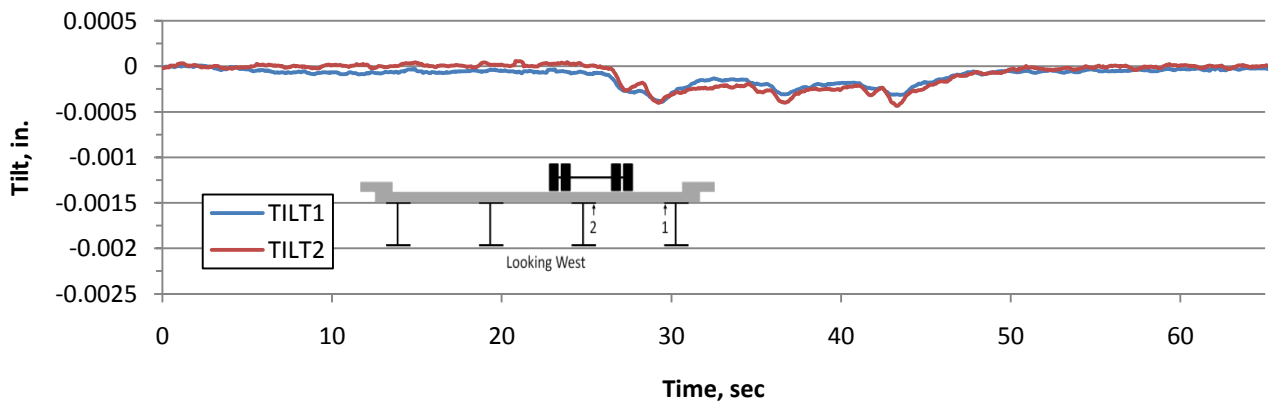
**Figure 16. Load Case 1: Iowa DOT Snooper, Truck 2 and Truck 1 traveling back-to-back and separated by approximately 20 feet and traveling in the middle of the north lane.**

**Figure 16** shows plots of gradient strain in the web gap on Girder 1, deck displacements in two “girder bays” and top flange tipping displacements on Girders 1 and 2. The loading consisted of the Iowa DOT snooper, Truck 2 and Truck 1 (Load Case 1) crossing the bridge approximately 20 ft apart in the north lane.

The maximum recorded strain was approximately 15 micro strain (equivalent to 0.45 ksi). The stress range (i.e. change from positive to negative stress) for the complete time record would only be slightly larger as the positive strain values are less than 2 or 3 micro strain. The GS14 and GS15 gradient gages (Figure 16a) are the two farthest down on the web away from the web/flange fillet weld.

The qualitative displacements of the deck in girder Bays 1 and 2 (negative in Bay 1 and positive in Bay 2) are reasonable given the test truck transverse wheel positions. The top flange tipping displacement also seems reasonable given the test truck transverse positions, and in a qualitative sense correlate well with the gradient strain and deck displacement records.

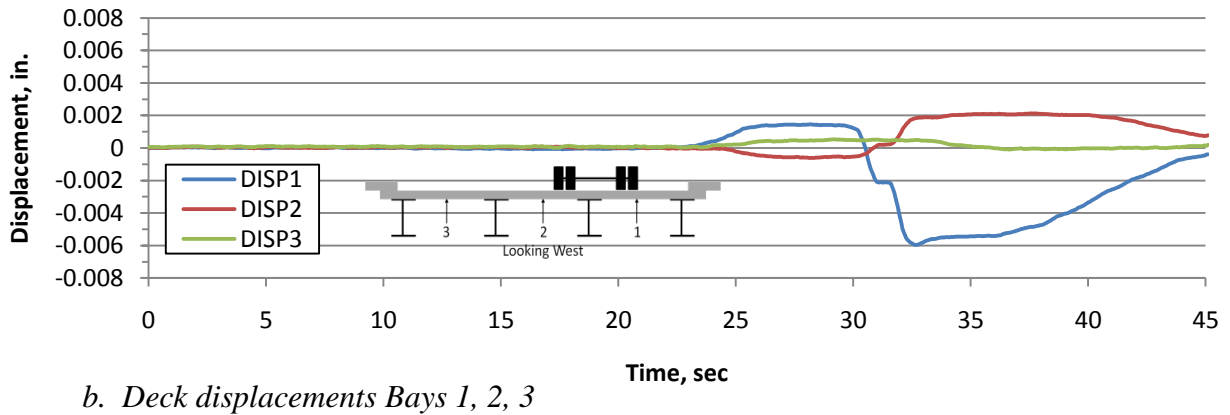
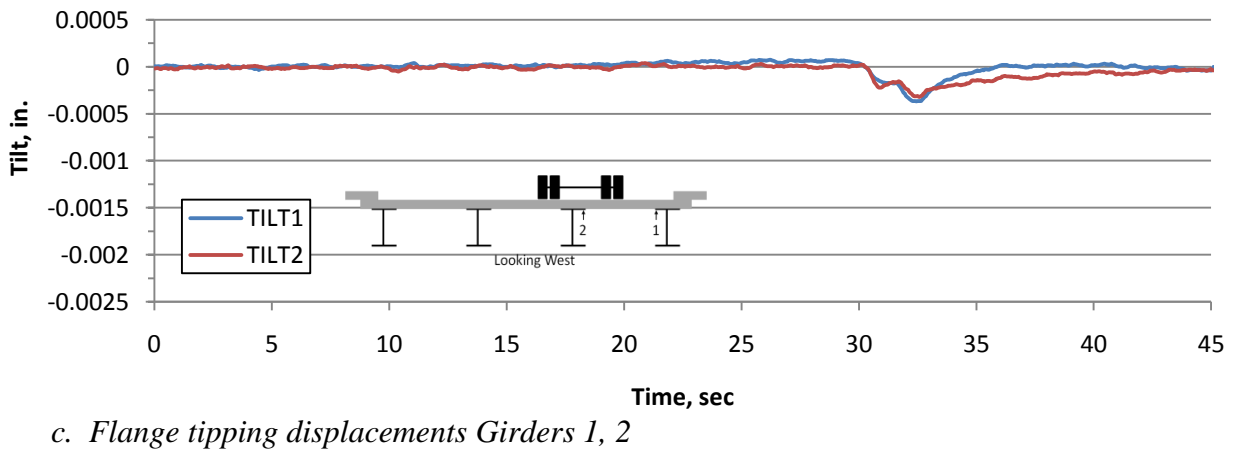
**Figure 17. Load Case 3: Truck 1 traveling in the middle of the north lane (which would be approximately 5 ft-4 in. from the face of curb).**

**Figure 17** shows plots of gradient strain in the web gap on Girder 1, deck displacements in all three “girder bays” and top flange tipping displacements on Girders 1 and 2. The loading consisted of only Truck 1 (Load Case 3) crossing the bridge in the north lane.

The maximum recorded strain was approximately 10 micro strain (equivalent to 0.3 ksi). The stress range (i.e. change from positive to negative stress) for the complete time record would only be slightly larger as the positive strain values are less than 2 or 3 micro strain.

The deck displacement in the girder bays 1 and 2 seem reasonable given the test truck transverse wheel positions. The top flange tipping displacements also seem reasonable given the test truck transverse positions. Qualitatively the top flange tipping and deck displacement correlate well. However, in a qualitative sense the correlation between the gradient strain and both the deck displacement and the flange tipping displacement are not as clear as in Figure 16.

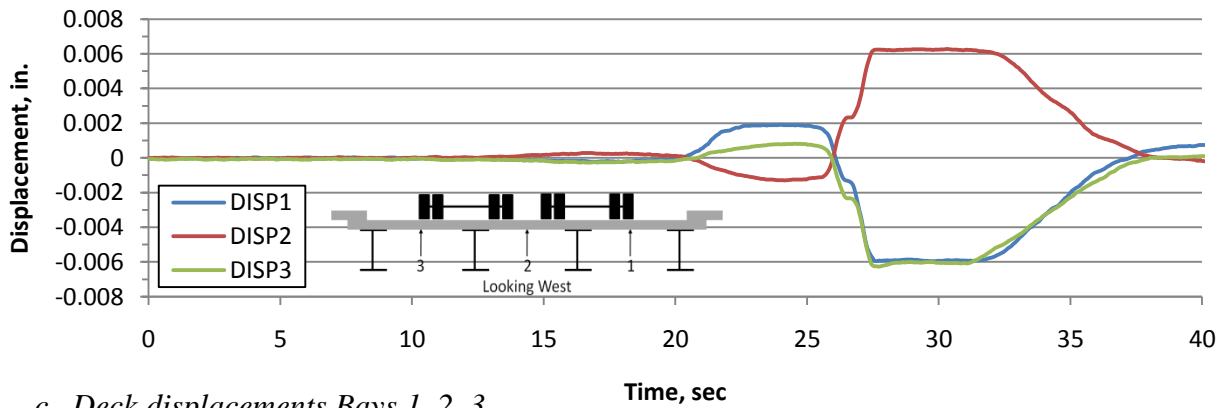
**Figure 18. Load Case 8: Truck 1 in south lane, Truck 2 in north lane, side-by-side in middle of lanes.**

**Figure 18** shows plots of gradient strain in the web gap on Girders 1 and 4, and the associated deck displacements in all three “girder bays”. The loading consisted of Truck 1 in the south lane and Truck 2 in the north lane (side by side).

The maximum recorded strain in the web gap of Girders 1 and 4, respectively, was approximately 10 micro strain (equivalent to 0.3 ksi) and 28 micro strain (equivalent to 0.8 ksi). Note that at Girder 1, the two gradient strains should be correlated with GS 44 and GS 45 at Girder 4 since they are at similar positions in the web gaps. The stress range (i.e. change from positive to negative stress) for the complete time record would only be slightly larger as the positive strain values are less than 2 or 3 micro strain. It is interesting to note that the shape of the strain/time plot for web gap strain in Girder 1 and 4 are quite different, and certainly the maximum strain magnitudes differ as well. The displacements in girder Bays 1, 2 and 3 (negative in Bays 1 and 3 and positive in Bay 2) seem reasonable given the test truck transverse wheel positions.

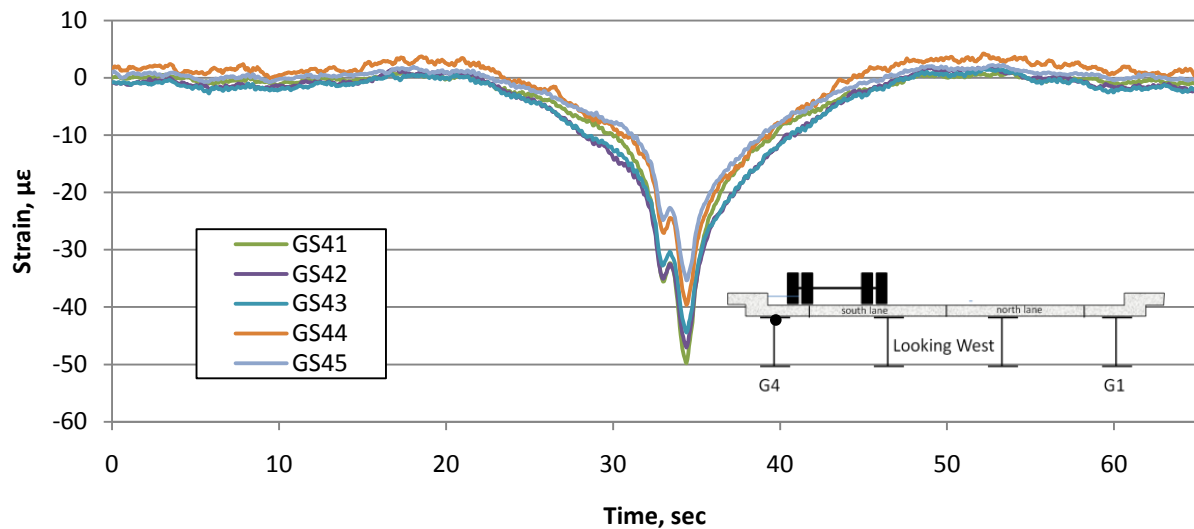
The broad inference of the observations above is that top flange tipping at the pier is caused at least partially by transverse bridge deck deformation. Subsequently, the top flange tipping induces web gap strains. However, for the data at Pier 3, the magnitudes of the strain range in the exterior girders are not relatively large (notwithstanding the fact that the measured strains would have been larger if the gradient gages had been placed nearer to the toe of the weld at the top flange). The maximum measured strain range corresponded to a stress range of 1.5 ksi (in Girder 4); the plot for this load case (Load Case 9; see Figure 19) was based on Truck 1 positioned in the south lane 2 ft from the face of the curb).

**Figure 19. Girder 4 gradient strains for Load Case 9: Truck 1 in south lane positioned 2 ft from the curb.**
