Test and Evaluation Report

Testing and Evaluation of the US63 Bridge in Davis County

November 11, 2005

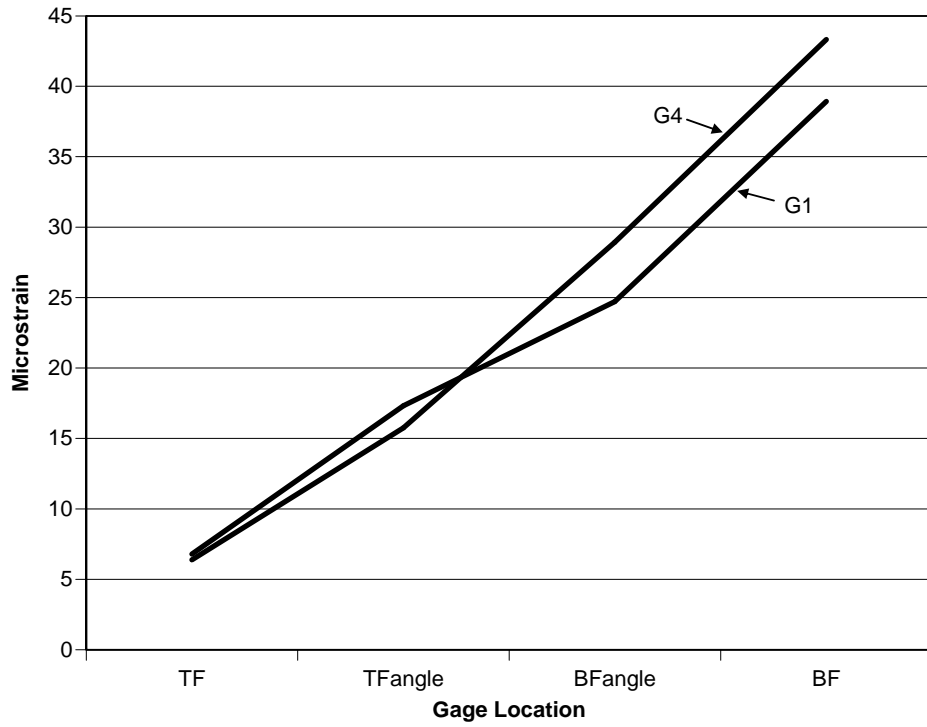
Figure 1 illustrates the strain distribution for girders G1 and G4, which were strengthened with steel angles, for load case 2, section 2. This figure is representative of the strain distribution for all exterior girders for all load cases. From Fig. 1 it is evident that there is a relatively linear strain distribution in the exterior girders with the steel angles included. This suggests that load is adequately being transferred to the steel angles and subsequently providing additional bending strength and stiffness.

Figure 1. Exterior girder strain distribution, Load Case 2, Section 2.
