**Final Report on the  
I-129 Missouri River Bridge  
Deck Condition Assessment Using Non-Destructive  
Testing Methods**

**Bridge No. 9700.0S129, Sioux City, IA**

**November 5, 2012**

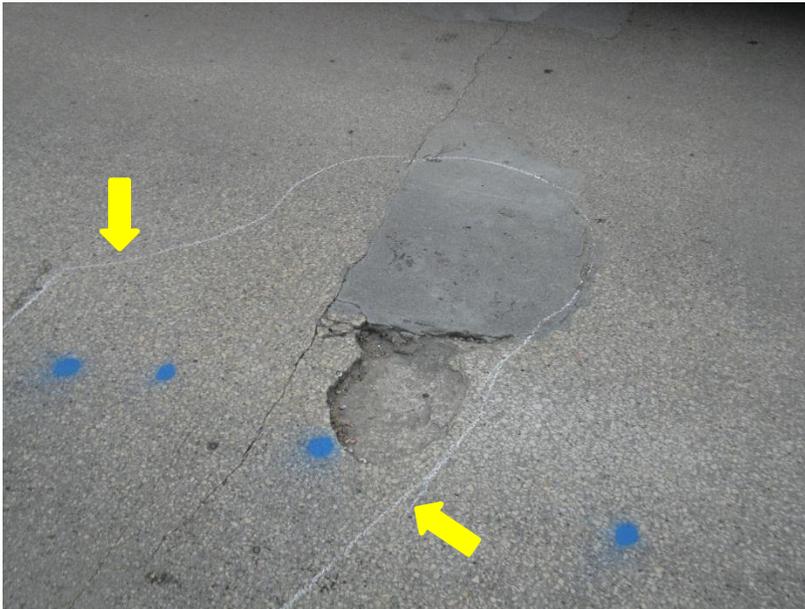
Several conventional patch repairs (see Figure 2.7) and the remains of multiple epoxy injection repairs (see Figure 2.8) were visible on the deck surface. It appears that the epoxy injection may have been used to treat cracks as well as to fill delaminations. In some cases, delamination continues to occur around the periphery of numerous delaminations injected previously with epoxy. However, it appears that the epoxy injection was reasonably successful at re-establishing bond at some locations where delaminations were present in 2008, and may also have reduced the quantity of delaminations that progressed to spalls.

*Figure 2.7. Existing concrete patch repair and cracking of deck. Note adjacent spall and new delamination (arrows) outlined in chalk.*

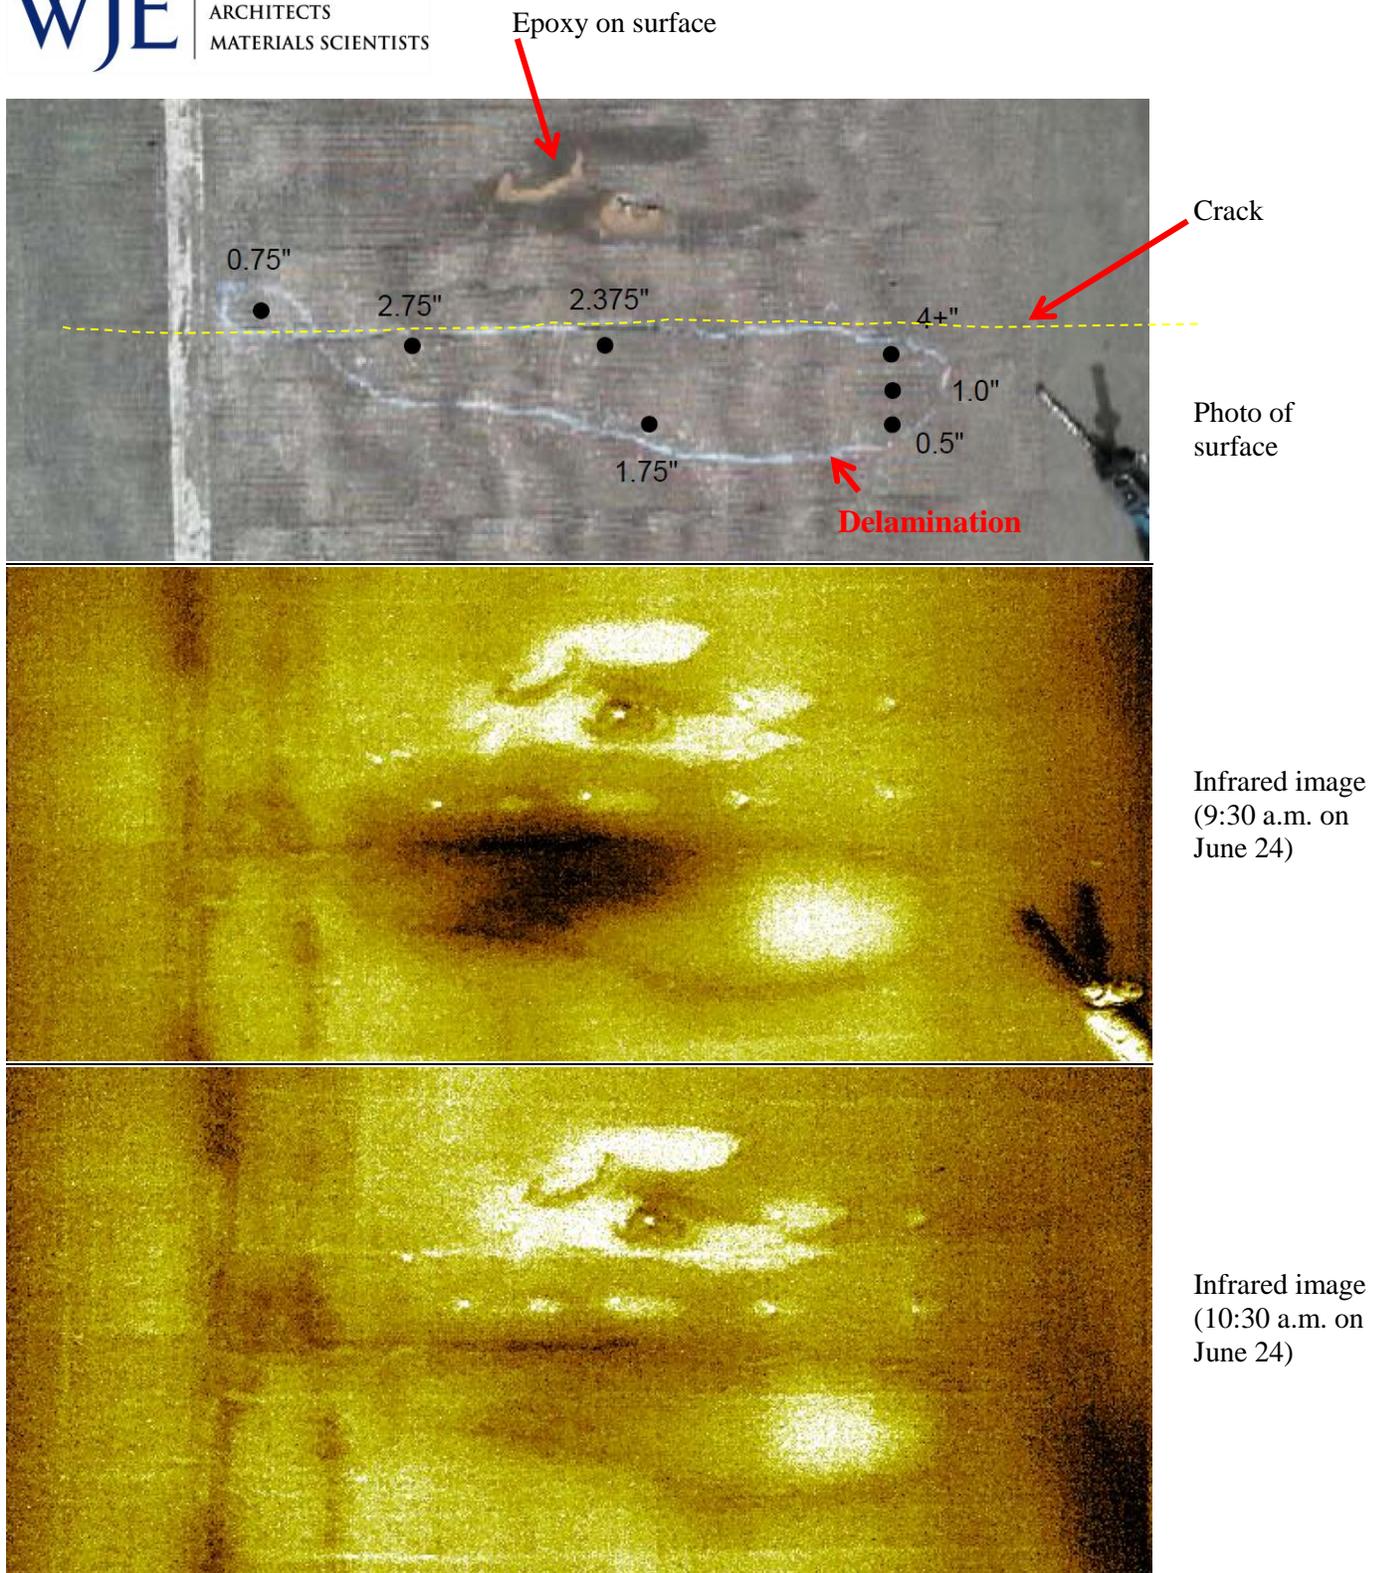
Figure 3.11. Study of depth of delamination in westbound lanes: photo of marked delamination with results from drilling indicating depth of delamination and crack location (highlighted in yellow); infrared image taken at 9:30 am on June 24; infrared image taken at 10:30 am on June 24 (top to bottom).

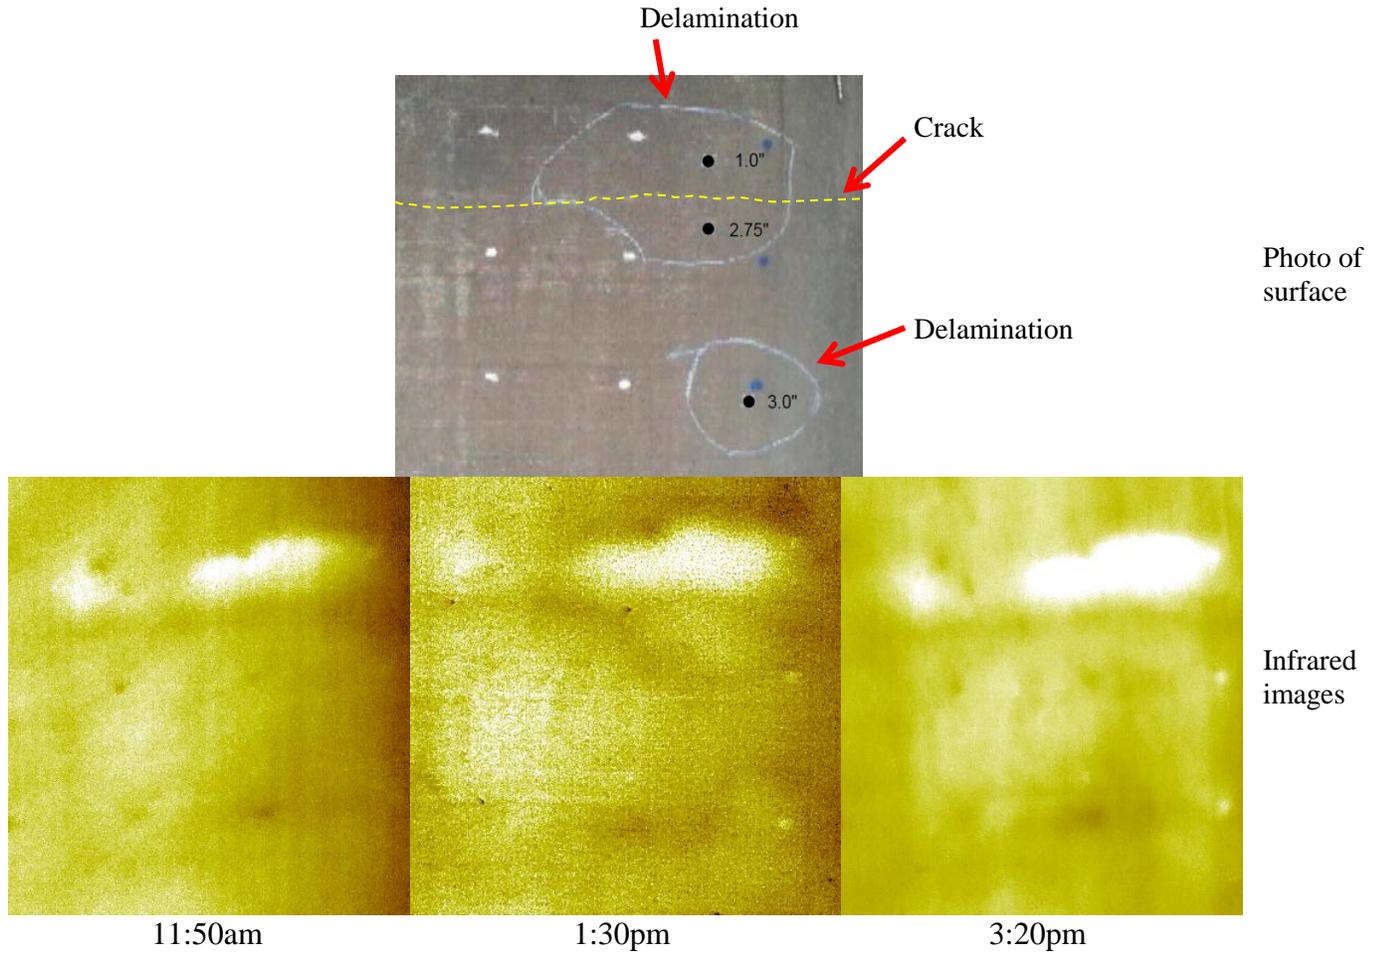
*Figure 3.12. Study of depth of delamination in eastbound lanes: photo of marked delamination with results from drilling indicating the depth of the delamination and crack location (highlighted in yellow, top); infrared images taken at the times shown (bottom). The bright spot observed in the top left of the infrared image is not associated with a delamination, but with a dark spot on the deck surface.*

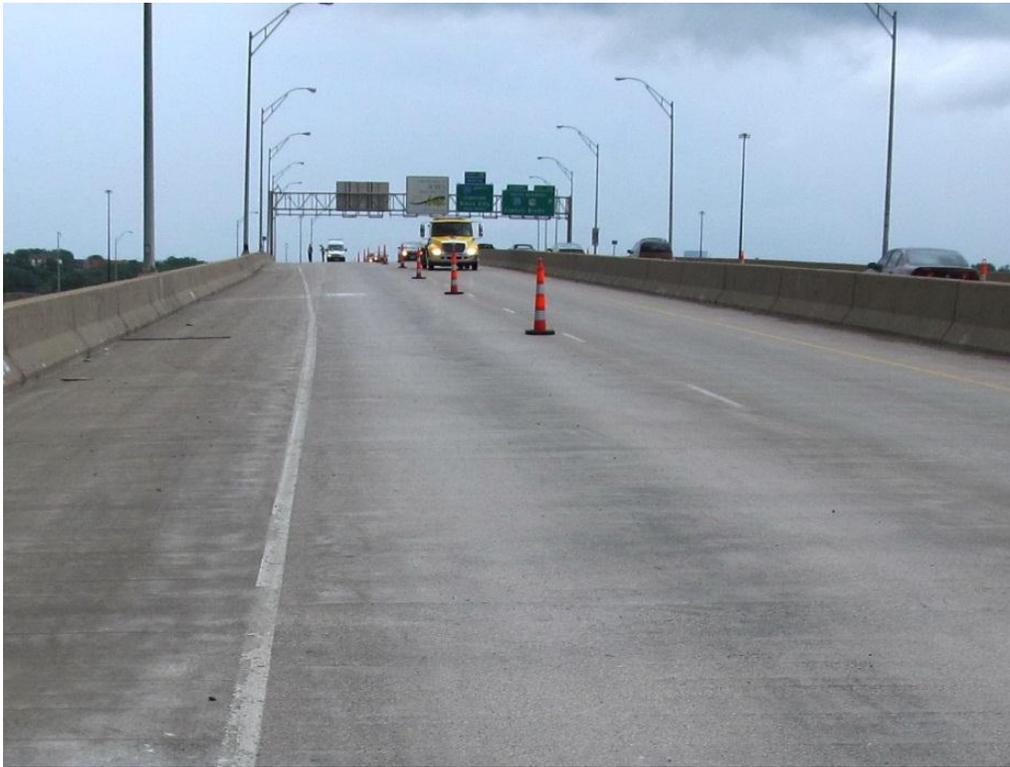
*Figure 3.13. Deck surface showing surface texture and color variation between wheelpaths and surrounding deck.*

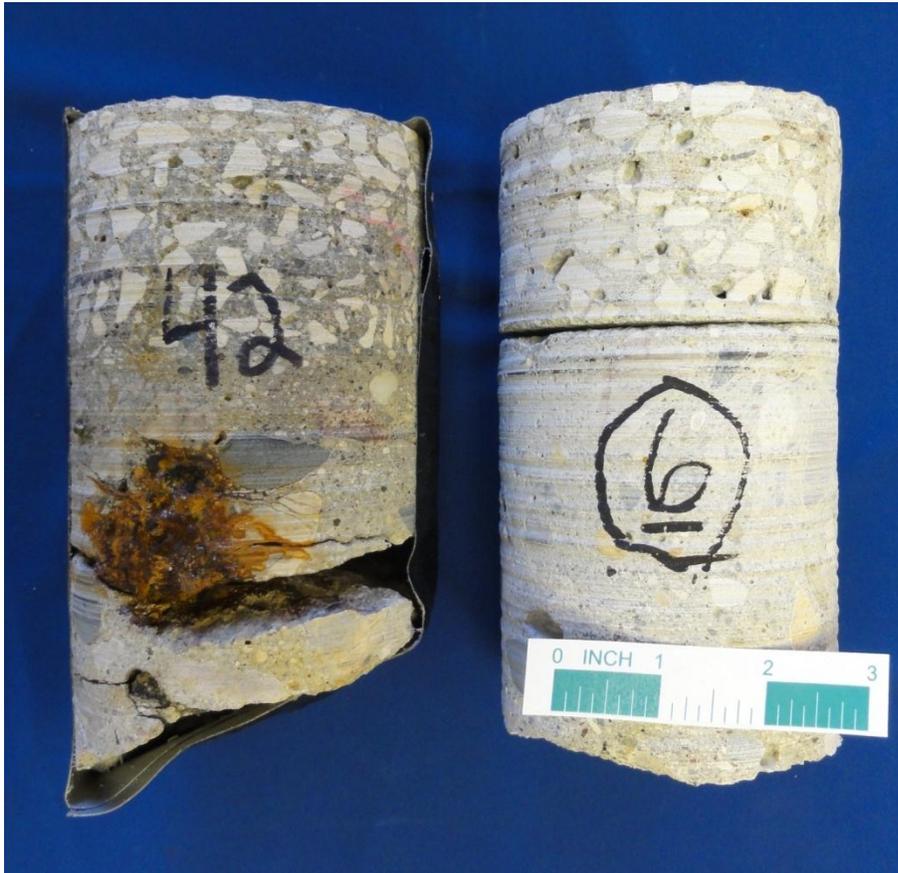
*Figure 1. Core 6 and 42 as received for petrographic studies. Topping layer in Core 6 as received was delaminated from the base concrete.*

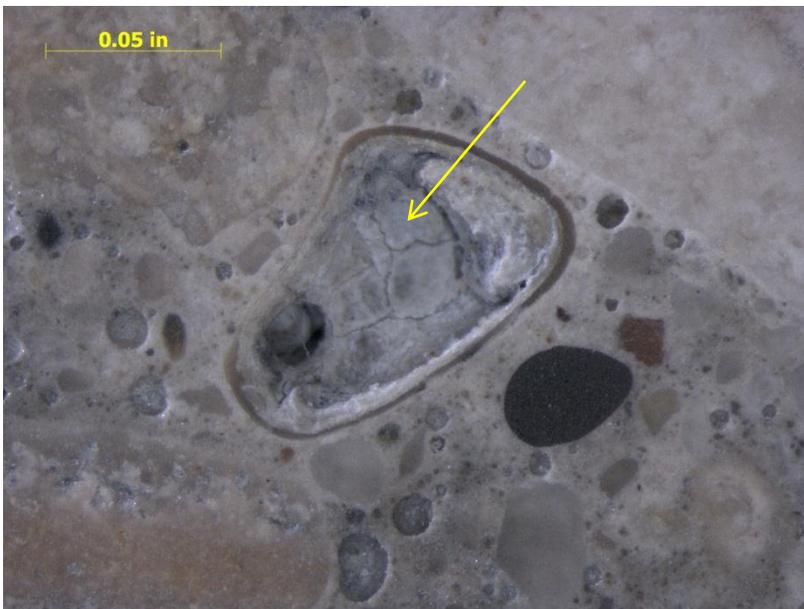
*Figure 5. Core 6 topping; the largest reacted fine particle of shale (encircled in Figure 2) located in close proximity to the intercepting microcracks. Most of the interior of this particle has been consumed in the alkali-silica reaction; gel was found on the surfaces of the microcracks.*

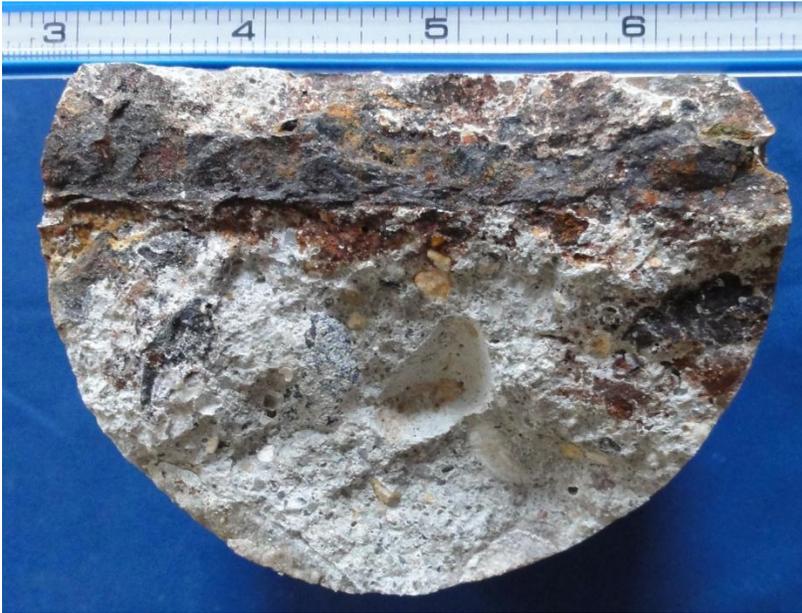
*Figure 8. Core 42; corroded rebar in base concrete at one of the transverse cracks.*

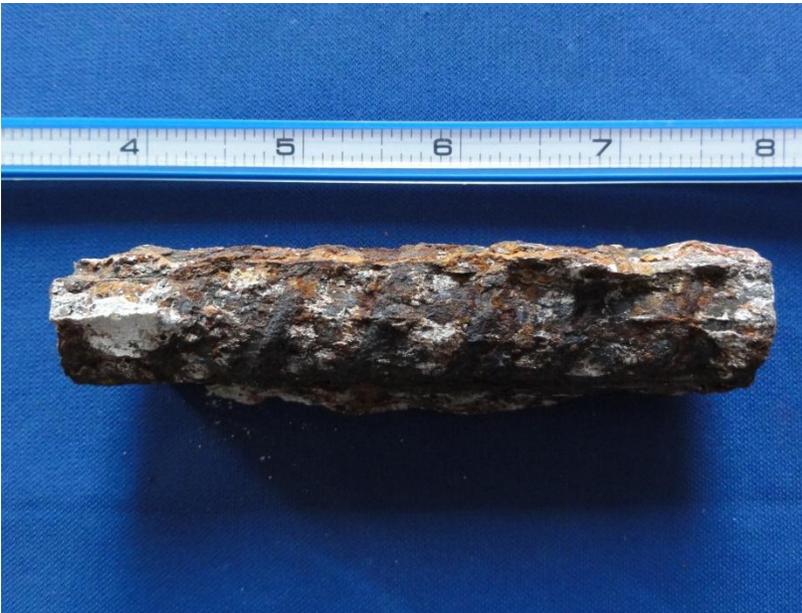
*Figure 9. Core 42: corroded rebar taken out of base concrete at one of the cracks.*
