Vibration Monitoring of Luminaires on the Burlington Cable-Stayed Bridge

The Iowa Department of Transportation

Iowa DOT
Kenneth F. Dunker

August 5, 2002

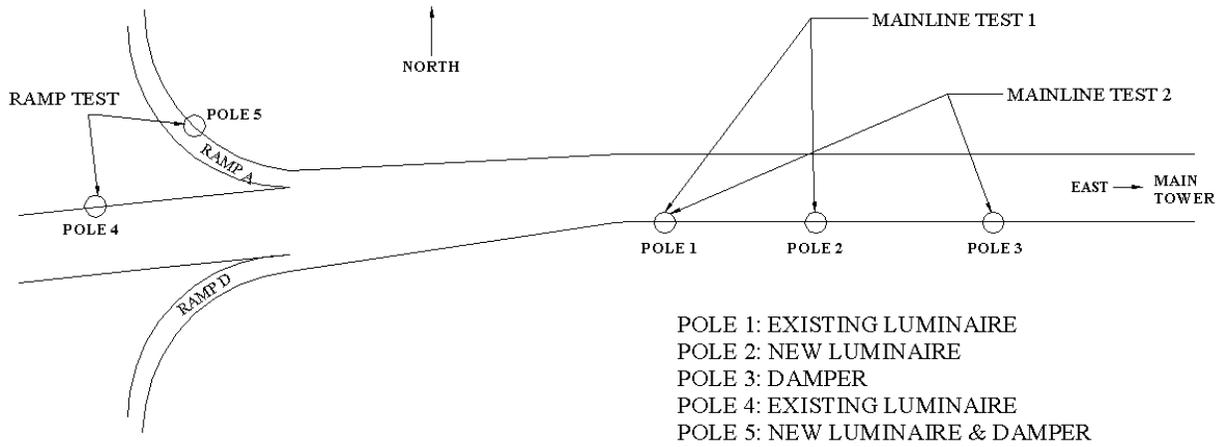
Figure 1. Condition and location of poles.

Evidently, as a result of the 1996 request, the bridge contractor or subcontractor repaired the poles by increasing the lengths of the tube extensions and reinstalling the luminaires properly. However, problems with the lighting persisted. In 1999, many lamps were continuing to fail at an early age and, in addition, some sockets were failing due to arcing at the lamp pin connections. Although the problems may have been more severe on the ramps and Iowa approach spans, there were problems throughout the LPS bridge lighting. Unfortunately, there were no available records to indicate if there were specific locations with higher or lower lamp failure rates.

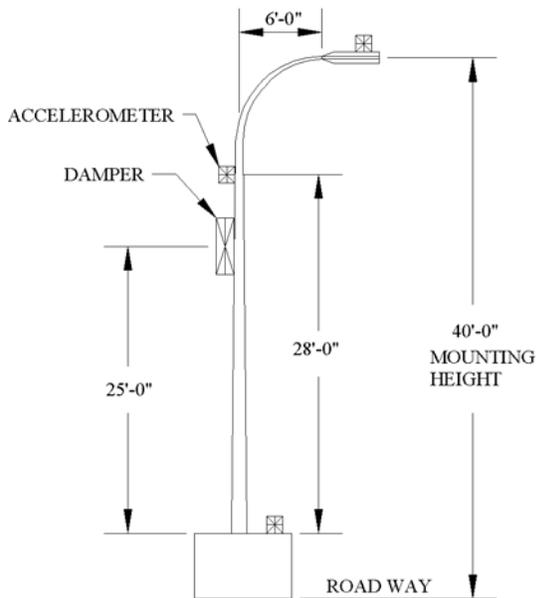
Figure 2. Location of accelerometer and damper.

Accelerometers for measuring vibration were installed at specified locations on the test poles prior to testing. A total of five light poles were instrumented. Notations for each general class of tests conducted (e.g., Mainline Test 1, Mainline Test 2 and Ramp Test) are given in Fig. 1. Accelerometers were typically installed at three locations on each of the poles and connected to a central data acquisition system. The accelerometers were placed on the luminaire casing, on the middle section of the pole approximately 28 ft from the base, and on the base of the pole as shown in Fig. 2. A typical photograph of the bridge is shown in Fig. 3. Also, typical photographs of the installment can be seen in Fig. 4.

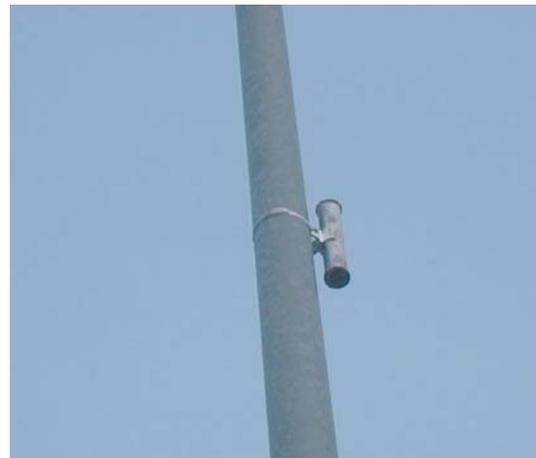
(d) Damper

This suggests that the damper was ineffective in reducing accelerations for the existing LPS luminaire and pole installation.
