# FIELD INSTRUMENTATION AND TESTING OF HIGH-MAST LIGHTING TOWERS IN THE STATE OF IOWA

## DRAFT FINAL REPORT

January 2006

Iowa Department of Transportation  
Office of Bridges and Structures  
800 Lincoln Way  
Ames, IA 50010

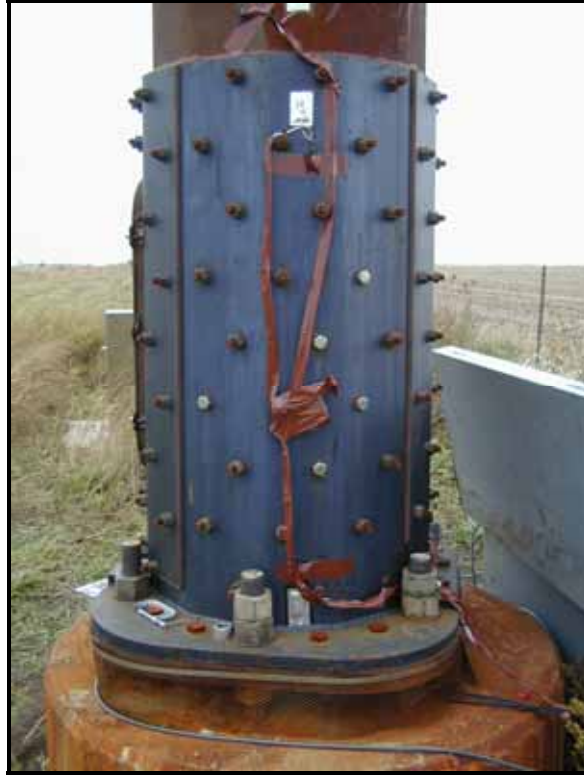
Figure 1.1 – Jacket retrofit designed by Wiss, Janney, Elstner, and Associates and installed in Clear Lake, Iowa

The second tower had been retrofitted with a steel splice jacket at the base as seen in Figure 1.1. The retrofit was designed by Wiss, Janney, Elstner, and Associates. Strain gages were installed on both the splice jacket and on the original tower just above the jacket. This tower is termed the “*Retrofit tower.*”

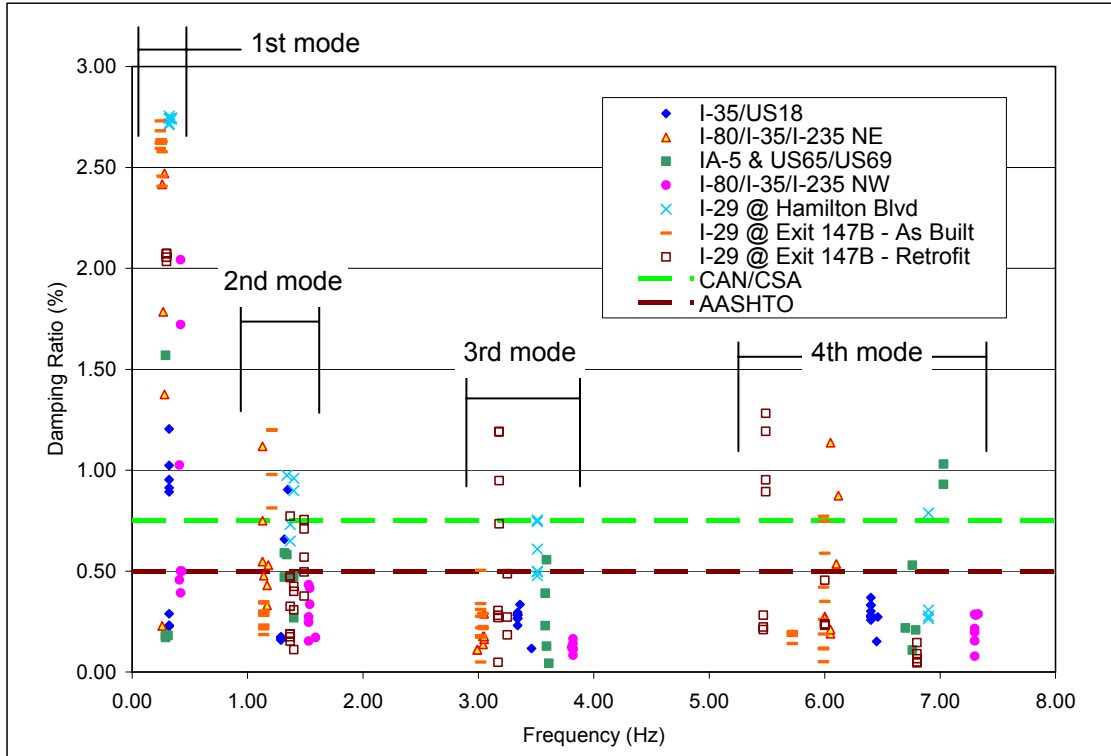
Figure 3.3 – Damping Ratio vs. Frequency

Plots of frequency versus the damping ratio of all the towers are shown in Figure 3.3. Also included in the plot are the specified damping ratios from the AASHTO and the CAN/CSA specifications. AASHTO recommends using a ratio of 0.5% when the actual damping ratio of the structure is unknown [2], and the Canadian Bridge Code (CAN/CSA) specifies a damping ratio of 0.75% when experimentally determined values are unavailable [3][4]. These plots show that the damping ratios in all four modes are in many instances considerably lower than the assumed values in the two different codes. Furthermore, the AASHTO and CAN/CSA specifications do not address the possibility of different damping ratios in the higher modes of vibration. These recommended damping ratios are not conservative estimations for the higher modes based on this research.

Structures with high damping ratios require fewer cycles for the vibration to attenuate. The high-mast towers have very low damping ratios and as a result experience a high number of cycles that can cause damage. These cycles can be accumulated during vortex shedding or following natural wind gusts. When a tower with low damping ratios is stressed beyond the constant amplitude fatigue limit (CAFL), a significant number of damaging cycles are accumulated before the stress range falls below the CAFL. The pole-to-base connection of these structures is assumed to be an E' fatigue detail per the code (but may be even worse), with a CAFL of 2.6 ksi, which means that low stress ranges can exceed the CAFL. Therefore, the low CAFL in combination with a low damping ratio can produce many damaging cycles on the high-mast light structures and consequently reduce the fatigue life. However, it should be noted that the designation of E' for the base plate connection is based on a very limited number of tests. It is likely that the actual fatigue performance of these connections is even worse than E' due to the thin baseplates and tube walls found on many high-mast towers.

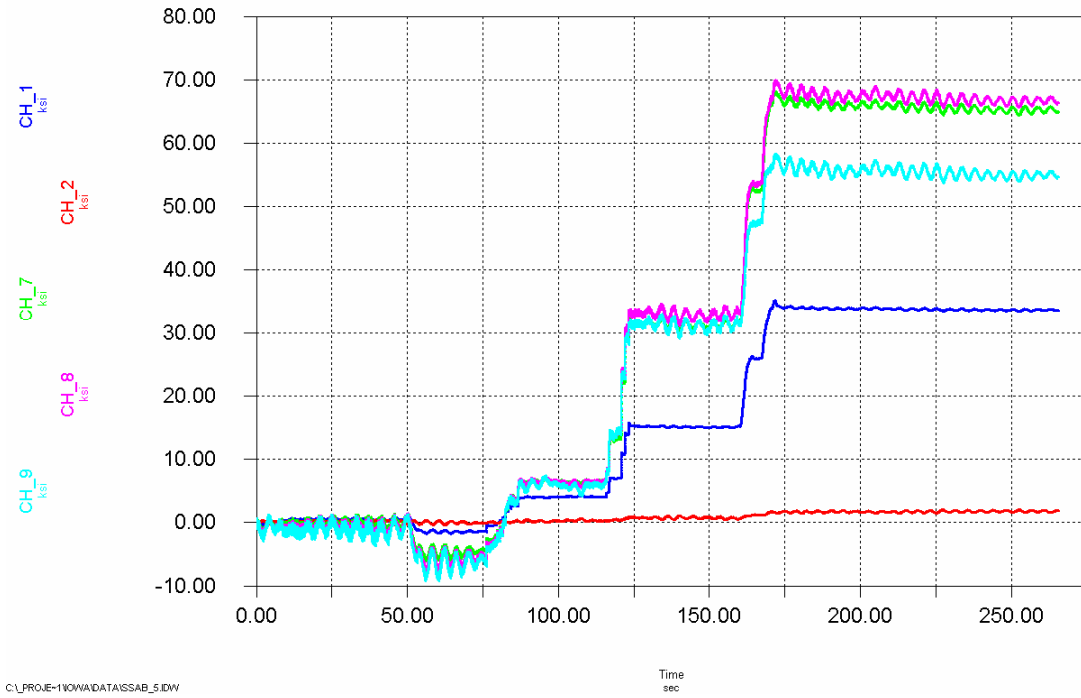
Figure 3.6 – Localized stress changes due to poor installation techniques

Strain gages CH\_7, CH\_8, and CH\_9 are located at the weld toe below CH\_1 (see Figure 2.9.) It can be seen that at the weld toe, very high stresses (70 ksi) are induced into the tube wall by tightening down the anchor nut. It is likely that the material locally yielded.

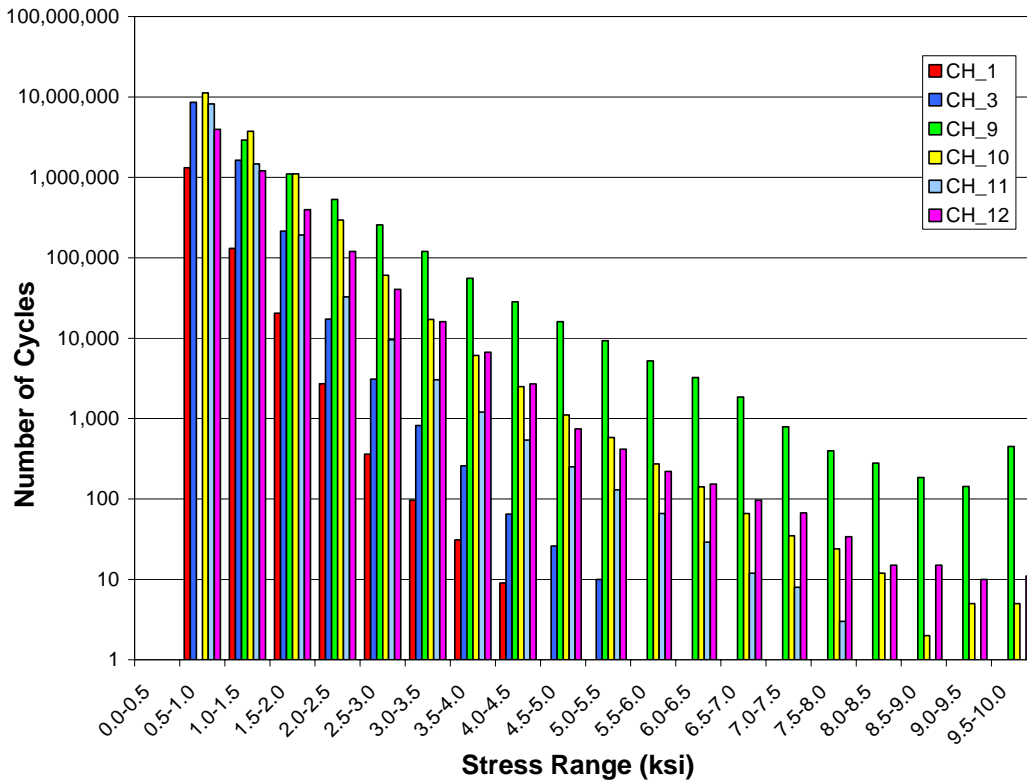
Figure 4.1 – Stress-range histograms for strain gages located on the As-built tower

Furthermore, the CAFL of all details (which may be conservative) was exceeded with a frequency of more than 1 in 10,000 at all gages. The stresses caused by vortex shedding were of a much lower magnitude.

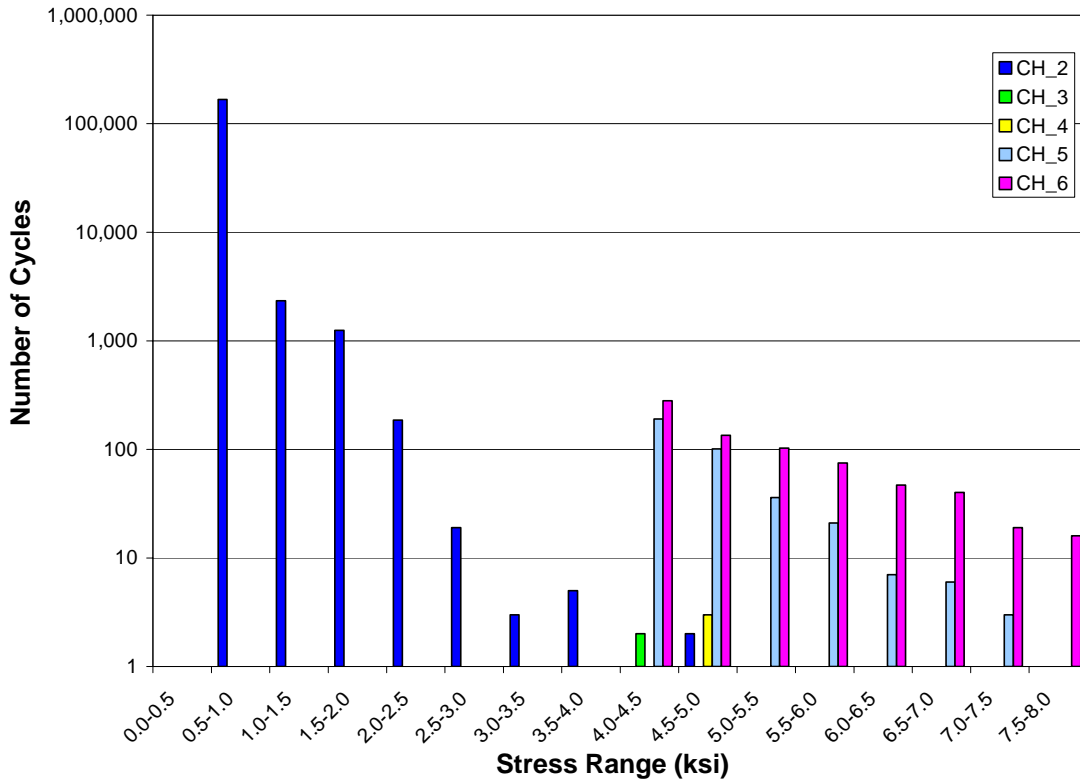
Figure 4.5 – Stress-range histograms for strain gages located on the Retrofit tower

The full penetration weld at the base of the tower (strain gage CH\_2) is considered at category E' per AASHTO [2], with a CAFL of 2.6 ksi. (It is noted CH\_2 is located on the jacket and not on the original tower wall.) All stress cycles less than 0.5 ksi were removed from the histogram. The maximum measured stress range in CH\_2 was 6.5 ksi. The CAFL was exceeded at a frequency of 0.02% which is greater than 0.01% (1/10,000), therefore, finite fatigue life can be expected. However, for this strain gage, the minimum calculated fatigue life is greater than 100 years, or effectively infinite life.

Strain gages CH\_3, CH\_4, CH\_5, and CH\_6 are installed at locations considered to be fatigue category B for a slip-critical bolted connection, with a CAFL of 10 ksi. As a result, all stress cycles less than 2.5 ksi were removed from the spectrum. It can be seen from Table 4.4 that the CAFL was never exceeded and therefore infinite fatigue life can be expected on the jacket itself.

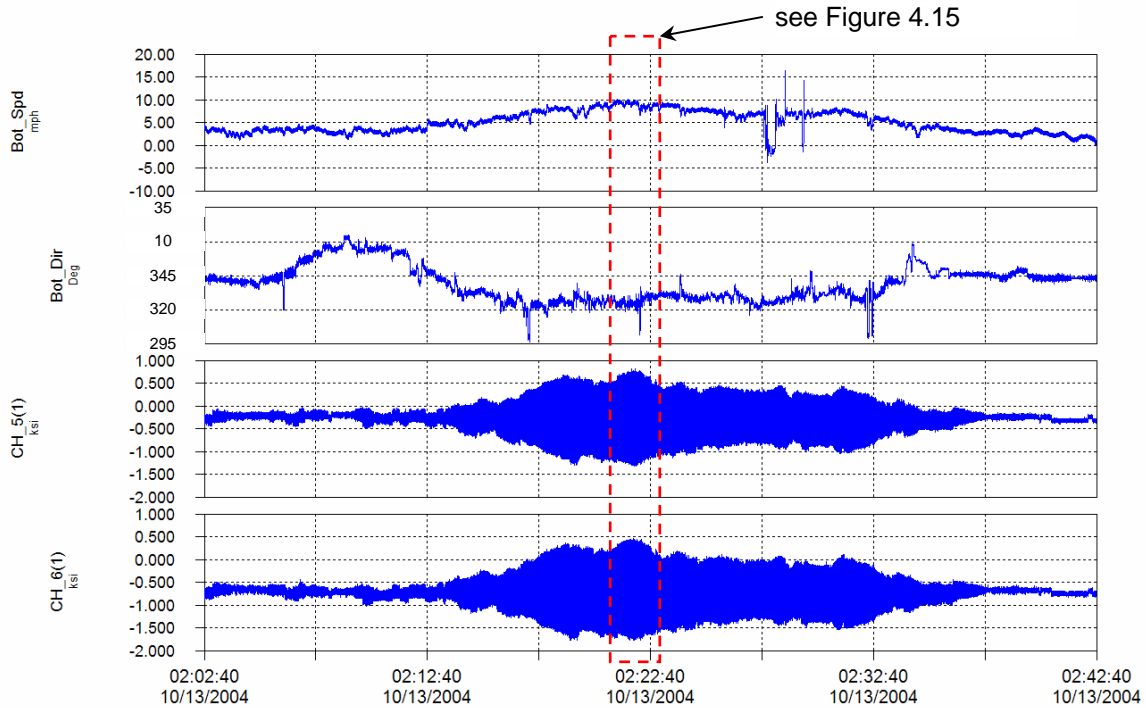
Figure 4.14 – Example of vortex shedding occurring in the second vibration mode (frequency = 1.32 Hz) showing response of strain gages CH\_5 and CH\_6

In this section the wind phenomena of vortex shedding will be examined. Good examples of vortex shedding were recorded at the Retrofit tower. Such an example is presented in Figure 4.14. Shown in the Figure is a segment of time equal to 30 minutes recorded on October 13, 2004. Four data traces are shown in the Figure, namely wind speed at the 33 foot elevation, wind direction (corrected to represent compass directions), strain gage CH\_5, and strain gage CH\_6. These strain gages are located on opposite sides of the tower on the tower just above the retrofit jacket. A zoomed-in segment of data indicated by the dashed box, is shown in Figure 4.15.

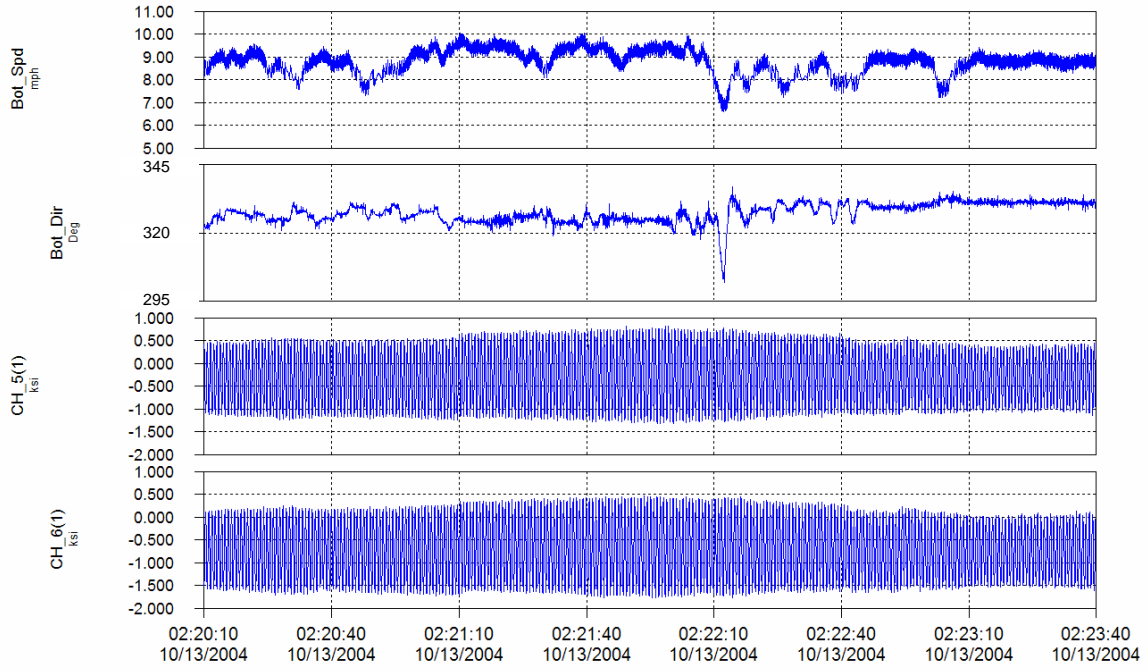
Figure 4.15 – Detail plot of vortex shedding occurring in the second vibration mode (frequency = 1.32 Hz) showing response of strain gages CH\_5 and CH\_6

Though this stress is not excessively high, there are approximately 1300 stress cycles caused by this single event. It has been found that the 2nd mode vortex shedding is most common at these towers, but that the measured stress range is low. However, due to the fact that the socket connection at the base has poor fatigue resistance (the CAFL

may be less than 2.3 ksi for  $E'$ ), vortex shedding has the potential to cause a large number of damage-causing cycles.
