Report on  
Evaluation of Interstate 80 Sign Truss

**Office of Bridges and Structures  
The Iowa Department of Transportation**

Terry J. Wipf  
Brent M. Phares

September 25, 2002

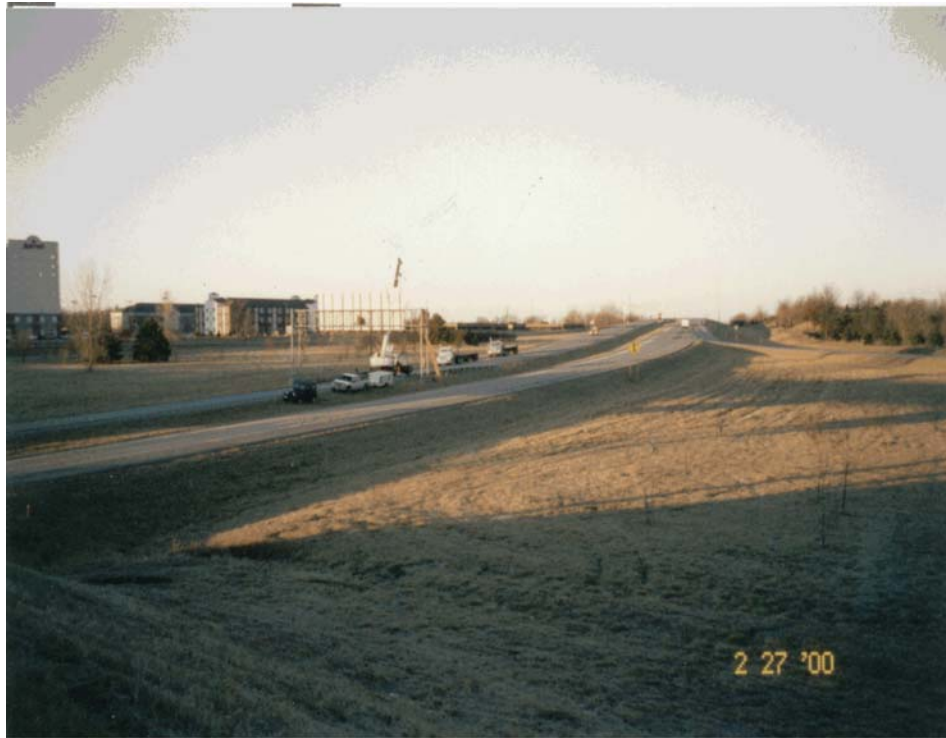
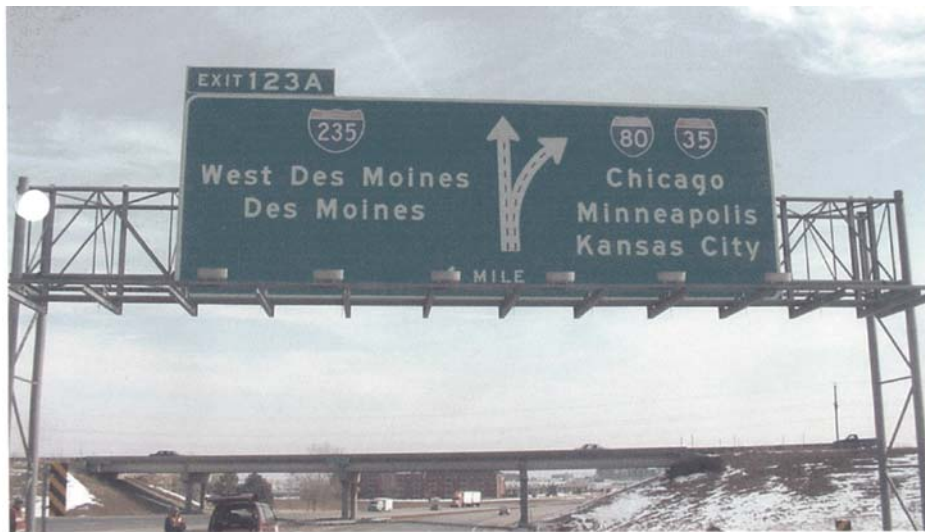
Figure 1. Photographs of Sign Truss before Removal.

The truss is a galvanized steel, four chord truss with a span of approximately 60 ft and carries a single 14 ft x 40 ft sign and associated lighting as shown in Fig. 1. Figure 2 shows a photograph of the deterioration of one of the bottom chord members near mid span.

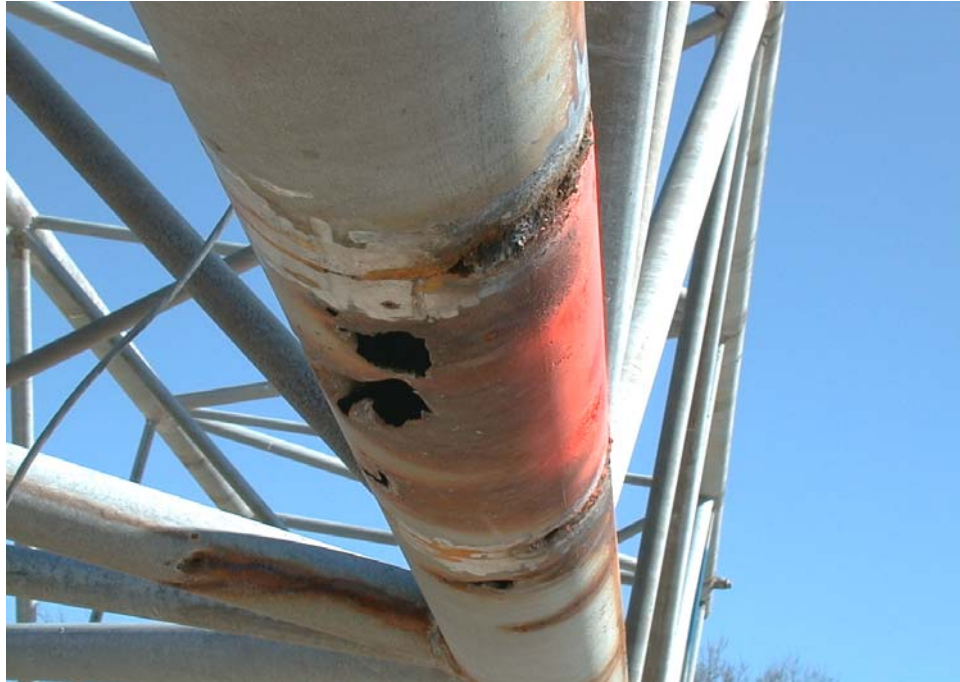
Figure 2. Deterioration of Bottom Chord Member of the Truss

A sign support truss over eastbound I-80 about 2 miles west of the west I-35/I-80/I-235 interchange near Des Moines, IA was removed in the spring of 2000. A routine inspection of the truss found that one of the bottom chord members was severely deteriorated. Corrosion of the bottom chord has caused significant thickness loss of cross section area of many members. This deterioration led to a concern about the structural adequacy of the truss.

The investigated truss had a badly corroded bottom chord member located at mid span. Many other members were also corroded. This damage likely affects the performance of the truss. However, the experimental tests and an analytical investigation indicated that the truss did not need to be removed due to potential structural inadequacy. It was found that the truss has redundant load paths that allow redistribution of the loads. Due to this load path redundancy, if one or more members were to fail due to corrosion or other means (e.g., over height vehicle impact, etc.), the load will likely be redistributed to other members. From these tests, it was found that after load redistribution, the strain levels in other members were still below the yield strain of steel. It appears that for the subject truss, it may have been sufficient to simply repair the corroded member. However, in general, the extent of corrosion damage must to be accurately assessed. The structural performance of the damaged structure can then be evaluated using an analytical model similar to the one discussed herein.

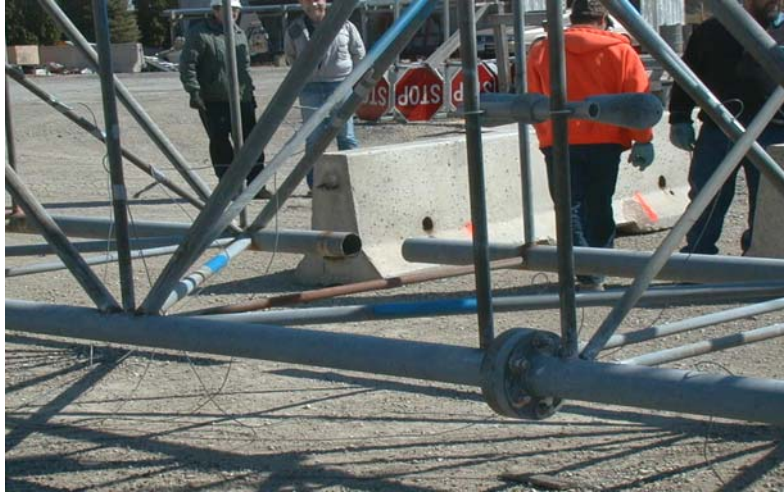
Figure 4. Sign Truss after Cutting the Bottom Chord Member.

The first tests conducted were intended to assess the structural behavior of the undamaged and damaged truss with a specific interest in structural redundancy. These tests were conducted in March 2000. Figure 4 shows a photograph of the truss after cutting the bottom chord member. The second set of tests were conducted in April 2000. These test were intended to assess the impact of removing other critical members from the truss. The second set of tests covered several cases. Each case involved removing additional truss members at critical locations. The results of this series of tests are not presented herein but further reified the conclusions developed from the tests conducted in March, 2000.

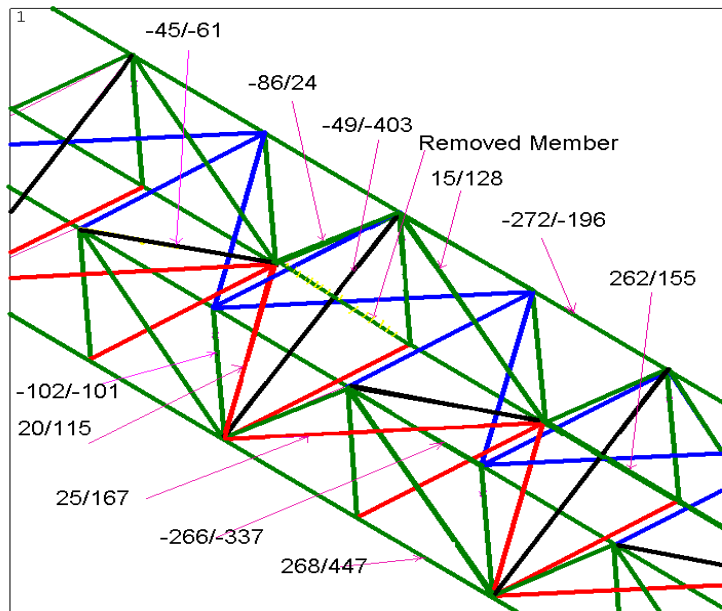
Figure 8. Analytical Element Axial Strains Undamaged/Damaged.

The model was analyzed for both test cases (i.e., undamaged and damaged {element 29 in the model}). The maximum deflection before removing the cut member was found to be 0.59 in.; after removal the deflection was 0.87 in. For comparison purposes, a simple 2D model of the structure was developed and analyzed. The results of the 2D model were found to be very close to those of the 3D model for the undamaged truss. This means that using simple 2D models would be sufficient to assess the overall structural behavior of the truss. However, it was found that a 2D model would not accurately predict the behavior of the damaged truss. The 3D analysis strain results are summarized in Table 2. Figure 8 shows the results for members in the vicinity of the removed member.

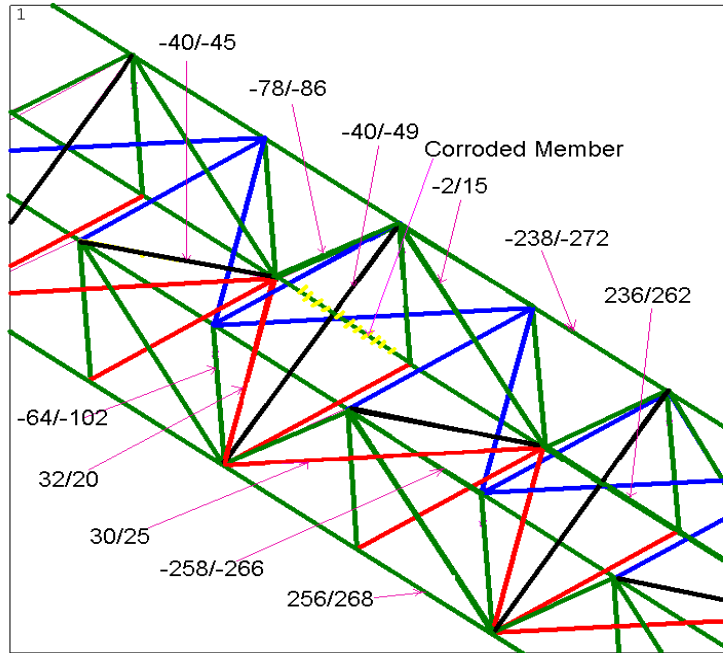
Figure 9. Experimental and Analytical Results for Undamaged Truss.

One objective of this project was to develop an analytical model that accurately represents the structural behavior of trusses so that the performance can be evaluated. To accomplish this, the results of the developed analytical model were validated using strain measurements from the load tests. Table 3 shows the experimental and analytical results before and after the bottom chord element cut. Figures 9 and 10 show the results in the vicinity of the cut member.

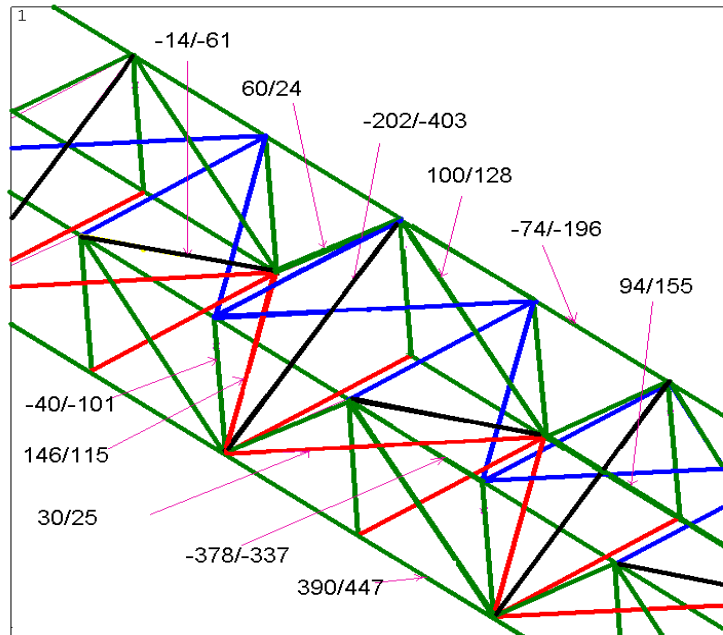
Figure 10. Experimental and Analytical Results for Damaged Truss

After the deteriorated member was cut (damaged condition), part of the load carried by the south truss near the removed member was transferred to the north truss by axial forces in the out of plane diagonals. This redistribution of load was evident from both the experimental and the analytical results. These results indicate a significant load redistribution property of the truss due to the highly redundant load paths in the structure.
