US 34 SUPER TWO PLANNING STUDY

Clarke, Lucas, and Monroe Counties

Existing Conditions Memorandum

Location and Environment Bureau | October 2023

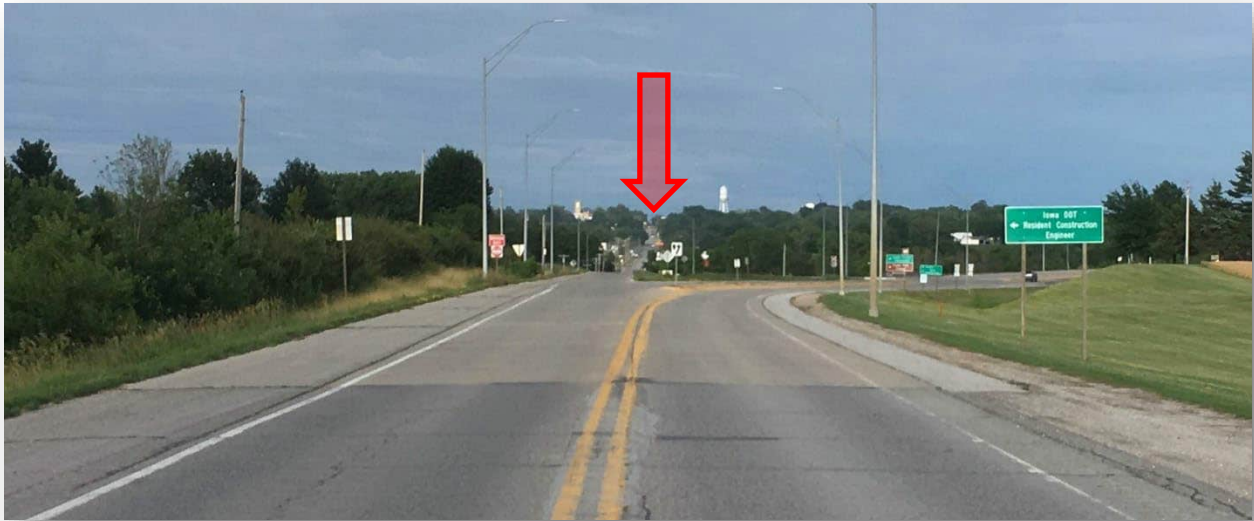
Figure 4. Visual Trap at a Horizontal Roadway Curve

A review of aerial photography and observations during the onsite field review identified one location (Table 4 and Figure 4) along the Study corridor where a visual trap may be present. Existing highway lighting exists through the curve, mitigating the risk of an approaching driver missing the curve in the roadway. No traffic signs or devices are currently in place to identify the roadway curve.

Local sideroad at Court Avenue creates the appearance that the roadway continues straight.

Single-vehicle crashes have occurred at the horizontal curve location noted in Table 4. Crash data from the Study are not conclusive of the degree to which, if any, the potential visual trap contributed to the individual crash events. The *US 34 Super Two Study: Existing Crash and Safety Performance Report* provides additional details regarding the Study’s crash data analysis (Jacobs, 2022).

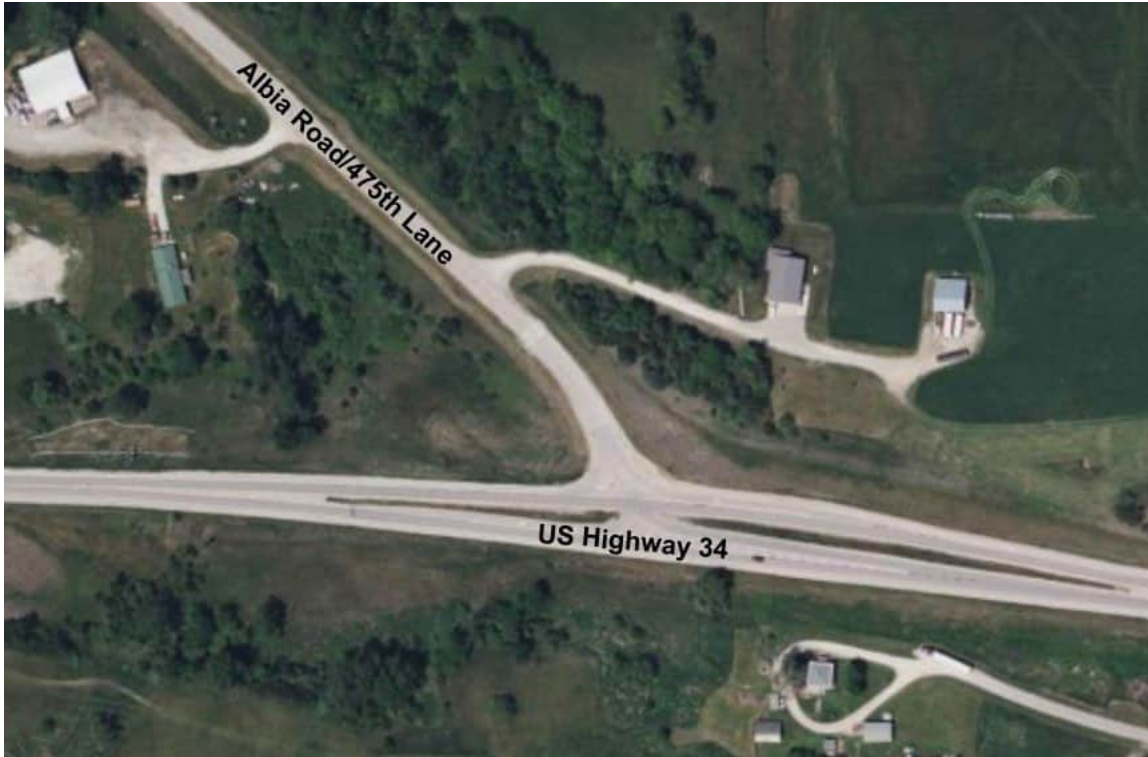
Figure 8. Example of Intersection Skew

Most of the intersections within the Study corridor have intersecting roadways that are nearly perpendicular (90 degrees) to each other. However, there is one intersection in the Study area that has a skew angle less than 60 degrees. Albia Road/475th Lane approaches US 34 at a 56-degree skew as shown on Figure 8. There is no notable crash history at this intersection.
