FINAL REPORT

LEXAN GATE ARM

EXPERIMENTAL PROJECT

IA - 86 - 09

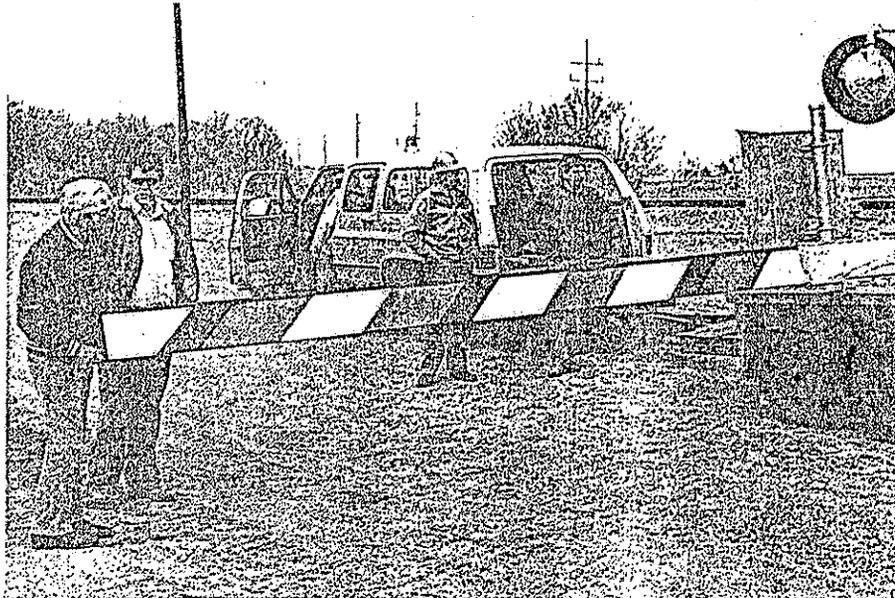
On April 18, 1986, the Department observed a test of the material under field conditions with the Transportation Company. The gate received four mid-center strikes at 5 MPH by a company truck while in the lowered position, and showed no damage. In a fifth mid-center strike at 15 MPH, the gate was visibly damaged at the connection to its raising mechanism, but continued to function though at a 5-10 degree drop. Several pictures of the gate and its saddle mechanism are shown in Appendix A of this report.

Lexan Gate Arm at 4/18/86 CNW Demonstration
