AN EVALUATION OF AN

EPOXY PAVEMENT MARKING SYSTEM

NOVEMBER 1978

IOWA HIGHWAY RESEARCH BOARD
FINAL REPORT HR-180

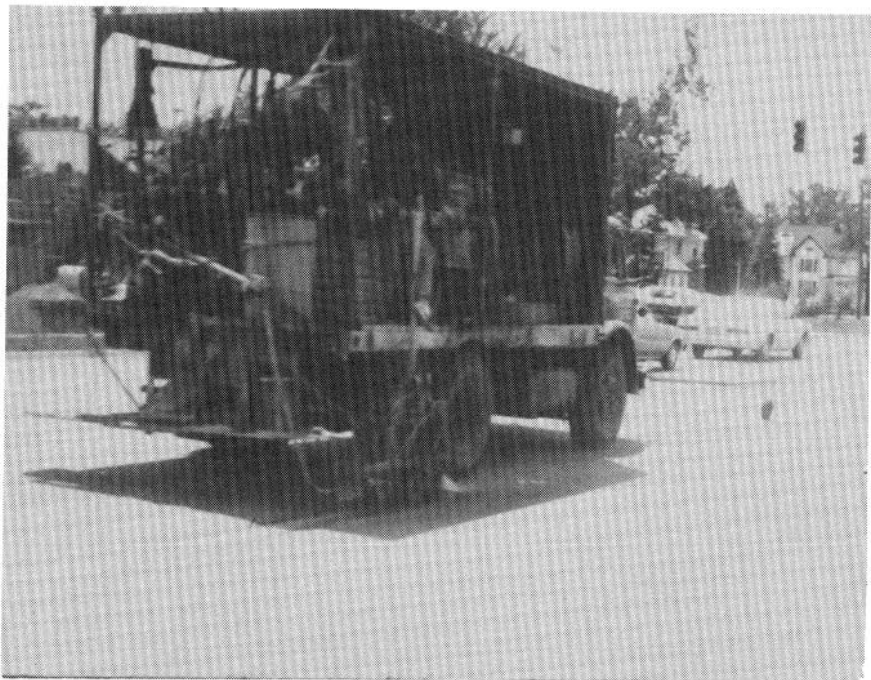
During the painting of the lane line from the University Avenue entrance ramp to the Des Moines River bridge near Second Avenue, the material solidified in the gun and a hose, consequently only one component was delivered to the pavement. The portion of the line from the East Fifteenth Street overpass to the river bridge immediately turned black. The black material did not harden immediately and was tracked over the pavement surface by traffic.

The H. B. Fuller Company representative said that several days would be required to remove the material from the gun and to rebuild the equipment, therefore, no more epoxy paint was applied. The remaining areas intended to be painted with epoxy paint were painted by the Iowa DOT with standard traffic paint.

Figure 2: Truck and equipment for applying epoxy paint lines

The original test application was not completed because of equipment failure. It is recommended that further research be conducted using updated equipment for surface cleaning and epoxy paint application.
