SPECIAL PROVISIONS FOR ASBESTOS ABATEMENT

Asbestos and Hazardous Materials Survey Report - Revised

Iowa City Gateway Project North Dubuque Street, Park Road, and Park Road Bridge Iowa City, Iowa

> December 8, 2015 Terracon Project No.06157085

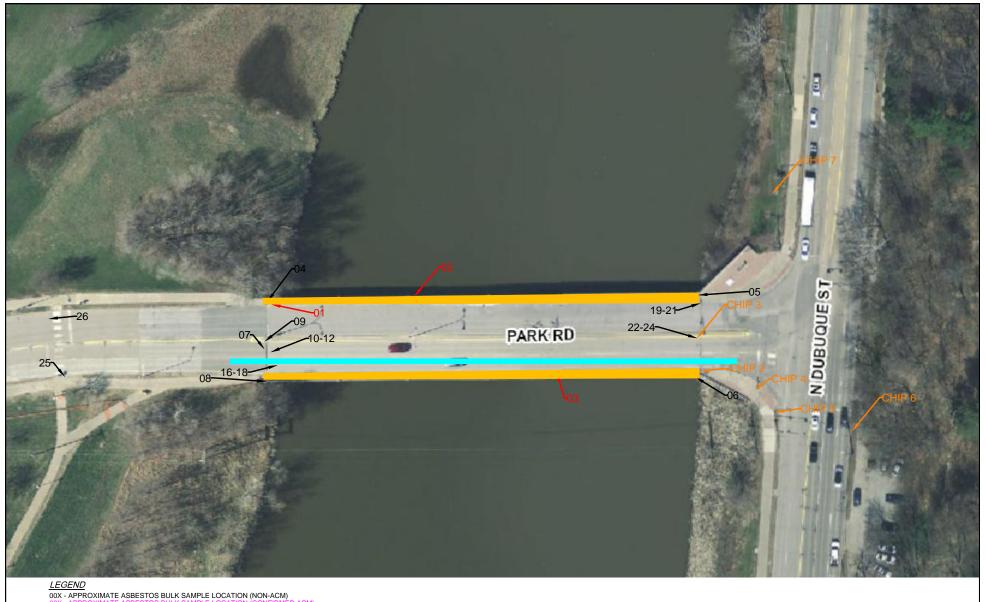
PARK ROAD/BRIDGE SAMPLE LOCATION DIAGRAM
SURVEY REPORT
CITY OF IOWA CITY
GATEWAY PROJECT
IOWA CITY, IOWA

- APPROXIMATE LOCATION OF ASBESTOS CEMENT PIPE
- APPROXIMATE LOCATION OF TRACE ASBESTOS CONTAINING CAULKING ON NEWEL POSTS
CHIP X - APPROXIMATE LOCATION OF PAINT CHIP SAMPLE

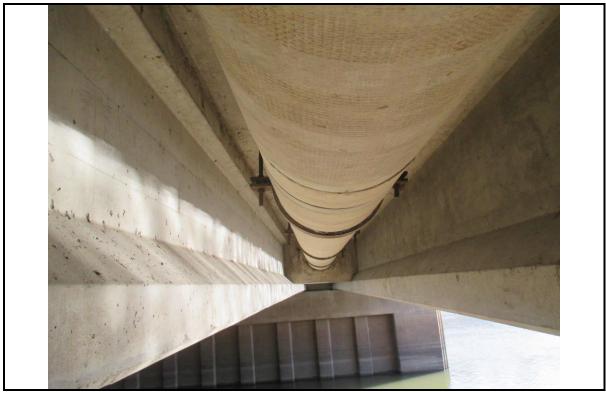
Photo 2: View of asbestos cement pipe under Park Road Bridge, looking east.

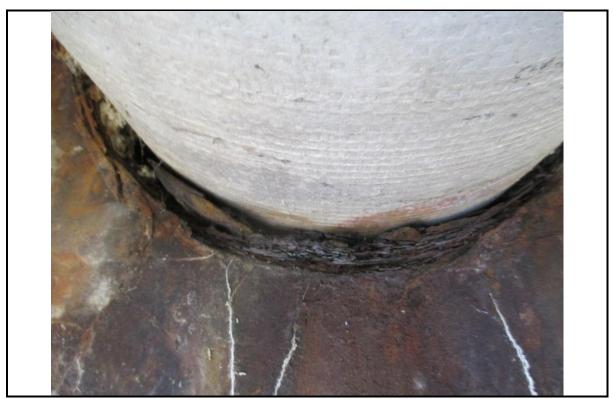
Photo 3: View of asbestos cement pipe as it enters the west abutment.

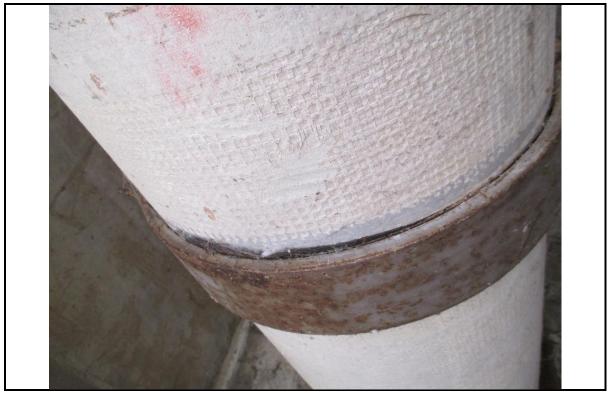
Photo 4: View of asbestos cement pipe hanger.

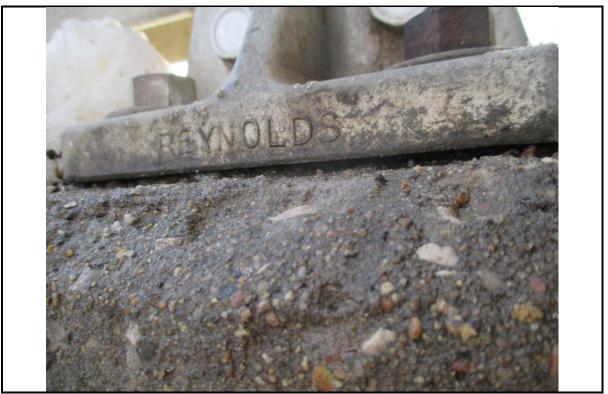
Based on the 400-point count procedure conducted by EMSL, the lab reported asbestos concentrations less than 1% in gray caulking under the guardrail newel posts on the Park Road Bridge. These materials are not considered asbestos-containing according to the USEPA definition; however, portions of OSHA's asbestos standards will be applicable regardless. Contractors should be notified of the presence of asbestos in such materials. It should be noted that general contractors typically have an asbestos exclusion clause under their insurance policy; therefore, they typically are barred from working with materials that contain asbestos, regardless of content. Those materials are identified in Table 2 in Appendix B. Terracon recommends that contract documents clearly define these materials.

Photo 5: Photo showing trace asbestos under the guardrail post on Park Road Bridge.

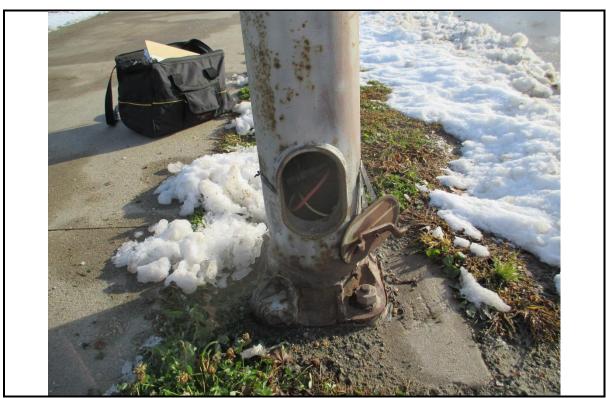
Photo 7: Photo showing chip location #1, and wiring inside of light post.

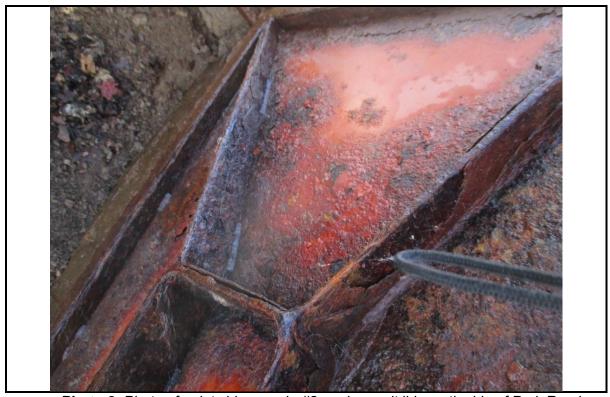
Photo 8: Photo of paint chip sample #2, under vault lid, south side of Park Road Bridge.

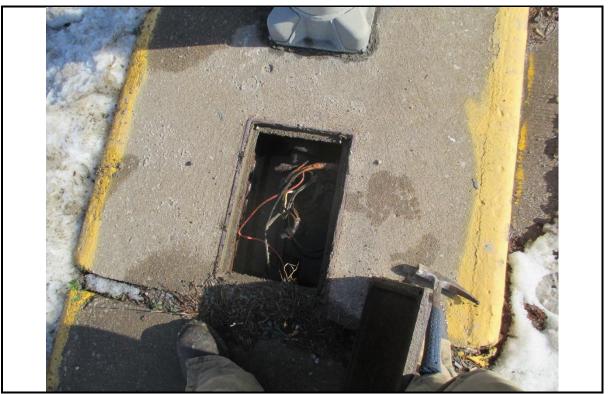
Photo 9: View of chip sample #3, median of Park Road Bridge and asbestos samples 22-24, in vault access.

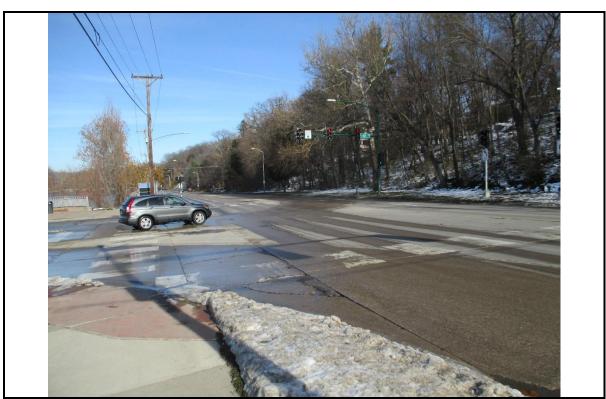
Photo 10: Vie of intersection of Park Road and Dubuque Street, with chip sample on cross walk markings (chip sample 4).

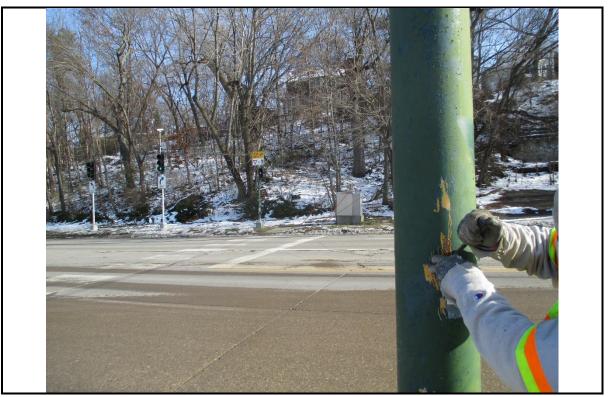
Photo 11: View of chip sample #5 on the traffic control pole, at the intersection of Dubuque Street and Park Road.

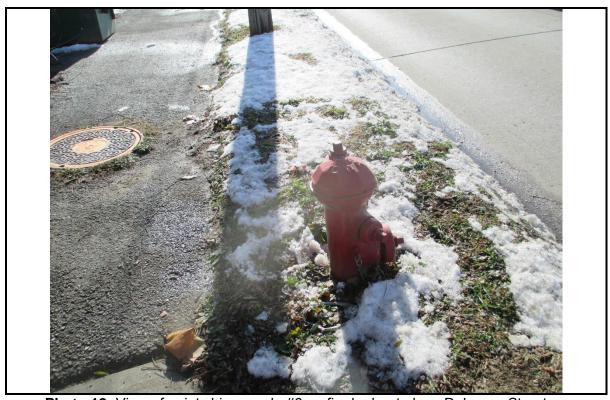
Photo 12: View of paint chip sample #6 on fire hydrant along Dubuque Street.

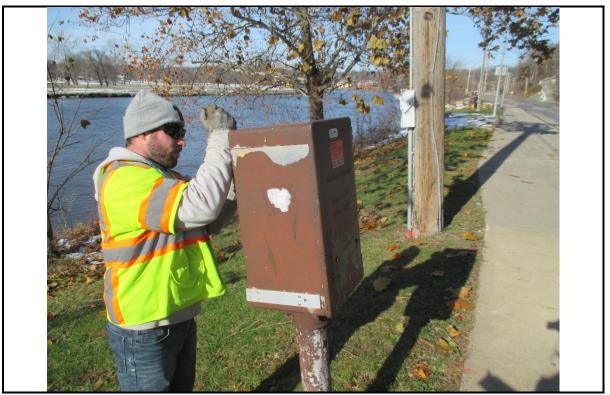
Photo 13: View of traffic control box north of Park Road, along Dubuque Street, chip sample #7.

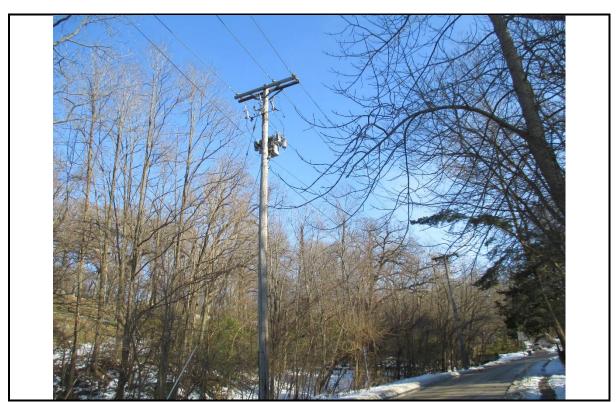
Photo 17: View of pole mounted transformer along Kimball Road.

Terracon was not able to physically assess for PCB containing ballasts in light poles along the right-of-way. We estimated one ballast per light pole/traffic signal light; for the purposes of this survey, the reported number of ballasts should be treated as if all were PCB containing. Pole mounted transformers were identified along the roadway/right-of-way. Subsurface transformer vaults were not readily observed. Typically, the power company is responsible for the removal and disposal of PCB waste generated from transformers.

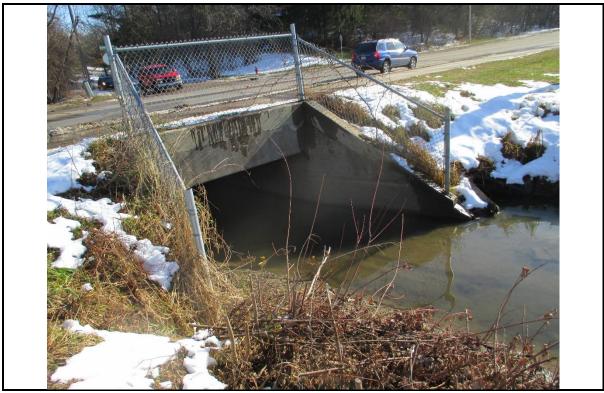
Photo 18: View of culvert east of Kimball Road; asbestos samples 28 and 29.
