Strengthening Steel Girder Bridges with CFRP Plates

T. J. Wipf B. M. Phares
F. W. Klaiber Y. S. Lee

*Bridge Engineering Center
Iowa State University*

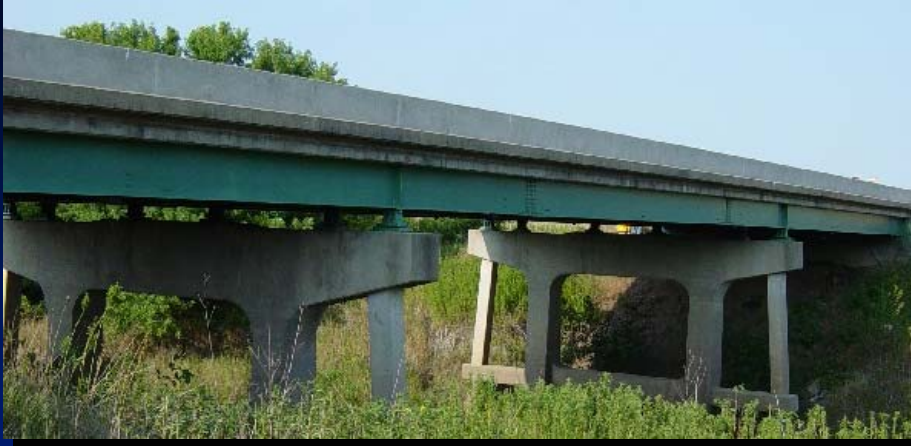
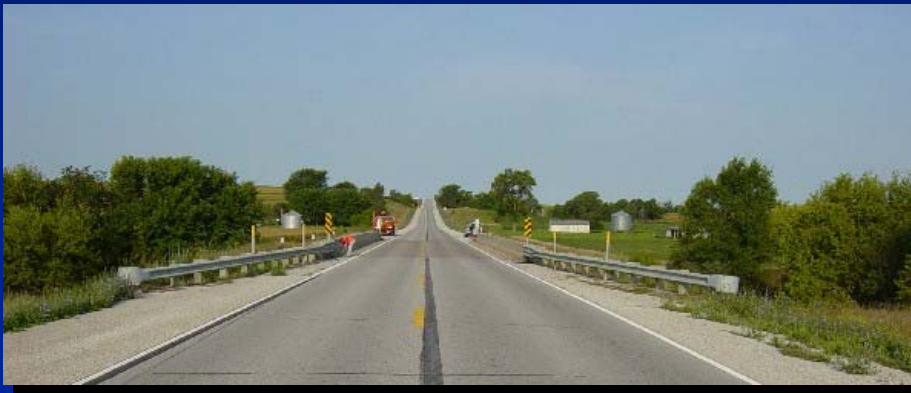
- Located in Pottawattamie County, IA on State Highway IA 92
- Three-span continuous steel girder bridge
- Roadway width = 30 ft [two traffic lanes]
- Total length = 150 ft
 - Two 45.5 ft end spans and a 59 ft center span

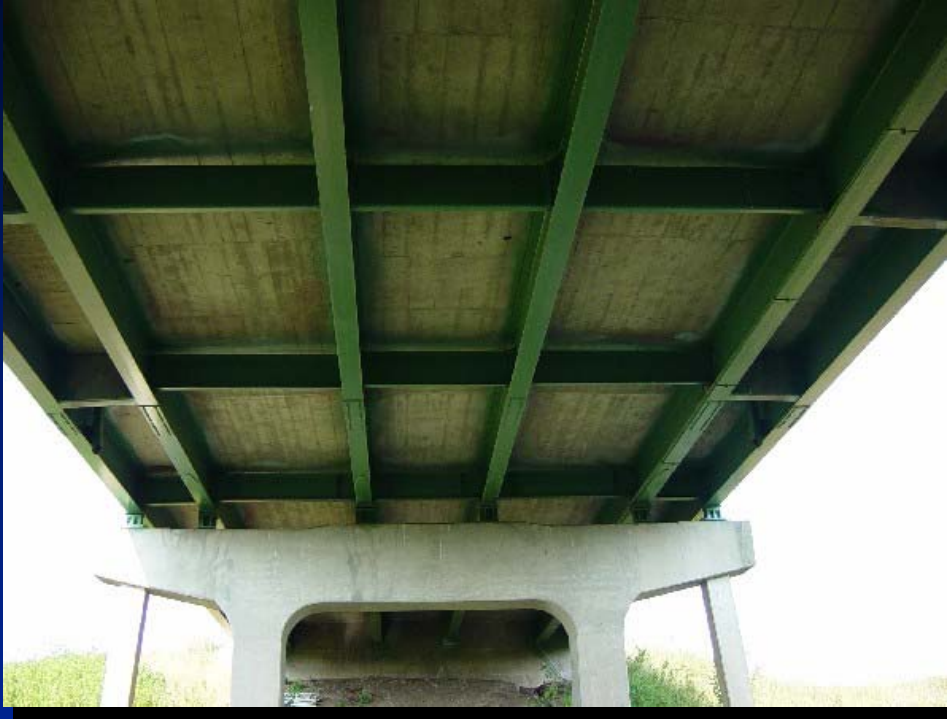
- Constructed in 1938, the bridge was originally non-composite
- In 1967, it was widened by adding two composite exterior girders

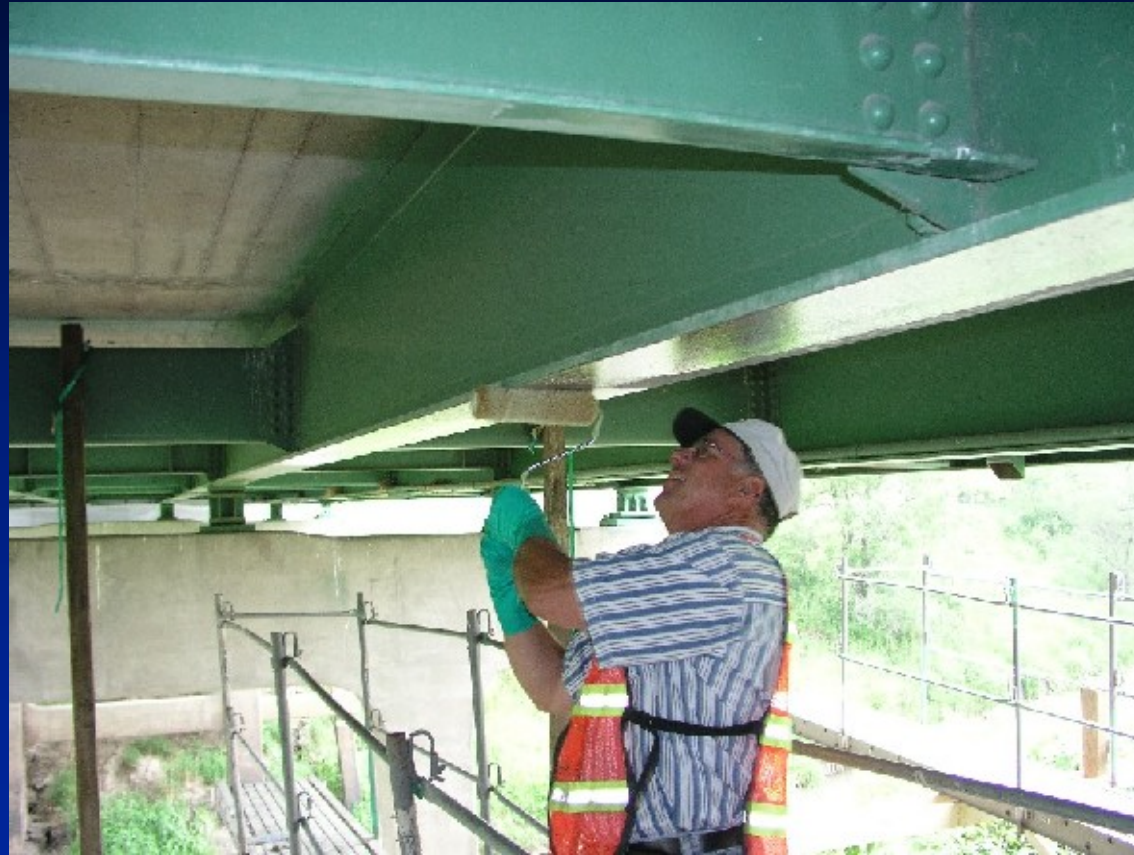
Installation of FRS Primer

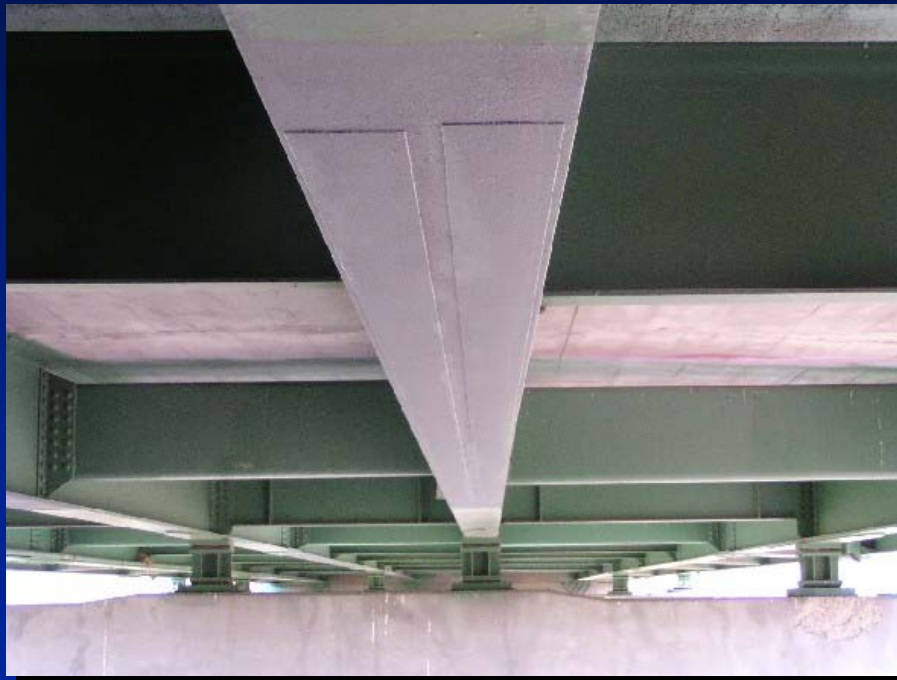
One layer (West end span)

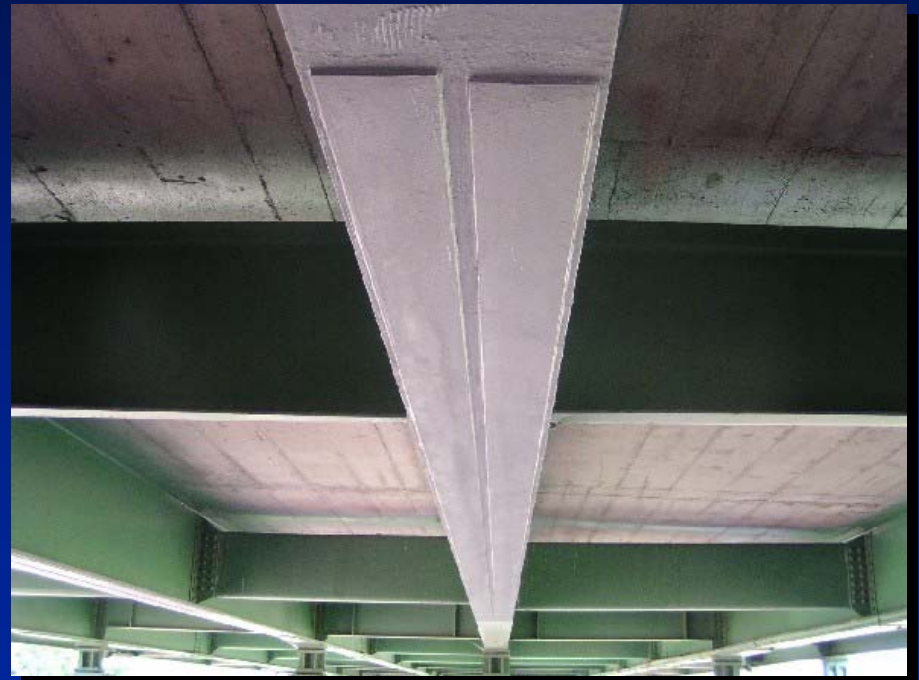
Three layers (East end span)

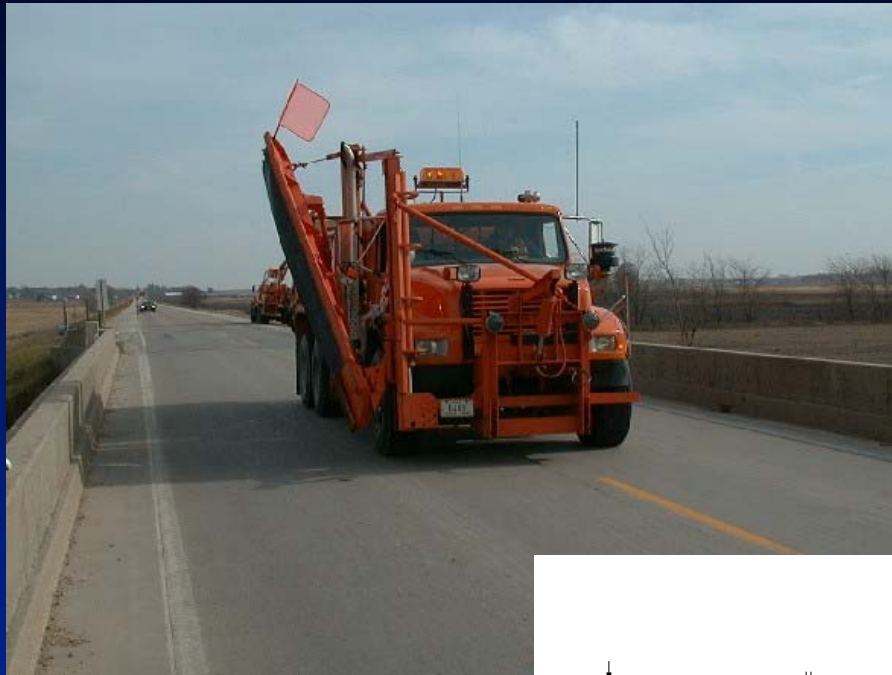
- Half of bridge was instrumented
- 3-axle truck used in three different load paths
- Data collected continuously as truck crossed the bridge
- Initial test and two follow-up tests completed to date

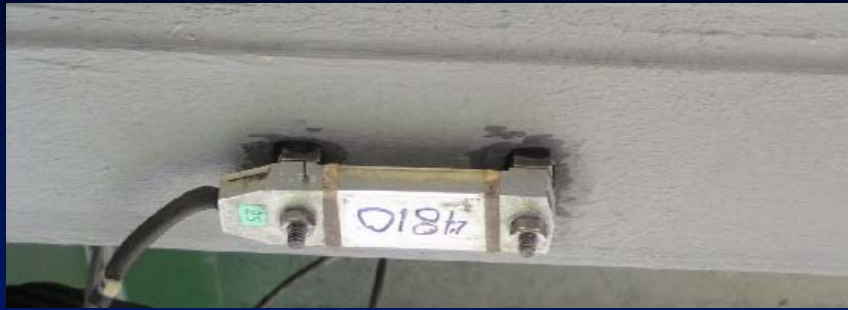
Bond Performance

$$\epsilon_{EXT} = \frac{(\epsilon_T + \epsilon_{TB}) * h_{CFRP}}{h_{web}} - \epsilon_T$$

- Critical to have adequate bond for force transfer
- Gages installed on CFRP plate to investigate the bond performance
- Analytical model developed based on strain compatibility relation
- Extreme fiber strains were predicted and compared with experimental data
