Testing and Evaluation of an FRP Temporary Bypass Bridge

Travis K. Hosteng
Bridge Engineering Center, Iowa State University

FRP Temporary Bypass Bridge

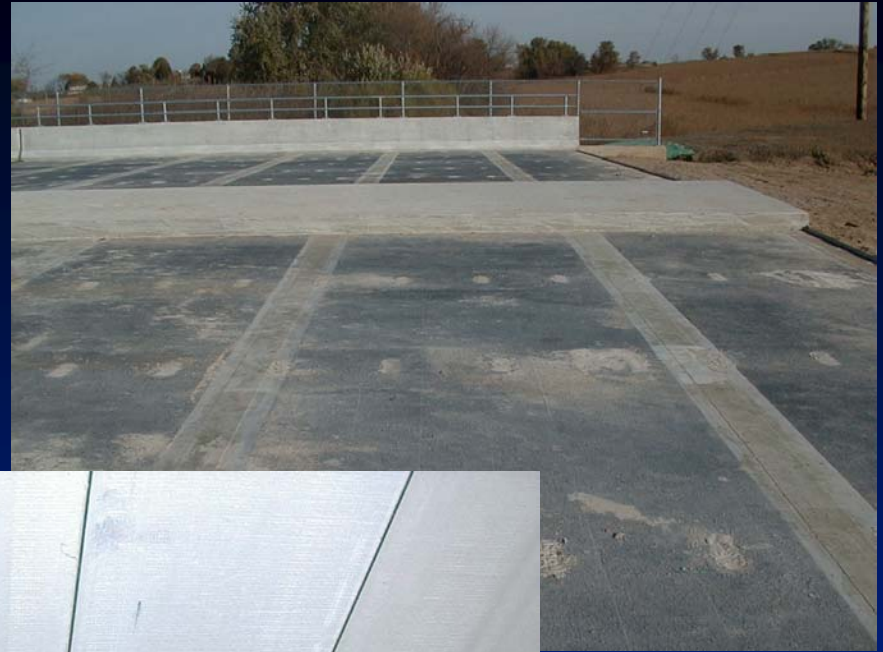
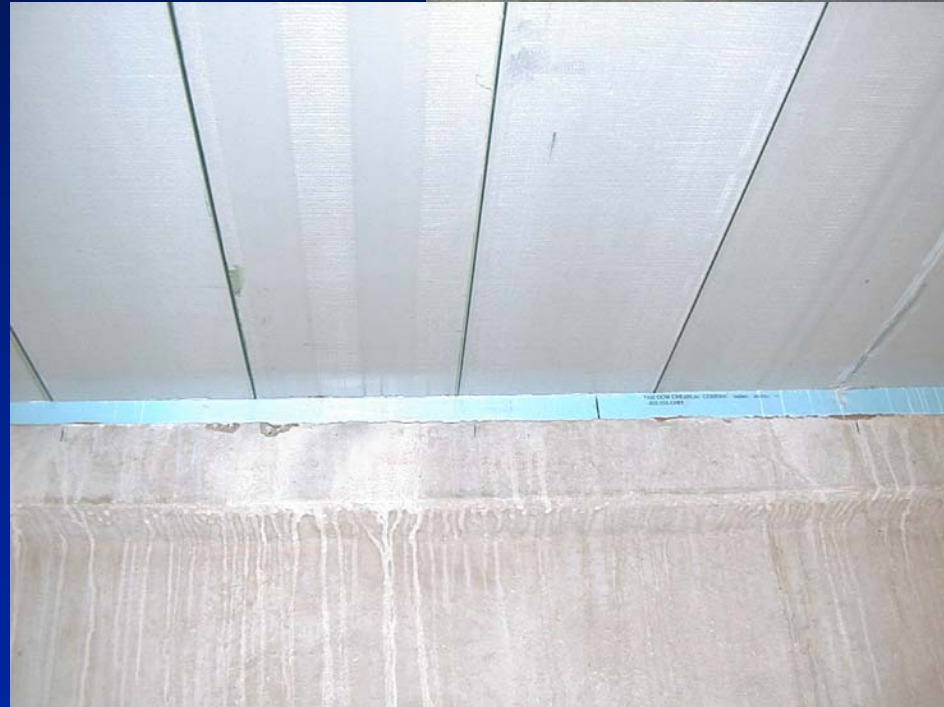
- Deck on girder
- Deck slab

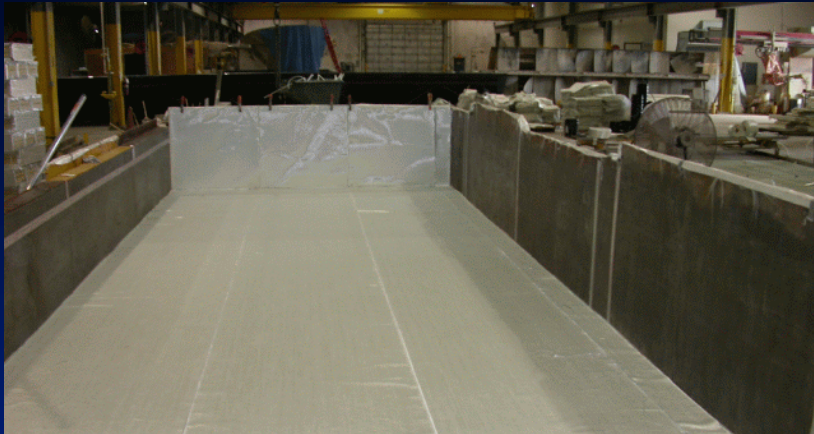
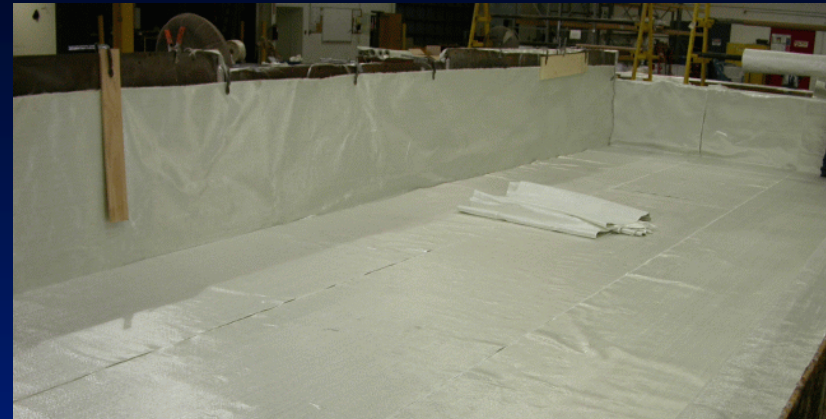
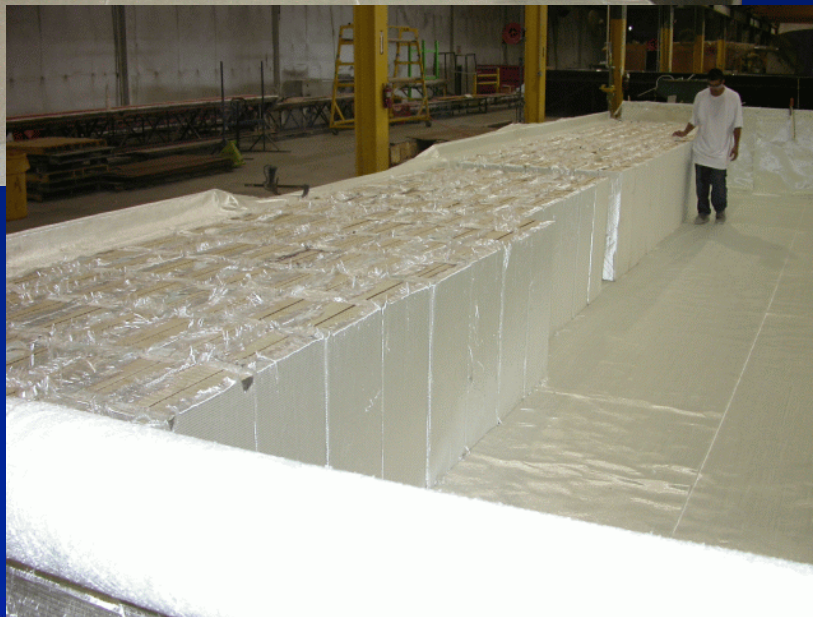
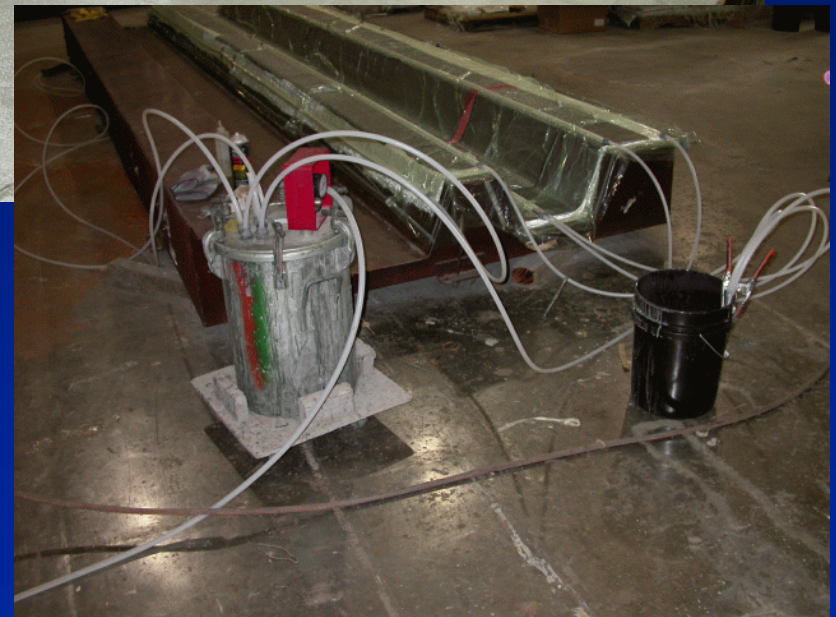
FRP Deck Slab Bridge - Fabrication

- FRP Temporary Bypass Bridge
 - Two sections, connected with steel plate
 - Each section composed of:
 - 600 8in. x 16in. x 36in. Foam bottles
 - Stitch bonded TV3400 FRP (bottle wraps)
 - Stitch bonded QM6408 FRP (exterior plies)
 - Vacuum Assisted Resin Transfer Molding (VARTM)
 - Vinyl Ester Resin
 - 3/8 in. epoxy wearing surface
 - ~35% lighter than current steel bypass bridge
 - Corrosion Resistant
