**Evaluation of Corrosion
Resistant Steel Reinforcing in
the Deck Slab of a Three-span
Prestressed Concrete Girder
Bridge**

Objective and Scope

Bridge Description

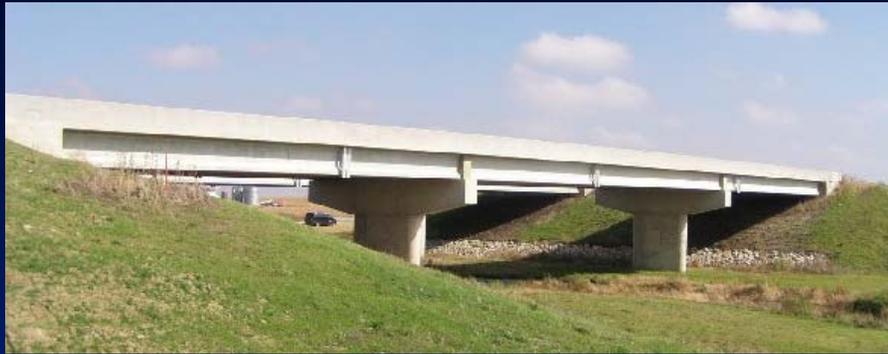
MMFX bridge

- Twin 83.5m x 12m three-span prestressed concrete girder bridges constructed in May 2002, and open to traffic in Aug 2003
- Located in Grundy County, IA carrying relocated Highway U.S. 20
- Each bridge deck constructed with different types of reinforcing steel
 - East bound : MMFX steel (MMFX bridge)
 - West bound: Epoxy coated steel (Epoxy Bridge)

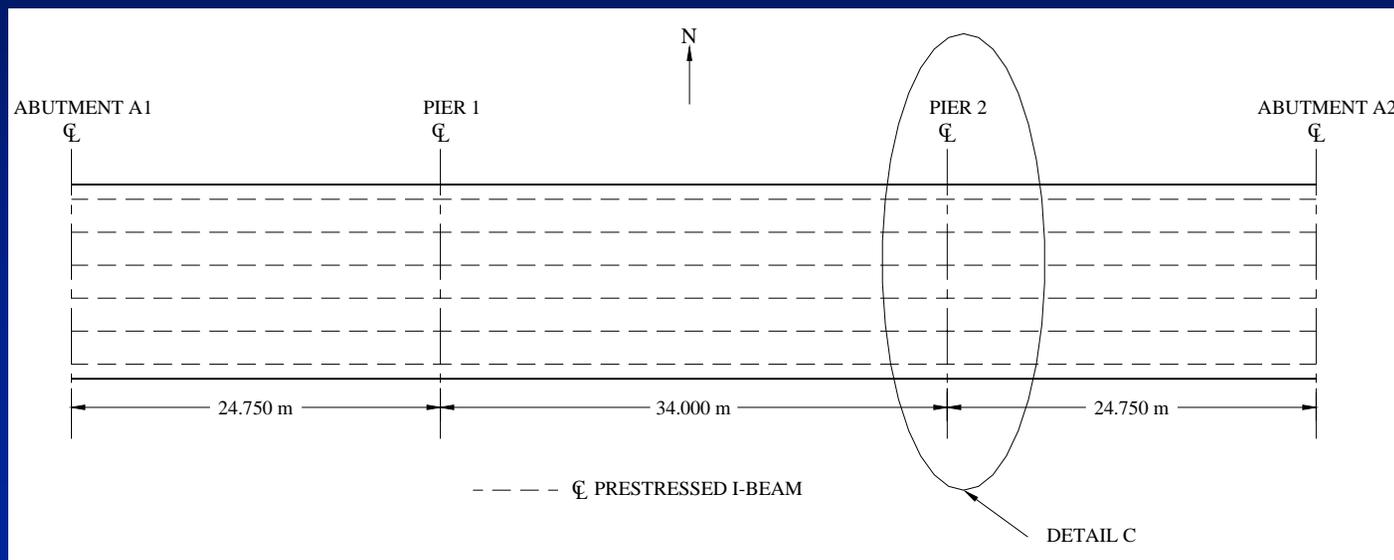
- Sensors on Ten bars in each bridge deck
- Negative bending moment region near the eastern drainage points

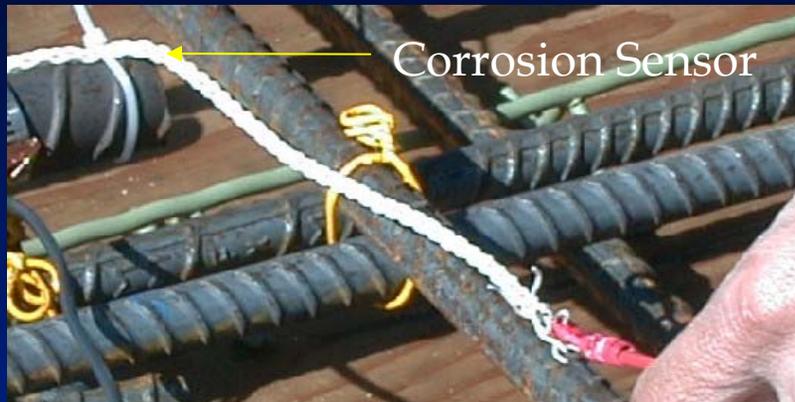
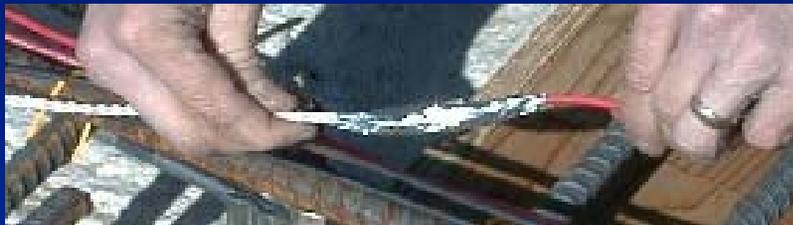
- Lead wires run out of deck to measure voltage and electric current

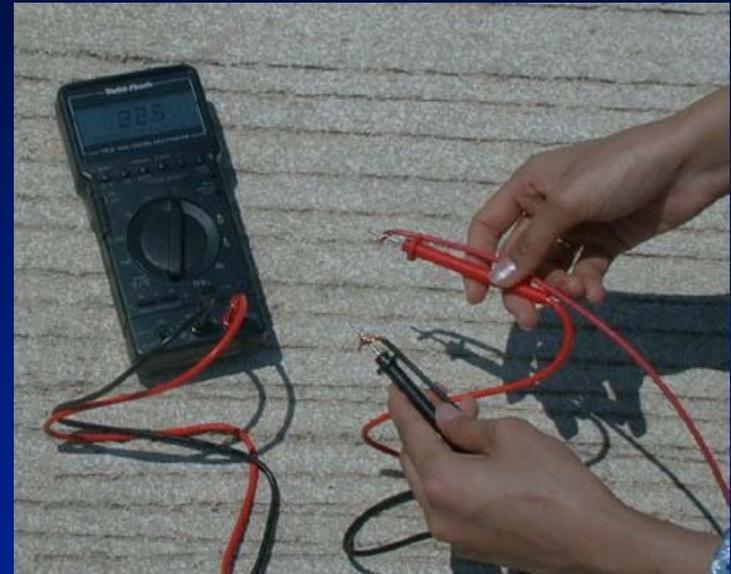
- Increase in electric potential and internal voltage with presence of active corrosion
- DC voltage and DC current measured with a Voltmeter

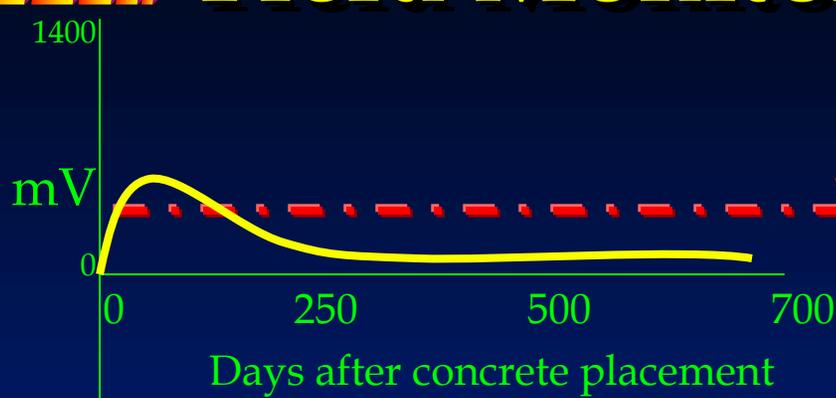
- Output dependent on conditions of concrete after placement
- Normal to expect high voltage levels with fresh and uncured concrete (could be over 1000 mV)
- Initial “spike” subsides back to within the “normal” range of less than 400 mV
- Corrosion indication
 - Electric Current above 0.100 mA (1000 μ A)

- In general, Readings on MMFX bridge lower than Epoxy bridge
- No significant active corrosion
 - Electric Current reading close to zero
- On-going investigation
 - More Data to be collected
