# Summary of Ultra-High Performance Concrete Laboratory Testing

- Confirm adequacy of the Wapello County bridge design
- Investigate flexural behavior
- Investigate shear behavior

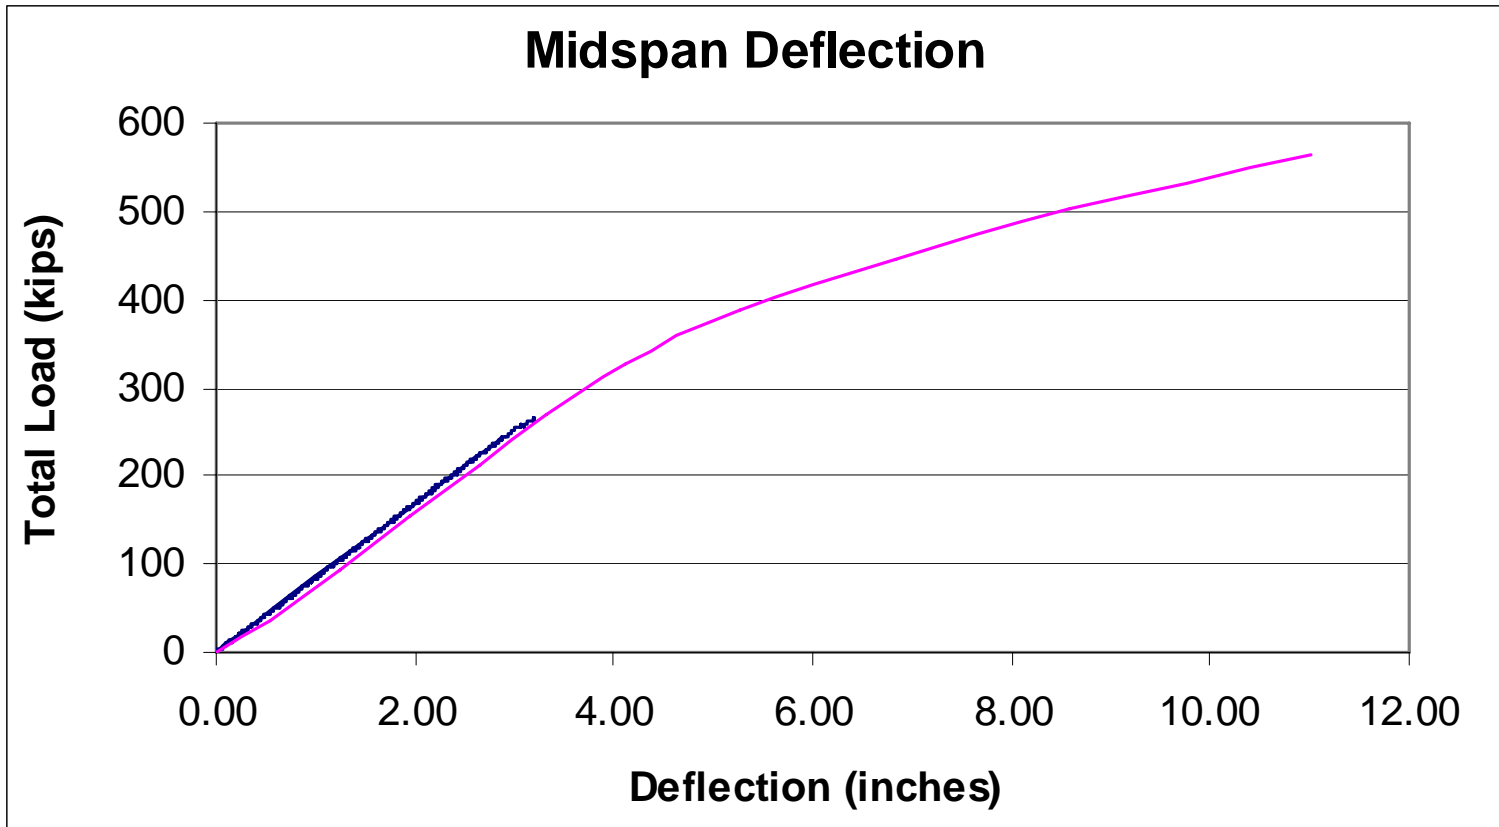
# Deflection

— Experimental      — Analytical

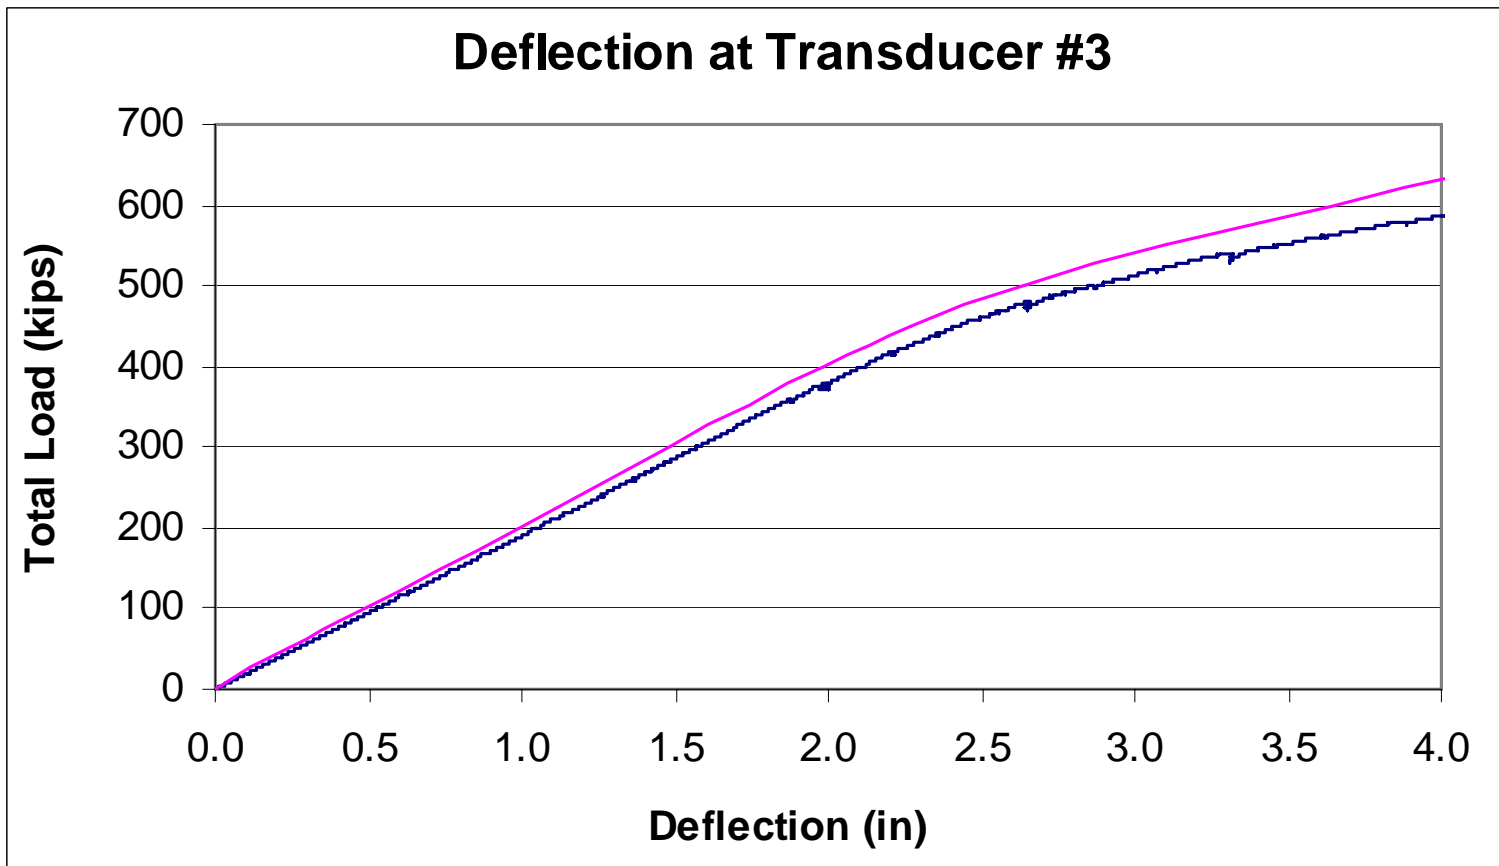
# Deflection

— Experimental      — Analytical

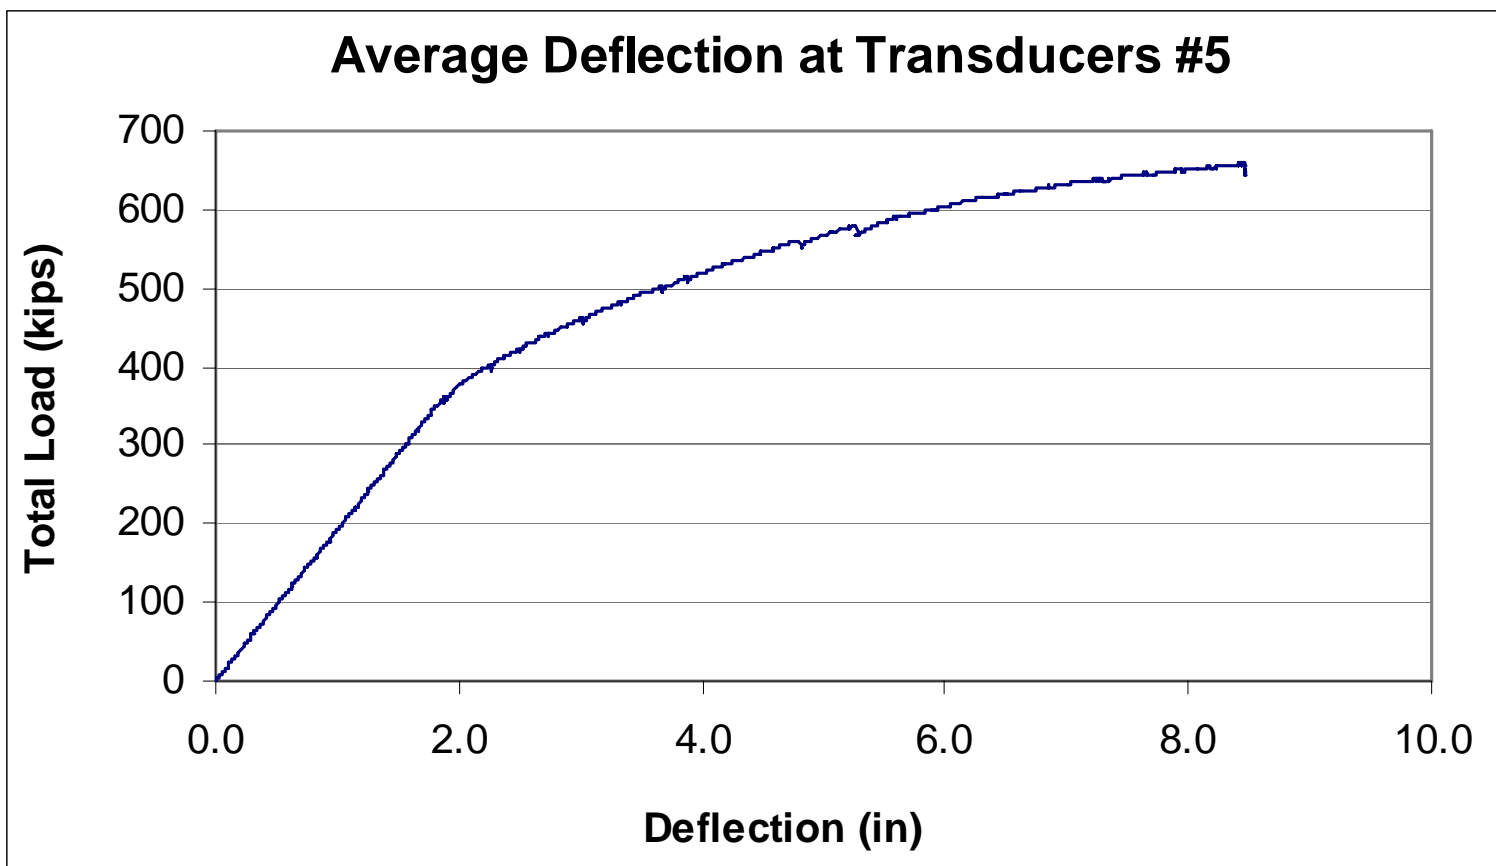
# Deflection

- Still Under Investigation
- Flexural and Shear Cracking Occurred
- Failure did not occur by breaking, rather the load vs. deflection curve became flat.

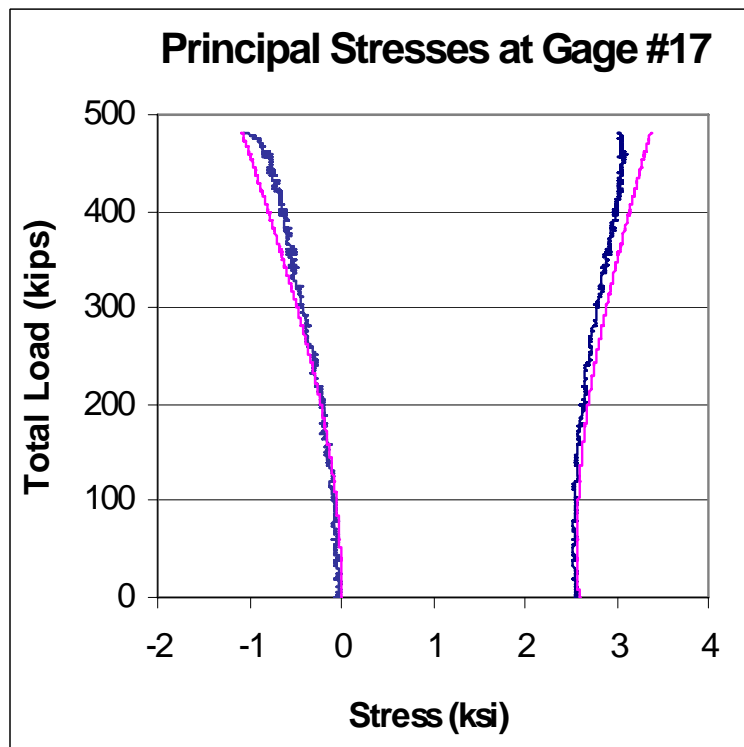
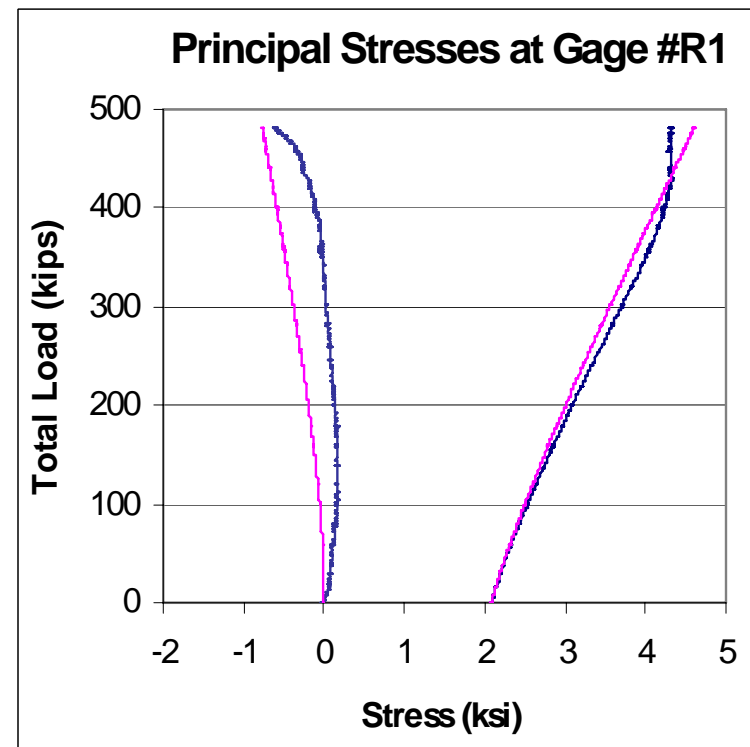
# Principal Stresses

— Experimental      — Analytical
