TABLE OF CONTENTSSUMMARY OF RECENT BRIDGE RESEARCH IN IOWA

PowerPoint Presentation - May 14, 2008 Prepared by: Ahmad Abu-Hawash, PE Chief Structural Engineer - Office of Bridges & Structures Iowa Department of Transportation E-mail: ahmad.abu-hawash@dot.iowa.gov

Summary of Recent Bridge Research in Iowa

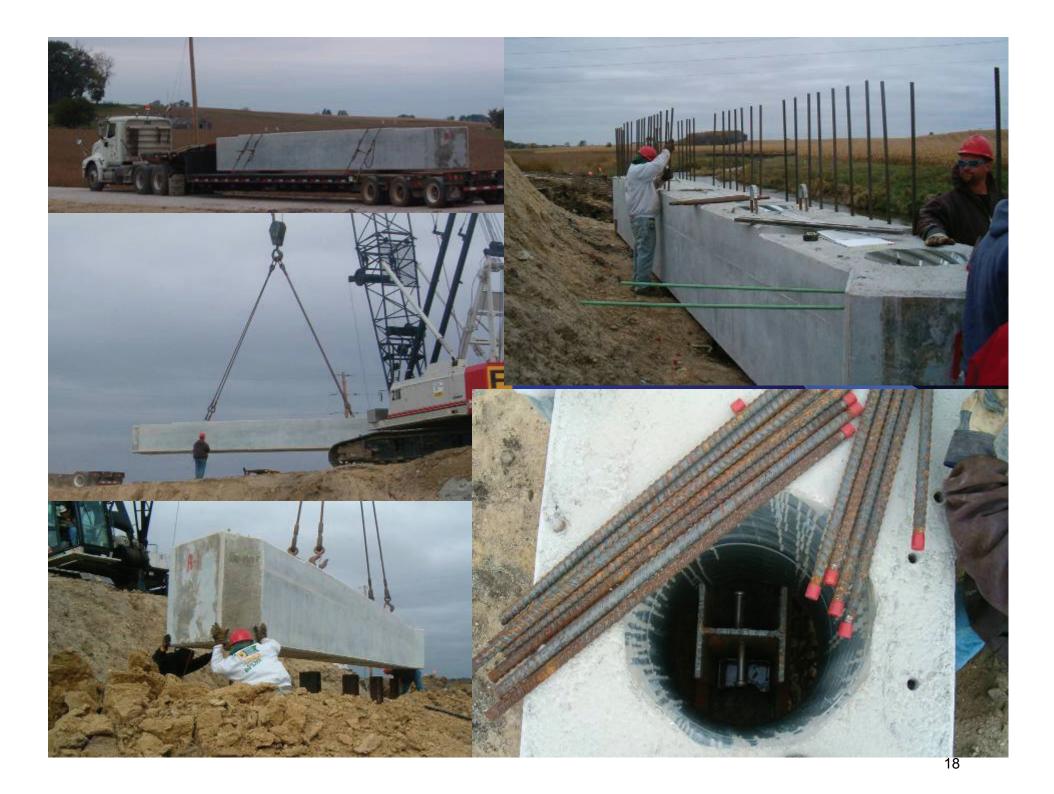
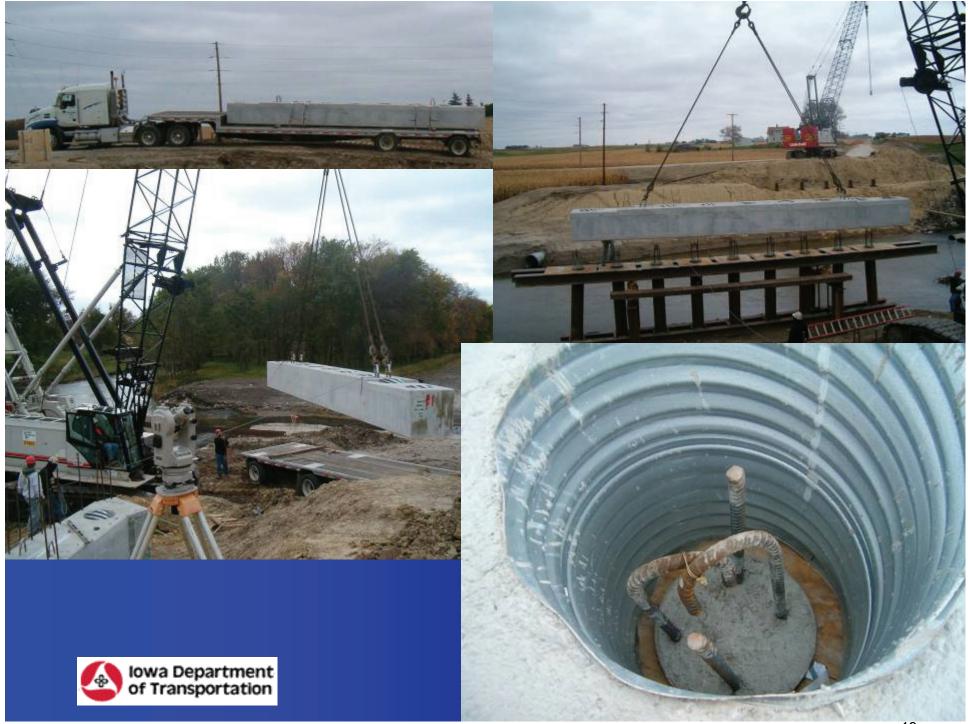
Substructure Construction

Integral AbutmentPrecast Abutment Footing (Pile Cap)

P10A Pier (Pipe Piling)Precast Pier Cap

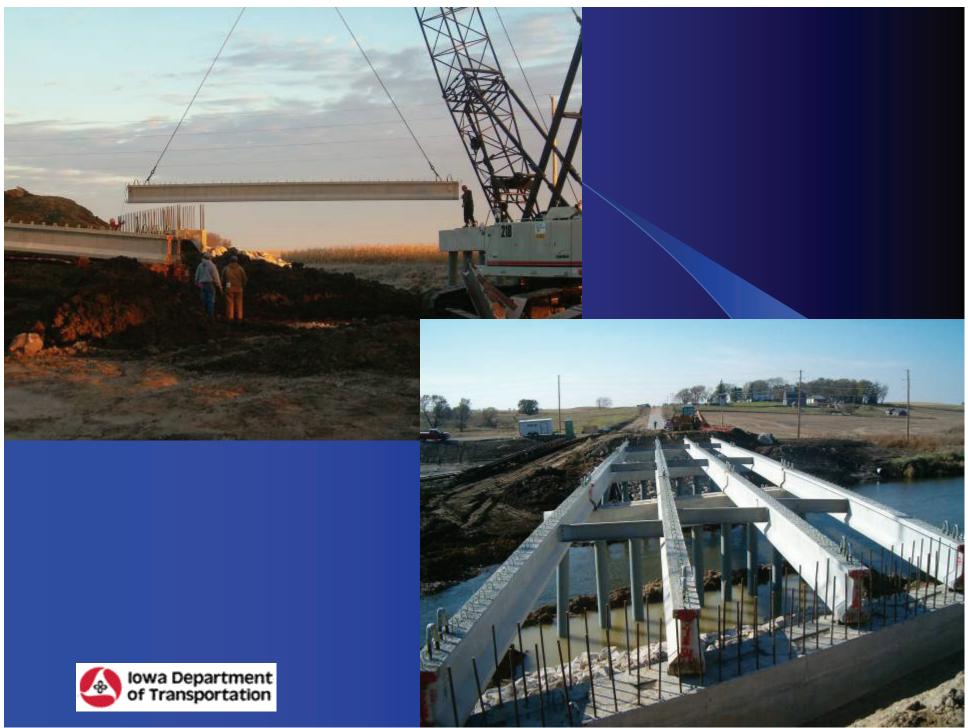
Superstructure Construction Pretensioned Prestressed Concrete Beams Precast Deck Panel Fabrication Deck Construction

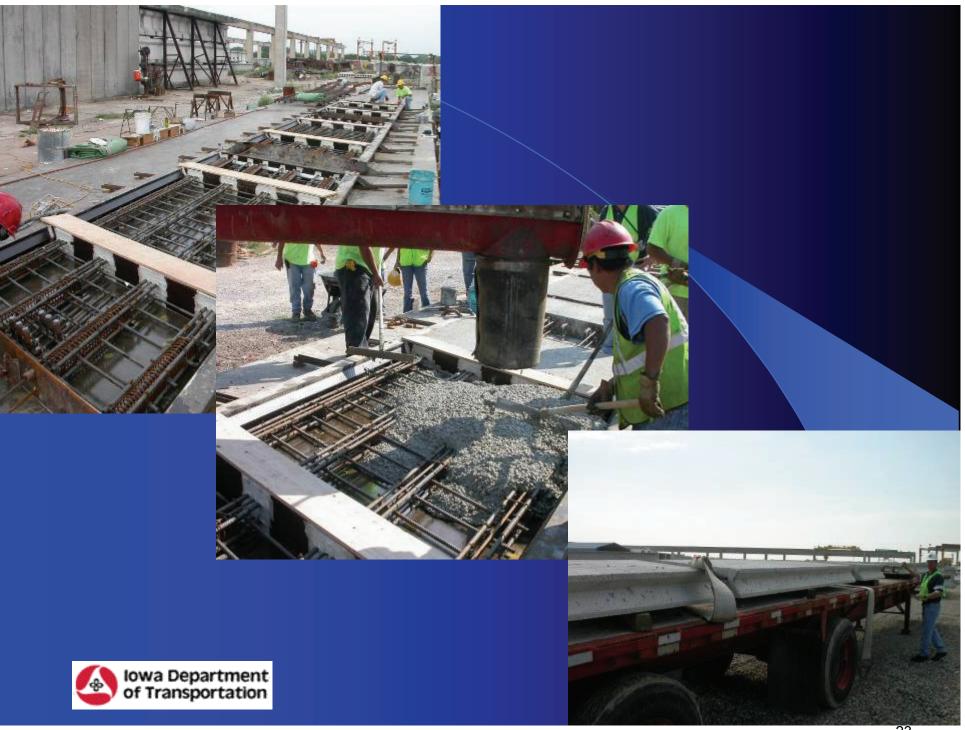
Deck Panel Fabrication

Pretensioned Transversely
Post-tensioned longitudinally
32 Interior deck panels
4 End panels with PT anchorage zones

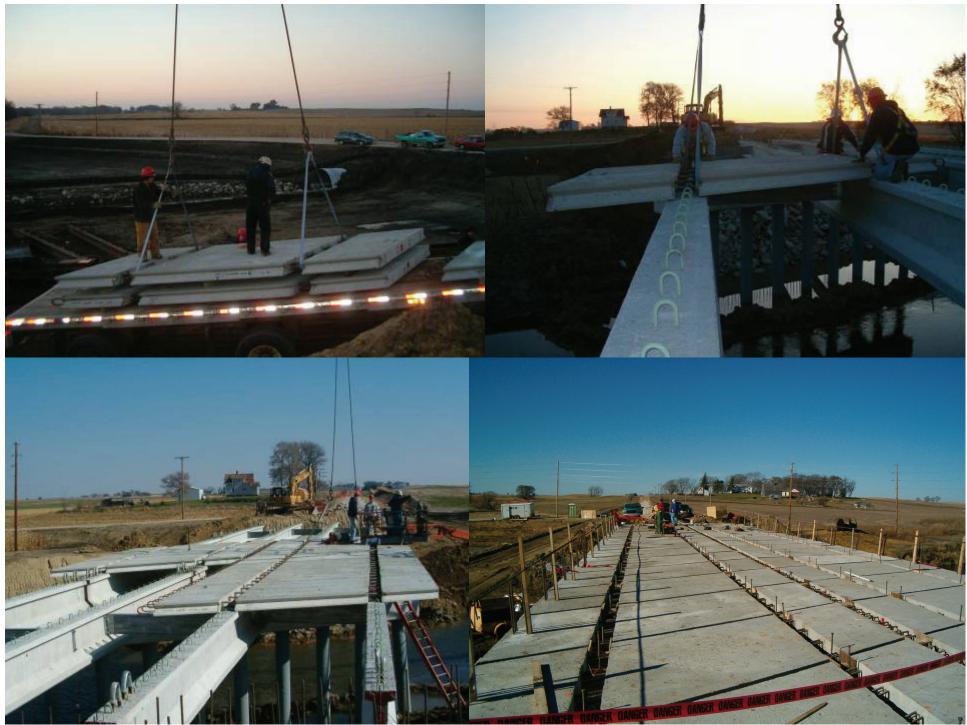
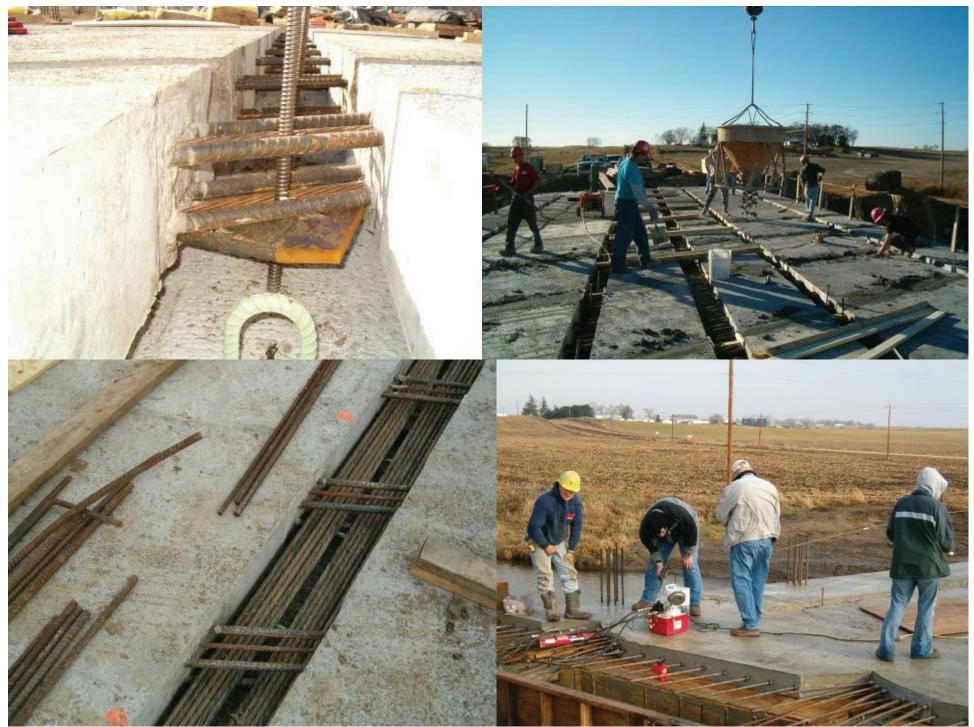
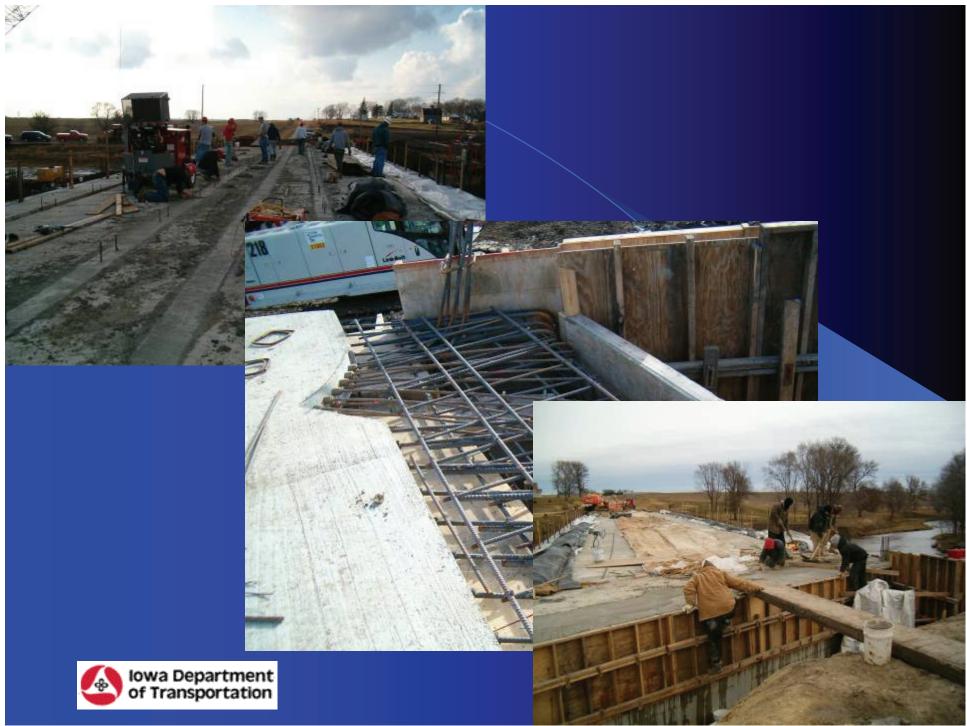
Deck Panel Erection

Setting Panels
Leveling Panels
Casting Transverse Joints
Post-Tensioning
Casting Longitudinal Joints and Abutment Diaphragms

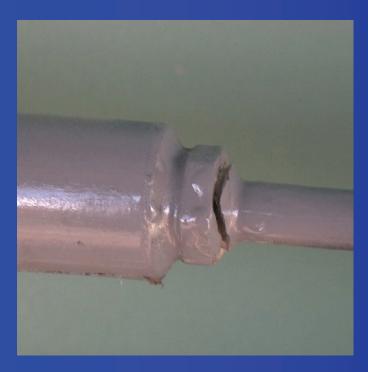
Slip of CFRP bar shortly after application of P-T force

Slip observed at the bar to steel tube anchor interface
Laboratory testing

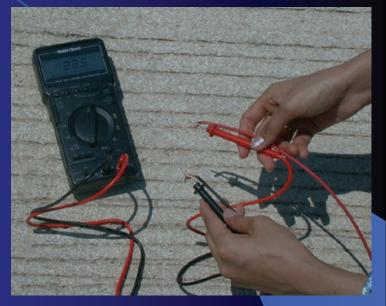
- Increase in electric potential and internal voltage with presence of active corrosion
- DC voltage and DC current measured with a Voltmeter

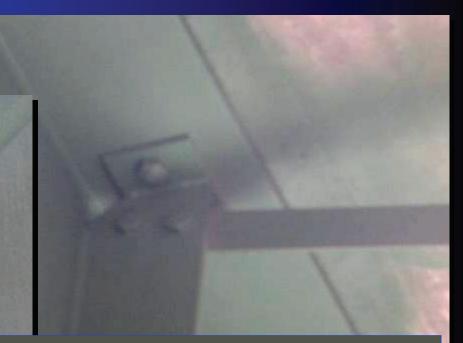
New Bridges -Weld or bolt to top flange Existing Bridges -Loosen Bolts in connection

- Loosen bolts in diaphragm/girder connections.
- Leave diaphragms in place to support girders.

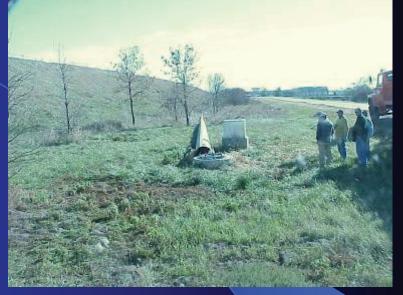
HML Support Base Failure - IA

- There have been several failures of support structures - likely due to fatigue
- There are deficiencies in the understanding of the impact of dynamic wind loadings on support structures
- Thus, a more representative and comprehensive design procedure for the AASHTO Specifications is needed

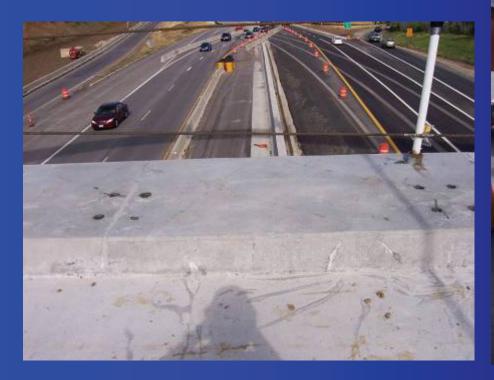
Concrete Panel Cracking Minor cracking of panels occurred during 2003 construction

- Unequal loading of hanger rods considered most likely cause of panel cracking
- ISU Bridge Engineering Center hired to perform monitoring during construction of 2005 bridges
- Goals of monitoring:
 - Short term eliminate panel overstresses during construction
 - Long term monitor redistribution of loads in hangers (concrete creep)

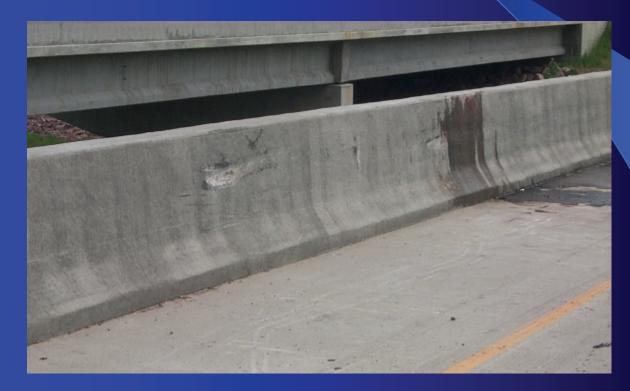
Bridge damage near Alton, Iowa resulting from a suspected vehicle impact: minor scratches and gouges < 1 /4" deep

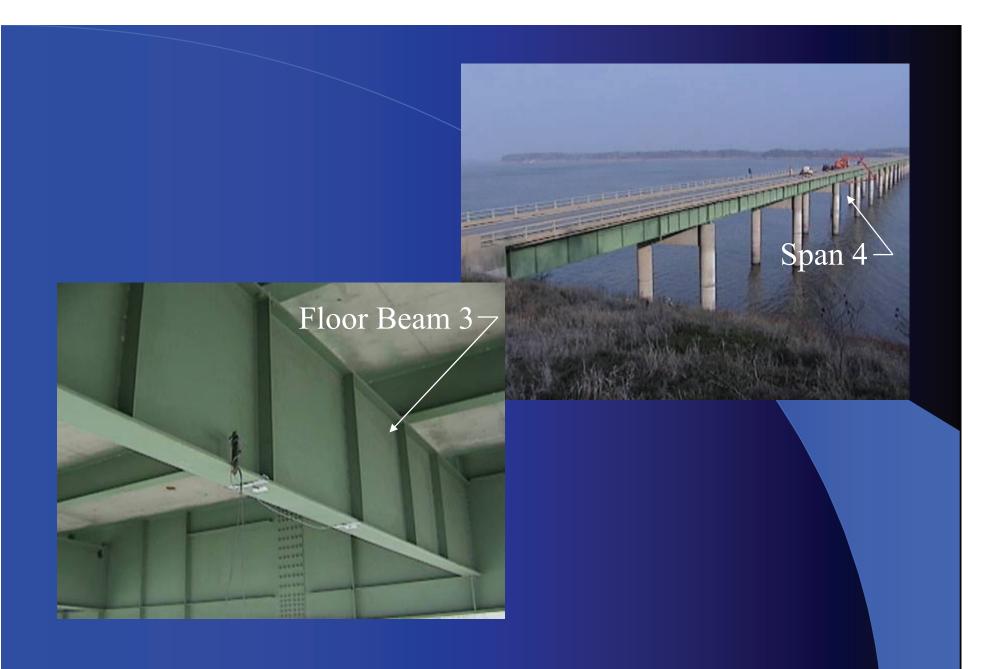
- Span 4 Floor Beams instrumented on bottom flanges
 - Floor Beam 2 (no plug welds)
 - strain gage under east stringer (global)
 - strain gage under mid-span (global)
 - Floor Beam 3 (plug welds)
 - Strain gage under east stringer (global)
 - Strain gage under mid-span (global)
 - Six gradient strain gages around typical plug welded hole (local)

View A Top of Bottom Flange
