Bolt Loosening Retrofit to Inhibit Fatigue Cracking in Steel Girder Bridges

> David Tarries, Brent M. Phares, Terry J. Wipf, Lowell Greimann, Douglas Wood Iowa State University

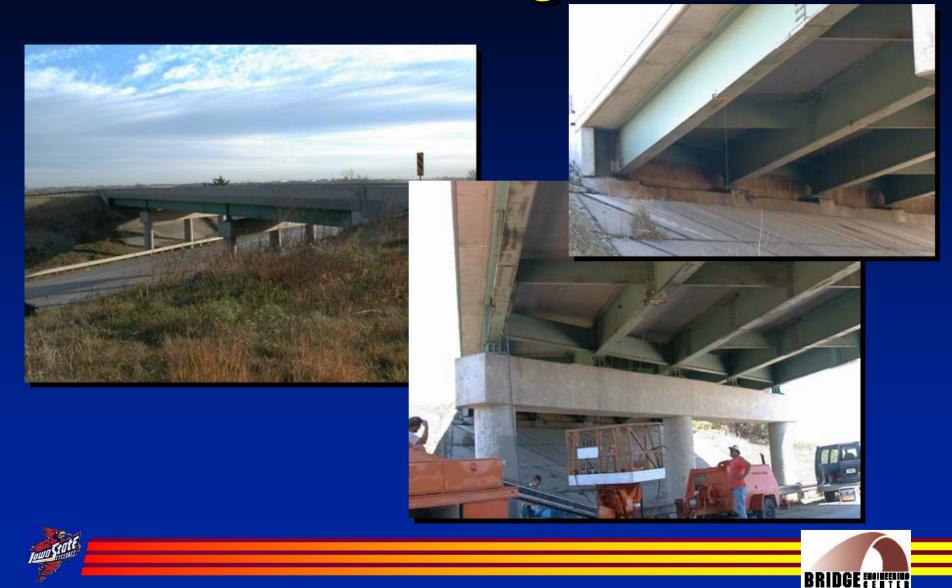
Interstate-35 Bridge

• Three span, five girder bridge with channel diaphragms.

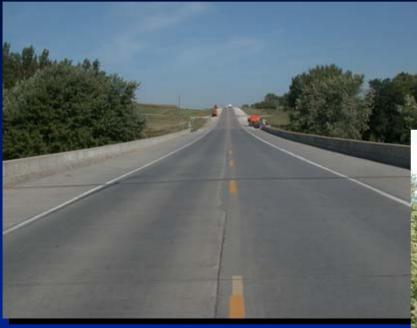
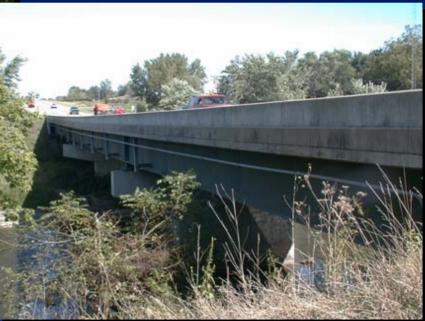
III Iowa-17 Bridge

- Three span, five girder bridge with Xtype cross-bracing.
- Long-term testing.

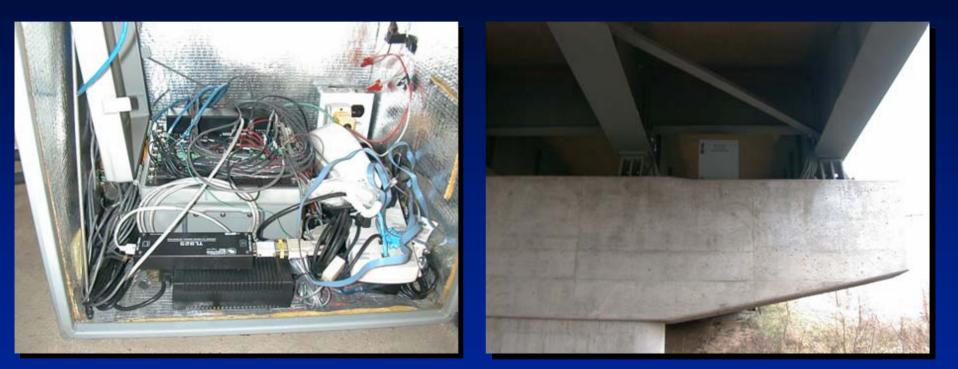
Health Monitoring System

- A Campbell Scientific CR 9000 was selected for remote monitoring of ambient truck traffic on the bridge.
- Strain gages, displacement transducers, and thermocouples were installed and connected to the CR 9000.

- 24 input channels.
- Connected to local power grid for continuous operation.
- Phone line installed to allow data acquisition and program adjustments.
- Trigger programmed into system to collect only data larger than a designated threshold set to register truck loads.
