**IOWA DOT**

**TRANSIT ASSET MANAGEMENT**

**GROUP PLAN**

September 30, 2022

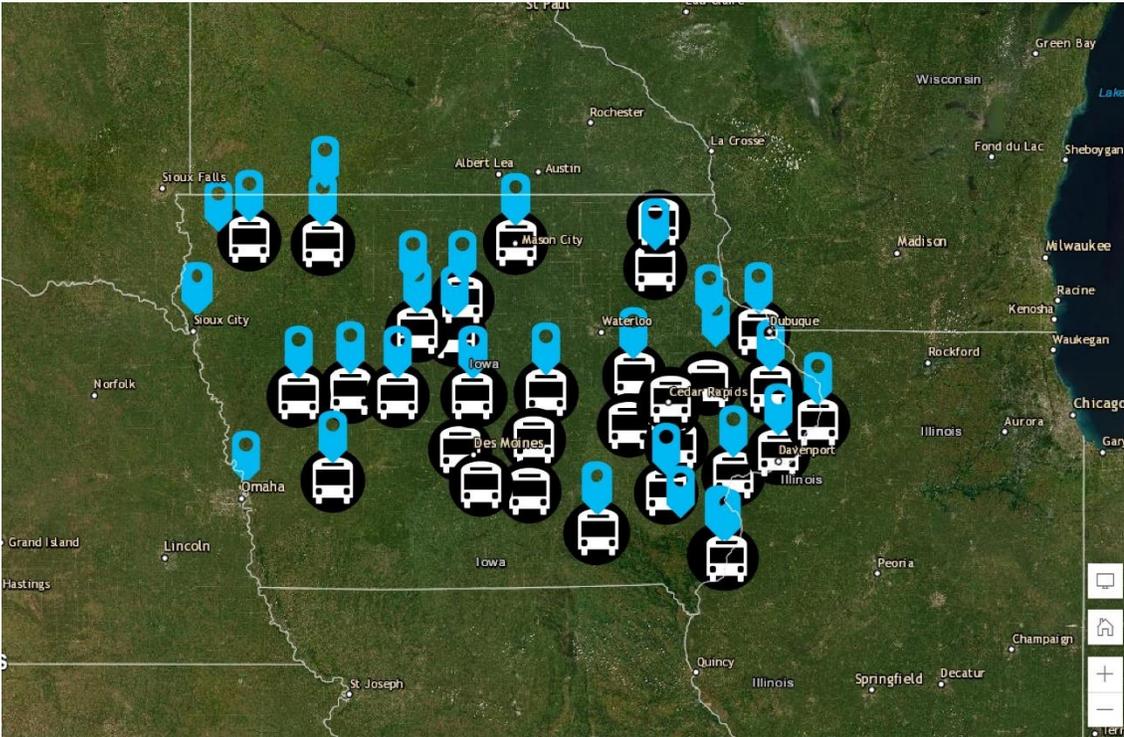
The assessor can choose a facility on the map to begin a new assessment:

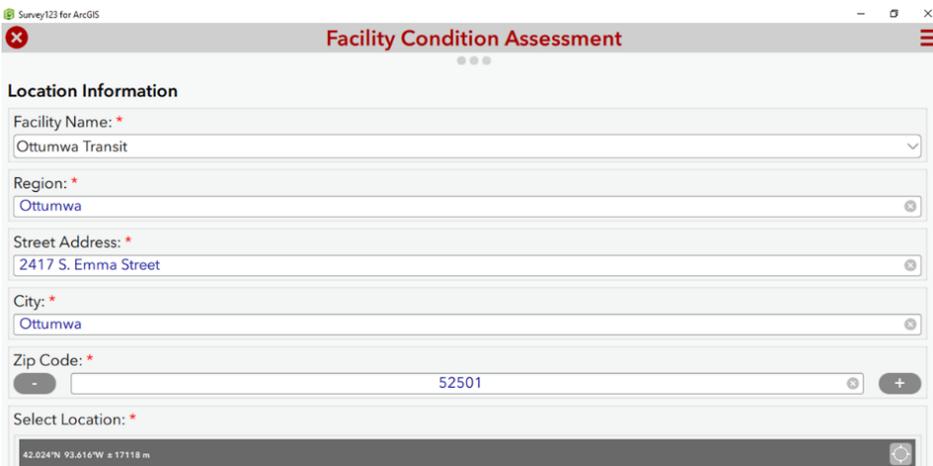
Iowa DOT staff also loaded basic information (e.g. geolocation, address, facility type, square footage) for all the relevant transit facilities across the State into the app to help expedite the condition assessment process.

The assessment date will auto-populate in the app. Each of the following nine subcomponent can be expanded to do the assessment.

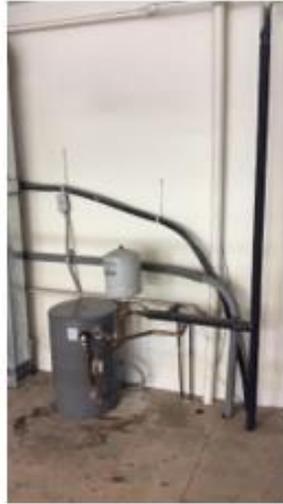
**Photo**

Piping in garage

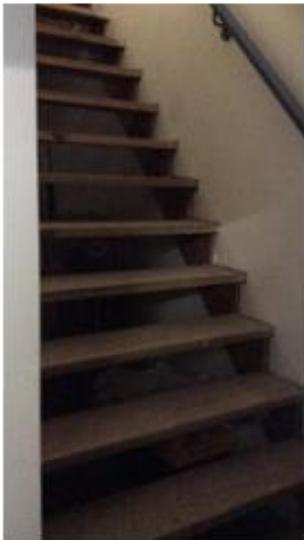
**Photo**

Interior - Stairs
