IOWA STATE
UNIVERSITY

**Institute for
Transportation**

March 2024 MPO-RPA Quarterly Meeting

Trail Management Program

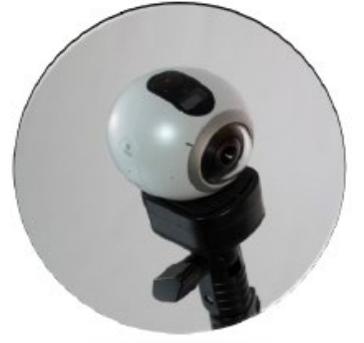
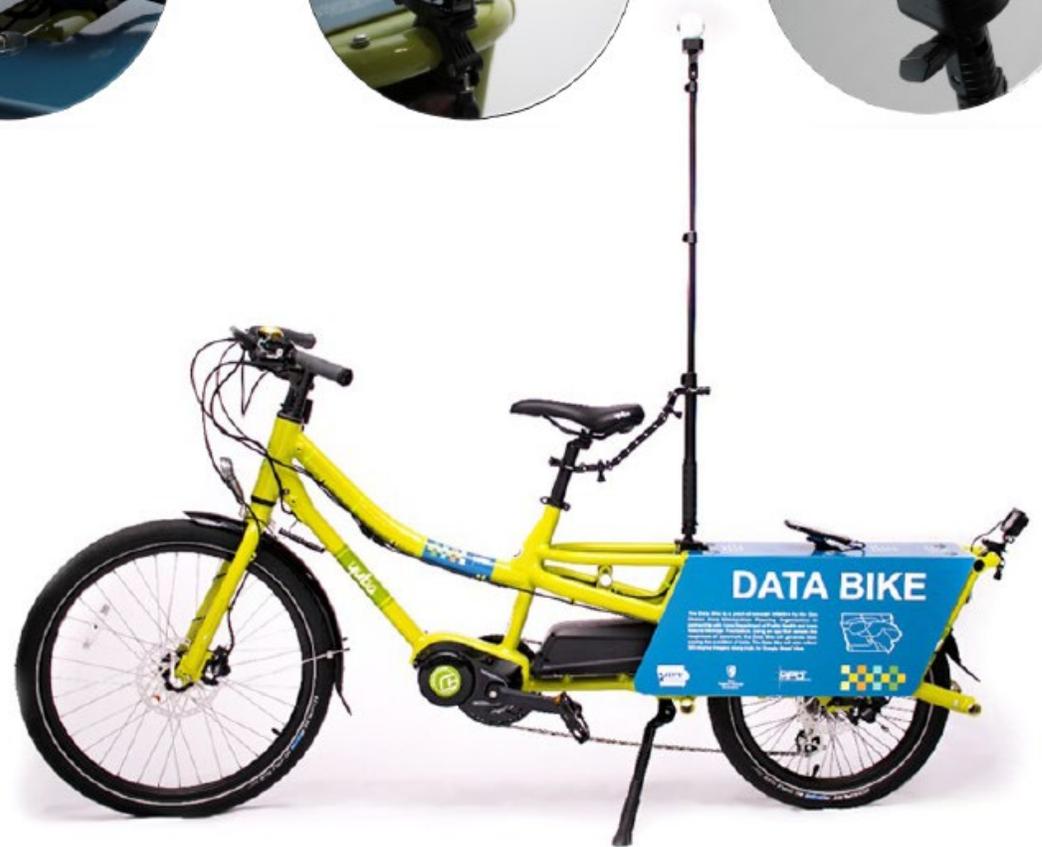
Iowa Data-bike

Develop a bike-based data collection vehicle to improve the efficiency of collecting data on the extensive trail network.

iPhone

Go Pro Camera

360 camera

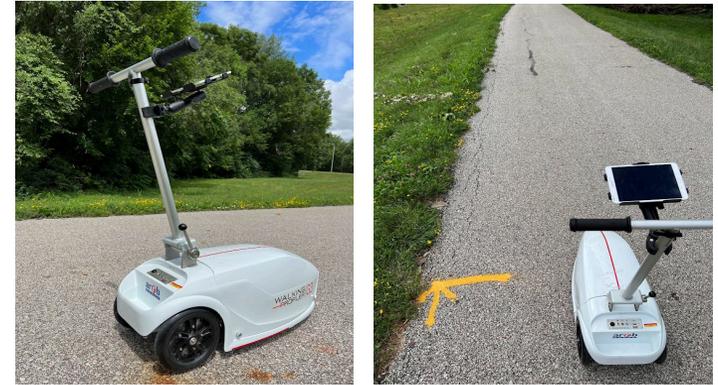
Reference Profiler

- Used as reference to the roughness measurements
 - To calibrate inertial profiler measurements.
- The device registers the longitudinal measuring profile of the pavement surface
 - by continuously lowered metal foot and for each measuring section reregisters the summed height in relation to the initial point.
- Measure surface roughness
 - Expected accuracy ~ **94-99%** depending on the walking speed

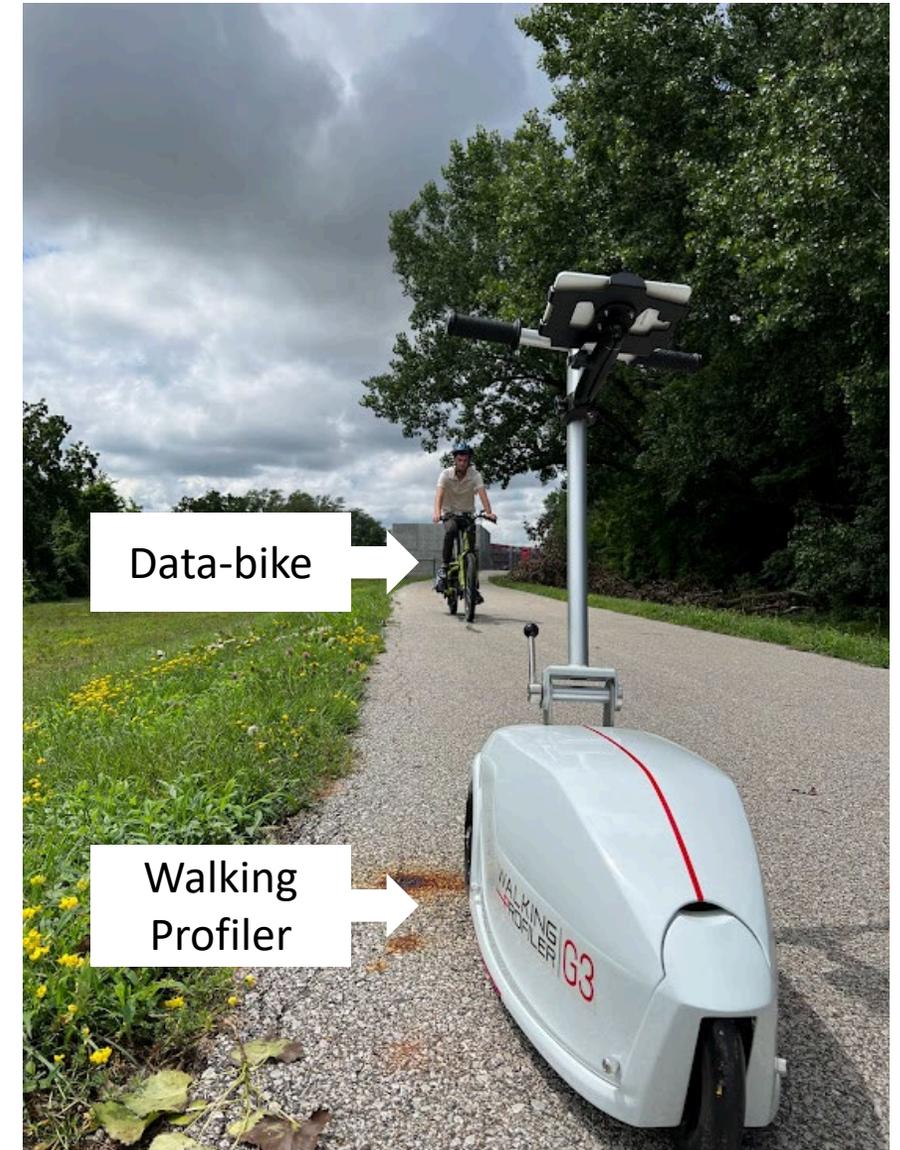
Control Sites Data Collection

- Both Walking profiler and Data-bike
- Data collected at right lane path
 - 04 Runs per segment (2 runs in each direction)
- Walking Profiler
 - Walking speed- 1.8 mph
 - 3 runs per segment
- Control sites were collected in 2022 & 2023.

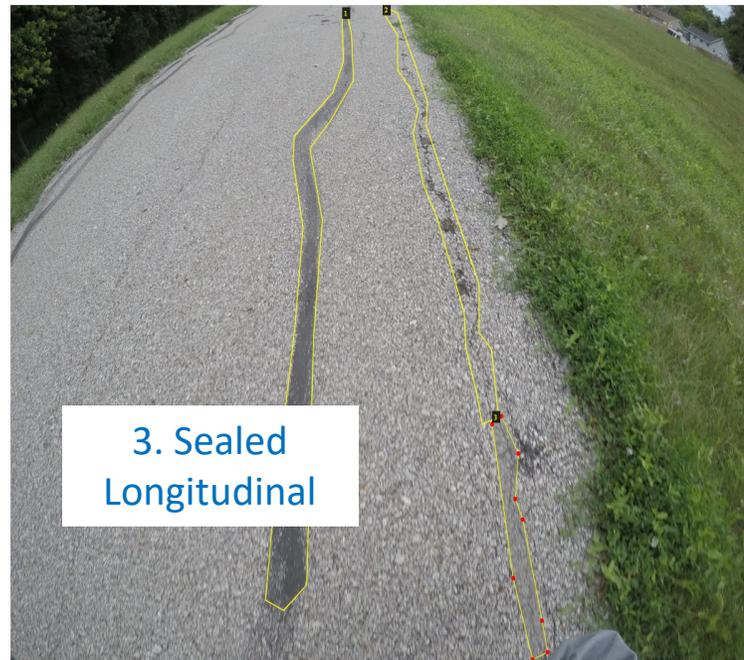
Proposed Trail Surface Distresses

- No standardized guidelines have been found in the literature to classify trail surface distresses.
- **Eight (08) distress classes were proposed.**

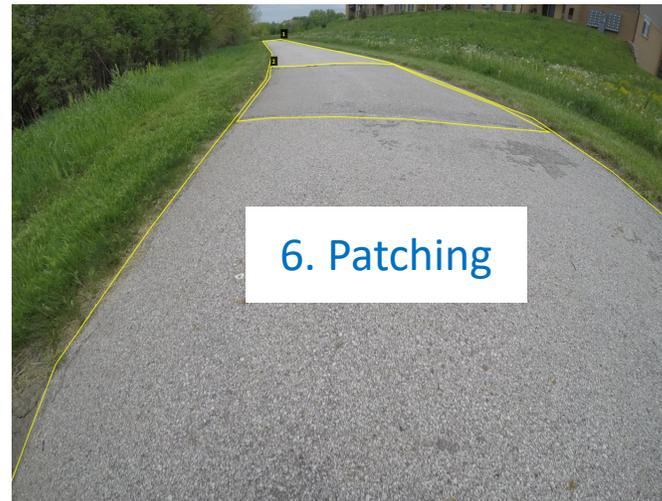
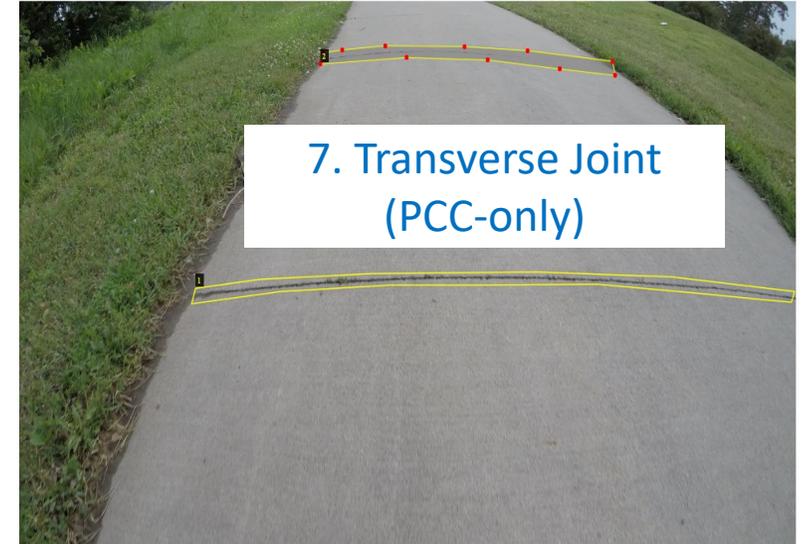
Proposed Trail Surface Distresses

- Some distresses are specific to surface type.

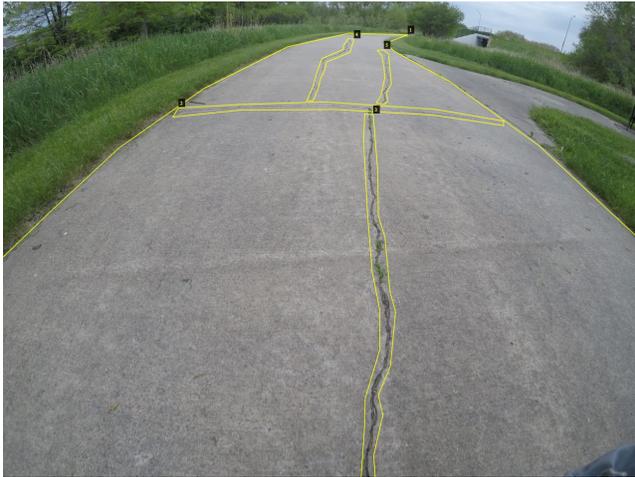
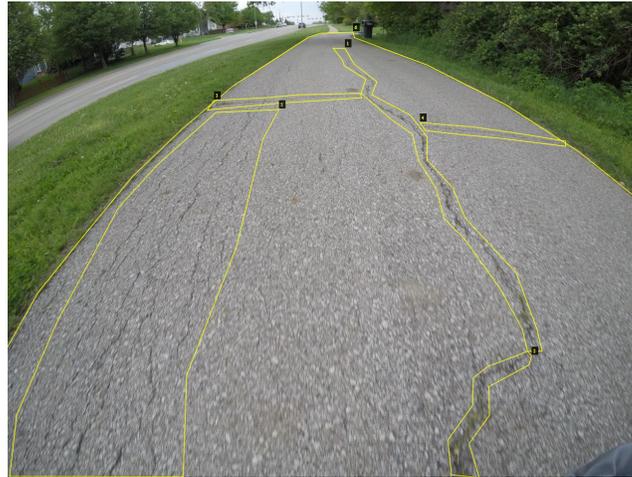
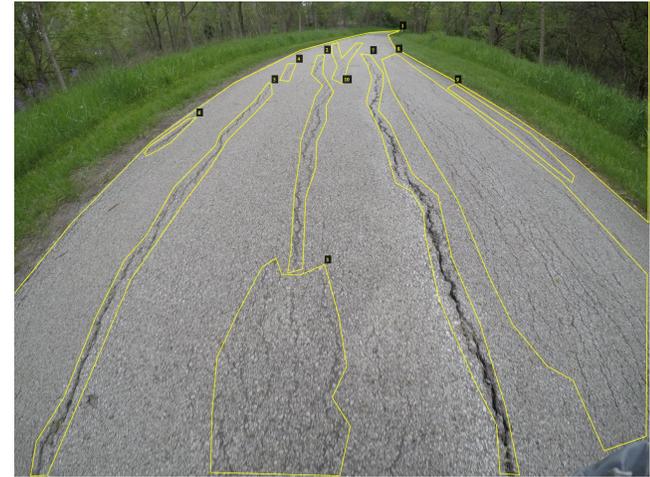
Data preparation

- Annotate with VGG Image Annotator
 - Draw polygon
 - Assign classes to each polygon

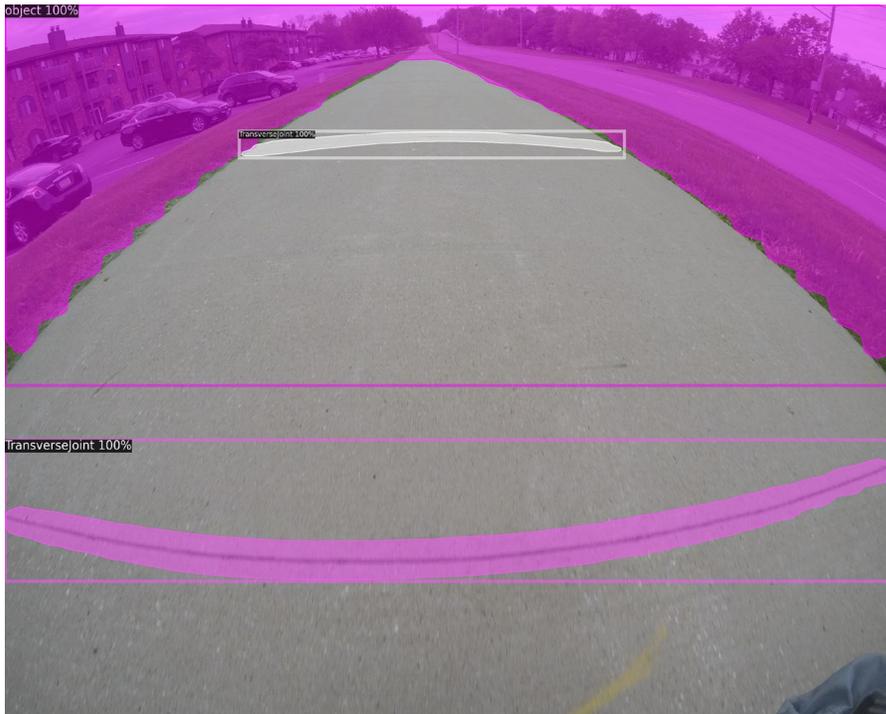
Model Prediction: PCC

- ✓ Performed robustly on concrete surfaces.
 - Transverse Joints (left)
 - Longitudinal cracks and Transverse joints (right)

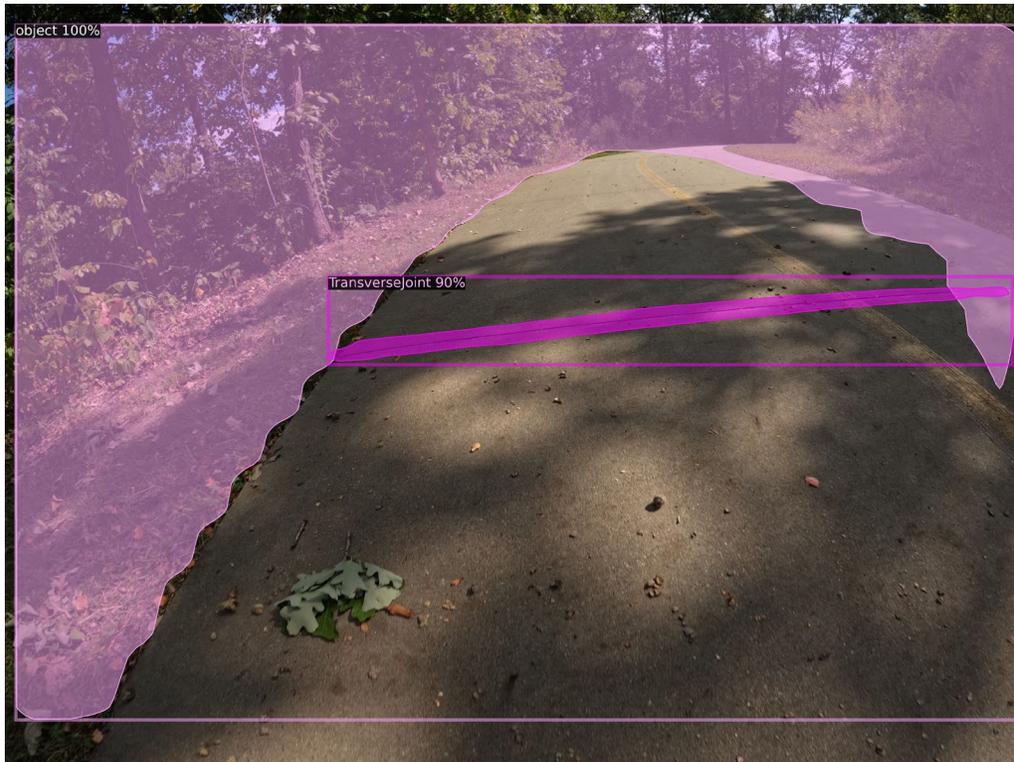
Model Prediction: PCC

- ✓ Detection performance on shadowed images
 - Transverse Joints (left)
 - Spalling (right)

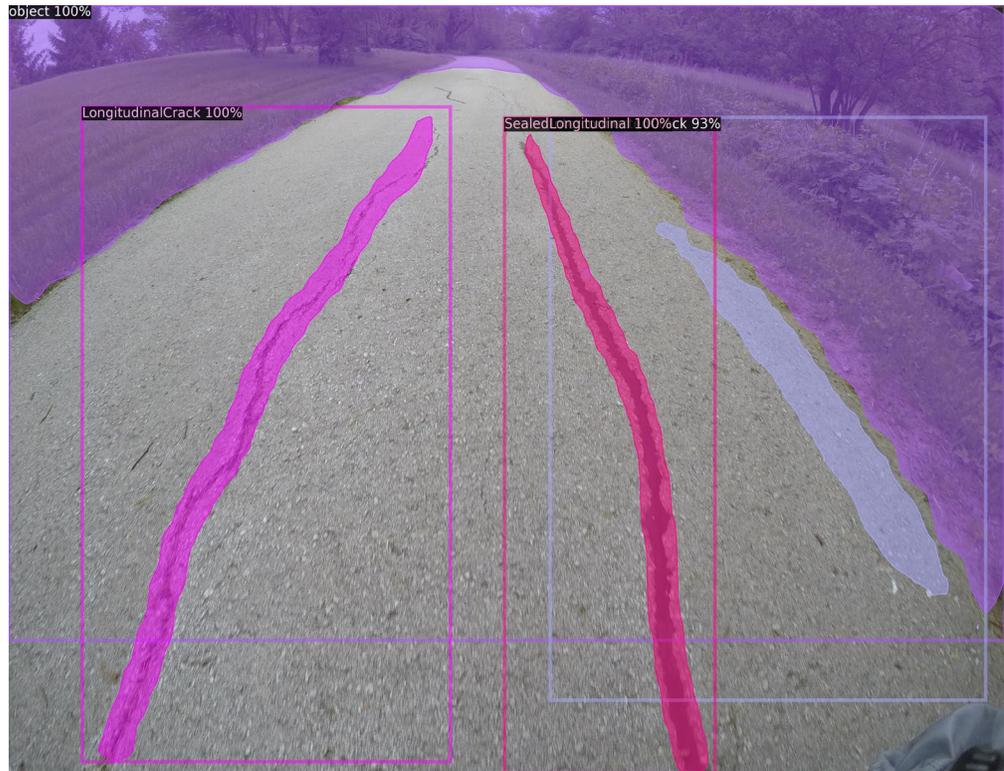
Model Predictions: AC

- ✓ Distinguishes the sealed longitudinal cracks that need no maintenance.

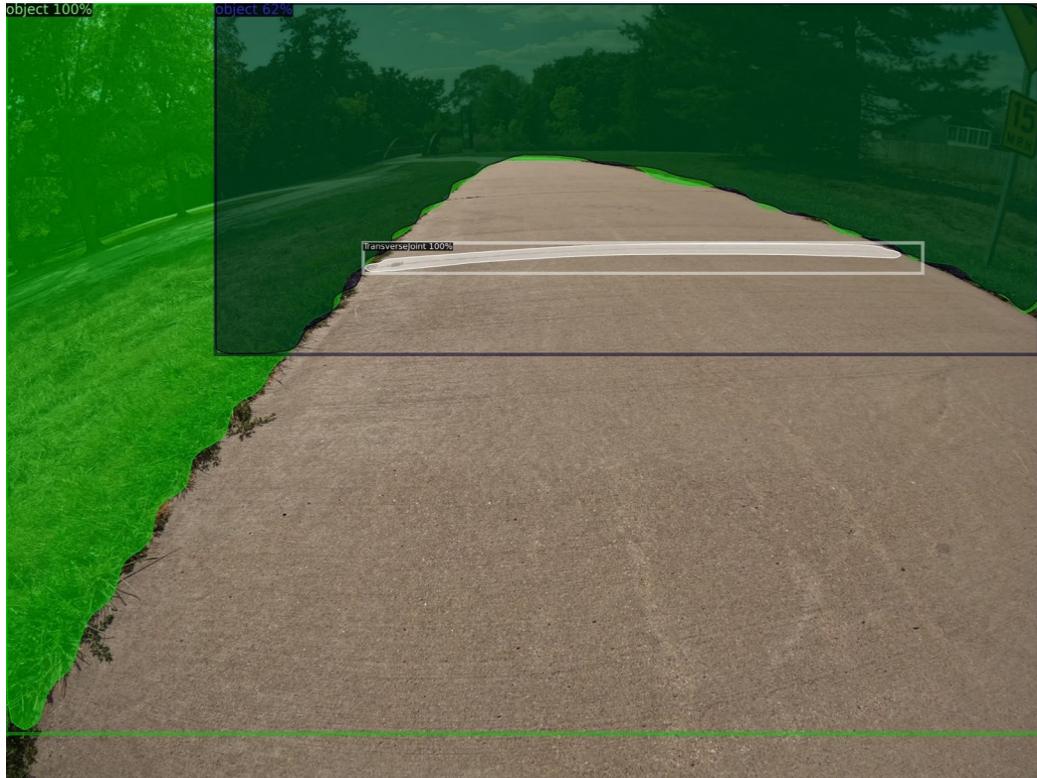
- Joints far-away not detected

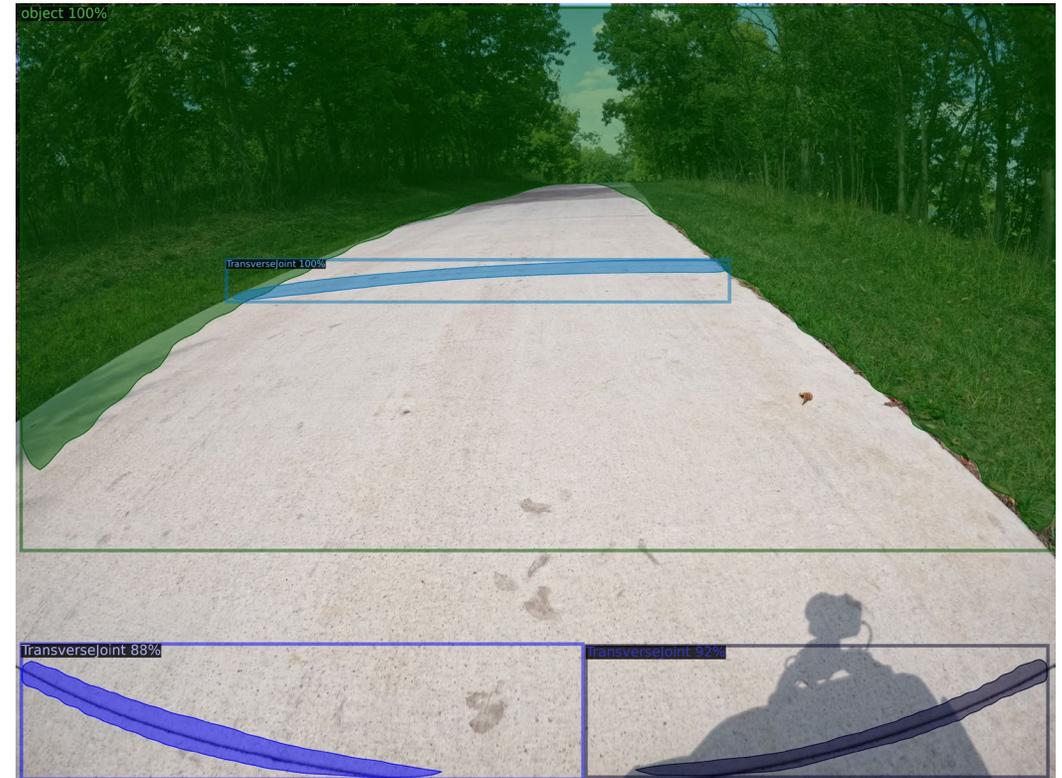
- Two joints detected due to image distortion
