Performance of an Accelerated Constructed Bridge: The 24th Street Bridge Council Bluffs, Iowa:

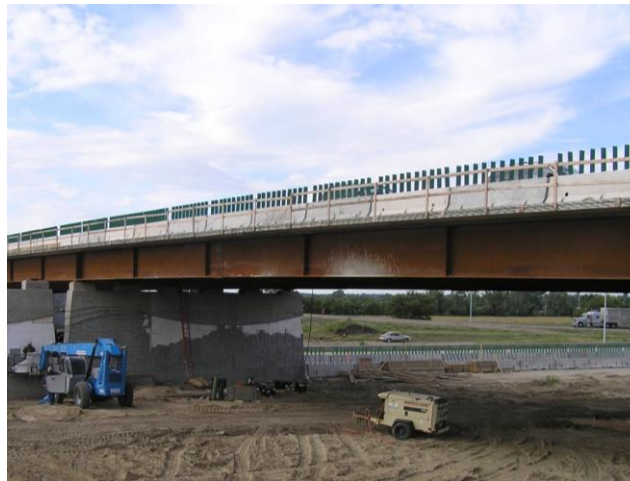
The superstructure of the 24th St. Bridge is comprised of 70 pre-stressed precast deck panels supported and composite with high performance steel plate girders. The completed bridge has 12 lines of girders spaced at 9 ft-0 in. on center. The girders have a depth of approximately 60 in. The flange thickness varies from 1 in. near the abutments to 2 in. at the pier. Each girder has two bolted field splices with a maximum girder length between splices of 121.75 ft. Figure 1. shows the pier and girders during Phase I construction.

Figure 1. Bridge Pier and Girders during Phase I construction

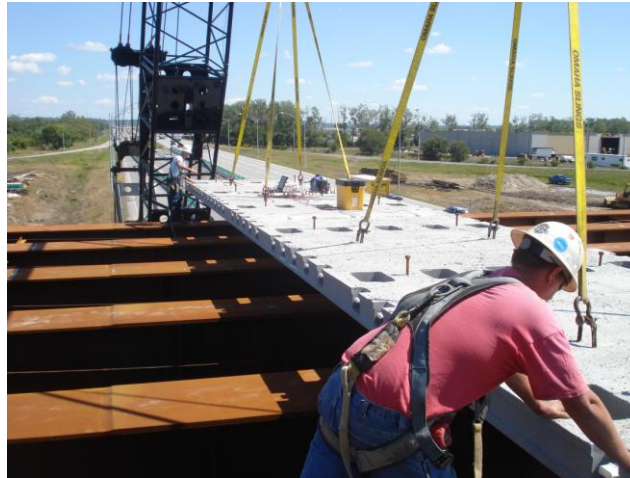
The deck panels were instrumented in the staging yard at the construction site. The panels were then lifted using 8 pick points. The panels were lifted with a crane and maneuvered into place as shown in Figure 4. The monitored panels had final placement over the pier during the phase II construction. Each panel took about 20 minutes (1200 seconds) to place. The strain gauges continuously recorded data during the 20 minutes

Figure 4. Final maneuvering and placement of precast deck panel placement

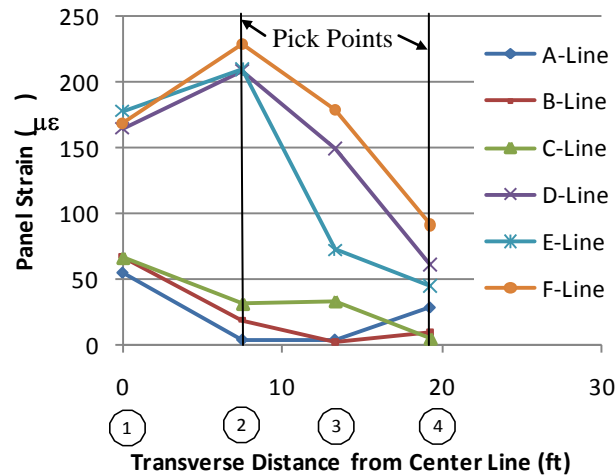
Strain profiles along gridlines A, B, C, D, E, and F are shown in Figure 5. when the strain of the panel is approximately maximum. At location zero of Panel No. 1 (i.e., A, B, and C), which is gridline 1 and center line of the panel, the strain is at its maximum of approximately $68 \mu\epsilon$. In general, the strain decreases as it moves away from the center of the panels. The strain at and between the pick points have very little consistency between gridlines. The strain profile for Panel No. 2 (i.e. D, E, and F) starts at approximately $170 \mu\epsilon$ then increases to the pick point at gridline 2. The maximum strain of $230 \mu\epsilon$ occurred at location F2. The strain then decreases to gridline to 4.

Figure 5. Strain profile along gridlines Panel No. 1 and 2

1. All corrosion electrodes indicate that no corrosion is taking place in the strands.
2. During deck panel placement the peak strain in the panel was 230 $\mu\epsilon$ located at F2, which was near a pick point location.
3. The maximum north span deflection was observed to be -0.41 in., which corresponds to a span to deflection ration of L/5120.

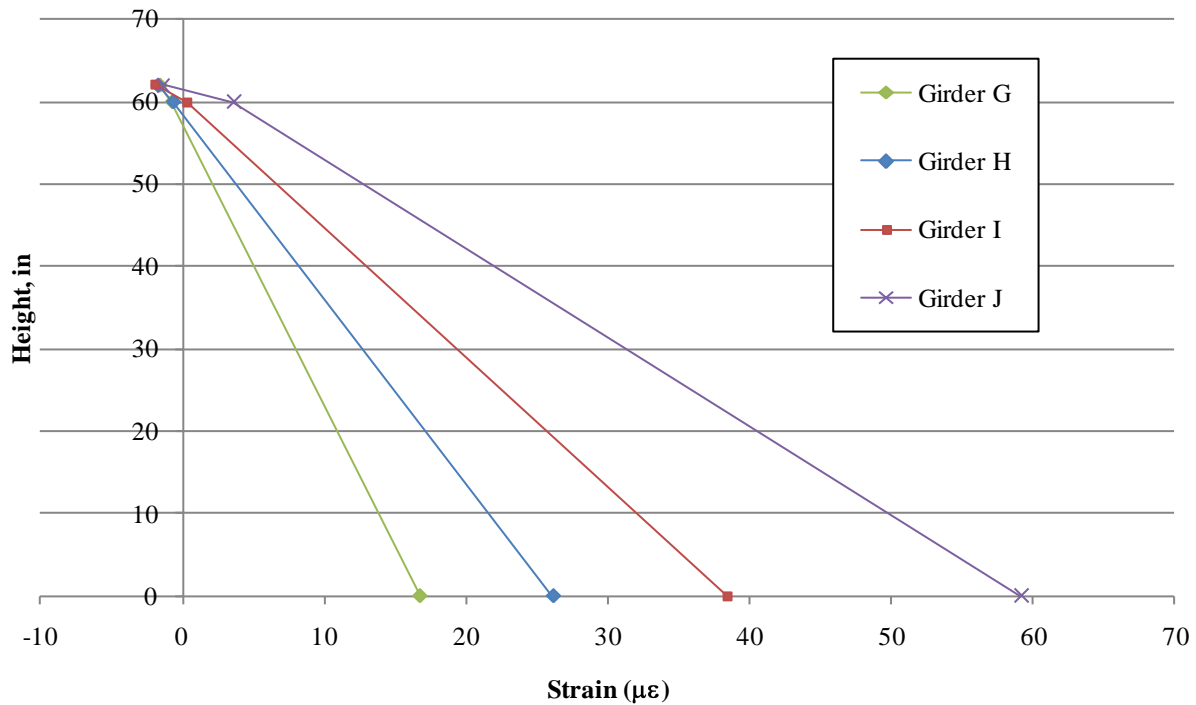
The girders with strain configuration #3 were used to estimate the location of the neutral axis during testing. Figure 13 shows the strain profile for girder G through J for LC2. The steel girder total depth was 61 in. with 1 in. flanges top and bottom. A girder haunch existed between the precast panel and girder of between $\frac{1}{2}$ in. to 1 in. The location of the neutral axis during testing was approximately 58 in. to 61 in. from the bottom of the girder. The neutral axis location appears to be located near the top of the steel girder but not within the grouted haunch region or in the precast slab. In addition, the top flange strain and the strain on the bottom of the slab are very similar indicating composite action between the girder and slab is taking place.

Figure 13. Strain Depth Profile for Girders G through J, Load Case 2

4. The maximum strain of $+66 \mu\epsilon$ occurred at the midspan of girder L during LC1. The maximum strain range of $88 \mu\epsilon$ occurred at the same location and load case.
5. The maximum strain range at the pier and abutment bottom flange locations were $19 \mu\epsilon$ and $18 \mu\epsilon$ respectively.
6. The closure pour differential movement was less than 0.04 in.
7. A maximum load fraction of 0.25 was seen at girder K during LC1.
8. The largest load distribution factor was found at girder H with a value of 0.63. The lowest load distribution factor of 0.30 occurred at girder A.
9. The load distribution factors obtained from field testing were within AASHTO LRFD load distribution requirements.
10. The neutral axis lies near the top of the steel girder but not in the haunch or deck slab.
